SERVICE BULLETIN	
Service Bulletin #	AASB-1-1-2011
Superseded Bulletin #	n/a
Issue Date	1-31-2011
Effective Date	1-31-2011
Limitations for Completion	Next scheduled inspection
Make & Model Affected	Lightning LS-1 SLSA &ELSA
	SN78 thru 107
Page 1 of 3

1. Applicability: Lightning LS-1 SLSA or ELSA aircraft in the effected serial range of SN87 thru SN107.

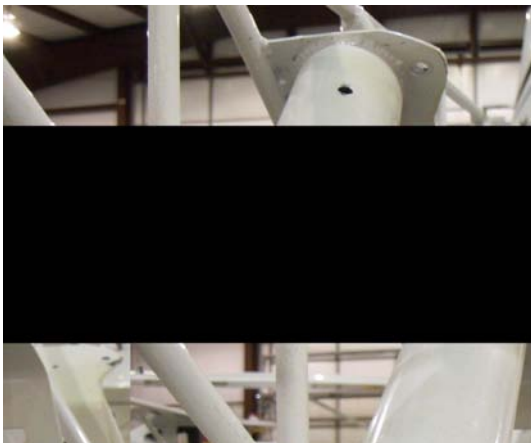
Figure 1: deformation of rear 1/2" tube box V1

Refer to figure 1: The lowest and most aft tube adjacent to the gear plate must be inspected. This tube is about ½” in diameter and should be flat with no upwards bowing to it. If deformed upwards it will be the greatest at the outboard end of the lower socket plate. Use a straight edge on the tube to determine if it is bent. Any deformation in this tube is cause for replacement.

If it is found that upon inspection the rear spar-box has deformed, section 4 of this SB must be complied with, within the next 25 hours of service. Arion Aircraft LLC must be notified before any service is to take place.

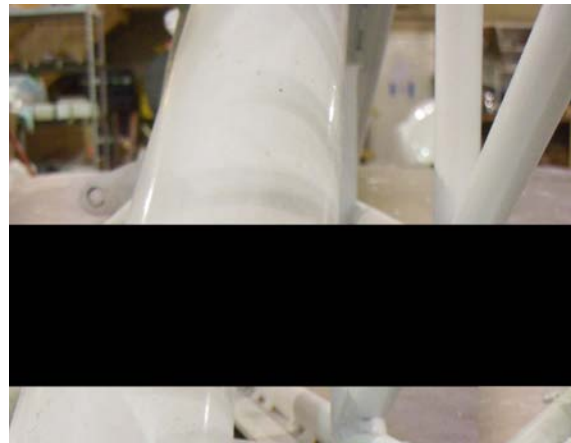
Figure 2: deformation of lower socket plate V1

Refer to figure 2: The lower socket plate must be inspected as well. This plate may have up to 1/16” flex upwards and be with in serviceable tolerance. However should more than that be found upon inspection the box should be replaced. Check by using a short straight edge set between the spar box tubes across the plate. Measure the deflection if any.

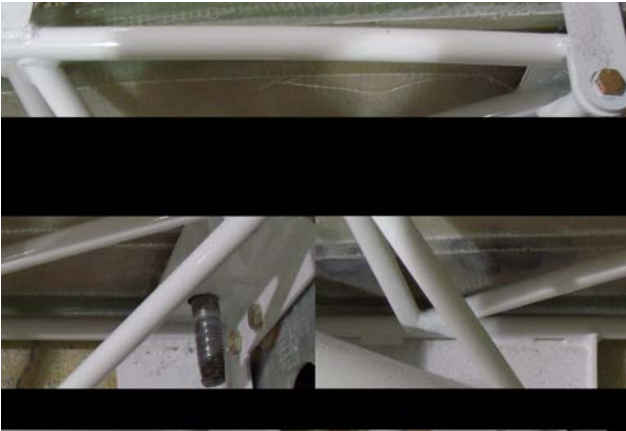
Figure 3: Compression tubes added V2

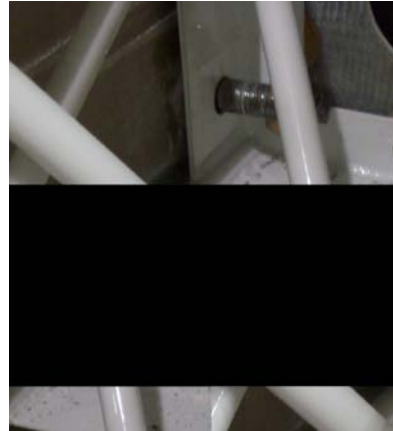
Figure 4: Gusset added to lower plate V2
