# Property Inspection Report

**Property Address:**  
65 West 1st Street  
Inspectionville NJ 76666

**Terra Home Inspections LLC**

<b>Date:</b> 9/16/2015	<b>Time:</b> 10:00am	<b>Report ID:</b> 20150288
<b>Property:</b> 65 West 1st Street Inspectionville NJ 76666	<b>Customer:</b> Tony Inspection	<b>Real Estate Professional:</b> Sally Realtor

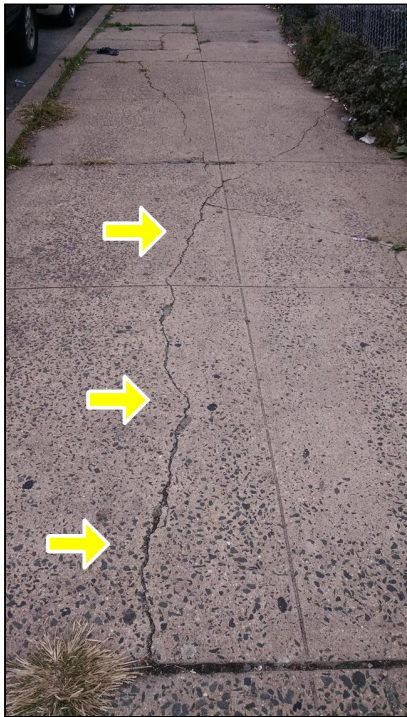
1.1 Item 1(Picture)

1.1 The front sidewalk as well as the front and right side walkways all have numerous cracks present. If the walkways and sidewalk are not repaired, further deterioration could occur. Recommend further evaluation for repairs by a qualified, licensed contractor.

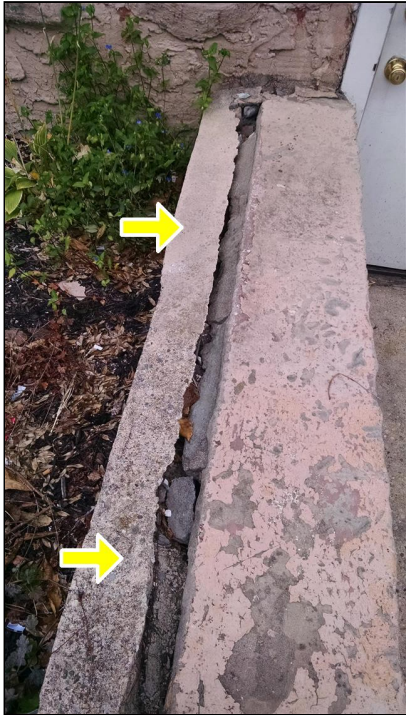
1.4 Item 1(Picture)

1.4 The front masonry retaining wall is extremely deteriorated. If not repaired, further deterioration of the retaining wall could occur. Recommend further evaluation for repairs by a qualified, licensed contractor.

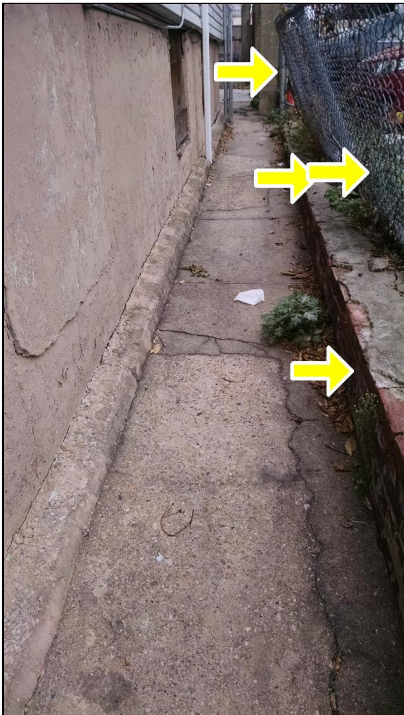
1.5 The retaining wall and the chain link fencing on the right side of the house is in need of repairs. The retraining wall is deteriorating and the fencing is damaged and leaning. Part of this may or may not be on your property. I would consult with your agent and also look on a survey of the property for reference. Recommend further evaluation for repairs if this is part on your property.

1.5 Item 1(Picture) Right side retaining wall and fencing is in need of repairs

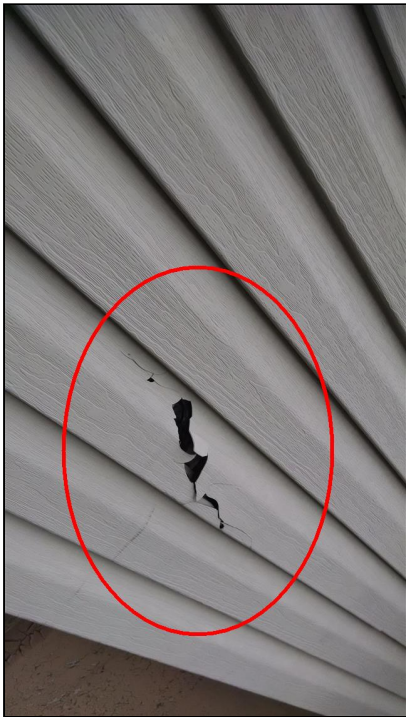
2.0 Item 1(Picture)

**2.0** There were numerous small sections of vinyl siding that appeared to be damaged or missing on the front, right side and rear of the house. Further damage to the siding and deterioration of the structure behind the siding could occur if the needed repairs are not completed. In addition, in the rear where the vinyl siding is missing, you can see what appeared to be 3 different types of exterior cladding that was installed on the house over the years. The middle exterior cladding material is called fiber cement siding may contain asbestos fibers. Asbestos cement is a composite material consisting of Portland cement reinforced with asbestos fibers. Asbestos fiber cement siding has been known to have been used on homes built from the 1920's until the early 1970's. In 1973, the EPA banned the use of asbestos in the manufacturing of building products. Asbestos materials are considered safe by the EPA if they are not disturbed, torn, ripped, or damaged. No torn, ripped, or damaged fiber cement siding materials were observed. All of the suspect fiber cement siding except where it is visible in the rear and in the rear basement stairwell appears to be covered up by the vinyl siding that is on the house currently. Recommend further evaluation of all of the exterior siding on the house for repairs by a qualified, licensed contractor. If client has any concerns regarding asbestos materials, an asbestos testing lab should be consulted for further review to ensure safety prior to closing.

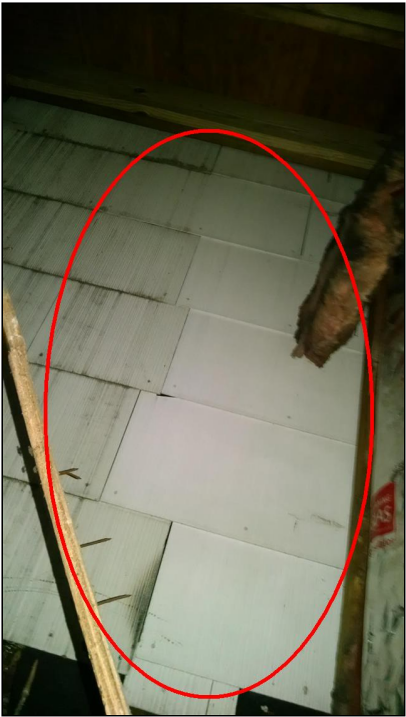
2.0 Item 5(Picture) Fiber cement siding visible in rear basement stairwell

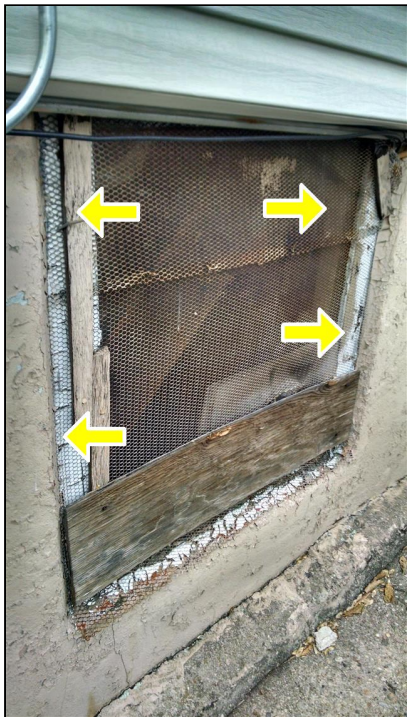
2.2 Item 2(Picture)

2.2 (2) The paint on numerous areas of the wood trim on the exterior of the house (doors, windows, etc.) as well as the some of the door jambs was peeling leaving the wood exposed to the elements. If not repaired, moisture damage and wood rot could occur. Recommend further evaluation of all of these areas for repairs by a qualified, licensed contractor.

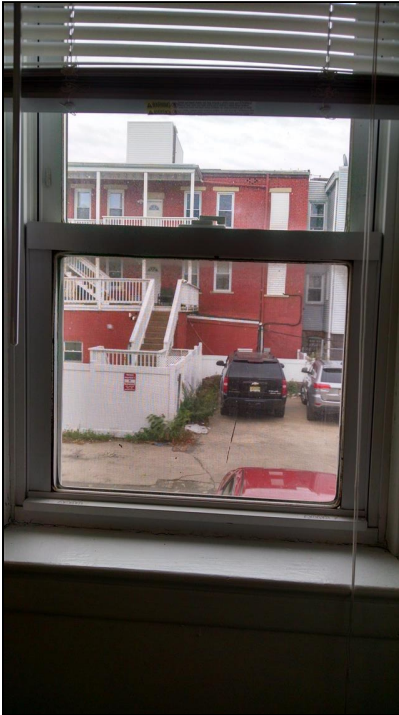
2.3 Item 1(Picture)

**2.3** The window in the 1st floor bathroom was not functioning properly. The bottom window sash would slam down when you opened it. This is a safety issue and should be repaired. Recommend further evaluation for repairs by a licensed contractor.

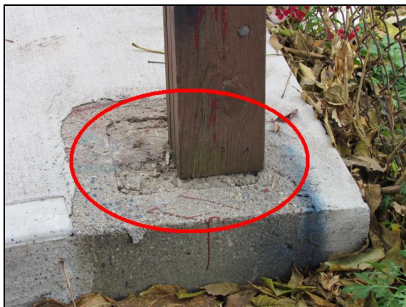
2.8 Item 1(Picture)

2.8 Numerous issues were observed pertaining to the rear deck...to name a few- 1) there are no support post to footing mechanical connectors 2) there are no support post to beam mechanical connectors 3) there are no beam to joist mechanical connectors 4) the entire guardrail assembly is extremely loose, not properly mechanically attached to the primary structure of the house and deck and is just overall poorly built 5) the main vertical support posts are made up of 3 framing member lag bolted together (these should be solid 6"x6" posts) 6) the two support posts on the right are not plum and are leaning 7) there are no lag bolts attaching the ledger boards to the primary structure of the house 8) no portion of a deck should be attached to any cantilevered portion of the house 9) there were two splices in the main support beams that did not have any support posts under them (any splices should have a support post underneath it). These are all safety and structural issues and with the guardrail being so loose, I would recommend not using this deck until the entire deck is further evaluated by a qualified, licensed contractor and the needed repairs are completed.

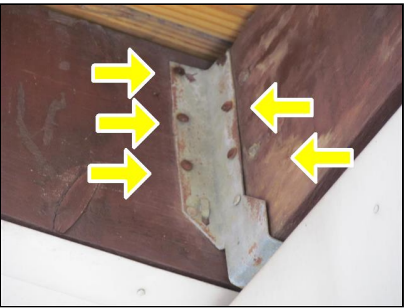
2.8 Item 11(Picture) Rusted nails

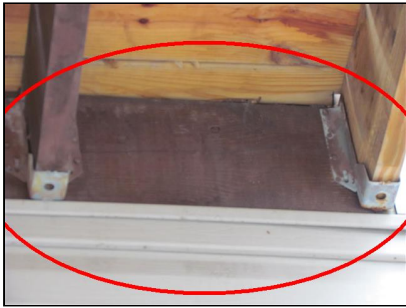
2.8 Item 12(Picture) No lag bolts

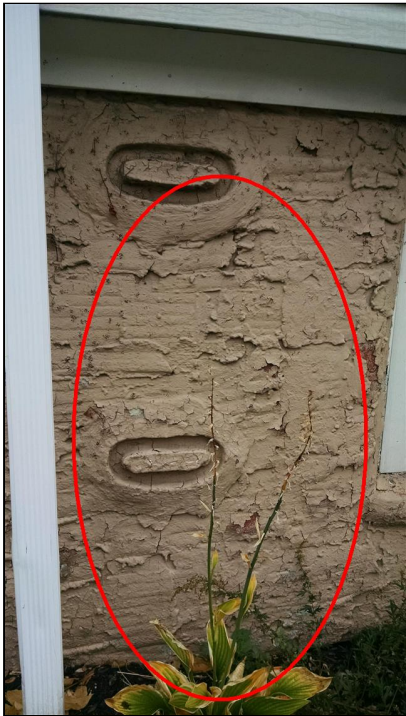
4.0 (1) Observed on the interior and exterior masonry foundation wall surfaces, there were several vertical cracks visible and the paint was peeling off of these surfaces in numerous areas. In addition, the parging on several areas of the interior and exterior foundation walls was cracked/missing/flaking off, portions of the basement concrete floor were cracked and portions of the brick foundation in the rear was deteriorated. Further deterioration of the foundation could occur if the needed repairs are not completed. Recommend further evaluation of the entire foundation (interior and exterior) for repairs by a qualified, licensed contractor.

4.0 Item 1(Picture) Peeling paint front

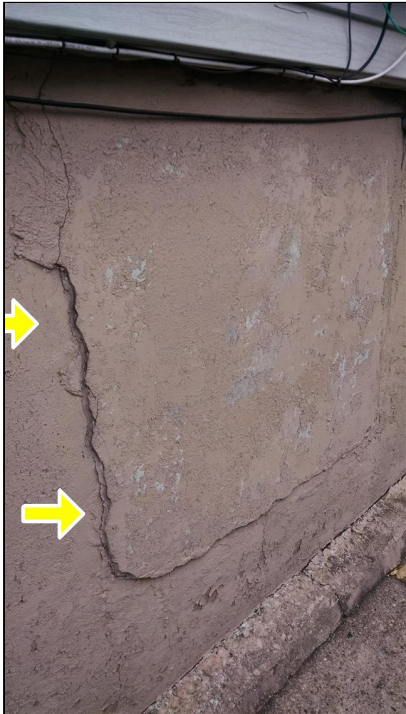
4.0 Item 4(Picture) Cracks on right side

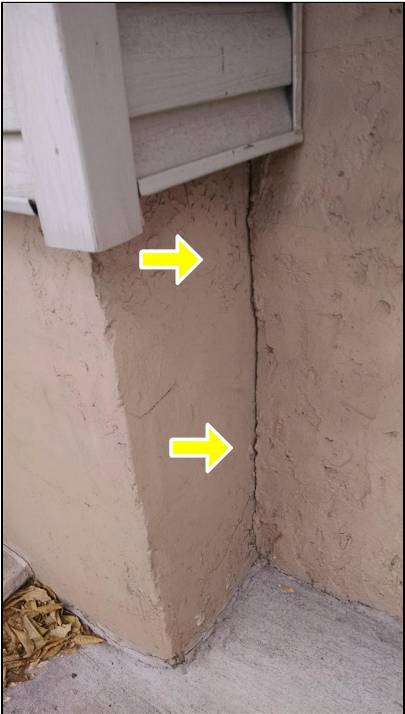
4.0 Item 5(Picture) Crack in rear

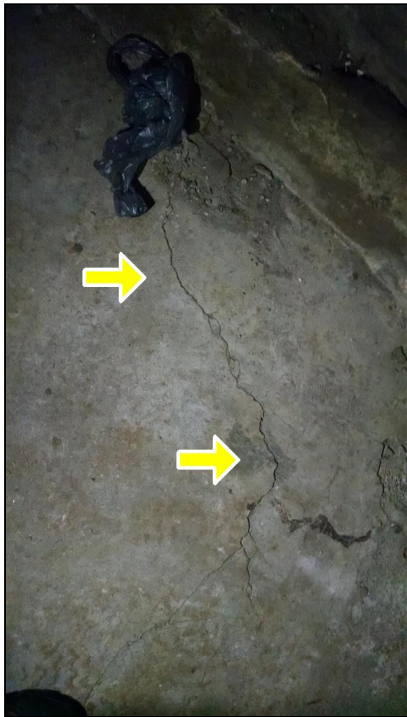
4.0 Item 13(Picture) Cracks in basement floor

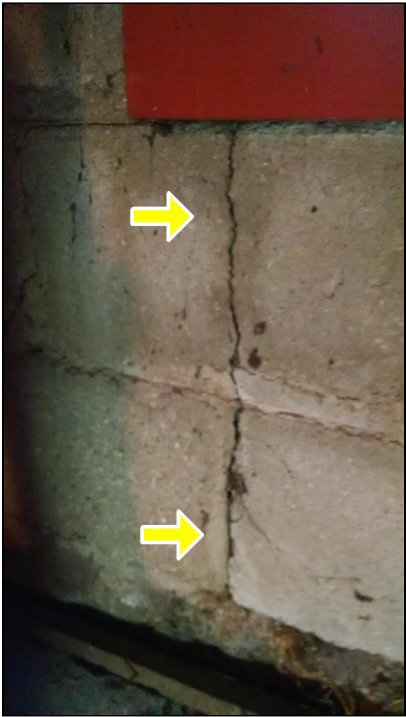
4.0 Item 17(Picture) Crack-interior right side basement wall

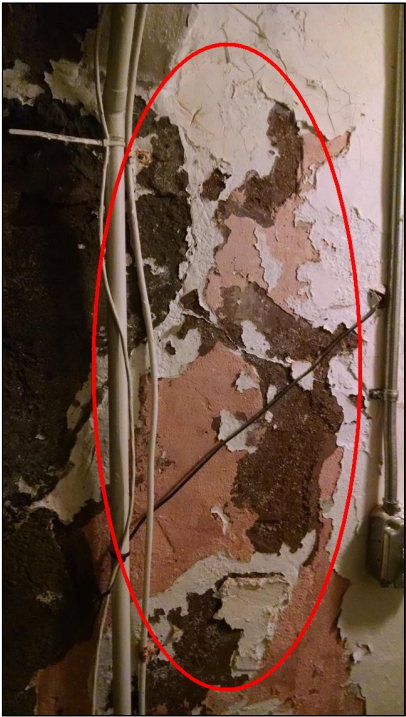
4.0 Item 18(Picture) Peeling paint and parging deteriorated in front basement

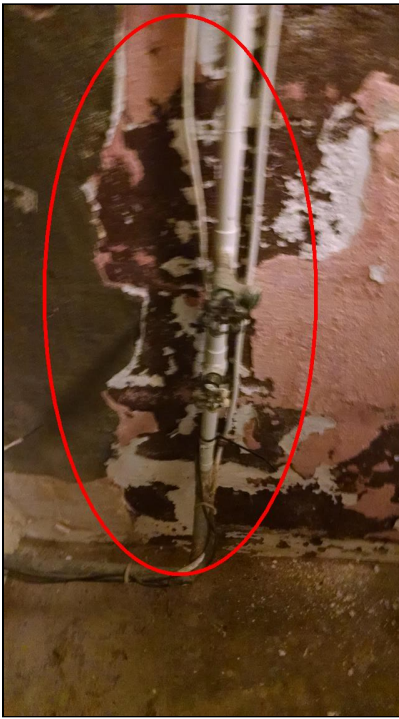
4.0 Item 19(Picture) Peeling paint and parging deteriorated in front basement

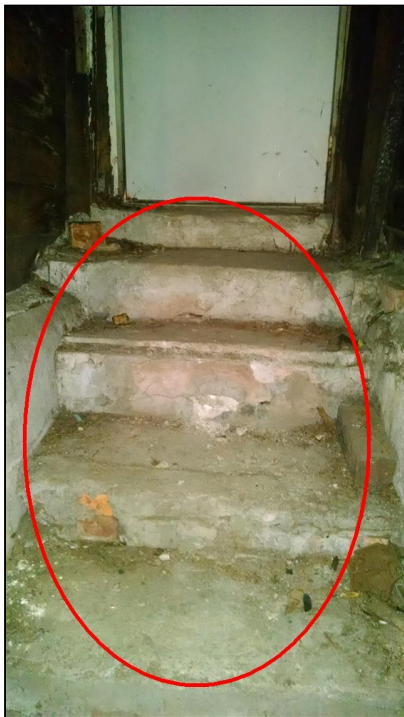
4.0 Item 20(Picture)

**4.0 (2)** The masonry staircase in the rear of the basement for the exterior rear door is severely deteriorated. Further deterioration of this staircase could occur if the needed repairs are not completed as well as this being a safety issue. Recommend further evaluation of the entire foundation (interior and exterior) for repairs by a qualified, licensed contractor.

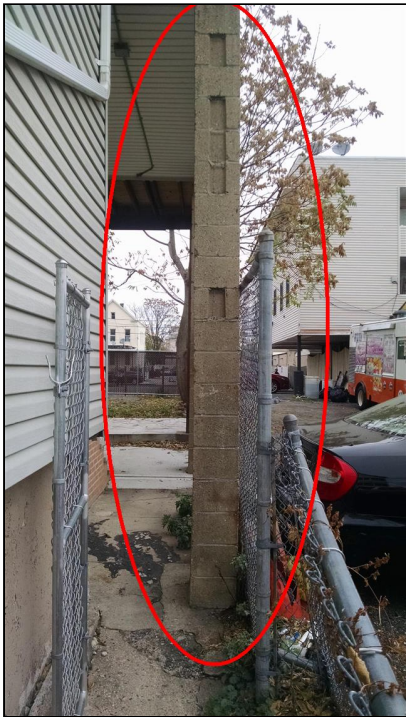
4.1 Item 1(Picture)

**4.1** The front masonry support column supporting the cantilevered portion of the 2nd floor in the rear has a slight bow in the middle of it. Portions of it are not plumb and there is a crack in the mortar joint between the 4th and 5th blocks at the bottom. This is a safety concern as there may be some structural issues within the house that are causing the column to bow. In addition, just to bring this to your attention, there is no protection in place for these columns from the cars parking in the parking lot on the property to the right of the house. Due to the fire damaged structure that is still in place, the sloping floors and this issue, I would recommend further evaluation of the entire structure of the house for repairs by a qualified, licensed structural engineer.

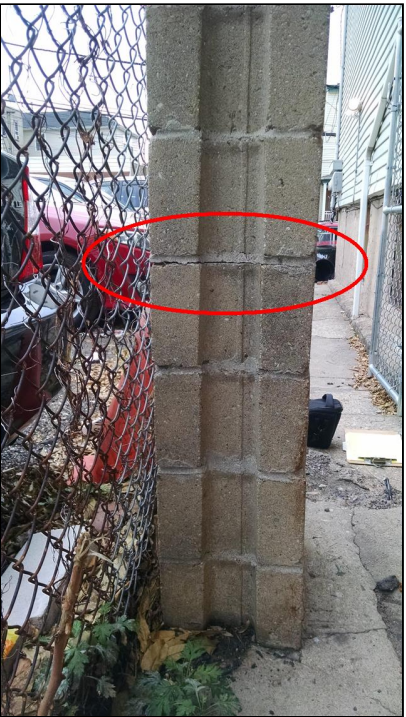
4.1 Item 3(Picture) Crack in mortar joint

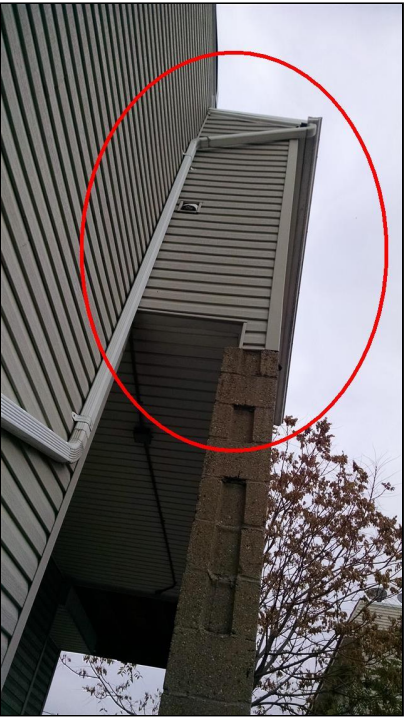
4.1 Item 6(Picture) Columns supporting rear of house

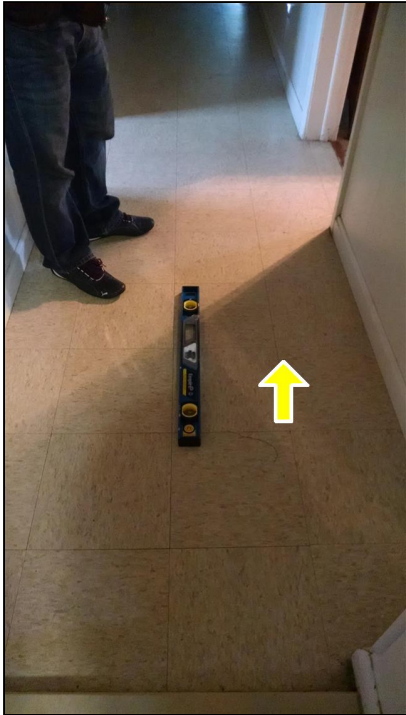
4.5 (2) There were numerous rooms in the house that had noticeable sloping floors present. The areas of concern are as follows- 1) the 2nd floor kitchen floor was sloped downward left to right 2) the 2nd floor hallway floor was sloped downward from the rear to the front 3) the 1st floor kitchen floor was sloped downward from the rear to the front and it had a noticeable hump in it on the left side 4) the 1st floor front bedroom floor was sloped downward from right to left 5) the 1st floor living room floor was sloped downward from the front to the rear. Due to the fire damaged structure that is still in place, the exterior masonry column issues and this issue, I would recommend further evaluation of the entire structure of the house for repairs by a qualified, licensed structural engineer.

4.5 Item 10(Picture) 2nd floor hallway

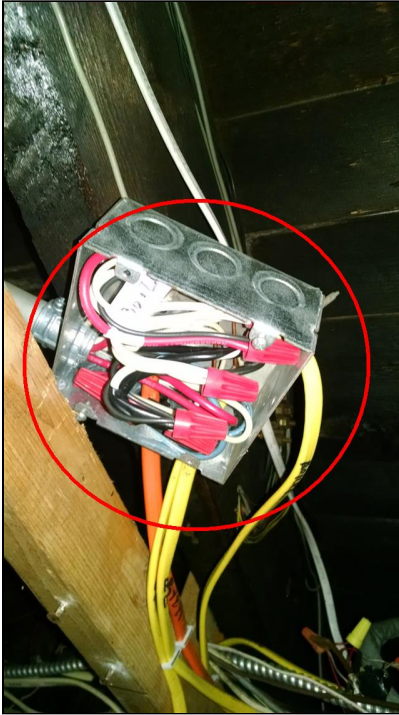
7.7 Item 1(Picture)

**7.7** There were numerous electrical junction boxes observed in the basement area that didn't have the required cover plates on them. The cover plates are required in order to contain any arcing which would potentially cause a fire. If a wire is loose, the amperage will go up, which causes heat. This excessive heat is also capable of causing a fire. The idea is to keep all splices enclosed to reduce the risk of fire and to prevent damage to the wires due to accidental contact. Recommend further evaluation for repairs by a qualified, licensed electrician.

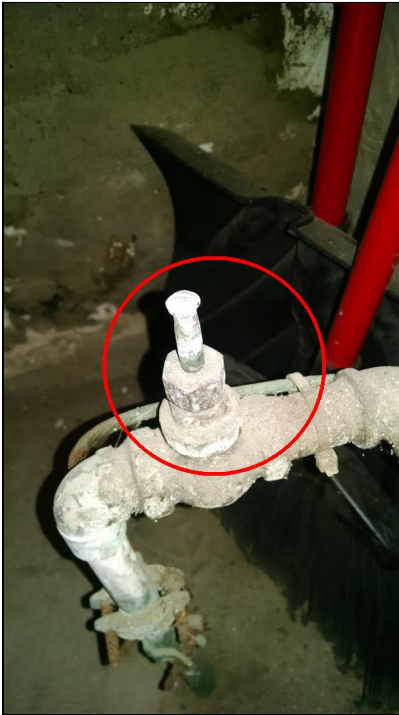
8.0 Item 1(Picture)

**8.0** One of the main water supply shutoff valves located in the basement is missing the required handle. In the event of an emergency, this valve could not be closed. Recommend installing the required handle.

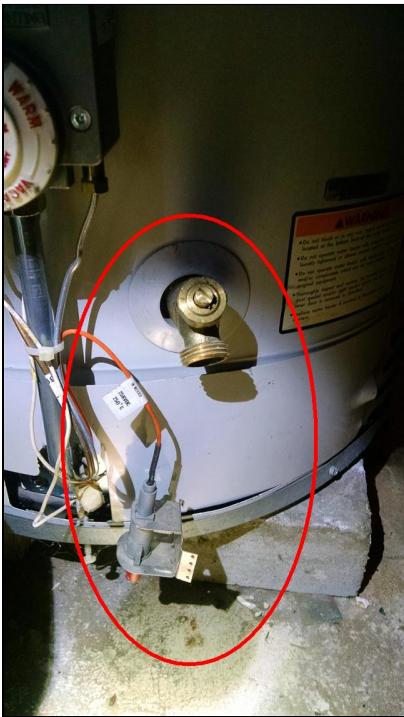
9.0 Item 1(Picture)

9.0 (1) There was a visible water leak at the drain valve at the bottom of the water heater ending in serial #6100. This leak is it were to become worse, could result in water damage and/or a flooded basement. Recommend further evaluation of the entire water heater for repairs by a qualified, licensed plumber.

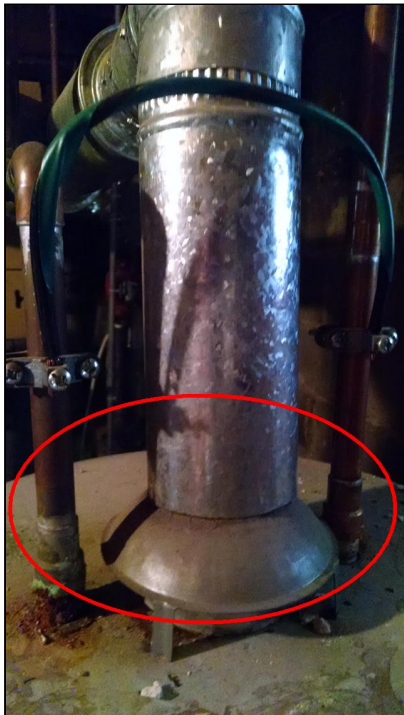
9.1 Item 1(Picture)

**9.1** The vent connectors on both of the water heaters are not properly screwed to the draft hoods on the top of the water heaters and are sloped downward. This is a safety issue as carbon monoxide could leak out and enter the basement space if the vent connector were to get knocked off the draft hood. In addition, the vent connectors appeared to be oversized for the draft hoods. They are not the proper size to fit on the top of the draft hoods. Recommend further evaluation for repairs by a qualified, licensed plumber.

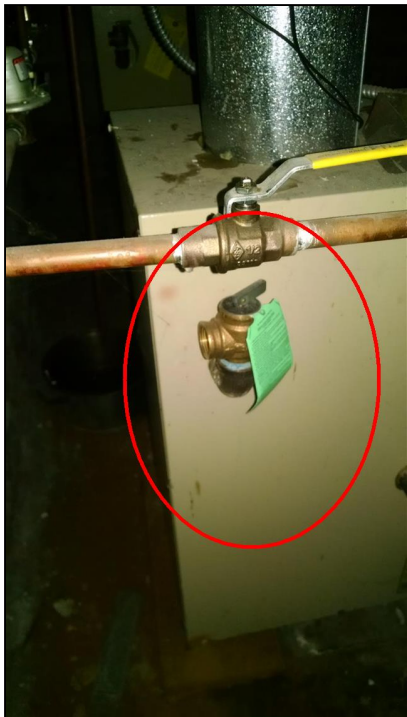
10.0 Item 1(Picture)

10.0 There was no discharge piping on the TPR (temperature pressure relief) valves on either of the two Weil-McLain boilers present in the basement. Proper discharge pipes are needed and should be within 6 inches from the basement floor. This is a safety issue as a person in the vicinity boilers could get scalded should a discharge situation occur. Recommend further evaluation for repairs by a qualified, licensed plumber.

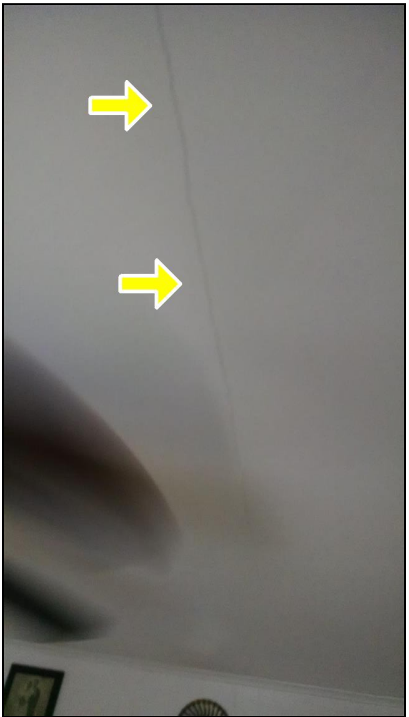
12.1 Item 4(Picture)

12.1 (2) There was a crack observed in the ceiling surface in the 2nd floor living room. This crack could get bigger if the needed repairs are not completed. Recommend further evaluation by a licensed contractor.

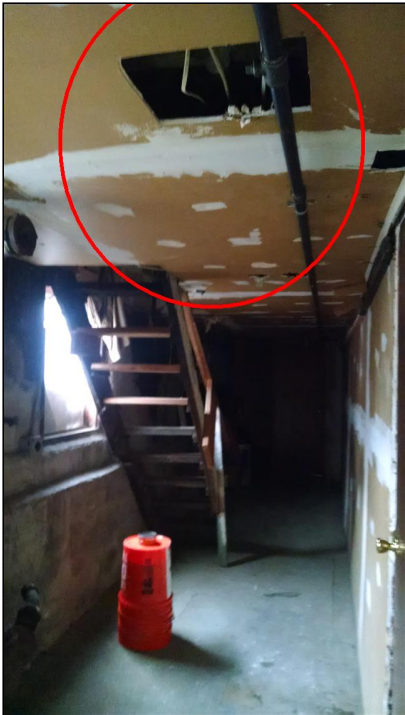
12.1 Item 6(Picture)

12.1 (3) There were numerous sections in the basement that was missing drywall on the ceiling. The basement ceiling should be 100% sealed up to provide the proper fire protection for the basement living space as well as the units above. Recommend further evaluation of all of the ceiling and wall surfaces for repairs by a qualified, licensed contractor.

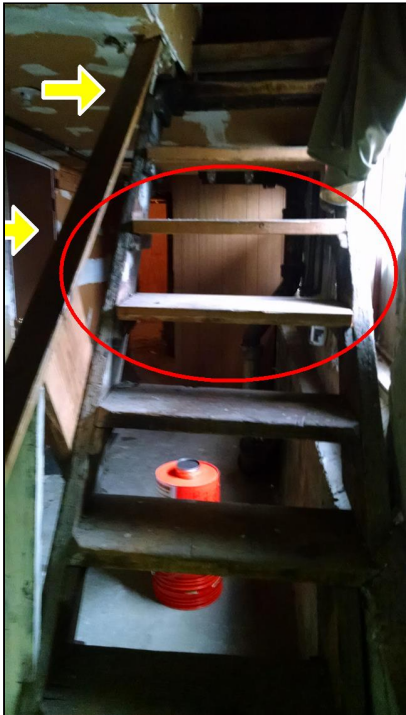
12.5 There were numerous issues observed pertaining to the basement staircase- 1) some of the wood structure was charred from a previous fire 2) the supporting wood supporting the stair treads was inadequate 3) the handrail was mounted too low and was missing the required balusters 4) the risers were opened and should be boxed in 5) the staircase itself was very narrow. These are safety issues and for safety, the needed repairs should be completed. Recommend further evaluation by a licensed contractor.

12.5 Item 1(Picture) Open risers, handrail too low and no balusters

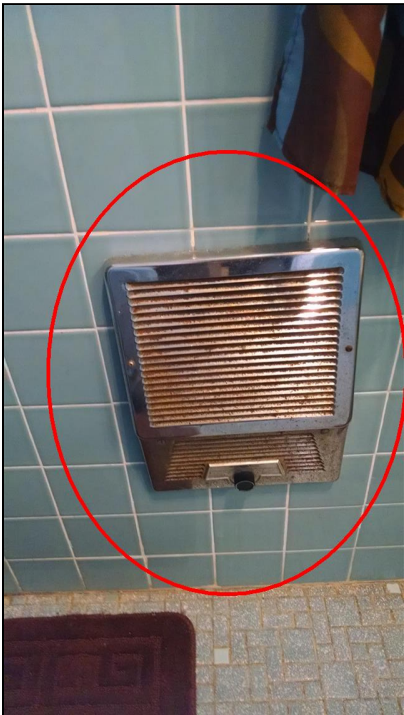
13.0 Item 1(Picture)

**13.0** There was what appeared to be a wall mounted electric heater present between the shower and the toilet in the 2nd floor bathroom. This is a safety issue as this heater is very close to an open water source and it is not appear to be GFCI protected. For safety, GFCI protection is required in all areas within a close proximity of a water source. A ground fault circuit interrupter (GFCI) is a device (outlet or circuit breaker) that shuts off an electric power circuit when it detects that current is flowing along an unintended path, such as through water or a person. It is used to reduce the risk of electric shock. They can also prevent fires, like when a live wire touches a metal conduit. For safety purposes, I would recommend a further evaluation of this heater for GFCI protection to be done by a qualified, licensed electrician.

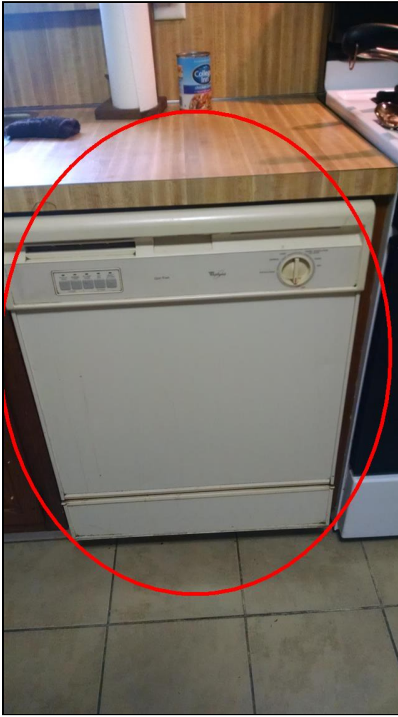
14.5 Item 1(Picture)

**14.5** The dishwasher present in the 2nd floor kitchen was not functioning when tested. Recommend further evaluation for repairs by a qualified, licensed appliance repair professional.

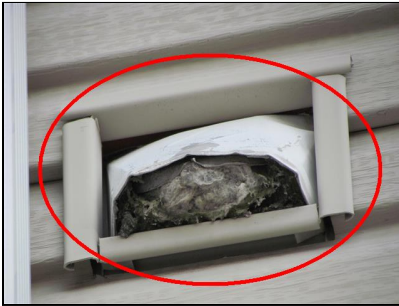
15.4 Item 1(Picture)

**15.4** The dryer vent for the 2nd floor dryer appears to be clogged. This is a fire hazard and it may also effect the performance of the clothes dryer. Recommend further evaluation for repairs by a licensed contractor.
