**Goat Peak Ranch  
South Cle Elum, WA**

**Community Wildfire Risk Assessment  
02/29/2016**

**Conducted By:  
Scott Chambers  
Landowner Assistance Forester  
Department of Natural Resources  
Southeast Region**

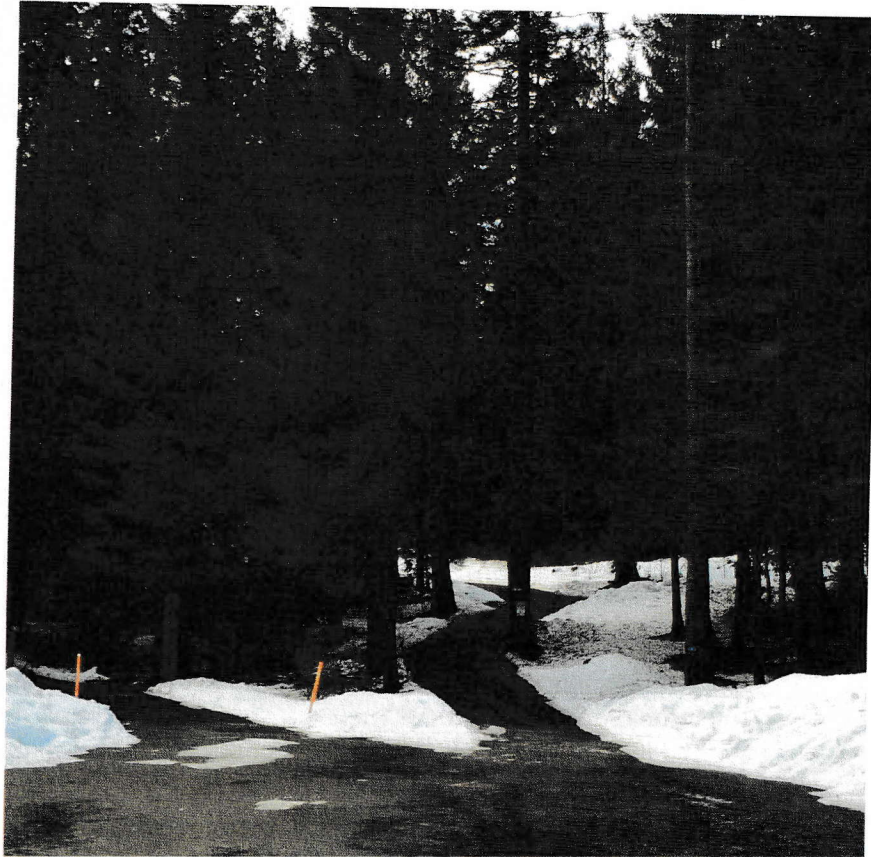
Fire service access evaluates driveway length and turnaround ability. There are a number of homes in the community that have short driveways and some turnaround potential for large fire service vehicles. Some of the properties however, have long driveways with not enough room at the home to turn around a large fire service vehicle. There are a couple with fairly steep long gravel driveways which could impede the fire service's ability to defend the home from wildfire. (Figure 1) Driveways 300' or longer with no turnaround are generally considered less safe for fire services in the event of a wildfire. Vegetation encroachment on the driveway is also a concern for access, there is heavy vegetation growing along and over some of the driveways in the community.

**Figure 1-** Long narrow driveway impeding fire service access

The length of the longer driveways is an issue, but can be somewhat mitigated with vegetation treatment, and development of larger turnaround areas at the home. The primary access concern is the dead end roads and cul-de-sacs as identified in A1, Ingress and Egress.

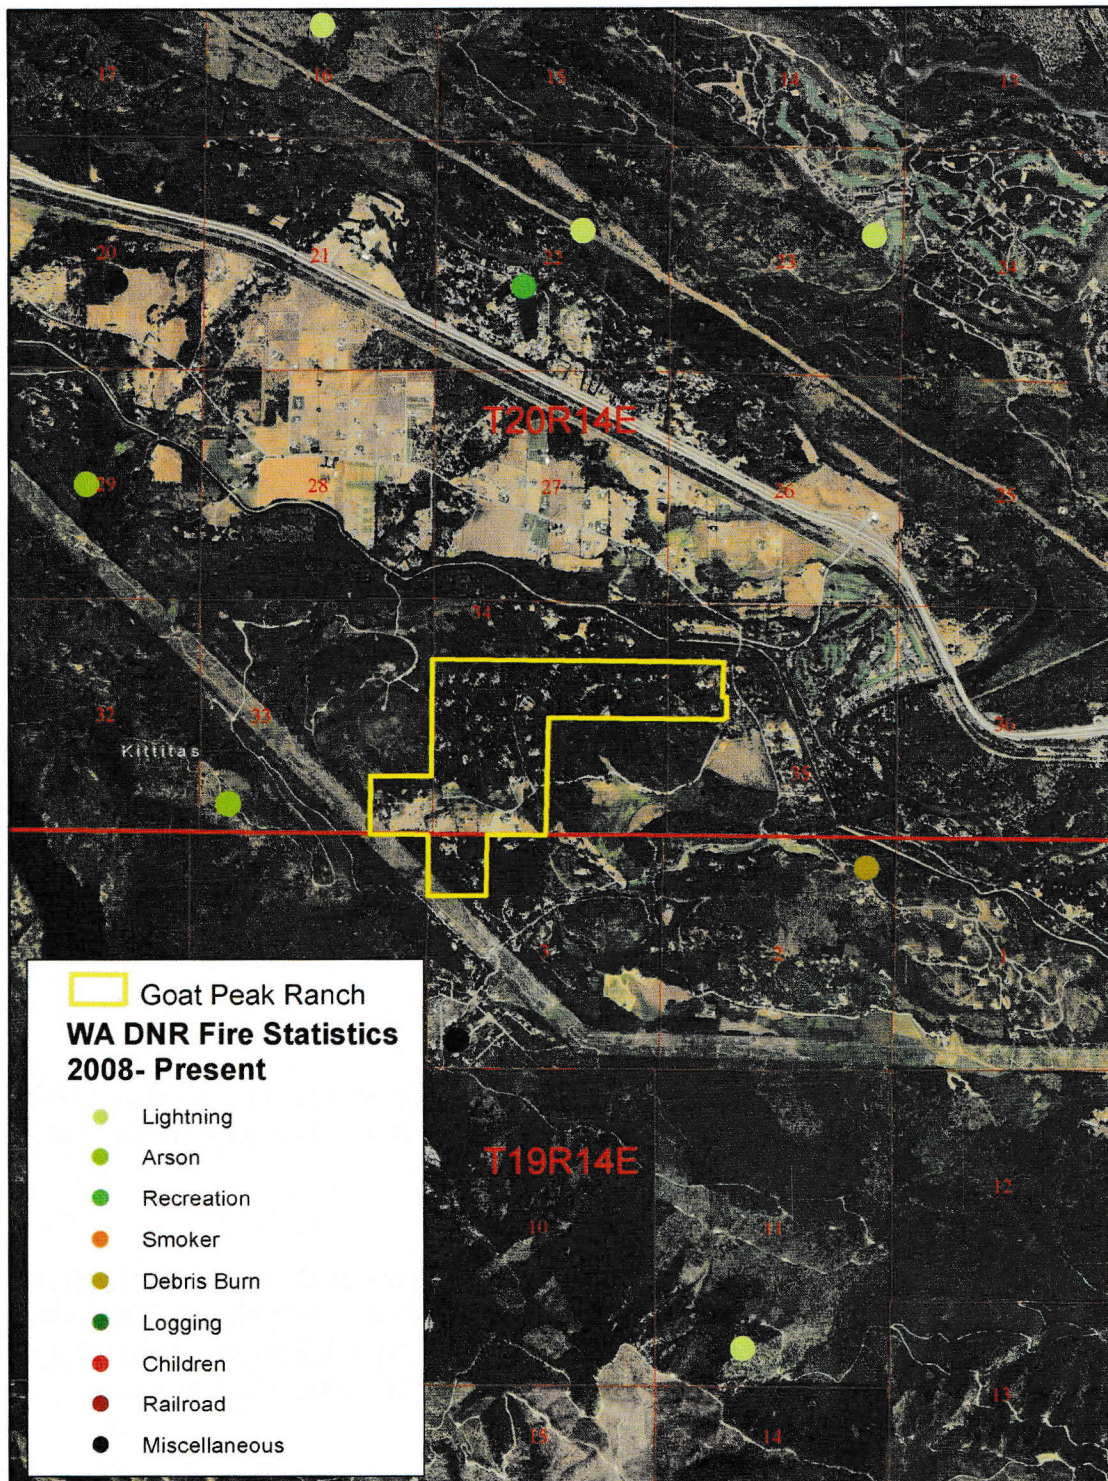
Figure-2

Goat Peak Ranch is located near South Cle Elum, Washington. According to DNR statistics there have been at least 10 fire starts in the area since 2008. Several fires have threatened the community in the past, including the South Cle Elum Ridge fire in 2014. Lightning, debris burning, and other human caused starts are the majority. (Figure 2)

Residents within Goat Peak Ranch can help prevent fire starts by being extra careful during fire season. Information on wildfire prevention can be passed along to community members at board meetings and through mailings from the homeowners association. Community members should follow forest protections rules and regulations.
