**CODE 3 Property Inspections, PLLC**

# Property Inspection Report

123 Anystreet Ave.  
McKinney, Texas 75069

**Prepared For:** Joe and Susie Customer  
**Concerning:** 123 Anystreet McKinney, Texas 75069  
**Inspection Date:** 02/14/2017  
**By:** Inspector Name: Chris DeBord License: TREC # 21042  
Phone: 469.601.6108 E-Mail: chris@code3propertyinspections.com

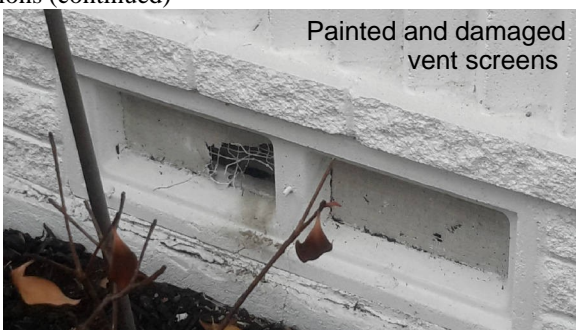
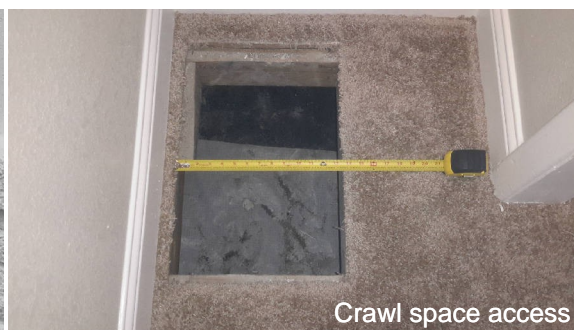
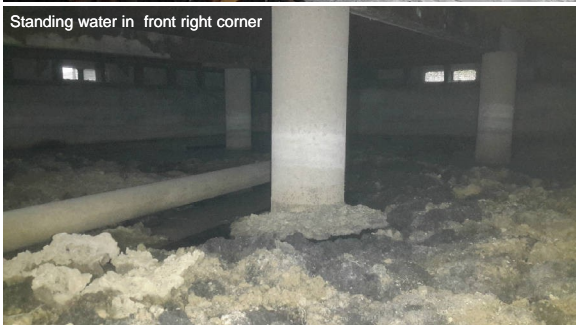
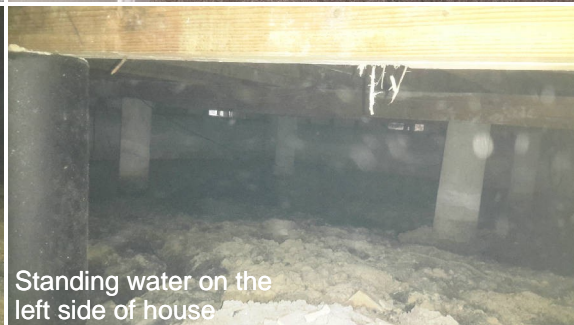
**A. Foundations (continued)**

D - Vent screens were observed to have paint overspray, this partially blocks the needed airflow.

D - Damaged vent screen located on the left side of the house.

D - The access opening to the crawl space appears to be inadequate. The access opening must be at least 18 X 24 inches and/or any area where headroom is less than 18 inches.

D - Large amounts of standing water was observed in several areas of the crawl space.

D - Some piers were not plumb, this was observed on the right side of the house.

D - Wood shims were observed between the floor joist and the concrete piers.

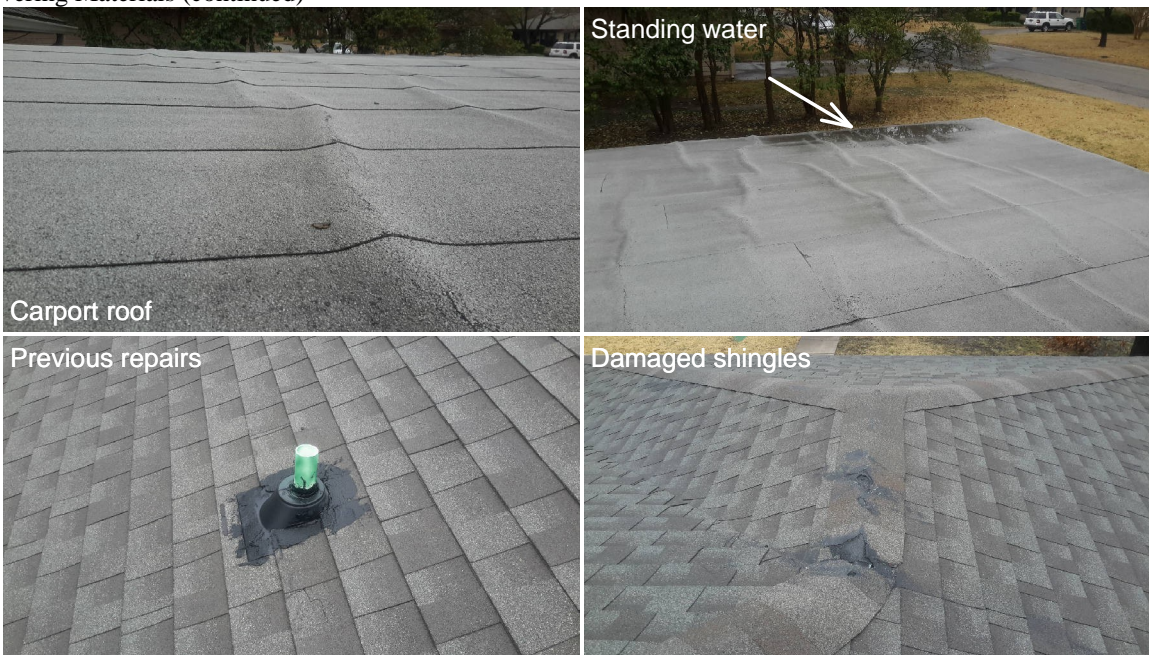
**C. Roof Covering Materials (continued)**

D - Rolled roofing over the carport is wrinkled, cracked and missing granules.

D - Standing water observed on the carport roof.

D - Previous repairs observed roof cover material, skylights, flashing and/or other roof penetrating material.

D - Exposed nail heads observed on roofing and/or flashing materials: recommend sealing all fastener heads to reduce risk of water penetration in these areas.

D - There are some damaged shingles noted on the roof surface. This condition could allow moisture to get beneath the shingle and into the roof structure.

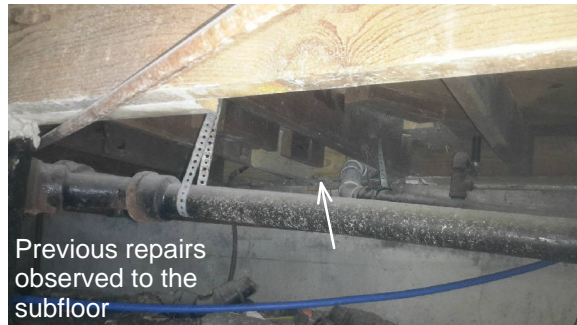
Comments: Types of ceilings and floors - Drywall, Wood, Tile, Concrete, Carpet -  
D - Sloping floor and or / bulges / dips in the floor are noted the right side of the house. Determining the exact cause is not within the scope of this inspection. A qualified structural engineer should be consulted to verify the integrity of the structure.  
D - Previous repairs were observed to the subfloor under the laundryroom.  
D - Wood ceiling observed above the furnace, sheetrock is recommended.

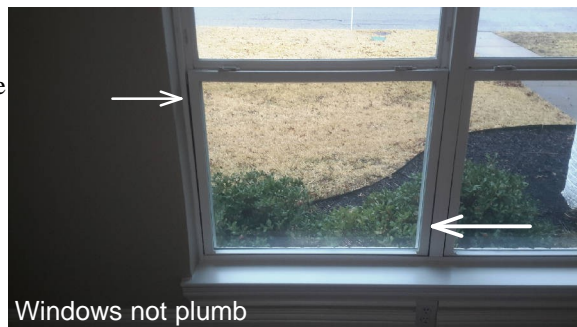
Comments: Type of windows - Vinyl casement -  
D - Several windows throughout the house do not fit properly inside the frame, windows are able to opened without operating the side latches.  
D - A visual inspection of the windows indicates that some of the screens are missing and/or damaged.

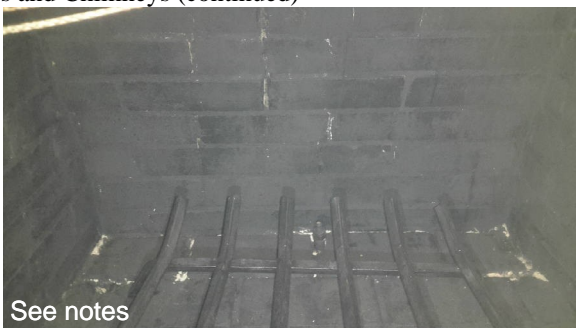
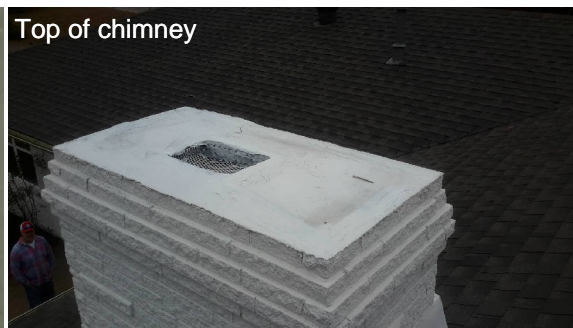
J. Fireplaces and Chimneys (continued)

Comments: Type of Fireplace - Wood burning with gas log lighter -  
D - Missing mortar along with small cracks in the bricks, recommend sealing.  
D - No visible gas valve inside the firebox.  
C - Recommend that the chimney be cleaned.  
D - The mortar cap on the chimney is damaged. A chimney cap restricts moisture from entering the chimney that can cause damage.  
D - The chimney spark arrestor is missing. The spark arrestor restricts animals and birds from entering the chimney as well as minimizes sparks that can exit from the chimney and cause fire or damage to the roof.  
D - Standing water on top of the chimney.

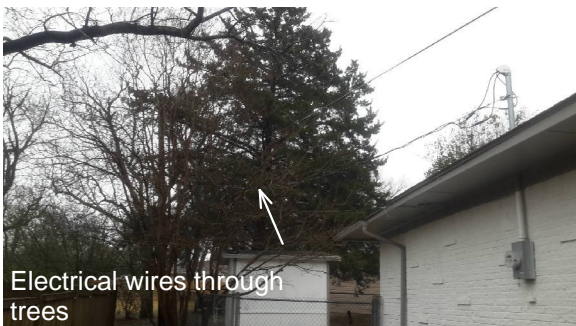
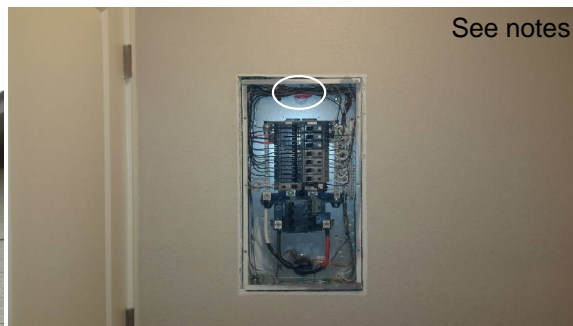
D - There are vines and tree branches touching the electrical service entrance conductors. Contact your local utility provider to remove branches.

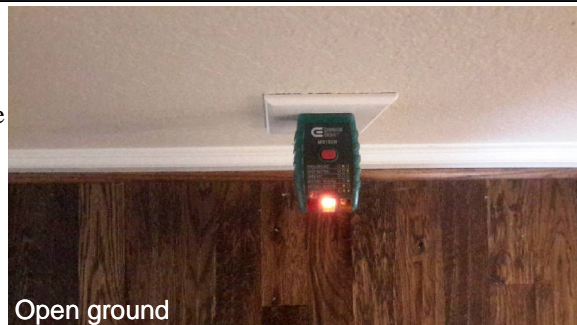
D - There is unprotected electrical wiring within 6 feet of the attic opening. It should be protected to prevent damage and causing a shock hazard.

D - The electrical outlet located in the master bathroom, is cover with wall covering material, recommend cleaning before use.

D - There is an open ground receptacle present in several outlets throughout the house. This means the third prong on an appliance plug is not getting ground protection. This may be a concern with items such as computers and other electronic devices.

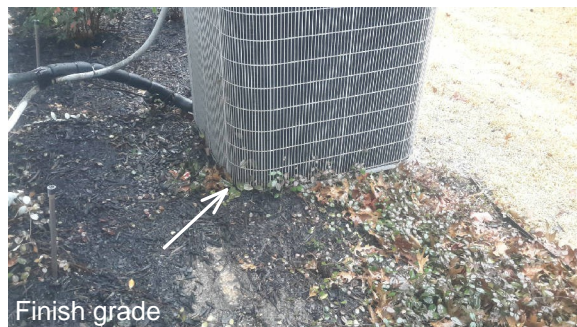
D - The auxiliary/secondary condensation drain line is not installed.

D - The primary condensate drain to the cooling system drains to the

outside and keeps the foundation moist. This may affect foundation performance. The line should be re-routed to a trapped sewer drain.

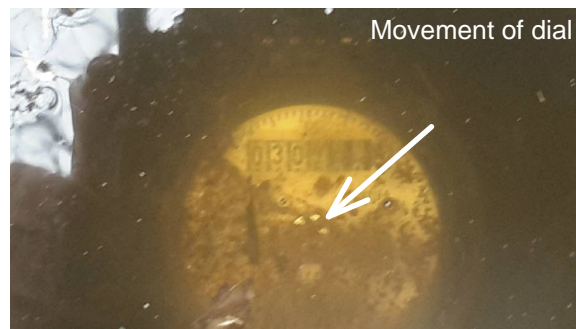
D - Uninsulated water supply lines observed under the house, recommend insulating.

D - Movement was observed to the small dial at the water meter, recommend a licensed plumber for further evaluation. No performance test was being performed to the house at the time of viewing of the water meter.

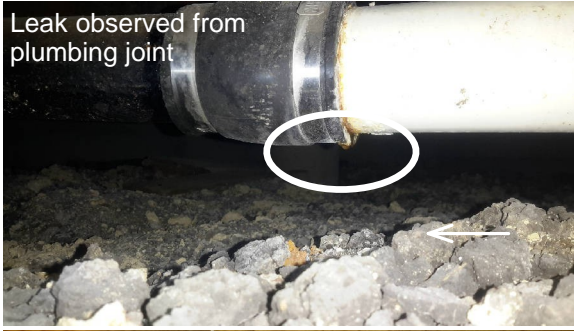
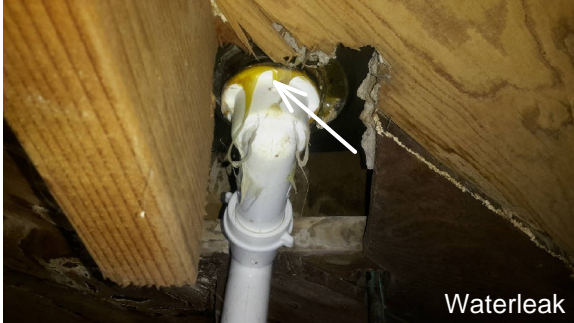
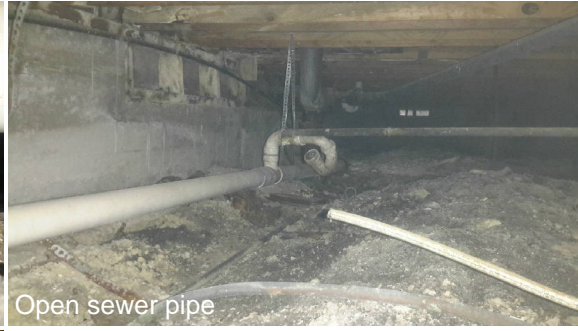
B. Drains, Wastes, and Vents (continued)

D - Due to the movement of the foundation a hydrostatic test of the drain lines is recommended to verify the integrity of the drainage system.

D - Water leaking from the drain line under the house, coming from kitchen/bathroom drain on the right side of the house.

D - Water leak observed from the drain line of the hall bathtub when viewed from the crawl space.

D - Water leak observed from the dishwasher drain line under the kitchen sink.

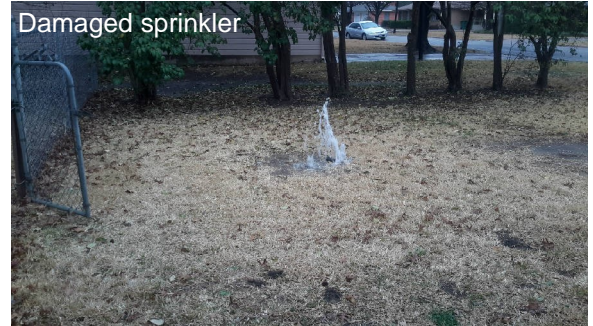
D - Rain/moisture sensor was either not visible or installed.

D - Sprinkler head damaged on the left side of the garage.

C - Valve to the sprinkler system that is located in the front yard was shut off prior to the inspection.
