JTL Consultants

August 13, 2015

Re: Tree failure of Italian stone pine at Kidspace Museum, Pasadena, California

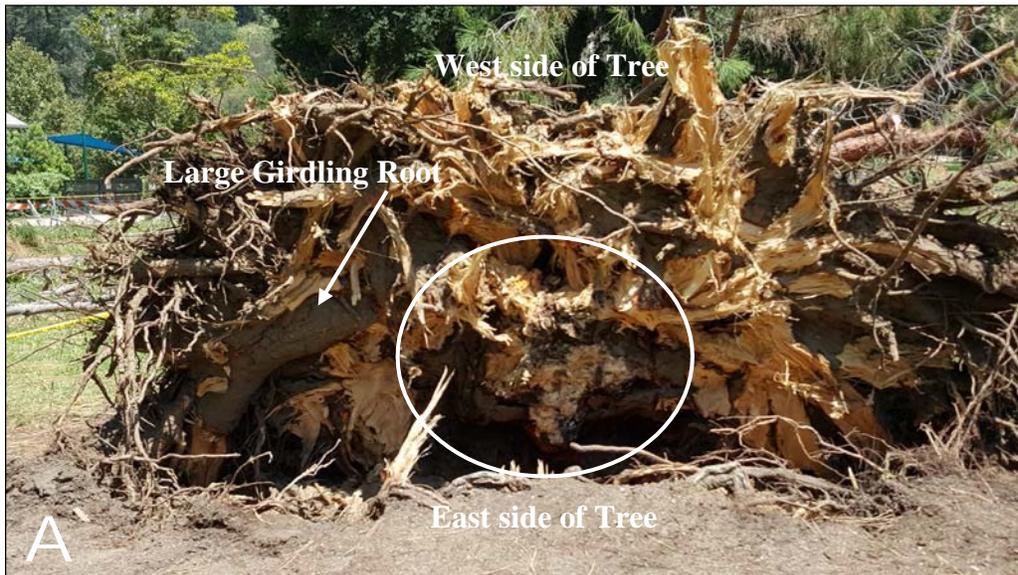
- The tree did not have a distinct root crown on the west side of the tree, the side opposite the direction of the fall (Photo H). The dislodged root section was asymmetrical, with the narrowest width being in the direction the fall (Photo A).

- The roots that dislodged from the ground did not displace a large area of soil, suggesting that the tree did not have wide-spreading anchoring roots (Photo A).

- There were girdling roots growing on the west side of the tree and on top of the root crown (Photo H).
- There were large girdling roots within the uplifted root system (Photos A and F).

Photo A showing overview of root plate of failed Italian stone pine. The circled area indicates the tree section shown in Photo B. Note the roots in the lower portion of the photo show that the roots left in the ground after the tree fell were girdled and relatively small.

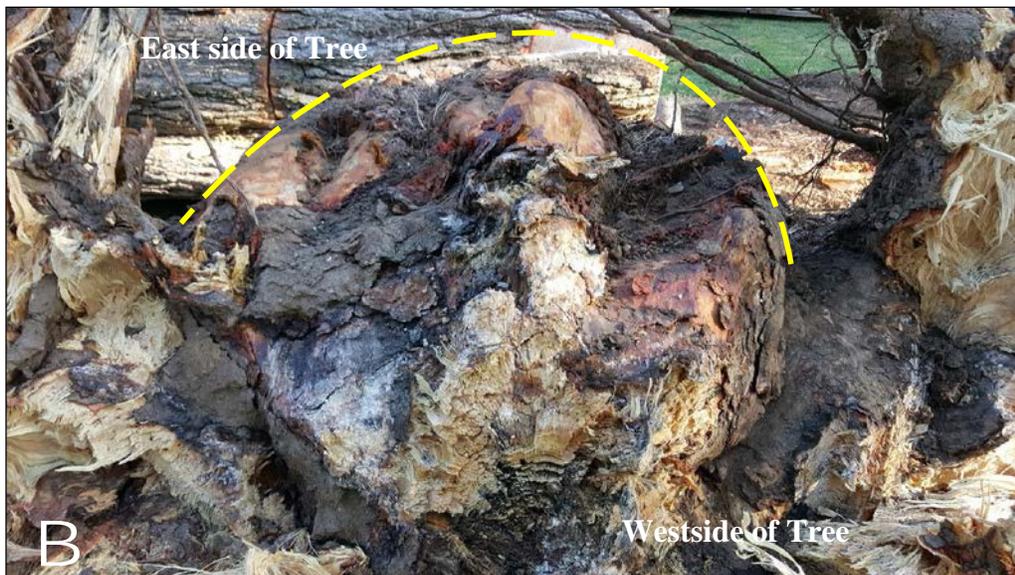
- Tree height: 85 feet; canopy width: 60 feet by 60 feet; trunk diameter: 42 inches.
- The tree fell in an easterly direction.
- The tree did not have a root crown (the area at the base of the tree where the roots and trunk merge) on the east side of the tree, in the direction of the fall (Photos B, C, and D).

- No spongy wood was found, which would suggest that root rot fungus was not present.
- Black charcoal and white ash were discovered in a cavity on the underneath side of the tree, indicating previous fire damage, possibly from hot barbeque coals (Photo B).

Girdling roots prevented the formation of a root crown on the east and the west side of the tree (Photos B and H). Tree trunks typically flare out where they enter the ground, but girdling roots wrapped around the root crown will inhibit the development of the flare and the trunk will appear flattened or sunken (Photos C, D, and H). Girdling roots also prevented the formation of large anchoring roots that would normally extend outward from the tree. Photos A and H show a girdled and underdeveloped root system. Girdling roots prevented the formation of a root crown and the formation of large anchoring roots. The roots left in the ground after the tree fell were girdled and relatively small. This condition resulted in the tree being poorly anchored in the ground.

Photo B showing lack of root crown on the east side of tree, indicated by the yellow dashed line, and evidence of burn on the underside of the tree. This photo was taken after the lower section of the trunk was cut and turned over.

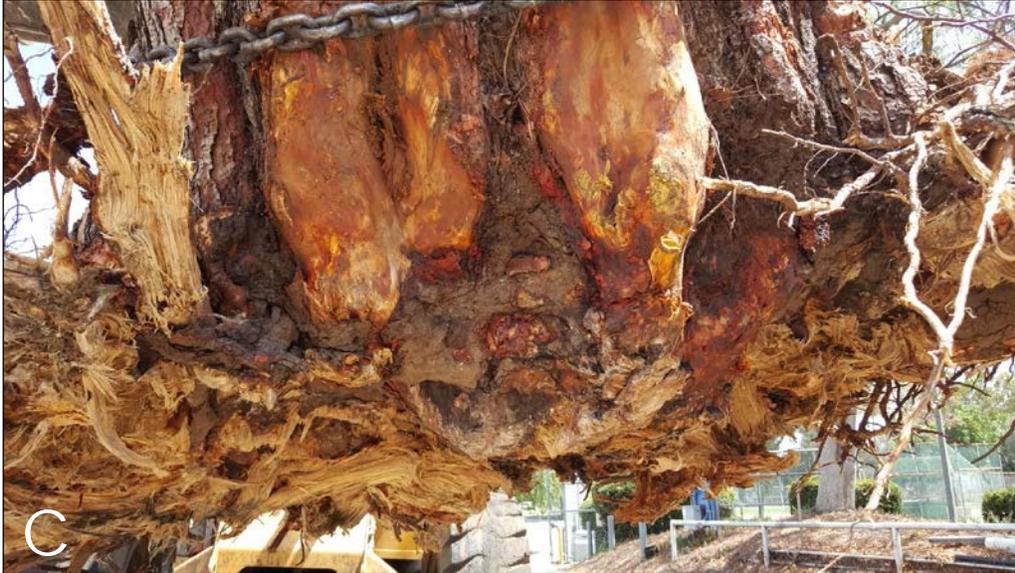
Photo C showing underneath the eastside of the tree. Note the absence of a root crown.

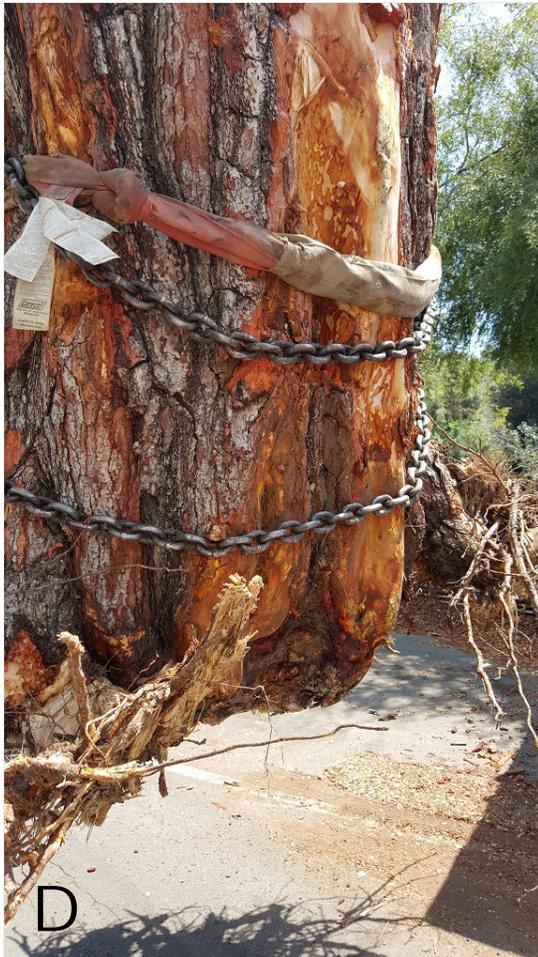
Photo D showing side view of eastside of tree. Note that there are no roots growing from the area that has compartmentalized. This area is flattened with no developed root crown.

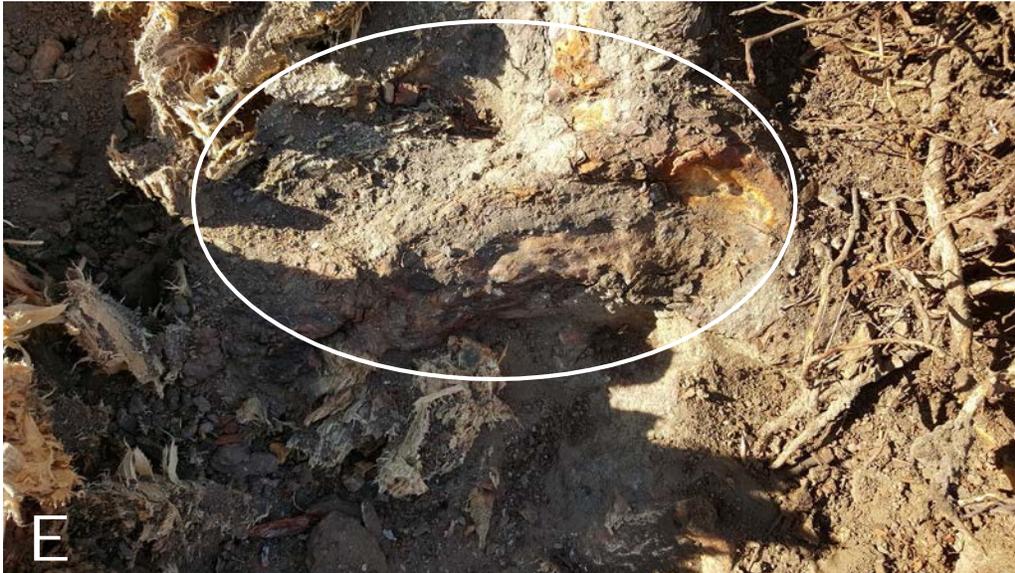
Photo E showing the root plate that remained in the ground after the tree failed. Note that the area indicated by the circle was not attached to the section of the tree that fell. There is no signs of ripping or tearing of wood. The east side of the tree that was compartmentalized was directly above this section. The tree was not attached at this point. This section is approximately 12 inches by 12 inches.

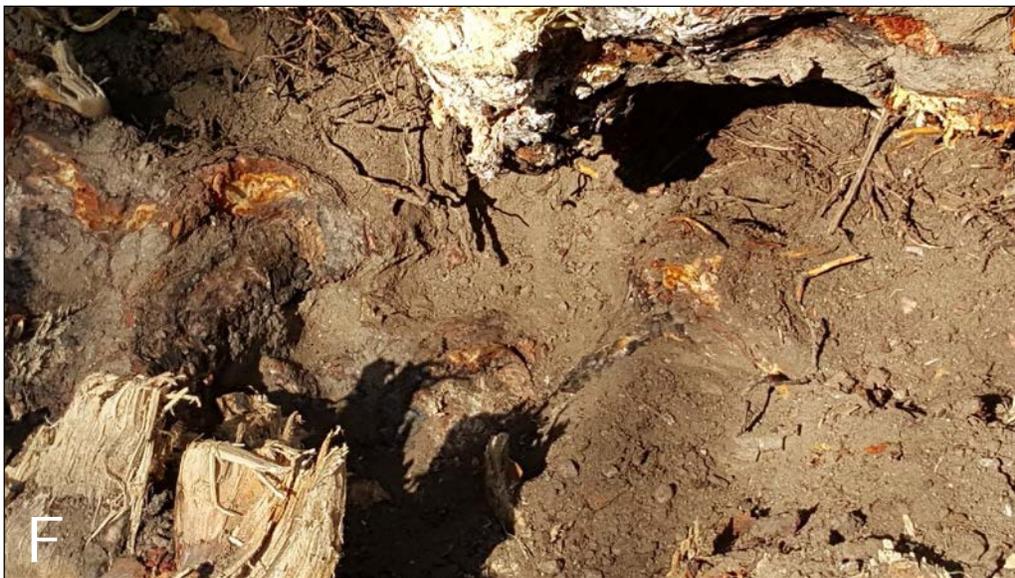
Photo F showing a section on the underneath side of the tree where the trunk was not attached to the roots.

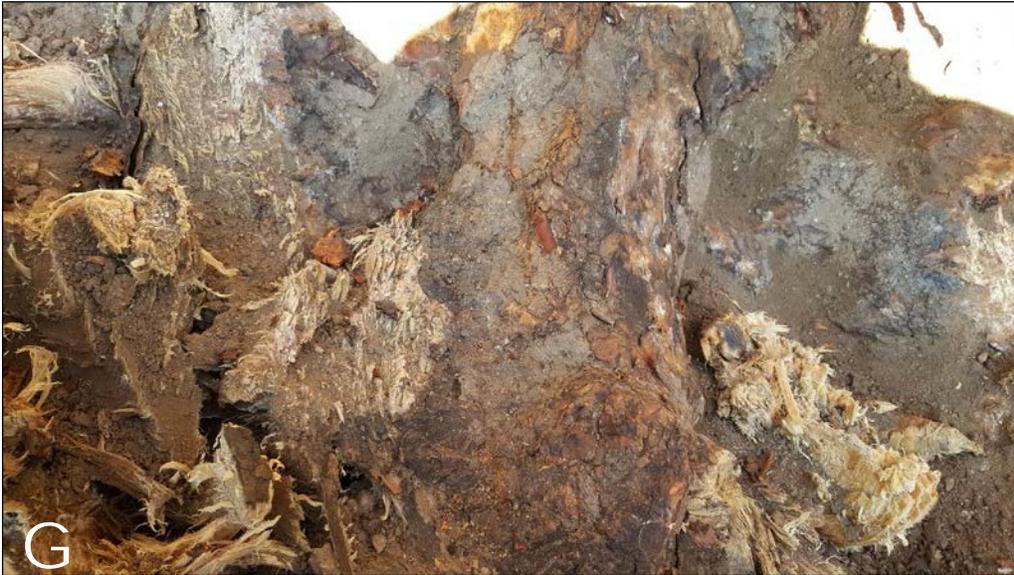
Photo G showing what appears to be a compressed girdling root on the underneath side of the tree.

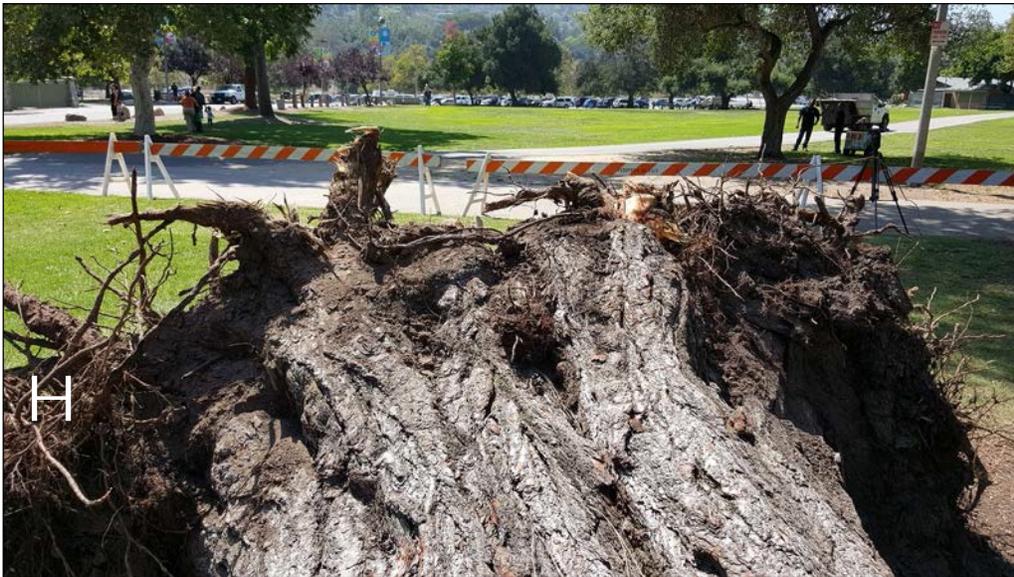
Photo H showing lack of a root crown and girdling roots on the west side of the tree.

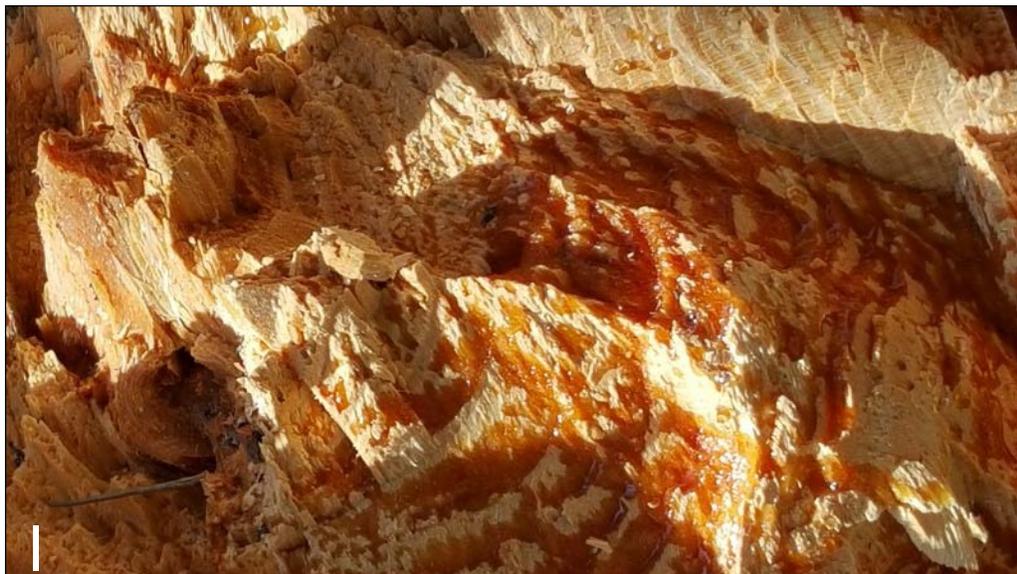
- Sap was oozing out the top of the tree, 75 feet from the roots, approximately 20 hours after the tree became disconnected from the root system (Photo I).

California is currently in its fourth year of drought, where it is receiving abnormally low rainfall amounts. This probably resulted in the Italian stone pine not receiving adequate amounts of water. According to US Climate Data, the Pasadena area received .61 inches of rain on July 19 and 20, 2015, less than ten days prior to the tree failure. This increased the amount of water uptake in the tree. Trees uptake large amounts of water into their system through their roots and release the water through their leaves or needles, a process known as evapotranspiration. The Italian stone pine probably could not release water as quickly as it was taking water in, causing a substantial increase in weight throughout the tree. The increased water in the tree was visible by the sap still oozing from broken limbs and the trunk approximately 20 hours after the roots were separated from the soil (Photo I).

Photo I showing sap flowing from a broken section at the top of the tree.
