# Environmental Arborist Services

## TREE ASSESSMENT

<b>PROJECT TITLE:</b> Arborist Tree Inspection- Along 12 Ave. between Coral Way and SW 12 <sup>th</sup> street, Miami FL 33145	<b>DATE:</b> 10-04-17	<b>DAY:</b> Wednesday	<b>REPORT NO.</b> 1	<b>PROJECT NO.</b> 13-00060
<b>TEMPERATURE</b> 88° F	<b>CONTRACTOR:</b>		<b>FIRM:</b> MILLER LEGG	
<b>Weather Condition:</b> Partly cloudy			<b>PROJECT MANAGER:</b> Mike Kroll	<b>Proj. Superintendent:</b>
<b>VISITORS:</b> N/A		<b>MIAMI-DADE :</b> N/A

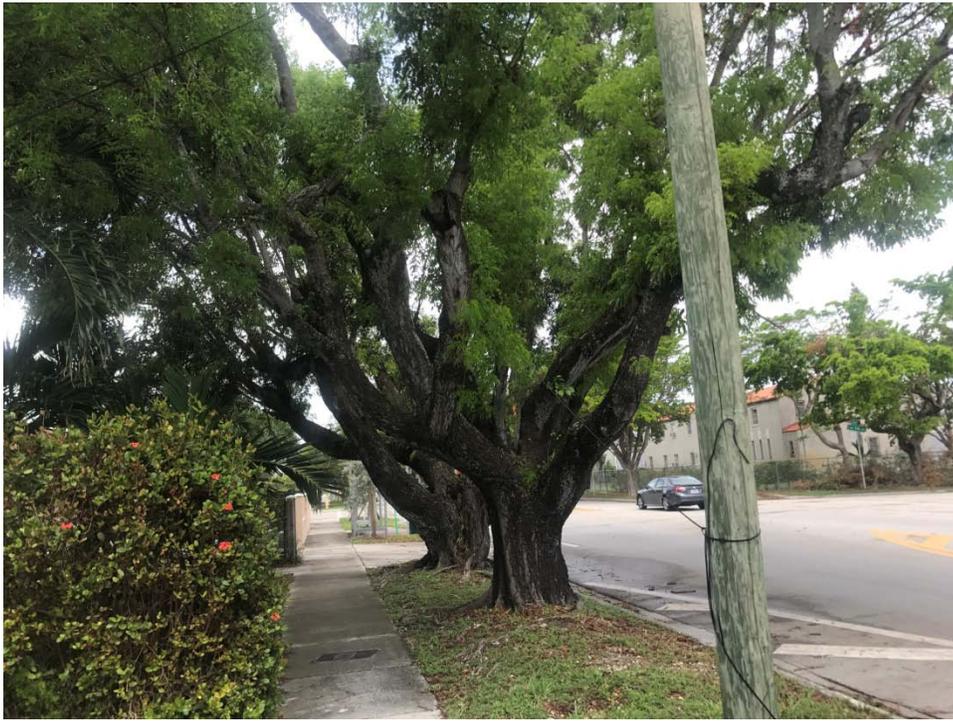
Tree 1 Mahogany (*Swietenia mahagoni*): Station Number Between 38 – 39 - Southern of two trees found here – Photos 1 - 5  
**Recommend structural trimming and potential removal.** Co dominance of major tree trunks with poor structure of leaders. Trunk leaders bent and contain minor and major damage. Limbs also contain major damage and most extend away from perpendicular line of trunk over pedestrian sidewalk and vehicular street. Tree found in poor condition. Major damage caused by FPL trimming off power lines. Root constriction from sidewalk and road way.

**Photo #1: Tree 1. View of overall tree. Branches extend over roadway and sidewalk.**

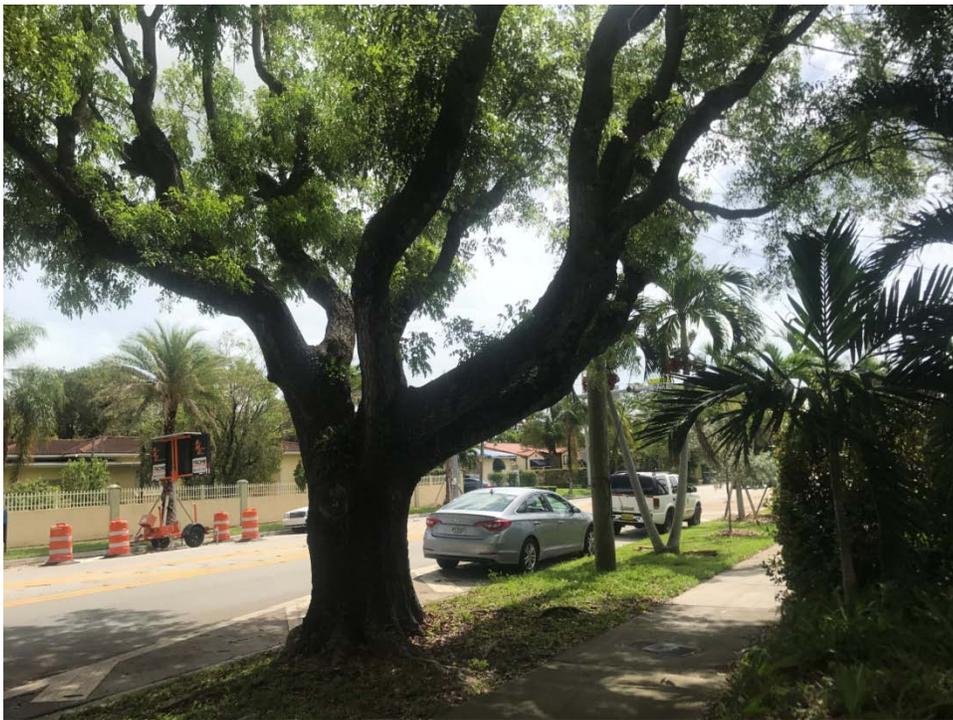
**Photo #2: Tree 1. View of overall tree. Major leader over sidewalk.**

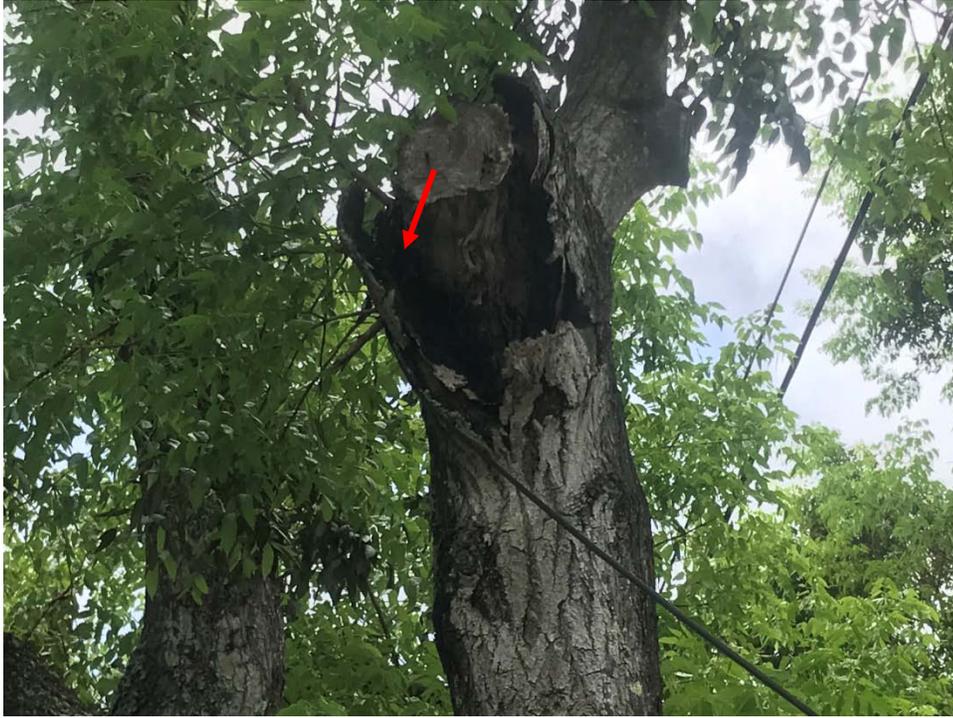
**Photo #3: Tree 1. View of decay in branch.**

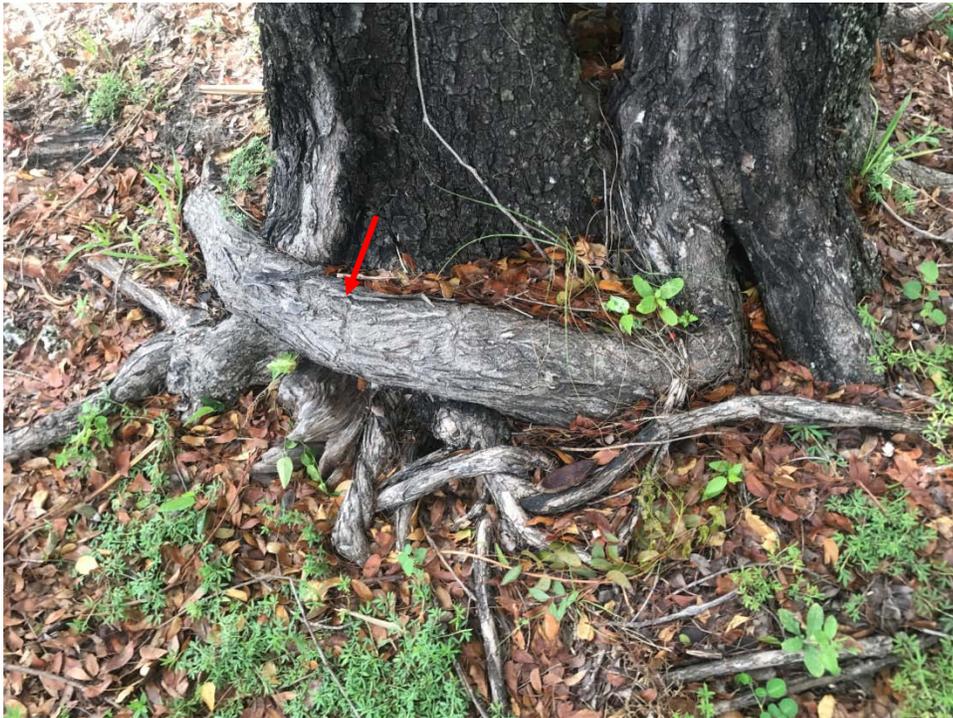
**Photo #4: Tree 1. Large root girdling around more than 35 % of trunk.**

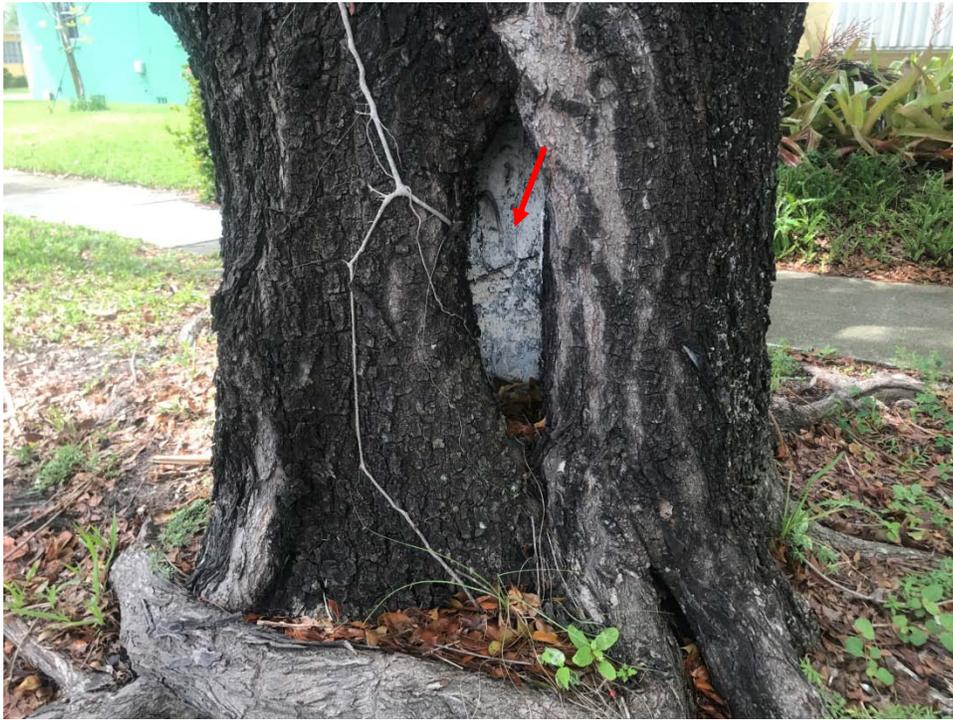
**Photo #5: Tree 1. Major damage to trunk and decay found.**

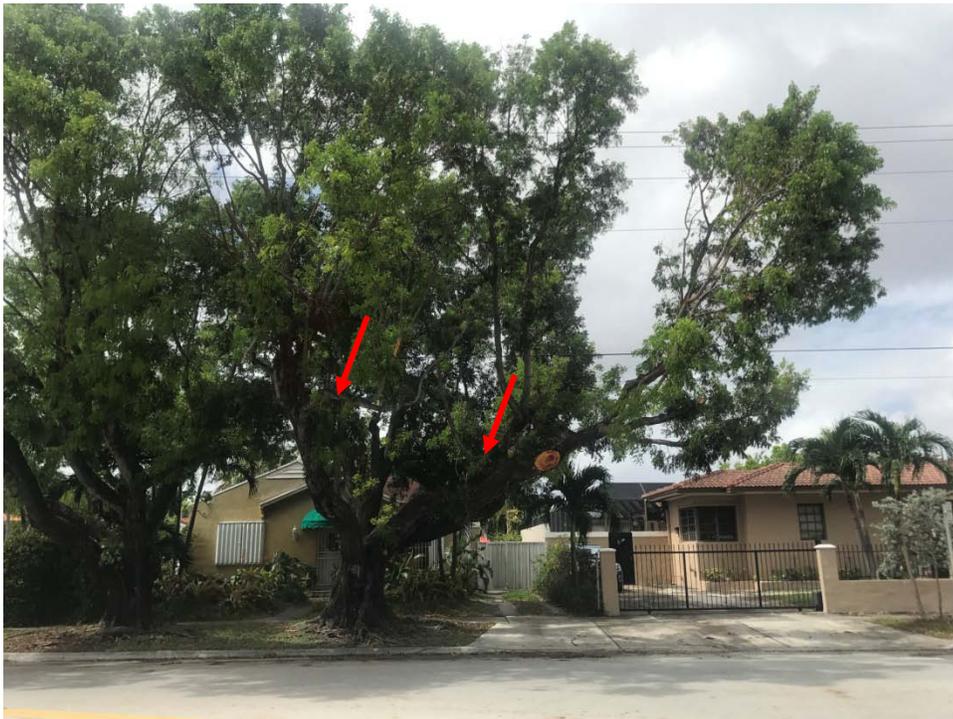
Tree 2 Mahogany (*Swietenia mahagoni*): Station Number Between 38 – 39 - Northern of two trees found here – Photos 6 - 11.  
**Recommend removal.** Co dominance of major tree trunks with poor structure of leaders. Decay observed in trunk and limbs. Limbs also contain major damage and most extend over roadway and sidewalk. Tree found in poor condition with significant decay of trunk and included bark. Canopy adjacent to power lines and has been severely trimmed.

**Photo #6: Tree 2. View of overall tree. Branches extend over roadway and sidewalk. Damage to limb hanging over roadway observed.**

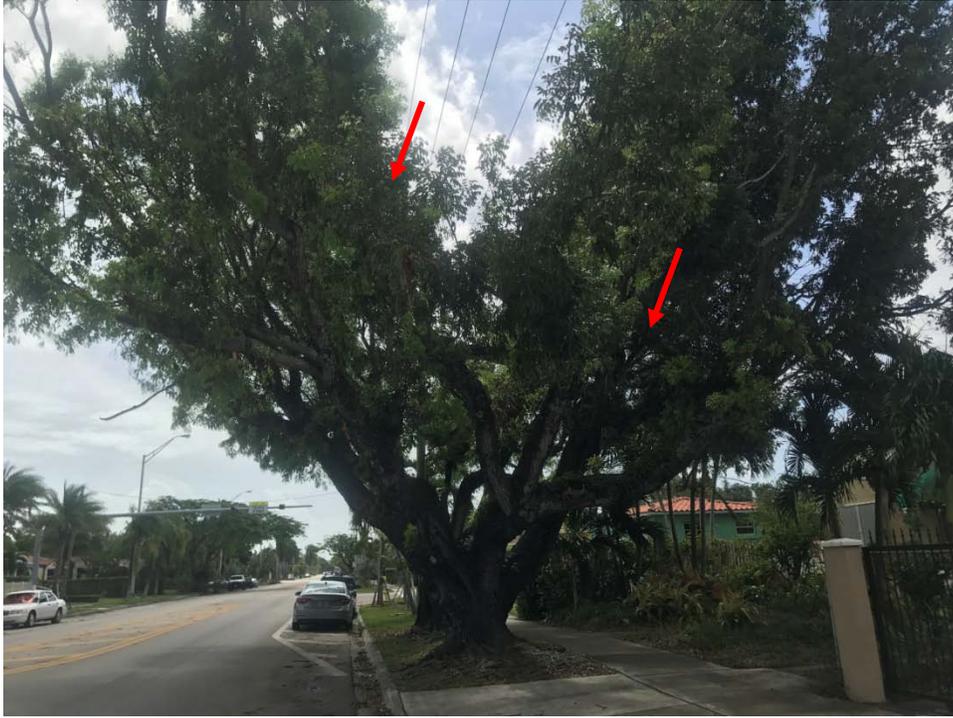
**Photo #7: Tree 2. View of overall tree facing south. Large branches hanging over sidewalk and resident driveway. Major limb damage from FPL trimming.**

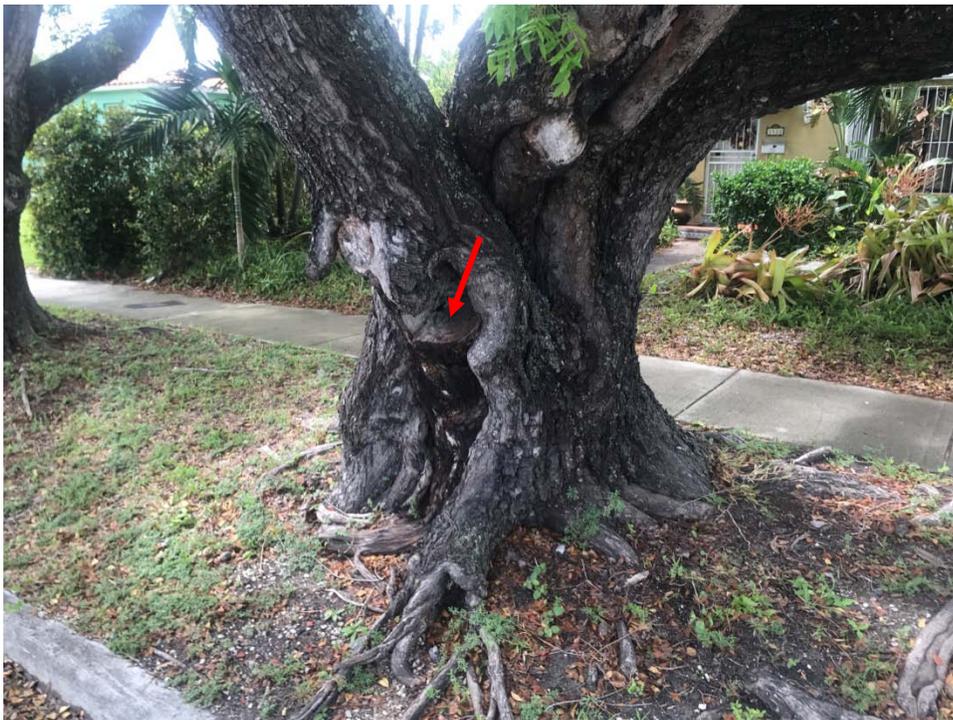
**Photo #8: Tree 2. Major damage to trunk and decay observed.**

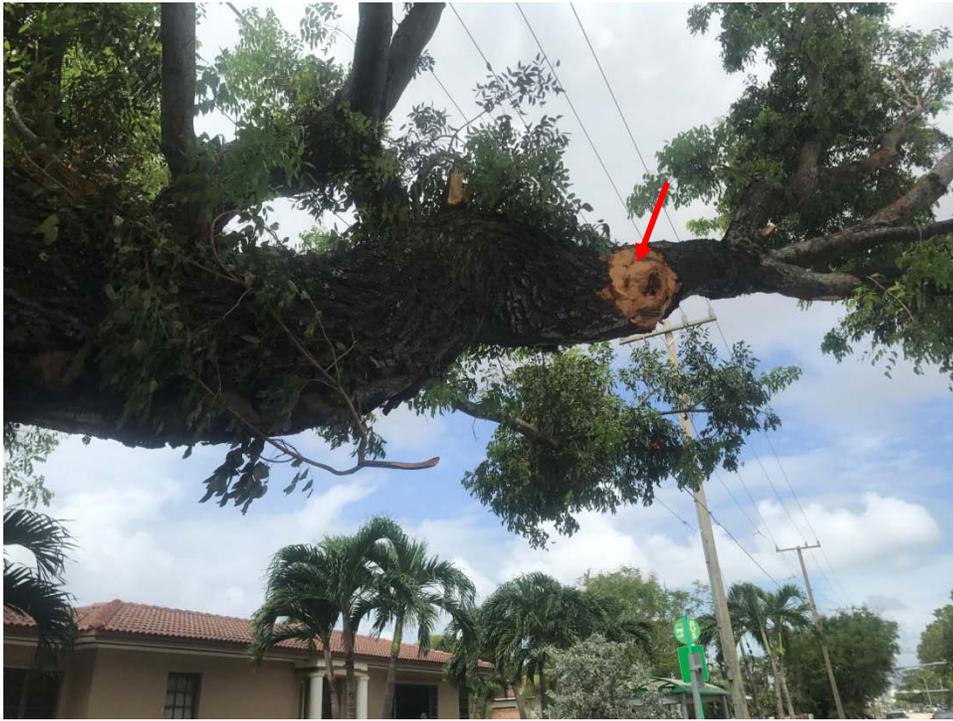
**Photo #9: Tree 2. Major limb damage observed over roadway.**

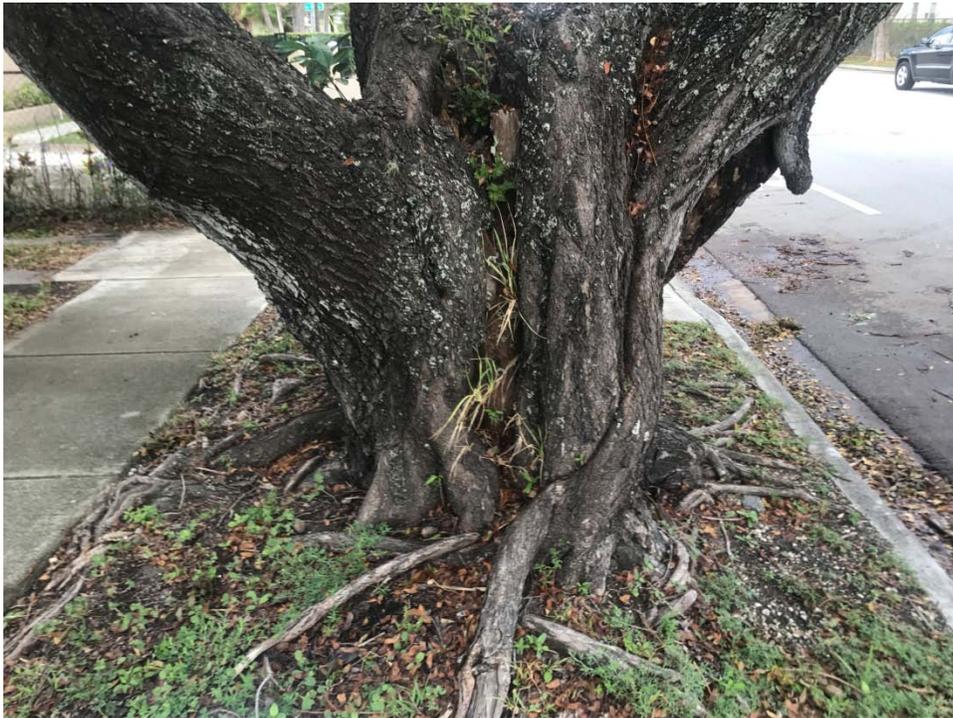
**Photo #10: Tree 2. Major trunk damage observed with included bark. Decay observed.**

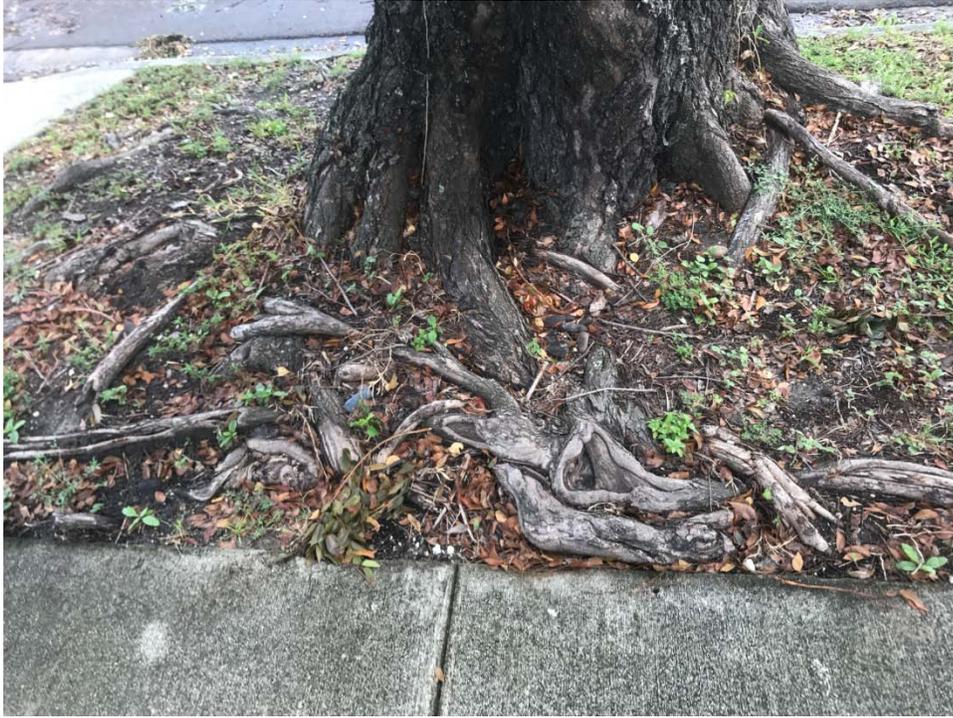
**Photo #11: Tree 2. Root constriction due to sidewalk and roadway.**

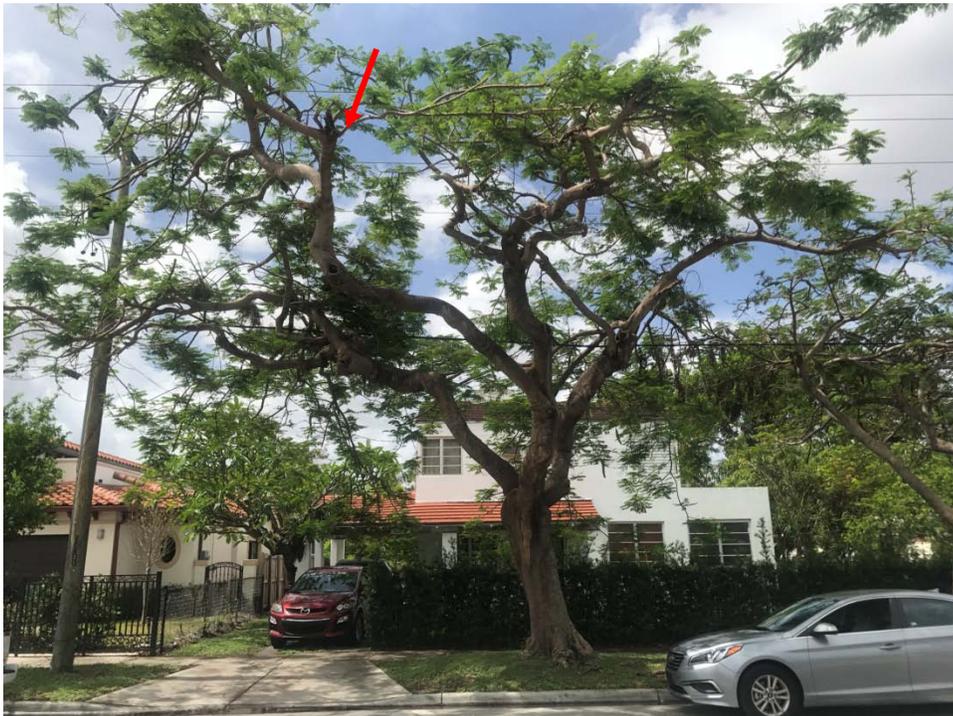
Tree 8 Royal Poinciana (*Delonix regia*): Station Number Between 33 - 34 - Photos - 12 - 14.  
**Recommend structural trimming and follow-up inspections.** Co dominance of major tree trunks with poor structure of leaders. Decay observed in trunk with cavity observed. Limbs also contain major damage and most extend over roadway and sidewalk. Tree found in fair to poor condition.

**Photo #12: Tree 8. Royal Poinciana tree overall view.**

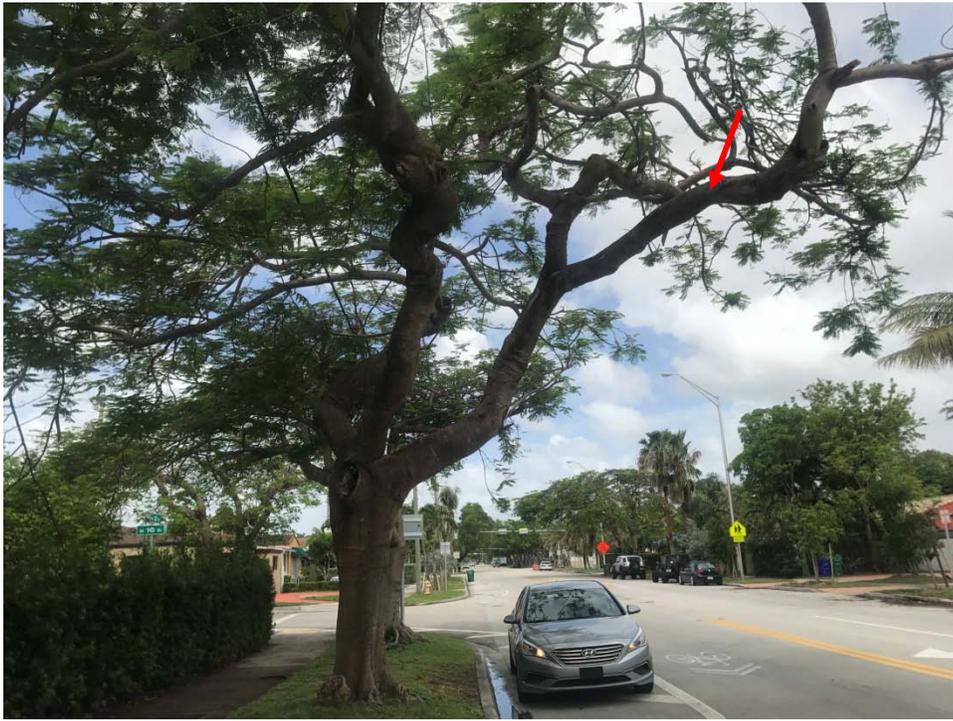
**Photo #13: Tree 8. Large limb observed over roadway.**

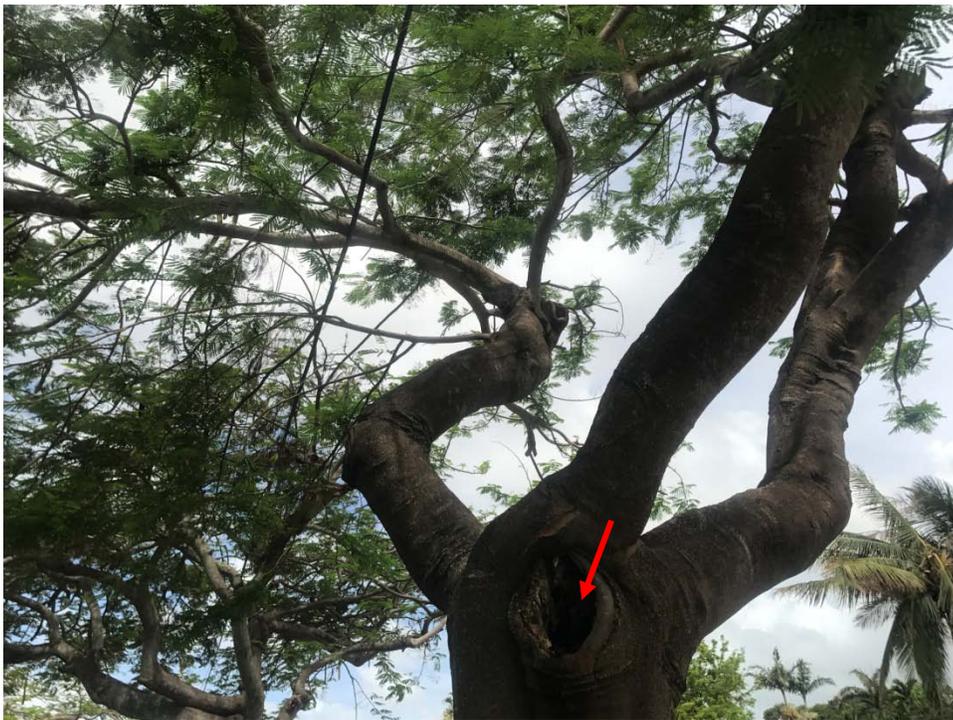
**Photo #14: Tree 8. Decay observed.**

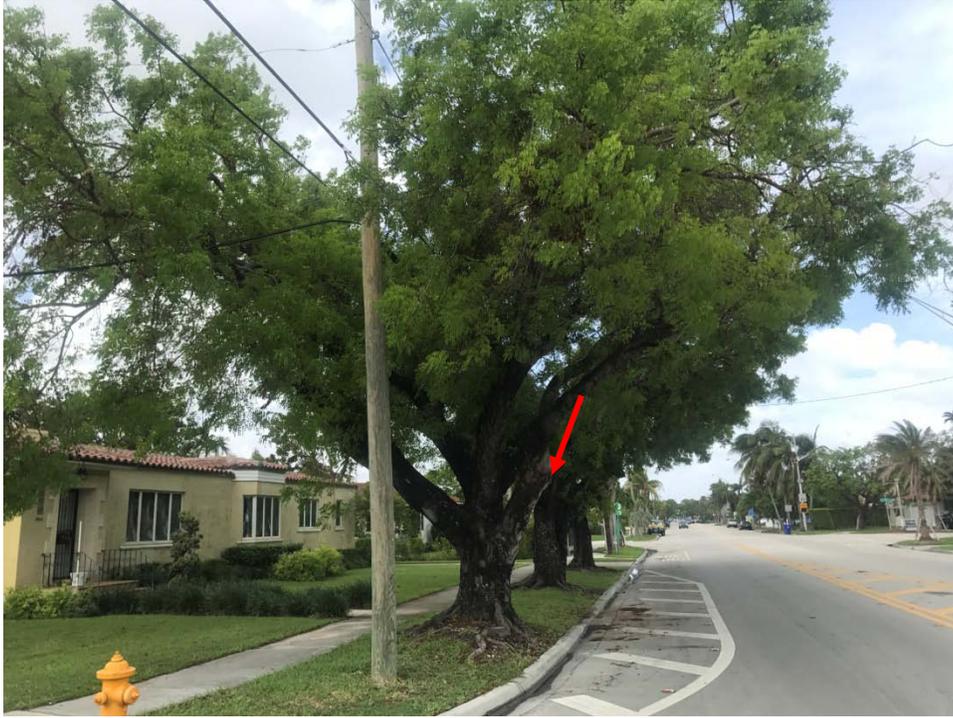
Tree 3 Mahogany (*Swietenia mahagoni*): Station Number Between 23 - 24 - Southern of two trees found here – Photos – 15 - 17.  
**Recommend structural trimming and removal of 6 feet stub cut trunk at a minimum.** Major limb damage observed with 6 feet limb needing immediate removal. Stub cut observed. Co dominance of major tree trunks with poor structure of leaders and canopy. Minor damage observed in trunk and limbs. Limbs also contain major damage. Most limbs extend over roadway and sidewalk. Tree found in poor condition with included bark. Canopy adjacent to power lines and has been severely trimmed.

**Photo #15: Tree 3. Six foot stub cut observed.**

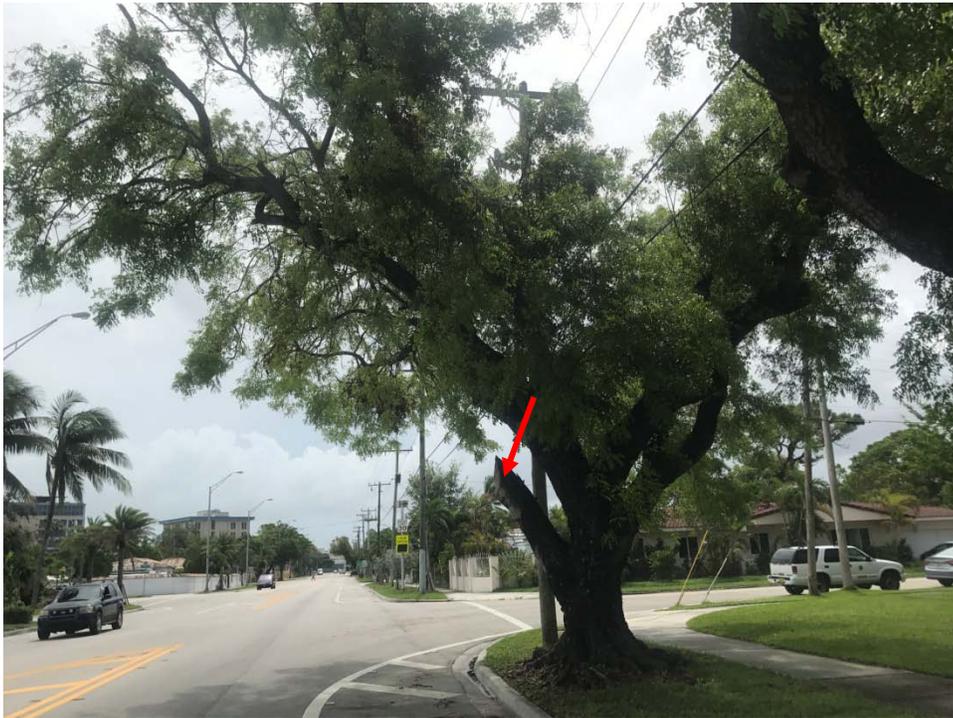
**Photo #16: Tree 3. Stub cut observed requiring removal.**

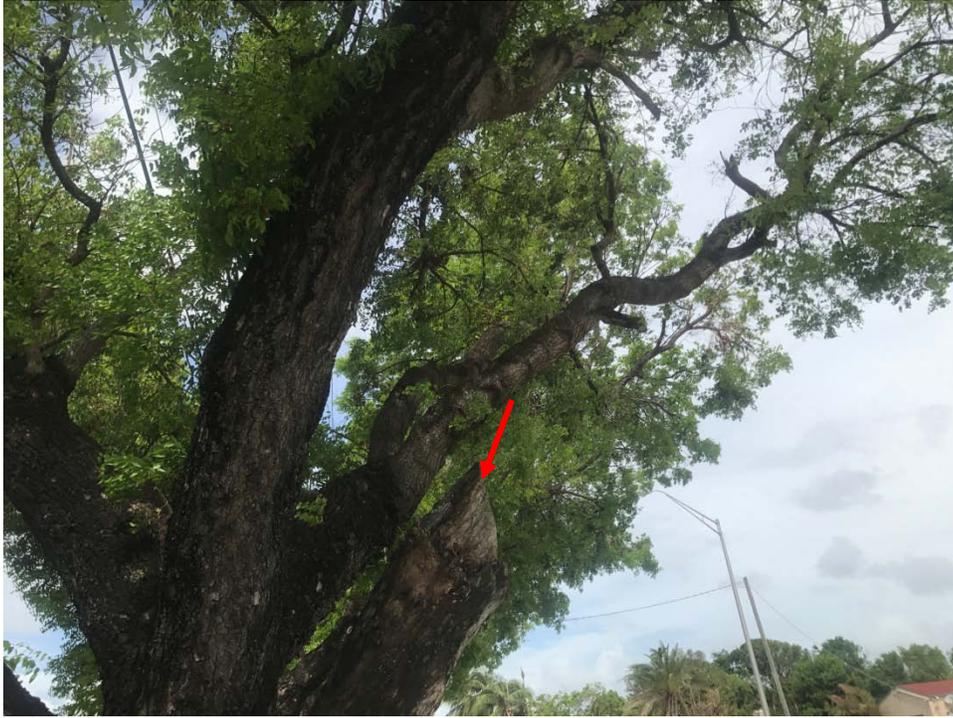
**Photo #17: Tree 3. Significant damage to co dominant trunk observed.**

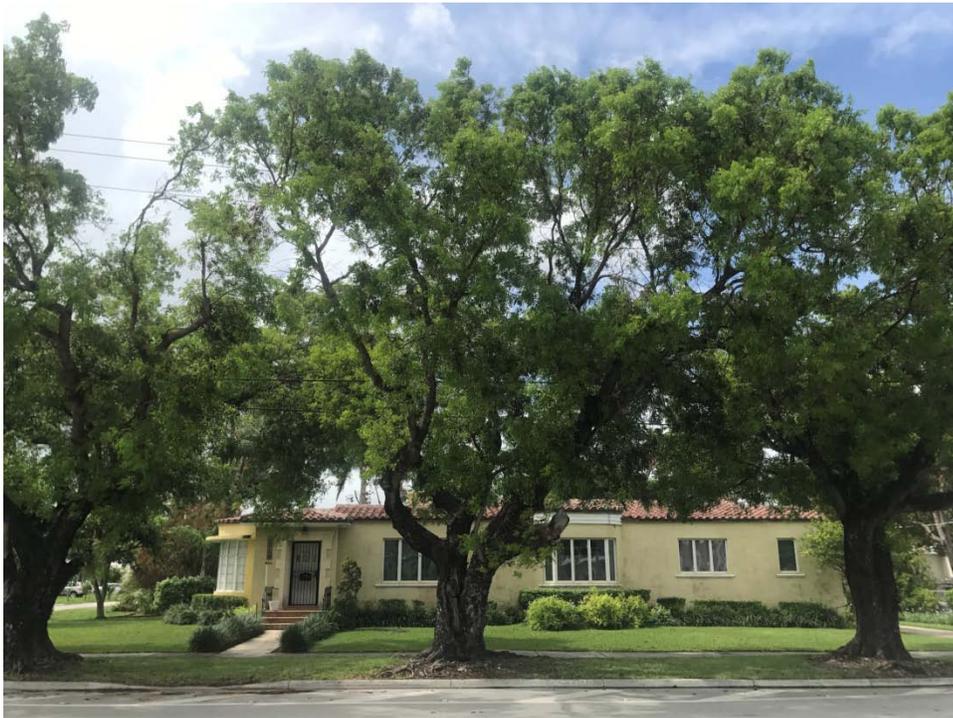
Tree 4 Mahogany (*Swietenia mahagoni*): Station Number Between 23 - 24 - Northern of two trees found here – Photos 18 - 21.  
**Recommend removal.** Co dominance of major tree trunks with poor structure of leaders. Major decay observed in center of trunk with included bark. Limbs also contain major damage and most extend over roadway and sidewalk. Bent leaders. Tree found in poor condition with significant decay of trunk. Root constriction observed. Canopy significantly altered from FPL trimming.

**Photo #18: Tree 4. Overall view of tree. Facing west.**

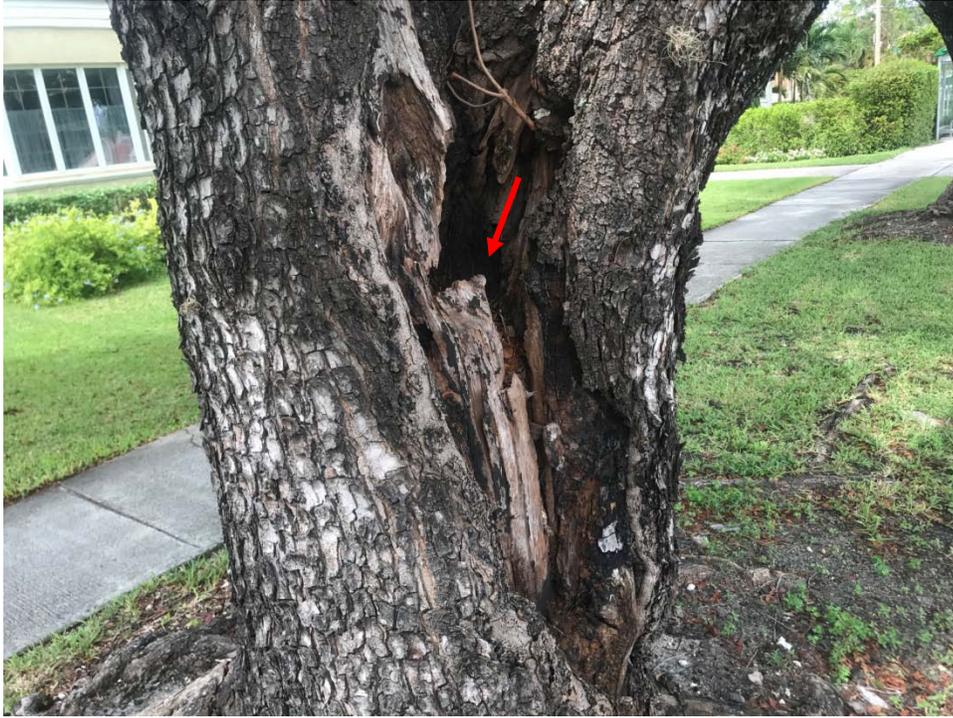
**Photo #19: Tree 4. Major decay observed.**

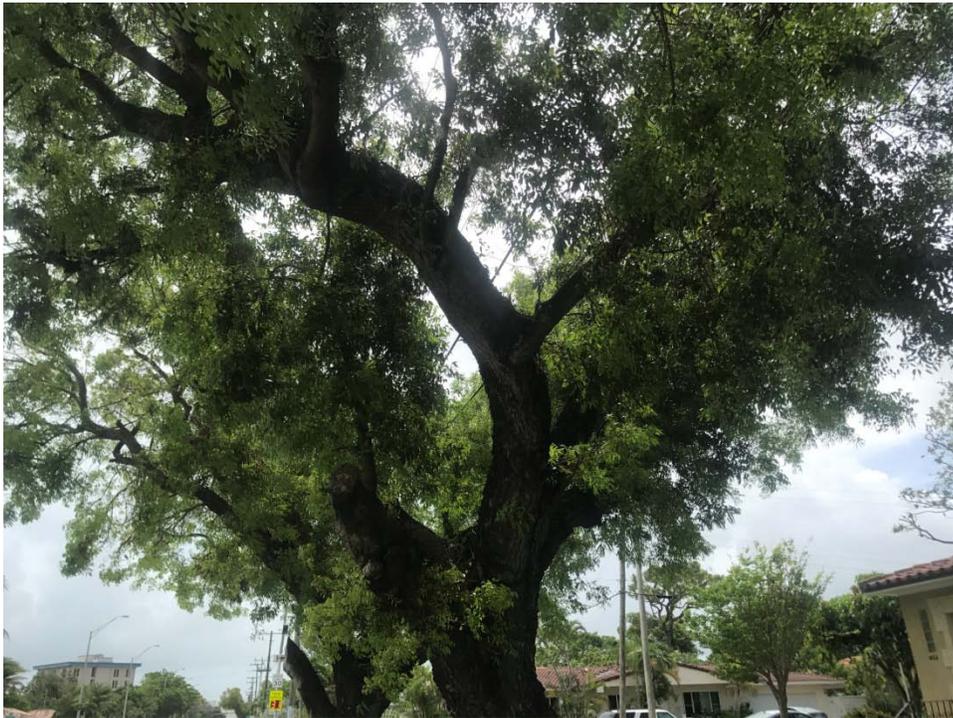
**Photo #20: Tree 4. Facing south. Bent leader observed.**

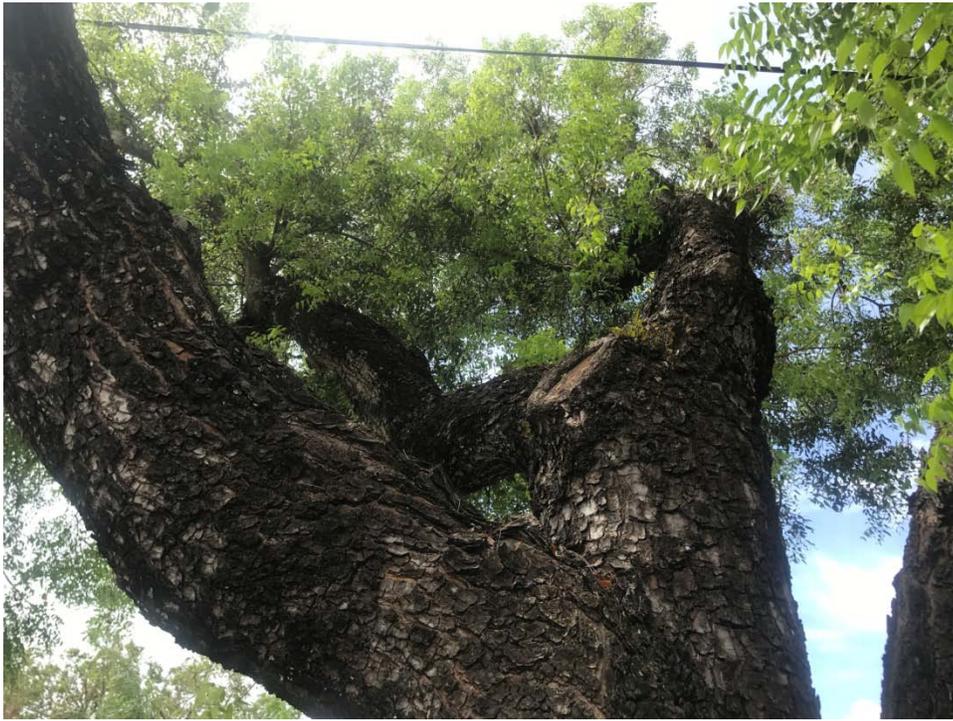
**Photo #21: Tree 4. Severe pruning from power lines.**

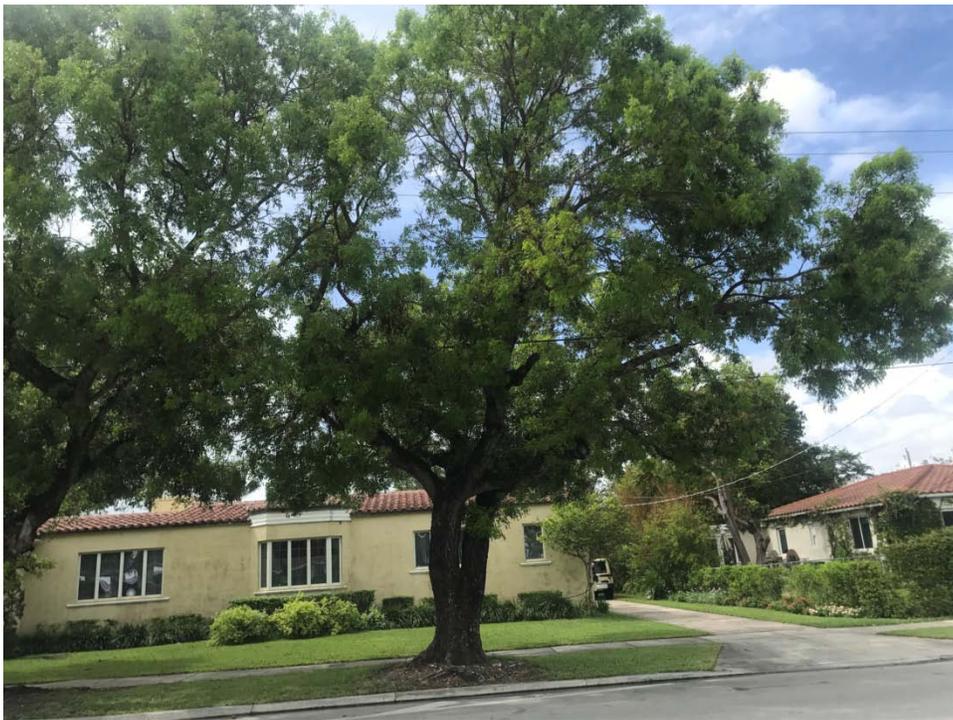
Tree 5 Mahogany (*Swietenia mahagoni*): Station Number Between 24 - 25 - Photos – 22 - 25.  
**Recommend structural trimming and potential removal.** Co dominance of major tree trunks with poor structure of leaders. Severely bent leaders. Minor decay observed in trunk and limbs. Limbs also contain damage and most extend over roadway and sidewalk. Limbs observed overlapping and rubbing other limbs causing damage. Stub cuts observed. Tree found in poor condition with included bark and major limb damage. Canopy adjacent to power lines and has been severely trimmed.

**Photo #22: Tree 5. Overall view of tree facing west.**

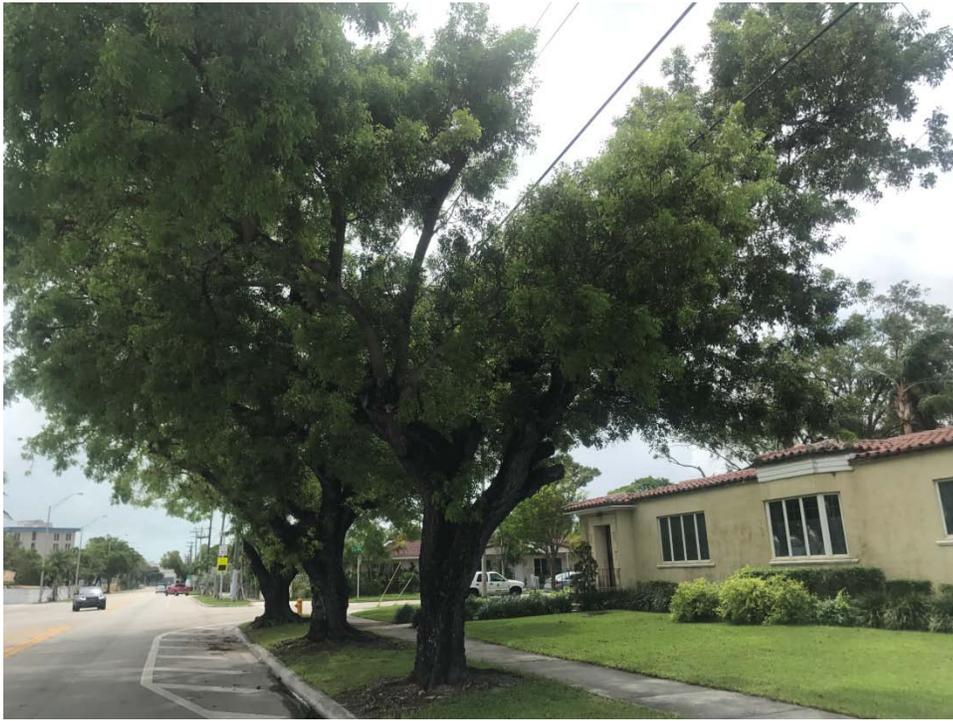
**Photo #23: Tree 5. Overall view of tree facing south.**

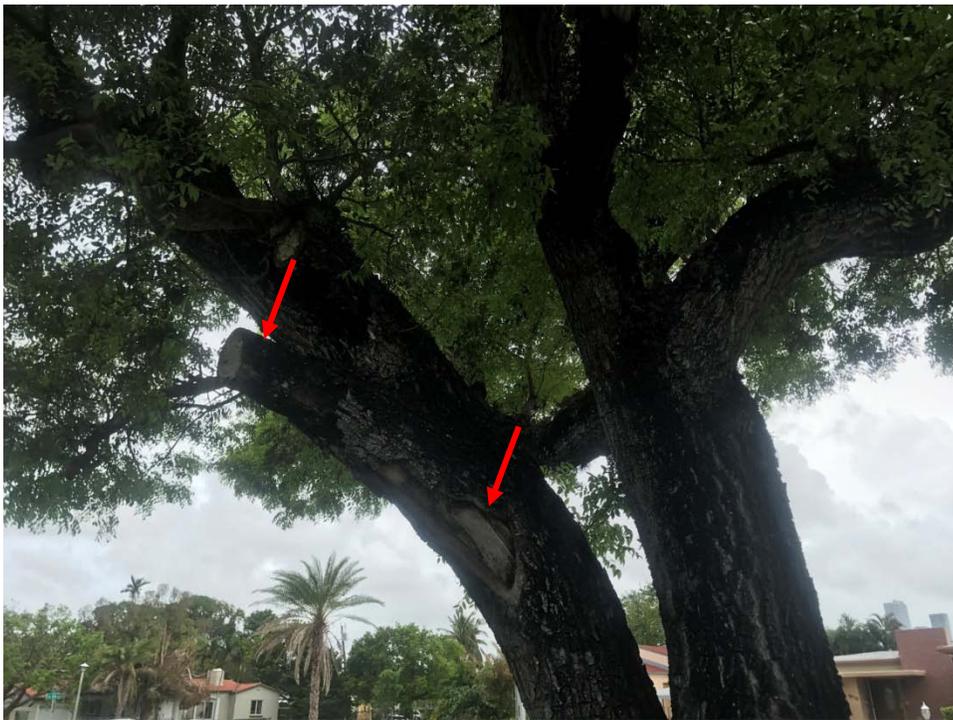
**Photo #24: Tree 5. Stub cut and trunk damage observed.**

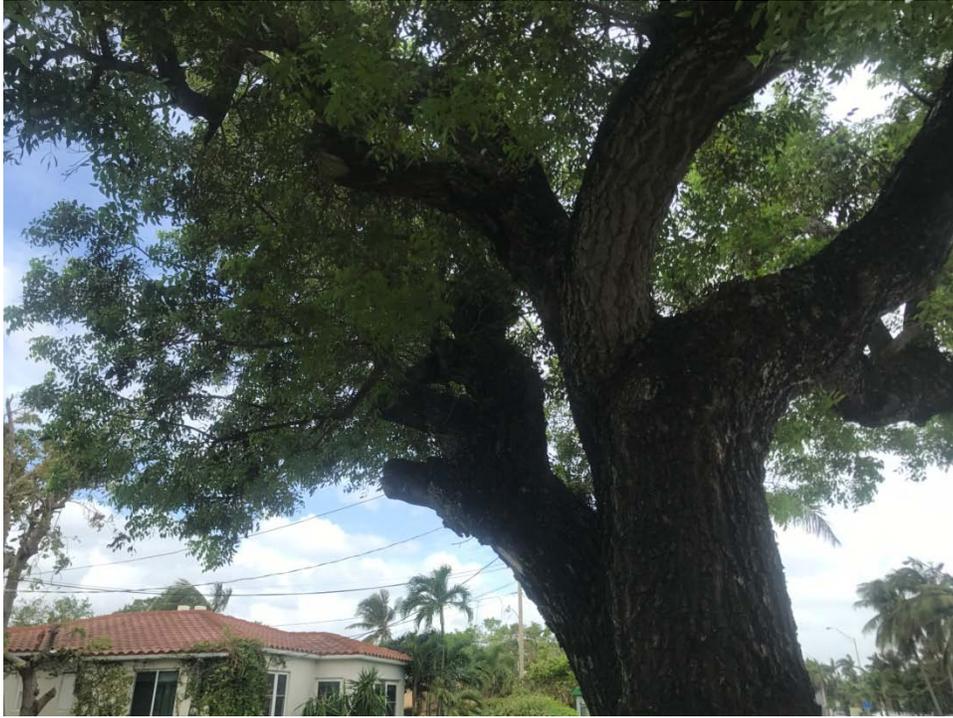
**Photo #25: Tree 5. View of poor structure.**

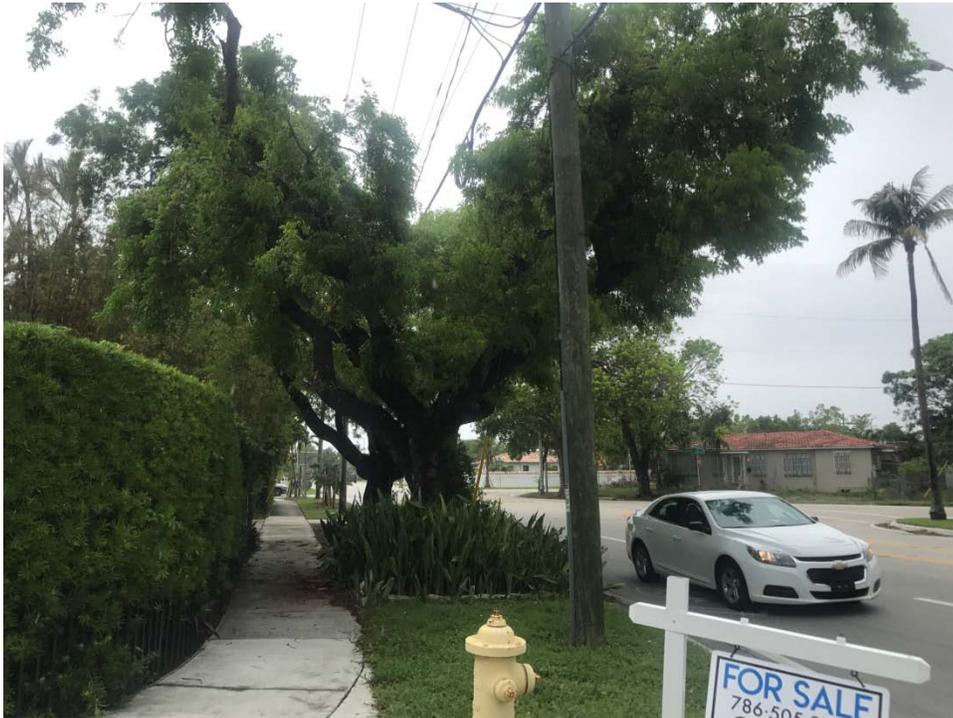
Tree 6 Mahogany (*Swietenia mahagoni*): Station Number Between 15 - 17. Southern of two trees found here. Photos 26 - 2.  
**Recommend removal.** Co dominance of major tree trunks with poor structure of leaders. Bent leaders leaning over roadway and pedestrian walk way. Limbs contain major damage and most extend over roadway and sidewalk. Tree found in poor condition. Canopy adjacent to power lines and has been severely trimmed. Root Constriction observed. Canopy significantly altered from FPL trimming.

**Photo #26: Tree 6. Overall view of tree. Facing north.**

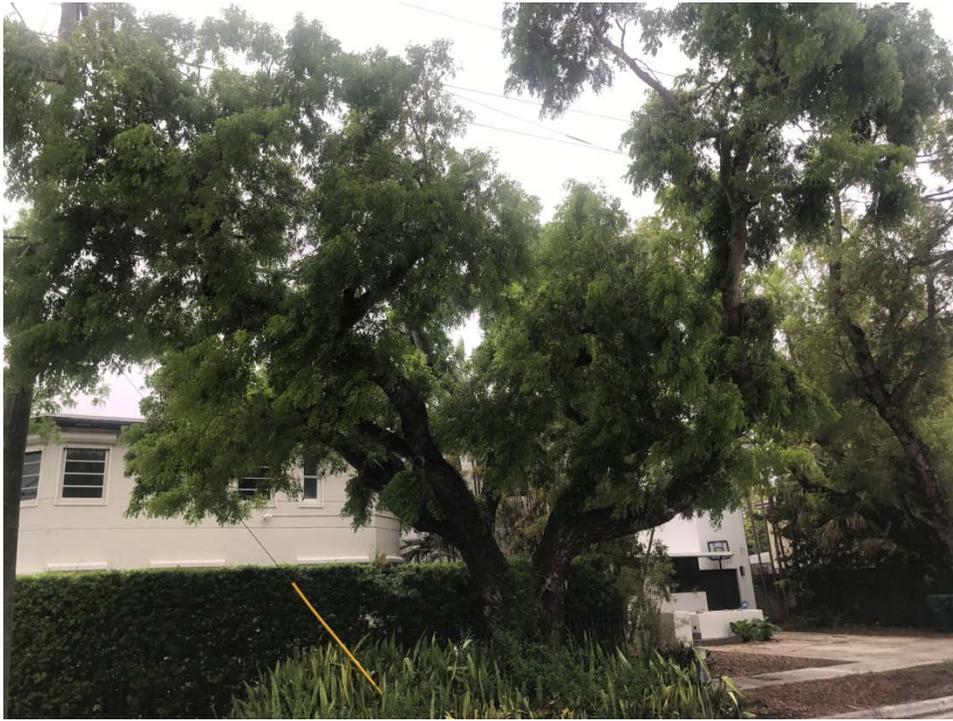
**Photo #27: Tree 6. Overall view of tree. Facing west.**

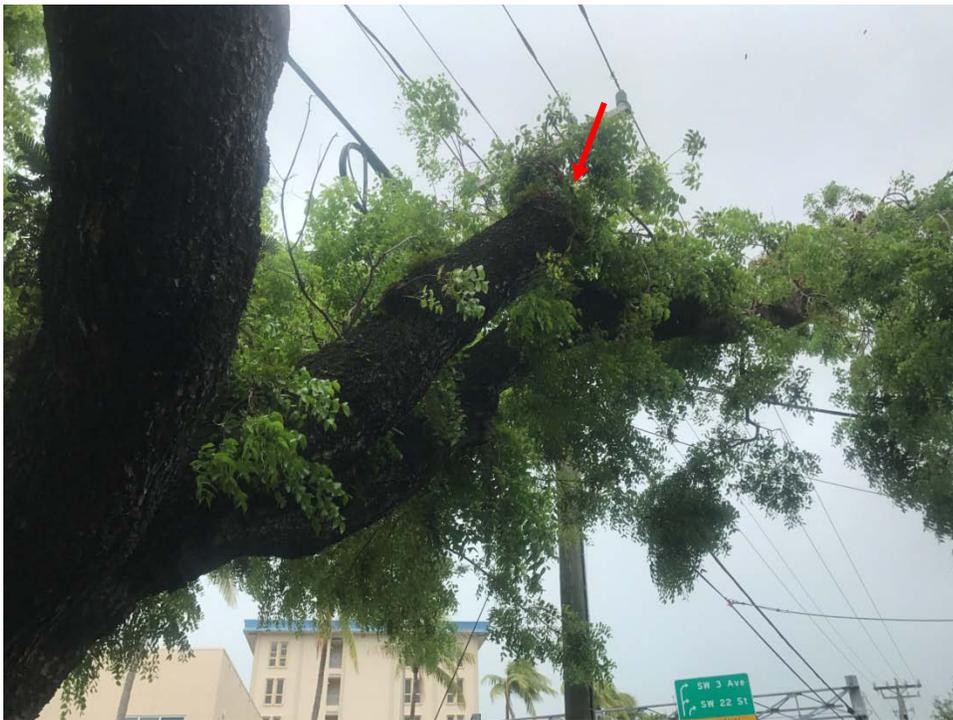
**Photo #28: Tree 6. Major limb damage observed.**

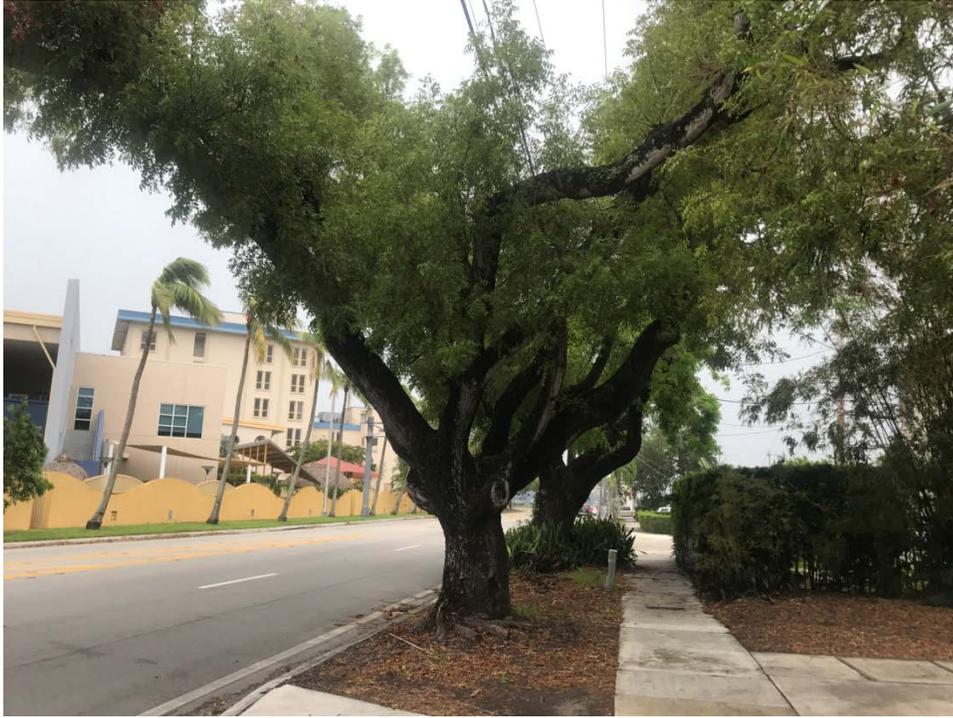
Tree 7 Mahogany (*Swietenia mahagoni*): Station Number Between 15 - 17- Northern of two trees found here. Photos 29 - 32.  
**Recommend removal.** Co dominance of tree trunks. Major limb damage. Poor structure and bent leaders. Stub cuts observed with decay. Limbs and co-dominant trunks extend over roadway and sidewalk. Tree found in poor condition with significant decay of trunk and included bark. Canopy adjacent to power lines and has been severely trimmed.

**Photo #29: Tree 7. Overall view of tree. View south.**

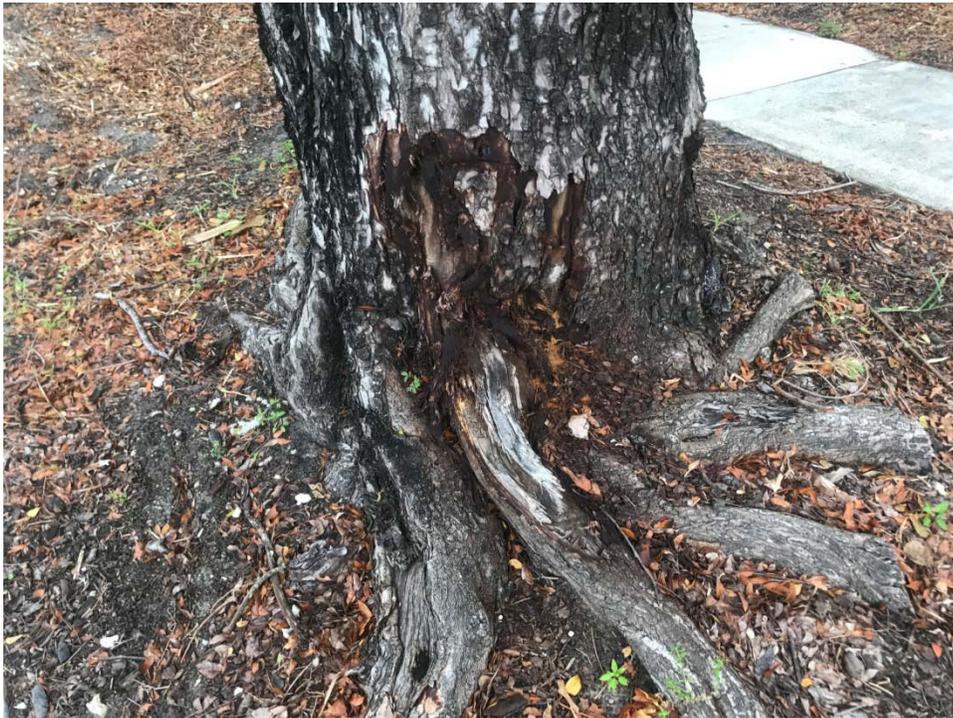
**Photo #30: Tree 7. Trunk damage observed.**

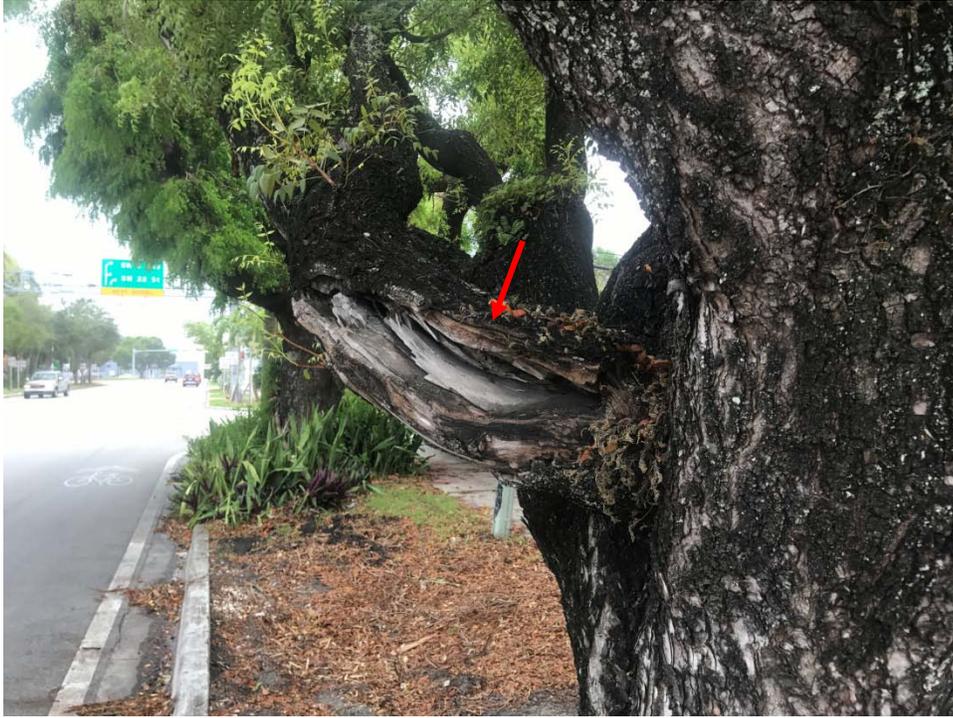
**Photo #31: Tree 7. Major limb damage observed.**
