# Environmental Arborist Services

## TREE ASSESSMENT

<b>PROJECT TITLE:</b> Arborist Tree Inspection- Along 12 Ave. between Coral Way and SW 12 <sup>th</sup> street, Miami FL 33145	<b>DATE:</b> 10-04-17	<b>DAY:</b> Wednesday	<b>REPORT NO.</b> 1	<b>PROJECT NO.</b> 13-00060
<b>TEMPERATURE</b> 88° F	<b>CONTRACTOR:</b>		<b>FIRM:</b> MILLER LEGG	
<b>Weather Condition:</b> Partly cloudy			<b>PROJECT MANAGER:</b> Mike Kroll	<b>Proj. Superintendent:</b>
<b>VISITORS:</b> N/A		<b>MIAMI-DADE :</b> N/A

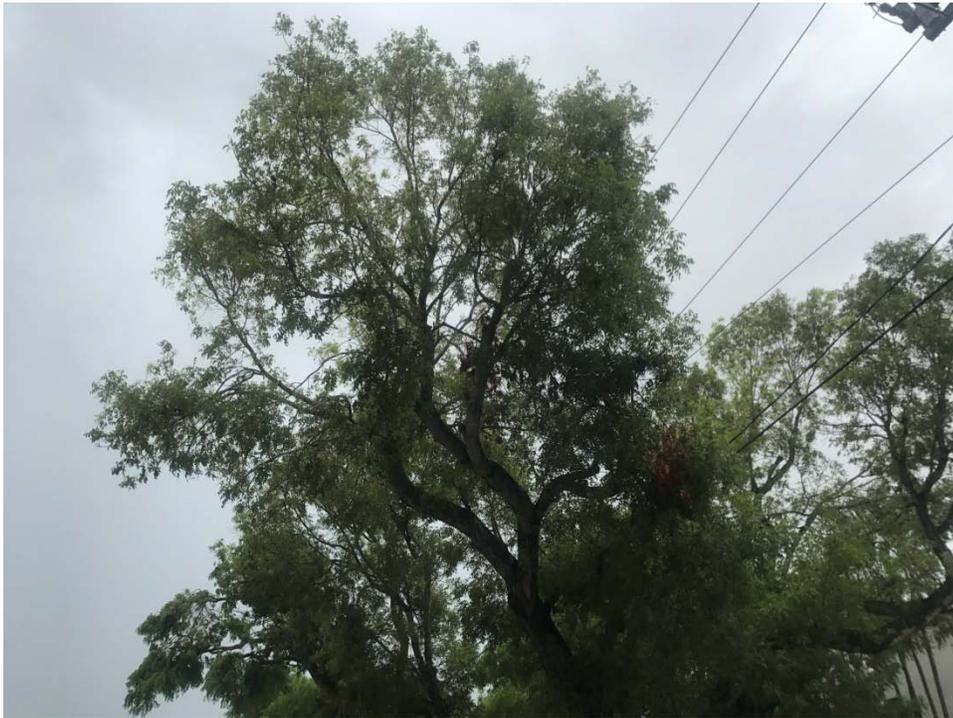
Tree 7 Mahogany (*Swietenia mahagoni*): Station Number Between 15 - 17- Northern of two trees found here. Photos 29 - 32.  
**Recommend removal.** Co dominance of tree trunks. Major limb damage. Poor structure and bent leaders. Stub cuts observed with decay. Limbs and co-dominant trunks extend over roadway and sidewalk. Tree found in poor condition with significant decay of trunk and included bark. Canopy adjacent to power lines and has been severely trimmed.

**Photo #32: Tree 7. Damaged canopy observed from trimming adjacent to powerlines.**
