Analysis of New Centrifugal Pump Installation Exhibiting Excessive Vibration

Ken Singleton
Manager KSC Consulting
19676 Serenity Lane
Bristol VA 24202
Office/Fax 276-669-8459
ksingleton@vibrationconsulting.com

Robert R McGinnis P.E.
M M Engineering
429 Fondulac Drive
Kingsport TN 37663
Office/Fax 423-239-9713
Mmengineering@charter.net

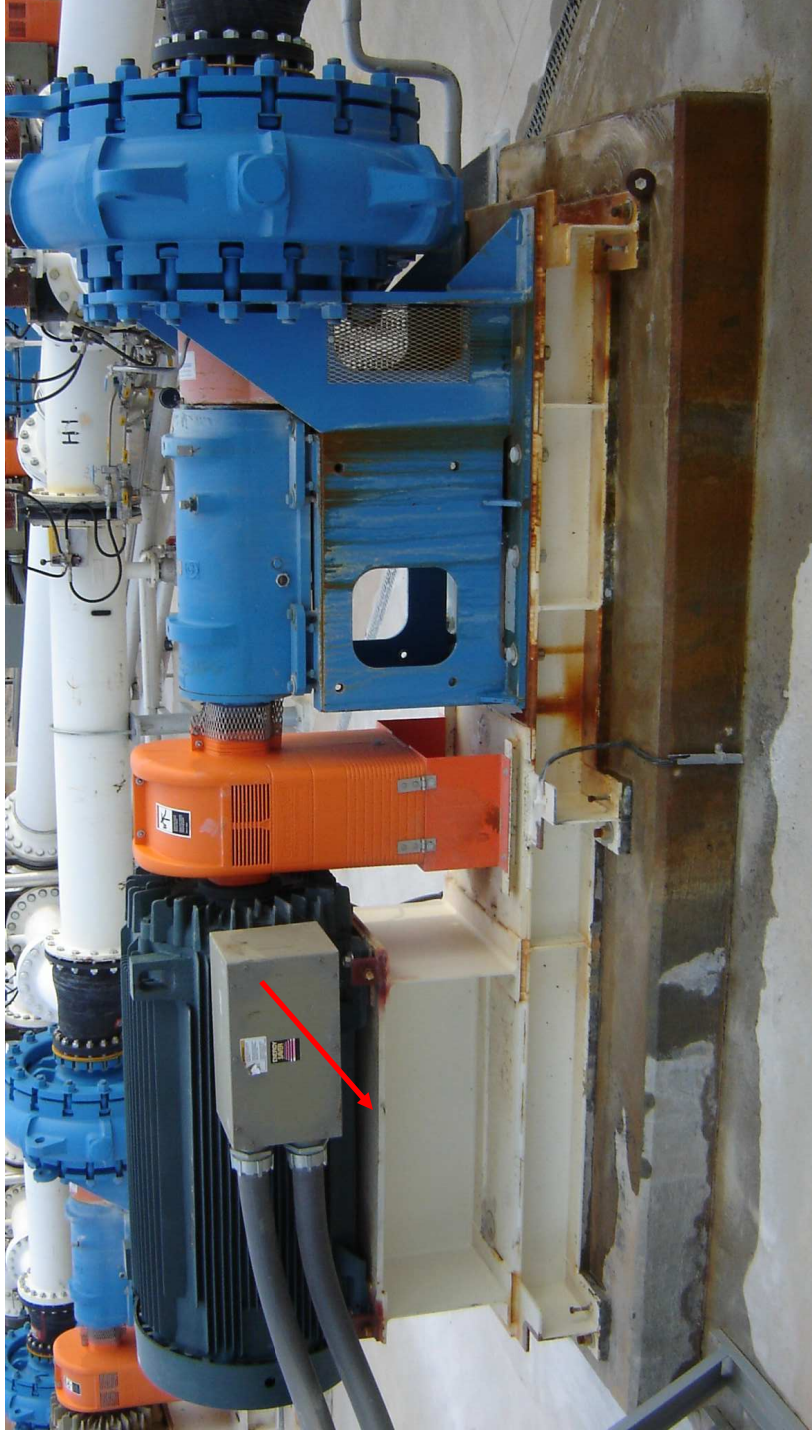
Fabricated Motor Pedestal: 1" Plate Welded to 16" wide flange beams.

The Vertical center plate was welded to the Wide Flange beams.

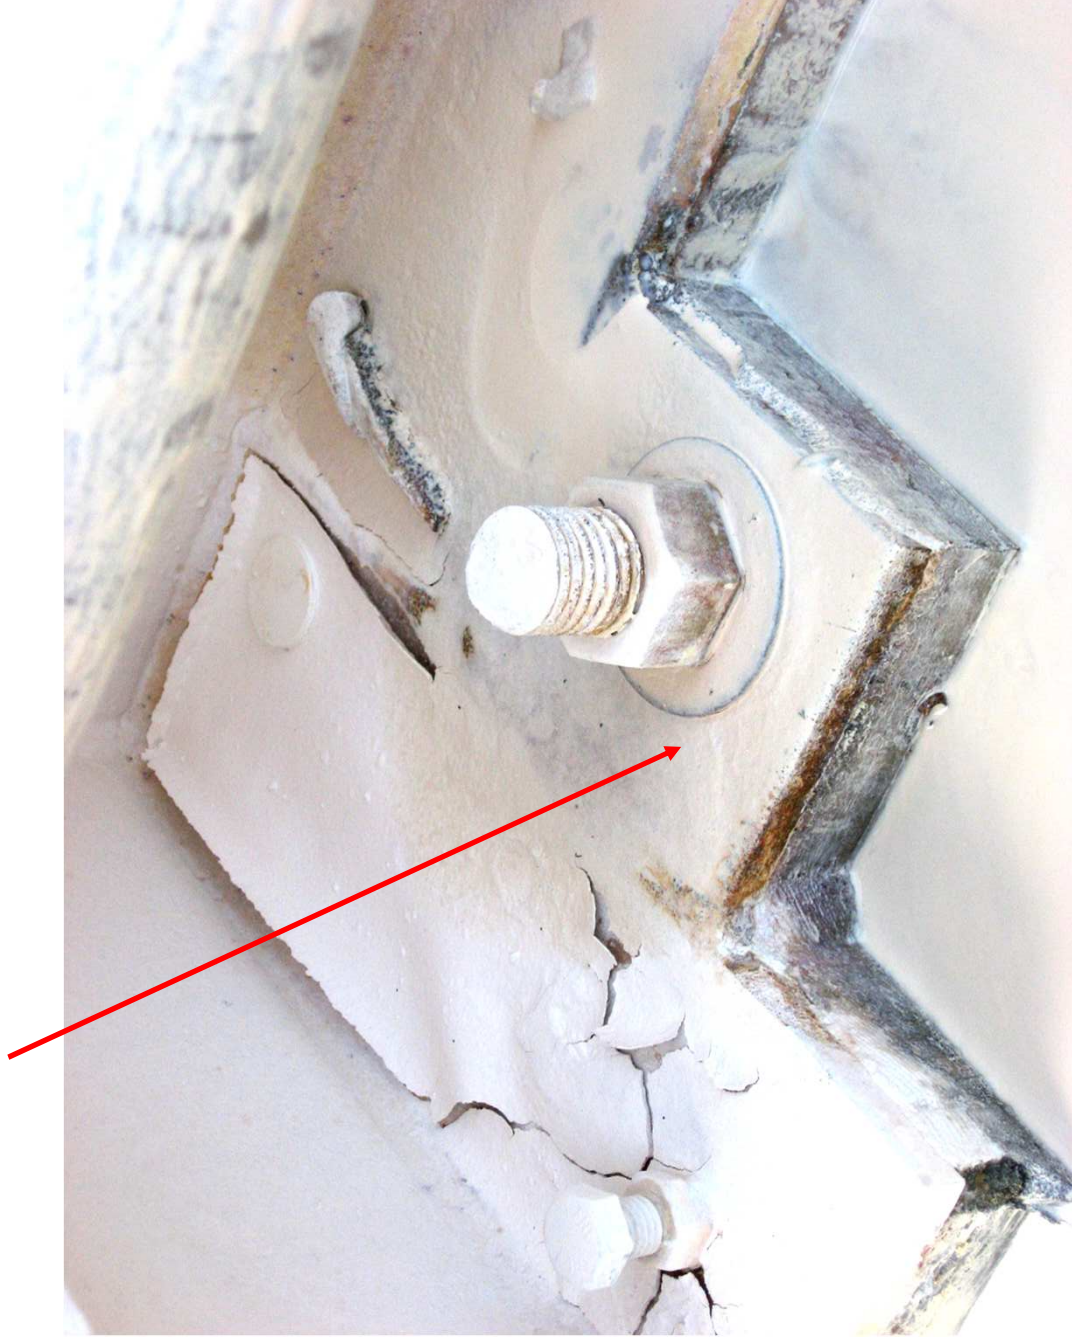
Plate Welded to Skid at the Pump End For Anchor Bolt.

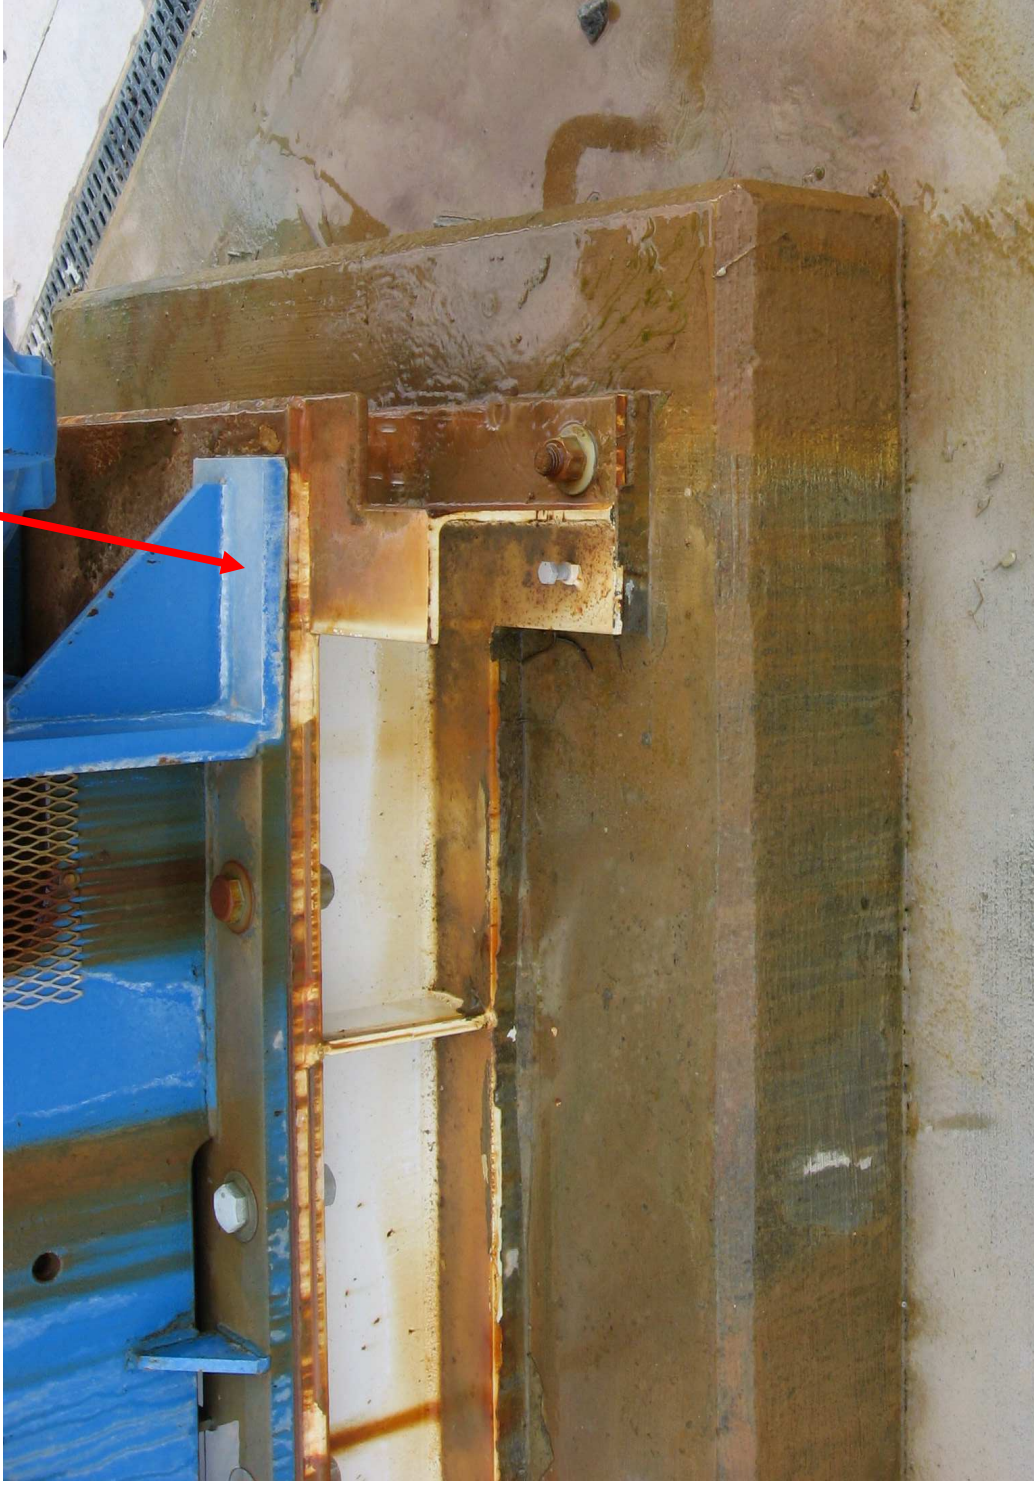
No Hold Down Bolt At End of Pump Base For Attaching Base to The Skid.

9. Install Hold Down Bolts Through Pump Base and Skid Both Sides.

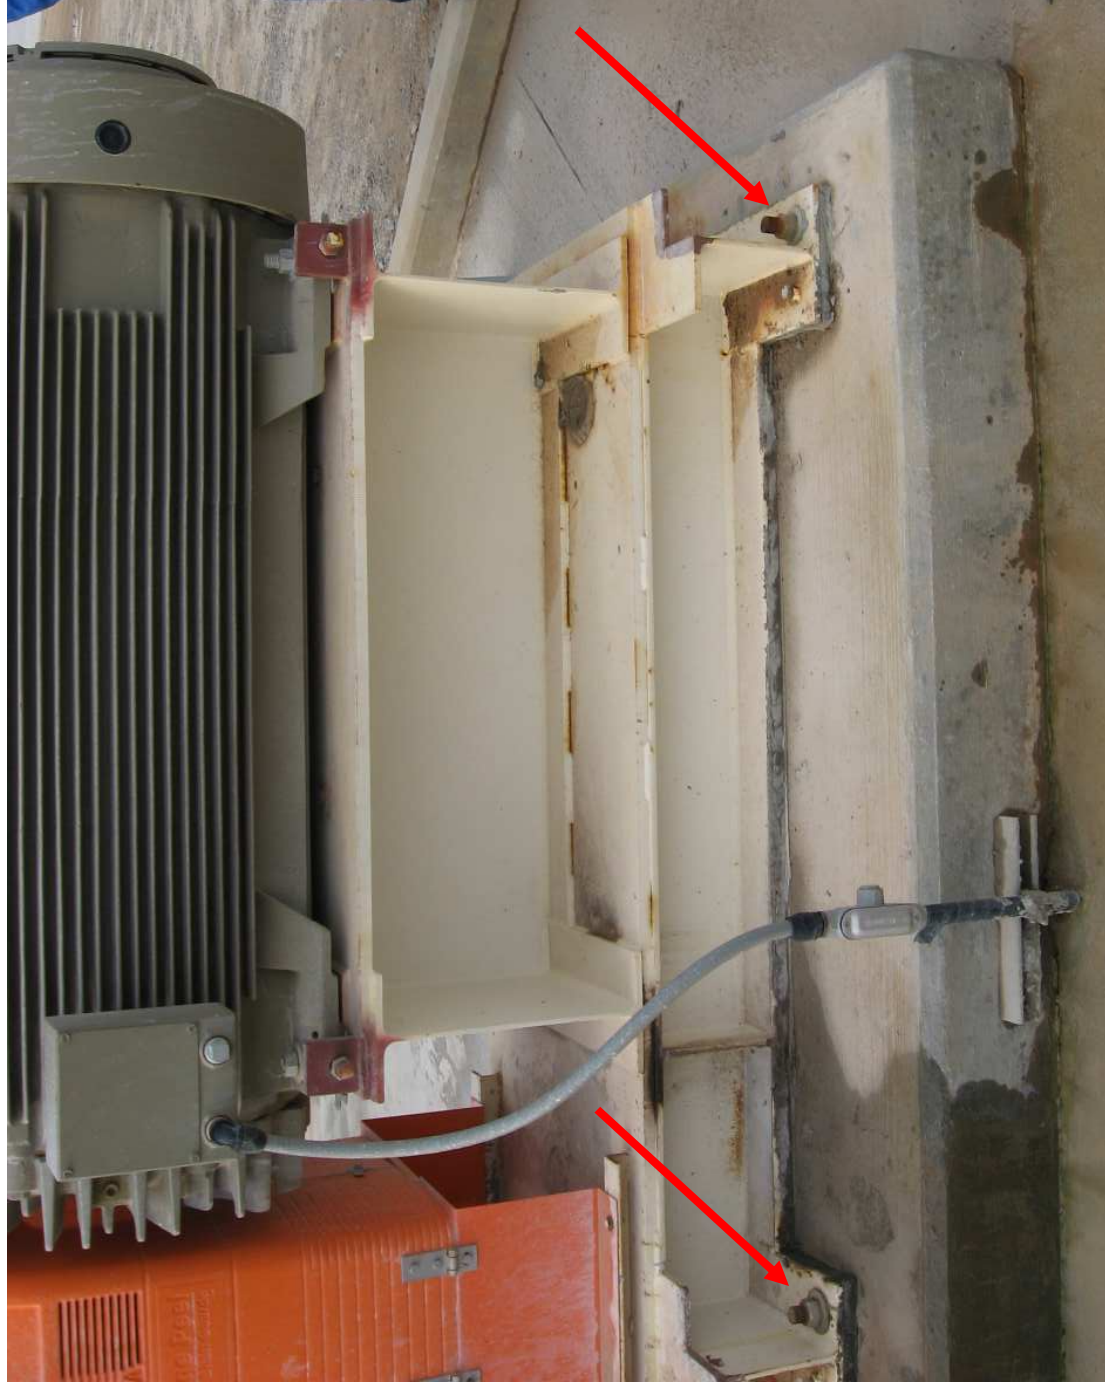
Wide Flange Beam Skid Extensions Used For Anchor Bolt Hold Downs were very flexible.

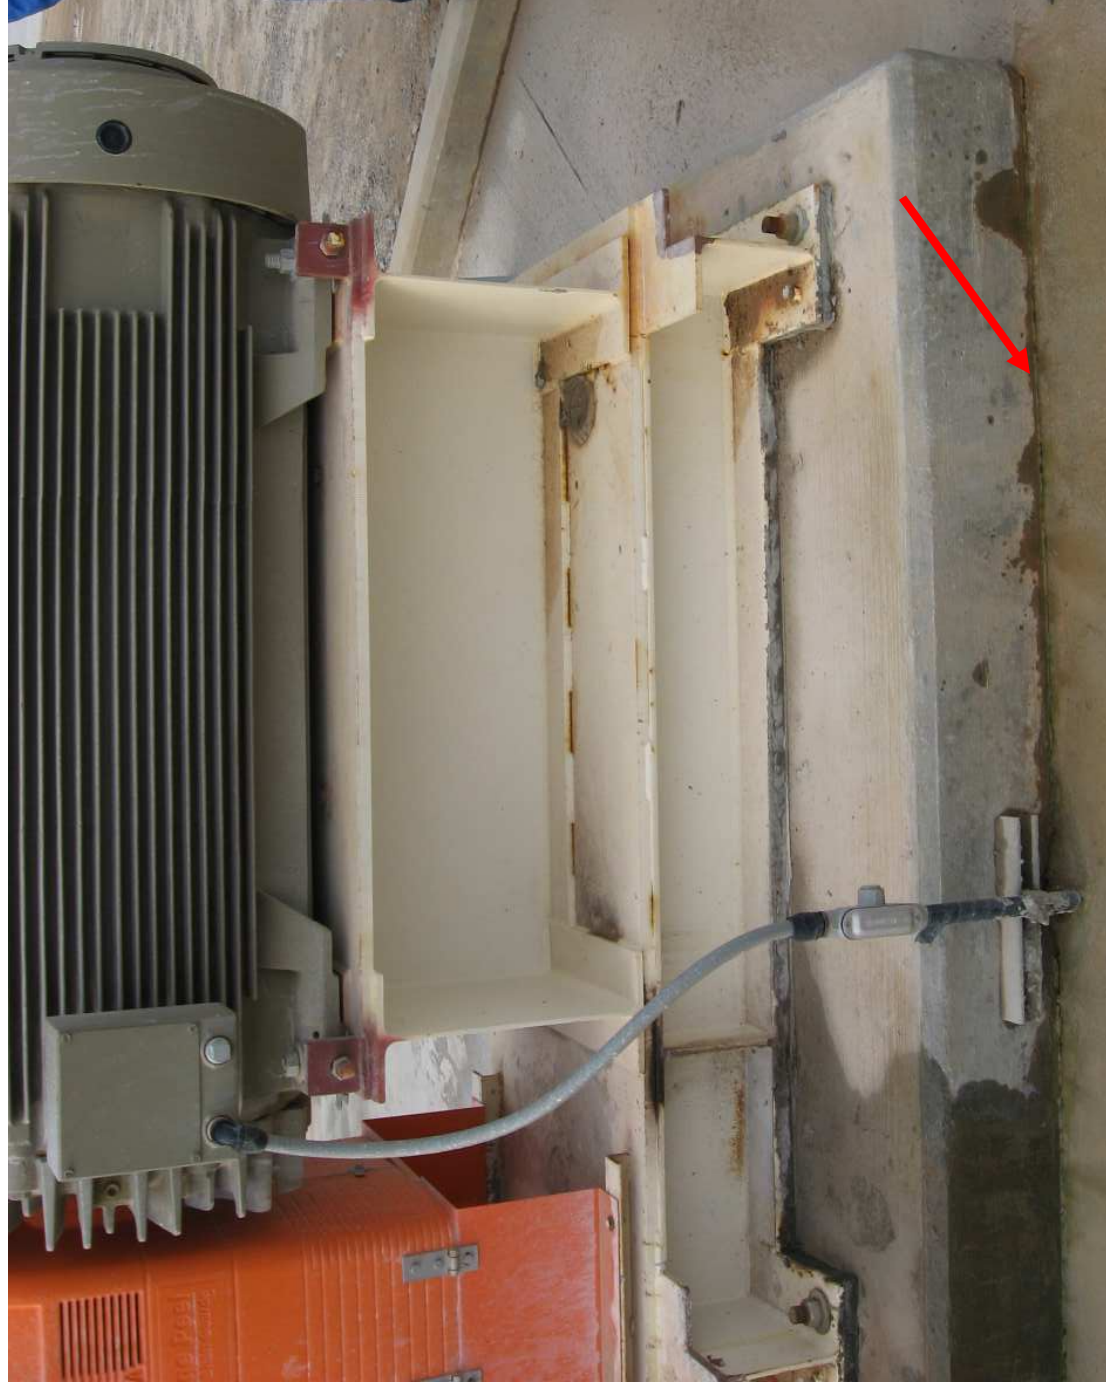
Lack of Bonding of the Concrete Base to the Concrete Mat.

6. Replace anchor bolt washers with washers a minimum $\frac{1}{2}$ " thick and hole size no more than $\frac{1}{16}$ " larger than the bolts.
7. To correct the relative movement between the concrete base and concrete pad, injection of epoxy grout should be considered. If stiffening of the structural steel is successful, then grout injection may not be required.

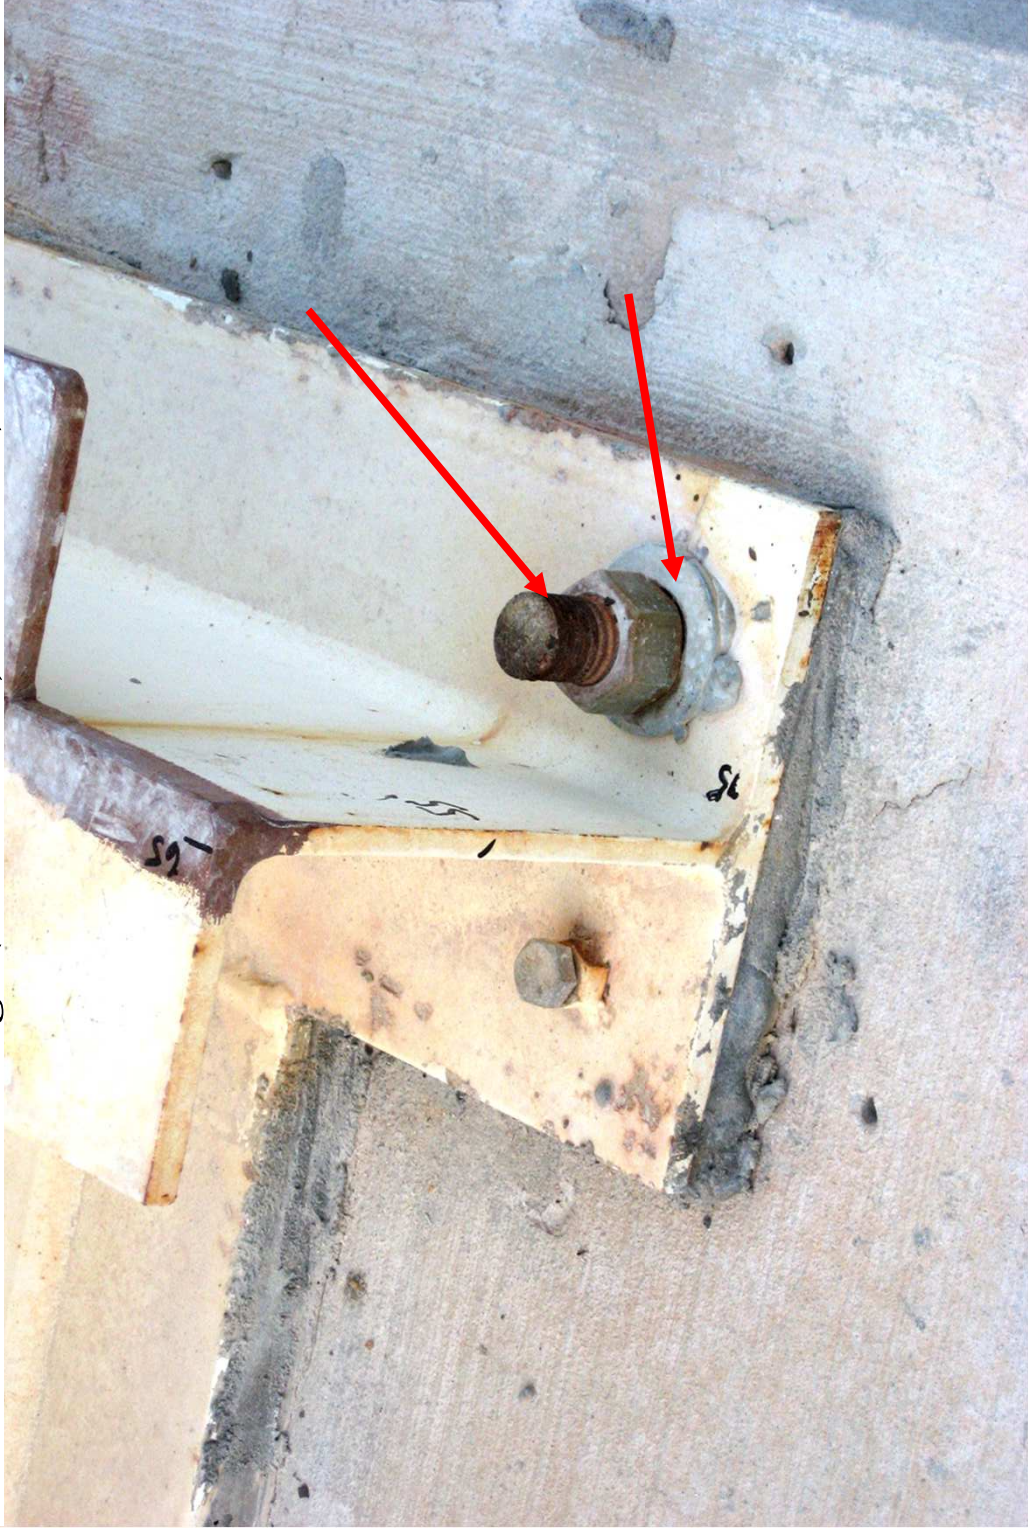
**Anchor Bolts of Carbon Steel instead of 304 Stainless.
Bolts exhibited corrosion.
Washers were too Large (1" Washers, 7/8" Bolts).**

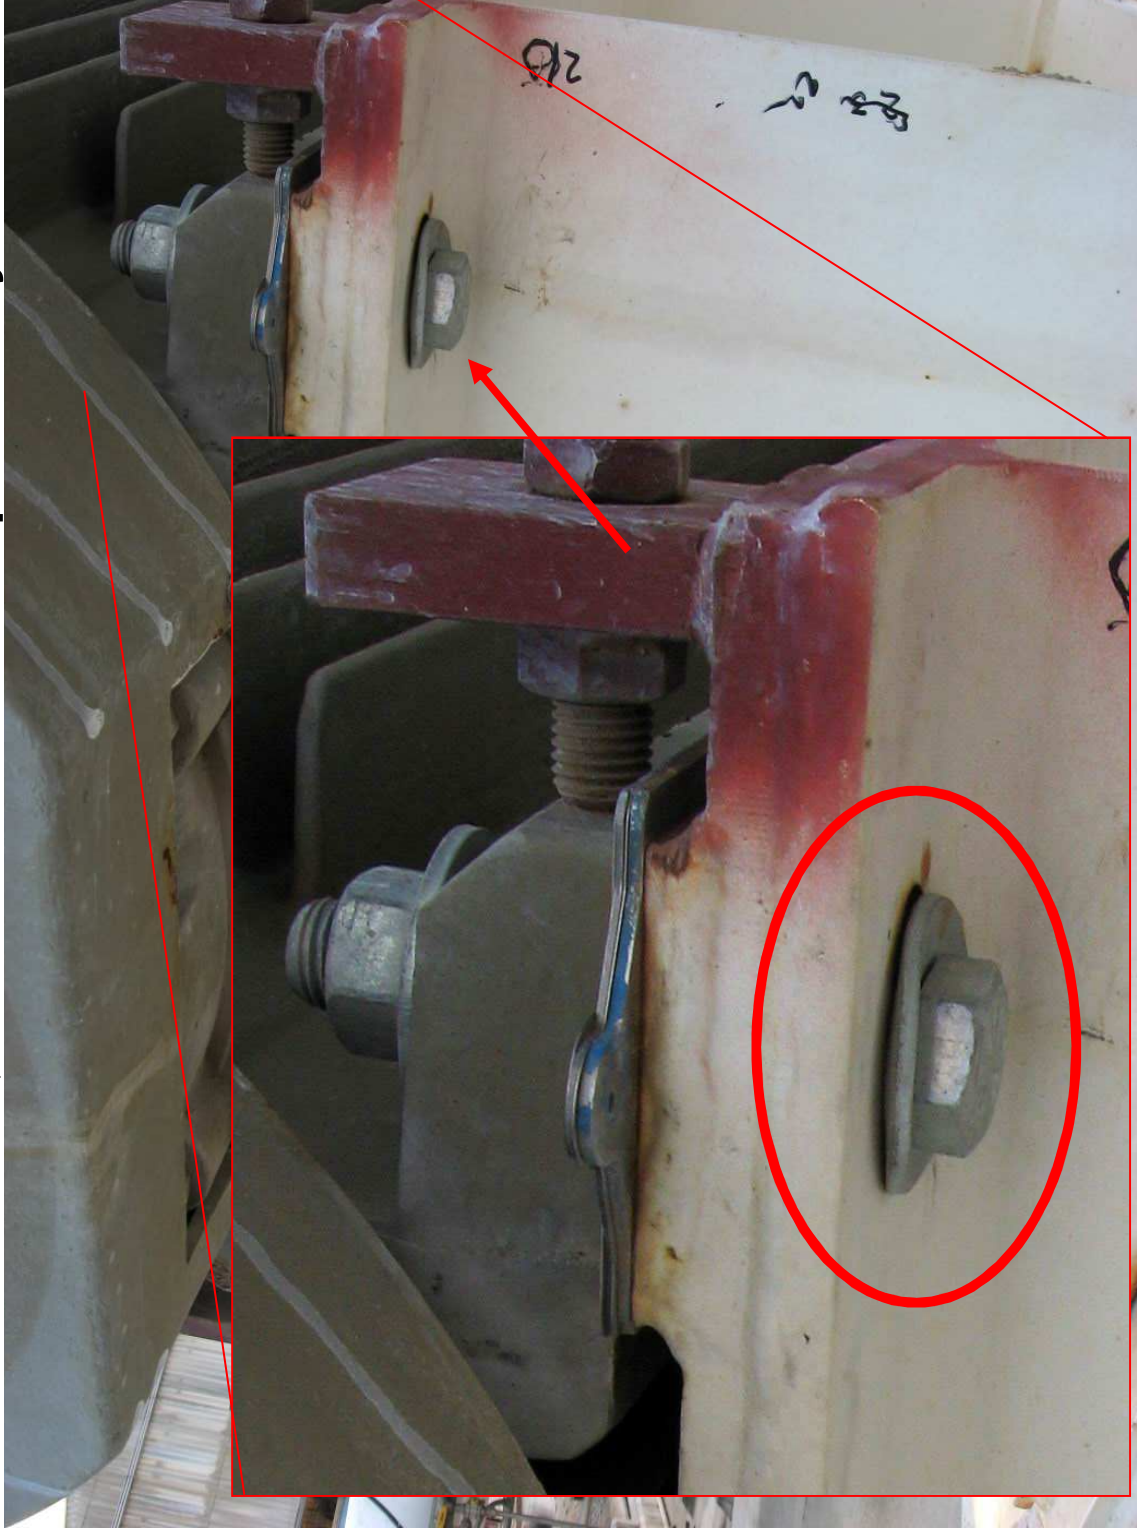
Motor Hold Down Bolts; Oversized Washers Had Deformed Resulting in No Bolt Preload, Motor Foot Not Clamped Firmly to Plate.

5. Replace the motor hold down bolt washers with washers a minimum of $\frac{1}{2}$ " thickness and hole size no more than $\frac{1}{16}$ " larger than the bolts.

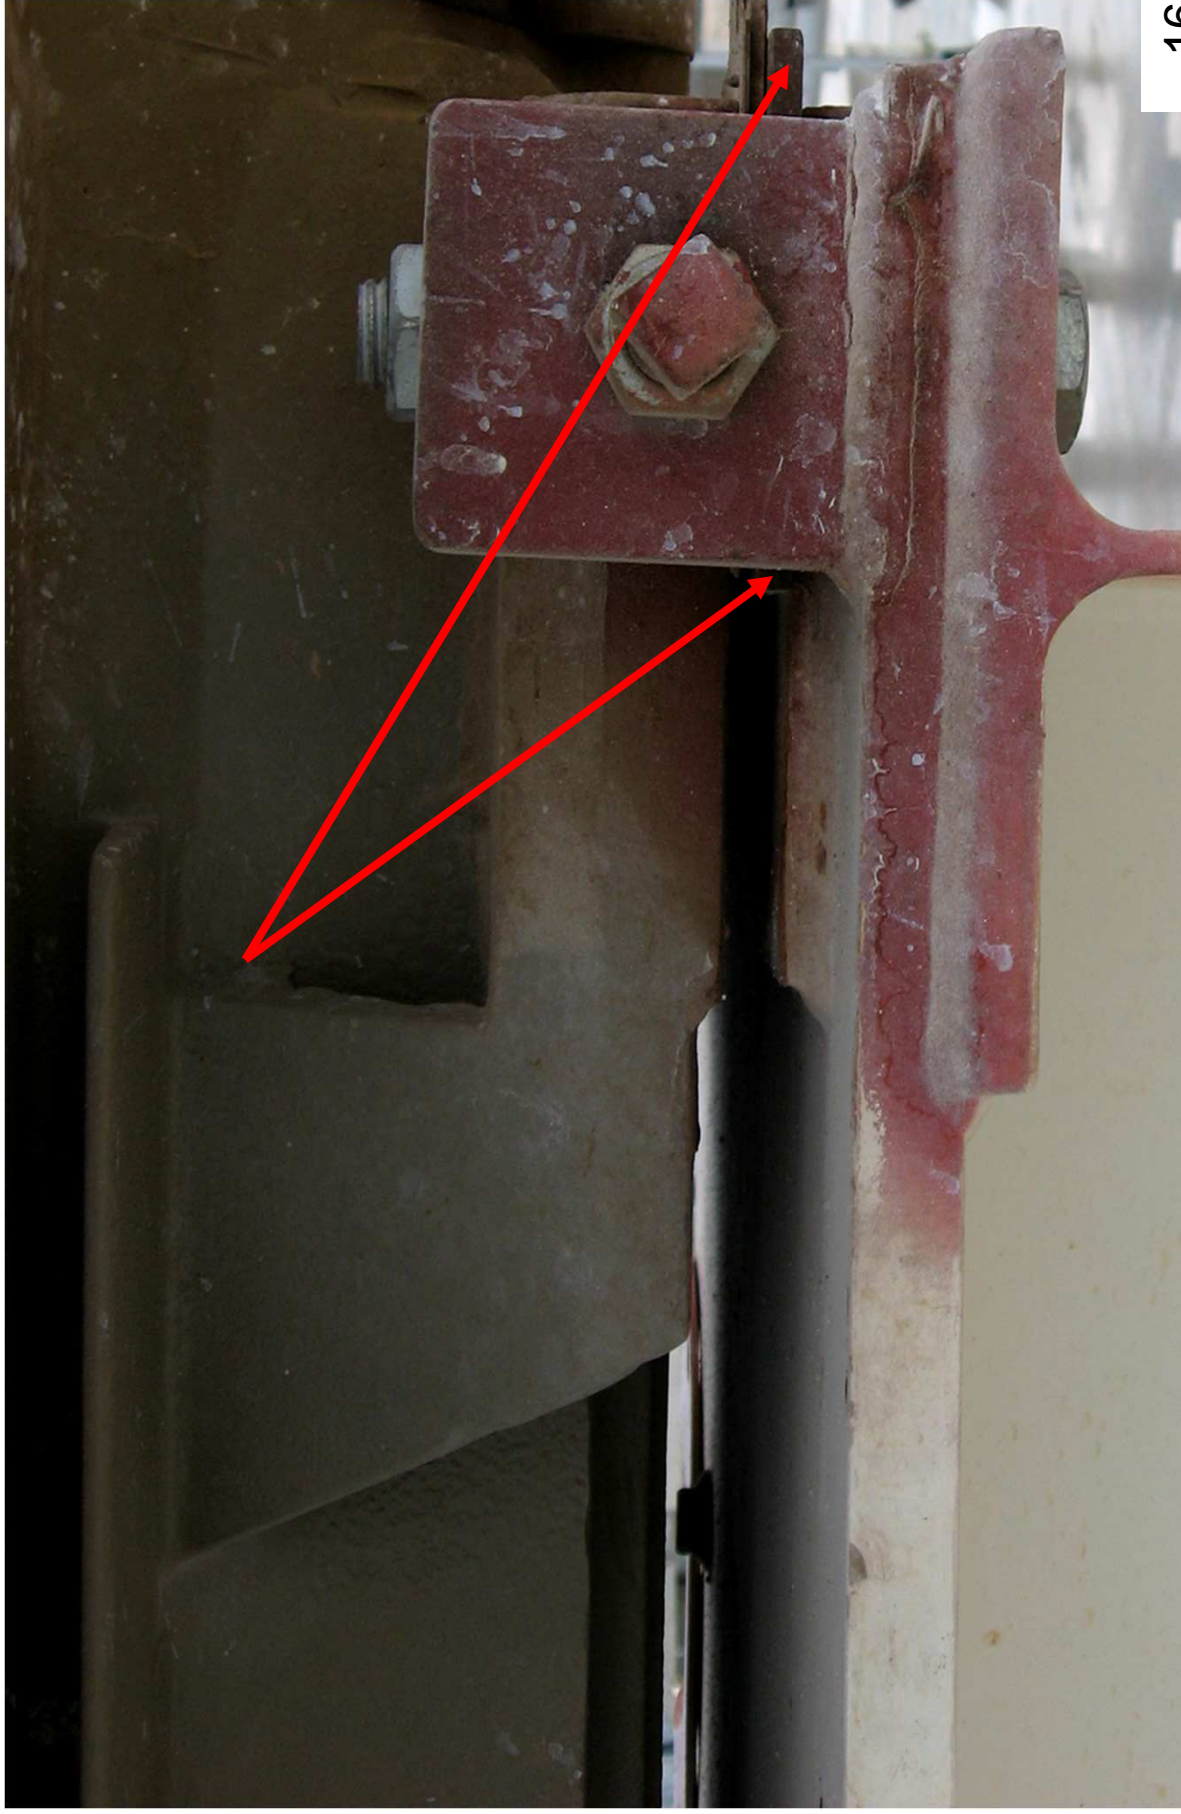
Carbon Steel Shim used under Some Motor Feet had Corroded.

4. Remove the carbon steel shims from the motor shim stack and replace with ground stainless steel shims. Limit shim stack to 5 shims.

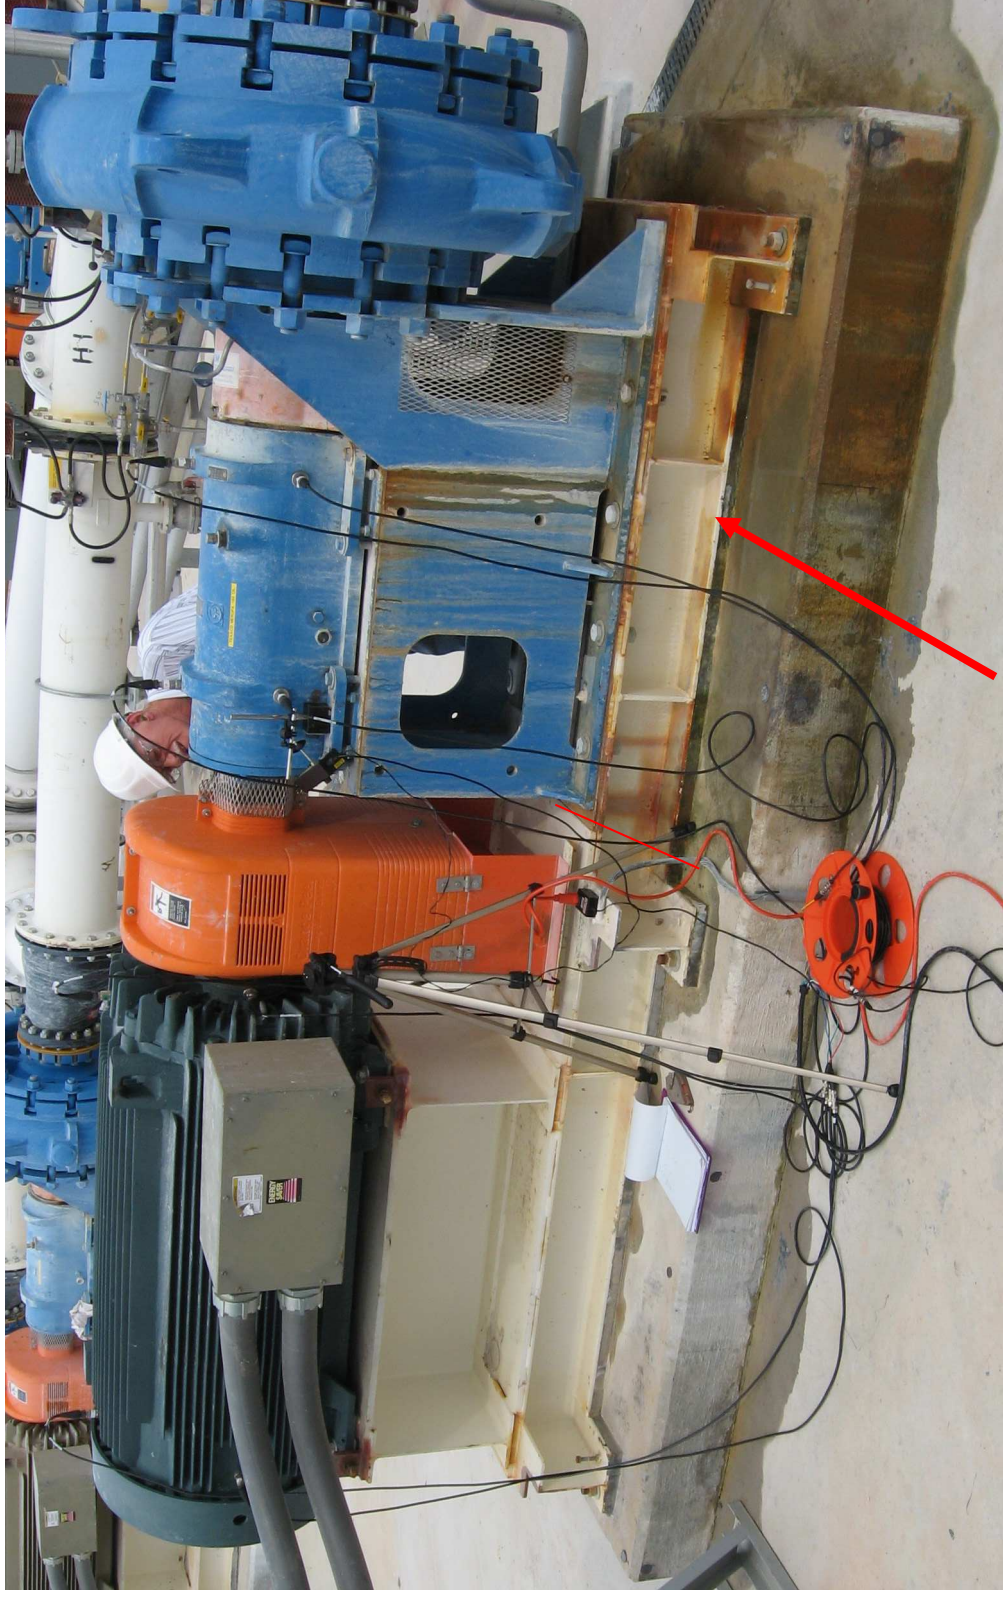
Relative Movement at the Grout and Concrete Interface under the Skid, (“pumping water”) - Indication of Lack of Bonding of Epoxy Grout.

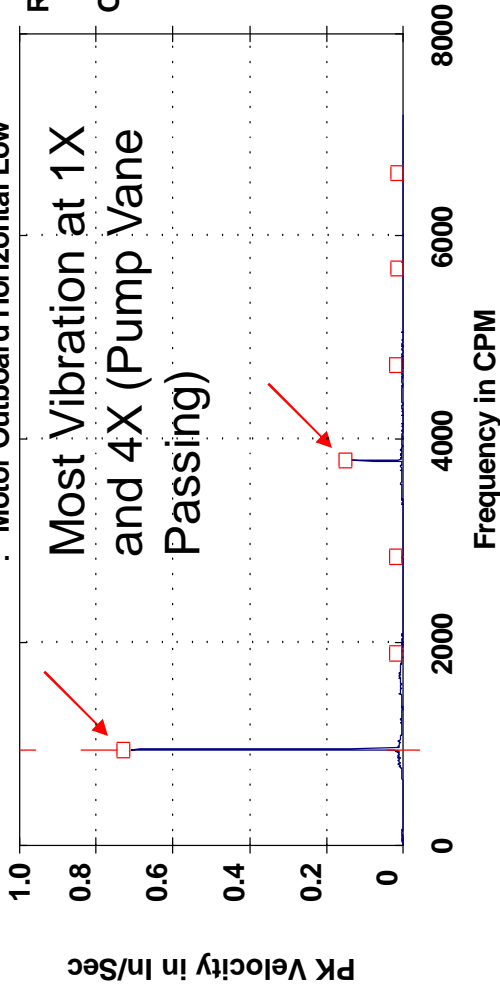
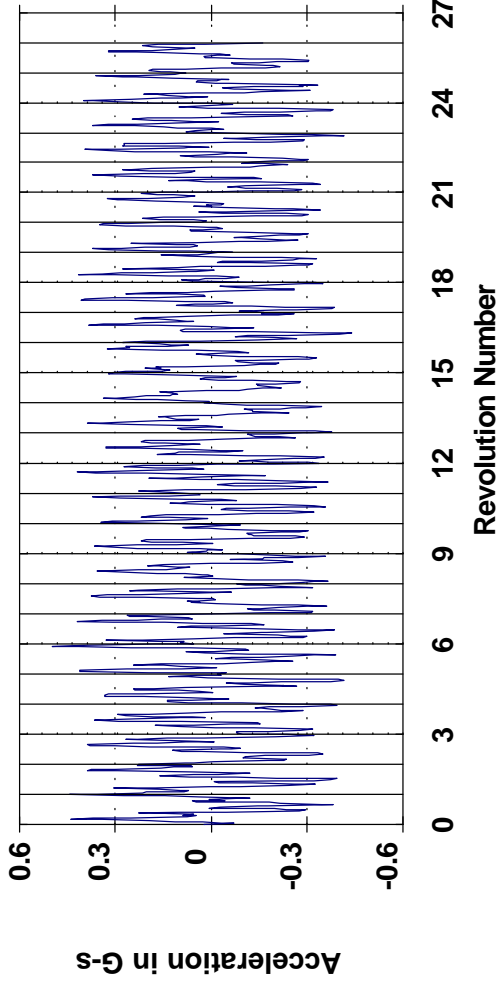
Vibration Data Measured at the #1 Motor & Pump Bearing Housings. Amplitudes Very High in Horizontal Direction. Motor OB Highest.

.713 in/sec at 1 X RPM
(Horizontal Direction) –
was over 12X higher than
in Vertical Direction)

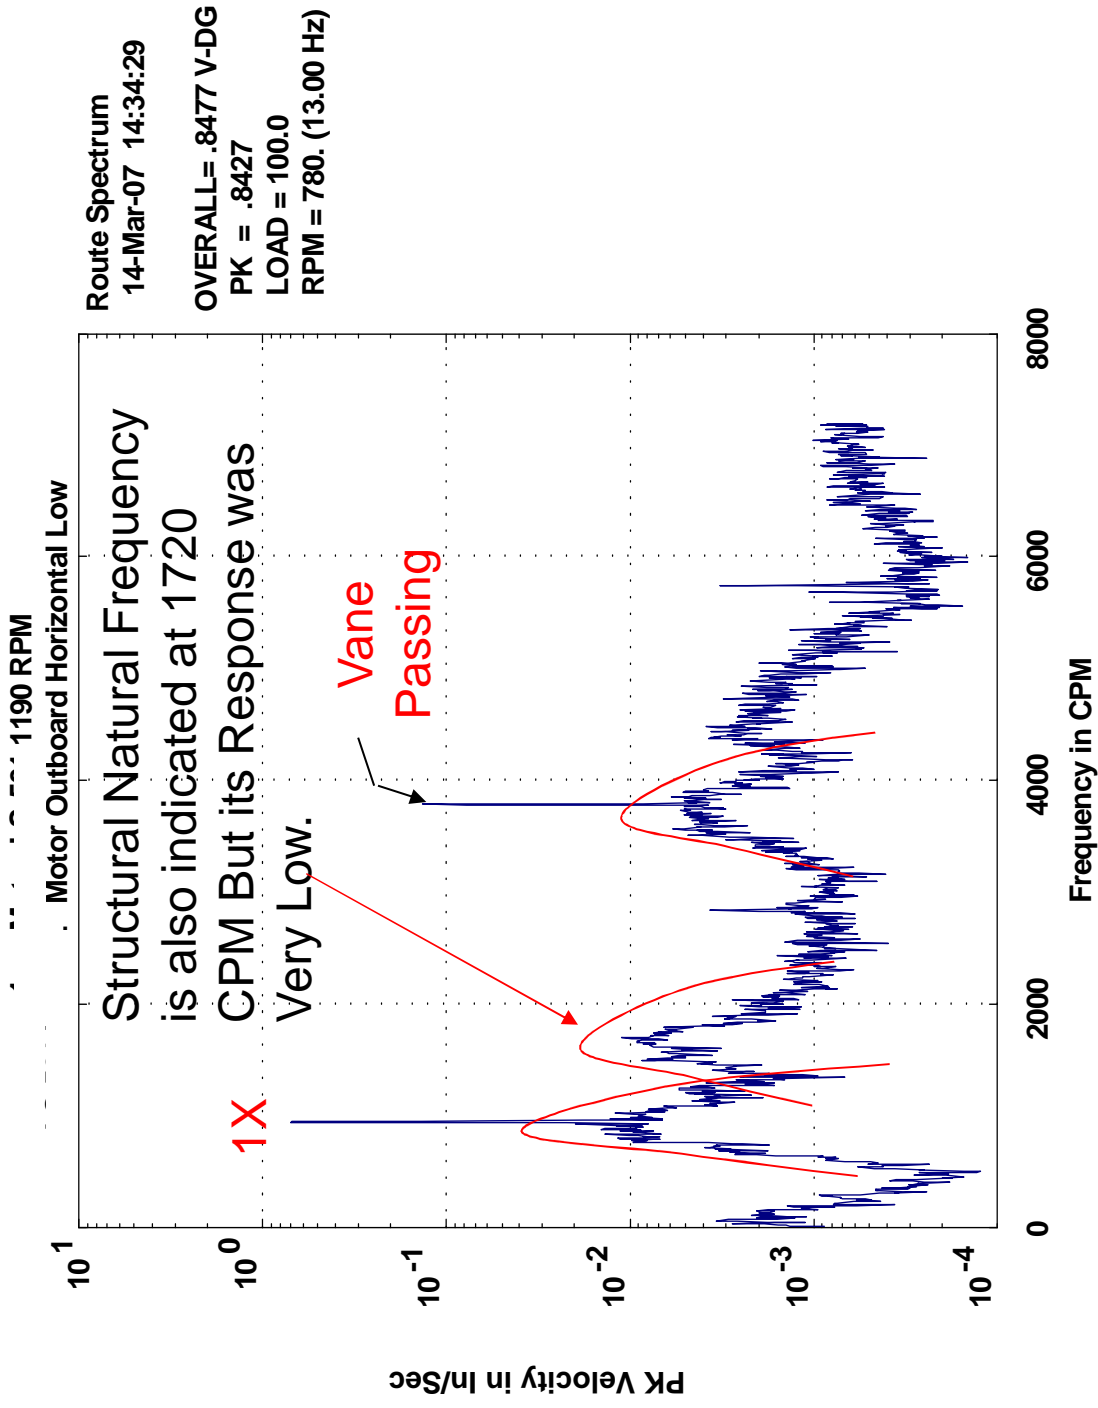
Plotting Spectrum Data in Log Magnitude Indicated Resonance at 1X and Vane Passing Frequency.

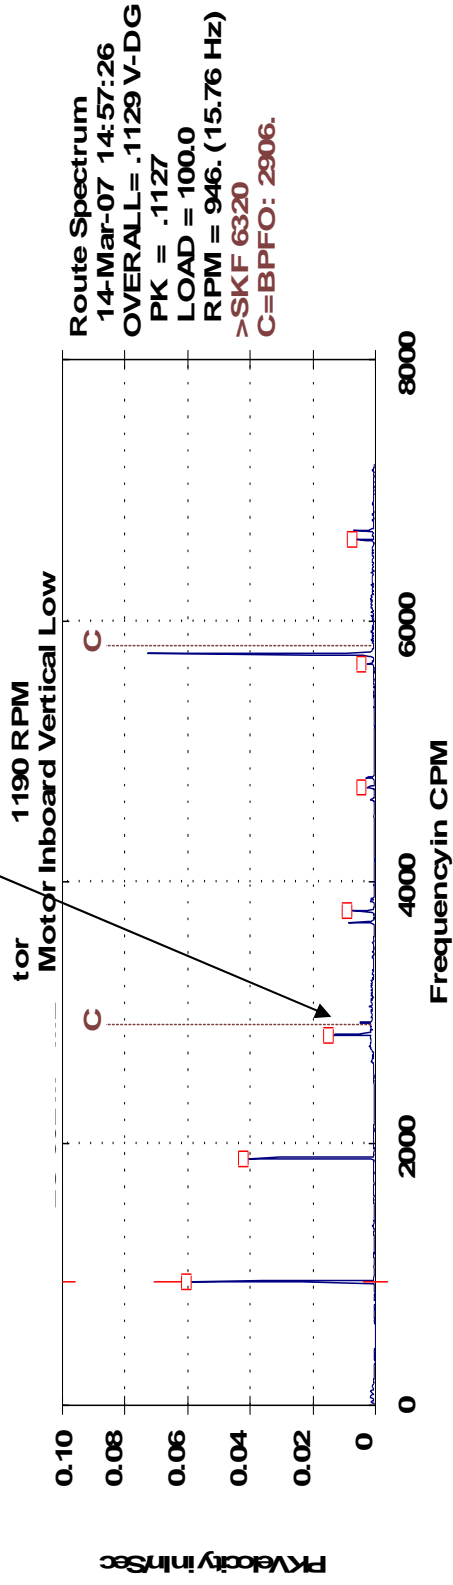
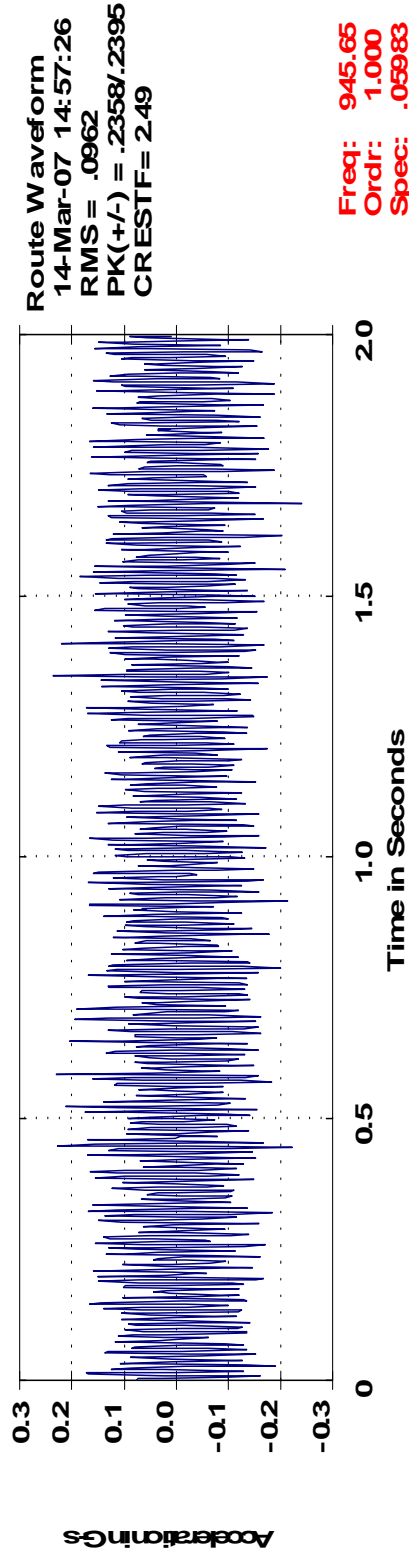
Motor Inboard Bearing Defect Frequency for the Outer Race Appeared in the Spectrum Data.

The Outer Race Ball Passing Defect Frequency of the SKF 6320 Bearing was also Evident in Data Measured at the Motor Inboard Bearing Housing.

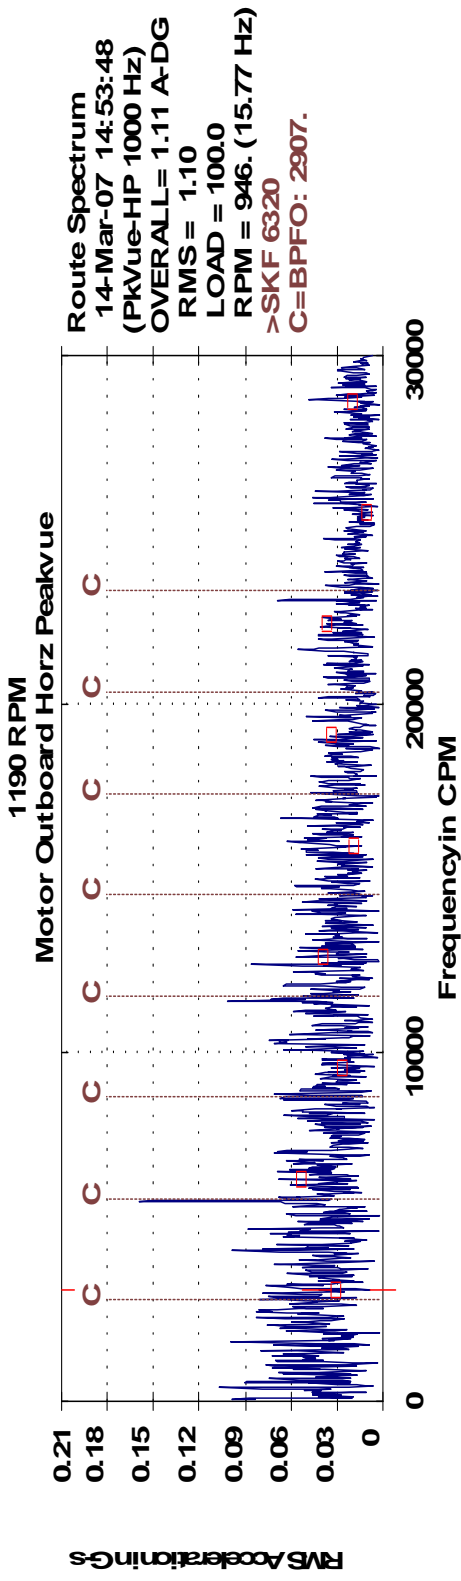
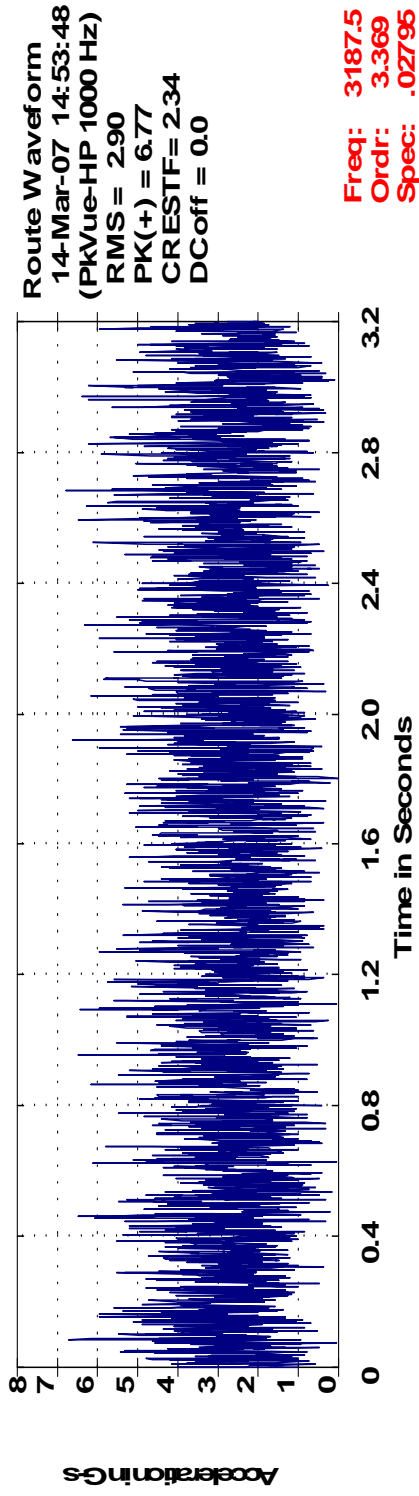
CSI PeakVue Data was Above Alarm Level in the Time Domain. Twice Line Frequency of the VDF was The Primary Frequency.

PeakVue Data at the Motor OB Brg Housing Measured about 6 g's (Alarm Level).
Line Frequency of the VFD was the Highest Amplitude Frequency.

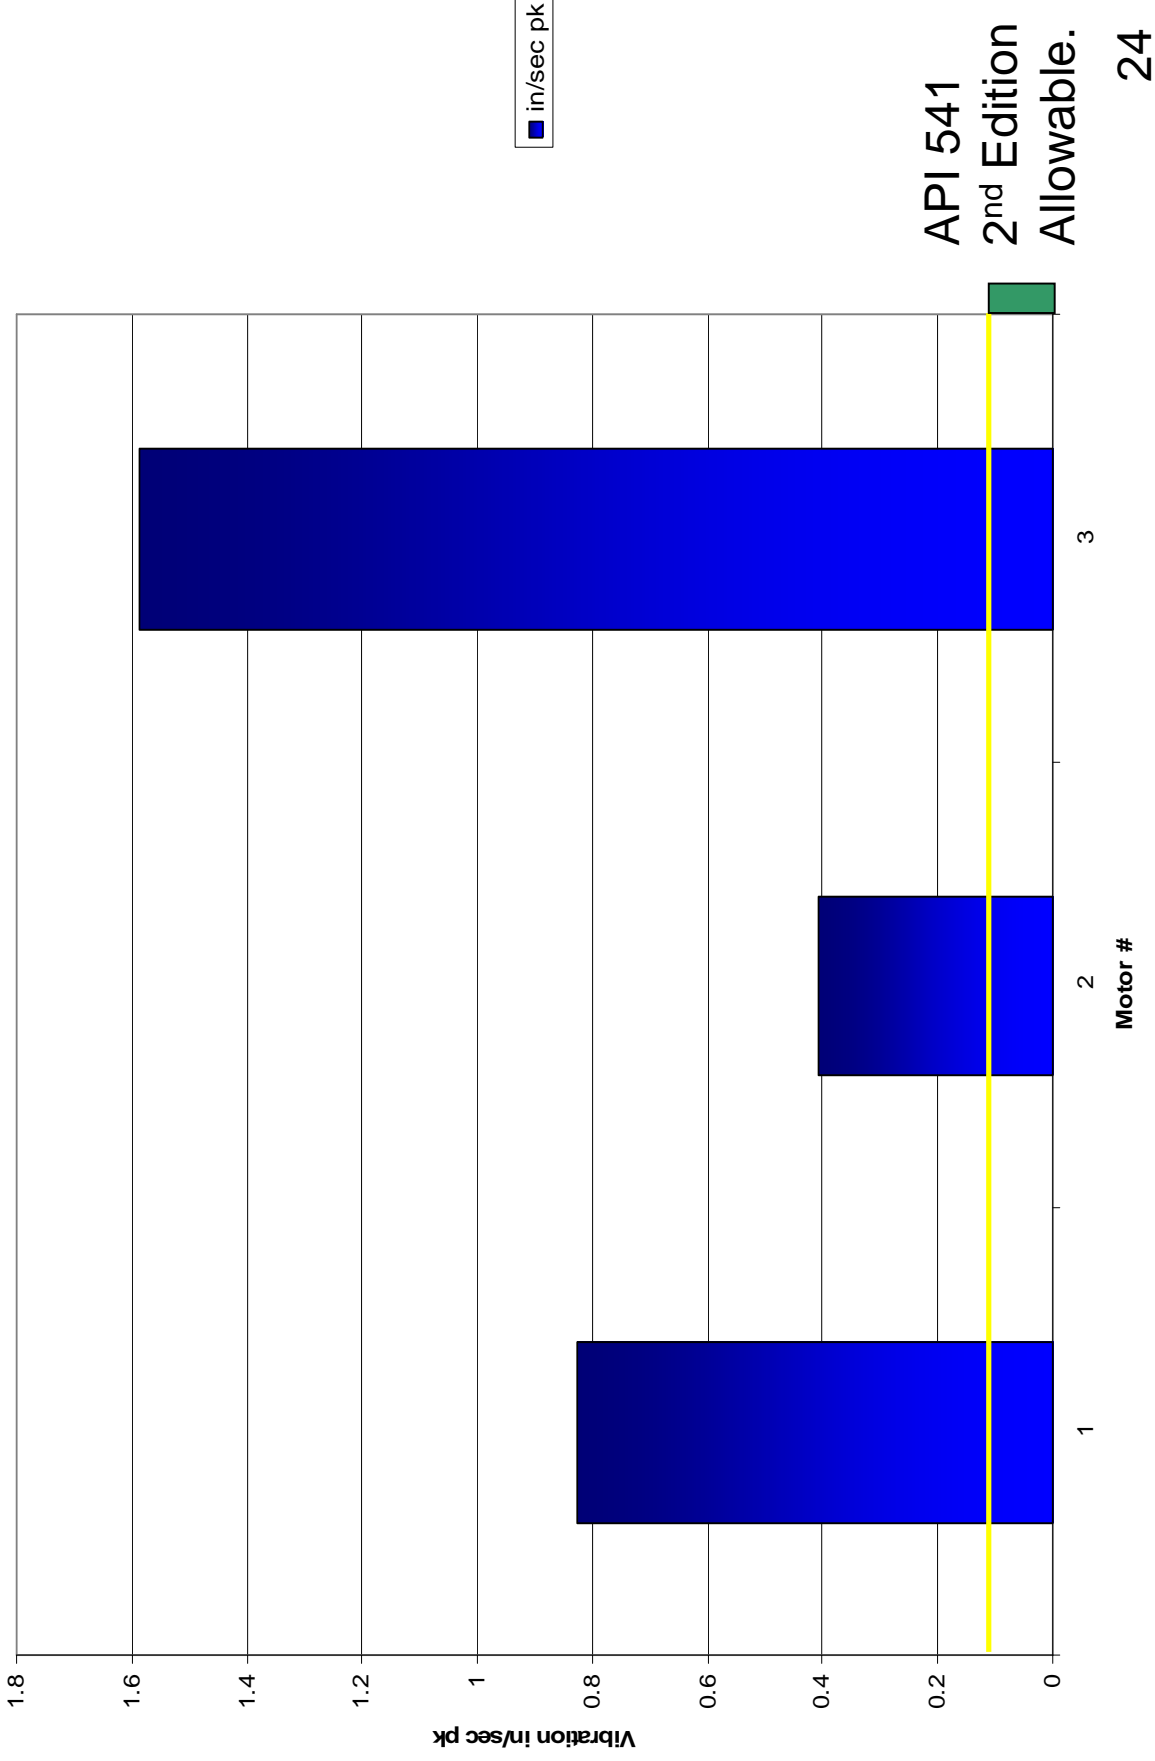
- Motor OB Bearing Housings in Horizontal Direction Had Highest Vibration.
 - **Motor 1**
 - OB Hor 1X 0.713 in/sec pk ~ 14.4 mils, pk-pk
 - OB Ver 1X 0.059 in/sec pk
 - Ratio of Horizontal to Vertical Vibration = 12:1 - Indication of Resonance, Looseness and/or Support Flexibility.
 - **Motor 2**
 - OB Hor 1X 0.408 in/sec pk ~ 8.2 mils, pk-pk
 - **Motor 3**
 - OB Hor 1X 1.586 in/sec pk ~ 31.95, mils pk-pk
