Analysis of New Centrifugal Pump Installation Exhibiting Excessive Vibration

Ken Singleton
Manager KSC Consulting
19676 Serenity Lane
Bristol VA 24202
Office/Fax 276-669-8459
ksingleton@vibrationconsulting.com

Robert R McGinnis P.E.
M M Engineering
429 Fondulac Drive
Kingsport TN 37663
Office/Fax 423-239-9713
Mmengineering@charter.net

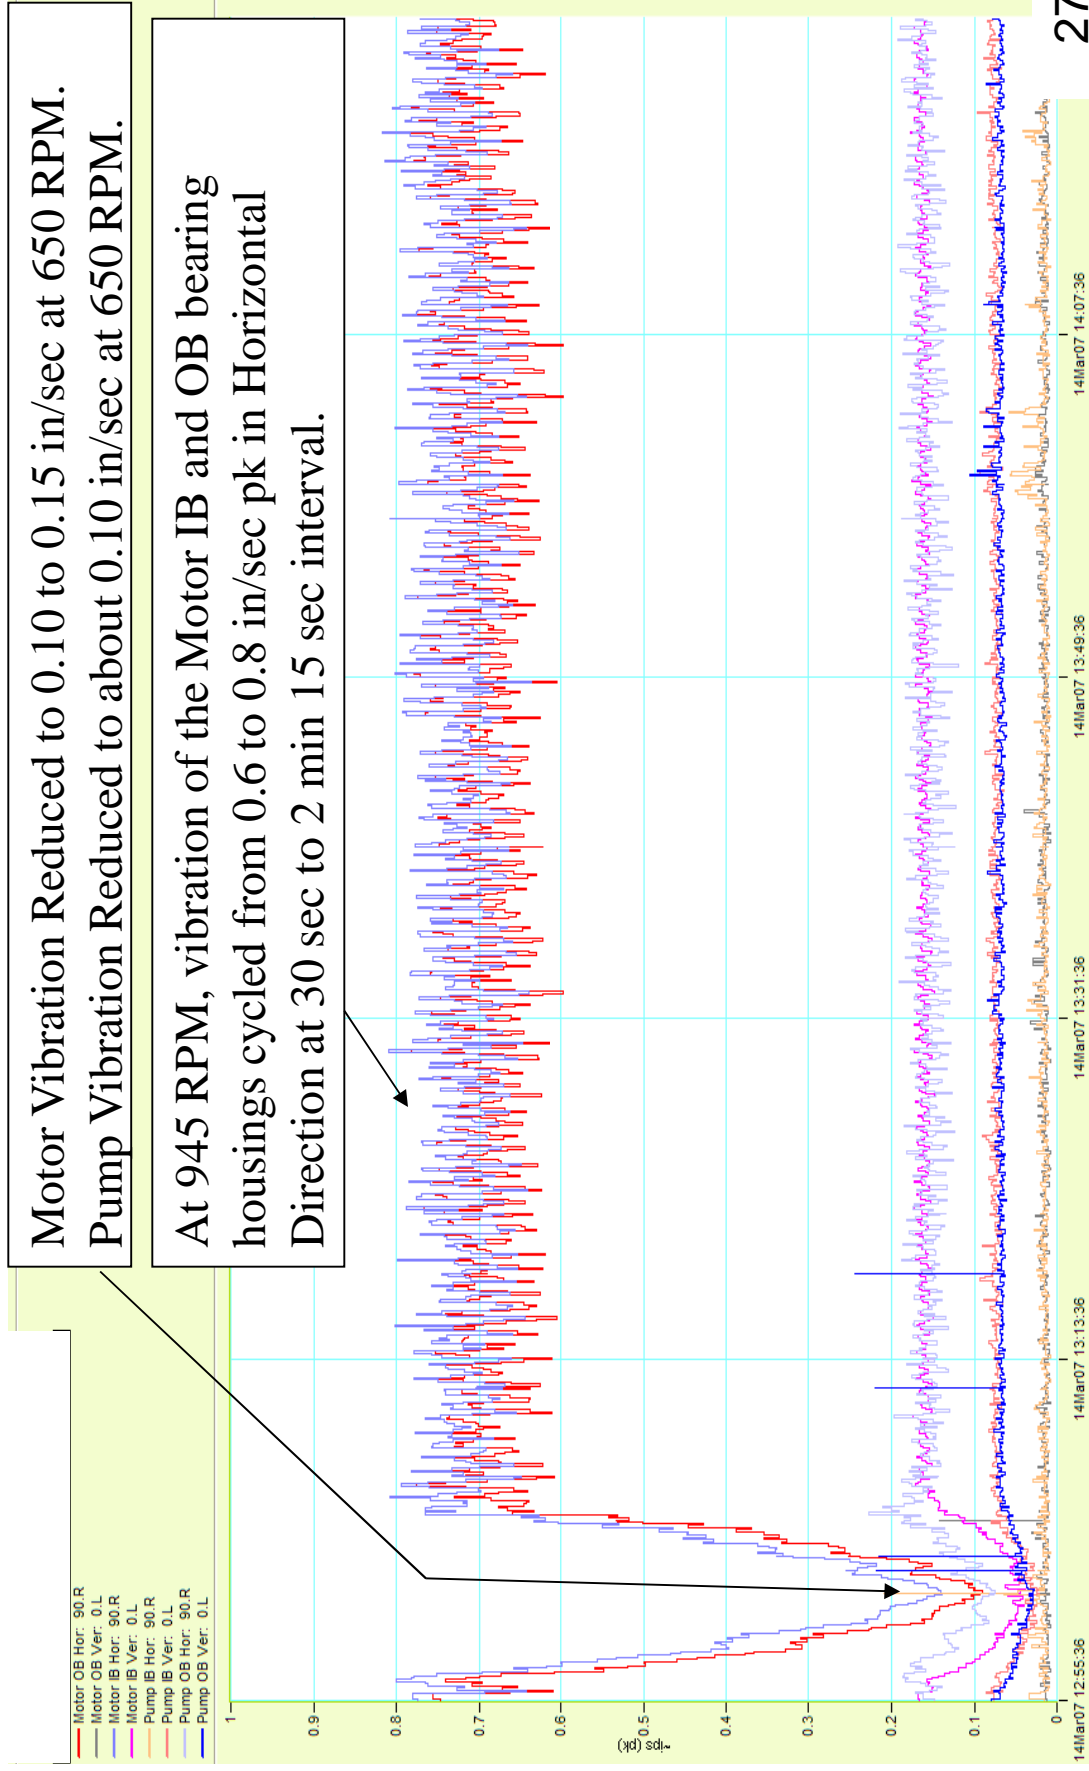
Vibration dropped dramatically with speed reduction from 945 to 650 RPM.

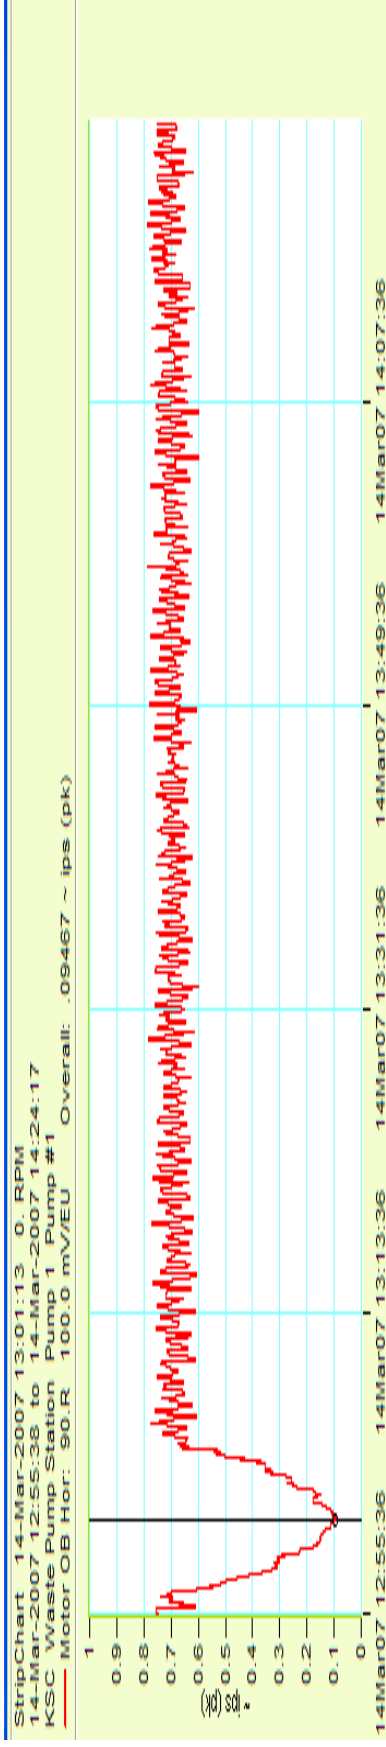
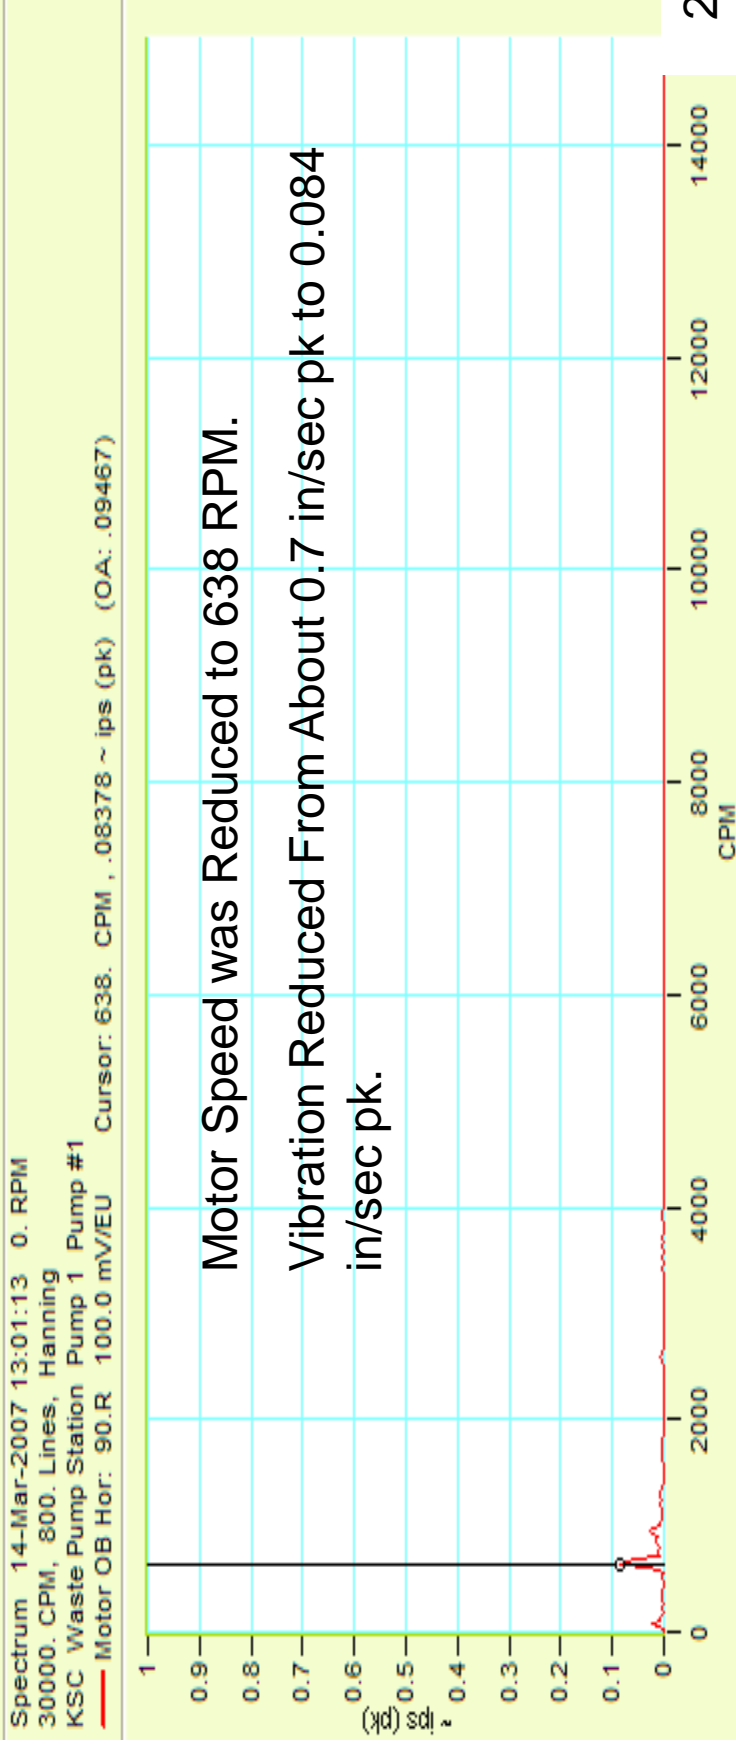
Vibration dropped dramatically with speed reduction from 945 to 650 RPM.

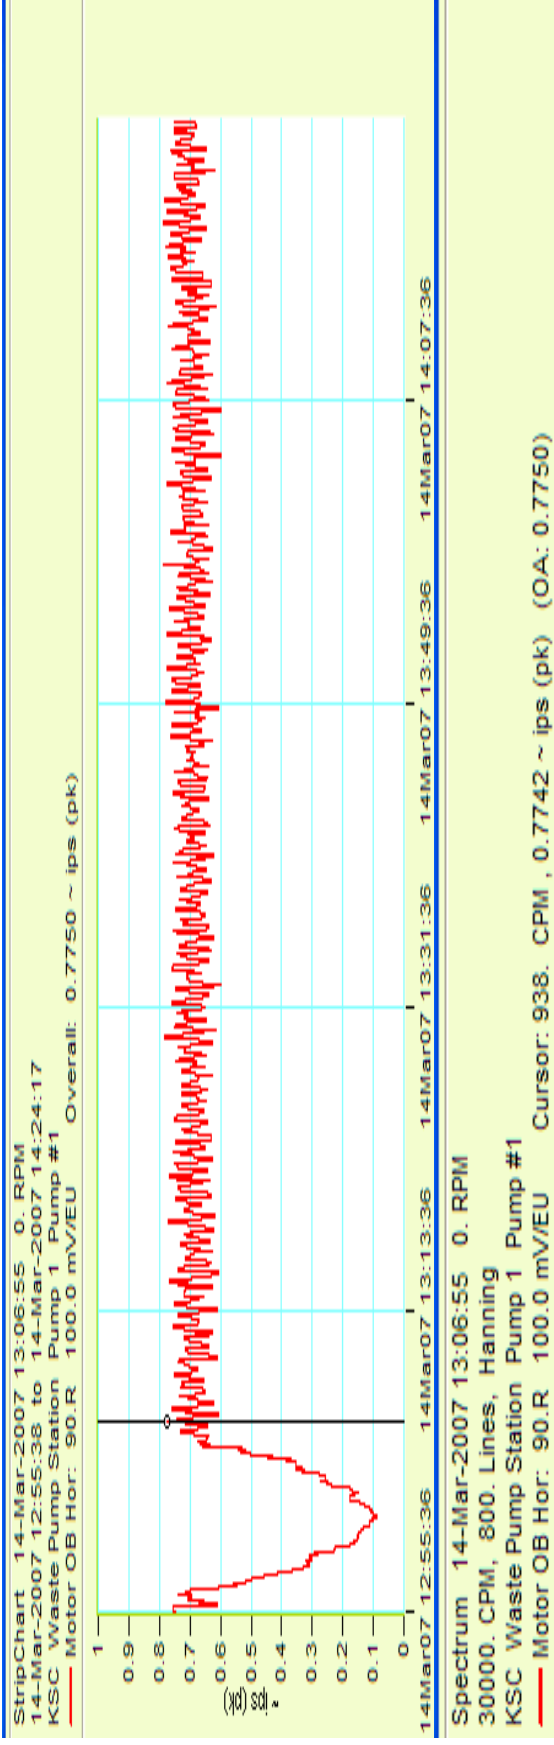
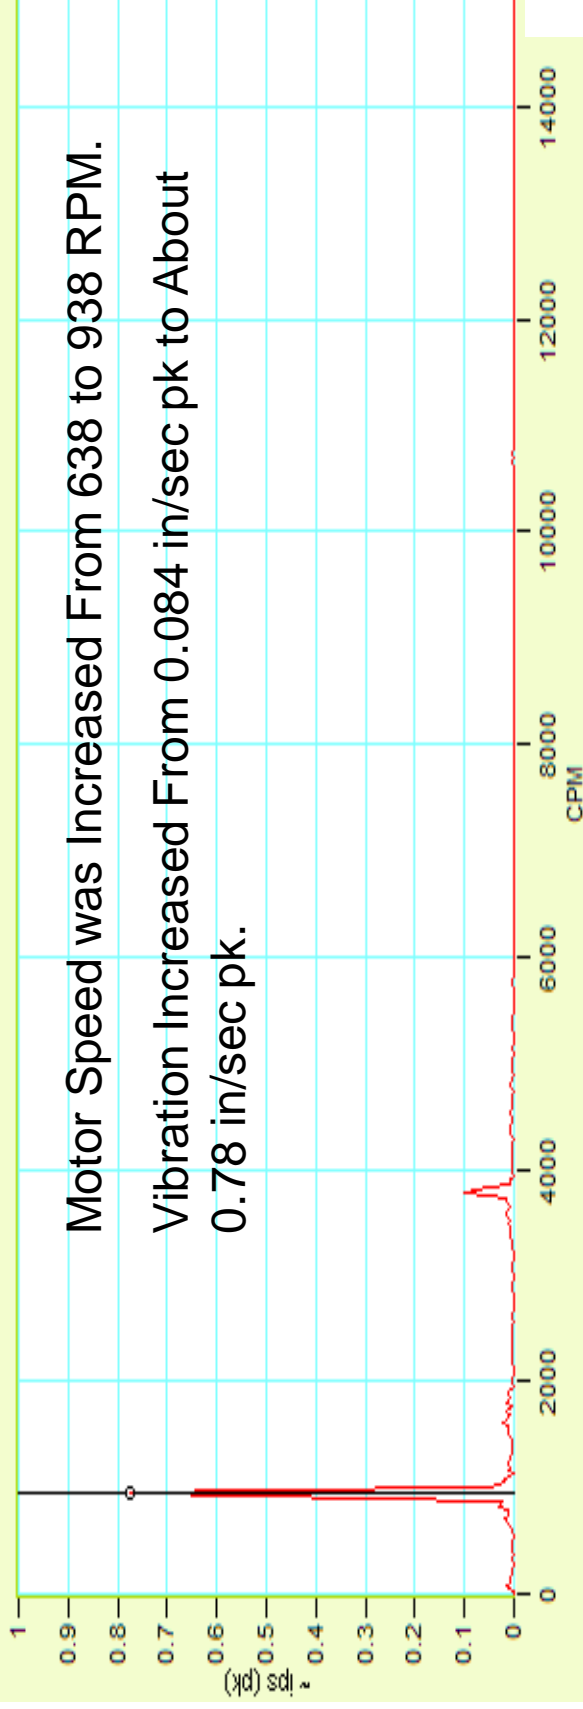
Vibration levels returned to the same levels as before the speed reduction.

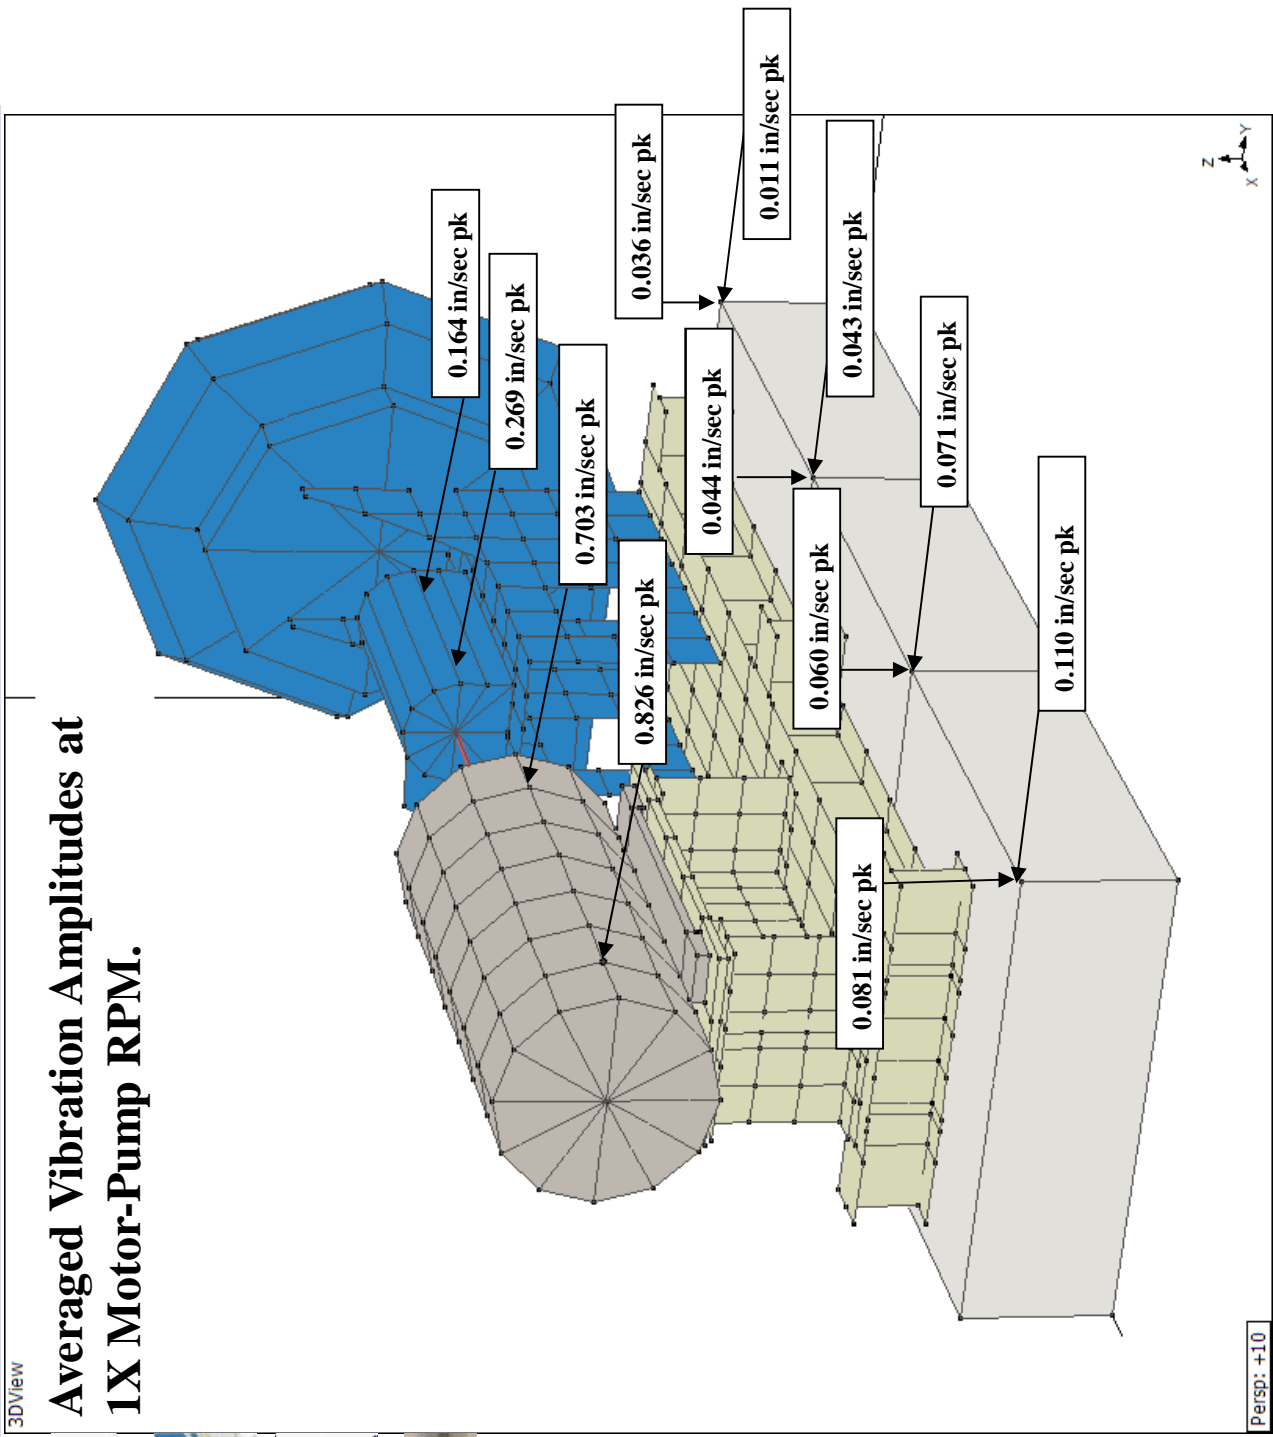
Figure 7. Average Vibration Amplitudes for Operating Deflection Shape at Running Speed Frequency.

- 1X Run Speed** – Side to side flexure of the motor pedestal.
- Flexure of the skid.
 - Relative motion between the skid and concrete base.
 - Side to side rocking motion of the concrete base, but low amplitude.

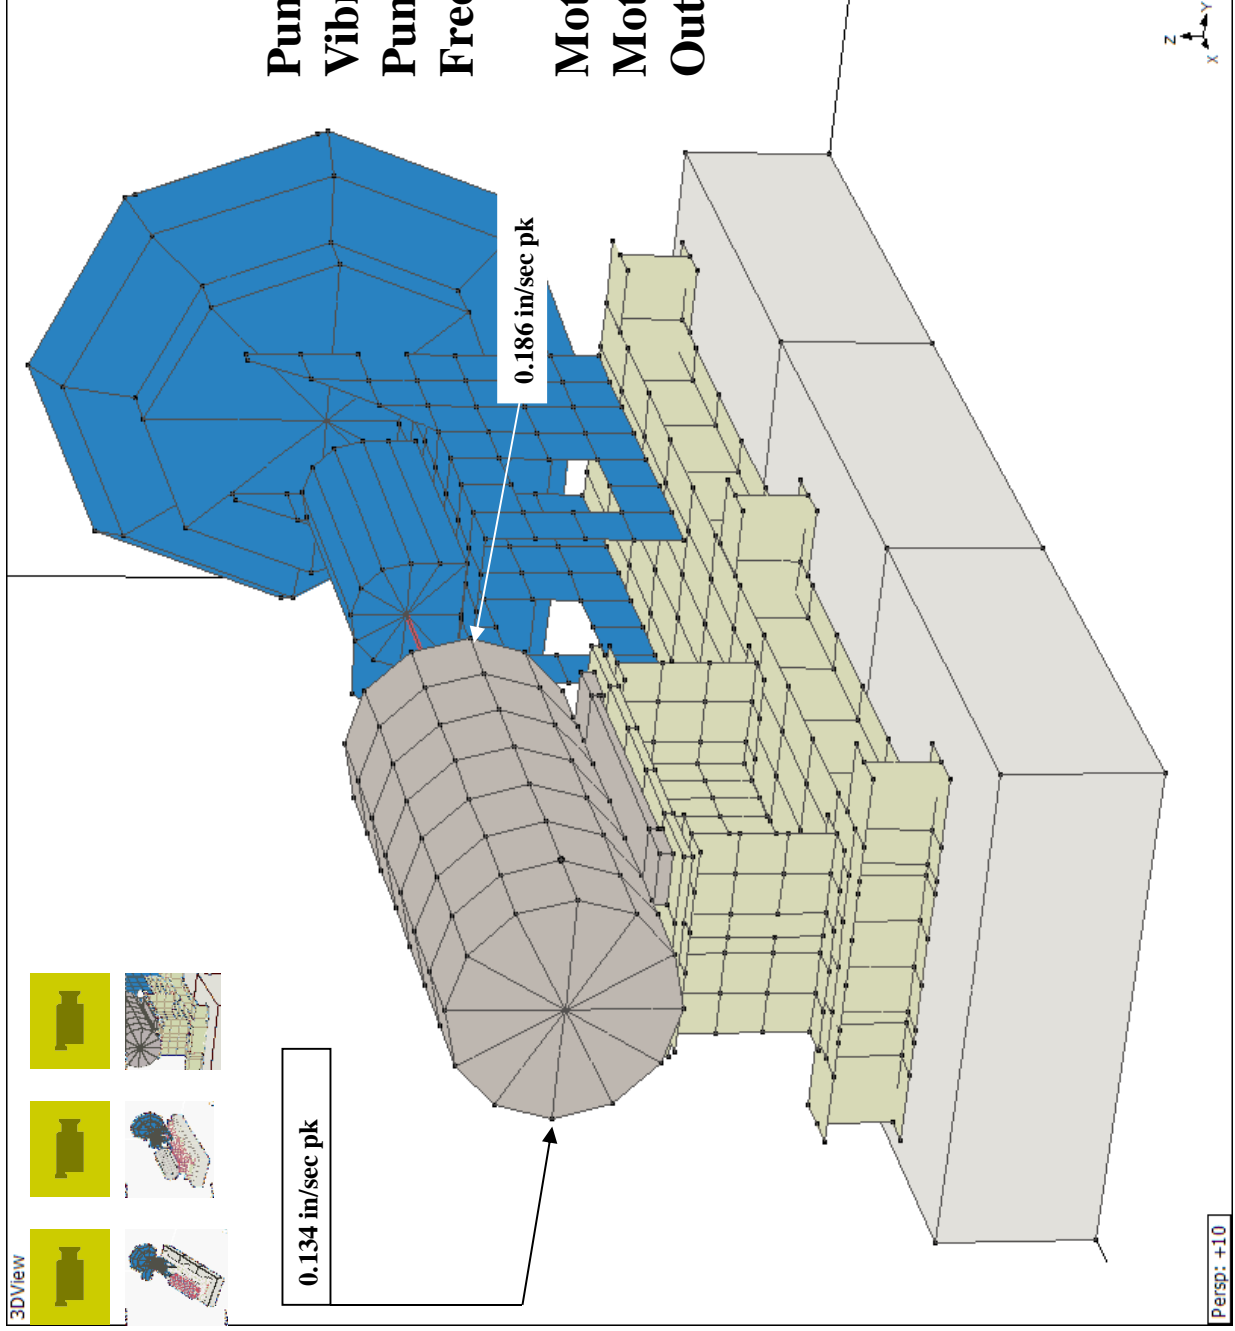
**Pump 1: Averaged
Vibration Amplitudes At
Pump Vane Passing
Frequency.**

**Motion at Each End of
Motor was 180 Degrees
Out of Phase.**

Vane Passing – Twisting of the motor pedestal about the Z axis.

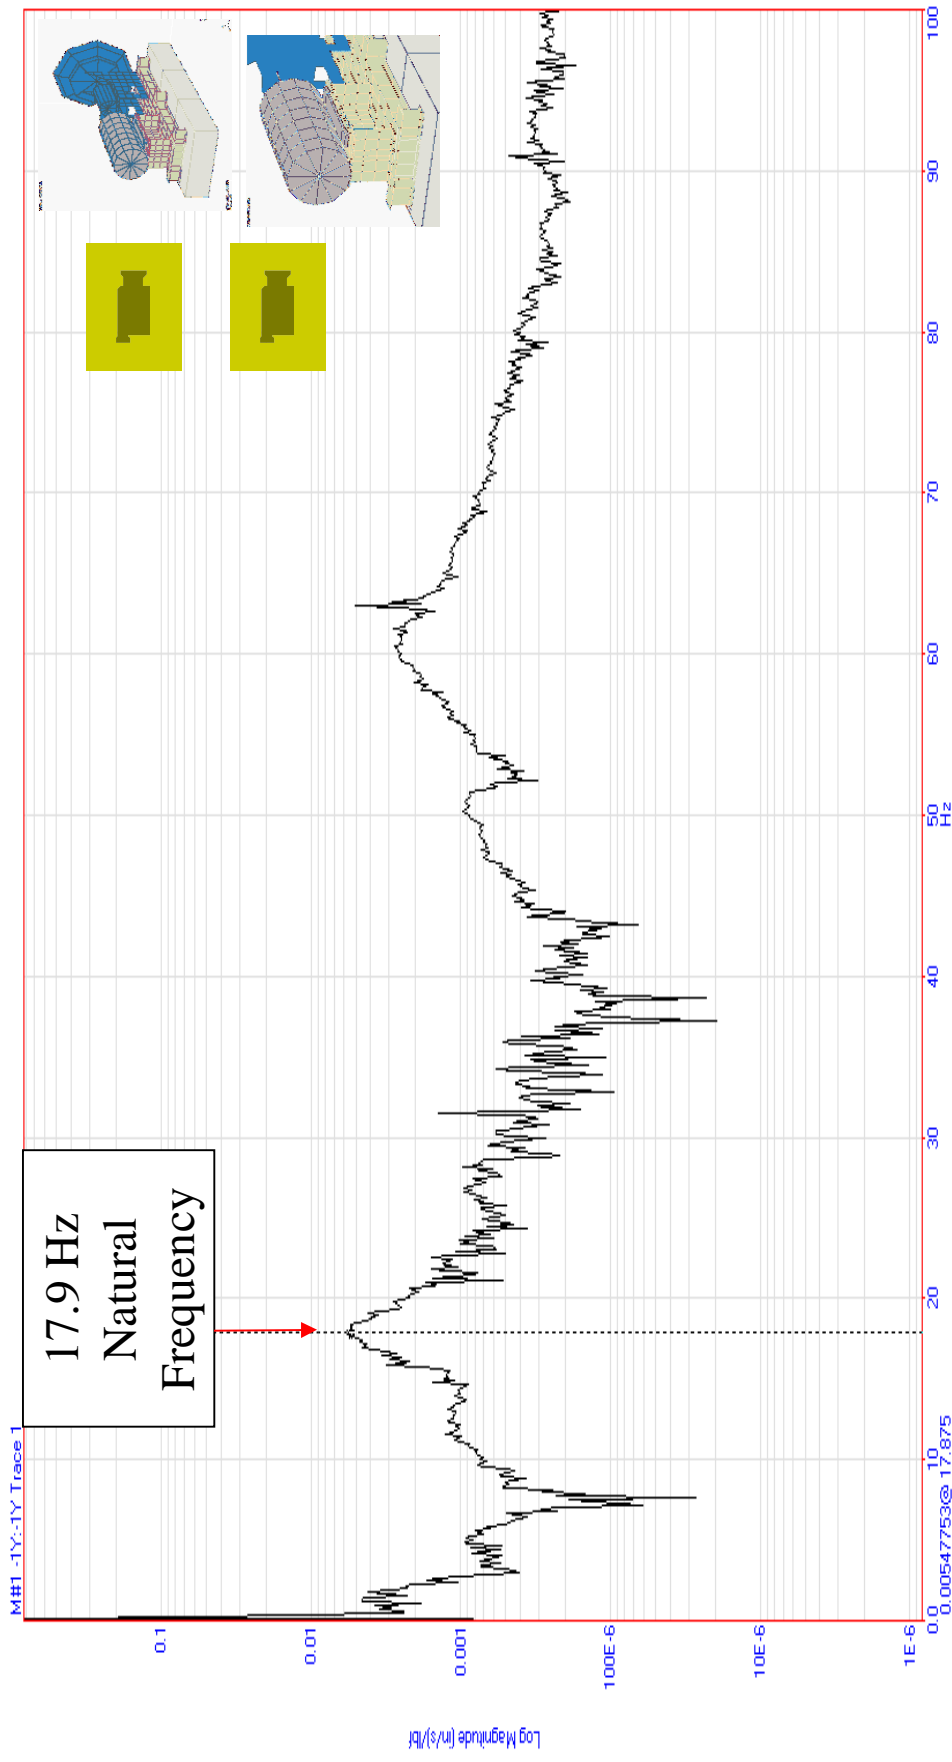
17.9 Hz ~ 1074 CPM natural frequency near pump operating speed. Mode shape was side-to-side motion of the motor with flexure in the supporting structural steel pedestal and skid frame. Very little participation of the concrete base in the mode shape.

1. Stiffen each skid and the motor pedestal (to increase horizontal natural frequency above the running speed and pump vane passing frequency).
2. Install two additional anchor bolts at the Motor Inboard Skid location to reduce flexure of the skid.
3. Weld gussets to the left side of the pump skid at the pump end to increase stiffness of the skid at the anchor bolt location.

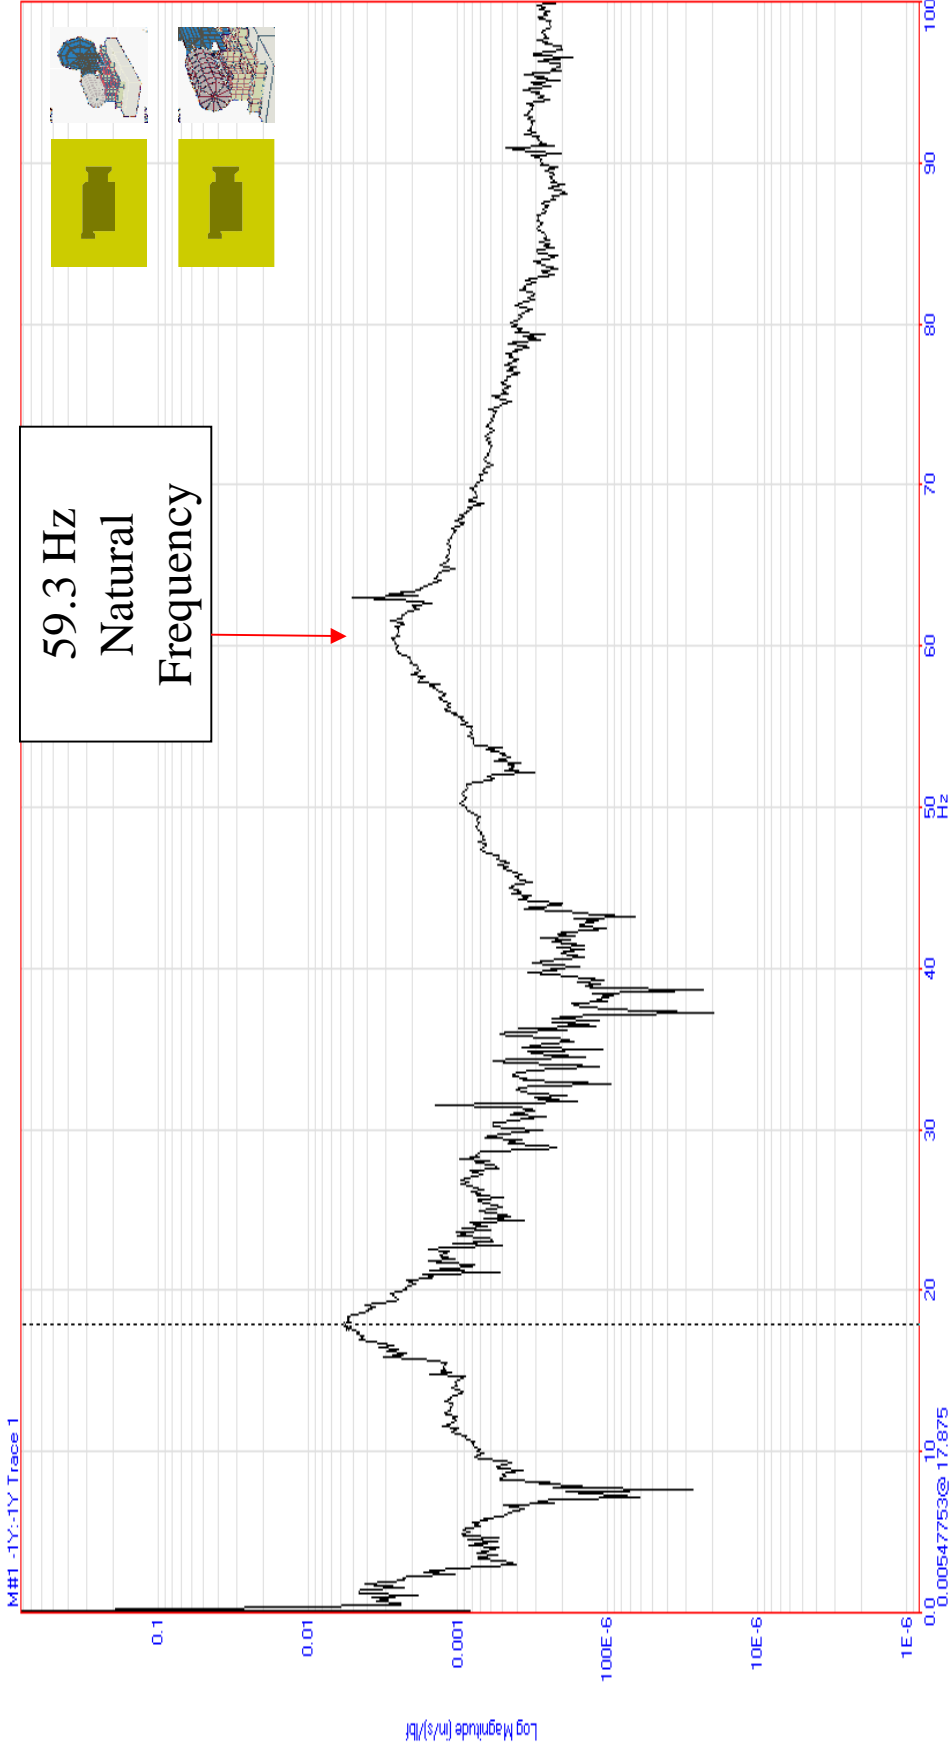
59.3 Hz ~ 3558 CPM Natural Frequency near Pump Vane Passing Frequency.

- Twisting of the motor and pedestal about the Z axis.
- Flexure of the 16" wide flange beams. Bending in Z axis of the skid frame.
