# Property Inspection Report

**Property Address:**  
9 Big Court  
Great City New Jersey 07000

**Frank Glomb**

**Terra Home Inspections LLC**

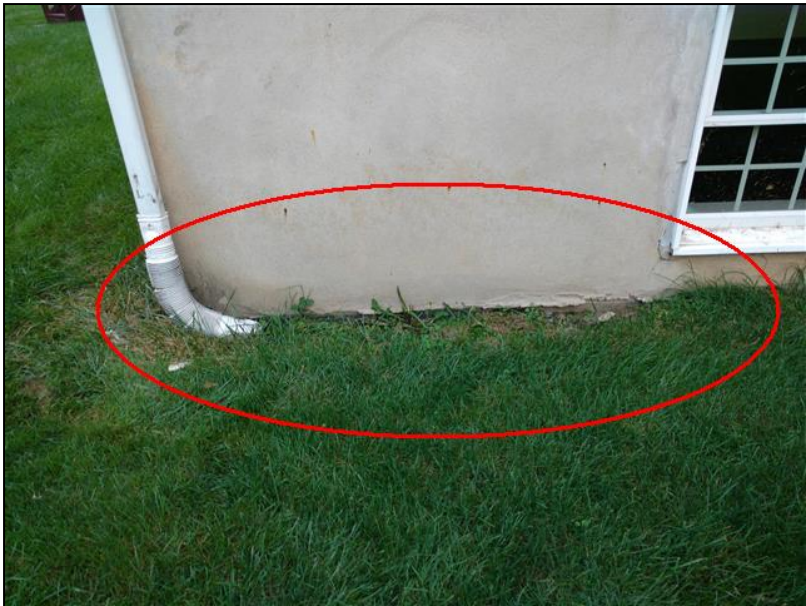
- 1.0 Driveway
- Comments: Inspected
- 1.1 Sidewalk/Walkway(s)
- Comments: Inspected
- 1.2 Grading
- Comments: Repair/Replace
- The grading (slope of ground surface) next to the left side foundation was pitched towards the foundation. The grading whenever possible should be pitched away from the foundation to prevent moisture intrusion from entering the foundation walls and basement. The ground was being undermined by the downspout that was dumping water next to the foundation. Recommend further evaluation of all of the exterior grading by a qualified, licensed contractor and repair as necessary.

- 1.2 Item 1 (Picture) Ground getting undermined
- 1.3 Vegetation Affecting Structure/Property
- Comments: Inspected
- 1.4 Retaining Wall(s)
- Comments: Not Present
- 1.5 Fencing
- Comments: Inspected
- 1.6 Shed
- Comments: Not Present
- 1.7 Exterior Fireplace
- Comments: Not Present

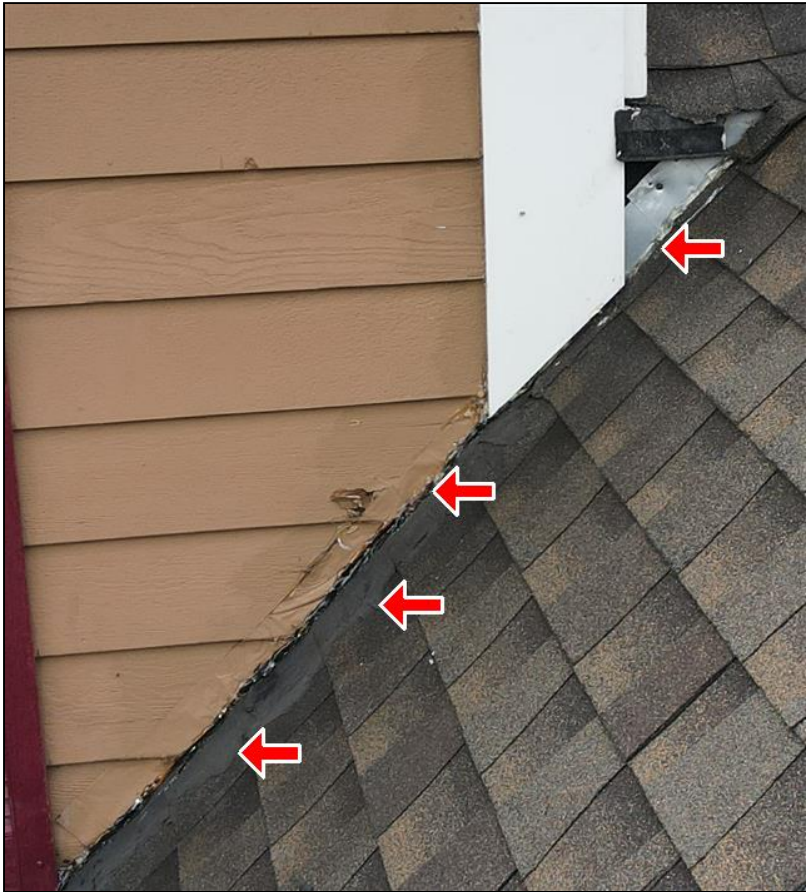
2.0 Item 1 (Picture)

(1) As observed on the exterior, there were portions of some of the exterior elements (windows, window frames, window flashings, doors, door frames, door flashings, siding/cladding, masonry, brick and/or stone veneer, trim, framing, flashings, eaves, fascias, soffits and/or gable ends) that were either missing, had open gaps/holes/unsealed joints, were not functioning as intended, were deteriorated/damaged and/or had a peeling paint condition. The main issue is the siding/cladding was cupping/curling on all four sides of the exterior. Some of the siding/cladding was pulling off the house with the nails pulling out as a result of the cupping/curling. The condition of the noted elements/areas may worsen as well as possible structural/moisture damage behind/under these elements could occur if the needed repairs are not completed. Damage to the interior finishing materials may also occur. **A further evaluation of the ENTIRE exterior of the dwelling should be completed by a qualified, licensed contractor and the necessary repairs be completed. There may be hidden moisture damage, deterioration and/or wood destroying insect damage within the structure behind/under the effected exterior elements that was not visible at the time of the inspection.**

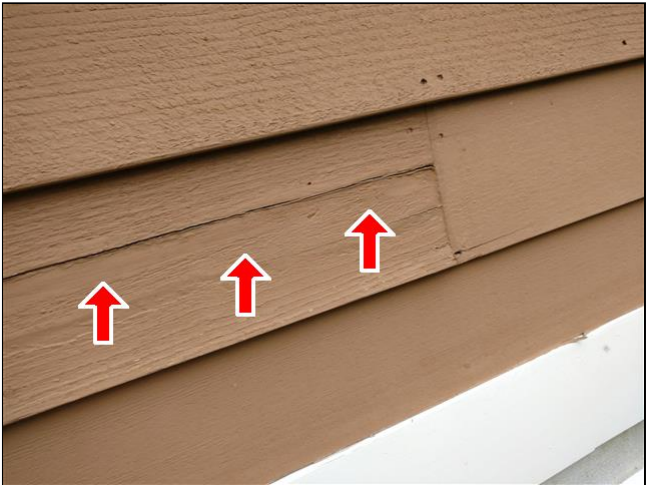
2.0 Item 13 (Picture) Cracked

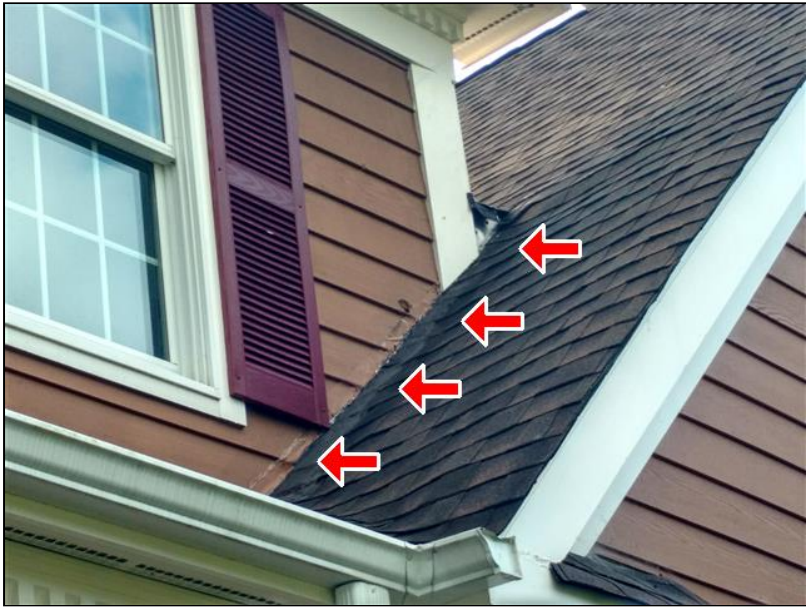
2.0 Item 15 (Picture) Sub standard repair

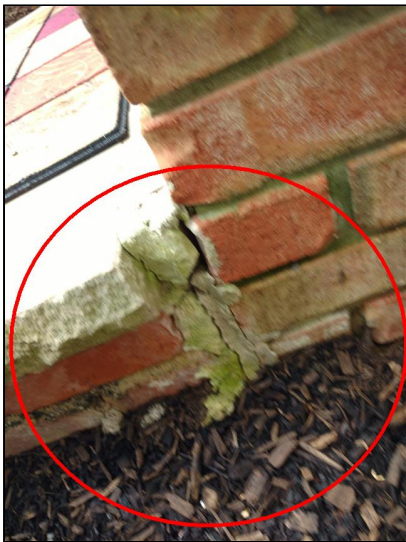
2.0 Item 33 (Picture) Front steps

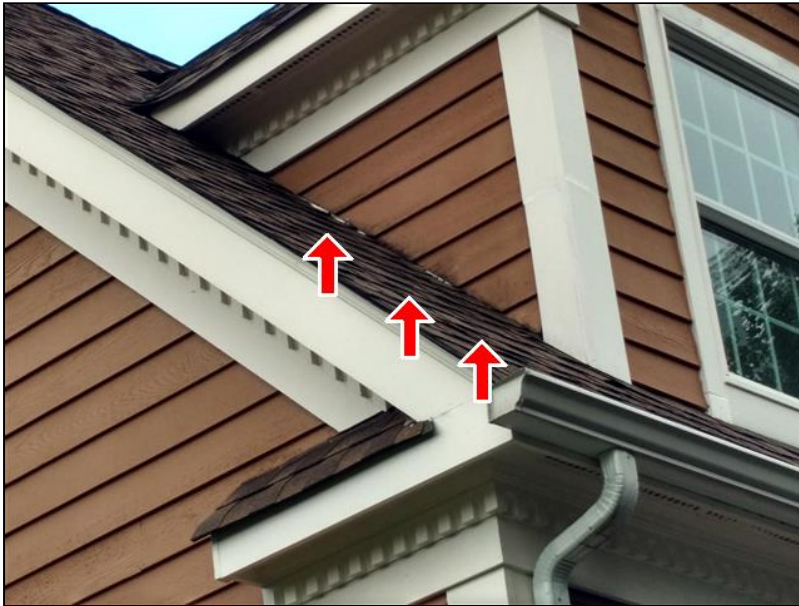
2.0 Item 34 (Picture)

(2) The bottom portion of some of the exterior wood lap siding/cladding was deteriorated slightly as a result of what appears to be excessive moisture present from the roof covering. The roof covering should not be in contact with the wood siding. There should be a 1/2"-3/4" gap between the bottom of any exterior cladding and the roof covering to prevent this type of deterioration. Further deterioration of the wood siding as well as possible moisture intrusion into the structure behind the siding could occur if the needed repairs are not completed. Recommend further evaluation by a qualified, licensed contractor and repair as necessary.

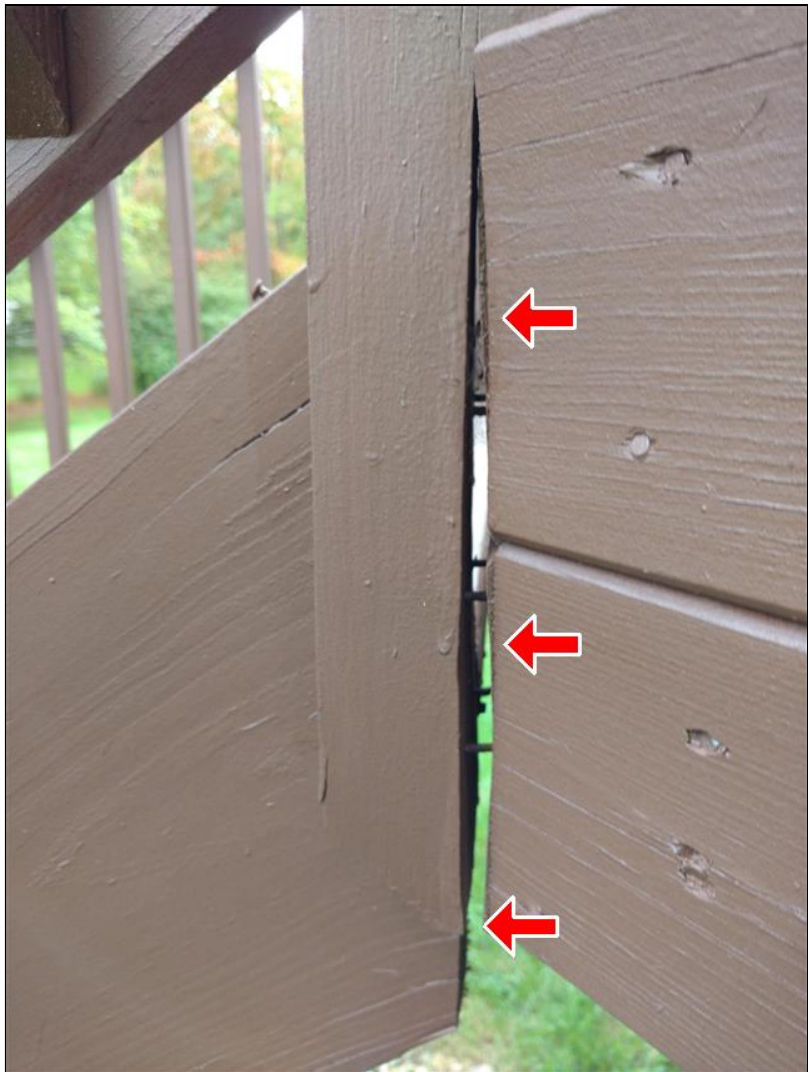
2.10 Item 1 (Picture)

(2) There were numerous issues were observed pertaining to the rear wood deck. They included:

- 1) There were no beam to joist and stair stringer to the deck structure mechanical connectors present.
- 2) There were numerous nails that were sticking up from the deck surface which is a major concern if your walking on the deck with bare feet.
- 3) The staircase was separating from the main deck structure.
- 4) The handrails were loose.

These are safety concerns. These conditions may also worsen if the needed repairs are not completed. A further evaluation of the ENTIRE deck should be completed by a qualified, licensed deck contractor and the necessary repairs be completed.

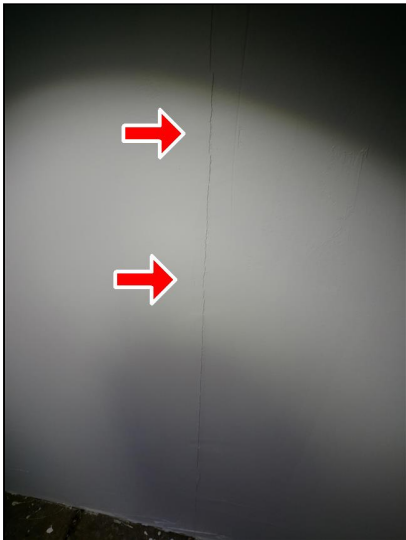
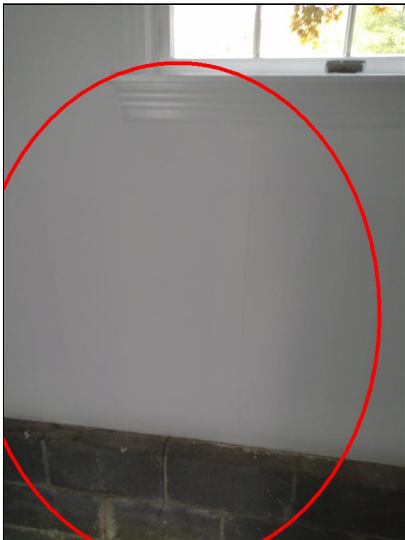
(2) A few sections of the garage wall drywall were cracked. These conditions may worsen. Recommend further evaluation by a qualified, licensed contractor and repair as necessary..

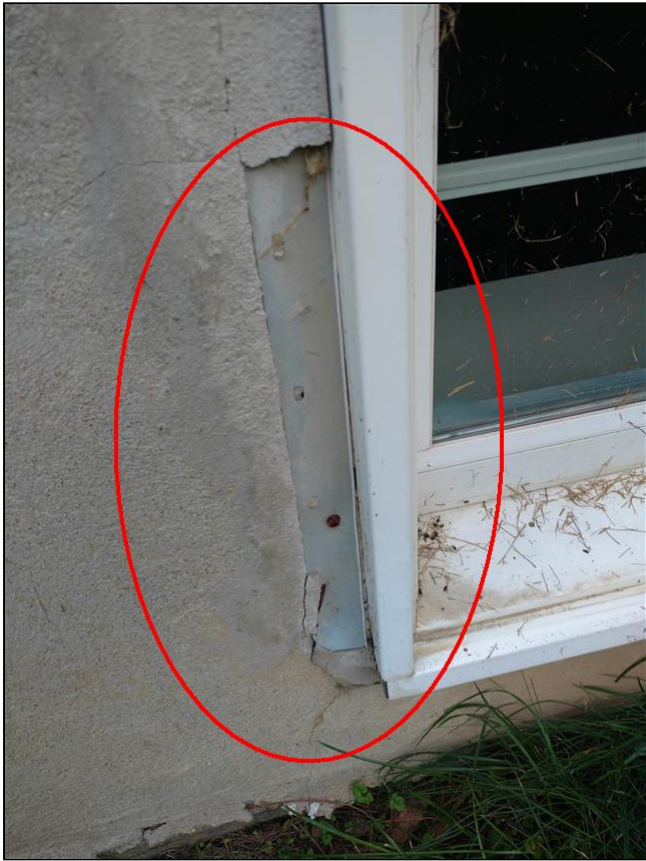
4.0 Item 1 (Picture)

There were numerous cracks and/or deteriorated areas present on some portions of the interior and/or exterior foundation wall/floor surfaces. These conditions if not repaired may lead to possible moisture intrusion into the foundation walls and the basement along with possible deterioration of the foundation walls and the interior finishes of the house. These conditions may also worsen if the needed repairs are not completed. A further evaluation of the ENTIRE foundation (both interior and exterior) should be completed by a qualified, licensed structural contractor and the necessary repairs be completed. **These conditions may also exist behind finished basement walls/floors. They may be less severe or worse than what was visible.**

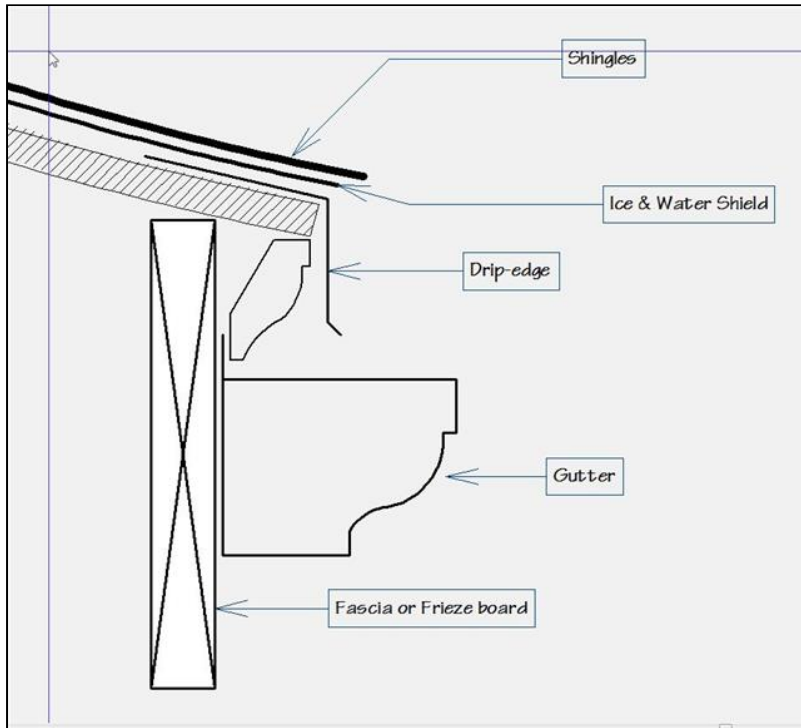
4.6 Item 1 (Picture)

As observed in the rear of the attic space, there were sections where the roof decking meets the fascia board that daylight could be seen. You should not see any daylight at these joints as there should be drip edge flashings that go over the roof decking and then wrap down onto the fascia board. Drip edge flashings may not be present. **The concern is these gaps may allow unwanted wildlife (insects, mice, etc) to get into the attic space.** Recommend further evaluation by a qualified, licensed contractor and repair as necessary.

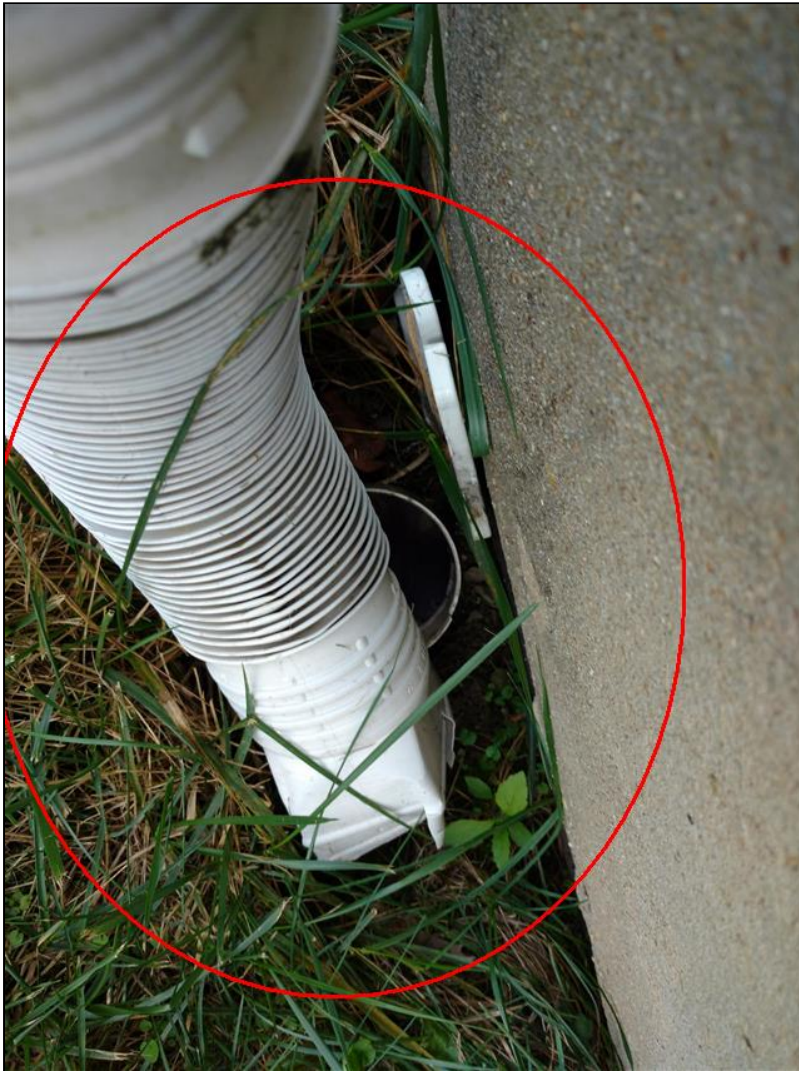
5.2 Item 1 (Picture)

The downspouts that are not directed into underground drainage pipes should be extended at least 4-6 feet (or as far away as possible) from the foundation of the house. Ideally, they should be extended away with rigid downspout material or PVC pipe. The accordion style extenders that are sometimes present often fail, deteriorate and may collect water in the ripples where mosquitos may breed in the standing water. Extending the downspouts helps shed water away from the foundation. Water can weaken and deteriorate the foundation and can possibly migrate into the basement. Recommend extending the downspouts as necessary. Also to note, some of the downspouts are currently piped into underground drainage. While this is a great arrangement as it is supposed to carry the roof runoff water away from the house, it is unknown if the system is functional and not clogged with debris. If the underground drainage gets clogged, the water may spill out at the downspout connection and possibly migrate into the foundation/basement. It should be ascertained as to where all this underground drainage is draining to. **Also, it is recommended a further evaluation and testing of the ENTIRE underground drainage piping/system be completed by a qualified, licensed contractor to insure it is fully functional and not clogged with debris.** Any needed repairs should be completed. There was also a downspout in the left rear corner that was not connected to the underground drainage and was discharging its water right next to the foundation. This may result in moisture intrusion. In addition, the gutter above the garage needs to be cleaned out as there was vegetation growing out of it.

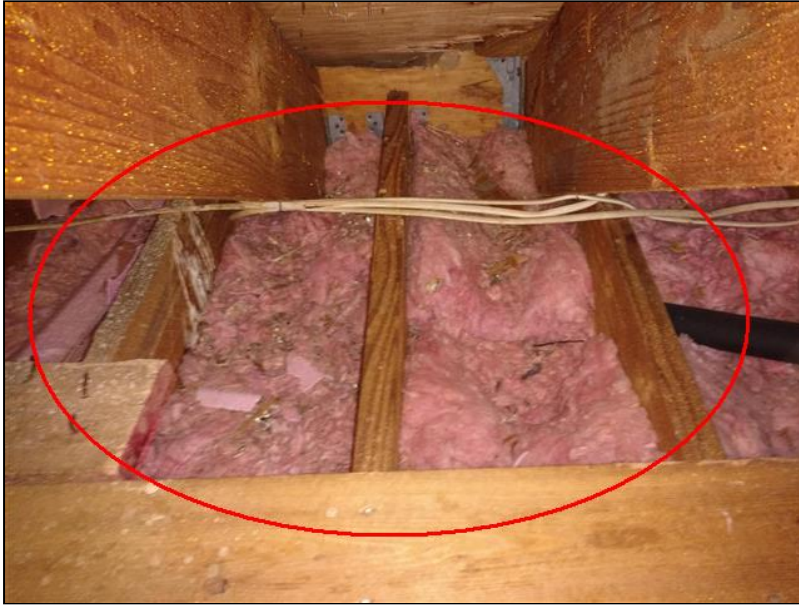
6.0 Item 1 (Picture)

There was what appeared to be fecal matter/possible urine from mice/squirrels or similar vermin observed in numerous areas in the attic space as well as several areas of the attic insulation that was damaged. There was also a section of the HVAC ducting that was damaged along with sections of the electric wiring. This is a health concern. **A further evaluation of the ENTIRE attic space should be completed by qualified, licensed pest control professional and the necessary repairs/remediation should be completed ASAP. The wiring needs to be repaired by a qualified, licensed electrician and the insulation should be repaired by a qualified, licensed contractor. The access points into the attic space should also be repaired/sealed up.**

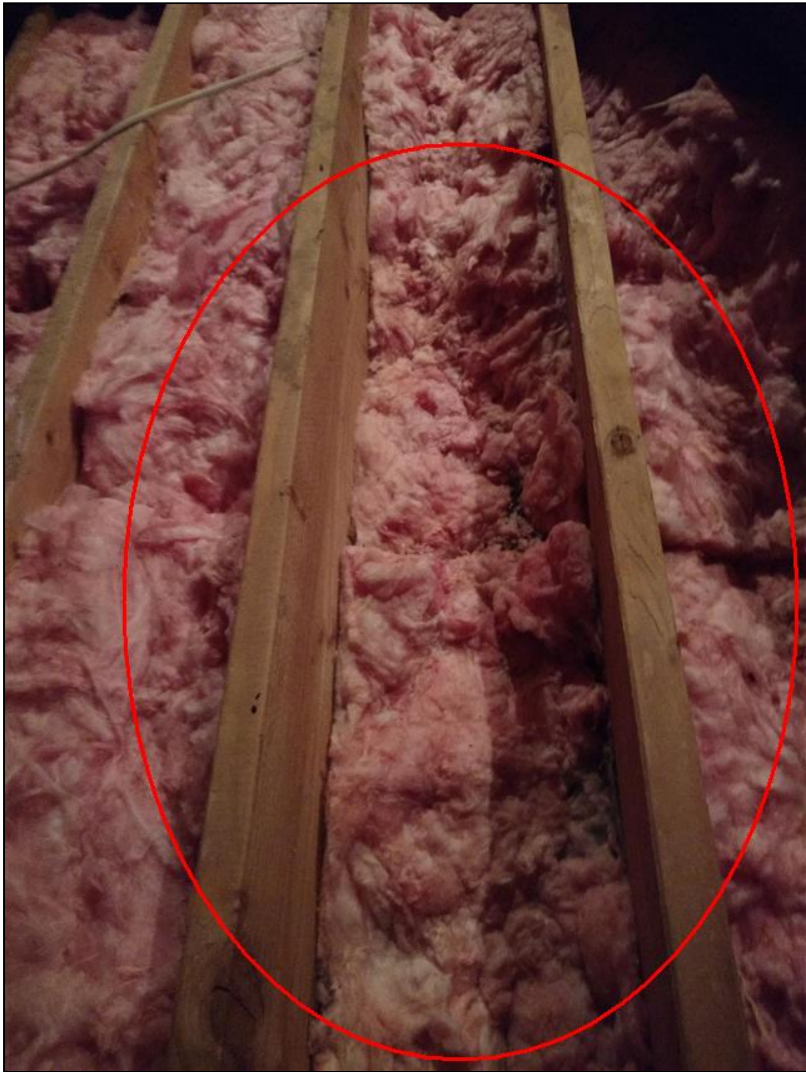
6.0 Item 3 (Picture) Damaged insulation

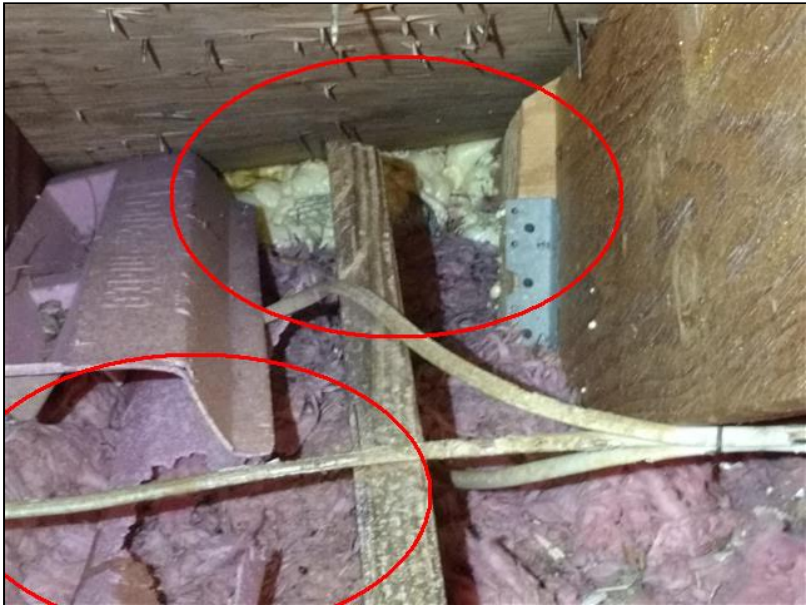
6.0 Item 9 (Picture) Baffles damaged

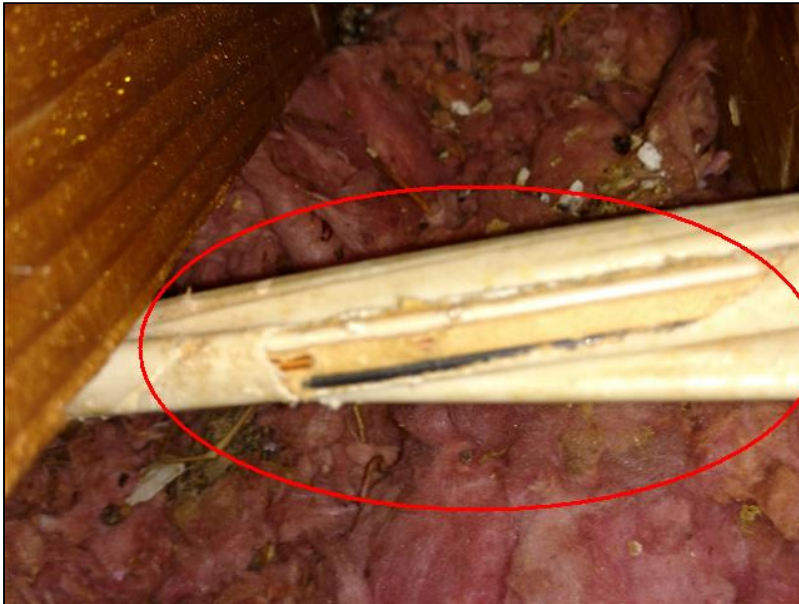
7.7 Item 4 (Picture)

(2) As observed in the front portion of the attic space, there was at least two visible sections of the electric circuit branch wiring that were chewed/damaged from what was assumed to be a squirrel/mice, etc. There was other damage to the attic space. This is a MAJOR safety concern and a fire hazard. There may be other damaged wiring that was not visible. **The necessary repairs should be completed ASAP and ALL of the circuit branch wiring in the attic space should be further evaluated by a qualified, licensed electrician.**

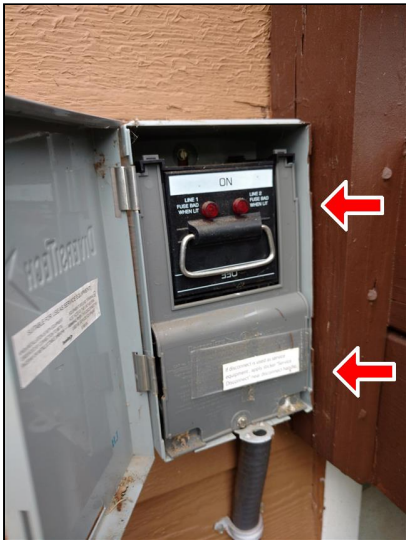
7.8 Item 5 (Picture)

(3) One of the A/C disconnect switches front cover would not close all the way. It was hitting the deck. Recommend further evaluation by a qualified, licensed electrician and repair as necessary.

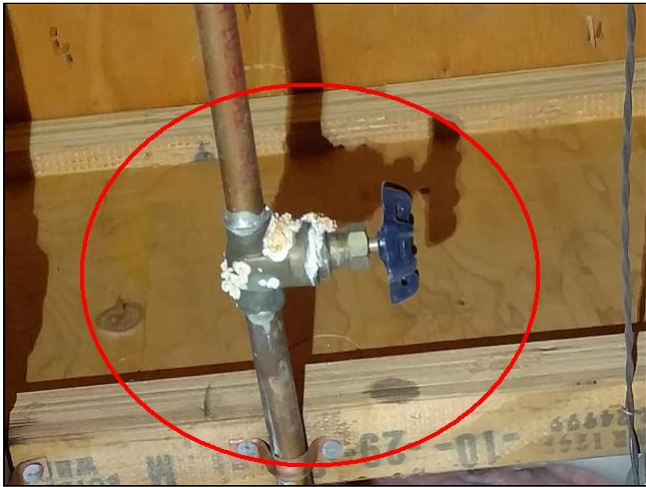
8.1 Item 1 (Picture)

**Therefore, a further evaluation of ALL of the water shut off valves in the dwelling (basement, under sinks, behind toilets, etc.) and any on the exterior should be completed by a qualified, licensed plumber and any necessary repairs/valve replacements should be completed.**

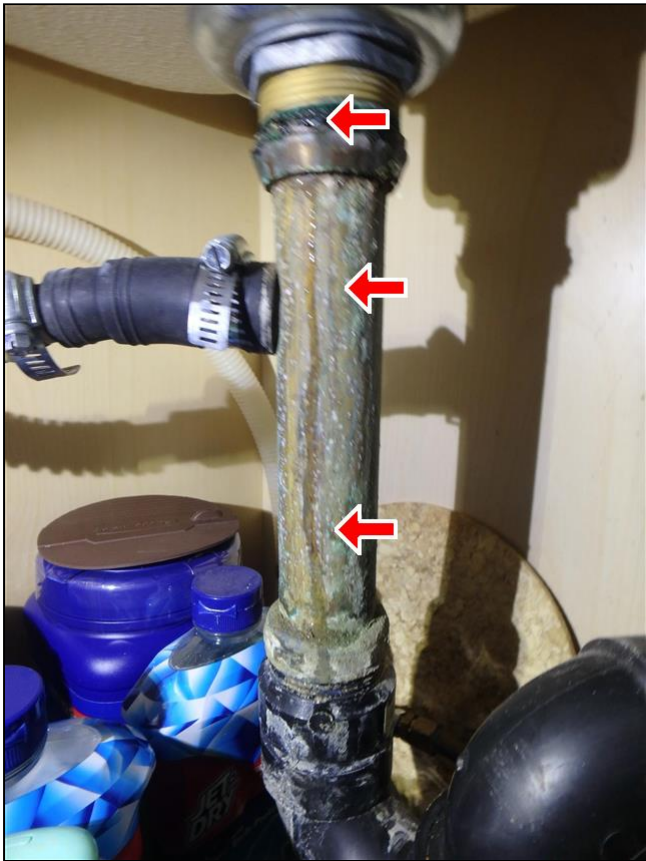
8.2 Item 1 (Picture)

(2) The kitchen sink drain was leaking. If this leak is not repaired, moisture damage to the surrounding area and/or a mold condition could occur. Also to note, in the basement next to the electric panel, one of the clean out plugs on the ABS DWV piping may be leaking. There was staining on the outside of the pipe. Recommend further evaluation by a qualified, licensed plumber and repair as necessary.

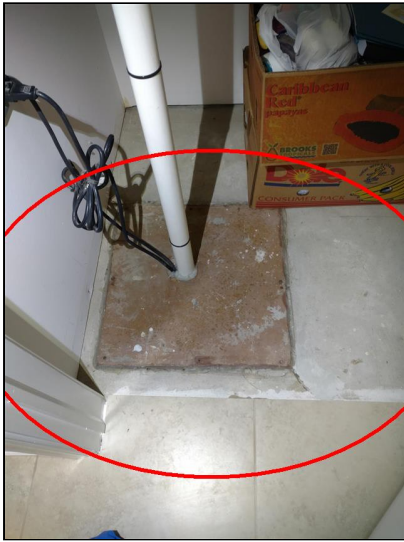
8.4 Item 1 (Picture)

The top covers on the sump pump pits were sealed and could not be removed to check the operation of the sump pumps. Therefore, the inspection of the sump pumps, discharge piping and the sump pump pits was limited. The sump pumps could not be manually tested for proper functionality and may not be functional. The sump pumps should be further evaluated/tested by a qualified, licensed plumber to make sure it is functioning as intended to avoid possible flooding of the basement. Any needed repairs should be completed.

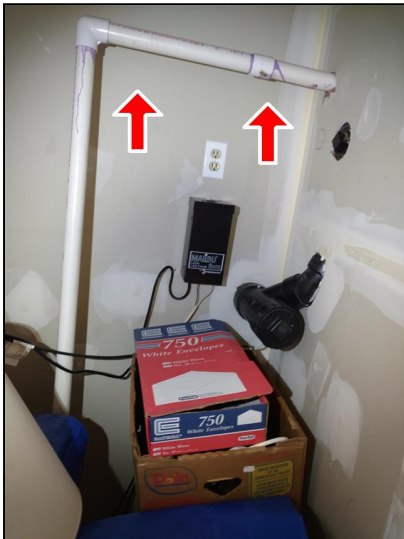
8.5 Item 1 (Picture)

(2) The left front sump pump drainage pipe was going out the left side foundation wall. But, on the exterior there was no drainage pipe visible. It is unknown where this sump pump is draining to which is a concern. It may back up or affect the function of the sump pump if it is not draining in a proper fashion. Also, the discharge water could possibly migrate back into the foundation/basement. Recommend further evaluation by a qualified, licensed plumber and repair as necessary.

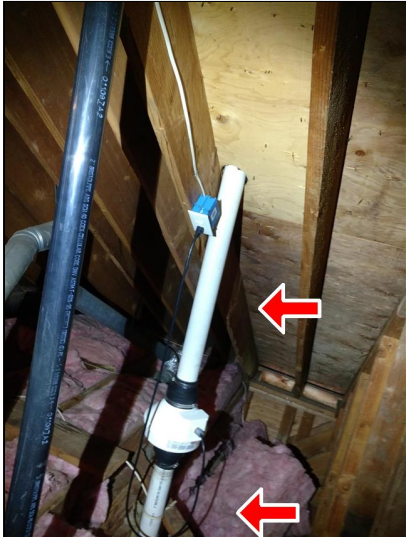
8.9 Item 1 (Picture)

There were two active radon mitigation systems present. The suction fans were located in the attic and the basement was finished. The suction pipes/points in the basement could not be viewed. The radon systems did not have a warning device. A warning device must be installed to alert you if an active system stops working properly. Examples of system failure warning devices are: a liquid gauge, a sound alarm, a light indicator, etc. The warning device must be placed where it can be seen or heard easily. This is a concern as not having potentially non-functioning radon mitigation systems is a health hazard for the occupants. **A further evaluation of the ENTIRE radon mitigation systems should be completed by a state licensed radon mitigation contractor and the necessary repairs should be completed to insure the safety of the occupants.**

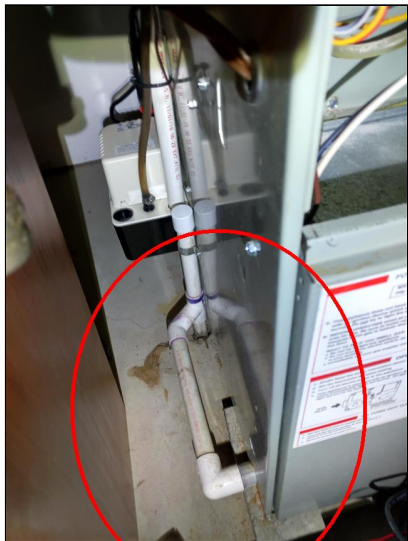
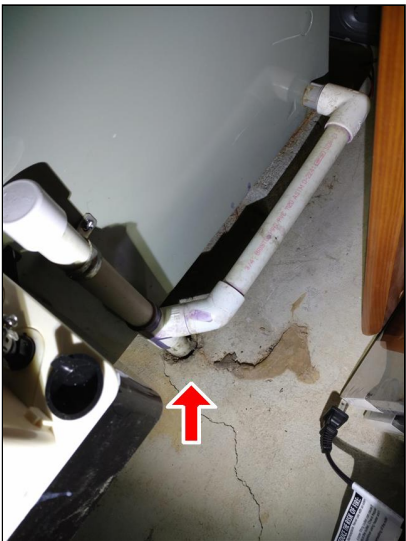
(2) The condensate drain pipe for the basement furnace was draining the condensate (water) it produces into the basement concrete slab. This is not an ideal arrangement as this condensate may cause the earth under the basement concrete floor to undermine which may cause damage to the basement floor. This arrangement may also cause a high humidity level in the basement space. Some townships will allow this arrangement and some will not. Ideally, the condensate should be draining into the condensate pump that the A/C is draining into. Recommend further evaluation by a qualified, licensed HVAC professional and repair as necessary.

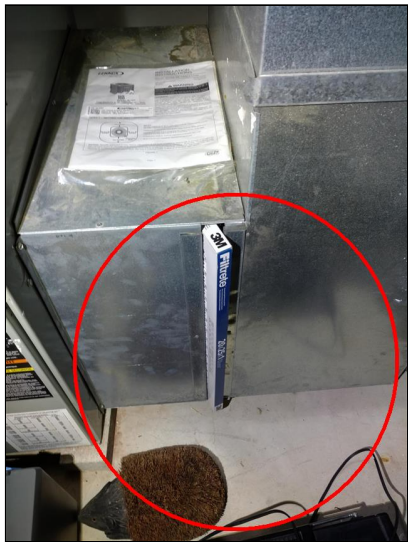
10.5 Item 1 (Picture)

The installed disposable type filters for the HVAC units were not the proper size for the return air ducting they are installed in. The filter should be inside the ducting and the opening in the ducting for the filter should be covered. This is a potential health concern as it may effect the indoor air quality as well as possibly changing the pressure balance of the system. It could also cause the water heater to possibly backdraft. Recommend further evaluation by a qualified, licensed HVAC professional and repair as necessary.

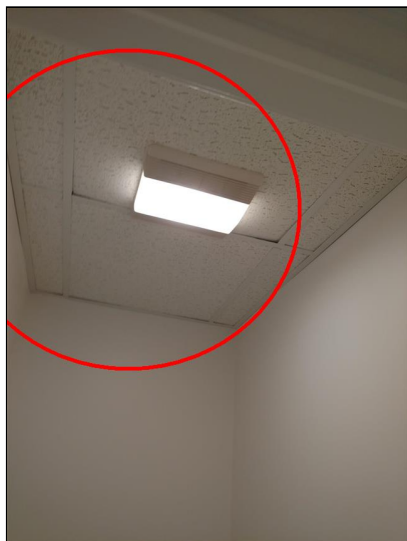
12.1 Item 1 (Picture)

There was a drop ceiling present in the basement bathroom which covered the entire ceiling. This is an issue as the metal framing could possibly rust due to the moisture while taking a shower and also moisture could possibly get trapped in the space above the drop ceiling and the floor subfloor above. Mold could possibly form on the ceiling tiles as well as the space above the drop ceiling. There was an exhaust fan in the bathroom but it was in the toilet closet and not in the central shower area.. Recommend further evaluation by a qualified, licensed contractor and repair as necessary. Also to note, there was a crack ceiling tile in the basement.

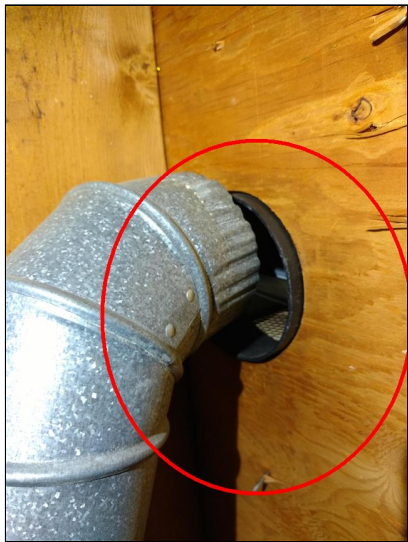
13.1 Item 1 (Picture)

As observed in the attic space, one of the bathroom exhaust fan vents was not secured to the roof mount. This venting should be terminated outdoors and may cause moisture damage/a mold condition to the surrounding structure if the needed repairs are not completed. Recommend further evaluation by a qualified, licensed contractor and repair as necessary.

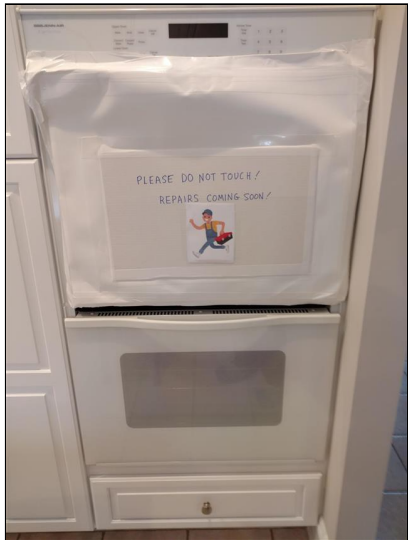
14.9 Item 1 (Picture)

The wall oven was not functioning and was being repaired. Recommend further evaluation by a qualified, licensed appliance professional and repair/replace as necessary.

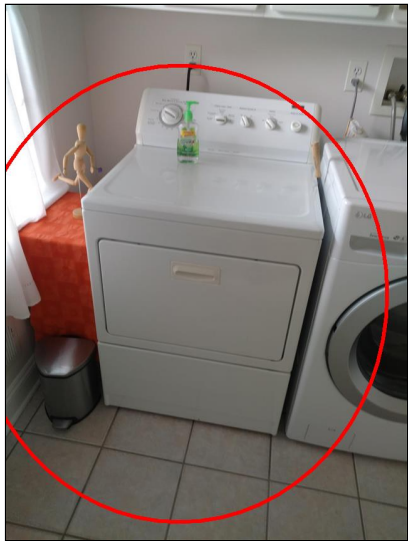
15.3 Item 1 (Picture)

The safety switch that turns the dryer off when the front door is opened was not functioning which is a MAJOR safety concern. Recommend further evaluation by a qualified, licensed appliance professional and repair as necessary.

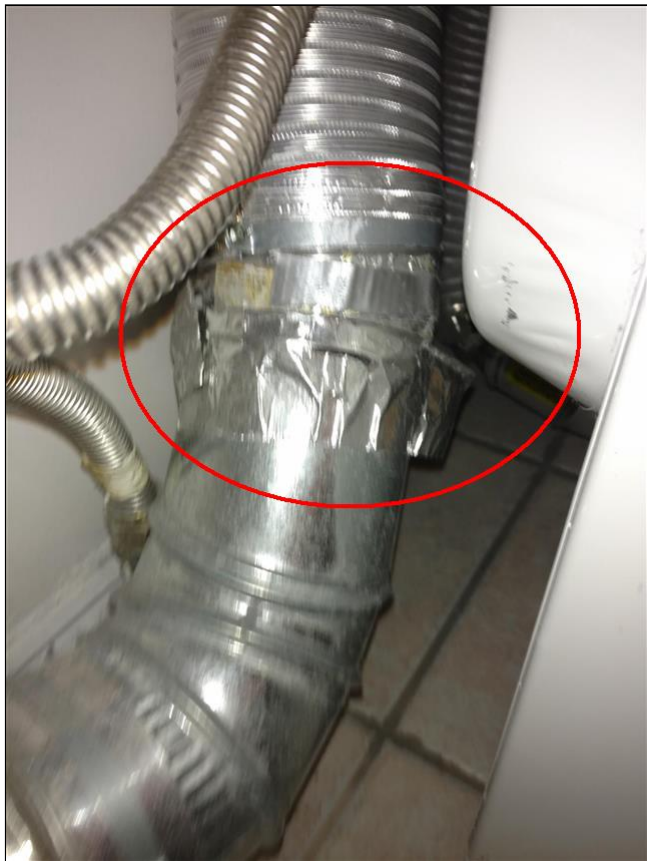
15.4 Item 1 (Picture)

The exterior vent assembly for the clothes dryer was missing. This condition could allow unwanted wildlife to enter the vent ducting which could affect the performance of the clothes dryer and possibly restrict the venting which may start a lint fire in the vent ducting or dryer. The dryer duct was also semi-blocked by the deck ledger board. The dryer ducting was also disconnected behind the dryer. The ENTIRE dryer ducting should be repaired ASAP by a qualified, licensed contractor.
