Home Inspection Report

**Delk
Home
Inspections**

Sample Inspection Report, Gloucester, Va.

Report Number: 4534 Temperature: 50's Conditions: dry

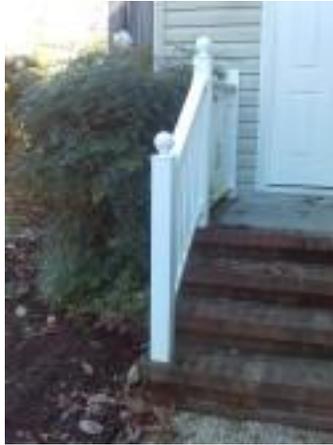
The railing on the garage side of the house is very loose and needs to be re-secured.

The railing on the driveway side of the house is very loose.

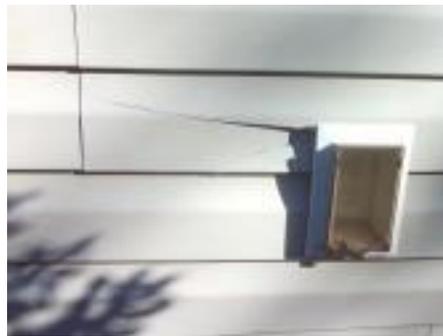
There is a crack in the vinyl siding on the driveway side of the house that needs repair/replacement. Note: Matching vinyl siding pieces are in the storage shed.

Crack in vinyl siding on driveway side.

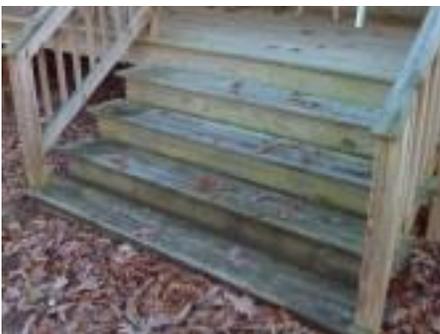
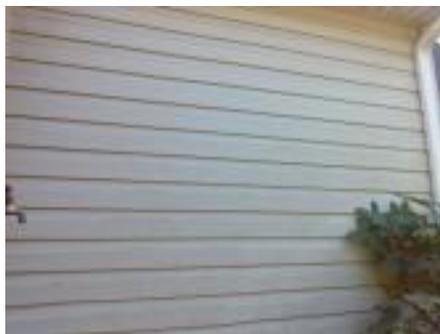
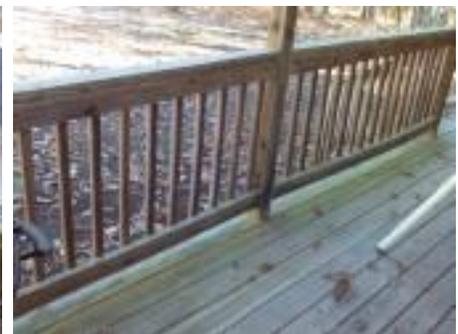
There is light growth on the NE and NW (shaded sides) of the house. Cleaning/power washing is recommended.

Light growth on NE and NW side of house.

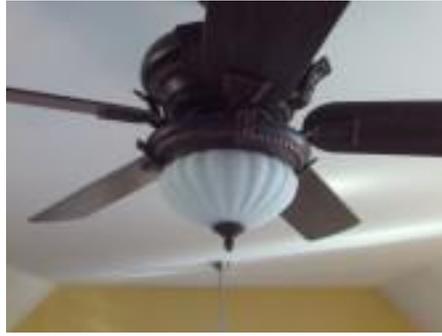
The 2nd floor, front, ceiling fan light did not operate. (likely a burnt bulb)

The 2nd floor ceiling fan light did not operate.

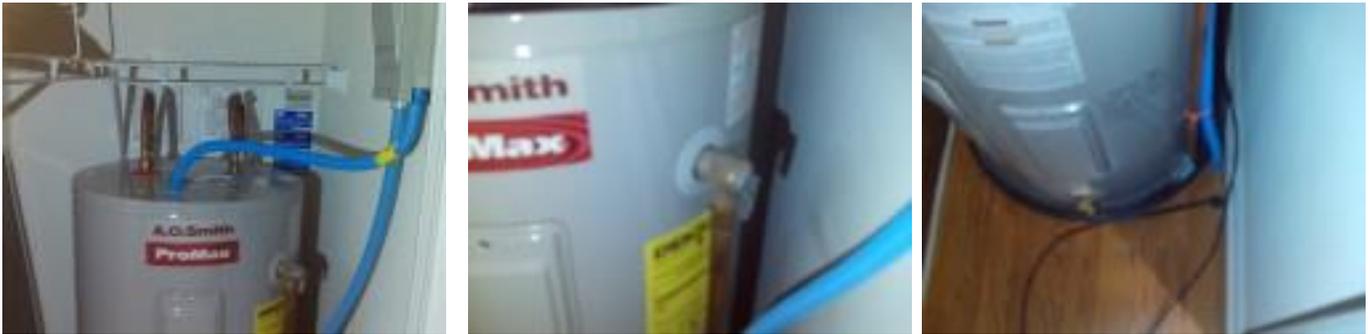
The pressure release valve for the water heater is leaking and needs replacement.

The pressure relief valve is leaking.

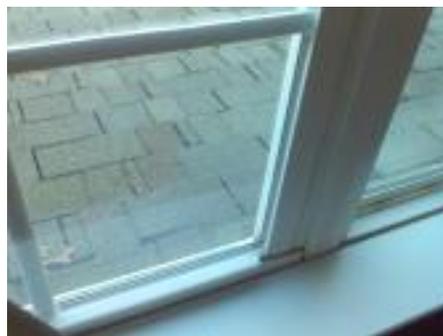
The window latch in the 2nd floor bathroom is broken and needs repair/replacement.

Window latch broken.

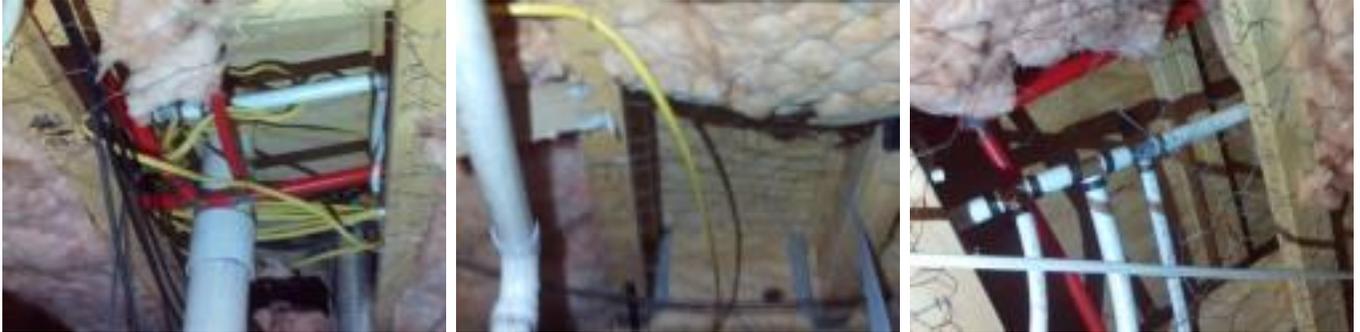
Six small sections of insulation are missing in the crawl space. Replacement is recommended.

Insulation is missing in a several areas.

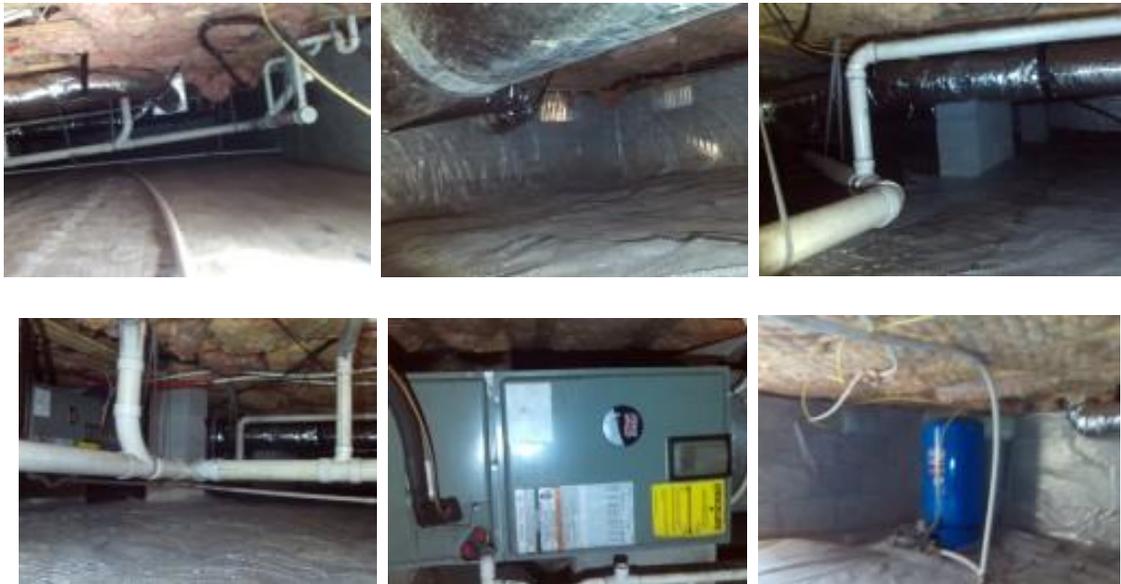
One junction box cover in the crawl space is missing. (near the center of the house)
Installation on the cover is recommended.

Junction box near center of house missing cover.
