Canyon Country Club Estados Conservation Review Report

Submitted on July 1, 2016 by Jessyca Frederick, CEO of Water Wise Now, LLC
WaterWiseNow.com | jessyca@waterwisenow.com | Toll free: 844-LESS-H2O x 700

Project Summary

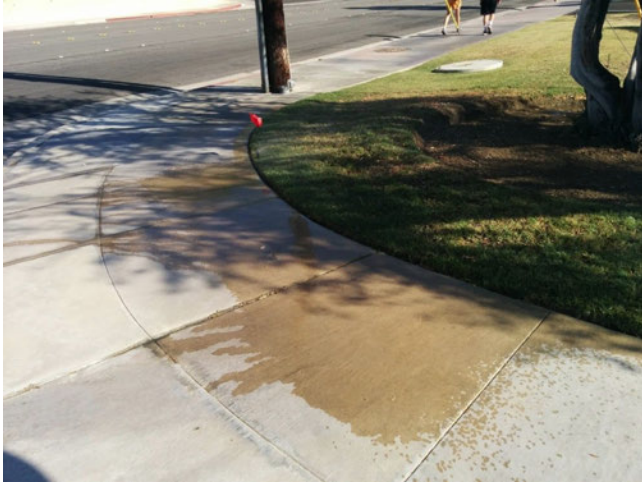
Overspray onto sidewalk

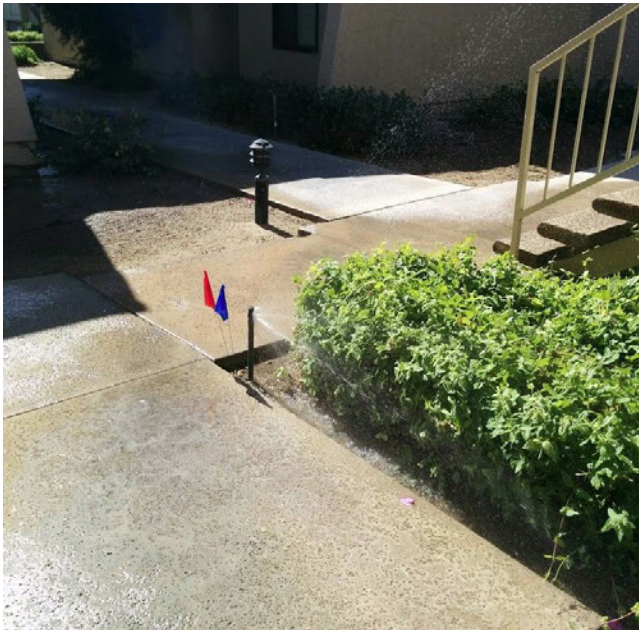
Broken sprinklers creating a lot of overspray.

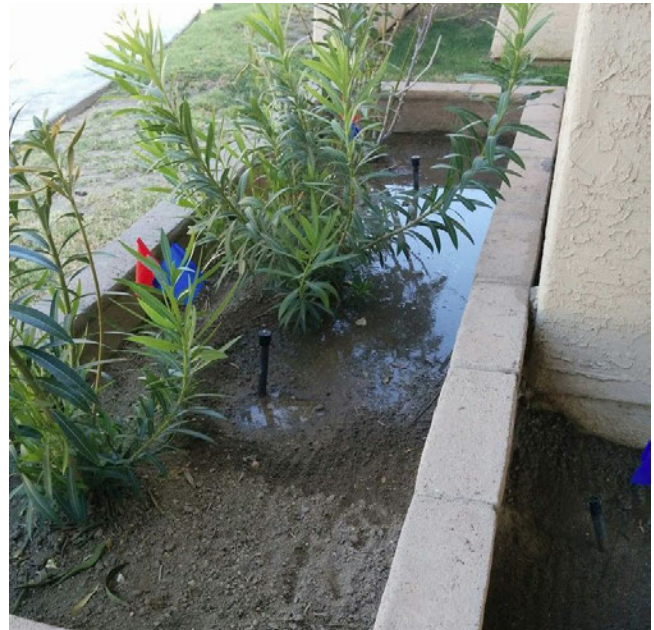
Not a good use of bubblers—too few plants. Oleander isn't a water-intensive plant, either.

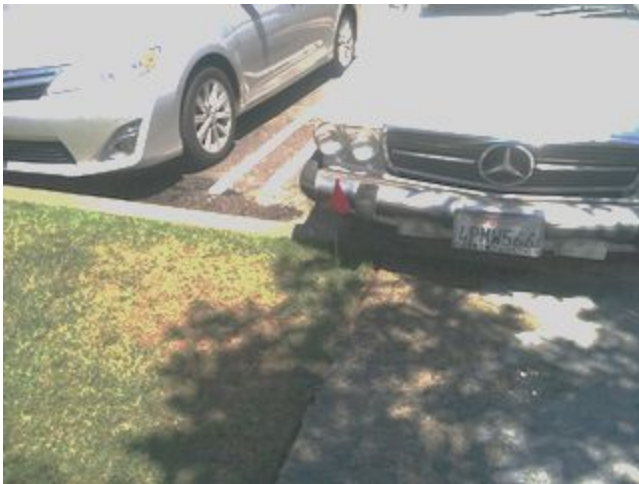
Sprinklers by cars, also poor efficiency and overspray.

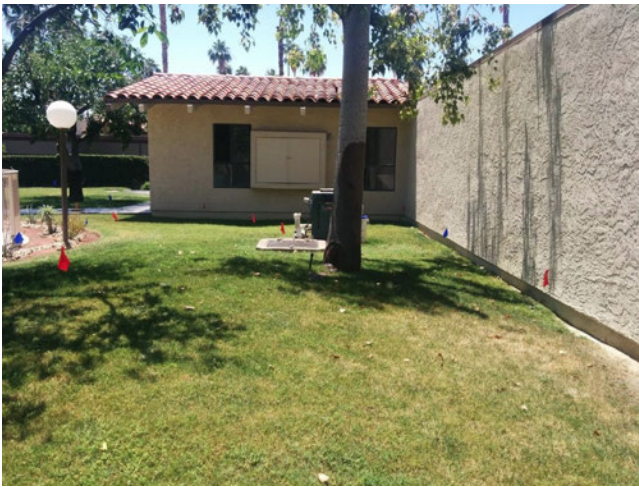
Uneven watering from poor efficiency

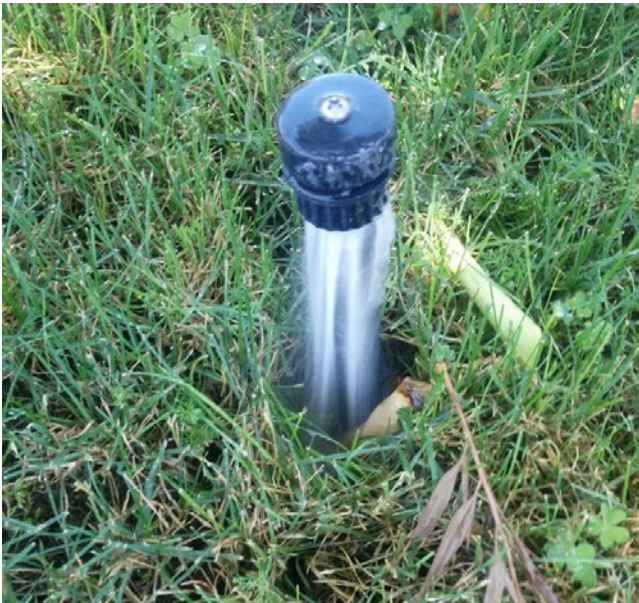
Why we don't leave equipment in place if we're not using it. They fail and no one notices.

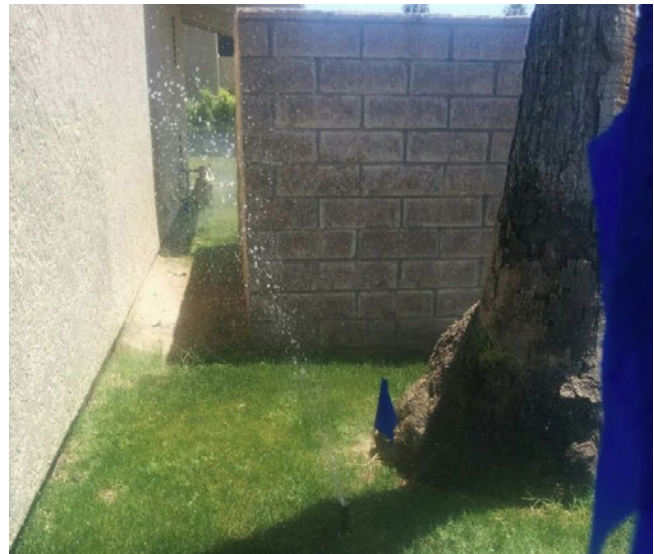
One of many sprinklers that were broken and would be detected with regular wet runs.

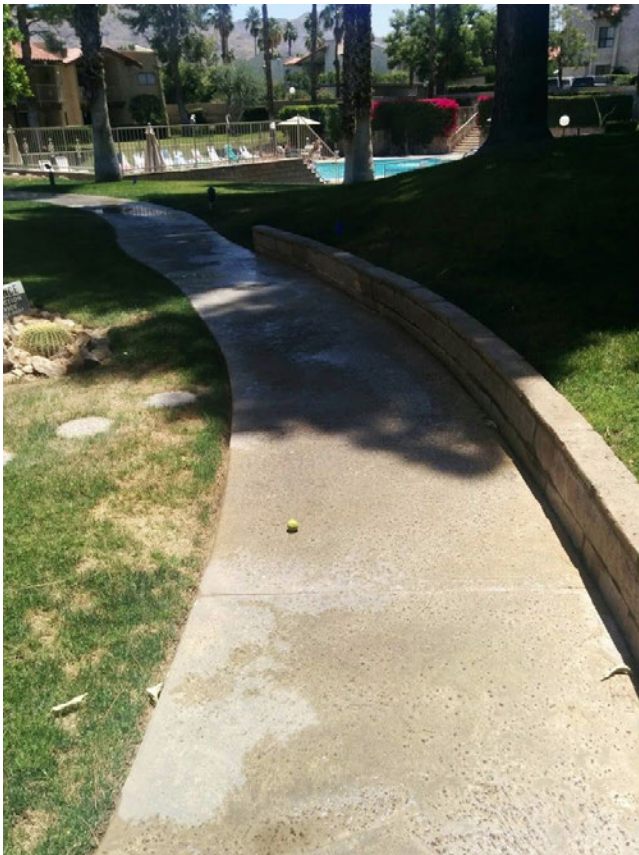
Overspray from hill and patchy lawn areas in shade

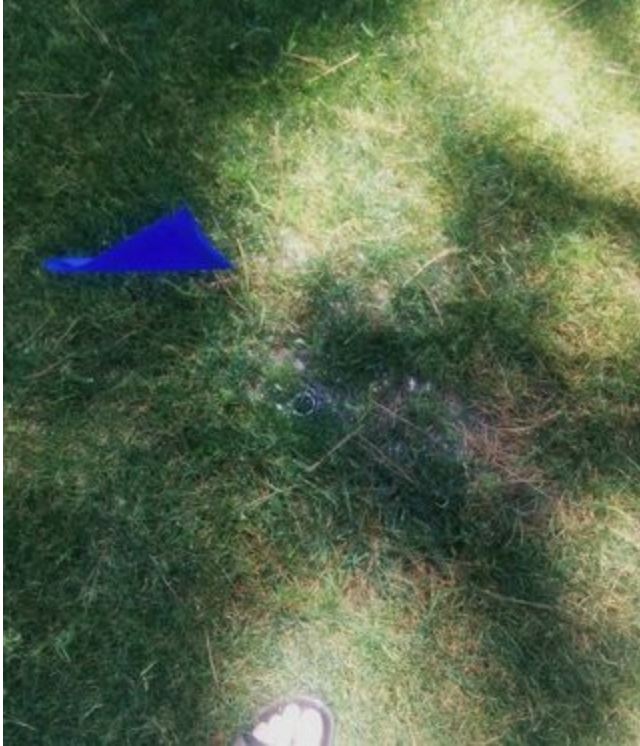
Broken sprinkler, doesn't pop up

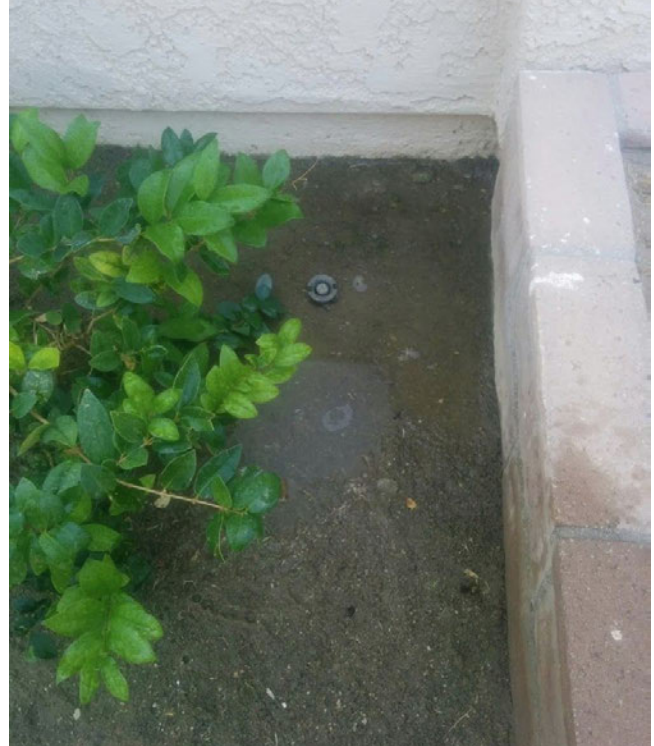
Another form of broken sprinkler, leaking

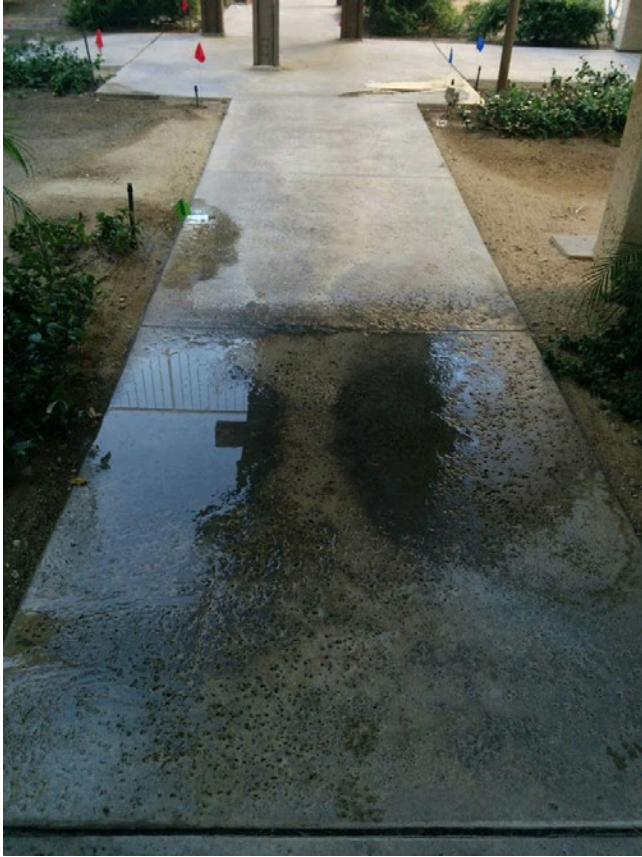
A lot of overspray and slippery concrete

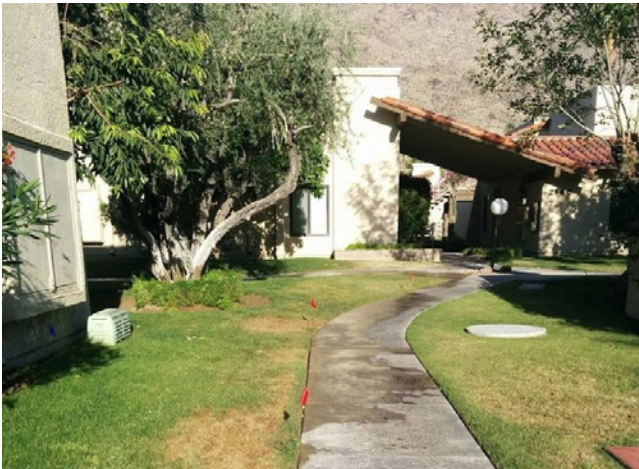
Overspray and patchy grass from inefficient sprinklers

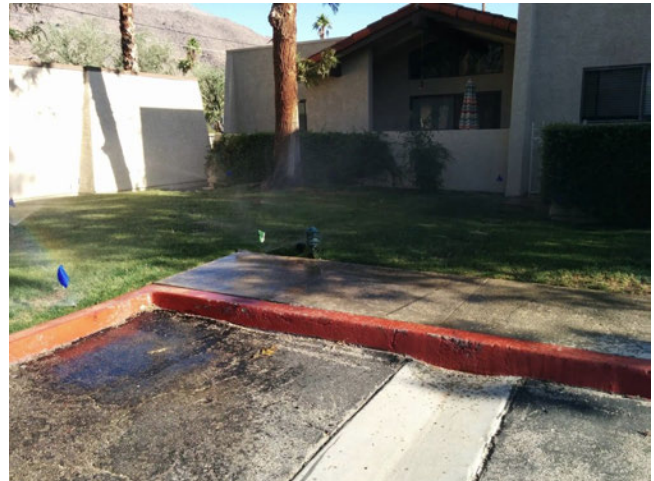
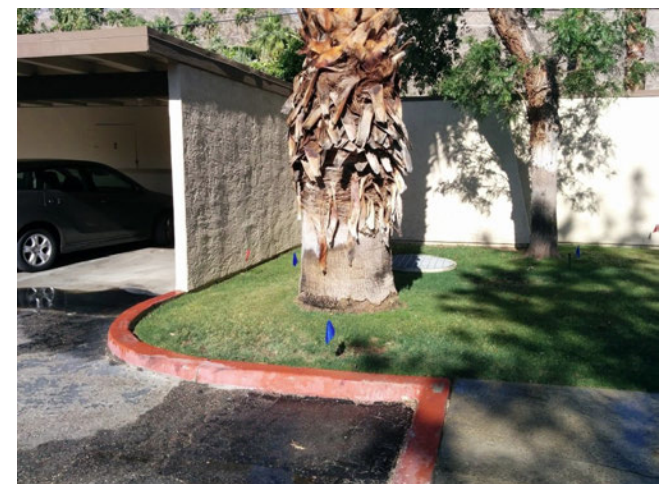
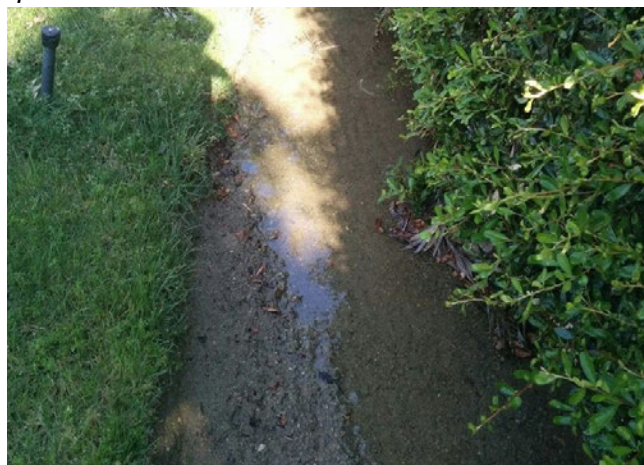
Flooding from blocked spray heads, another opportunity for drip tubing

Overspray onto sidewalks and asphalt (causing damage to the asphalt)

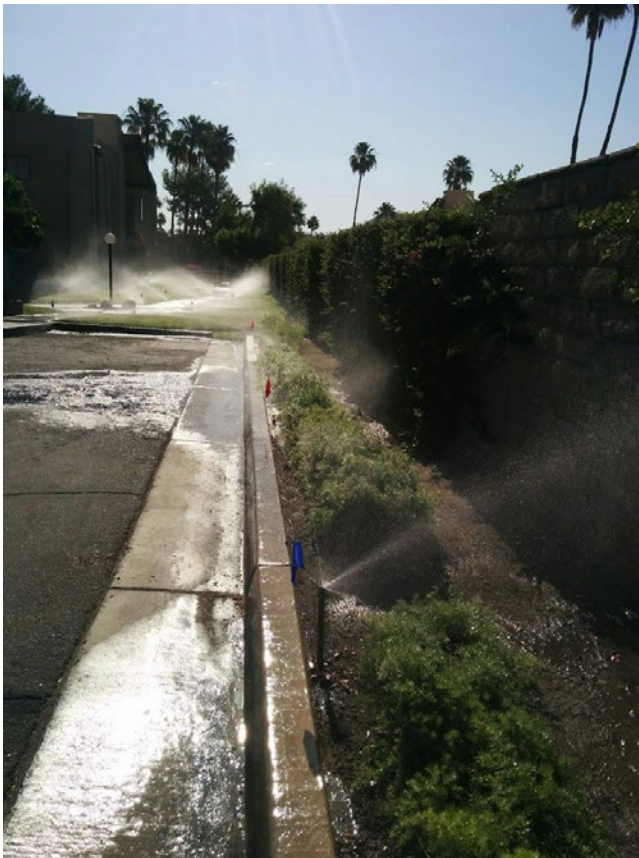
A lot of overspray and runoff into publically visible areas. Blocked sprays are causing flooding.

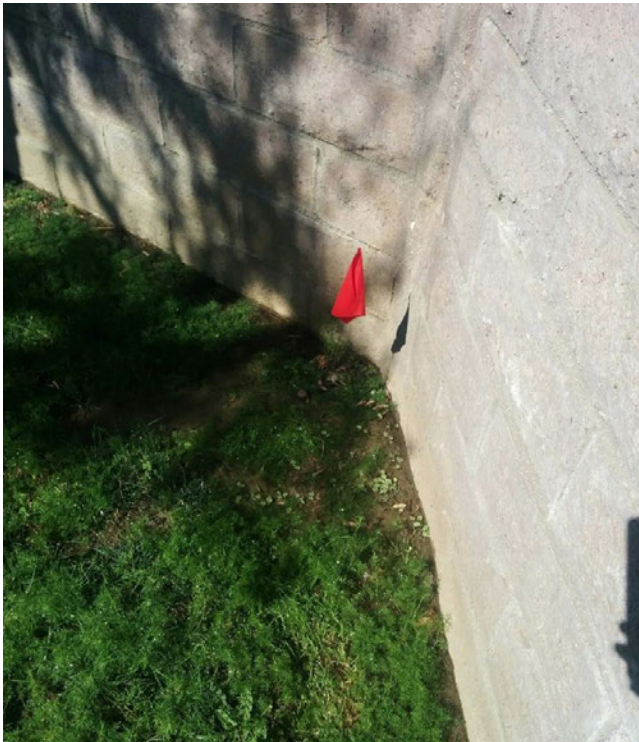
Broken sprinkler creating interesting ecosystem in the corner of the wall, very little grass, lots of other plants (weeds)

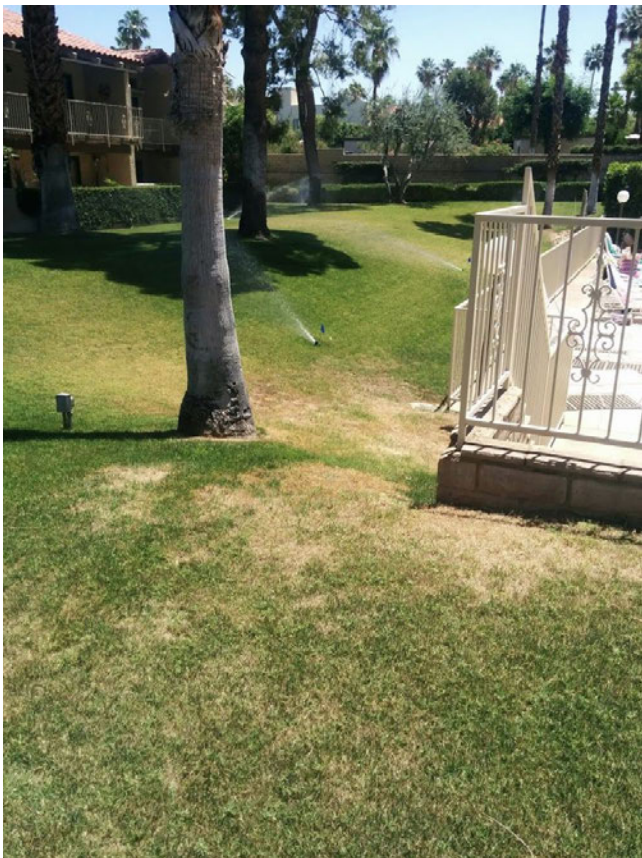
Patchy areas in turf related to poor coverage. Adjustments need to be made to spacing and sprinkler types.

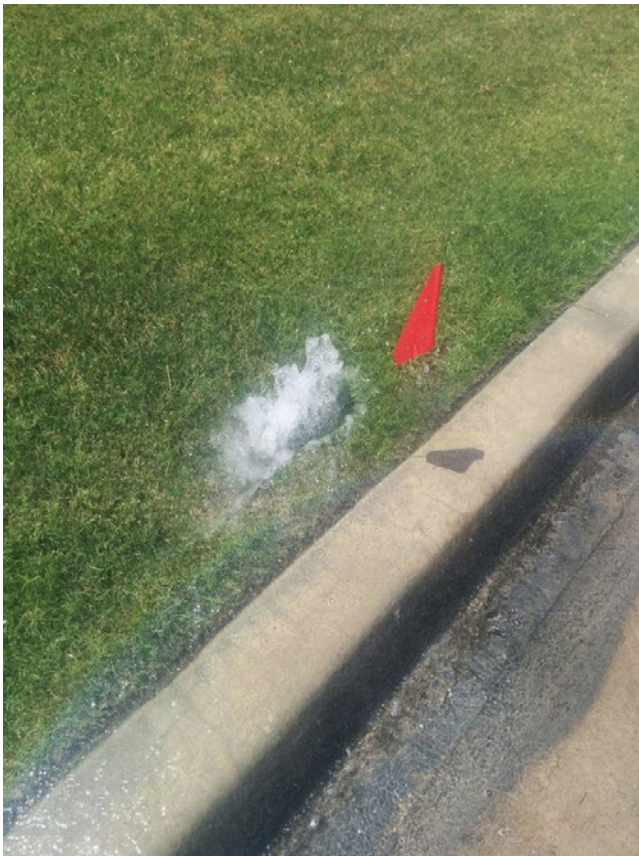
Broken sprinkler found during review. This sort of break would be detectable with wet runs or flow sensors.

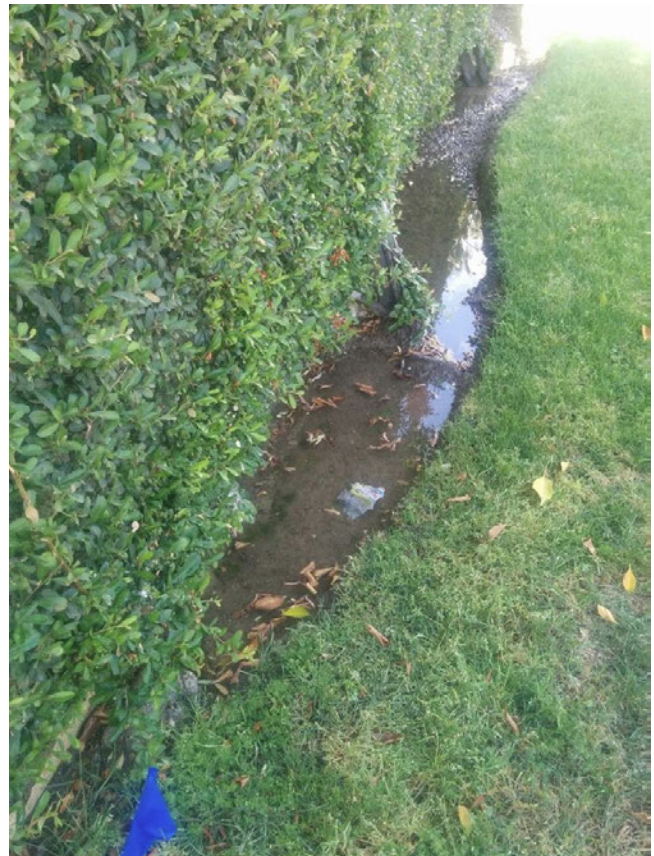
More flooding caused by using spray heads where drip tubing is more suitable.

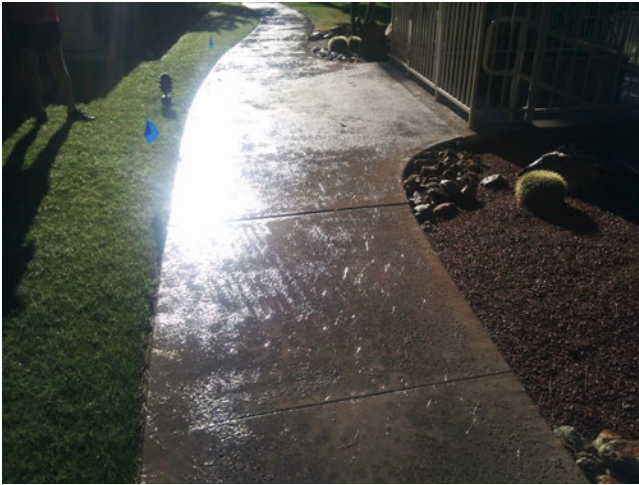
Overspray, not just onto sidewalk, but also into desertscape. This isn't good for either.

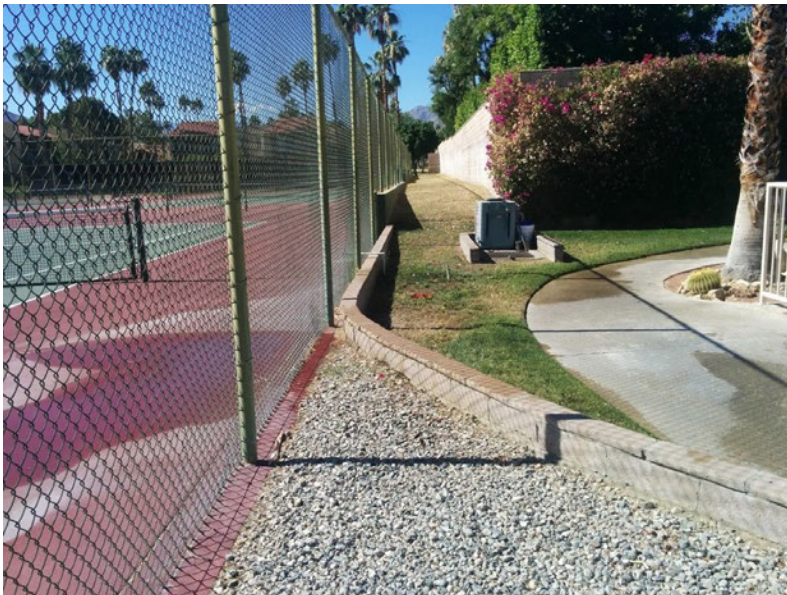
This corner is awkward for watering turf and it should be removed. Also note the overspray onto the tennis court.

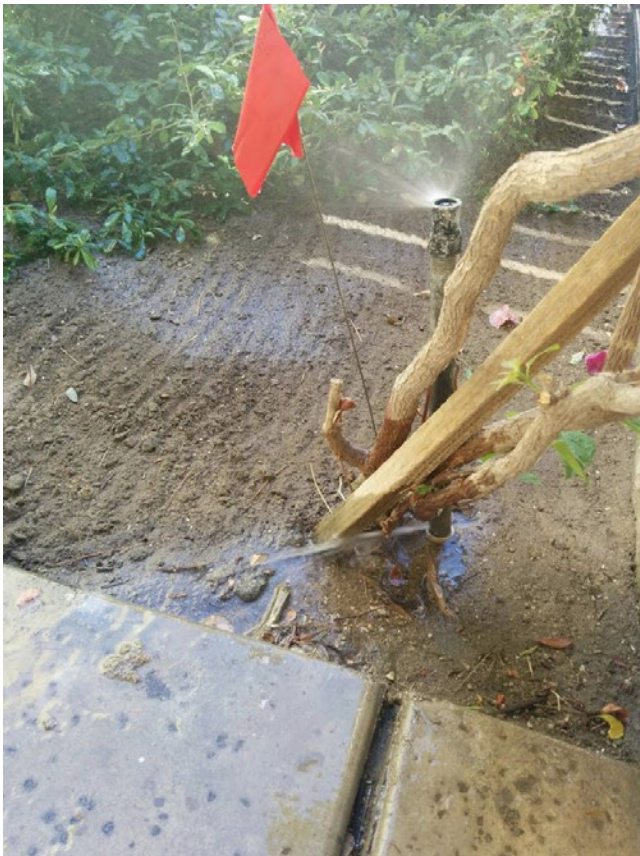
Broken sprinkler on a riser, probably caused by root damage because it was installed too close to the bougainvillea.

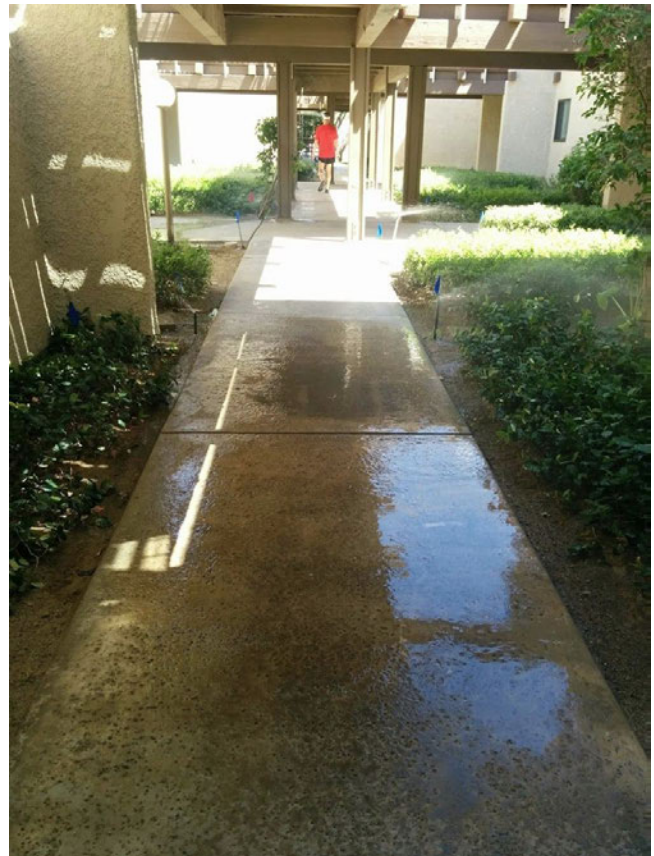
Tons of overspray creating dangerous conditions.

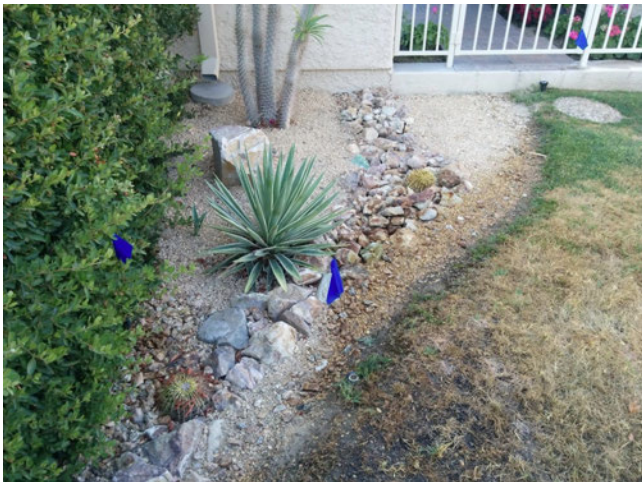
Brown patchy grass is because of pool sprinkler coverage.

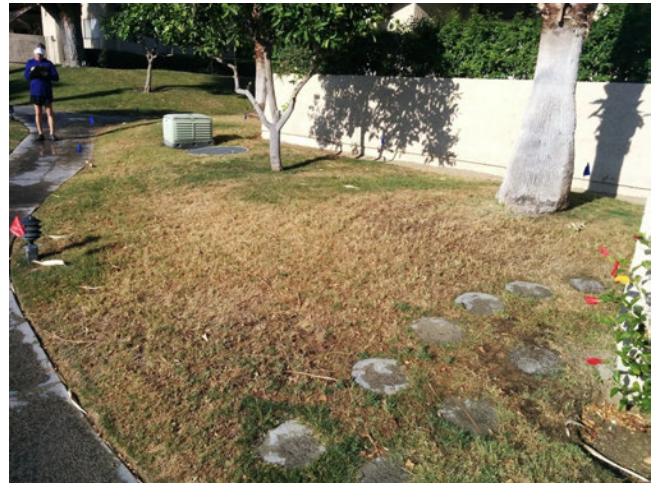
Brown grass is a result of a broken sprinkler. This should have been detected during wet runs.

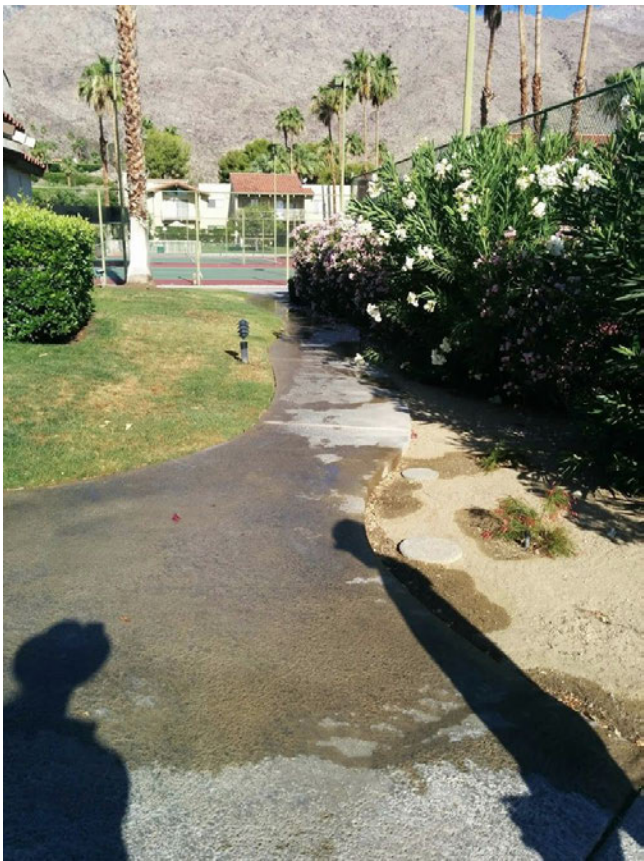
A lot of overspray from lawn areas.

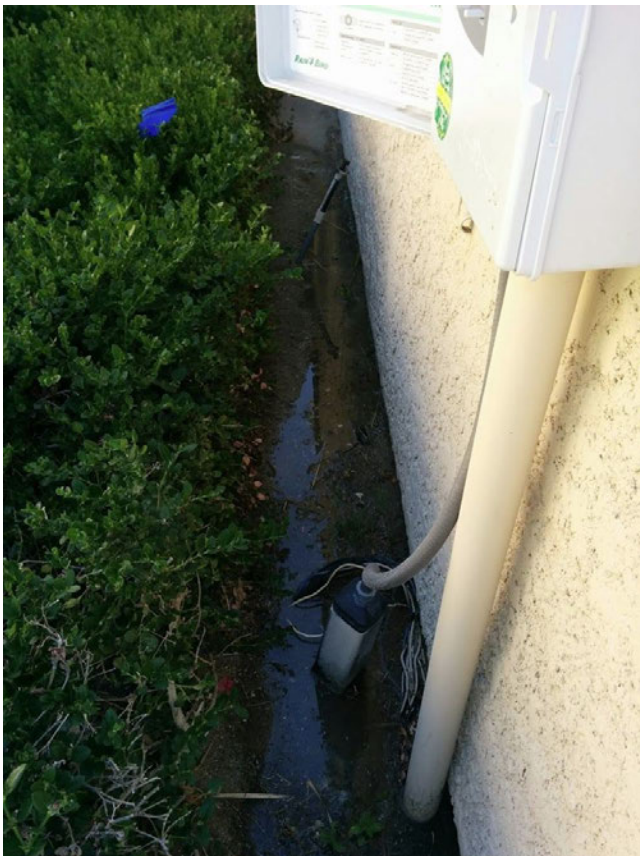
Flooding around the electrical wires for the controller, caused by blocked sprinklers. This is a good area for drip tubing.

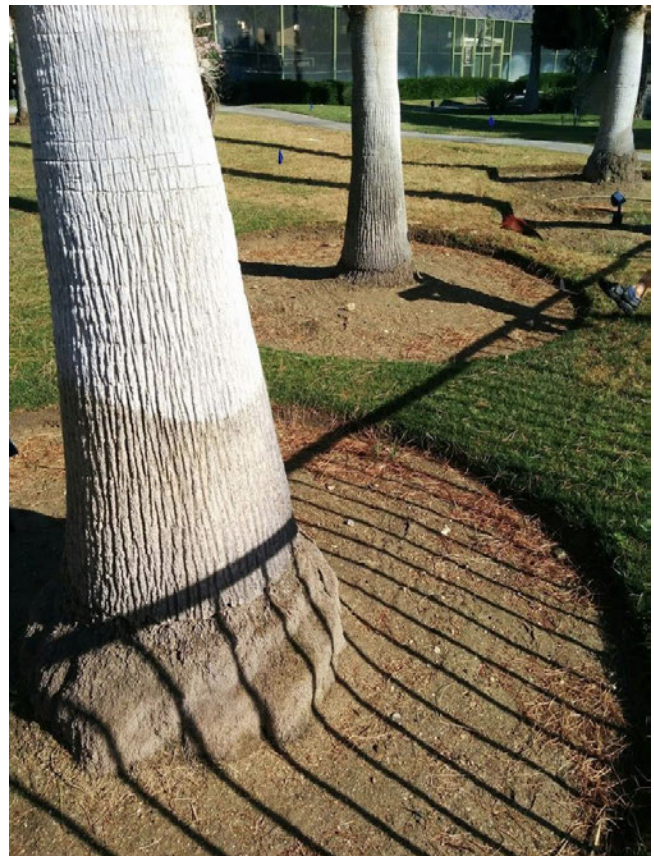
These trees are not getting the right kind of watering coverage. The brown loam indicates sprinkler inefficiencies.

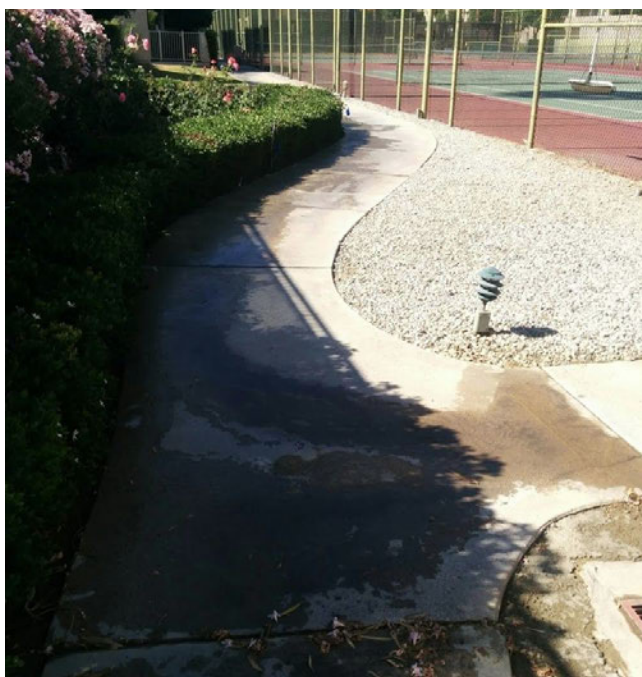
A lot of overspray from the hedges. These should also be watered with drip tubing.

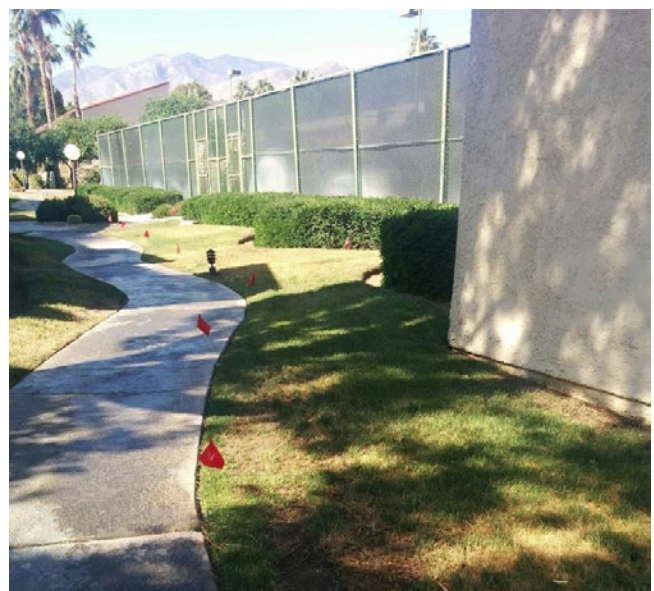
A very awkwardly shaped area for watering with sprinklers. This turf should be removed and the sprinklers for the hedges should be replaced with drip tubing to reduce the amount of overspray onto the tennis court.

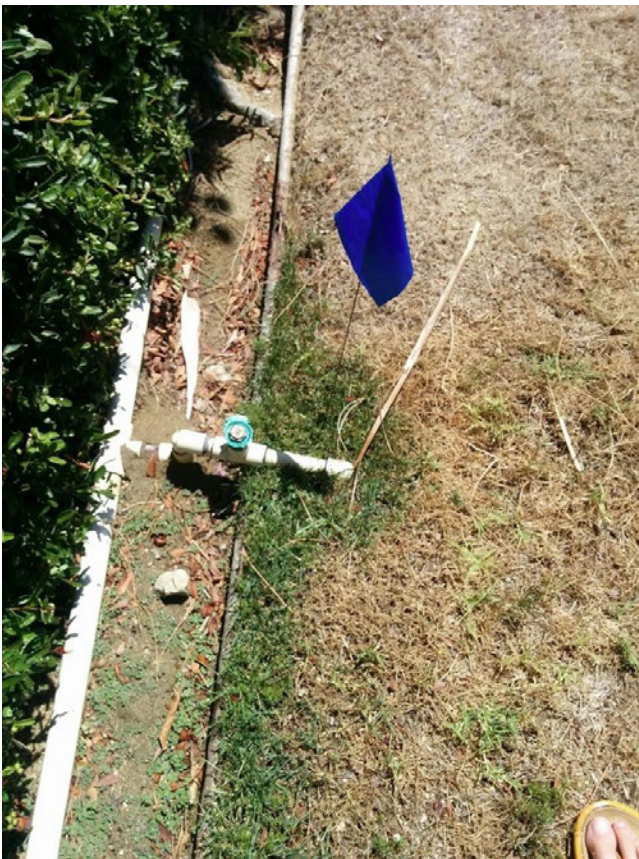
These exposed pipes are a trip hazard. This should be fixed with a proper pop-up sprinkler and drip tubing in the hedge. The pipe should be buried.

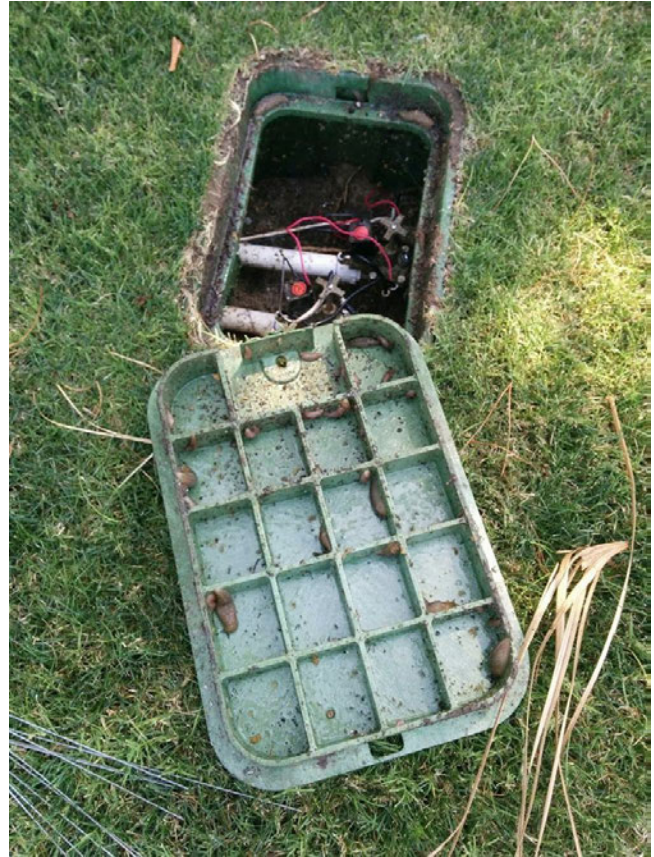
These valves are probably leaking, as the valve box was infested with larvae and slugs.

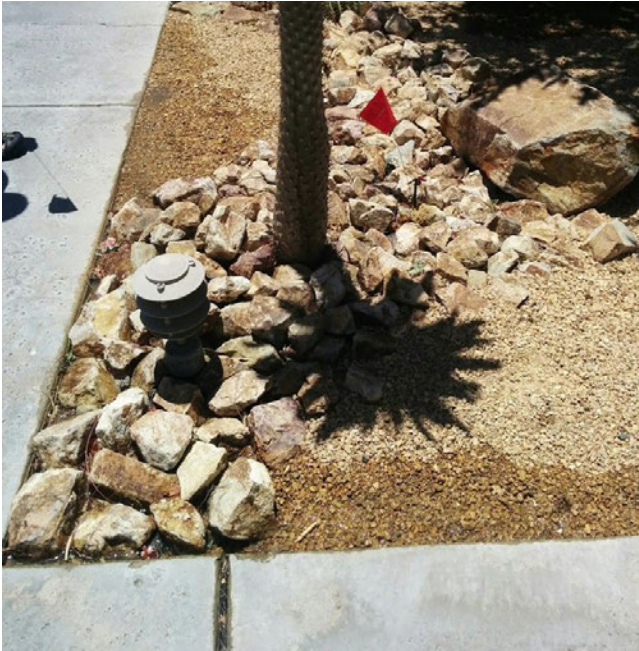
Water is pooling in the desertscaping from a broken emitter.

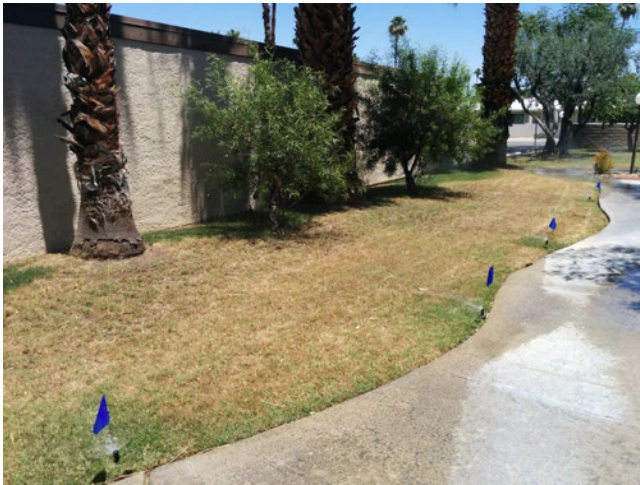
Inefficient and insufficient watering of these turf areas. A lot of overspray.

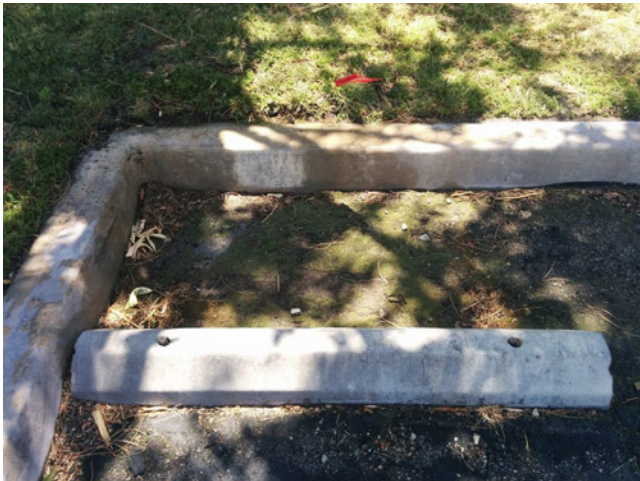
This sprinkler has been broken a long time, there is a thick layer of moss growing in this corner.

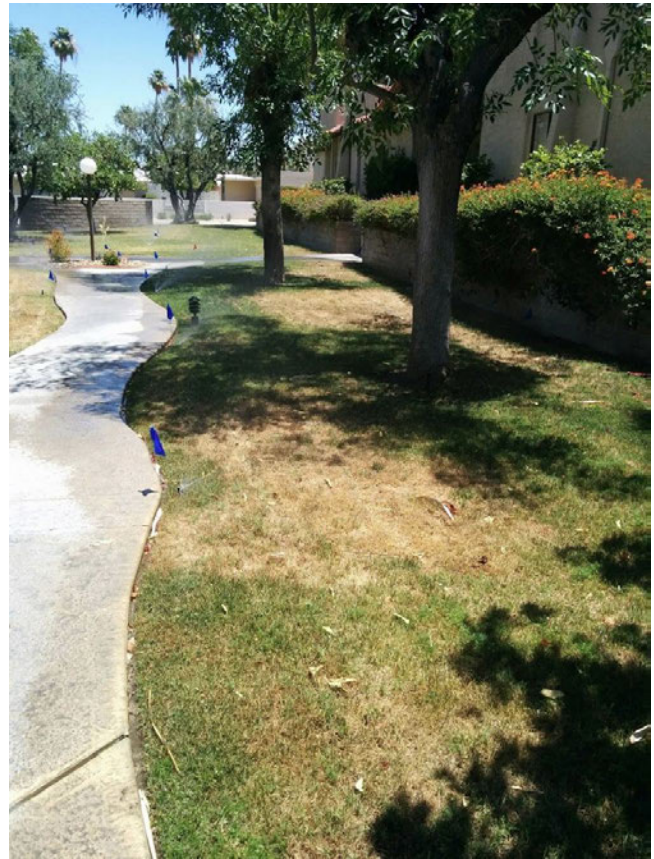
This photo also shows areas of Zone 12 with the same problems.

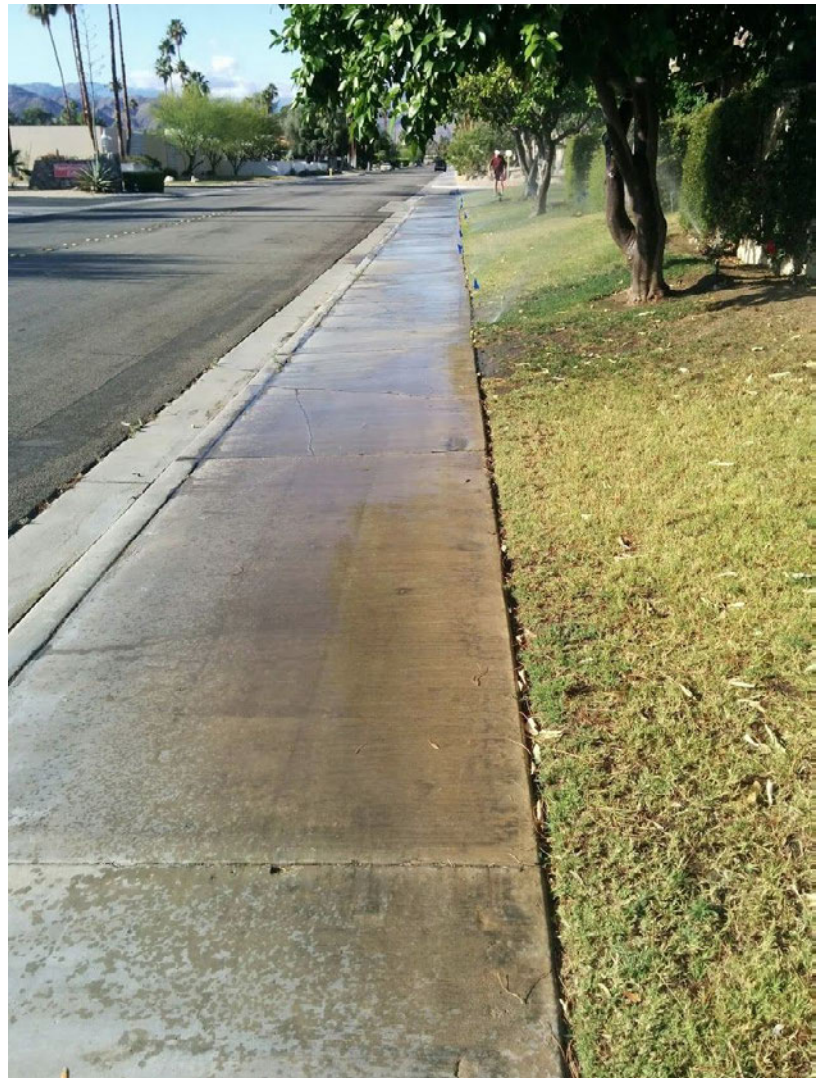
Overspray from watering turf on hillside

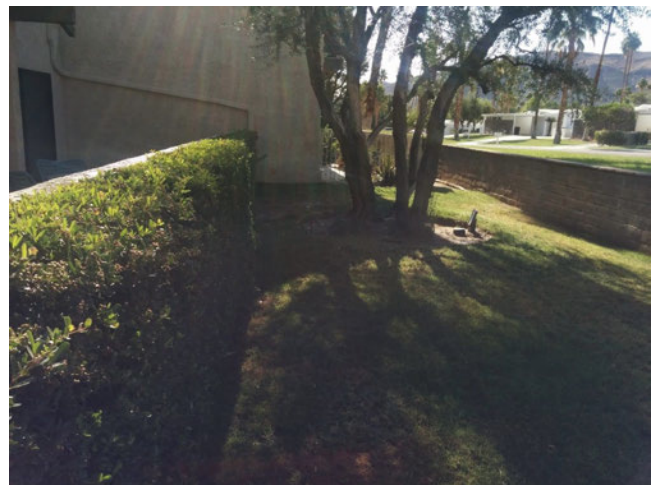
- Pressure was 50 psi.
- 6 sprinklers to be replaced, 18 sprinklers to be upgraded, 3 bubblers.
- **Broken lateral suspected in southwest corner, against the building.** This is in a low-traffic area. Jose was informed to look for the leak, but we don't know if it was repaired.

The location of the leak

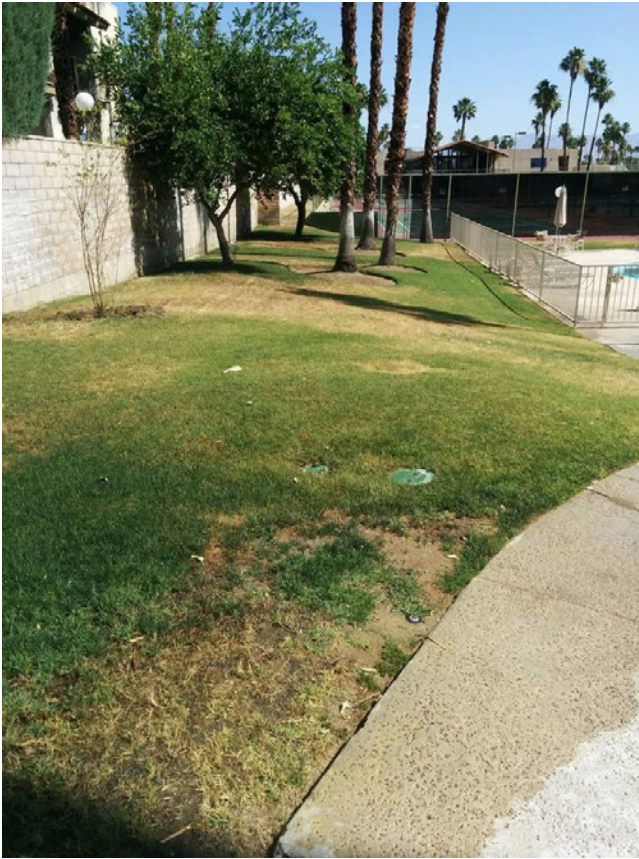
Patchy grass and brown spots are a combination of inefficient and insufficient watering.

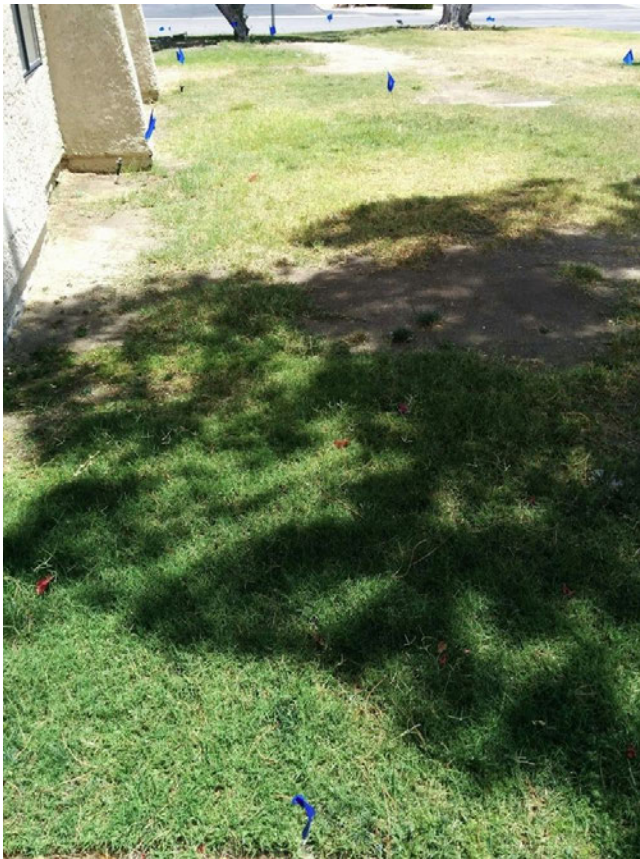
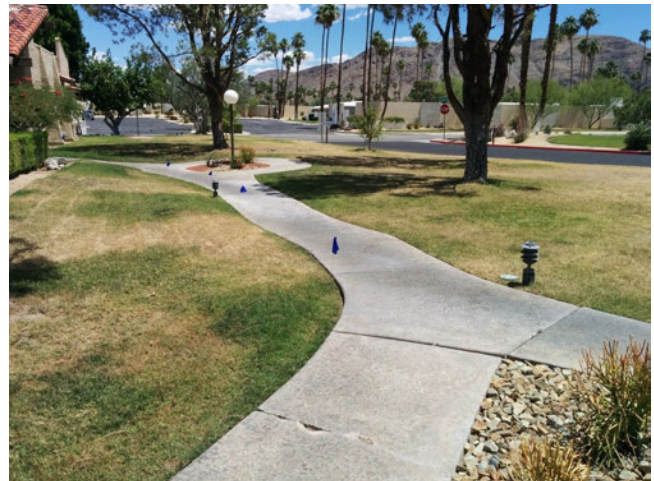
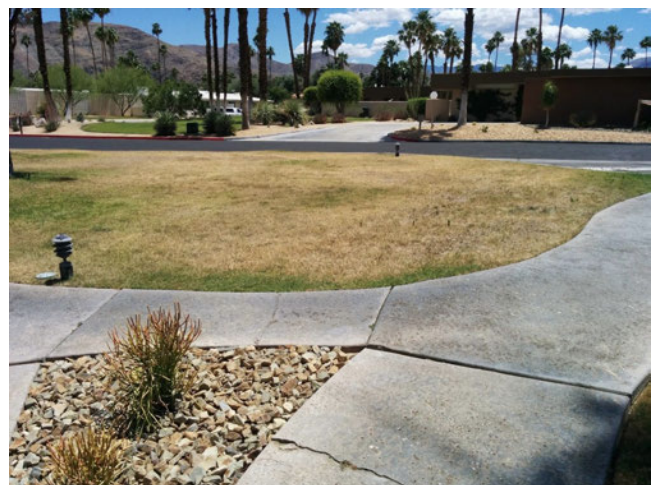
These photos are from Zones 1, 3, and 4 (they're all watering the same general area)

Old sprinklers and broken sprinklers were ubiquitous in these zones. Where there is still grass, it's very patchy as these sprinklers have been in disrepair for a long time.

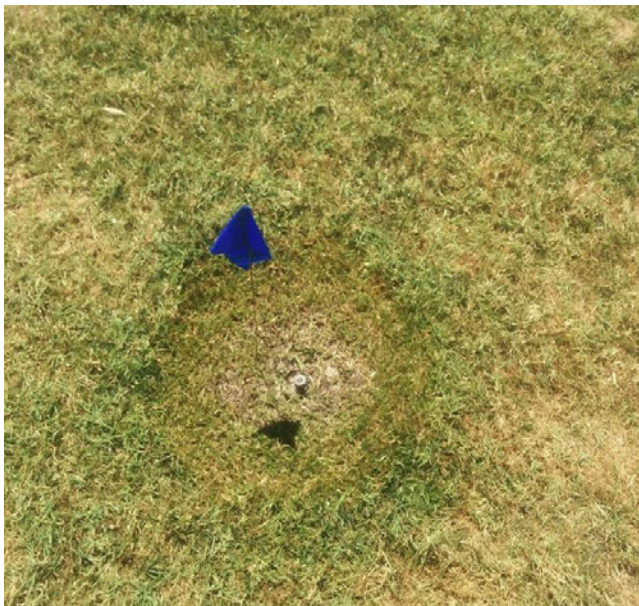
Very old sprinkler (to be replaced) putting out so much pressure and volume that it's created a crater in the lawn, preventing the water from escaping the little berm it created.
