SOMMERS HOME INSPECTIONS, LLC

## HOME INSPECTION

1234 Main Street  
Beaverton, OR 97005

Buyer Name  
07/14/2024 9:00AM

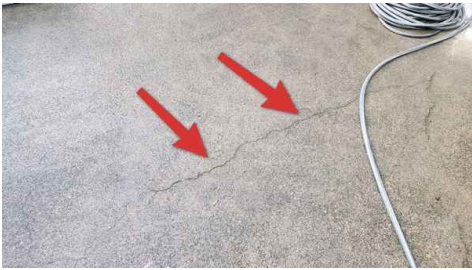
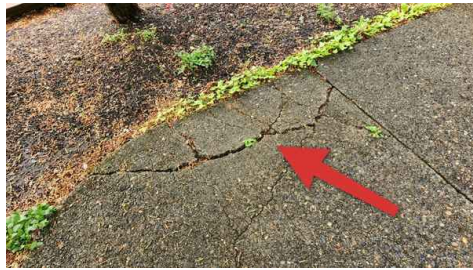
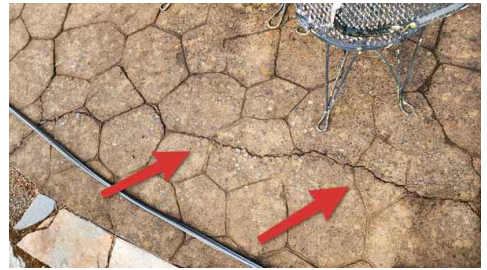
Southeast Corner

**CRACKS IN WALKWAY/PATIO**

Cracks are found in the walkway/patio. Consider sealing them to prevent further damage when moisture gets in and it freezes in the winter.

Seal cracks

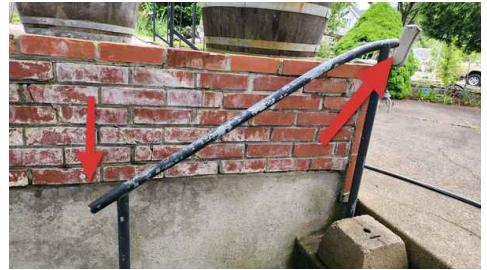
2.2.1 Decks, Balconies, Patios & Steps

**MISSING RETURN**

All handrails need to have a return for safety.

Add return

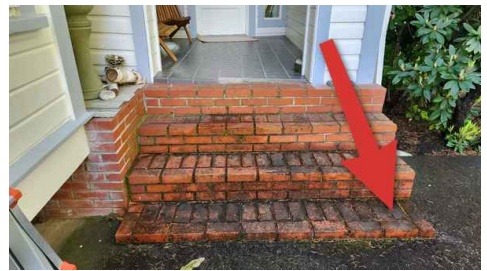
2.2.2 Decks, Balconies, Patios & Steps

**MISSING HANDRAIL**

The handrail is missing and needs to be installed.

Add handrail

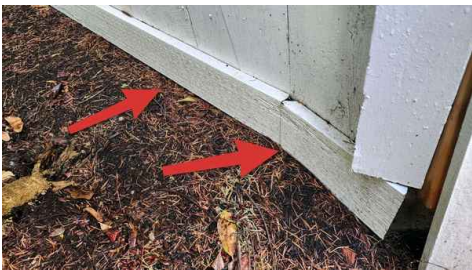
2.2.3 Decks, Balconies, Patios & Steps

Avoid wood to soil contact as it will cause rot overtime and invite wood destroying organisms.

Create a clearance

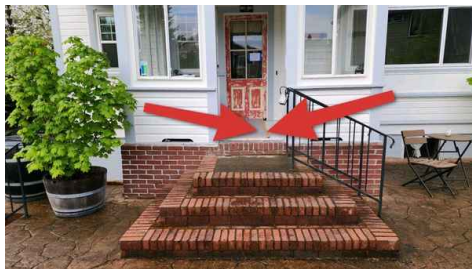
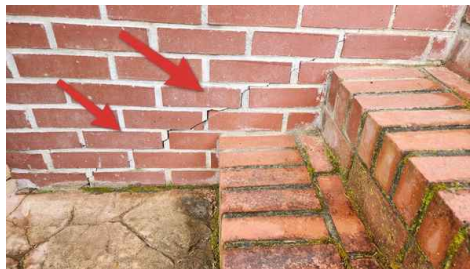
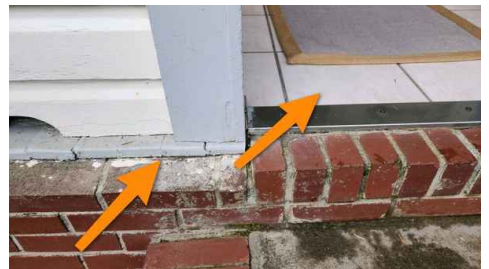
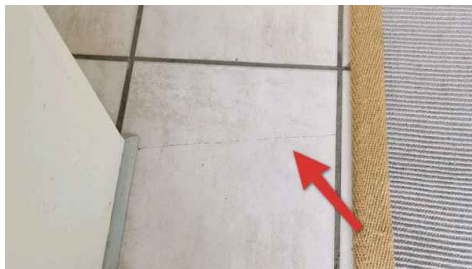
FRONT OF HOUSE

I observed settlement at the front porch. The stone are cracked which is a sign of movement. I am not able to determine how long ago this happened or if there is ongoing movement. Have this evaluated and upgraded as necessary. There is no access to the underside of the porch to inspect the structure below. Additionally, the original wood is exposed along the front of the porch. The main flooring is tile however. I am not able to determine if the wood was removed so the tile could be installed on backer board which is the right way to do. Some cracking is already noted in the tile.

Sagging

Settlement cracks

Cracked tile

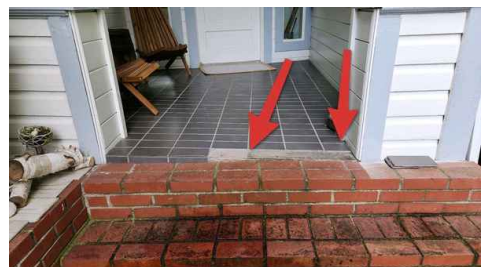
WEST SIDE

**MISSING TILE**

Tile are missing on the west porch. It looks like they were installed over wood wick should not be done. Wood contracts and expands with different temperatures which loosen the tile over time. A backer board should be added underneath instead.

Missing tile

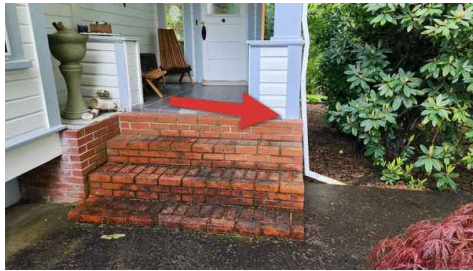
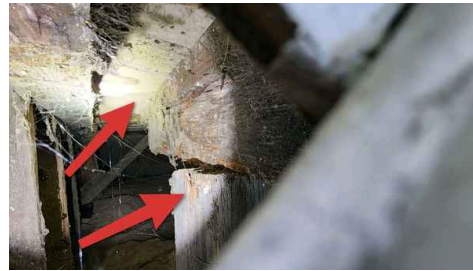
WEST SIDE

**DETERIORATION**

The west and back patio are pretty enclosed but I was able to shine my flashlight in between the slatted fencing. Deterioration is visible on the structural wood and upgrades will likely need to be made in the near future. This patio also has a substantial slope. A slope was often added to allow water to drain away from the house but in this case settlement might have contributed to it as well, given the old wood.

Settlement

Deteriorated wood

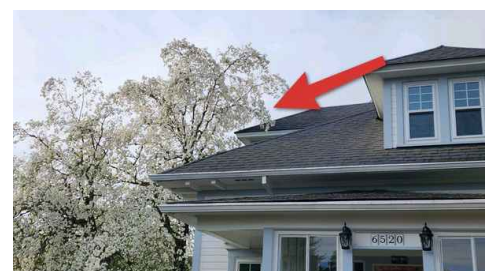
**TREE OVERHANG**

Trees limbs overhang the roof. This can cause damage to the roof and prevent proper drainage. Trim back to as needed.

Trim back

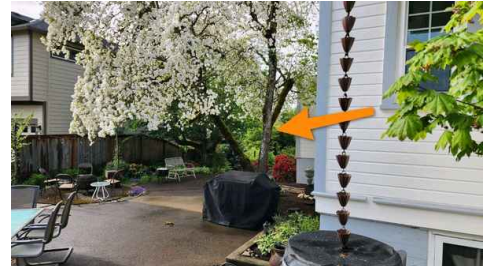
2.3.4 Vegetation, Grading, Drainage

**TREES CLOSE TO THE FOUNDATION**

Trees planted too close to the foundation may cause damage to the structure. Monitor the foundation and remove trees as needed.

Close to the house

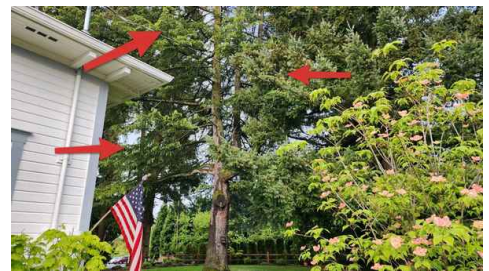
2.3.5 Vegetation, Grading, Drainage

Since the big tree/trees is/are fairly close to the house, I recommend having them evaluated by a licensed arborist to make sure they are healthy and there is less of a risk of them falling down during a storm.

Large trees

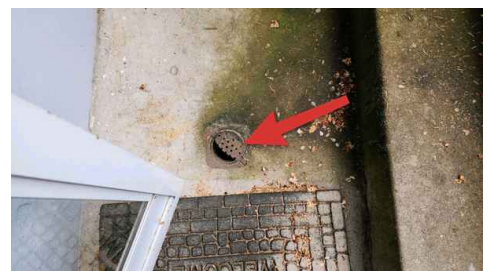
2.3.6 Vegetation, Grading, Drainage

A drain is installed at the basement entrance. I am not able to determine if it still functions properly. The cover plate should however be replaced.

Replace cover

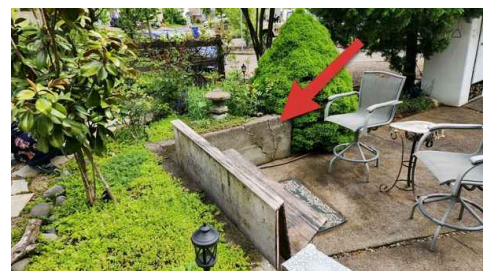
2.4.1 Retaining Walls & Fences

**CRACKS**

Cracks are noted in the retaining wall. There might be too much pressure from the other side. Consider adding some more drain holes to alleviate the pressure.

Cracked

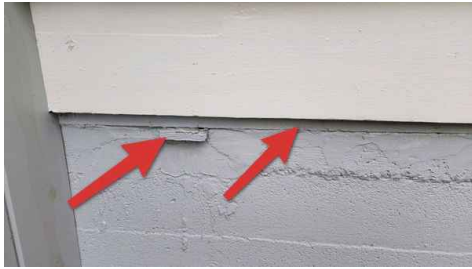
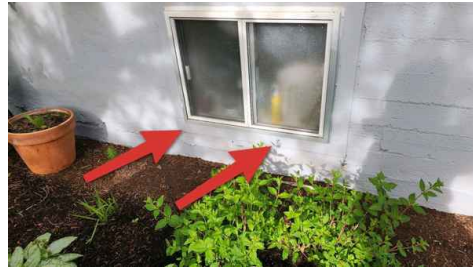
3.1.1 Foundation

The sill plate is exposed in some areas. I recommend having it covered with siding for best protection. A deteriorated sill is difficult and expensive to repair as the entire structure of the home rests on it.

Exposed sill plate

Exposed sill below window

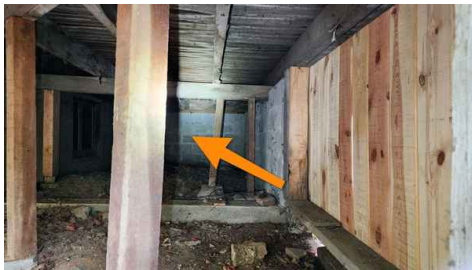
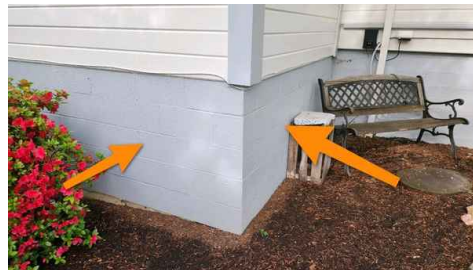
3.1.2 Foundation

**BLOCK FOUNDATION**

Sections of the home have a block foundation. If the hollow block is not completely filled with concrete, it does not provide the same structural support as a solid concrete wall would. I am not able to determine after the fact how it was installed.

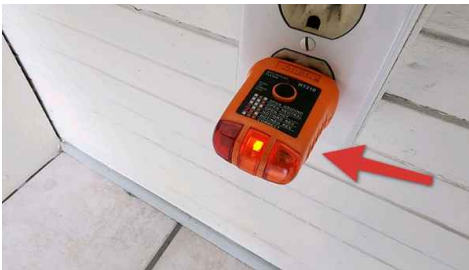
3.6.1 Lighting, Outlets & Doorbell

By todays standards, all exterior outlets should be GFCI protected. I recommend upgrading for safety. Since most of the outlets are not grounded, they also need to be labeled as such.

Also verify that the outlet for the water feature is GFCI protected. I did not want to trip it and then not find the reset.

Ungrounded three prong

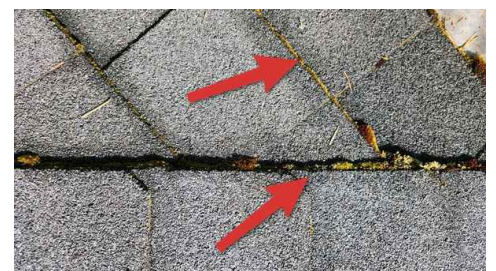
### MOSS

Moss is starting to grow. It has little roots which loosen the granulate and shorten the life of the shingles. Treat as needed.

Moss

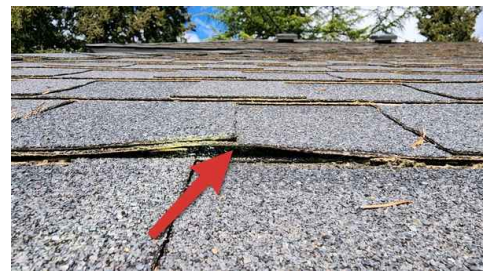
I noticed at least one nail pushing up. This may allow wind-driven rain to get pushed underneath the shingles, potentially causing leaks. I recommend having this corrected.

Nail pushing up

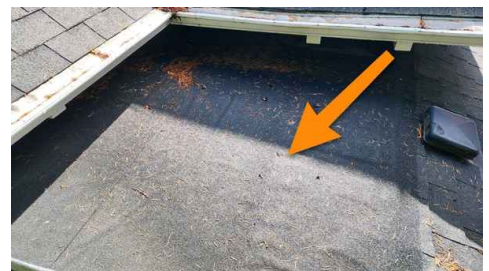
4.1.4 Coverings

A rolled roof material was installed on the flat section. This does not have a long life expectancy and I recommend replacing it with TPO or PVC when the time comes.

Flat section

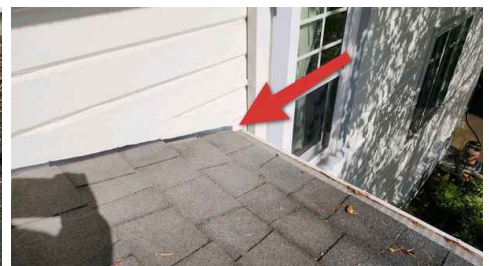
4.2.1 Flashings

Adequate kick out flashing should be installed where the roof meets the house so water is less likely to run down between the gutter and the wall, eventually causing damage to the structure. It is supposed to be 4" long and 4" high.

Too short

Missing on east side

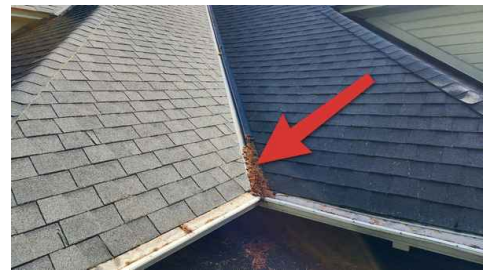
4.2.2 Flashings

Keep the valleys clear of leaves and other debris to prevent moisture buildup that can wick underneath the shingles.

Clean valleys

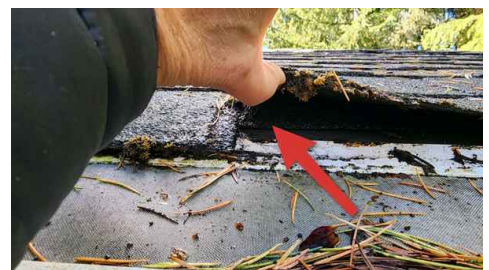
**IMPROPER STARTER COURSE**

Where I randomly checked at the back patio, the starter course is too short or missing and there is nothing between the upper layer of shingles. This can lead to moisture intrusion. Flashing is however installed behind this area.

Inadequate starter course

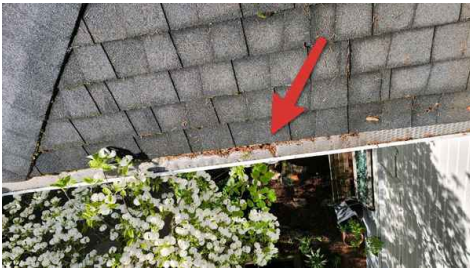
4.4.1 Gutters and Downspouts

**GUTTER GUARDS**

Gutter guards are installed. They still need to be cleaned on a regular basis so leaves or needles will not pile up. This can allow moisture to get pushed under the shingles.

Keep clean

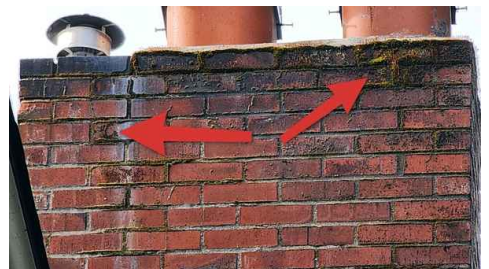
### MOSS GROWTH

All moss needs to be removed on a regular basis. It has strong roots that can grow into the mortar and lead to deterioration.

Moss

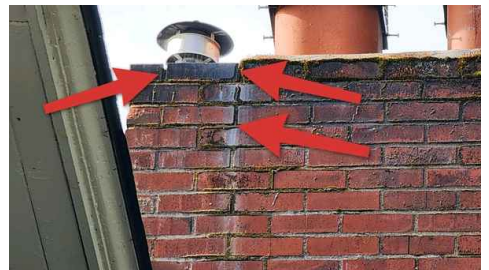
#### 4.5.3 Chimneys

### SEAL CHIMNEY CROWN CRACKS

Seal all cracks in the chimney crown to prevent moisture intrusion. Judging from what is visible from a distance, some concrete is missing and the mortar on the brick is exposed. This has already led to damage on the brick below the crown.

Repair crown and stone

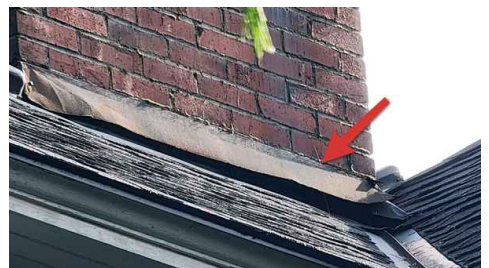
#### 4.5.4 Chimneys

### UPGRADE COUNTER FLASHING

It is always better to replace the counter flashing when the step flashing is upgraded during the roof replacement. It is usually bent up and cannot be bent back as flush as new flashing would.

Counter flashing no longer flush

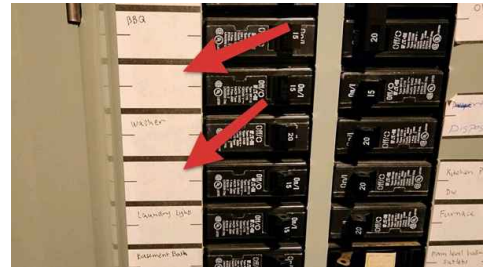
#### MISSING LABELS ON PANEL

Some breakers are either not labeled or improperly labeled. Make sure all labeling is correct so you can quickly turn off any breaker in question during an emergency. You can check proper labeling by turning off one breaker at a time and verify that there is no power in the home on those circuits.

Missing label

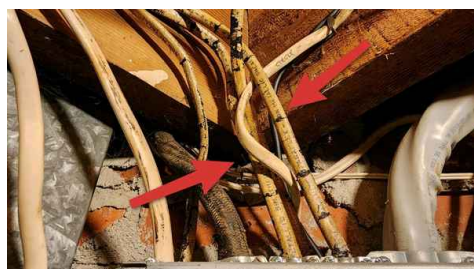
The older cloth wrapped wires are still present in the home. I suggest gradually upgrading to new wiring as you remodel. Some deterioration is noted on these wires.

Older

Deterioration

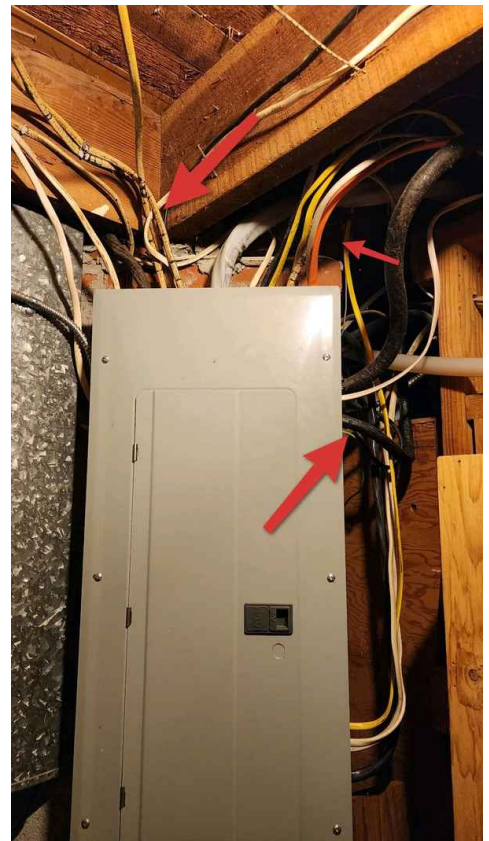
AROUND PANEL

The wiring around the panel should be a better protected and I recommend covering it.

Protect wiring

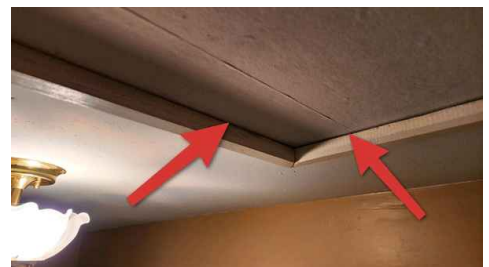
ACCESS

I recommend adding weather stripping to seal the attic access better, prevent heat loss and condensation related issues such as mold growth.

Add GFCI weather stripping

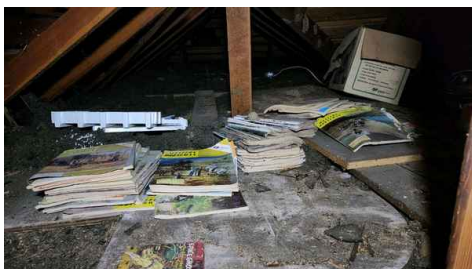
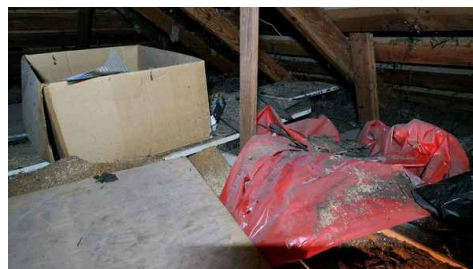
6.1.3 Roof Structure & Attic

There are boxes, old carpet, old magazines and other remnants in the attic that should all be cleaned out.

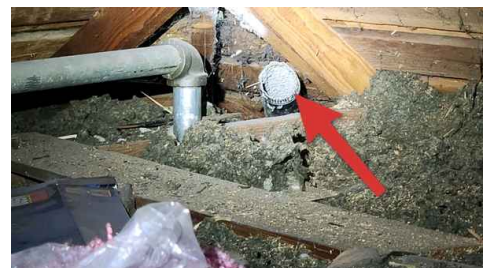
6.3.1 Ventilation

**BATHROOM VENTS INTO ATTIC**

The primary bathroom improperly vents into the attic which needs to be corrected to prevent mold growth. Ideally, a dedicated bathroom vent should be installed on the roof.

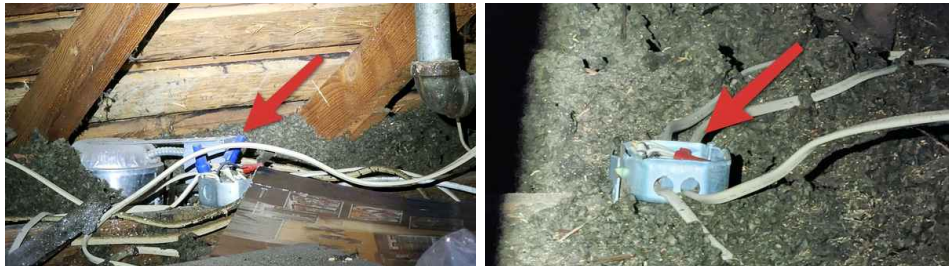
6.4.1 Wiring/Lighting

**COVER JUNCTION BOXES**

All junction boxes and wire splices need to be protected by a cover plate. Open junctions are a fire hazard. Repair as needed.

Add cover plates

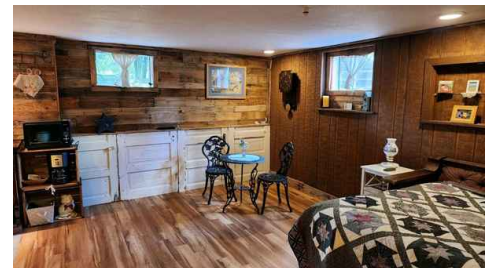
### OLD FOUNDATION

Concrete foundations have an average life expectancy of 100 years. In the early 1900's they were essentially built of sand and stone. They get porous over time, causing the foundation to get brittle. A skim coat is sometimes added to smooth out the wall but it doesn't provide structural support and can make it difficult to inspect the actual foundation.

Since the basement walls are finished, none of the foundation is visible on the inside and could therefore not be inspected.

Finished walls

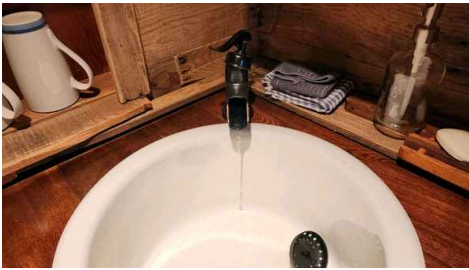
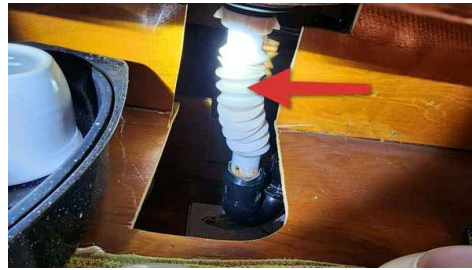
8.2.3 Interior

There is barely any hot water at the sink. The cold water works. Upgrade as necessary.

Additionally, a flexible drain pipe is installed underneath the sink. These are not allowed and should be replaced with a rigid pipe.

Hot water flow

Replace flexible drain

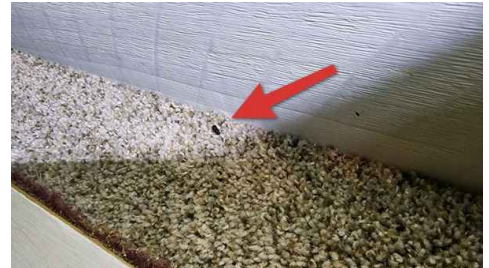
8.2.4 Interior

I noticed a rodent dropping behind the theater chair. I recommend setting some traps, also around the house. If this is an ongoing issue, consult with a pest control company about options.

Rodent dropping

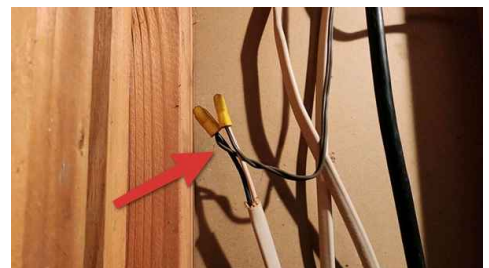
8.3.2 Electrical

Open wire splices are a fire hazard. They need to be placed in a junction box and covered with a plate for safety.

Critical Issues

Place in junction box

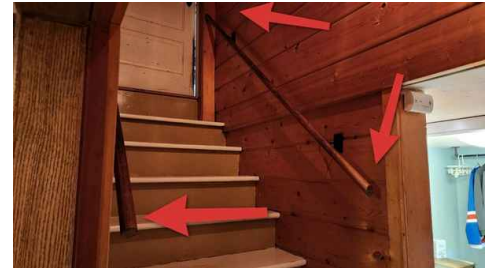
I recommend adding a return on the handrail for safety.

Add return

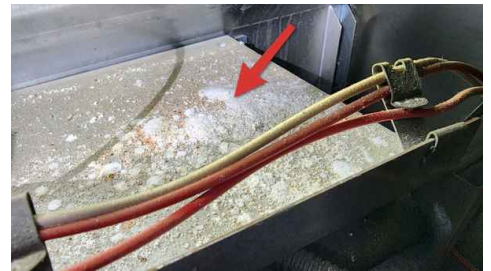
The white ash around the burners is an indication of incomplete combustion and needs to be evaluated, it can indicate a larger issue.

White ash

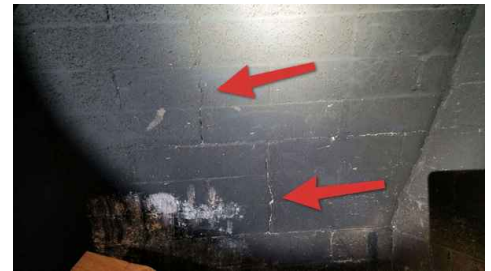
Cracks are visible in the firebox walls. This may allow carbon monoxide to enter other areas of the living space. Have the fireplace evaluated and repaired by a licensed fireplace contractor.

Cracks in firebox

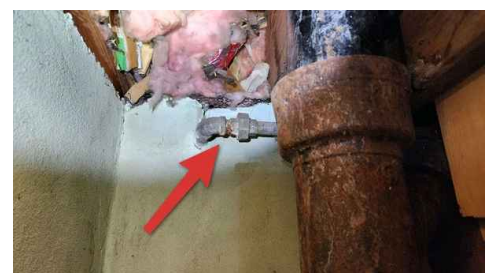
Corrosion

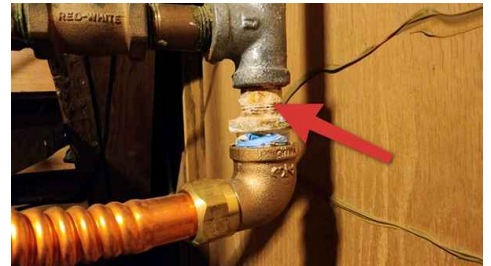
Corrosion

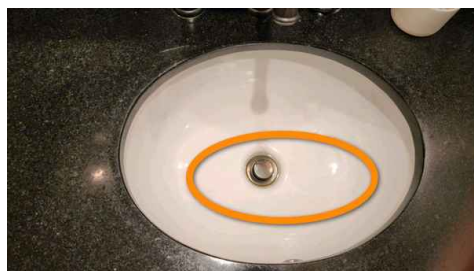
The stopper does not work, repair as needed.

Adjust stopper

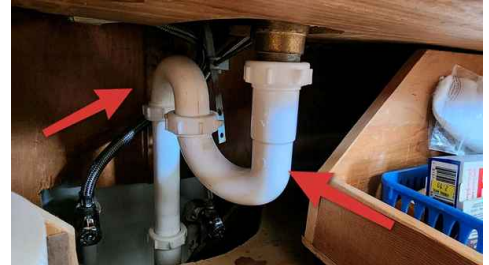
S traps are not permitted. In a worst case scenario water can syphon out the trap and allow sewer gases to enter the living space. Have the trap repaired by a licensed plumber .

S trap

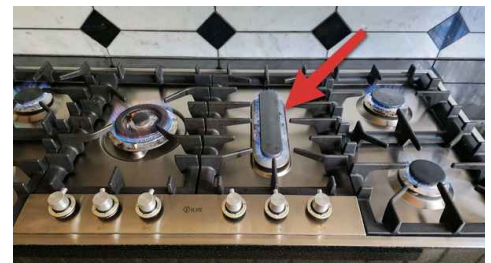
Difficult to turn on

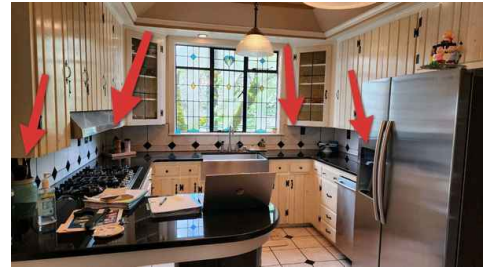
You are however required to have two separate GFCI circuits in the kitchen and right now you only have one. Additionally, I don't recommend having the refrigerator on a GFCI as it can spoil all the food if you don't notice it right away.

All outlets downstream of refrigerator outlet

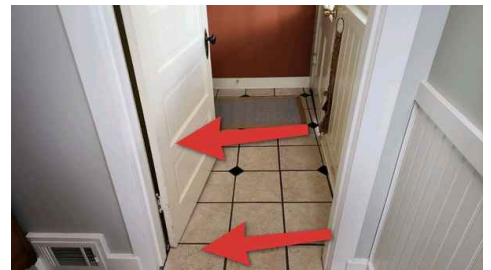
I noticed a substantial slope at the front entrance. The floor slopes down towards the center of the house. Since everything in the basement is finished, the structural framing is not visible. I don't see any cracks in the wall, indicating that this is a recent issue. Check with the homeowner to get more information.

Sloped

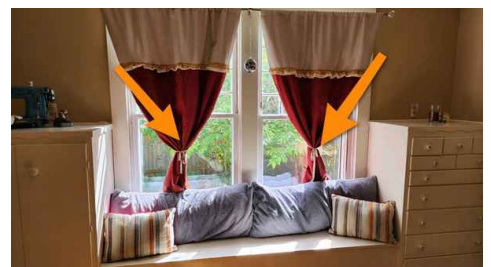
Since the windows are behind a sitting bench, they would by today standards be required to be made with tempered glass. I recommend upgrading for safety.

Upgrade with tempered glass

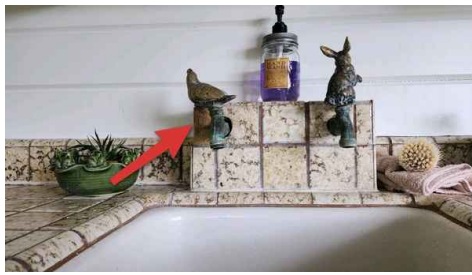
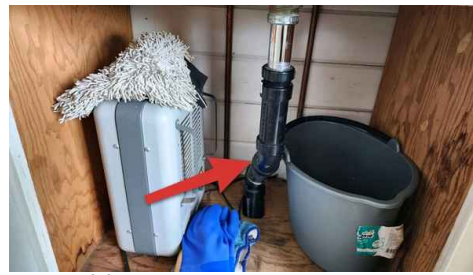
Additionally, there is no trap under the sink. There might be one below the floor but this cannot be verified. Without a trap you risk that sewer gases enter their living space.

Loose

No visible trap

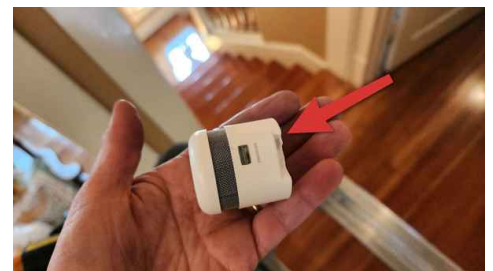
There is no label on the smoke alarms. I am not able to determine how old they are and whether they are allowed to be installed in the US. All US devices need to have a UL listing which is not visible here. I recommend replacing the alarms with photoelectric ones that have all the pertinent information on it.

No information
