**FINAL INSPECTION REPORT**

**PRIMARY REFERMER FURNACE 101-B**

**RISER AND CATALYST TUBES**

**NORTH COMPANY FOR FERTILIZERS (NCF)-BAIJI**

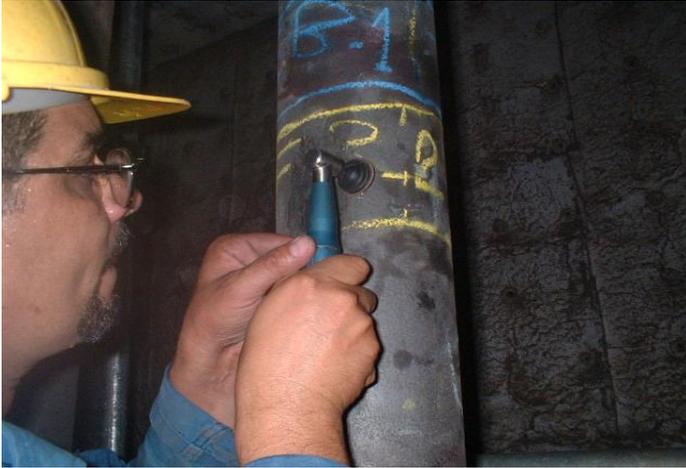
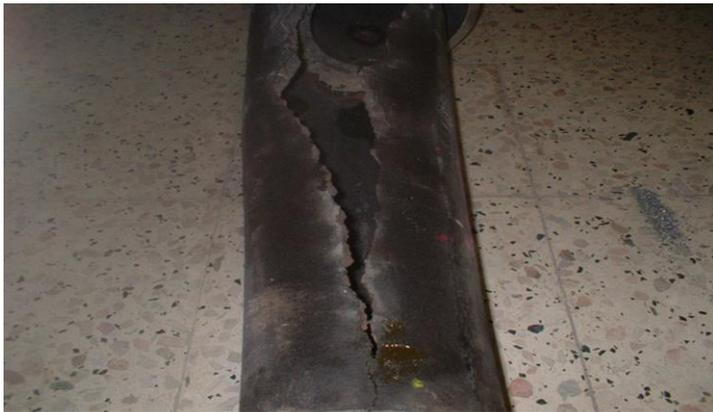
Visual inspection to the ruptured tube and the rest riser tubes (see the attached photos No. 1, 2, 3& 4) revealed the following:

- No indication of tubes over heating.
- No indication of flame impingement.
- No indication of bulging especially in the ruptured area.
- Riser tube “F” showed an indication of crack on the external surface.
- No indication of necking and thinning in the tube wall at the ruptured area.
- Riser tubes seemed to be subjected to some extent of deflection from the longitudinal axis of the tube may be due to excessive stresses.
- Riser tube “A” (the ruptured one) inside surface showed a thin layer of carburization.
- No indication of corrosion in the tube “A” inside surface.
- The failure occurred due to a longitudinal crack of 1.25 m long.
- The appearance of the crack section is vitreous similar to the brittle failure.
- Increase in diameter as revealed by the diametrical measurements.

PHOTO No. 1 RUPTURED TUBE "A"

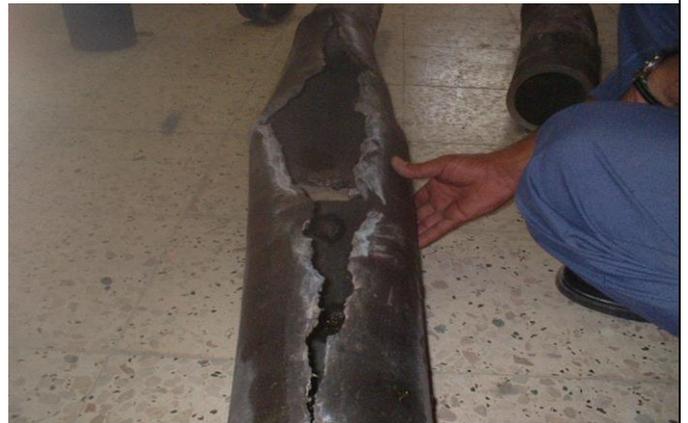
PHOTO No. 2 RUPTURED TUBE "A"

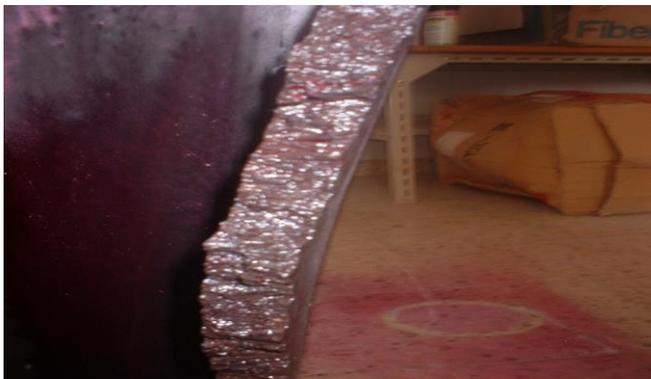
PHOTO No. 3 RUPTURED TUBE "A" SECTION

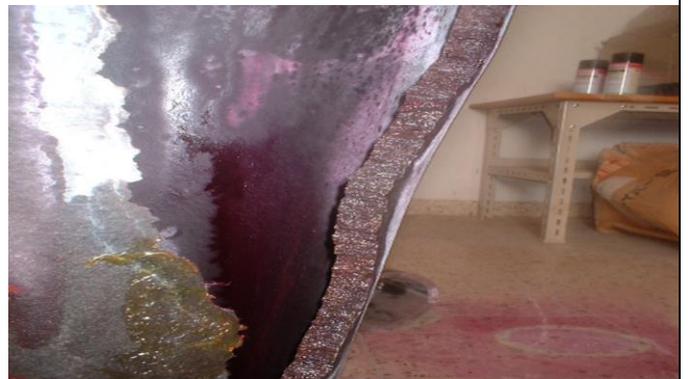
PHOTO No. 3 RUPTURED TUBE "A" SECTION

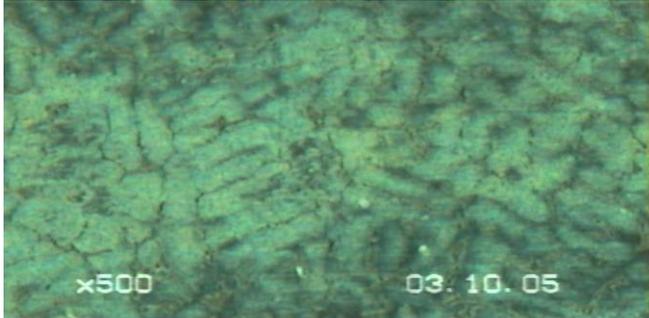
Replica on the tube outside surface revealed a net work of primary eutectic carbides between the austenite grains. See photo no. 5 and report no. 03/2006.

PHOTO No. 5 NEW RISER TUBE "A" MICRO-STRUCTURE

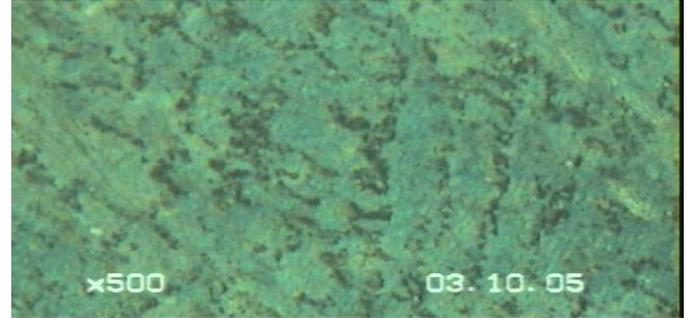
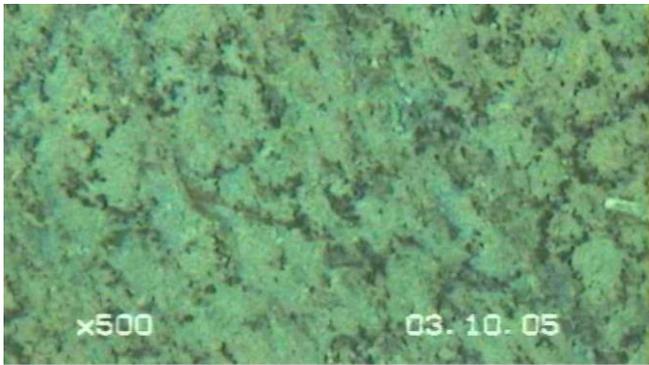
1. Inter-granular carbides precipitation (agglomeration) on the grain boundaries associated with micro -cracks.
2. Some degree of grain growth due to ageing. See photos no. 6 &7 and report no. 04/2006.
3. Formation of sigma phase ( $\sigma$ - phase) which is brittle in nature.

PHOTO No. 6 RUPTURED RISER TUBE "A" MICRO-STRUCTURE

PHOTO No. 7 RUPTURED RISER TUBE "A" MICRO-STRUCTURE

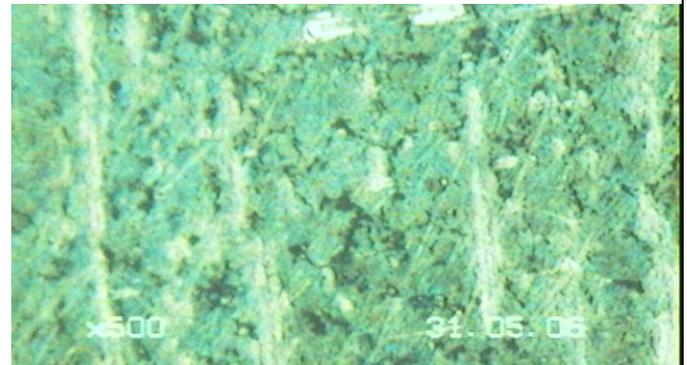
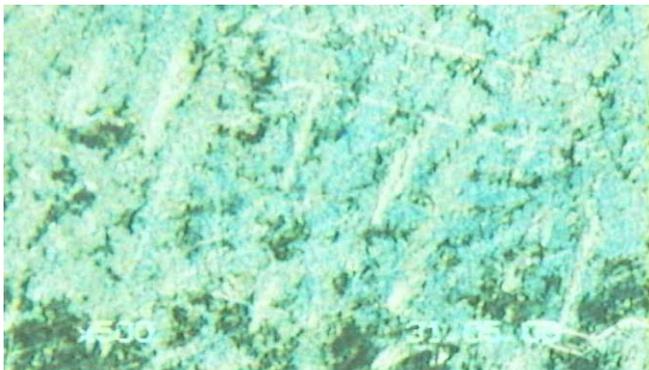
1. Carbides precipitation (agglomeration) on the grain boundaries.
2. Some degree of grain growth due to ageing. See photos no. 8 &9 and report no. 05/2006.

PHOTO No. 8 RUPTURED RISER TUBE "B" MICRO-STRUCTURE

PHOTO No. 9 RUPTURED RISER TUBE "B" MICRO-STRUCTURE

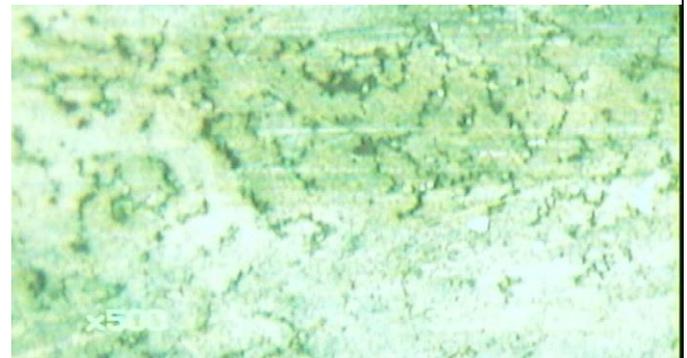
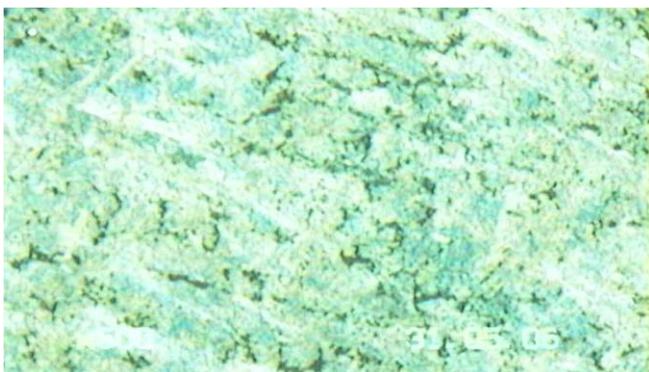
1. Carbides precipitation (agglomeration) on the grain boundaries.
2. Some degree of grain growth due to ageing. See photos no. 10 &11 and report no. 06/2006.

PHOTO No. 10 RUPTURED RISER TUBE "C" MICRO-STRUCTURE

PHOTO No. 11 RUPTURED RISER TUBE "C" MICRO-STRUCTURE

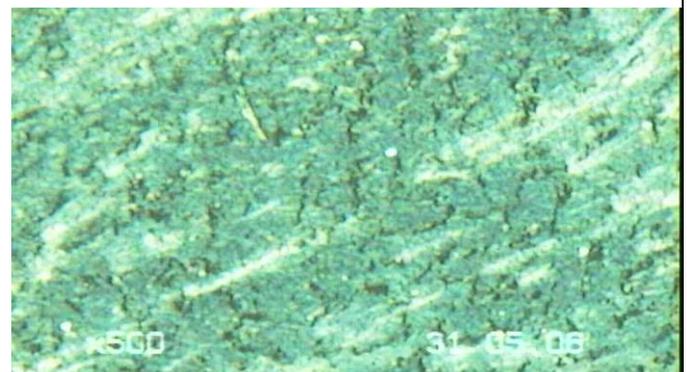
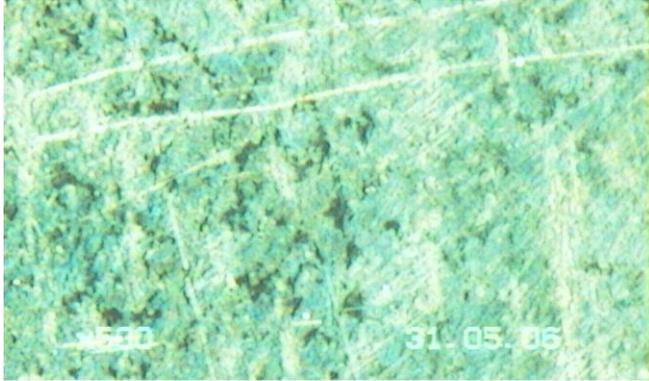
1. Carbides precipitation (agglomeration) on the grain boundaries.
2. Some degree of grain growth due to ageing. See photos no. 12 &13 and report no. 07/2006.

PHOTO No. 12 RUPTURED RISER TUBE "D" MICRO-STRUCTURE

PHOTO No. 13 RUPTURED RISER TUBE "D" MICRO-STRUCTURE

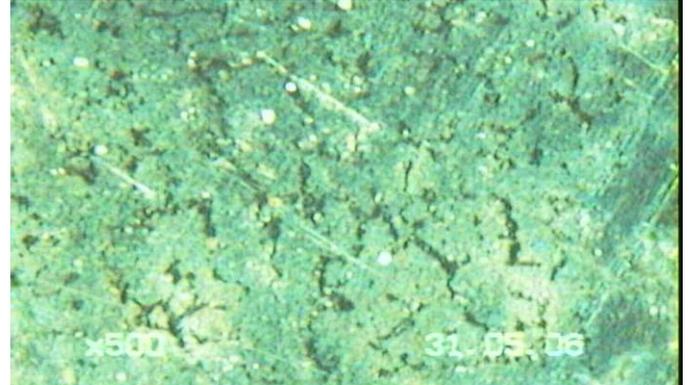
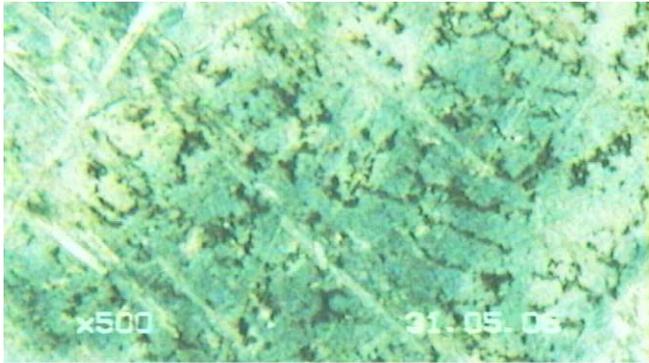
1. Carbides precipitation (agglomeration) on the grain boundaries associated with micro -cracks.
2. Some degree of grain growth due to ageing. See photos no. 14 &15 and report no. 08/2006.

PHOTO No. 14 RUPTURED RISER TUBE "E" MICRO-STRUCTURE

PHOTO No. 15 RUPTURED RISER TUBE "E" MICRO-STRUCTURE

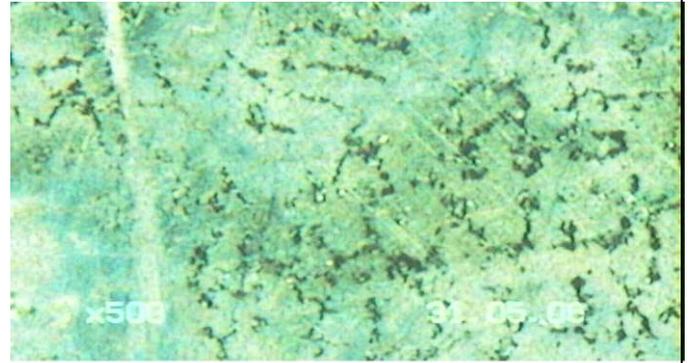
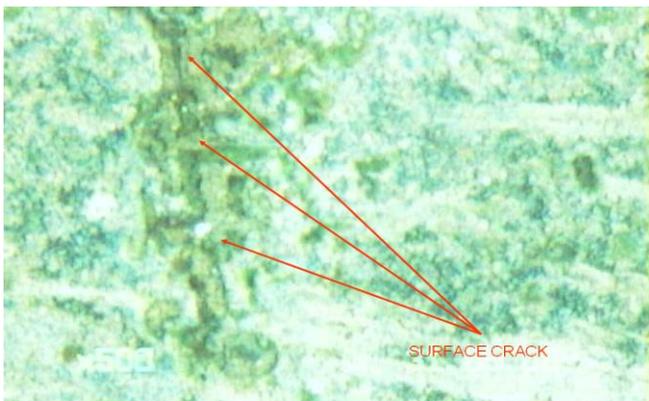
1. Carbides precipitation (agglomeration) on the grain boundaries (with micro –cracks)
2. Some degree of grain growth due to ageing. See photos no. 16 &17 and report no. 09/2006.

PHOTO No. 16 RUPTURED RISER TUBE "F" MICRO-STRUCTURE

PHOTO No. 17 RUPTURED RISER TUBE "F" MICRO-STRUCTURE

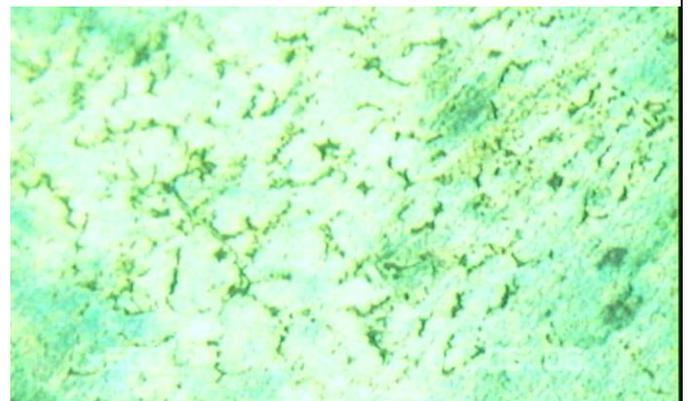
Replica on the tube outside surface revealed a net work of primary eutectic carbides between the austenite grains with some degree or grain growth due to ageing. See photo no. 18 and report no. 10/2006.

PHOTO No. 18 CATALYST TUBE No. 26 ROW "A"

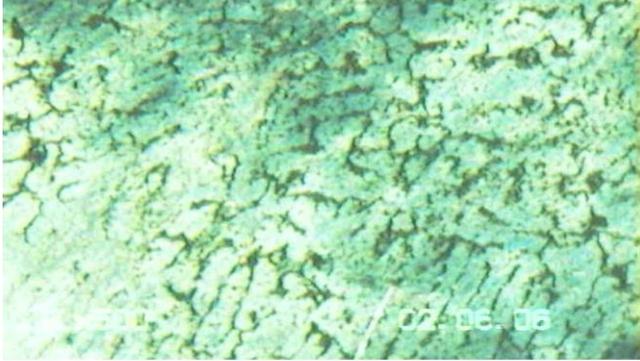
Replica on the tube outside surface revealed a net work of primary eutectic carbides between the austenite grains with some degree or grain growth due to ageing. See photo no. 19 and report no. 11/2006.

PHOTO No. 19 CATALYST TUBE No. 27 ROW "A"

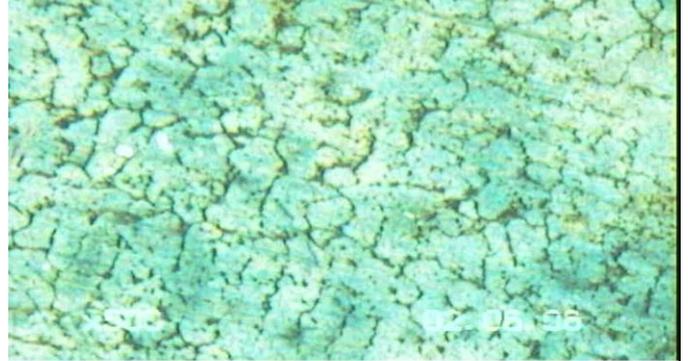
Replica on the tube outside surface revealed a net work of primary eutectic carbides between the austenite grains with some degree or grain growth due to ageing. See photo no. 20 and report no. 12/2006.

PHOTO No. 20 CATALYST TUBE No. 26 ROW "F"

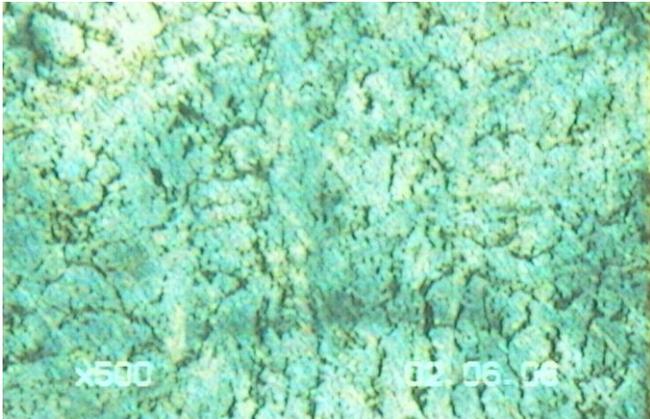
Replica on the tube outside surface revealed a net work of primary eutectic carbides between the austenite grains with some degree or grain growth due to ageing. See photo no. 21 and report no. 13/2006.

PHOTO No. 21 CATALYST TUBE No. 27 ROW "F"

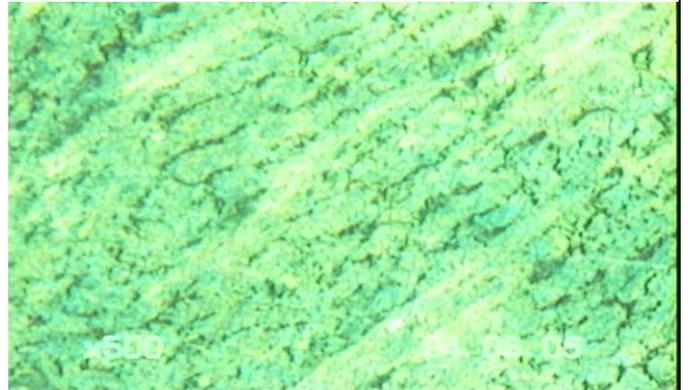
Replica on the tube outside surface revealed a net work of primary eutectic carbides between the austenite grains with some degree or grain growth due to ageing. See photo no. 22 and report no. 14/2006.

PHOTO No. 22 CATALYST TUBE No. 41 ROW "B"

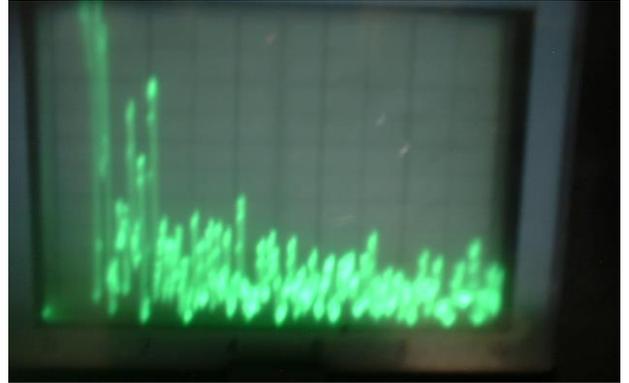
UT echoes revealed that the tube metal is of grade “D”. See photo no.24 and report no. 26/2006.

PHOTO No.24 RUPTURED TUBE "A" ECHOES SHOWED LARGE FAILURE

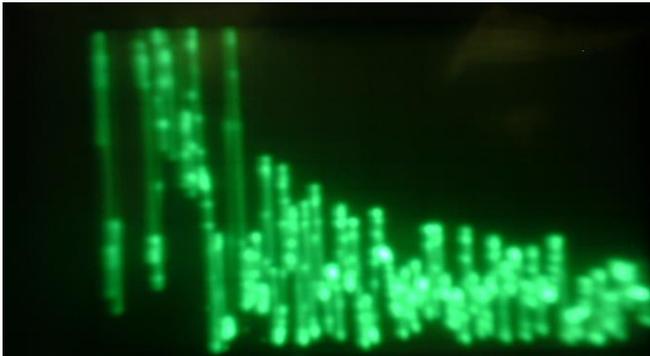
UT echoes revealed that the tube metal is of grade “C”. See photo no.25 and report no. 27/2006.

PHOTO No.25 TUBE "B" ECHOES SHOWED MODERATE FAILURE

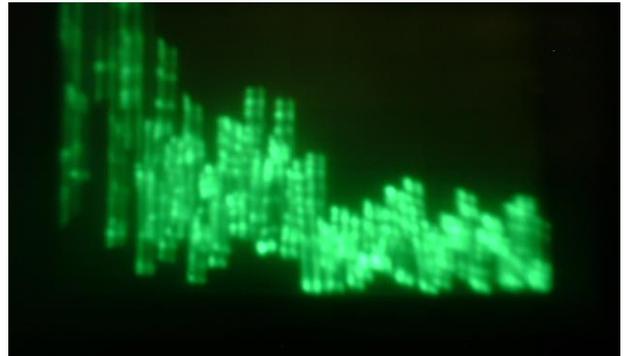
UT echoes revealed that the tube metal is of grade “C”. See photo no.26 and report no. 28/2006.

PHOTO No.26 TUBE "C" ECHOES SHOWED MODERATE FAILURE

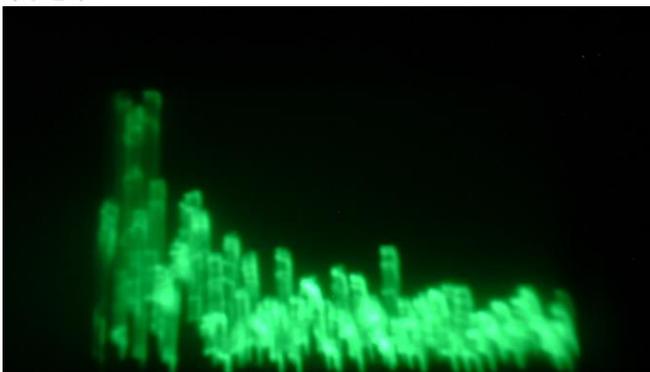
UT echoes revealed that the tube metal is of grade “D”. See photo no.27 and report no. 29/2006.

PHOTO No.27 TUBE "D" ECHOES SHOWED MODERATE FAILURE

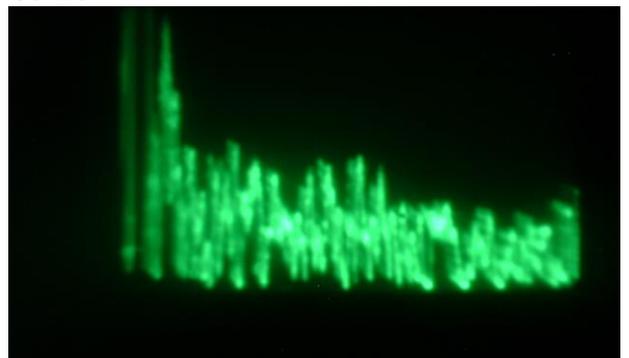
UT echoes revealed that the tube metal is of grade “D”. See photo no.28 and report no. 30/2006.

PHOTO No.28 TUBE "E" ECHOES SHOWED LARGE FAILURE

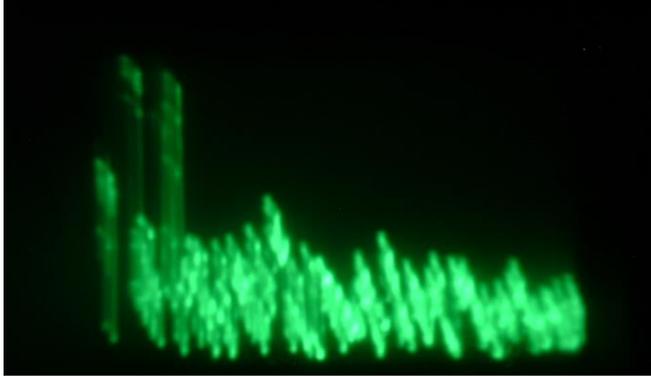
UT echoes revealed that the tube metal is of grade “D”. See photo no.29 and report no. 31/2006.

PHOTO No.29 TUBE "F" ECHOES SHOWED LARGE FAILURE

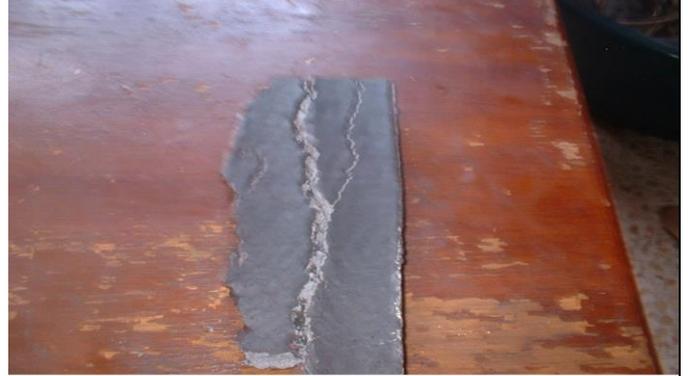
- ✚ Tensile test to the area opposite to fracture. One test specimen.  
Tensile test specimen was broken during the machining showing brittle nature fracture. See photo no. 30. the tube was abandoned
- ✚ Bending test to the area at vicinity of the fracture. Tow test specimens.  
Bending test specimens have failed in the test showing brittle nature fracture. See photo no. 31.

PHOTO No. 30 TENSILE TEST SPECIMEN FAILED DURING MACHINING

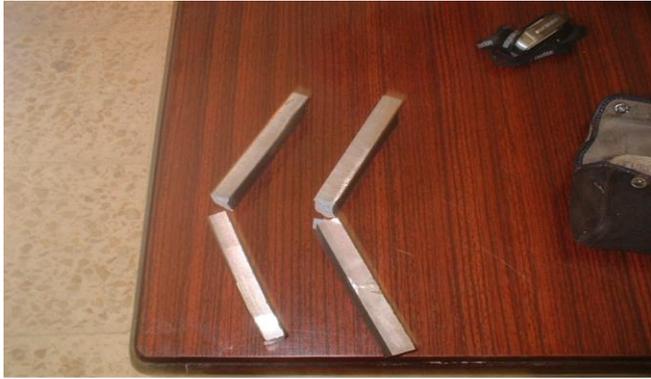
BEND TEST SPECIMENS FAILED SHOWING BRITTLE NATURE FRACTURE
