## Confidential Inspection Report

LOCATED AT:  
26875 Rancho Grande  
Laguna Niguel, CA 92677

INSPECTED ON:  
Tuesday, May 23, 2017

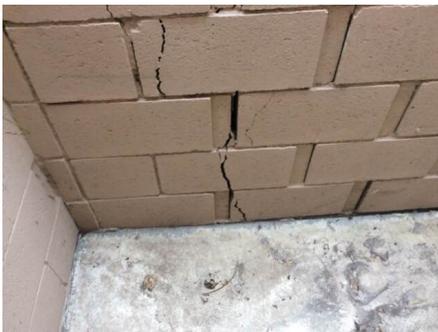
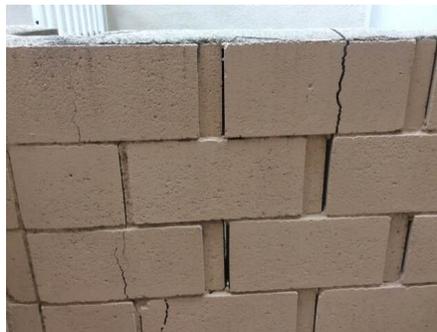
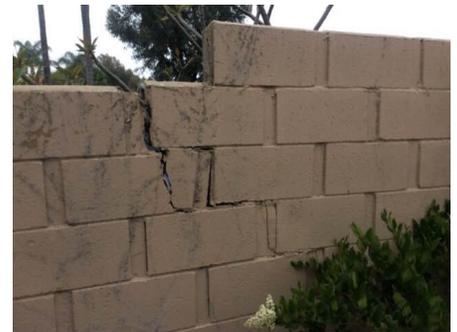
**CORR** 2: - • The cinder block yard walls have stress fractures, open grout joints or loose and missing blocks. This can lead to falling blocks or caps, leading to injury. Recommendation: The wall should be serviced or repaired by a qualified masonry contractor

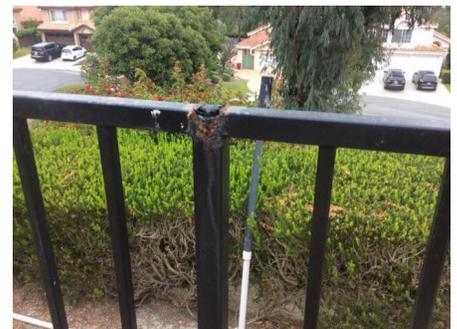
**CORR** 3: - • Sections of the wrought iron fence are deteriorated or rust damaged. This includes broken or rusted rails and connections. Recommendation: Evaluation and repair by a qualified specialist to secure and repair or replace the affected sections as necessary

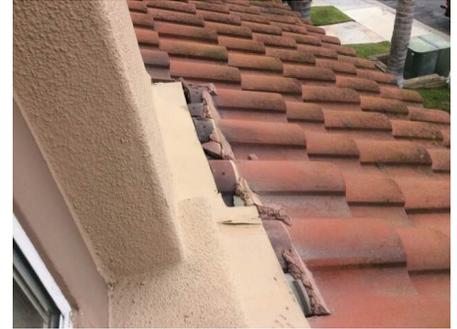
**CORR 4:** - • There are a number of displaced or broken tiles that have exposed the waterproof membrane. These areas will be subject to damage to the roof surface and potential leaks. Damage is noted at the front lower roof outside the bonus room, and missing tiles at the rear roof. Recommendation: Inspection of the exposed membrane, and repositioning or replacement of the missing and broken tiles as necessary, by a qualified roofing contractor

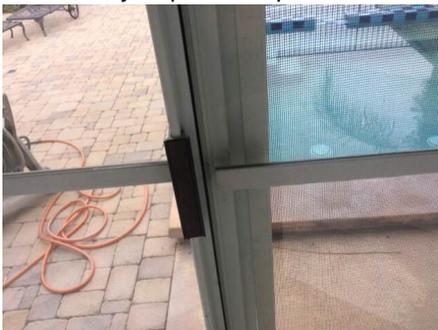
**CORR 6:** - • One or more window frame is loose or separated from the glass. This can lead to air, water and noise intrusion, and can cause injury from the exposed sharp glass edge. Recommendation: The window should be serviced to restore its integrity and seal by a qualified specialist

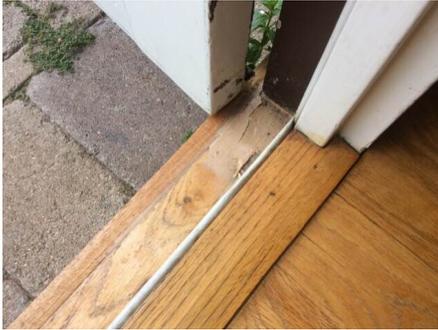
**CORR** 7: - • The exterior door trim or threshold is damaged. Conditions noted include softness and repair on the base. Recommendation: Service as necessary by a qualified specialist to repair or replace the door

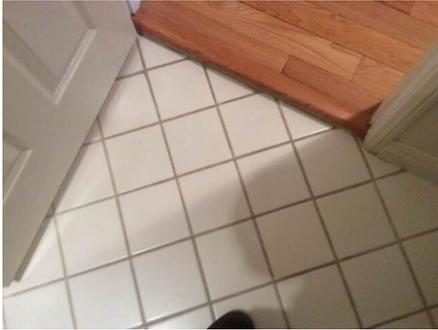
**CORR** 11: - • The interior bathroom entry door hits the floor, which prevents proper operation, it does not close and could lead to entrapment. Recommendation: The door or flooring needs to be adjusted, shaved or trimmed, to open and close easily

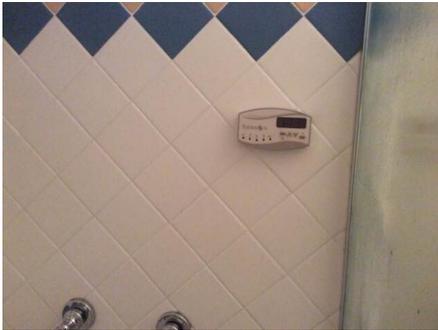
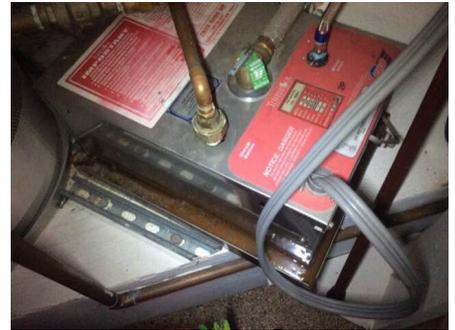
**CORR** 12: - • The steam shower is damaged, incomplete or not functional. There is no power to the controller, and it could not be activated. The pan under the steam unit in the garage is full of water, indicating a water leak from the heat exchanger or water connections. Recommendation: Service or replacement as necessary by a qualified specialist to restore operation of the steam shower. I unplugged and turned the water valve off to help prevent further leaking and damage

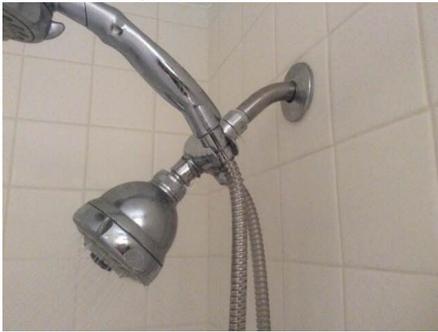
**CORR** 15: - • The hand sprayer in the tub-shower leaks. this can lead to water intrusion and damage. Recommendation: Service as necessary to correct this condition

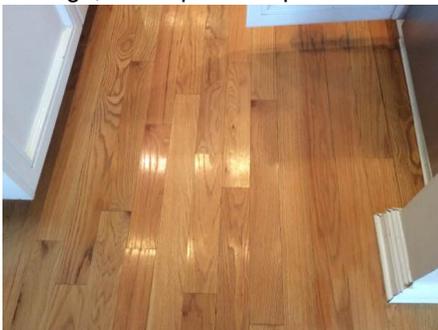
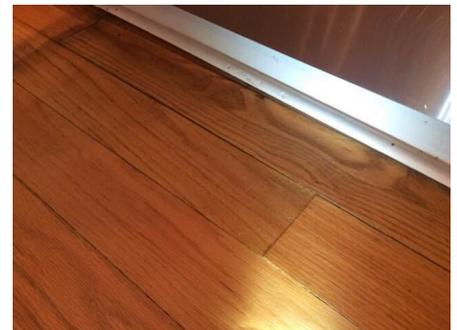
**CORR** 16: - • The hardwood floor in the kitchen is cupped, or moisture damaged, noted mostly in front of the dishwasher. Cupping occurs when the hardwood absorbs excessive moisture on the underside, which causes the expansion that results in cupping. If moisture is entering the floor under the hardwood, it may be from a slab leak, improper moisture barrier under the floor, or another condition that we cannot visually confirm. Recommendation: Further evaluation to determine the cause of this damage, and repair or replacement of the floor as necessary by qualified specialists

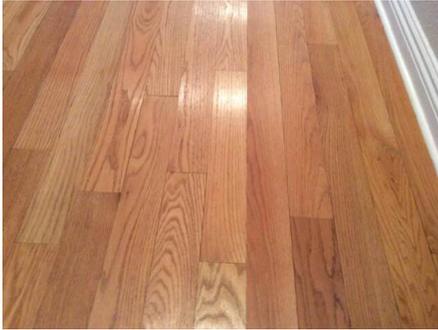
**CORR** 22: - • The hardwood floor in the hallway has cupping and damage, noted between the laundry and downstairs guest bath. Recommendation: Evaluation and service to repair this damage, by a qualified flooring specialist

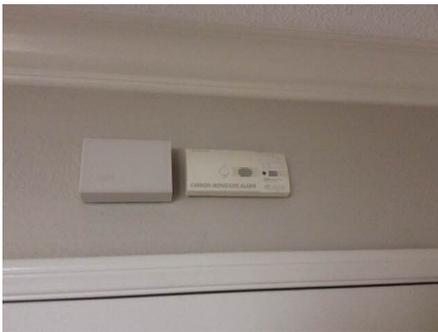
**SFTY** 23: - • New requirements are now in effect requiring the installation of Carbon Monoxide Detectors on each level. There is one present upstairs but not downstairs. Recommendation: Regardless of the law, we recommend installation of one or more of these devices on each floor for safety

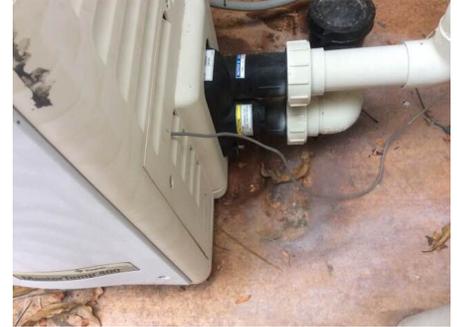
**CORR** 28: - • There is water leaking from under the heater housing. This may be a drain plug or a more significant leak from the heat exchanger, as the water connections to this heater appear to be dry. Recommendation: The source of this water located and repairs made by a qualified pool contractor

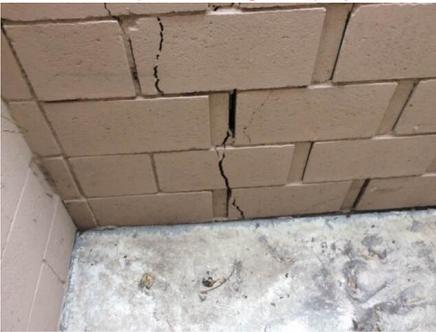
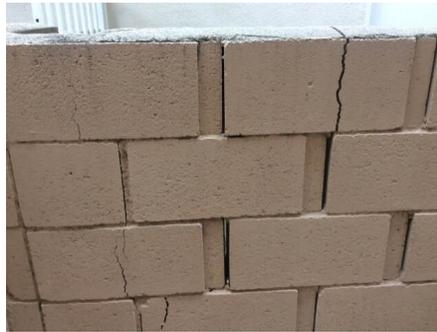
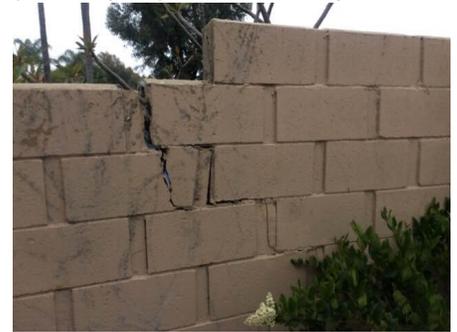
- CORR** • The cinder block yard walls have stress fractures, open grout joints or loose and missing blocks. This can lead to falling blocks or caps, leading to injury. Recommendation: The wall should be serviced or repaired by a qualified masonry contractor

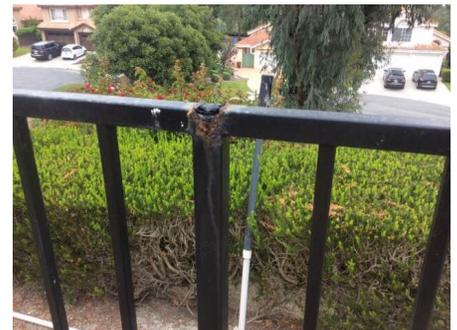
- CORR** • Sections of the wrought iron fence are deteriorated or rust damaged. This includes broken or rusted rails and connections. Recommendation: Evaluation and repair by a qualified specialist to secure and repair or replace the affected sections as necessary

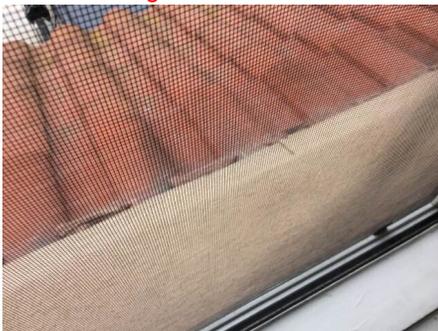
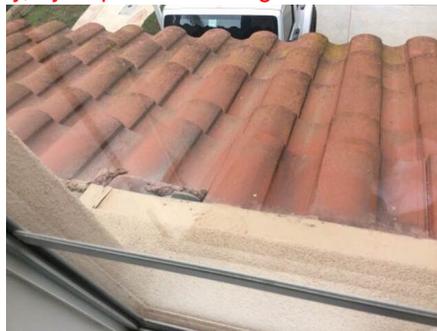
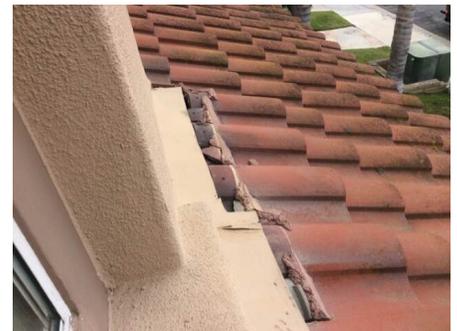
**CORR** • There are a number of displaced or broken tiles that have exposed the waterproof membrane. These areas will be subject to damage to the roof surface and potential leaks. Damage is noted at the front lower roof outside the bonus room, and missing tiles at the rear roof. Recommendation: Inspection of the exposed membrane, and repositioning or replacement of the missing and broken tiles as necessary, by a qualified roofing contractor

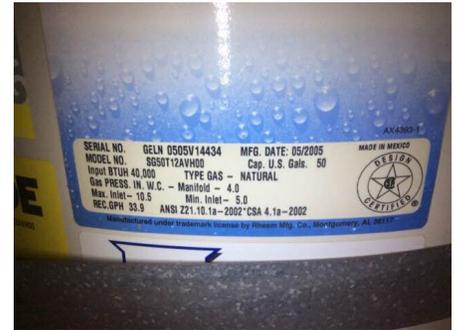
**ATTN** • The gas water heater is at or beyond the end of its expected useful life of eight to twelve years. For this reason, it will be more prone to leaks, or failure. Popping or banging noises are common at this age during burner operation, and indicate a build-up of sediment in the tank. This reduces the efficiency and available hot water in the tank. We recommend it be monitored closely, and if any signs of leaking are noted, it be replaced as soon as possible to prevent moisture or water damage. It would also be prudent to maintain a home protection warranty to help cover the cost of a replacement, which will be likely in the near future

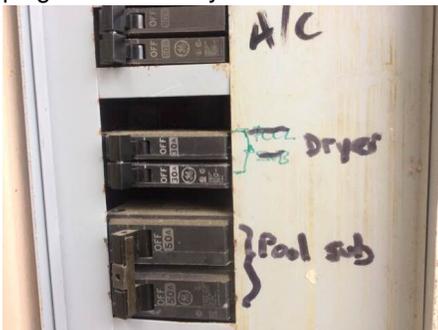
- ATTN** • There are voids or open knockouts in the interior cover of the main electrical panel. These can lead to injury from contact with the components inside, or critters entering and causing damage. We recommend the insertion of proper covers or plugs as necessary

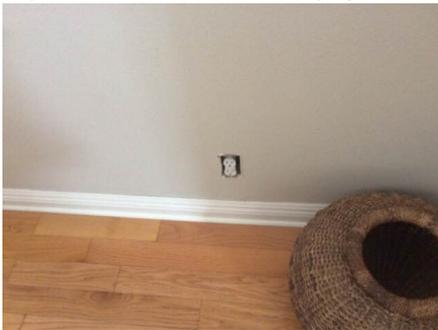
- ATTN** • There is one or more missing cover plate on receptacles or wall switches, noted in the living room. This can lead to exposed connections and injury. We recommend installation of covers as necessary

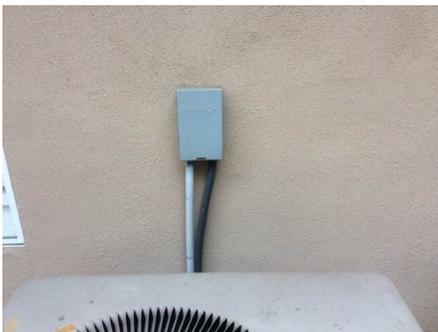
**ATTN** • The service disconnect is located directly above the coil. This is generally not recommended, as the disconnect should be accessible without reaching over the coil for safety. You may wish to have a specialist comment about this condition, or have it corrected

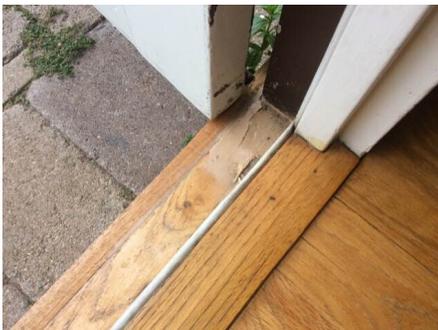
- CORR**
- The exterior door trim or threshold is damaged. Conditions noted include softness and repair on the base. Recommendation: Service as necessary by a qualified specialist to repair or replace the door

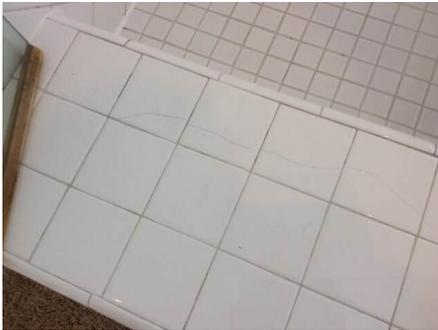
**ATTN** • There are cracked tiles or open grout joints in the stall shower area. While they appear to be firmly attached to the wall, there will be increased possibility of water intrusion and damage. We recommend the cracks be sealed and monitored as necessary

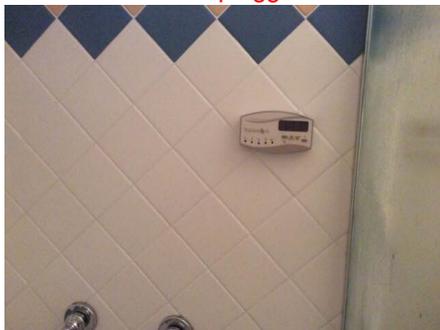
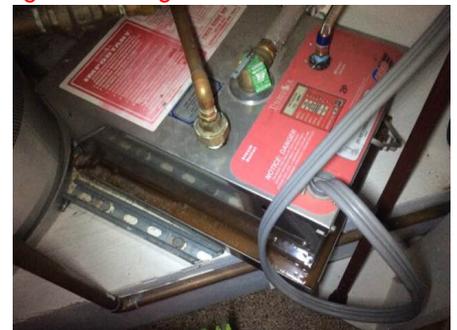
- CORR** • The steam shower is damaged, incomplete or not functional. There is no power to the controller, and it could not be activated. The pan under the steam unit in the garage is full of water, indicating a water leak from the heat exchanger or water connections. Recommendation: Service or replacement as necessary by a qualified specialist to restore operation of the steam shower. I unplugged and turned the water valve off to help prevent further leaking and damage

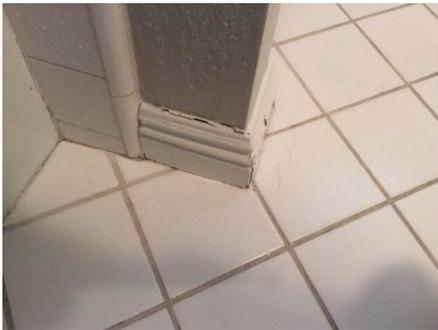
- CORR** • The wall is moisture damaged adjacent to the tub. This is not uncommon, typically caused by water splashing out from the enclosure or curtain. However, continued exposure to water can lead to significant damage. Recommendation: The wall be repaired, and the enclosure serviced to help prevent such water splash-out

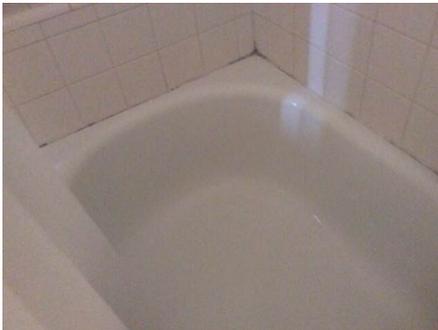
- ATTN** • The tub-shower enclosure needs to be cleaned and caulked, to forestall moisture damage

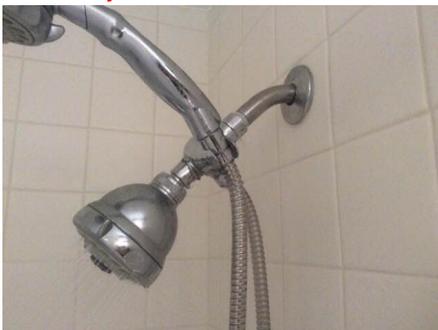
- CORR** • The hand sprayer in the tub-shower leaks. this can lead to water intrusion and damage. Recommendation: Service as necessary to correct this condition

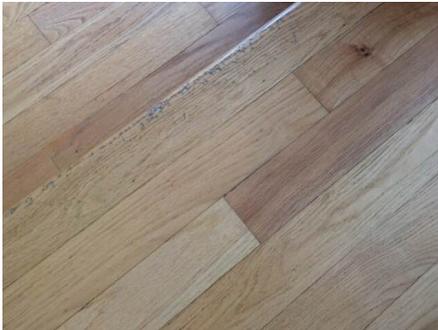
**ATTN** • The floor in the kitchen has cosmetic damage, which you may wish to evaluate for yourself

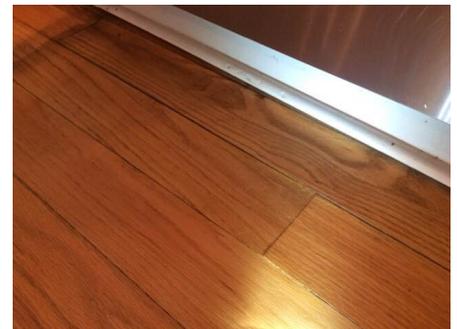
**CORR** • The hardwood floor in the kitchen is cupped, or moisture damaged, noted mostly in front of the dishwasher. Cupping occurs when the hardwood absorbs excessive moisture on the underside, which causes the expansion that results in cupping. If moisture is entering the floor under the hardwood, it may be from a slab leak, improper moisture barrier under the floor, or another condition that we cannot visually confirm. Recommendation: Further evaluation to determine the cause of this damage, and repair or replacement of the floor as necessary by qualified specialists

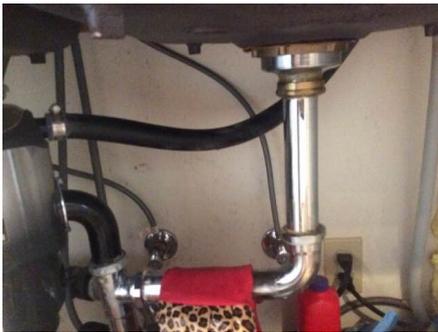
- ATTN** • The dishwasher drain hose from the anti-siphon valve to the disposer has a loop or low spot. This hose should drain directly to help prevent clogging of this hose or sour odors emitting from the disposal. We recommend re-routing or correcting this condition

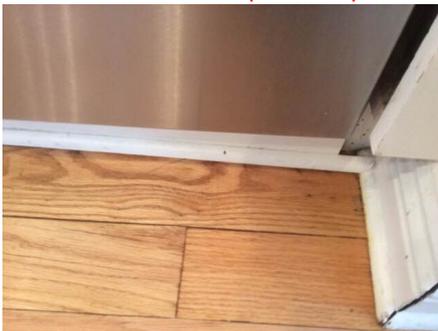
- CORR** • Pooling water was found on the kitchen floor during operation of the dishwasher. This indicates a leak in a supply or drain line, or from the door seal on this appliance. Water damage is possible, and this appliance should not be used. Recommendation: Repair or replacement of this appliance by a qualified specialist

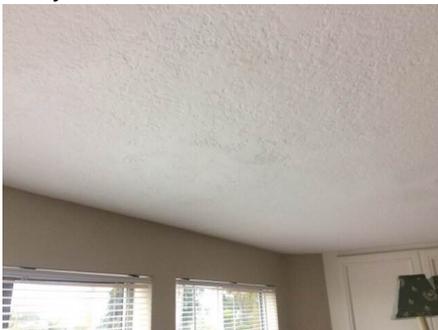
- ATTN** • There is a patch or repair in the breakfast area ceiling. We cannot determine the reason for this repair, but recommend that you ask the current owners about this to rule out recent water leaking or other potential damage

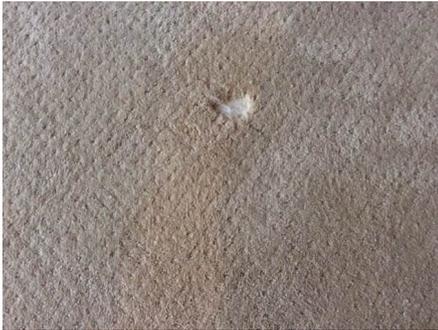
- ATTN** • The floor in the hallway has wear or damage that is commensurate with its age

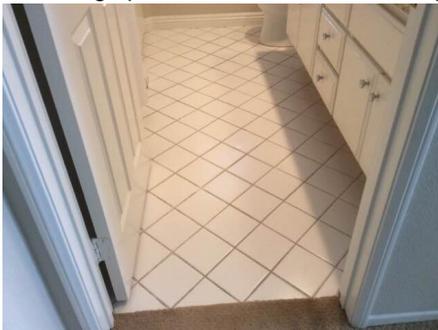
- ATTN** • The floor in the hallway is out of level, which may be due to installation over different floor finishes. This is noted mostly in the hall bath. We are unable to determine the reason for this condition. If this is a concern to you, we recommend consulting a flooring specialist about causes and possible corrections

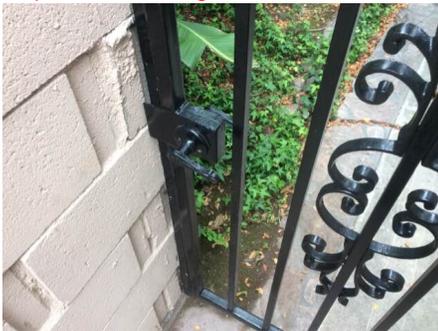
- SFTY** • The gate or gates that gives pool access does not fully comply with safety standards. Any gate that gives pool or spa access is required to self-close and include a latch at fifty-four inches, and should open away from the pool or spa, so that a toddler could not simply push open an unlatched gate. Further, there are newer requirements for door and window alarms that help alert the homeowner if a toddler were to exit the home. Recommendation: We recommend compliance with all safety requirements for gates, barriers and alarms

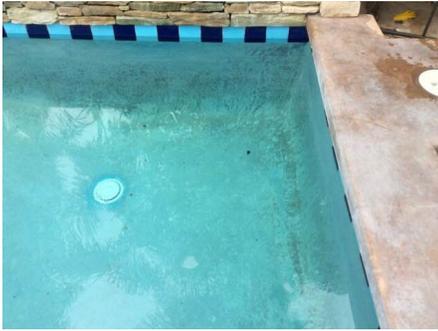
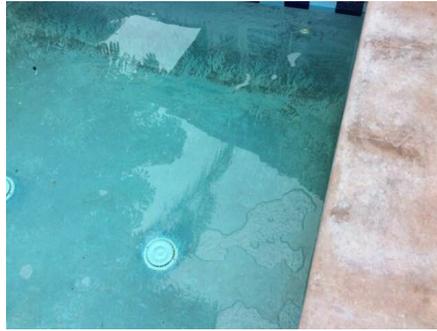
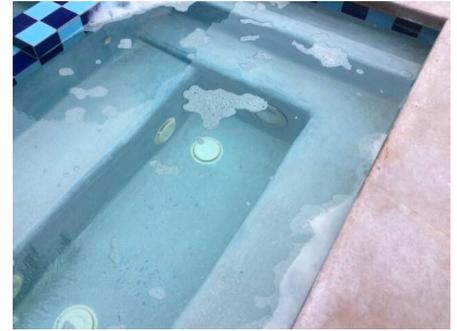
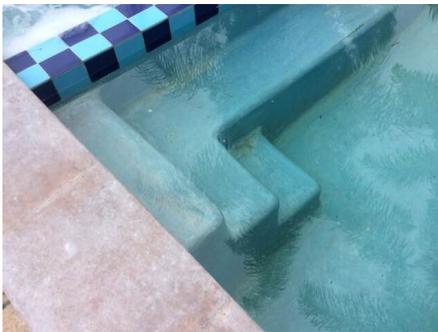
- ATTN** • The pool plaster is colored and mottled by calcium and other minerals leeching through to the surface, which is not uncommon with dark finishes. You may wish to discuss this condition with a pool contractor to determine if correction is warranted

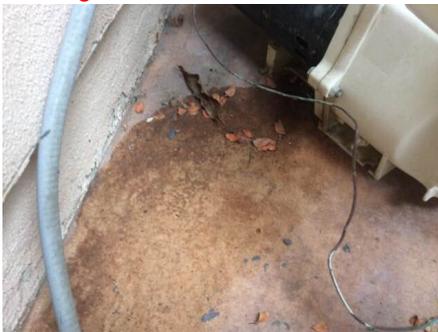
- CORR** • There is a leak at the impeller housing of the spa boost pump motor. This indicates a loose or broken connection or housing. Recommendation: Service as necessary by a qualified pool specialist to restore leak-free operation

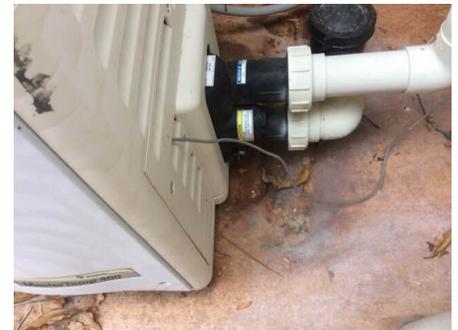
- CORR** • There is water leaking from under the heater housing. This may be a drain plug or a more significant leak from the heat exchanger, as the water connections to this heater appear to be dry. Recommendation: The source of this water located and repairs made by a qualified pool contractor
