Property Inspection Report

Property address: Windermere, FL 34768

Inspection date: October 21, 2015 8:54 am

Report ID: R20151021085452

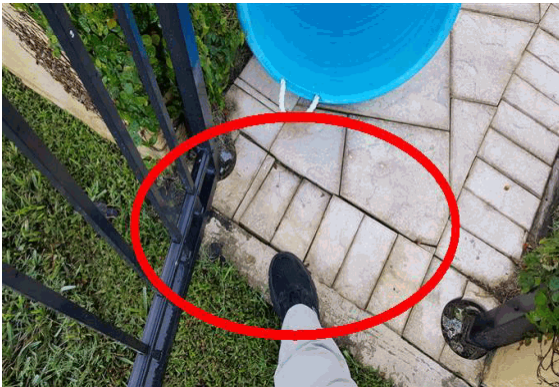
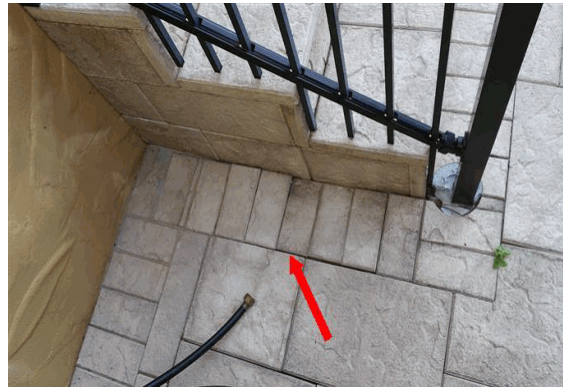
Deck

Status: **Repair/Replace**

Comment: **Loose Pavers**

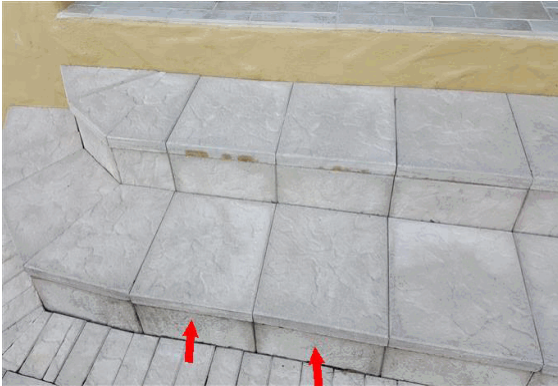
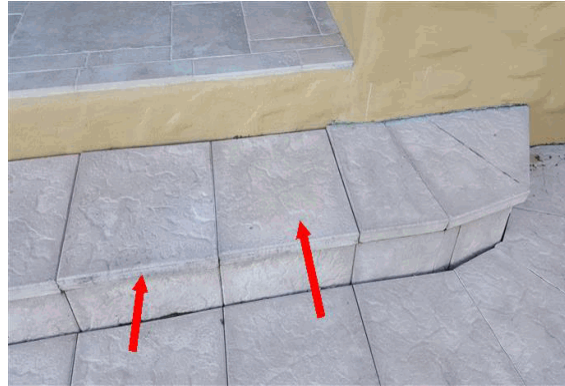
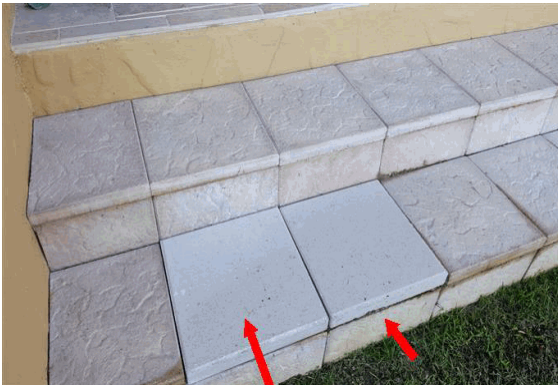
Steps

Status: **Repair/Replace**
Location: **Steps down to pool deck from home**

Description: **Concrete Tiles**
Comment: **Several lose tiles**

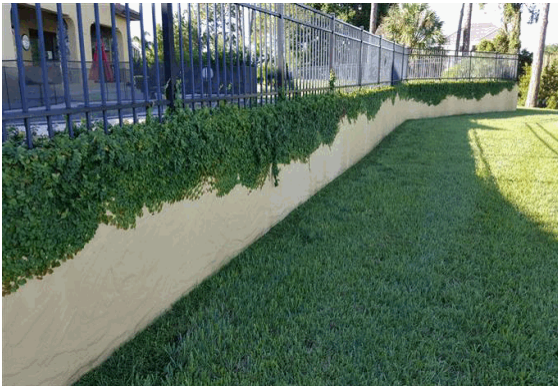
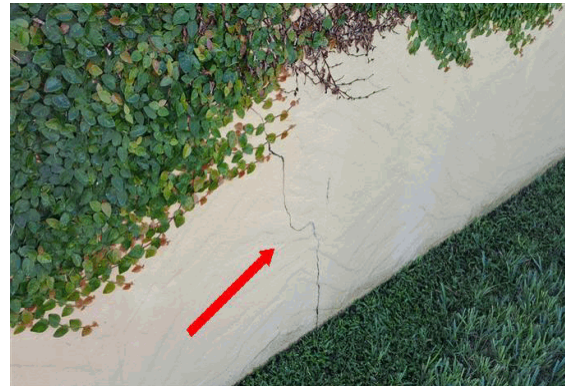
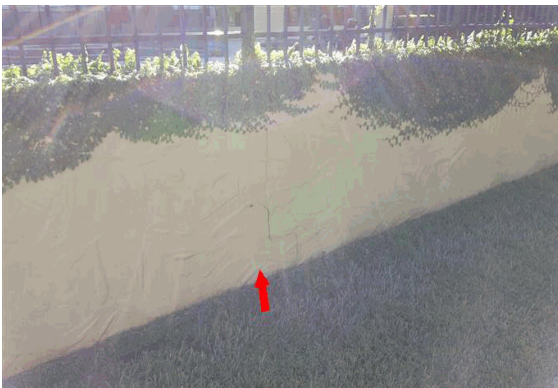
Fence/Wall

Comment: **Good condition minor cracking of stucco finish**

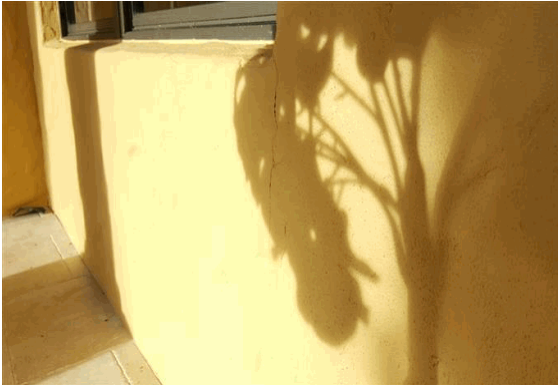
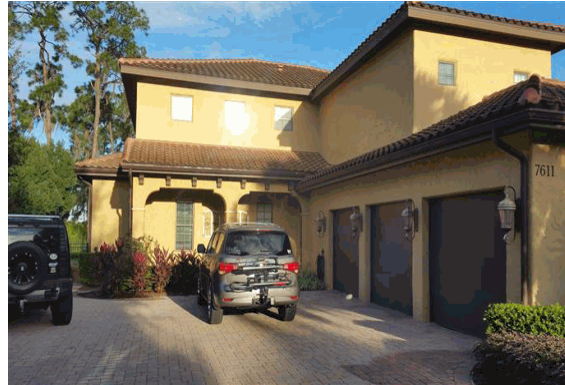
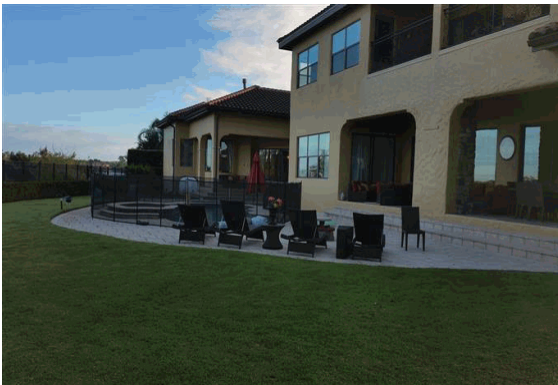
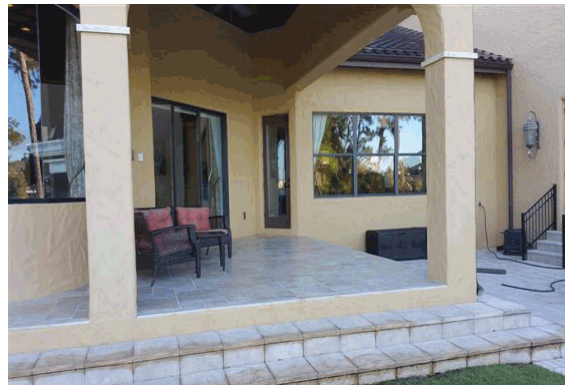
Exterior Surface

Additional comments: Minor cracks found, paint and seal

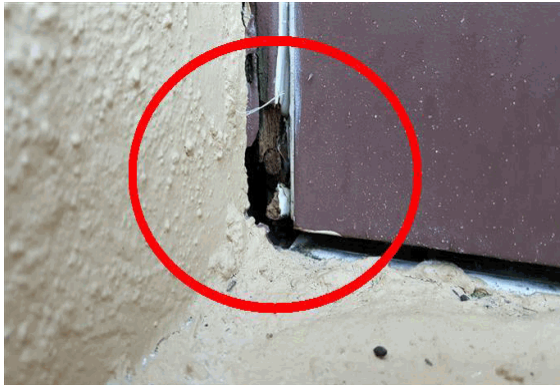
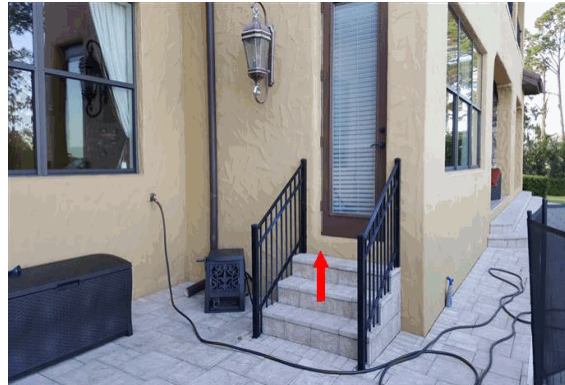
Patio door (2)

Status: **Repair/Replace**

Comment: **Base of frame has water damage**

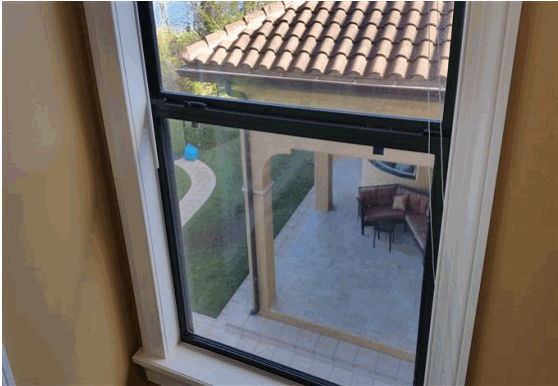
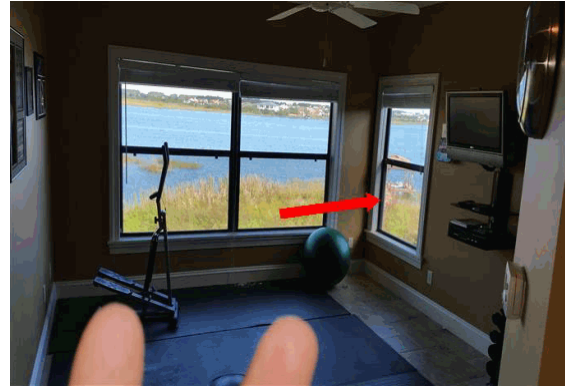
Windows (2)

Status: **Repair/Replace**

Comment: **Locking mechanism missing**

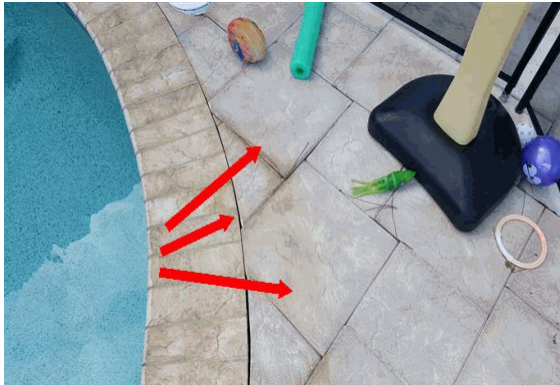
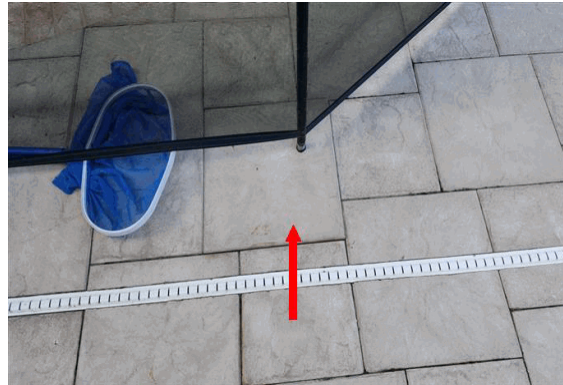
Deck

Status: **Repair/Replace**
Location: **Around pool**

Description: **Paver**
Comment: **Loose tile in a few locations**

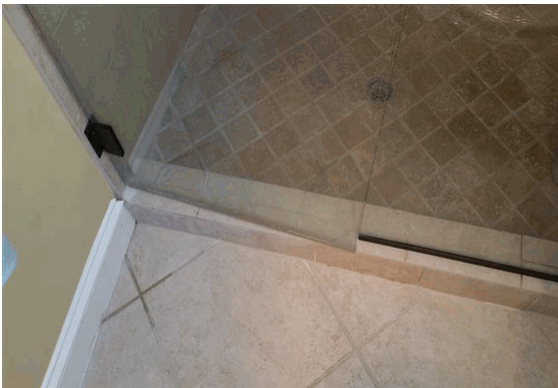
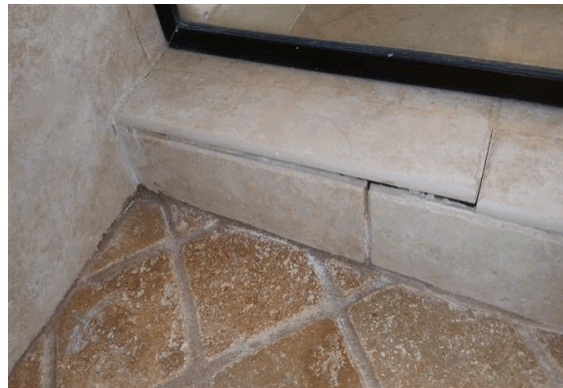
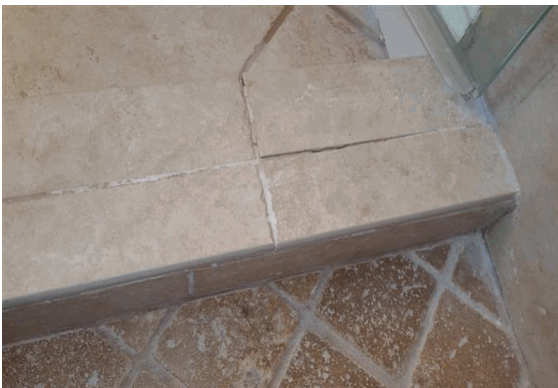
Status:	Repair/Replace	Description:	5 foot wide
Location:	Upstairs bedroom on south side of house	Comment:	Cracked Tile

Additional comments: cracked tiles at the bottom of the shower, also the glass door is touching the other glass.
