MGF and MGTF Stop Light Issues

Written by Rick Foster, Registered Professional Engineer – Queensland

Version 2 – 11-08-2022

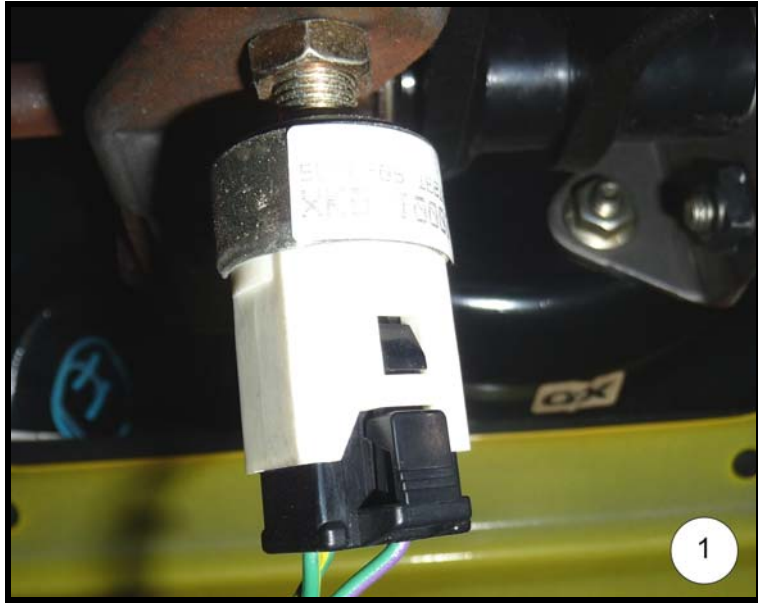
Figure 1 XKB10003 stop light switch

Note that in Figure 1, the switch is shown as having three wiring tails whilst in Figure 6, only two connectors are shown; this is because the 12v power is piggybacked with a 12v power out to the reversing lamp switch in order to use the same fuse.

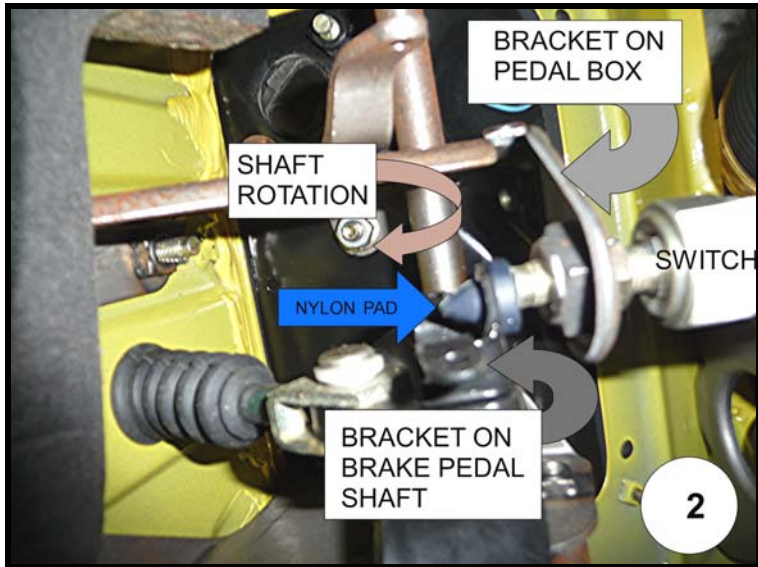
Figure 2 Pedal Box Arrangement

The switch which has normally closed contacts is screwed into a bracket connected to the pedal box. With the pedal fully up, the switch plunger is hard up against the blue nylon pad which is mounted on a bracket connected to the brake pedal shaft. The fully depressed plunger results in the switch contacts to be open – and the stop lights off.

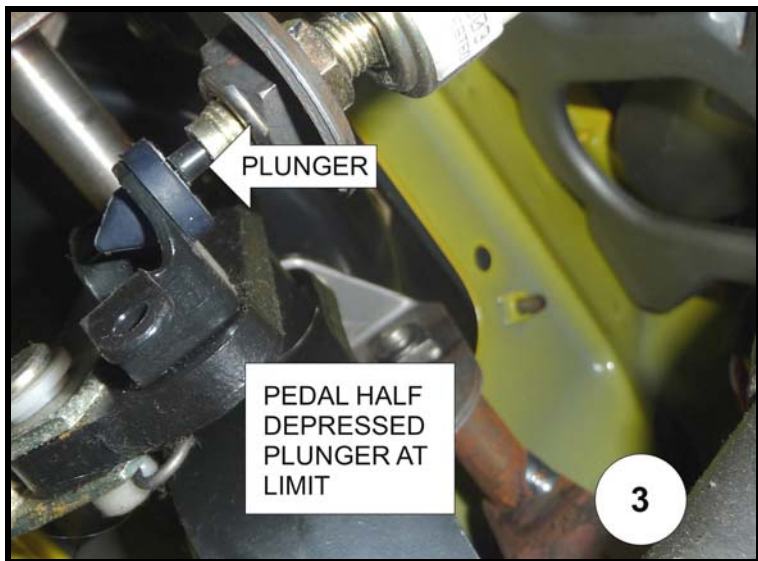
Figure 3 Plunger Extended

When the brake pedal is depressed the pedal shaft rotates moving the bracket and nylon pad away from the switch plunger. This causes the plunger to emerge from the switch body making the electrical contact and thus illuminating the stop lights.

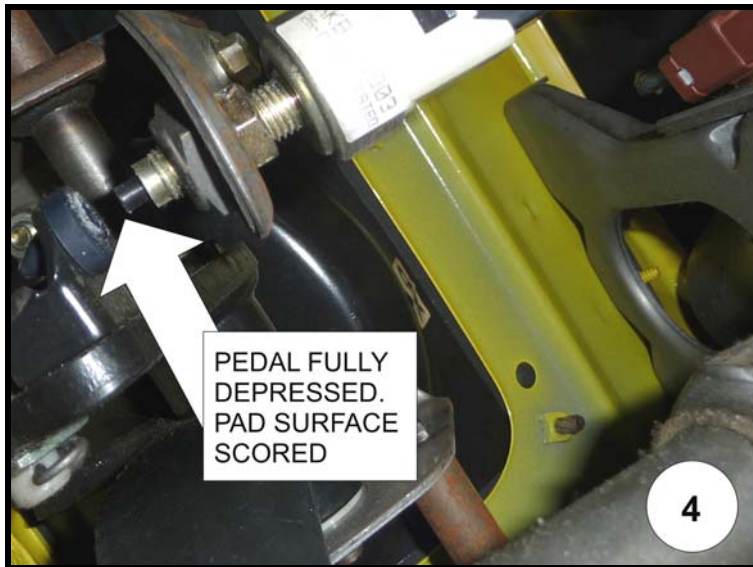
Figure 4 Plunger Fully Extended

The MG – Rover web site has advised that in older cars scoring of the blue pad can result in a depression of approx 1 to 1.5mm, thus confirming the owners’ experience that a 1 to 1.5 turn adjustment will overcome the pad depression – see Figures 4 and 5.

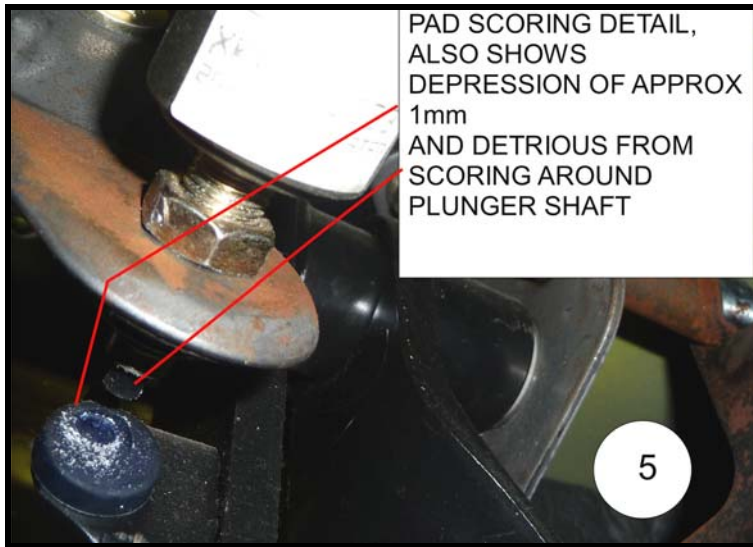
Figure 5 Pad Scoring

As far a flicker is concerned, this is either the result of small tolerances between on and off, the depression in the nylon pad, or, as MG River advises, either shards of disturbed nylon from the pad being caught between the plunger and the switch body, or a lip in the worn depression catching the plunger tip..

To be on the safe side my recommendation is that the nylon pad be cleaned up and with the brake pedal fully depressed, using 80 grit “wet and dry sandpaper” lubricated with WD40 the nylon pad body is sanded smooth so that the depression is reduced as far as possible and has no lip(s) that might “catch” the plunger tip. Then using a fine wire brush, brush the end of the plunger and the switch body to remove any nylon shards. This should restore the pad and plunger to a point where the adjustment can be effected.

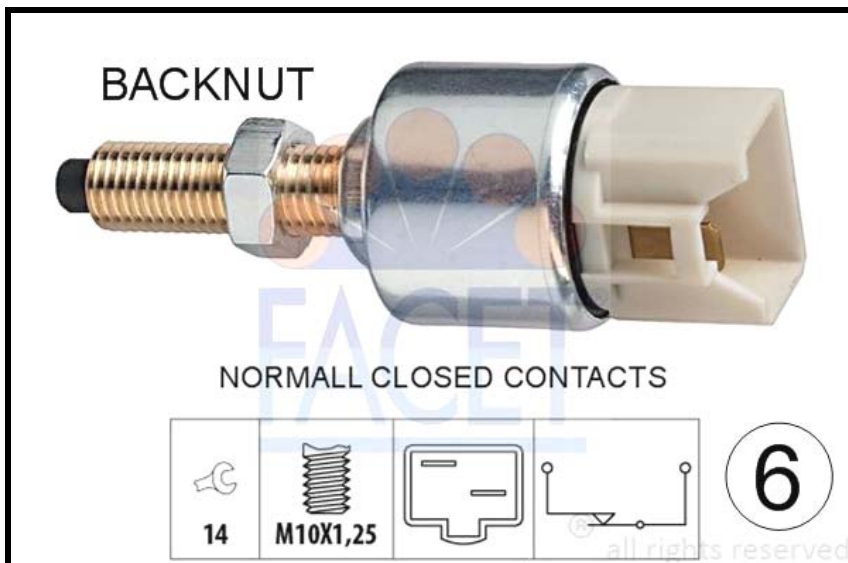
Figure 6 – XKB 10003 switch

XKB10003 – Model-**MGF** VIN YD514326 on & **MG TF** – shown at Figure 6

The adjustment developed by MGTF users consists of backing off the backnut as shown in Figure 6 and then screwing in the switch about one to one and a half turns (first disconnect the switch cable) this, measured by the screw tread appears to be about 1 to 1.5mm. Thereafter owners advise minor further

adjustments so that light pressure on the brake pedal such as brake “covering” does not release the plunger to make electrical contact.

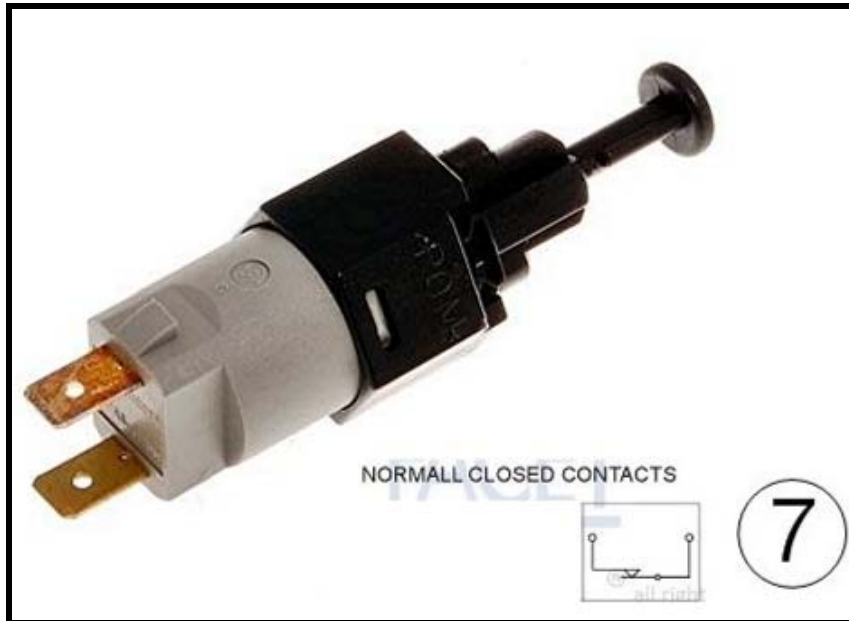
. Figure 7 – XKB 100080 switch

XKB100080 - Model-**MGF** to VIN YD514325 – shown at Figure 7

Note also that the MGTF Workshop Manual dated 2002 shows the XKB100080 switch being used. This is incorrect and the fitment and adjustment instructions shown therein should NOT be used.

“The switch is found up against the bulkhead next to the brake pedal itself. To remove it, you must rotate the switch body about 90 degrees, until the slots line up, and then pull it down out of the bracket.

The remedy is to remove the switch and forcibly pull the plunger back out. Then replace the switch. Don't allow the pedal to fly back up to its rest position, as would happen if your foot slipped of the pedal when you were braking. This will cause the problem to happen again because the pedal overshoots and pushes the plunger in too far.”
