# Chebeague Island School

## Facility Conditions Study

Stephen Blatt Architects

July 21, 2015

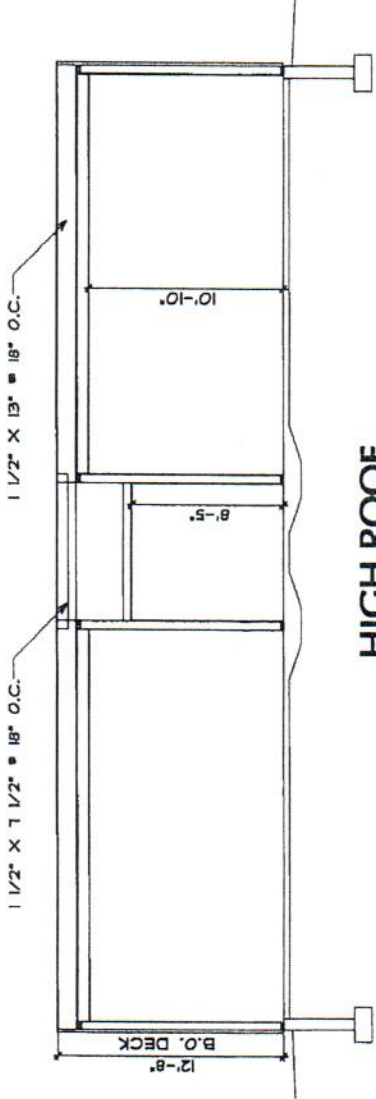
HIGH ROOF

The existing roof joists at the high roof over the classrooms are inadequate for the 23' span.

Cut down the span of the joists by adding beams below the roof joists. The beams would span the length of the classrooms and would bear on posts in the walls between the classrooms. This would require the removal of a strip of ceiling the length of a classroom, adding posts in the walls between rooms, and, more than likely, removing some floor slab to add footings below the floor. It is very unlikely that the existing floor slab would be capable of supporting the post loads. A new soffit would be required in the ceilings under the new beams.
