# 4<sup>th</sup> ICEPIM & OMIC GAS 2018

## Failure Investigation of Tie Rod used to control expansion of Bellow in Blast Furnace

Mr. Pradip K Patra , Mr. Subhasis Chakrabarty, Mr. Neel Kant  
JSW Steel Ltd. Dolvi Works

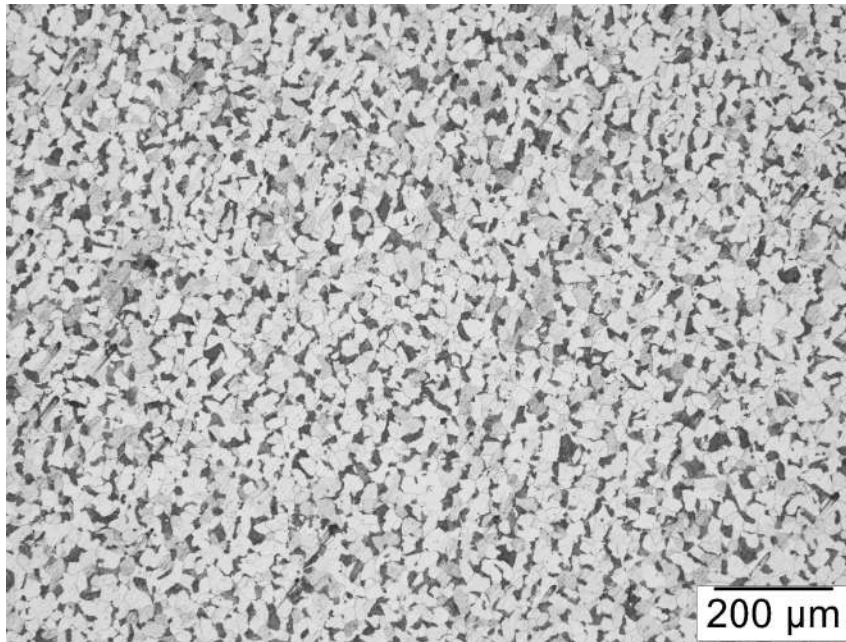
## Metallographical Test

ASTM Grain Size Number 8.30 according to Intercept Method ASTM E 112-12

Microstructure shows uniform coarse structure of pearlite in ferrite matrix

No cracks were found on the cross section of the sample

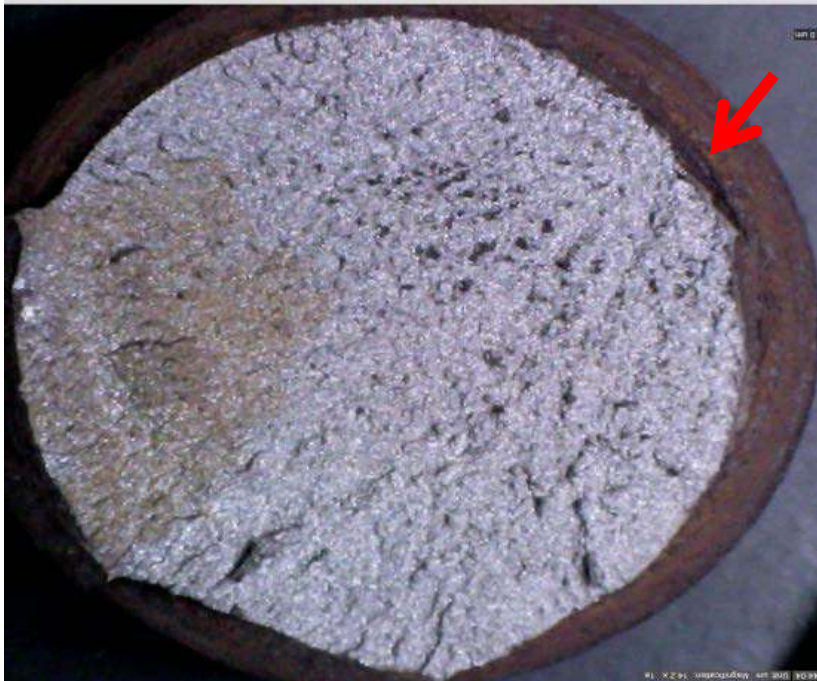
## Fractured Surface visual image

The location of failure is from the threads (most of the time)

“Chevron” pattern points to the origin of the brittle fracture (arrow)

Fatigue failure initiated at arrow and moved across the cross section, leads to catastrophic failure.

- Specification of the Tie rod material is replaced by EN 9.
- Material chosen having lower YS / UTS ratio to avoid catastrophic failure.
- Number of Tie rod increased from 4 to 16 to withstand load.

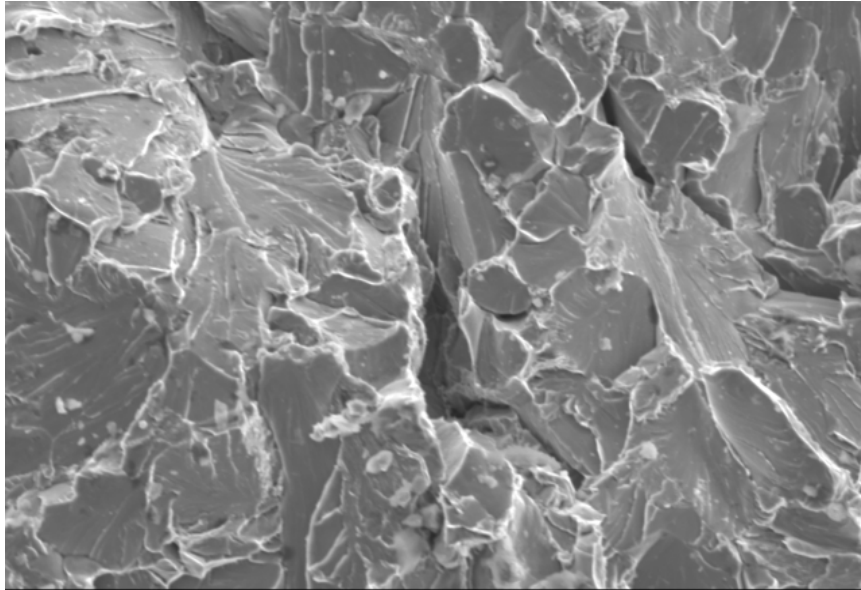
## SEM Image of Fractured Surface

Typical brittle fracture was found having river lines on the faces of the cleavage surfaces.

These type of fracture occur with very little plastic deformation near the of crack prior to rapture.

Grooves of the thread are the highest stress concentration point hence it become initiation point of crack generation.
