The through-bolt saga

AN ENGINEERING DETECTIVE STORY

BY RICK FRITH

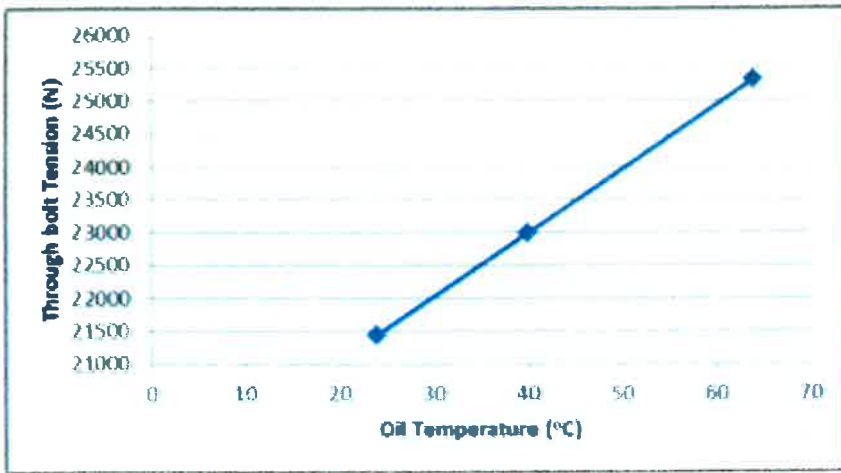
Fig. 3 - Through bolt tension variation with oil temperature - at thermal equilibrium.

A fundamental breakthrough came when a strain gauge was installed inside a through-bolt to measure the actual stress in an operating engine. When the engine was started, the stress was found to rise unexpectedly high, before declining to the level predicted from analysis. Due to the different thermal expansion properties between the aluminium engine block and the steel bolts, the block expands more than the bolts, increasing the tension in the bolts at operating temperatures. This was expected and is shown in Fig. 3.

The surprise finding was that on engine start-up, the bolts warmed up much more slowly than the aluminium block, so the block expanded faster than the bolts, further increasing the bolt tension beyond that shown in Fig. 3. As the bolts warmed up and expanded, the tension eventually reduced to the expected level. This observation of thermal stress peak cycling explains why flying school aircraft were experiencing the through-bolt failures. They typically have short flight times (single lessons) and, during each flight, do many touch and goes, imposing higher thermal stresses on each circuit as the engine is throttled back for descent and full power is re-applied for take-off. Furthermore, at sea level, the engine will deliver more power when the throttle is wide open. At higher altitudes, the engine will develop significantly less power. For example at 3,000ft, the loss is almost 10%. At the same rpm, peak cylinder pressure and the stress in the through-bolts are essentially proportional to power, so sea level operations maximise the

The solution for existing engines was simple - modify the 3/8" through-bolt design to make them more elastic and hence reduce the peak stresses generated by differential expansion rates. Flying school aircraft are required to replace through-bolts every 500 hours, ensuring a rapid take-up of the new design.

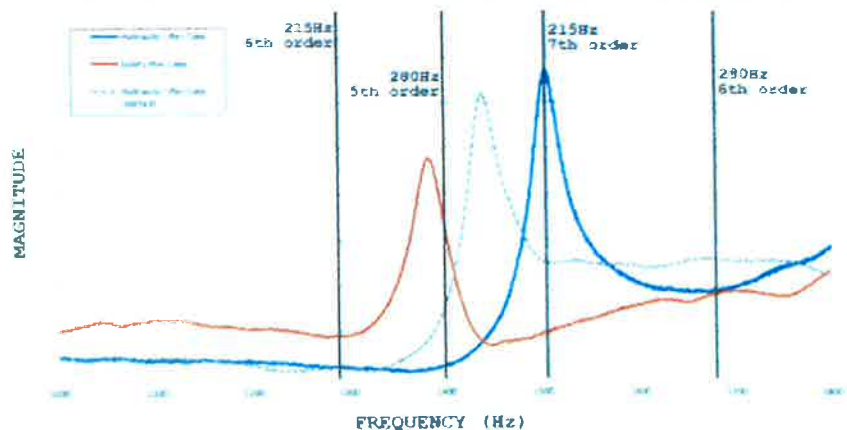
Fig. 4 - Spectral Diagram of crankcase resonances.

The second breakthrough came with vibration analysis of the hydraulic lifter and solid lifter engines. The measurements were so sensitive it was possible to observe the twelve vibrations produced each revolution as individual alternator magnets passed the induction coils. The vibration spectra of both operating engines and major engine components showed a significant difference between the resonant peaks for the two models (See Fig. 4). Anyone who has pushed a child on a swing will understand that small forces, if applied briefly at the right point in a cycle,

The resonance vibration was the true root cause of the problem. The differential thermal expansion effects were also present in the solid lifter engine, but did not cause failures because those forces alone did not exceed the SN curve. It appears the additional forces due to resonance further increased the loads sufficiently to cause fatigue failure. The thermal effects were a secondary, but essential contributing factor.

Red = Solid Lifter, Blue = Original Hydraulic Lifter, Dotted = Current "Slotted" Hydraulic Lifter

The solution to this resonance peak was to slightly modify the crankcase design to reduce

the frequency and bring it closer to the solid lifter engine frequency. As a supplementary measure, for existing unmodified crankcases, the latest 3/8" through-bolt design also incorporates a vibration damper to eliminate any detectable lateral vibration of the bolt.
