2004 Sea Ray 480 Sedan Bridge

"BIG BREEZE"

Report of Marine Survey

April 27, 2017

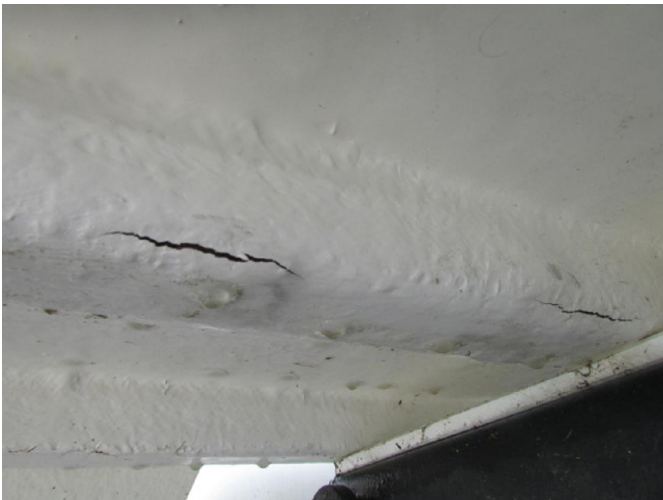
Note: There were five cracks sighted under the swim platform in the gelcoat, they appear superficial in nature (see attached photos). The parameter plastic finishing strip has three loose screws. The affected area's were sounded and checked for moisture without negative report at this time.

Gelcoat Crack Under Swim Platform

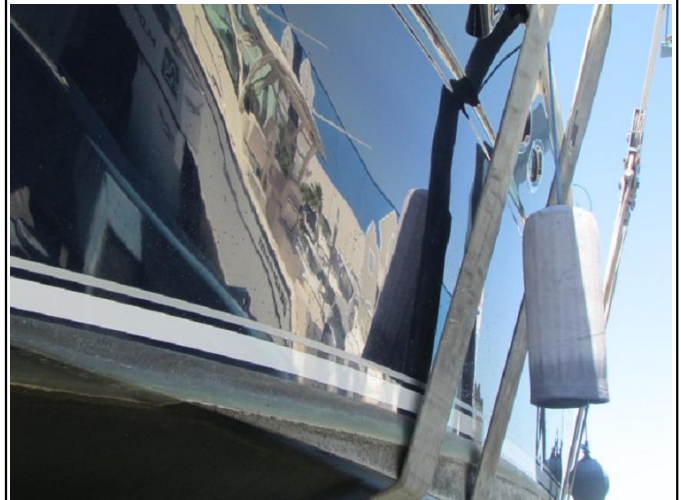
Gelcoat

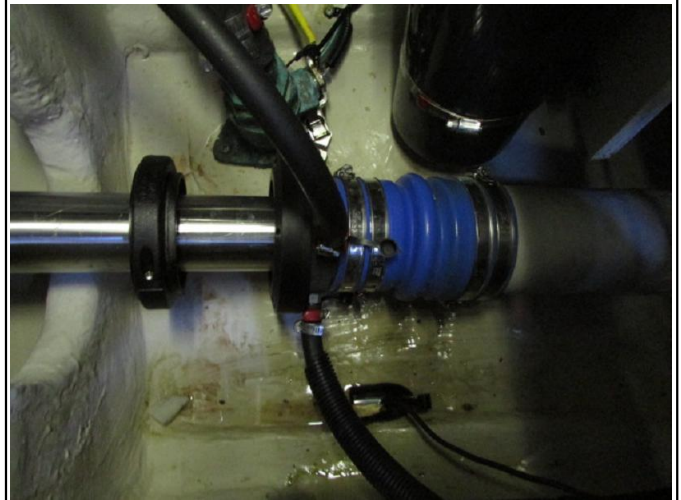
*Discharge thru-hull at engine space aft of starboard main engine, approved type hoses double clamped. Hoses and clamps serviceable. Note: The discharge thru-hull is leaking/weeping water where connected to the hull. (See findings B.1 Thru-Hulls List).

The blackwater sanitation discharge thru-hull is weeping/leaking where fastened to the hull, location behind the starboard main engine.

Leak At MSD Seacock

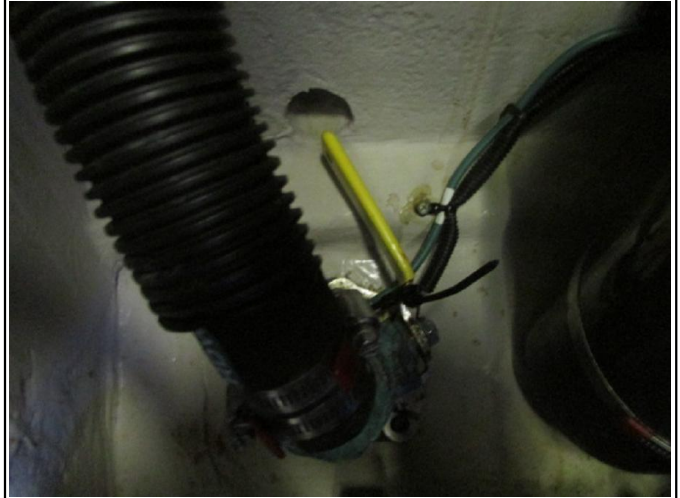
MSD Seacock Fixed Closed

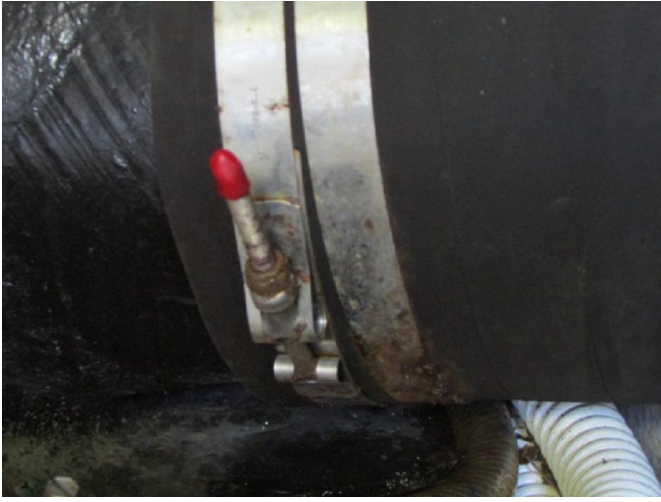
Note: The port exhaust connection flex hose to silencer, where the exhaust enters the silencer is leaking and clamps are corroded. (See findings A.1 Exhaust System). All but where noted the exhaust system appears to be in serviceable condition.

Port Exhaust Hose Clamp

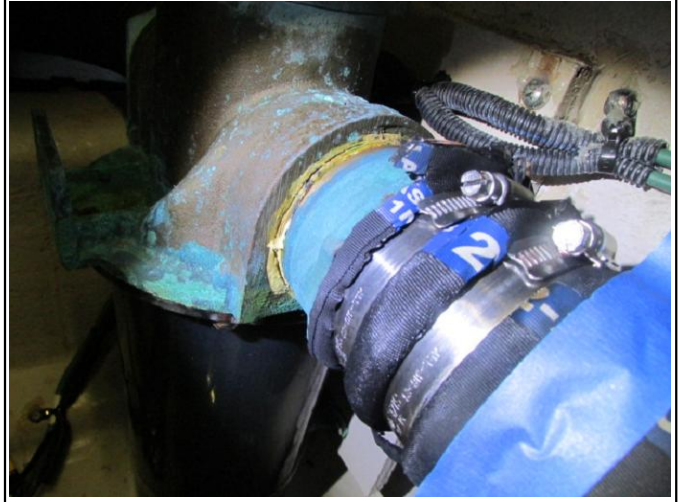
* Note: The starboard raw water inlet hose from the strainer to the main engine is showing signs of fatigue and is leaking at the clamp.

**Starboard Main Engine Raw Water Strainer Hose
Leak**

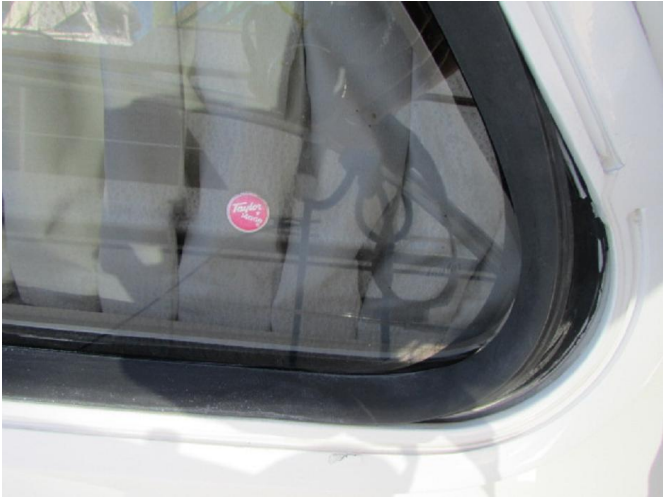
The port fixed window gasket has come loose from the frame and is deformed at the aft lower corner. It does not appear to be leaking at this time. (See photo).

Window Gasket Port.
