# ASSOCIATION RESERVES™

## "Full" Reserve Study

### The Oaks Condominiums Arvada, CO

**Report #: 40749-0**

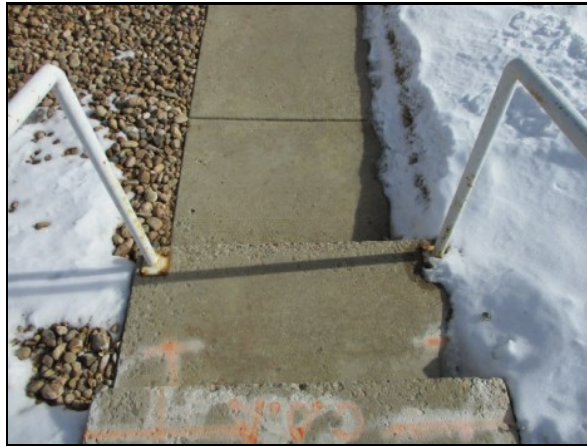
**Comp #: 21090 Concrete Walkways - Repair - 5%**

Comments: Concrete sidewalks determined to be in fair condition typically exhibit minor changes in slope and a moderate percentage of cracking and surface wear. Trip hazards may be increasing in frequency and severity and should be closely monitored to prevent further risks. Colorado is home to expansive soils. One of the causes of concrete damage in this type of soil moisture. Expansive soils tend to swell in size when wet and contract as they dry out. As the soil expands and contracts it can create enough force to cause major damage to sidewalks. Repair any trip and fall hazards immediately to ensure safety. As routine maintenance inspect regularly pressure wash for appearance and repair promptly as needed to prevent water penetrating into the base and causing further damage. In our experience larger repair/replacement expenses emerge as the community ages. Although difficult to predict timing cost and scope we suggest a rotating funding allowance to supplement the operating/maintenance budget for periodic larger repairs. Adjust as conditions actual expense patterns dictate within future reserve study updates.

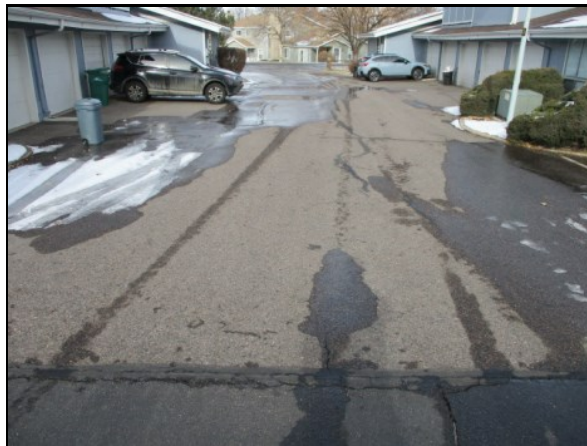
**Comp #: 21190 Asphalt - Seal/Repair**

Comments: Asphalt seal was observed to be in poor condition at the time of the inspection. The seal appeared to be weathered and faded. Exposed aggregate and a gravelly texture was noted. Plan to seal the asphalt soon. Regular cycles of seal coating (along with any needed repair) has proven to be the best program in our opinion for the long term care of lower traffic asphalt areas such as these. The primary reason to seal coat asphalt pavement is to protect the pavement from the deteriorating effects of sun and water. When asphalt pavement is exposed the asphalt oxidizes or hardens which causes the pavement to become more brittle. As a result the pavement will be more likely to crack because it is unable to bend and flex when subjected to traffic and temperature changes. A seal coat combats this situation by providing a waterproof membrane which not only slows down the oxidation process but also helps the pavement to shed water preventing it from entering the base material. Seal coat also provides uniform appearance concealing the inevitable patching and repairs which accumulate over time. Seal coat ultimately extends useful life of asphalt postponing the asphalt resurfacing which can be one of the larger cost items in this study (see component #21200 for asphalt resurfacing costs). Repair asphalt before seal coating. Surface preparation and dry weather during and following application is key to lasting performance. The ideal conditions are a warm sunny day with low humidity rain can cause major problems when seal coating and should never be done when showers are threatening. Incorporate any striping and curb repair into this project. Fill cracks and clean oil stains promptly in between cycles as routine maintenance. Prior to a seal coat application the areas will be cleaned with push blowers and wire brooms. Be aware that sealcoat will not adhere to heavily saturated oil spots. Vendors typically recommend infrared patching on areas with saturated oil spots to ensure adherence of sealcoat.

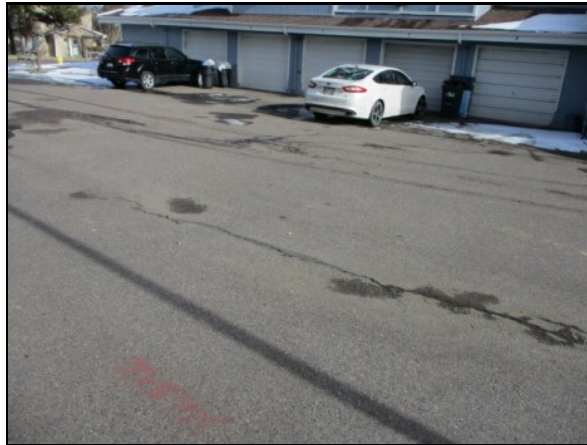
Comments: Asphalt pavement determined to be in fair condition typically exhibits a mostly uniform surface but with minor to moderate raveling and surface wear. If present crack patterns are normal for the age of the asphalt and not extreme and there are no signs of advanced deterioration such as large block cracking patterns "alligatoring" or potholes. Overall appears to be aging normally and still up to an appropriate aesthetic standard. Useful life below assumes regular seal coating and repairs. The lack of seal coating and repairs can greatly decrease the asphalt's useful life. Resurfacing is typically one of the larger expense items in a reserve study. When need to resurface is apparent within a couple of years consult with geotechnical engineer for recommendations specifications / scope of work and project oversight. As routine maintenance keep surfaces clean and free of debris ensure that drains are free flowing repair cracks and clean oil stains promptly. Assuming proactive maintenance plan to resurface at roughly the time frame below. If regular maintenance and sealing is deferred client may need more extensive repair and replacement projects. Funding below assumes that asphalt has adequate subgrade as well as asphalt fill depth. If fill depth is less than 2" client may need to consider a remove and replacement project which can increase costs by 50% or more. Further resources: Pavement Surface Condition Field Rating Manual for Asphalt Pavement. <http://co-asphalt.com/resources/maintenance-and-preservation/>

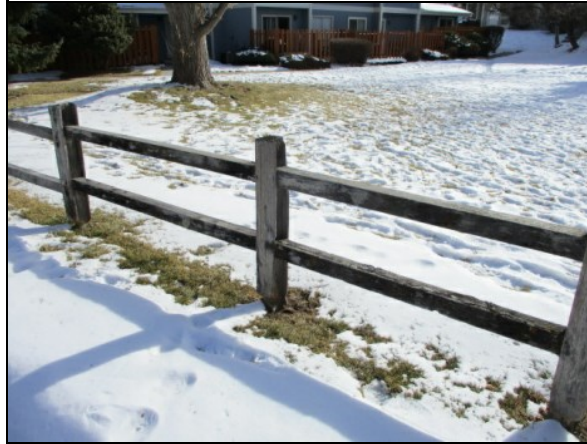
**Comp #: 21340 Site Fencing: Split Rail - Replace**

History: Client repaired (9) posts in 2020

Comments: The remaining useful life extended slightly based on repairs completed in 2020. Wood fencing determined to be in fair condition typically exhibits some minor to moderate amounts of surface wear and other signs of age which may include a small percentage of warped split and/or rotted sections. In general appearance is consistent but declining. As routine maintenance inspect regularly for any damage repair as needed and avoid contact with ground and surrounding vegetation wherever possible. Regular cycles of uniform professional sealing/painting will help to maintain appearance and maximize life. In our experience wood fencing will typically eventually break down due to a combination of sun and weather exposure which is sometimes exacerbated by other factors such as irrigation overspray abuse and lack of preventive maintenance. Recommendation and costs shown here are based on replacement with similar style and material. However the client might want to consider replacing with more sturdy lower-maintenance products like composite vinyl etc. Although installation costs are higher total life cycle cost is lower due to less maintenance and longer design life expectancy.

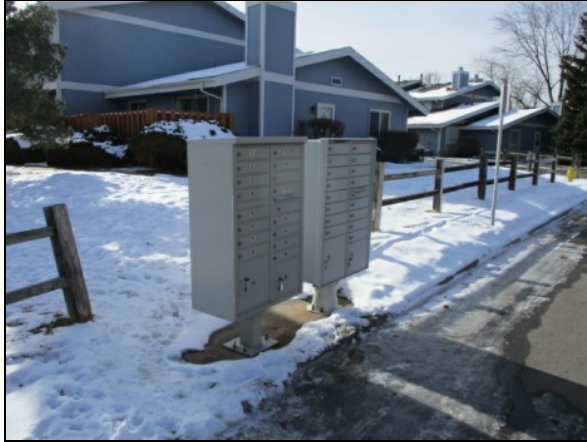
**Comp #: 21600 Mailbox Kiosks - Replace**

Comments: Mailbox kiosks determined to be in fair condition typically exhibit minor to moderate surface wear at this stage. All components and hardware appear to function properly but appearance is diminishing. Inspect regularly and clean by wiping down exterior surfaces. If necessary change lock cylinders lubricate hinges and repair as an Operating expense. Best to plan for total replacement at roughly the time frame below due to constant exposure usage and wear over time. Note USPS has a limited budget for replacement and should not be relied upon for purposes of long term planning.

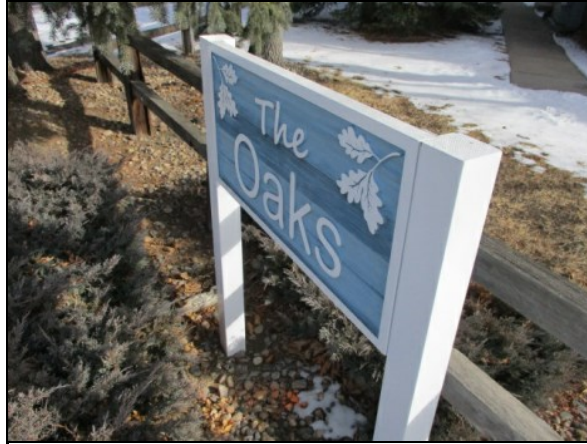
**Comp #: 21610 Sign/Monument - Refurbish/Replace**

History: Replaced in 2019

Comments: Monument signage determined to be in fair condition typically exhibits acceptable appearance and aesthetics in keeping with local area but with more weathering and wear showing on surfaces. If present landscaping and lighting are still in serviceable condition. At this stage signage may be becoming more dated and diminishing in appeal. As routine maintenance inspect regularly clean/touch-up and repair as an Operating expense. Plan to refurbish or replace at the interval below. Timing and scope of refurbishing or replacement projects is subjective but should always be scheduled in order to maintain good curb appeal. In our experience most clients choose to refurbish or replace signage periodically in order to maintain good appearance and aesthetics in keeping with local area often before signage is in poor physical condition. If present concrete walls are expected to be painted and repaired as part of refurbishing but not fully replaced unless otherwise noted. Costs can vary significantly depending on style/type desired and may include additional costs for design work landscaping lighting water features etc. Reserve Study updates should incorporate any estimates or information collected regarding potential projects.

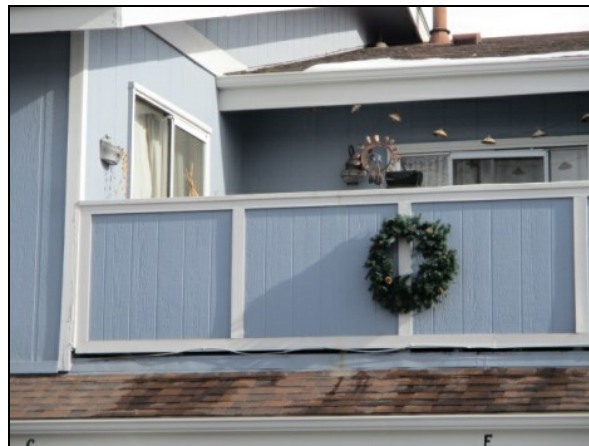
**Comp #: 23180 Composite Decks/EPDM - Replace**

Comments: Surface appearance was of that of a composite/plastic/PVC material. Typical warranty period based on a Trex type material is 25 years. However that warranty period is based on proper installation and maintenance. We recommend ongoing evaluations of all elevated decks by a qualified decking or waterproofing contractor to assess overall condition and performance of system components. As part of ongoing maintenance program inspect regularly for any damage/deterioration. Ensure that any rail assemblies are secure. Note project costs can vary significantly professional specifications soliciting several estimates and professional project oversight are recommended. Track actual expenses for inclusion within future Reserve Study updates. If properly installed composite decking systems should experience an extended useful life. Decks should be thoroughly evaluated by a decking or waterproofing contractor prior to re-coating in order to determine scope of any required repairs. If the deck system has a warranty the client should make sure to follow any requirements necessary to maintain said warranty such as re-coating at required intervals and conducting professional inspections. As a general rule potted plants and other items that may trap water should be elevated off the deck or used with a waterproof liner in order to prevent prolonged exposure.

Our inspection is limited to a visual evaluation of accessible areas and is not a substitute for a comprehensive inspection including destructive testing sub-surface moisture evaluation core sampling etc. Typical useful life of a flat (AKA "low-slope") roof is 15-20 years depending on the quality of the roof system installed and the maintenance receives throughout its life. As routine maintenance many manufacturers recommend professional inspections at least twice annually and after storms. Promptly repair any damaged sections or any other repairs needed to ensure waterproof integrity of roof. Keep scuppers drains gutters and downspouts clear and free of debris to allow proper drainage and prevent the ponding of water on the roof surface. We recommend using walk pads or extra roofing material to provide pathways in high-traffic areas such as around HVAC units or other equipment. Take care to minimize any penetrations in the roof system and to properly waterproof and all drains vent pipes conduit penetrations etc. For more information we recommend consulting with independent roofing consultants or with organizations such as the Roof Consultant Institute <http://www.rci-online.org/> and the National Roofing Contractors client (NRCA) <http://www.nrca.net/>. If the roof has a warranty be sure to review terms and conduct proper inspections/repairs as needed to keep warranty in force.

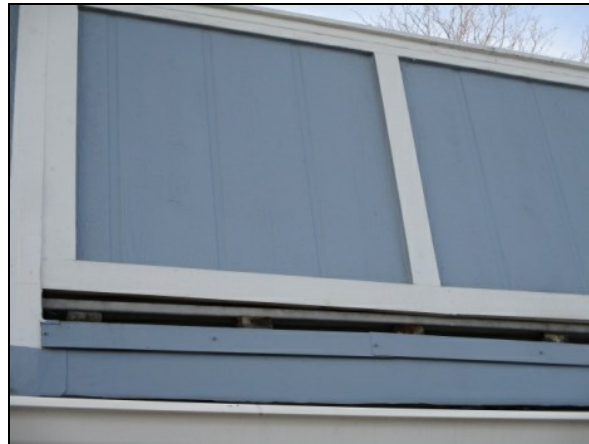
**Comp #: 23180 Composite Decks/EPDM-Replace(2015)**

History: Replaced in 2015 for ~\$6800/deck

Comments: Surface appearance was of that of a composite/plastic/PVC material. Typical warranty period based on a Trex type material is 25 years. However that warranty period is based on proper installation and maintenance. We recommend ongoing evaluations of all elevated decks by a qualified decking or waterproofing contractor to assess overall condition and performance of system components. As part of ongoing maintenance program inspect regularly for any damage/deterioration. Ensure that any rail assemblies are secure. Note project costs can vary significantly professional specifications soliciting several estimates and professional project oversight are recommended. Track actual expenses for inclusion within future Reserve Study updates. If properly installed composite decking systems should experience an extended useful life. Decks should be thoroughly evaluated by a decking or waterproofing contractor prior to re-coating in order to determine scope of any required repairs. If the deck system has a warranty the client should make sure to follow any requirements necessary to maintain said warranty such as re-coating at required intervals and conducting professional inspections. As a general rule potted plants and other items that may trap water should be elevated off the deck or used with a waterproof liner in order to prevent prolonged exposure.

Our inspection is limited to a visual evaluation of accessible areas and is not a substitute for a comprehensive inspection including destructive testing sub-surface moisture evaluation core sampling etc. Typical useful life of a flat (AKA "low-slope") roof is 15-20 years depending on the quality of the roof system installed and the maintenance receives throughout its life. As routine maintenance many manufacturers recommend professional inspections at least twice annually and after storms. Promptly repair any damaged sections or any other repairs needed to ensure waterproof integrity of roof. Keep scuppers drains gutters and downspouts clear and free of debris to allow proper drainage and prevent the ponding of water on the roof surface. We recommend using walk pads or extra roofing material to provide pathways in high-traffic areas such as around HVAC units or other equipment. Take care to minimize any penetrations in the roof system and to properly waterproof and all drains vent pipes conduit penetrations etc. For more information we recommend consulting with independent roofing consultants or with organizations such as the Roof Consultant Institute <http://www.rci-online.org/> and the National Roofing Contractors client (NRCA) <http://www.nrca.net/>. If the roof has a warranty be sure to review terms and conduct proper inspections/repairs as needed to keep warranty in force.

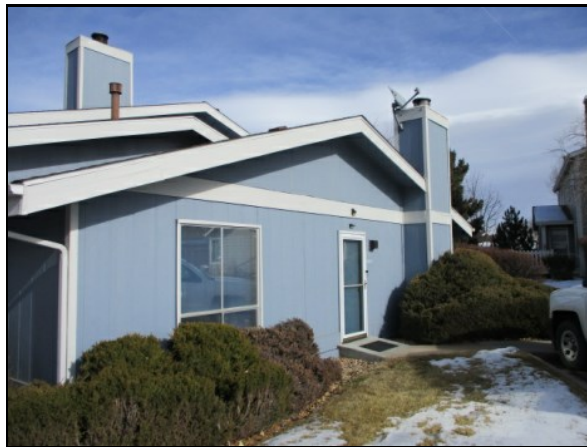
History: Replaced in 2019

Comments: Painted exterior surfaces determined to be in fair condition typically exhibit some minor to moderate signs of wear and age such as chalking peeling blistering etc. Problems tend to develop in more exposed areas first. Hairline cracks may be present at this stage. Overall appearance is satisfactory. As routine maintenance inspect regularly (including sealants) repair locally and touch-up paint as needed. Typical paint cycles can vary greatly depending upon many factors including type of material painted surface preparations quality of material application methods weather conditions during application moisture beneath paint and exposure to weather conditions. Proper sealant/caulking is critical to preventing water intrusion and resulting damage to the building structure. Incorrect installations of sealant are common and can greatly decrease its useful life. Inspect sealant more frequently as it ages to determine if it is failing. Typical sealant problems include failure of sealant to adhere to adjacent materials and tearing/splitting of the sealant itself. As sealants age and are exposure to ultra-violet sunlight they will dry out harden and lose their elastic ability. Remove and replace sealant as signs of failure begin to appear. Proper cleaning prep work and proper installation are critical for a long lasting sealant/caulking. Do not install sealant in locations that would block water drainage from behind the siding. Repair areas as needed prior to project. For best results the client may want to consult with a building envelope specialist or waterproofing contractor to specify types of materials to be used and define complete scope of work before bidding. Best practice is to coordinate this type of work with other projects whenever practical such as balcony sealing planter waterproofing etc.

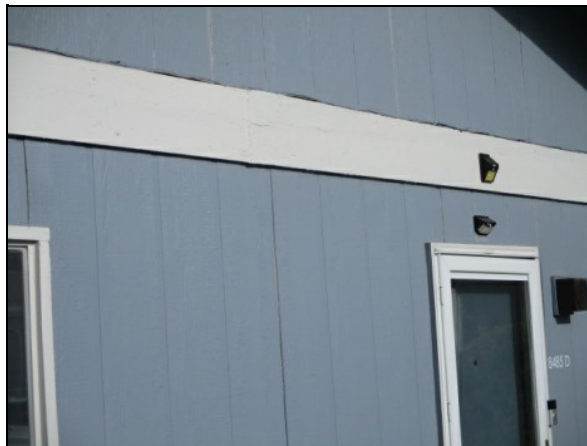
**Comp #: 23320 Wood/Composite Siding - Replace**

Comments: Wood siding determined to be in fair condition typically exhibits some color fading and inconsistency with minor isolated locations showing more advanced surface wear cracking splintering etc. Project costs can vary depending upon materials chosen and the condition of the underlying structural framing when exposed. We recommend the Board conduct research well in advance in order to define scope timing and costs including plan for some margin of contingency. Siding is horizontal clapboard. Surface was painted. No view of the critical underlying waterproofing was available as part of our limited visual review. Replacement may ultimately be needed due to the failure of the underlying waterproofing degrading over the decades and/or the end of the useful life of the siding materials from general aging. Many factors influence the useful life including exposure to (or protection from) wind driven rain and the quality of the waterproofing and flashing beneath the siding. Evaluate the siding and the critical underlying waterproofing (typically building paper or house-wrap) more frequently as the remaining useful life approaches zero years. Adjust remaining useful life as dictated by the evaluation. Align with window replacement for cost efficiencies and building envelope integrity when practical. Inspect annually and repair locally as needed using general maintenance funds. Keep the wood siding painted to protect the wood from decay caused by water. Another item that greatly influences useful life is the thoroughness of the original painting. Wood siding will last longer if each piece was painted on all six sides. Typically wood siding is painted on the two sides that are exposed and not on the back ends or top. Since we perform only a visual review we were unable to confirm the extents of the painting. It is reasonable to presume that not all six sides are painted. If the siding is not painted on all sides water can infiltrate and be absorbed into the wood on the unpainted sides which over time will lead to cupping warping and decay limiting its useful life.

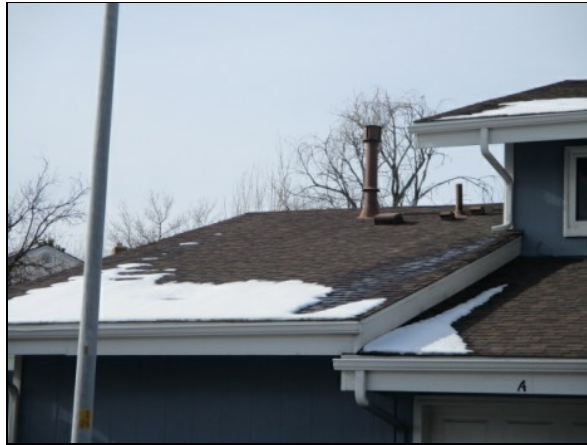
**Comp #: 23570 Roof: Composition Shingle - Replace**

History: Replaced in 2016

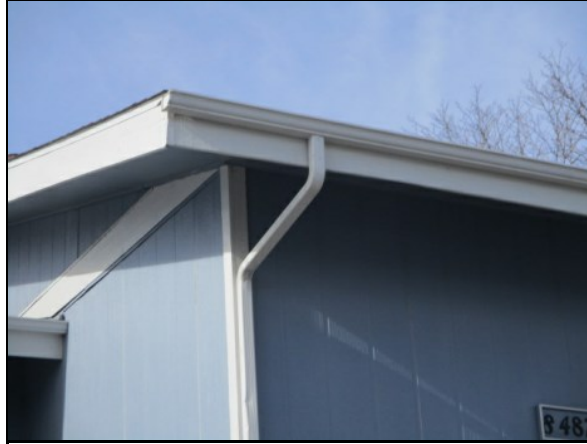
**Comp #: 23650 Gutters/Downspouts - Replace**

History: Replaced in 2016

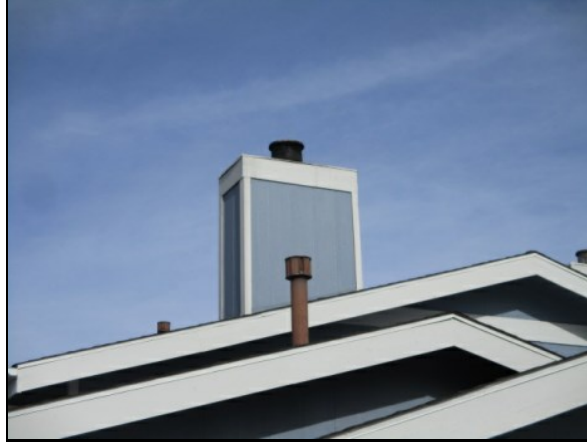
**Comp #: 23710 Chimney Covers/Flue Caps - Replace**

History: Replaced in 2016
