Summary

Property address: **123 Home Dr
 Anywhere CA 95835**

Inspection date: **Friday, July 01, 2016**

Property Inspection Report

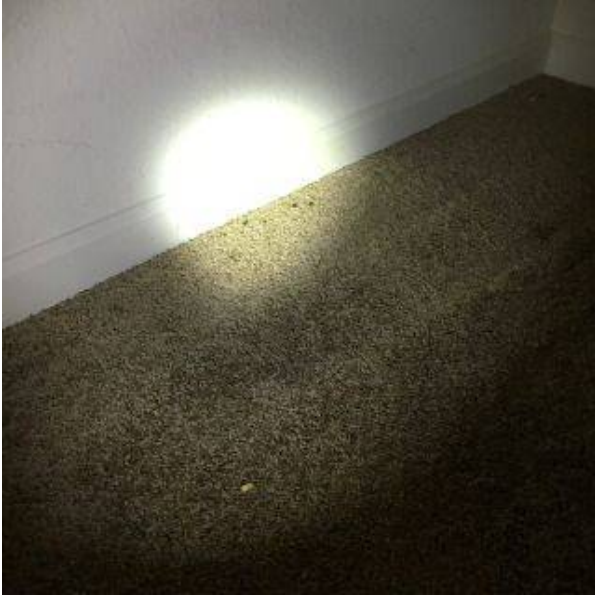
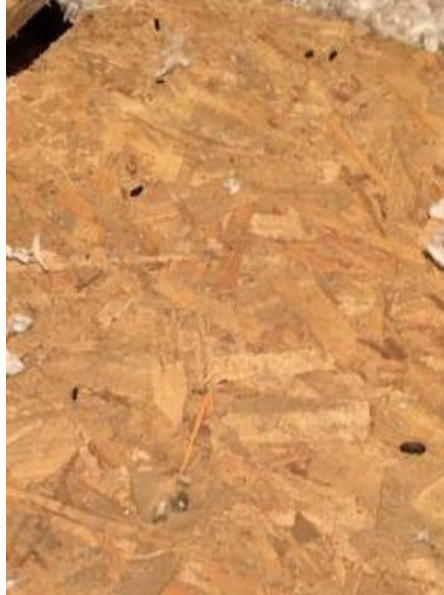
1 Repair/Replace - Evidence of rodent infestation was found in the form of feces in the attic and/or interior rooms. Consult with the property owner about this. A qualified person should make repairs to seal openings in the structure, set traps, and clean rodent waste as necessary. Recommend following guidelines in these Center for Disease Control articles:

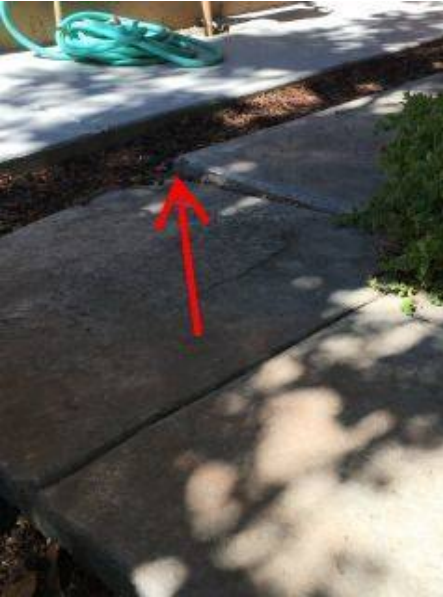
2 Safety, Repair/Maintain - Settlement, heaving and/or deterioration resulting in trip hazards were found in the sidewalks towards main electrical disconnect. For safety reasons, recommend that a qualified contractor repair as necessary to eliminate trip hazards.

Photo 2-1
Trip Hazard

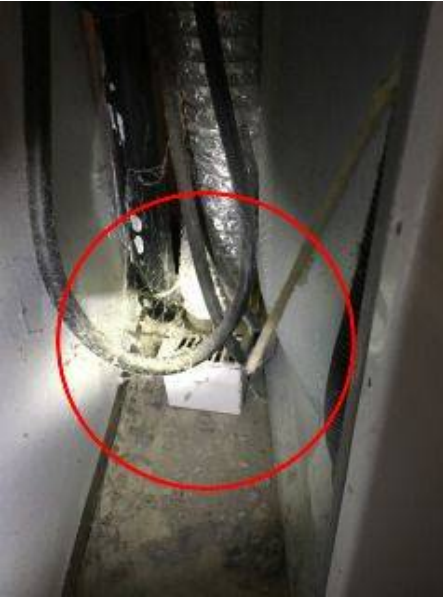
11 Safety, Comment - Hookups for a clothes washer and/or dryer were installed in the garage. The client should be aware that any source of spark or flame, including motors and circuitry in laundry equipment, are a potential source for spark (or flame with a gas-fired clothes dryer). Such equipment should be elevated at least 18 inches off the floor because vapors from gasoline or other flammable fluids that are heavier than air may be present. Dryer duct vents into garage. Suggest qualified contractor evaluate and correct as necessary.

Photo 11-1
Garage Dryer Vent Duct

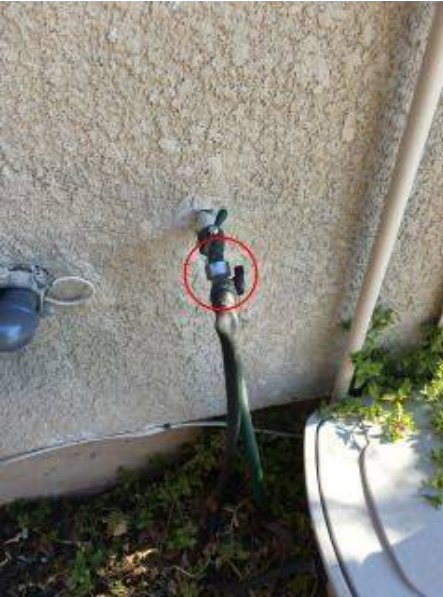
15 Safety, Minor Defect - One or more hose bibs were missing backflow prevention devices. These devices reduce the likelihood of gray water entering the potable water supply. Recommend installing backflow prevention devices on all hose bibs where missing. They are available at most home improvement stores and are easily installed.

Photo 15-1
No Anti-Siphon

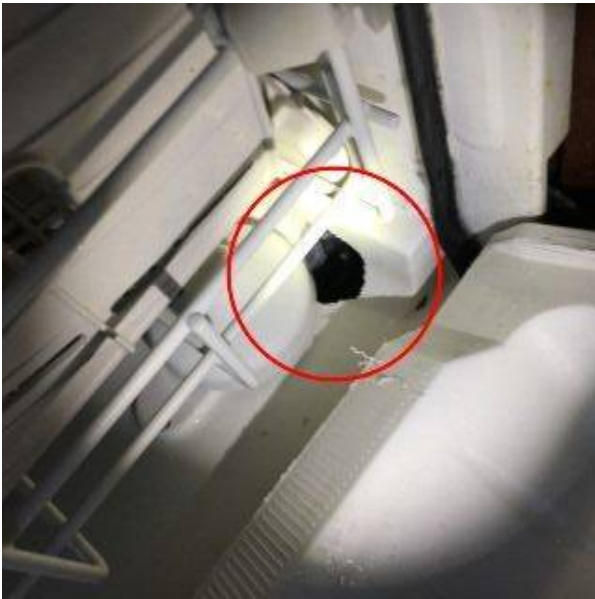
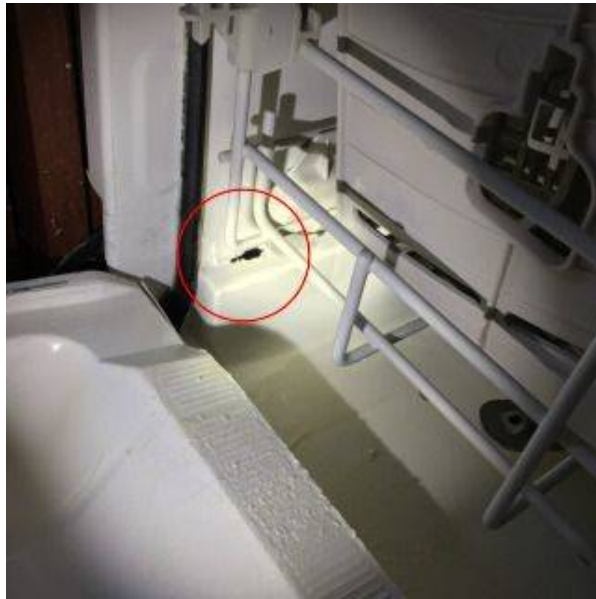
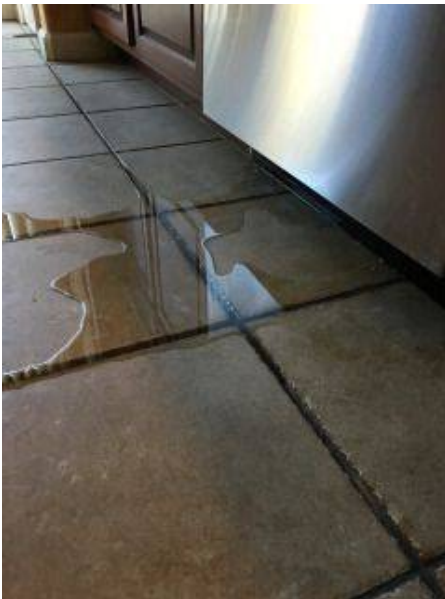
22 Repair/Replace, Evaluate - The dishwasher was leaking. Recommend that a qualified specialist evaluate and repair or replace as necessary.

Photo 22-1
Dishwasher Hole 1

Photo 22-2
Dishwasher Hole 2

Photo 22-3
Dishwasher Leak

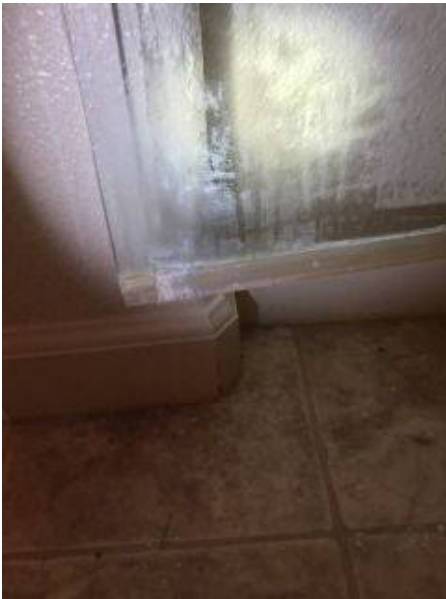
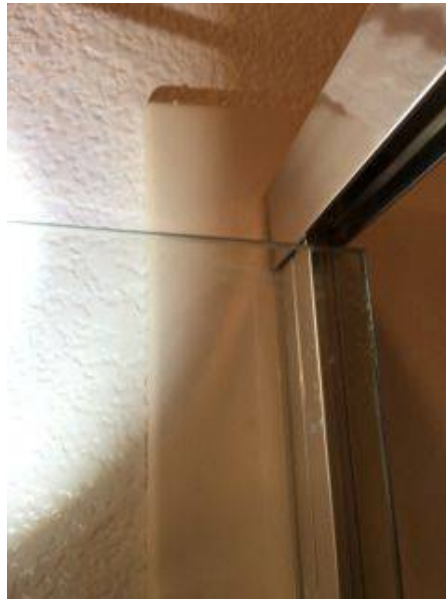
29 Safety, Repair/Replace, Evaluate - The inspector was unable to verify that the glass used in one or more enclosure walls by the shower at location #A was approved safety glass. Glazing that is not approved safety glass located in areas subject to human impact is a potential safety hazard. Standard building practices require that approved safety glass be used in enclosures for bathtubs, showers, spas, saunas and steam rooms, and in windows where the bottom edge of the window is less than 60 inches above the drain inlet or standing surface. Wire-reinforced glass is not acceptable. Recommend that a qualified contractor evaluate further to determine if glazing is approved safety glass, and replace glass if necessary, and per standard building practices.

Photo 29-1
No Evidence of Tempered Glass

Photo 29-2
No Tempered Glass Picture 2

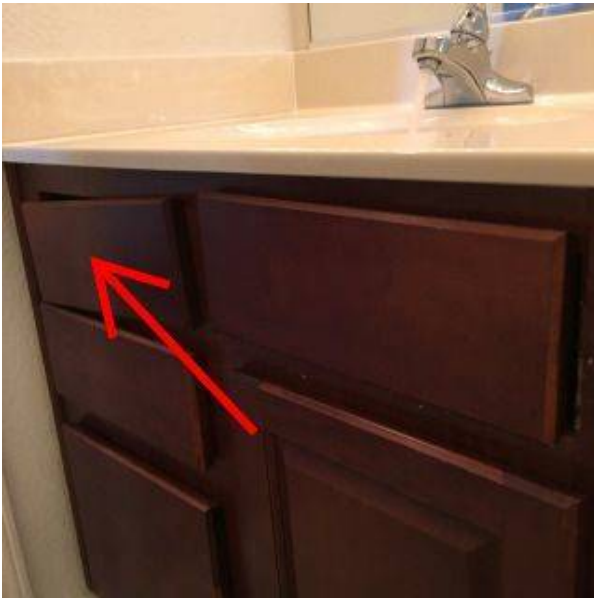
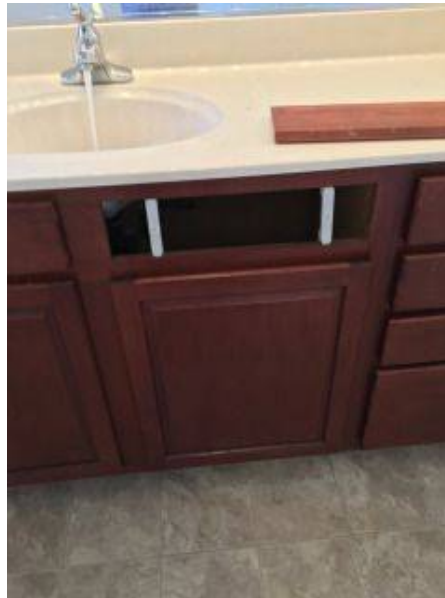
30 Repair/Replace - One or more cabinets, drawers and/or cabinet doors at location(s) #A and B were damaged, deteriorated or missing. Recommend that a qualified person repair or replace as necessary.

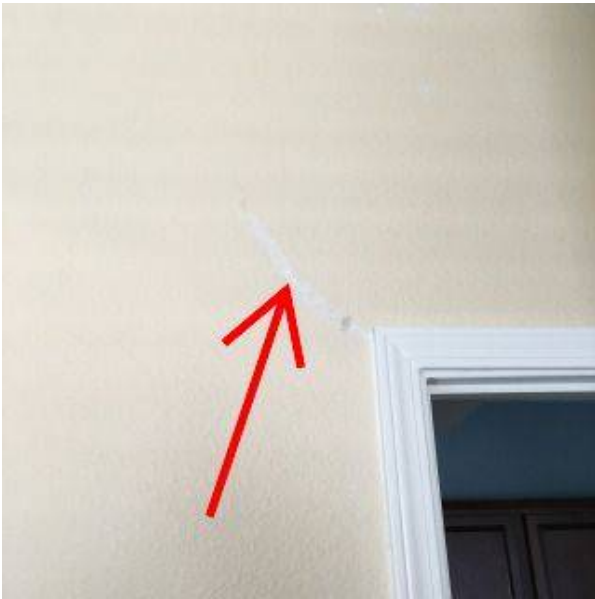
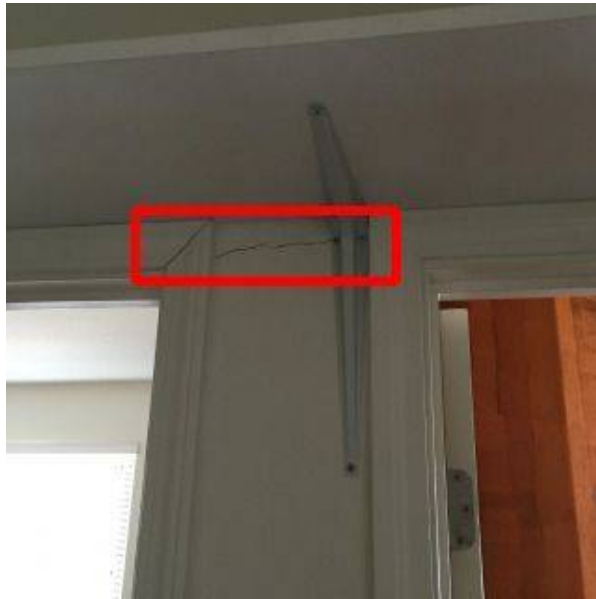
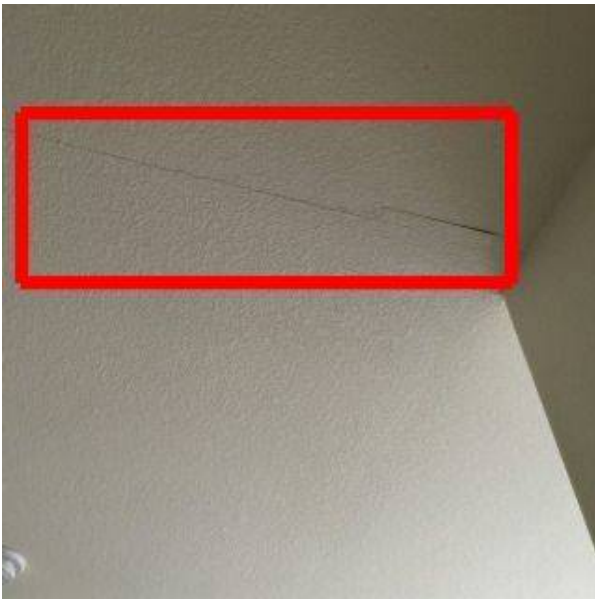
34 Repair/Replace, Evaluate - This structure appears to have settled, or was leaning significantly based on the presence of cracks in walls, ceilings or junctions between them, or numerous door frames not being square, or numerous doors binding in jambs. Recommend that a qualified contractor and/or engineer evaluate further. Significant repairs may be needed. If so, a qualified contractor should make repairs.

Photo 34-1
Drywall Crack 1

Photo 34-2
Drywall Crack 3

Photo 34-3
Ceiling Drywall Crack 2

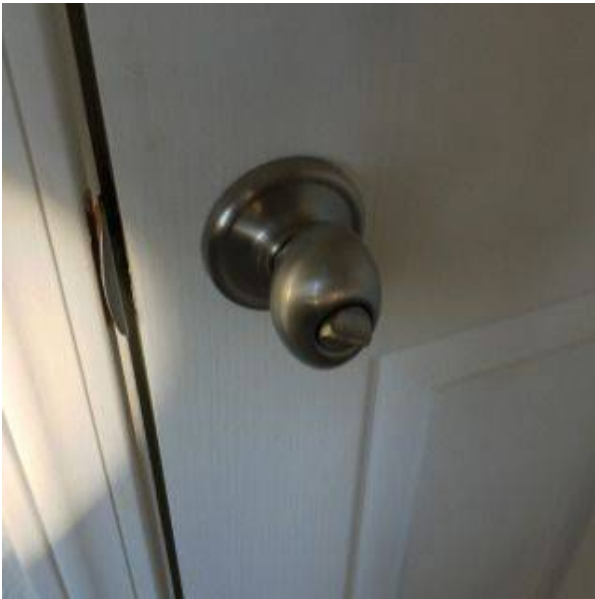
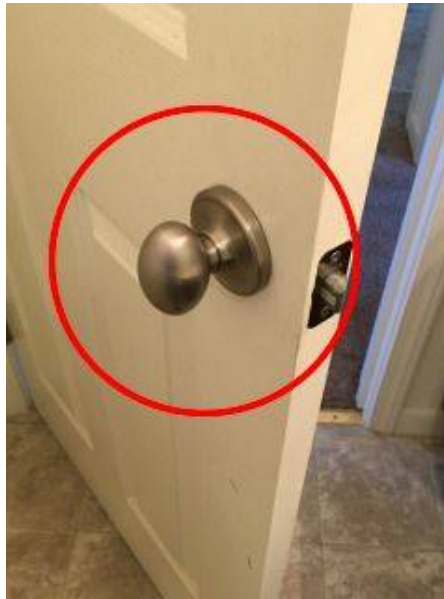
35 Repair/Replace - Some interior door hardware (locksets) were inoperable. Recommend that a qualified person repair or replace as necessary.

Master bathroom was not working. Bathroom #B (upstairs) does not have a lock as required per current building standards.

Photo 35-1
Faulty Bathroom Door Lock

Photo 35-2
No Bathroom Door Lock

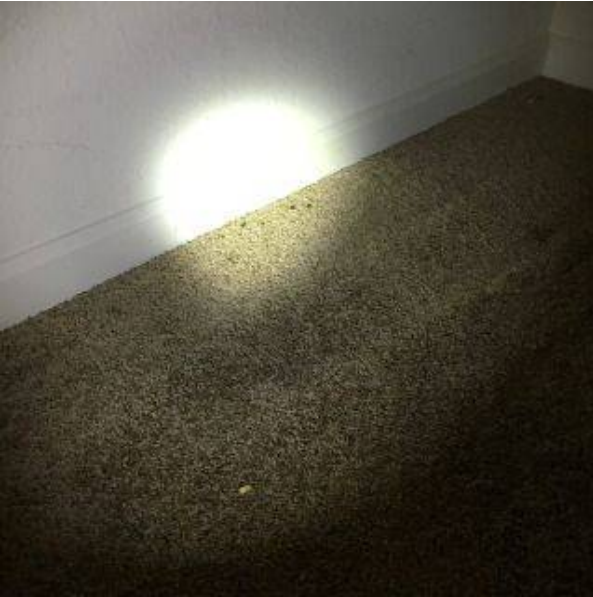
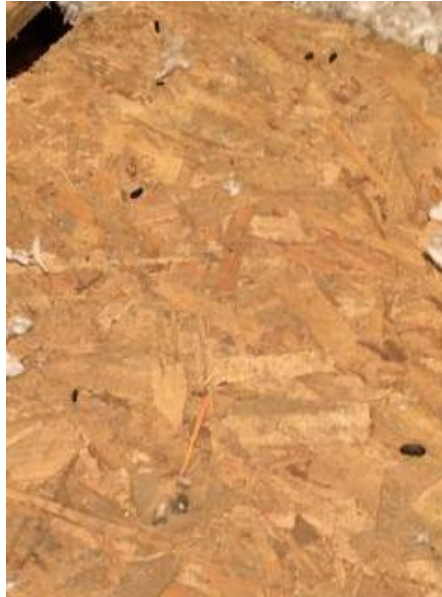
1) Repair/Replace - Evidence of rodent infestation was found in the form of feces in the attic and/or interior rooms. Consult with the property owner about this. A qualified person should make repairs to seal openings in the structure, set traps, and clean rodent waste as necessary. Recommend following guidelines in these Center for Disease Control articles:

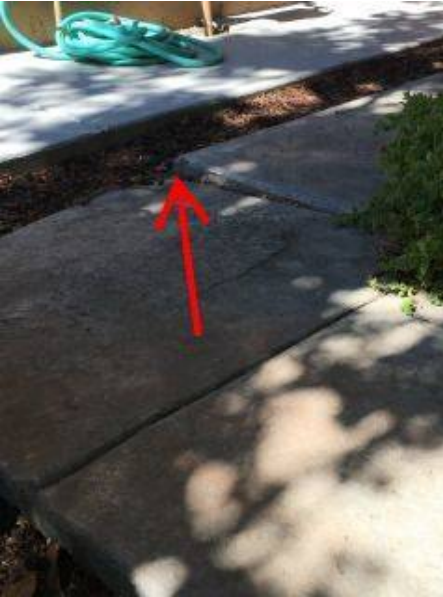
2) Safety, Repair/Maintain - Settlement, heaving and/or deterioration resulting in trip hazards were found in the sidewalks towards main electrical disconnect. For safety reasons, recommend that a qualified contractor repair as necessary to eliminate trip hazards.

Photo 2-1
Trip Hazzard

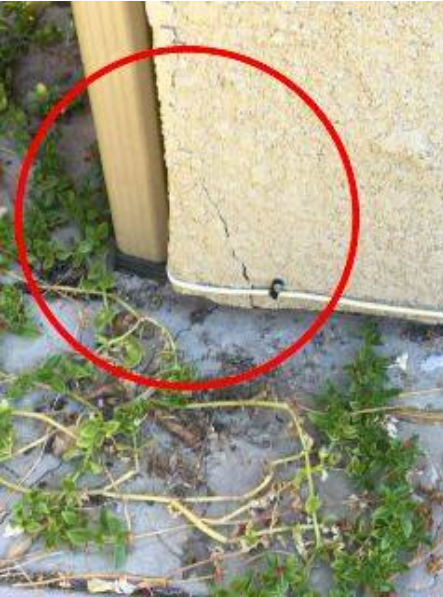
3) Repair/Maintain - One or more holes or gaps were found in siding or trim. Vermin, insects or water may enter the structure. Recommend that a qualified person repair as necessary.

Photo 3-1
Stucco Crack 2

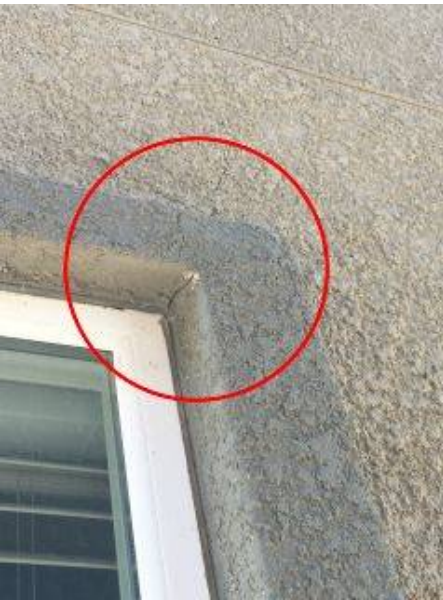
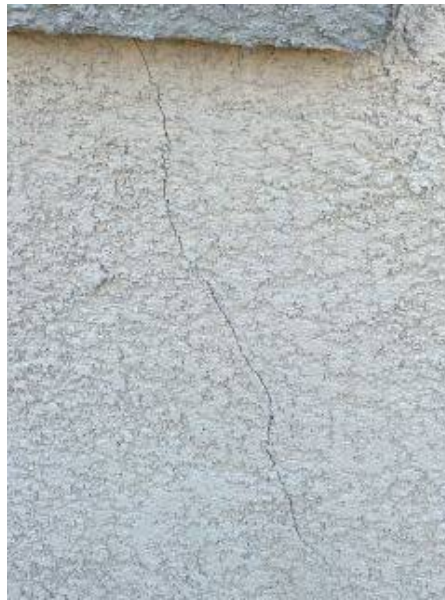
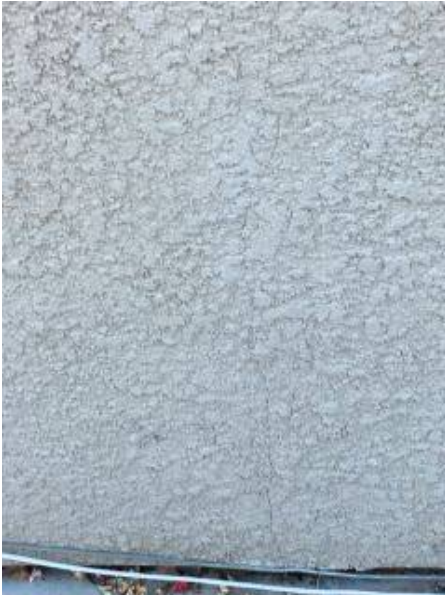
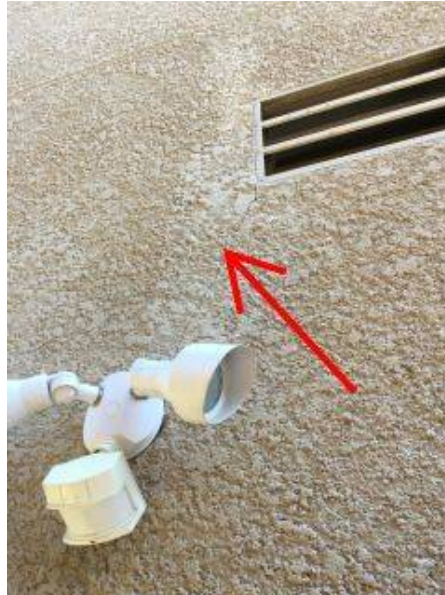
4) Repair/Maintain - Cracks, deterioration and/or damage were found in one or more areas of the exterior stucco finish. In damp climates, moisture may enter cracks or damaged areas and further deteriorate the stucco. Also the wall behind the stucco may become damaged from moisture. Note that areas behind the stucco are inaccessible and excluded from this inspection. Recommend that a qualified contractor repair or replace stucco as necessary.

Photo 4-1
Stucco Crack

Photo 4-2
Stucco Crack 3

Photo 4-3
Stucco Crack 4

Photo 4-4
Stucco Crack 5

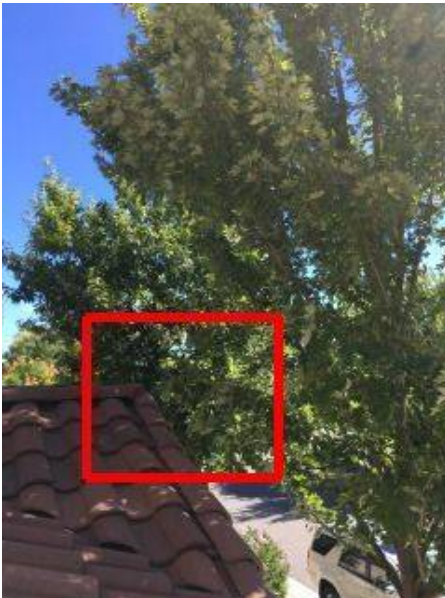
5) Maintain - Trees were in contact with or were close to the building at one or more locations. Damage to the building may occur, especially during high winds, or may have already occurred (see other comments in this report). Recommend that a qualified tree service contractor or certified arborist remove trees as necessary to prevent damage to the building exterior.

Photo 5-1
Tree Trimming

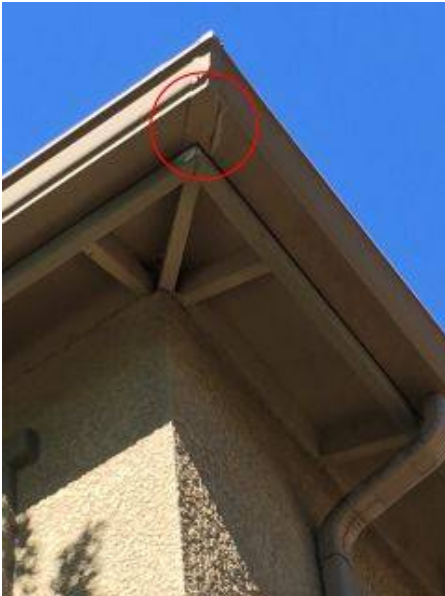
Photo 6-1

6) Monitor - Stains were found on one or more gutters that indicate past leaks have occurred. However, the inspector was unable to verify that the gutters do or don't leak because of lack of recent rainfall. Monitor the gutters in the future while it's raining to determine if gutters leak. If they do, then recommend that a qualified person repair as necessary to prevent water from coming in contact with the building or accumulating around the building foundation.

Gutter Discoloration

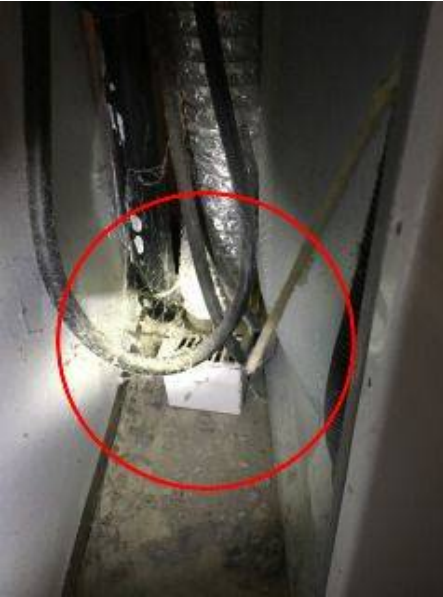
11) Safety, Comment - Hookups for a clothes washer and/or dryer were installed in the garage. The client should be aware that any source of spark or flame, including motors and circuitry in laundry equipment, are a potential source for spark (or flame with a gas-fired clothes dryer). Such equipment should be elevated at least 18 inches off the floor because vapors from gasoline or other flammable fluids that are heavier than air may be present. Dryer duct vents into garage. Suggest qualified contractor evaluate and correct as necessary.

Photo 11-1
Garage Dryer Vent Duct

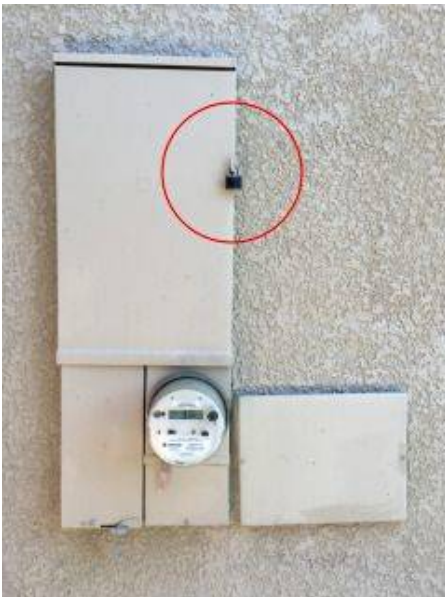
14) Evaluate, Comment - The inspector was unable to open and evaluate panel #A because panel was locked. This panel is excluded from this inspection. Recommend that lock be removed so panel can be opened and fully evaluation.

Photo 14-1
Main Electrical Locked

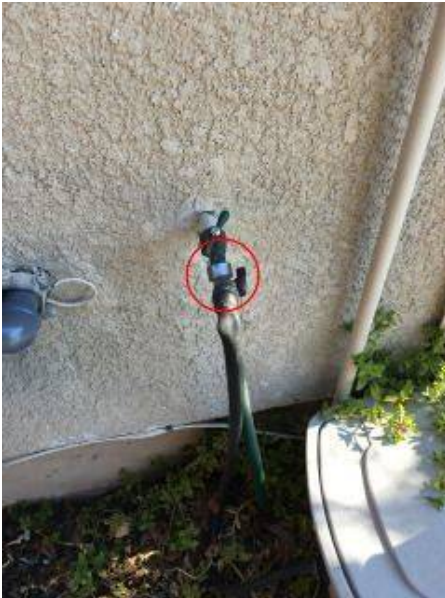
Photo 15-1

15) Safety, Minor Defect - One or more hose bibs were missing backflow prevention devices. These devices reduce the likelihood of gray water entering the potable water supply. Recommend installing backflow prevention devices on all hose bibs where missing. They are available at most home improvement stores and are easily installed.

No Anti-Siphon

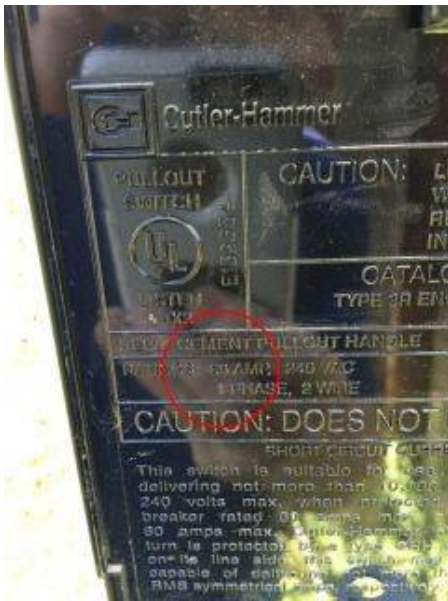
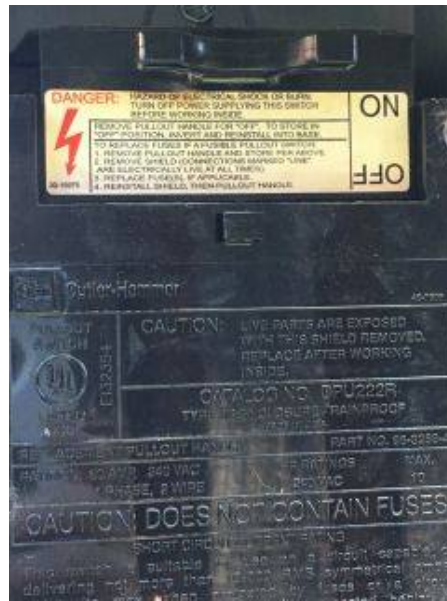
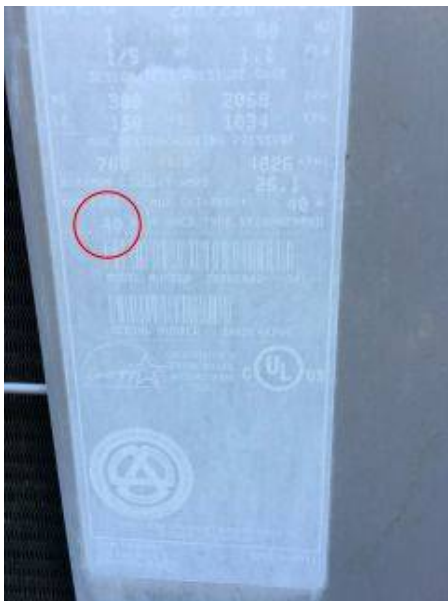
19) Evaluate - AC unit is rated for 40 AMP max fuse and disconnect is 60 AMP. Since main electrical panel was locked and inaccessible, unable to further diagnose wiring. Suggest a licensed electrician evaluate this and main panel wiring and repair as necessary.

Photo 19-1
AC Disconnect 60 Amp Rating

Photo 19-3
Difficult to see, but says 40 AMP Max fuse

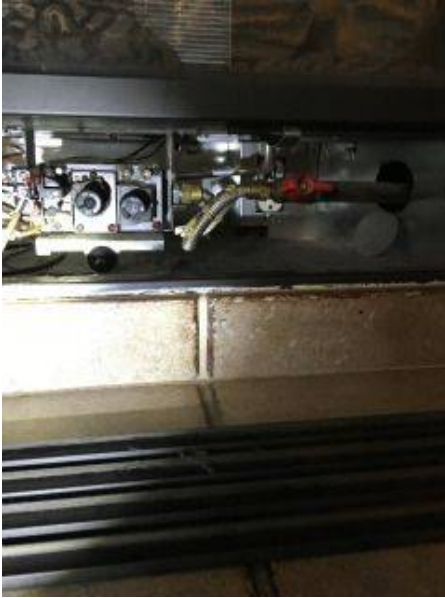
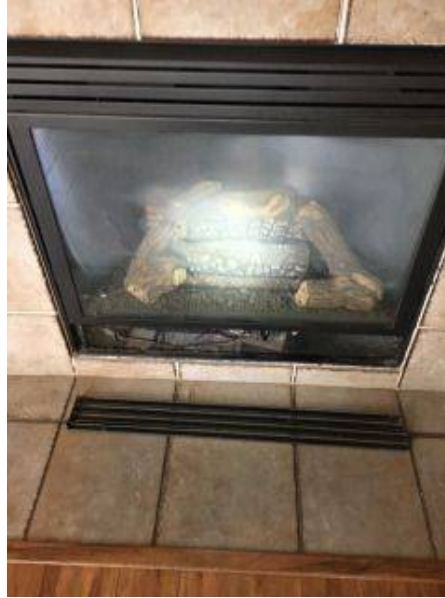
21) Evaluate - The gas fireplace was not fully evaluated because the pilot light was off. The inspector only operates normal controls (e.g. on/off switch or thermostat) and does not light pilot lights or operate gas shut-off valves. Recommend that the client review all documentation for such gas appliances and familiarize themselves with the lighting procedure. If necessary, a qualified specialist should assist in lighting such appliances, and make any needed repairs.

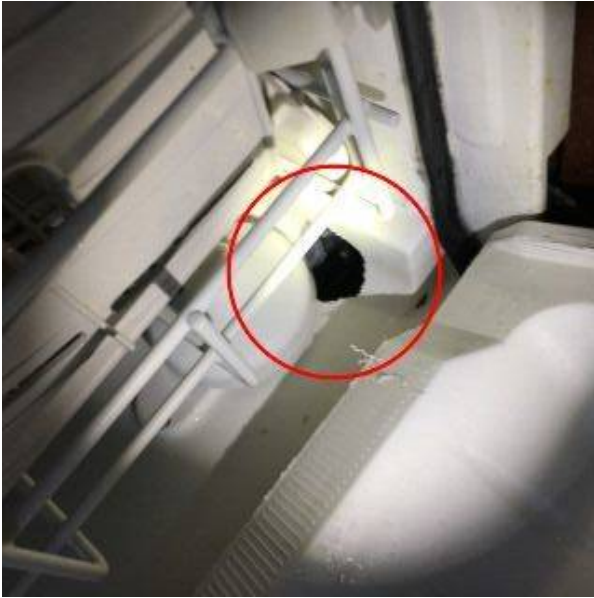
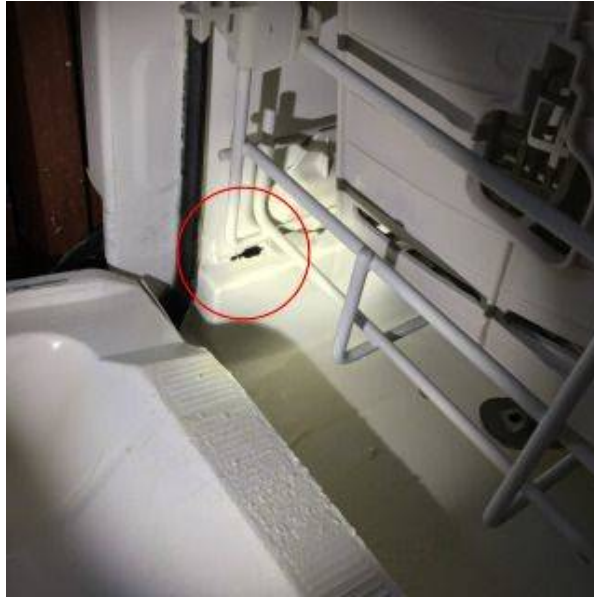
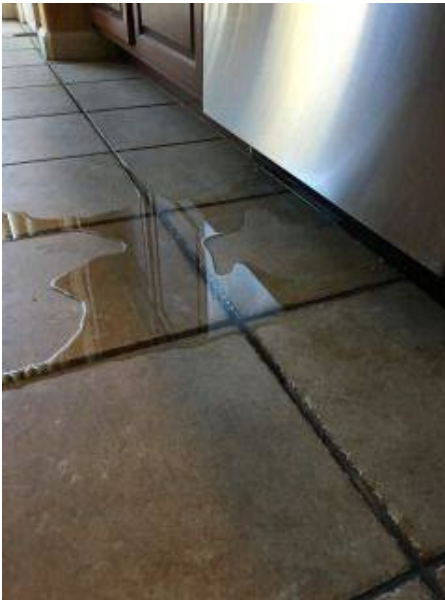
22) Repair/Replace, Evaluate - The dishwasher was leaking. Recommend that a qualified specialist evaluate and repair or replace as necessary.

Photo 22-1
Dishwasher Hole 1

Photo 22-2
Dishwasher Hole 2

Photo 22-3
Dishwasher Leak

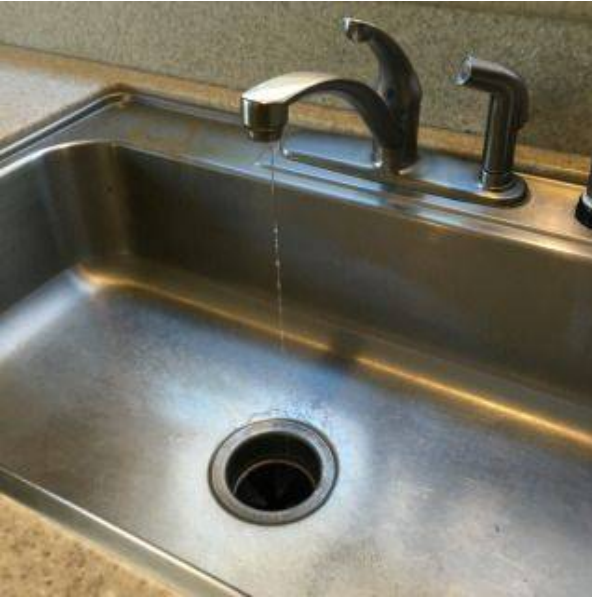
23) Repair/Maintain - The sink faucet was dripping in the "off" condition. Recommend that a qualified person repair as necessary.

Photo 23-1
Dripping Kitchen Sink

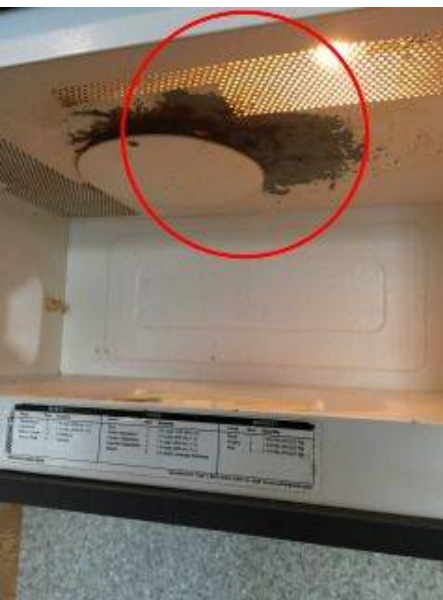
28) Comment - The microwave oven didn't have a built-in turntable. Rust near light. At or near service life.

Photo 28-1
Microwave

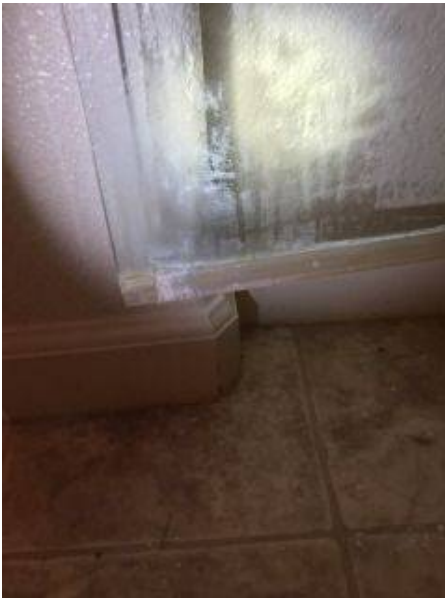
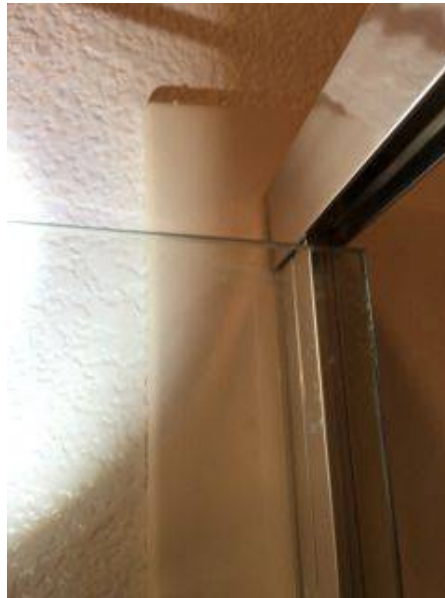
29) Safety, Repair/Replace, Evaluate - The inspector was unable to verify that the glass used in one or more enclosure walls by the shower at location #A was approved safety glass. Glazing that is not approved safety glass located in areas subject to human impact is a potential safety hazard. Standard building practices require that approved safety glass be used in enclosures for bathtubs, showers, spas, saunas and steam rooms, and in windows where the bottom edge of the window is less than 60 inches above the drain inlet or standing surface. Wire-reinforced glass is not acceptable. Recommend that a qualified contractor evaluate further to determine if glazing is approved safety glass, and replace glass if necessary, and per standard building practices.

No Evidence of Tempered Glass

No Tempered Glass Picture 2

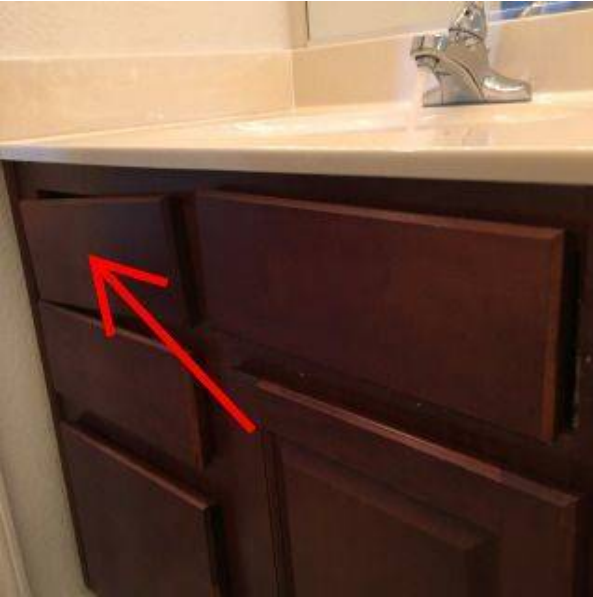
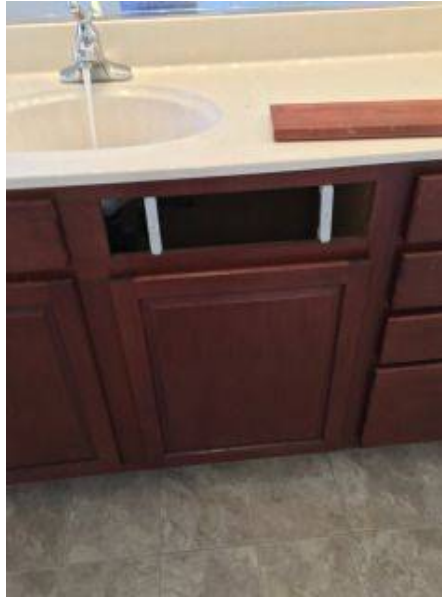
30) Repair/Replace - One or more cabinets, drawers and/or cabinet doors at location(s) #A and B were damaged, deteriorated or missing. Recommend that a qualified person repair or replace as necessary.

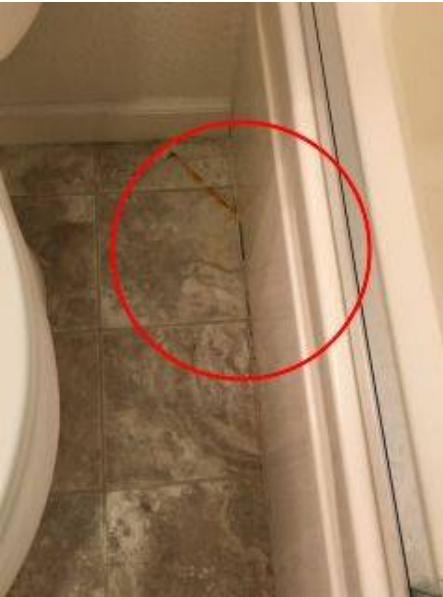
32) Repair/Maintain - Gaps, no caulk, or substandard caulking were found between the bathtub and the floor at location #B. Water may penetrate these areas and cause damage. Recommend that a qualified person re-caulk or install caulking as necessary.

Photo 32-1
Caulk Repair

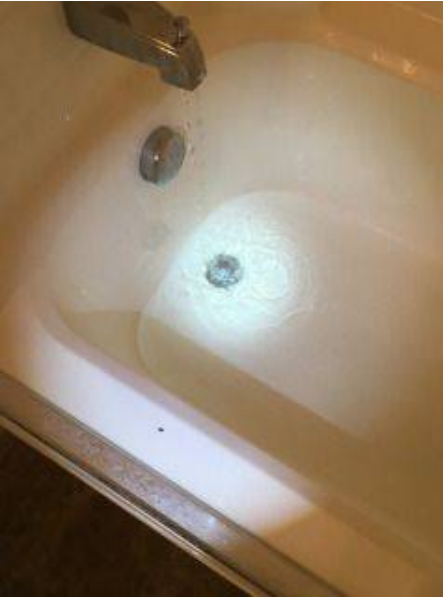
33) Repair/Maintain - The shower at location #C drained slowly. Recommend clearing drain and/or that a qualified plumber repair if necessary.

Photo 33-1
Slow Drain

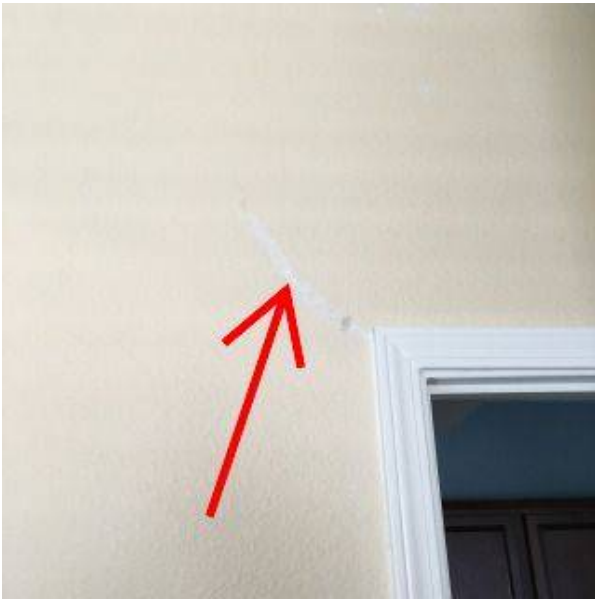
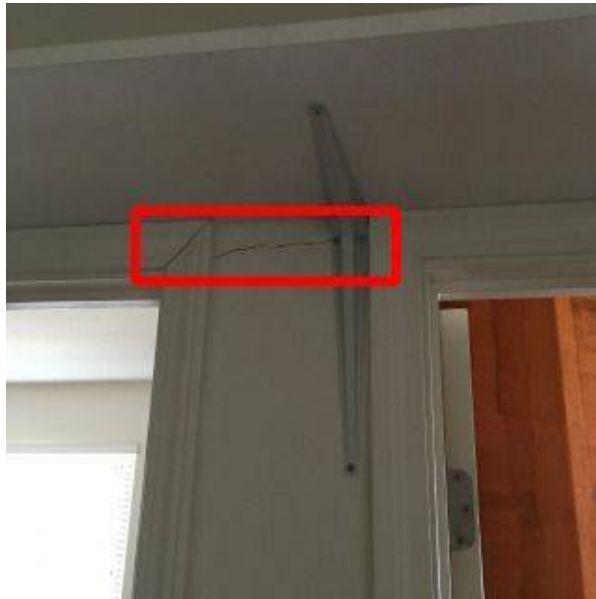
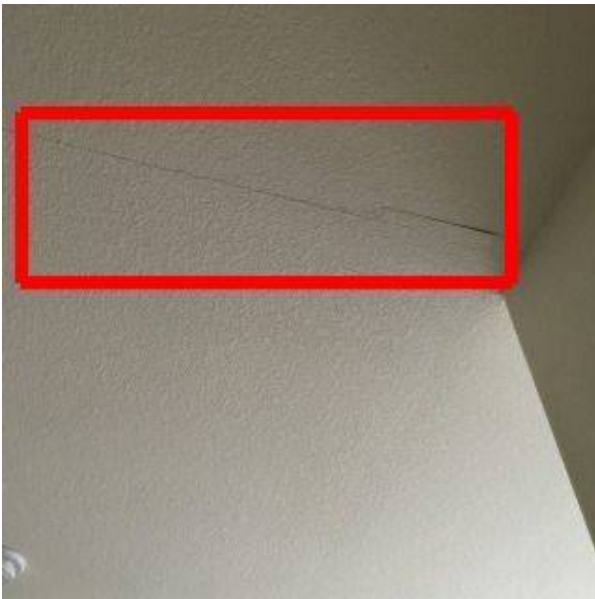
34) Repair/Replace, Evaluate - This structure appears to have settled, or was leaning significantly based on the presence of cracks in walls, ceilings or junctions between them, or numerous door frames not being square, or numerous doors binding in jambs. Recommend that a qualified contractor and/or engineer evaluate further. Significant repairs may be needed. If so, a qualified contractor should make repairs.

Photo 34-1
Drywall Crack 1

Photo 34-2
Drywall Crack 3

Photo 34-3
Ceiling Drywall Crack 2

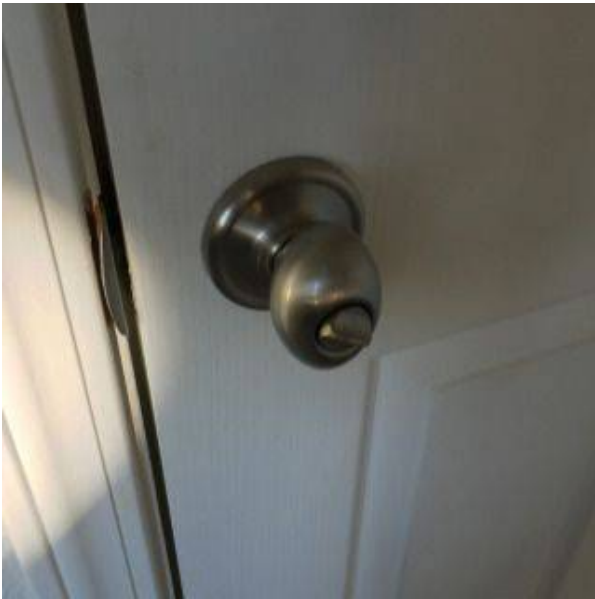
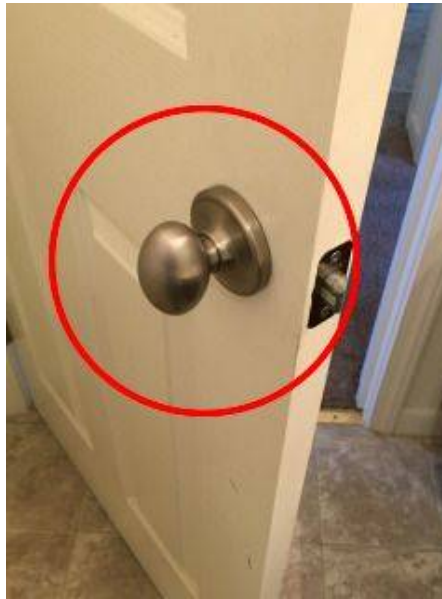
35) Repair/Replace - Some interior door hardware (locksets) were inoperable. Recommend that a qualified person repair or replace as necessary.

Master bathroom was not working. Bathroom #B (upstairs) does not have a lock as required per current building standards.

Photo 35-1
Faulty Bathroom Door Lock

Photo 35-2
No Bathroom Door Lock

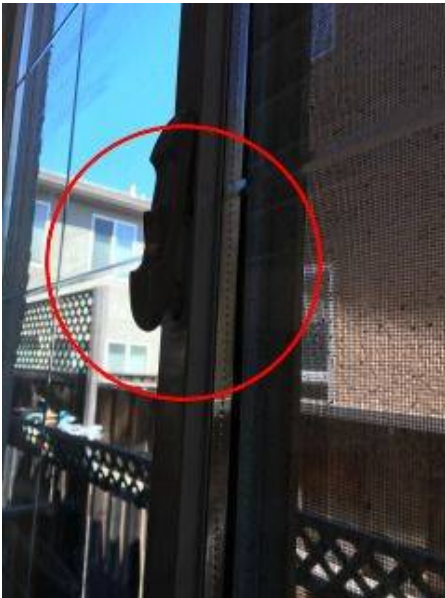
37) Repair/Maintain - Lock mechanisms on one or more windows were inoperable. This can pose a security risk. Recommend that a qualified person repair as necessary.

Above kitchen sink.

Photo 37-1
Kitchen Window Lock Faluty

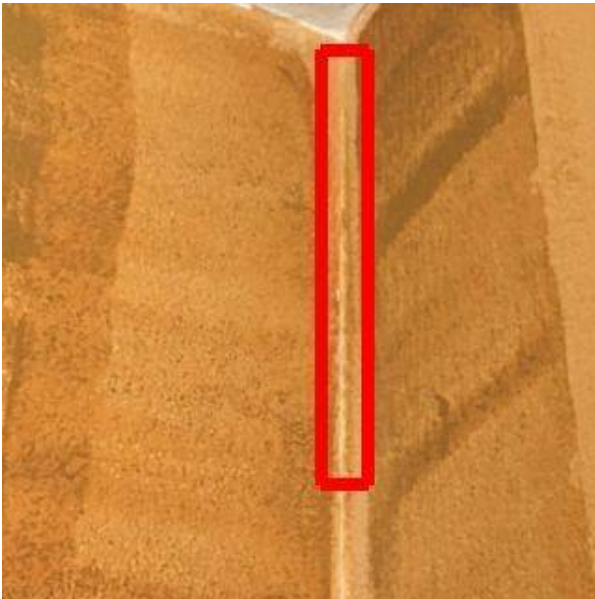
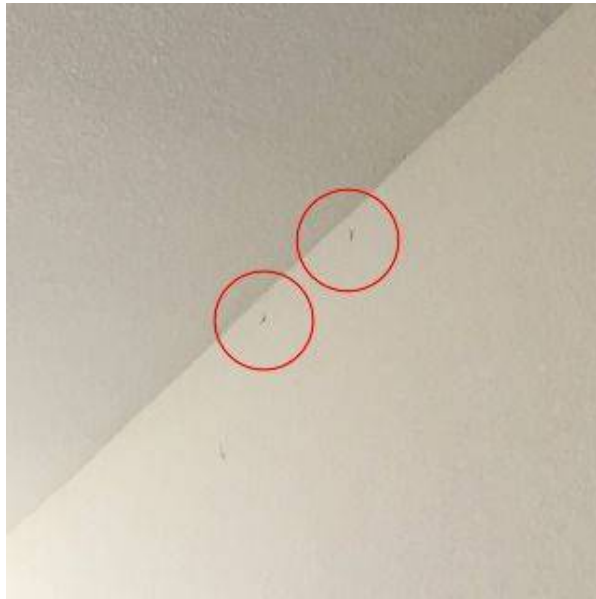
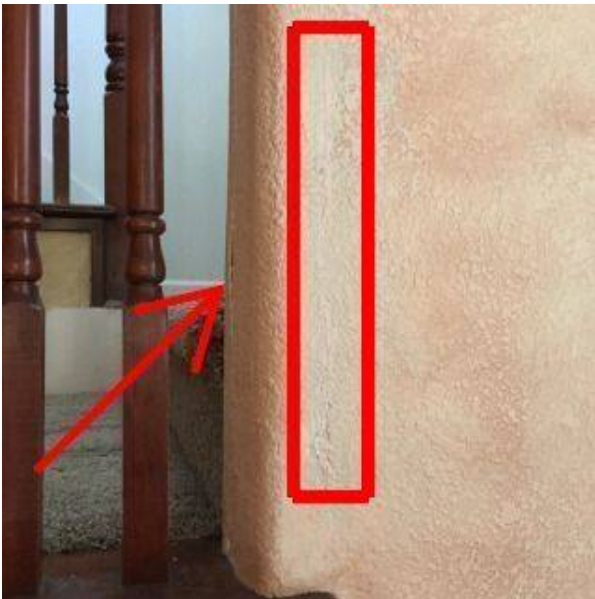
38) Minor Defect - Minor cracks, nail pops and/or blemishes were found in walls and/or ceilings in one or more areas. Cracks and nail pops are common, are often caused by lumber shrinkage or minor settlement, and can be more or less noticeable depending on changes in humidity. They did not appear to be a structural concern, but the client may wish to repair these for aesthetic reasons.

Photo 38-1
Drywall Crack 4

Photo 38-2
Drywall Nail Pops

Photo 38-3
Drywall Crack Stairwell
