Integrity Home Inspection

Inspection Report

ABC Street

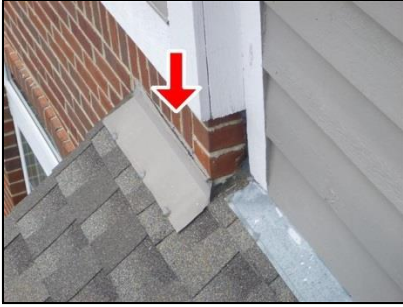
1.1 Item 1(Picture)

**1.1** The metal flashing at the front of home (below right bedroom window) has pulled away from brick veneer. Recommend securing and caulking against brick veneer.

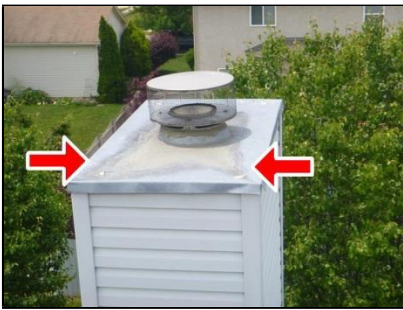
1.2 Item 1(Picture)

**1.2** The metal cap on top of the chimney is inverted. This area may result in rain water pooling. Deterioration and staining of siding may occur over time. Recommend repair as needed.

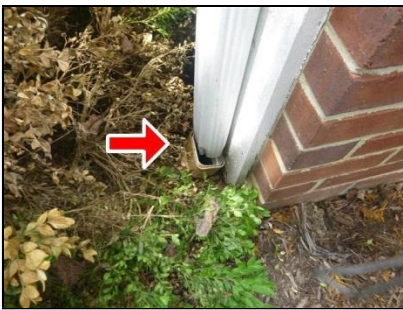
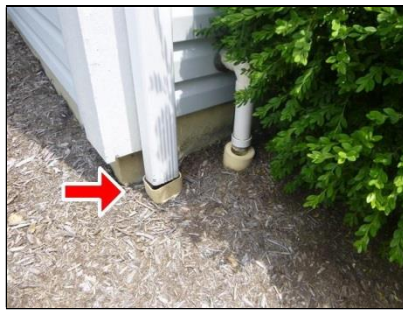
**1.3 (1)** Due to lack of rain I am unable to determine if underground drain lines will function properly.

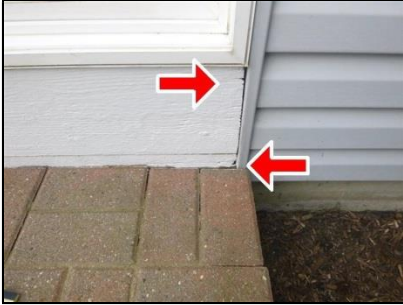
2.0 Item 1(Picture)

**2.0** (1) The trim board beneath the rear exterior sliding door is starting to deteriorate/softening and needs caulking on the right side. Replacement not needed at this time

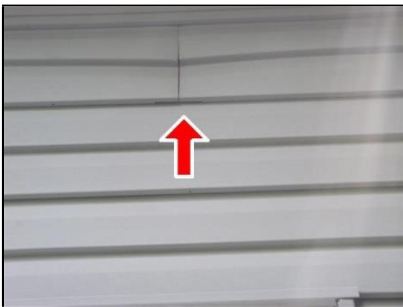
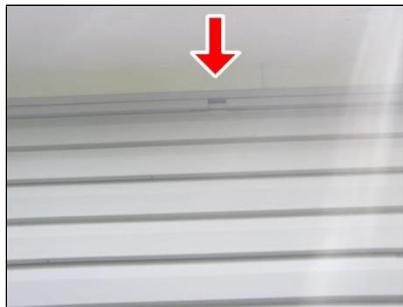
**2.0** (2) There are 2 small gaps in siding at the rear of home. Often the siding can be slid down to close gaps. This is a small repair.

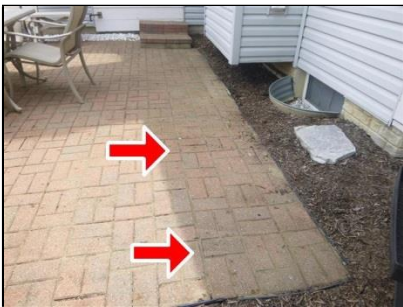
2.3 Item 1(Picture)

**2.3** Paver patio has settled toward home. This is typical with age and as settlement occurs. This area may pool water. Recommend leveling as needed.

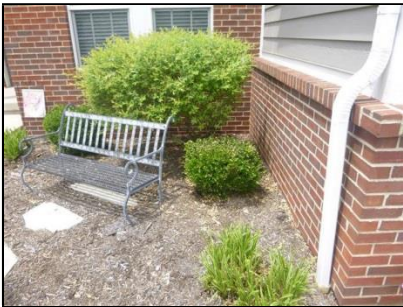
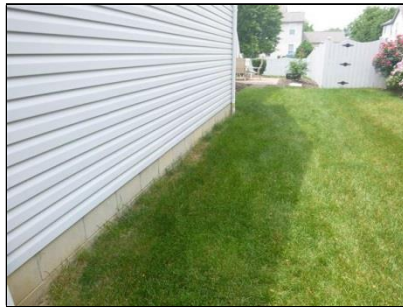
**2.4 (2)** Some of the shrubbery is in contact with the exterior of the house. This is not recommended as it traps moisture around the exterior of the house and attracts wood destroying insects. A six to eight inch clearance is recommended. Recommend improvement as needed.

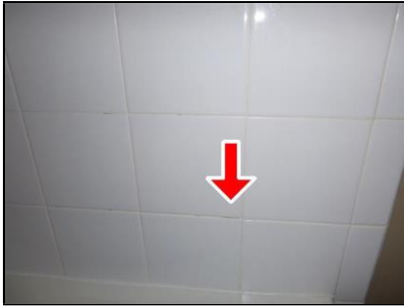
4.5 Item 1(Picture)

**4.5 (1)** The caulking at the master bath sink backsplash is failing in areas. A proper seal is recommended to minimize water intrusion behind sink. Recommend repair as needed.

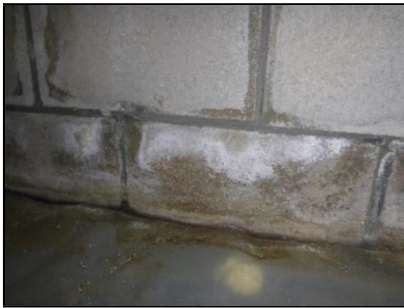
5.0 Item 1(Picture)

🏠 5.0 White efflorescence (powder substance) and discolored (damp) block on wall indicates moisture is in contact with the masonry. This does not necessarily indicate that intrusion will occur. I recommend checking the gutters and the downspout drain lines for proper operation. Also, a water proofing paint, proper ventilation and moisture barrier (floor) could be applied to the interior side of the block if necessary. Efflorescence/dampness is found on many homes without water intrusion occurring inside the home. But, it should alert you to the possibility that future steps may be needed.

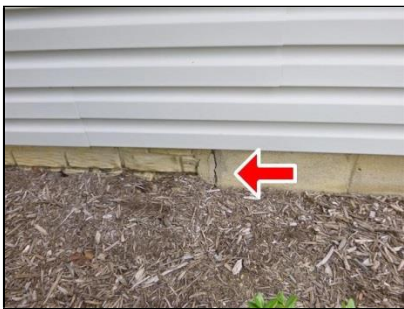
5.1 Item 1(Picture)

🏠 5.1 (2) Small crack in the foundation on the exterior should be sealed at the rear of the house.

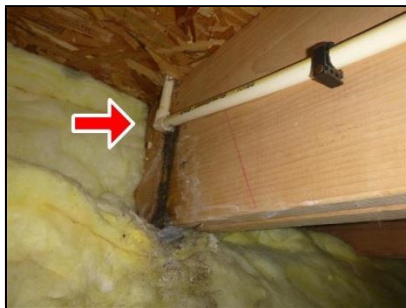
6.1 Item 1(Picture)

**6.1 (1)** The water supply line in the crawlspace below master bath appears to have leaked and resealed itself at the elbow connection. Some staining has occurred on the joist. Recommend monitor and repair as needed.

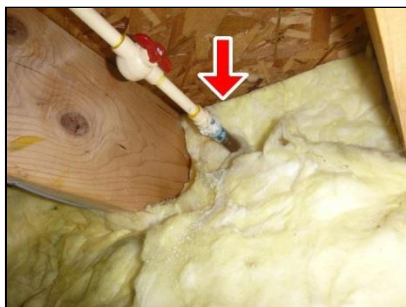
6.1 Item 2(Picture)

**6.1 (2)** The water supply line in the crawlspace for exterior water spigot appears to have leaked and resealed itself at the cvpc/copper connection. Recommend monitor and repair as needed.

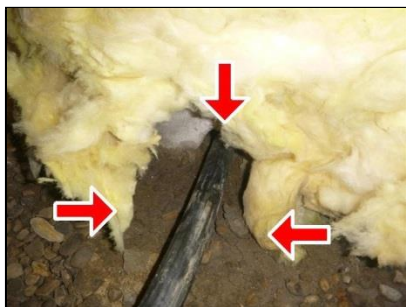
6.1 Item 3(Picture)

**6.1 (3)** Dampness found at point where main water line enters foundation. This may be due to cut out block and water seeping in from lack of proper grade at front of home. This is not a significant issue at this time. Recommend monitoring this area and repair if needed.

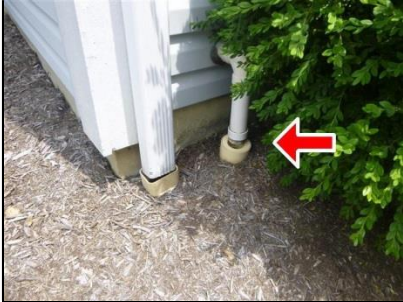
6.6 Item 1(Picture)

6.6 The exterior sump pump waste line has pulled away from ground drain line. This is a small repair. A qualified person should remedy as needed.

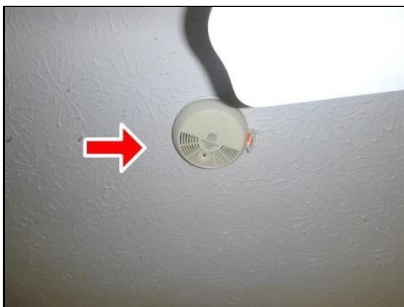
7.9 Item 1(Picture)

**7.9** The carbon monoxide detector is missing battery at common hallway to bedrooms.

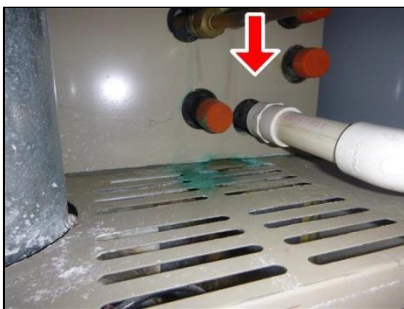
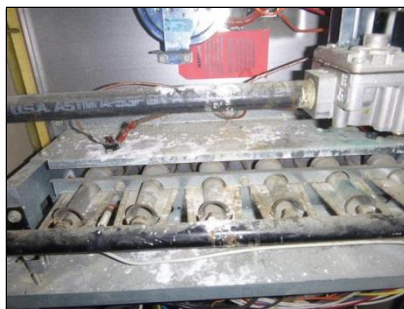
**8.0 (2)** The furnace is dirty and does not appear to have been serviced lately. It is recommended to have the unit serviced and cleaned, and thereafter on an annual basis as a preventive maintenance procedure.

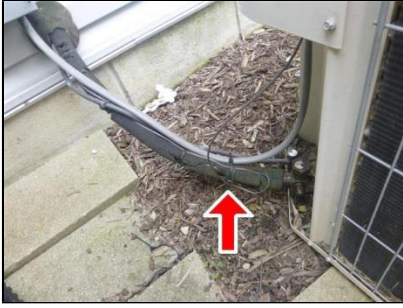
8.8 Item 1(Picture)

The foam sleeve on condenser line is missing in area(s) at outside unit. Missing foam on condenser line can cause energy loss and condensation. I recommend service or repair as needed.
