VISTA DEL PARQUE

Level 2 Reserve Study Update (With Site-Visit)

Prepared For Fiscal Year 2015

November 24, 2014

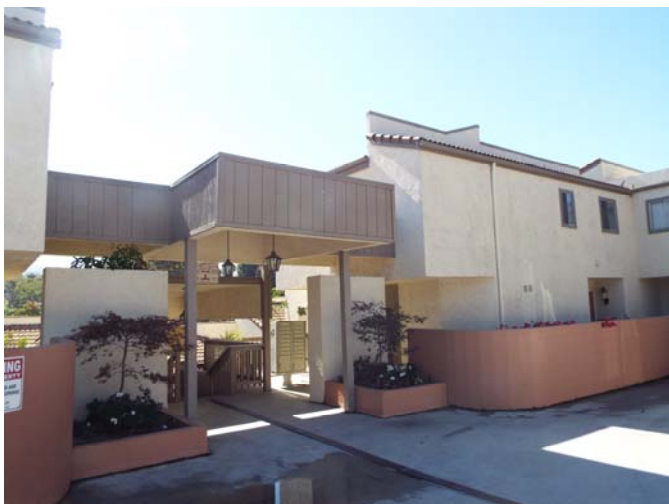
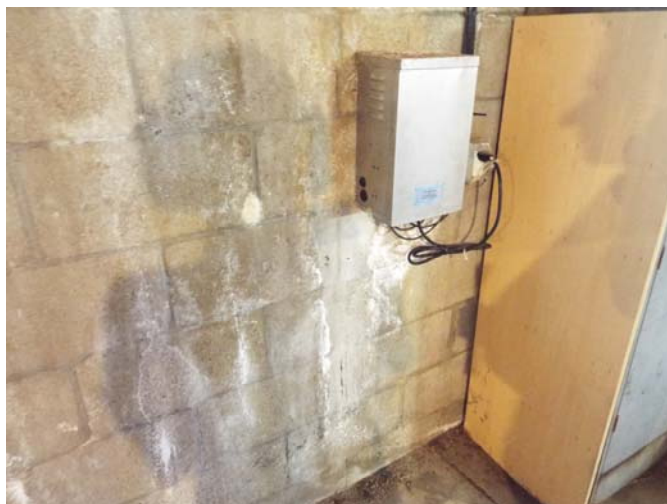
Efflorescence observed at block wall.

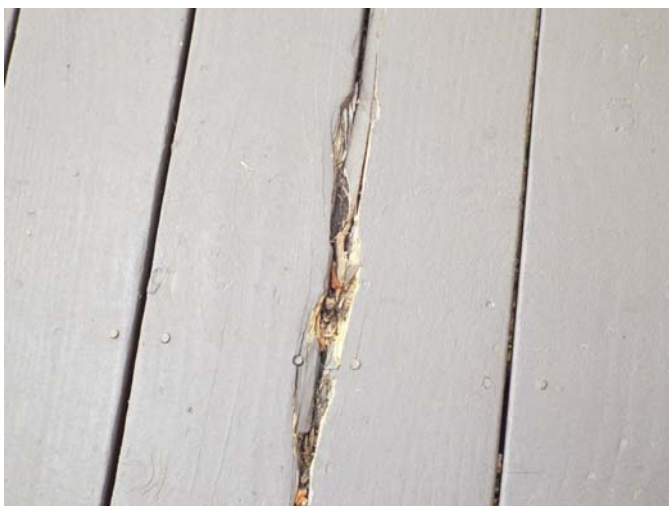
Isolated area of deteriorated wood.

Wood- Deteriorated or damaged wood must be removed/replaced & then primed prior to high quality coating application to afford protection from the elements.
