Advanced Home Inspections

Page 1 of 4
Well Info

Property Address 1000 E. 1st St.
City Midwest City State Okla. Zip -----

Well Information

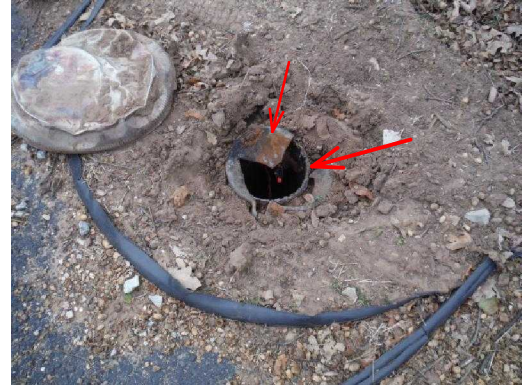
- 1. Location: Rear driveway
- 2. Type: Drilled well (steel casing)
- 3. Well head: Visible **Surface piping too short. Cap not water tight and may be prone to contamination or flooding.**

| | <u>Low</u> | <u>High</u> |
|---|---|---|
| Well head: The surface pipe of the well has been cut off below ground level which will allow surface water and contaminates to enter the well. The pipe needs to be extended up to approximately 8" above the ground and have a new cap installed to prevent contaminates from being able to enter the well. | \$ 150 | \$ 200 |

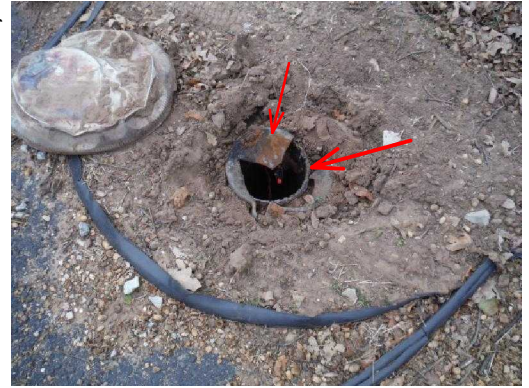
1. Well head: Visible Surface piping too short. Cap not water tight and may be prone to contamination or flooding.
