Confidential Inspection Report

LOCATED AT: 123 Creia Street
Rancho Santa Margarita, CA 92688

INSPECTED ON: Tuesday, May 22, 2018

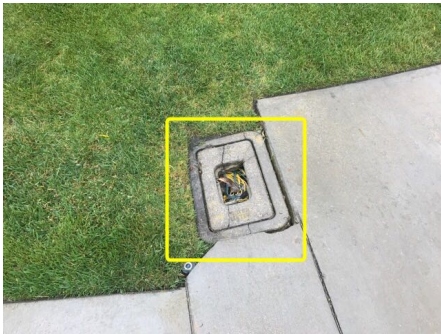
**32:** - Trip hazard on walkway. The cover is broken on the utility box. Recommend repair or replacement by a the utility company.

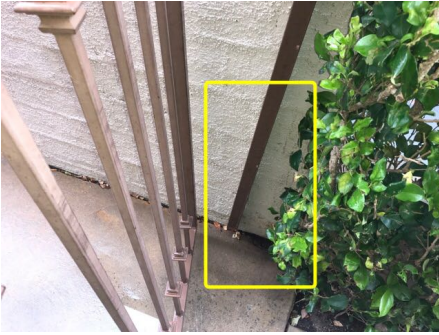
35: - Damaged gate observed. Recommend repair or replacement for enhanced security of your property, by a general contractor.

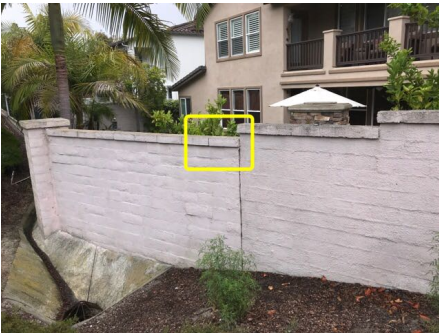
36: - Loose top blocks observed. Blocks could fall off and injure someone. This is a safety concern. Recommend repair or replacement by a general contractor.

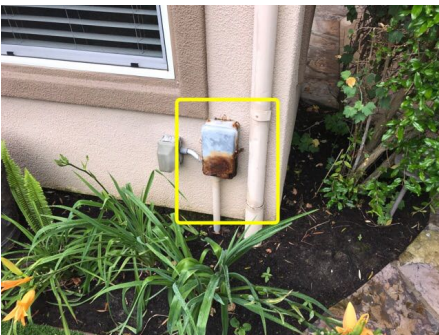
39: - Rusty timer box. Further deterioration could cause an electrical failure and create a shock hazard. Recommend repair or replacement by an electrical contractor.

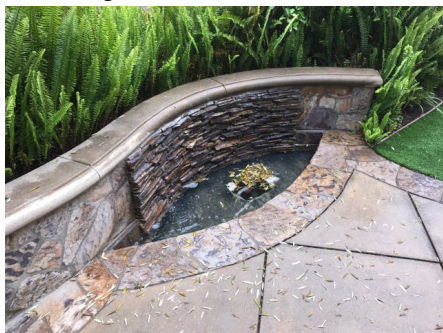
44: - Water feature present, beyond the scope of this inspection. Recommend you seek advice of a specialist in evaluating this system before use and I also recommend that you have the seller provide the instructions for programming or show you how to operate. I also recommend filling the basin with river rocks to prevent a drowning hazard.

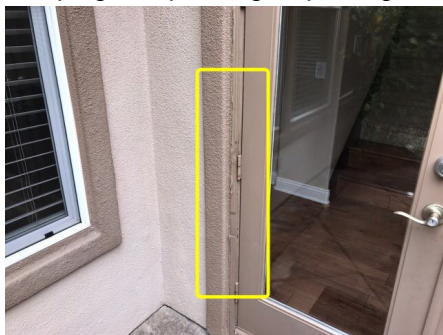
47: - Peeling paint on the trim observed. A fresh coat of paint will prolong the life of the trim. Suggest scraping and painting all peeling areas.

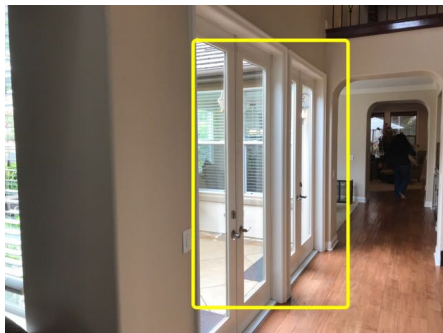
50: - Door is difficult to operate, this presents a safety hazard in the event of an emergency/fire. Recommend repair/adjusting of door to allow easy and smooth operation, by a general contractor.

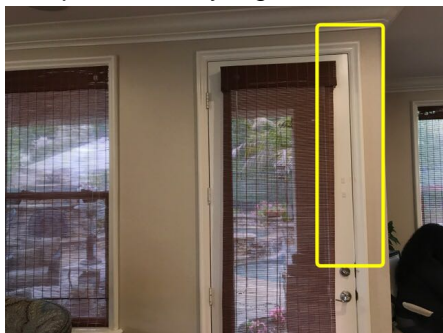
52: - Door is difficult to open and close; door sticks. Mechanism may not be installed true. Recommend repair or replacement by a general contractor.

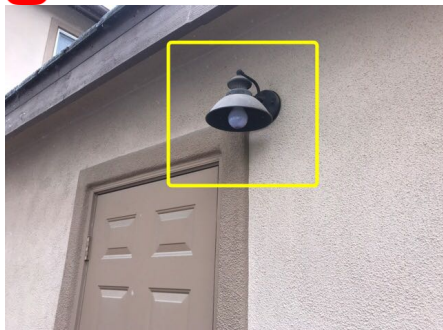
57: - Light globe missing. This is a safety hazard. Needs replacement.

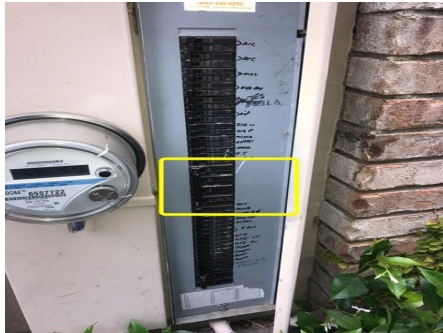
63: - Main disconnect is at the main electric panel. This switch will turn off all power to the house.

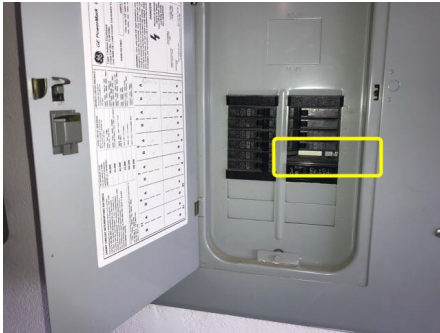
72: - Panel cover screws missing. Panel cover should be secured to the panel. This is a shock hazard. These screws should be approved, flat tipped screws. Screws can be purchased at any home improvement store.

73: - Open breaker panel slot at the panel box cover. This is a shock hazard. Recommend you have all breaker slots covered correctly by a licensed electrician.

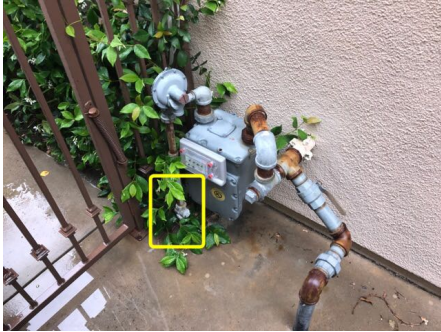
86: - Main gas shut-off valve is located at the gas meter. Visible portions of the gas pipes, at the meter, appear to be in acceptable condition and the gas piping, where visible, is steel.

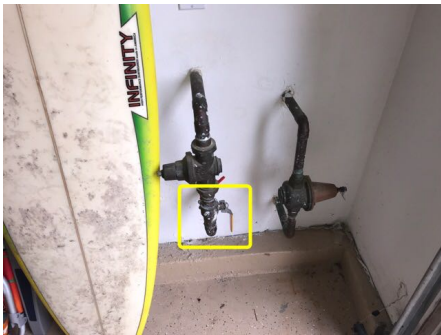
87: - House water shut-off valve is located in the garage.

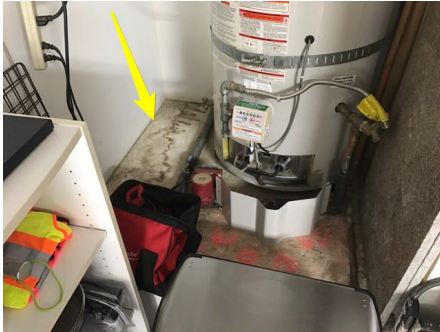
98: - Water heater base shows signs of water damage. Tested dry. Unable to tell if there is additional hidden damage under the base. Recommend repair or replacement by a plumbing contractor.

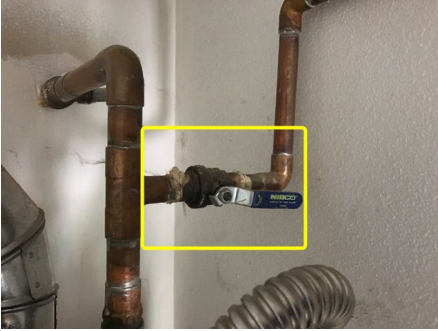
109: - Water shut-off valve connection above the tank is corroded. This is a moisture intrusion hazard. Recommend repair or replacement by a plumbing contractor.

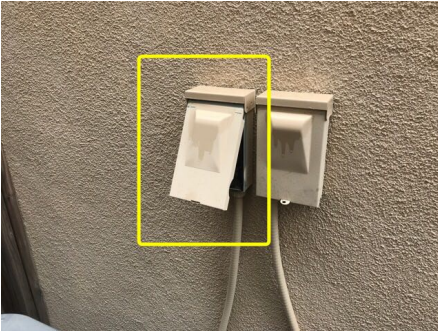
175: - Disconnect box damaged. This is a shock hazard. Recommend repair or replacement by an HVAC contractor immediately.

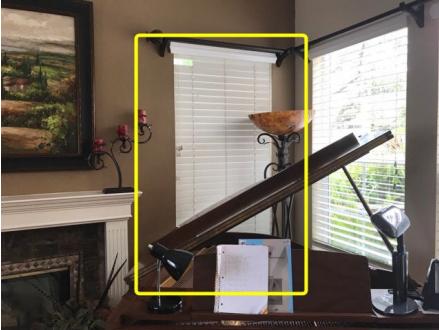
203: - Window was not inspected due to personal belongings in the way, limiting access to the window.

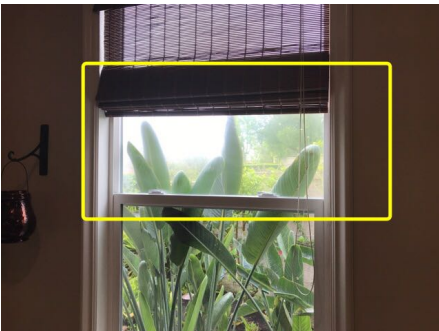
206: - Window shows sign of loss of seal/condensation. Recommend repair or replace by a window contractor to provide energy savings and prevent hazed window from limiting view out of window.

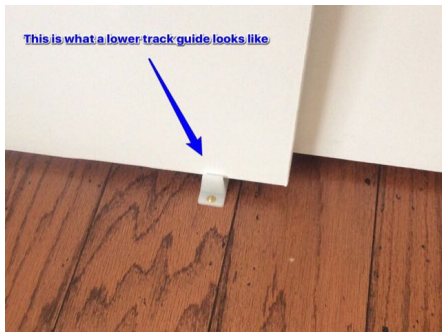
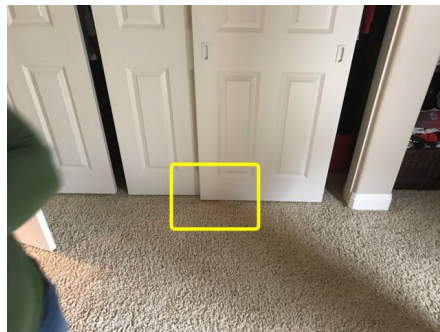
232: - Closet door is missing lower track guide. Children can get their hands stuck under this door. This is a safety hazard. Recommend installation of a lower track guide by a general contractor immediately.

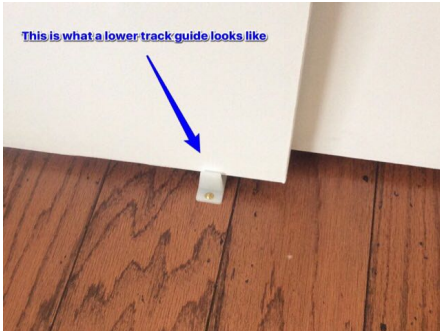
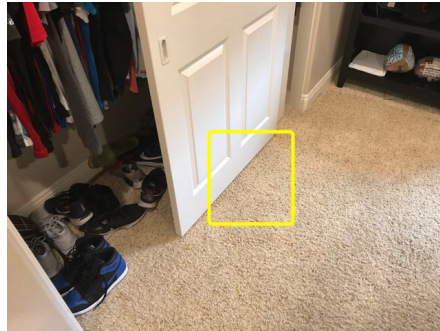
234: - Closet door is missing lower track guide. Children can get their hands stuck under this door. This is a safety hazard. Recommend installation of a lower track guide by a general contractor immediately.

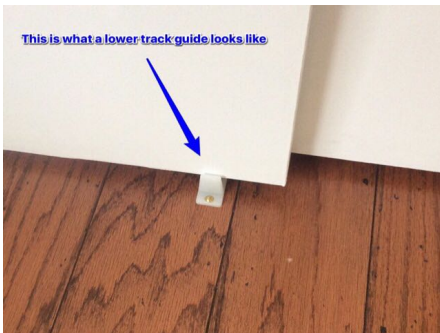
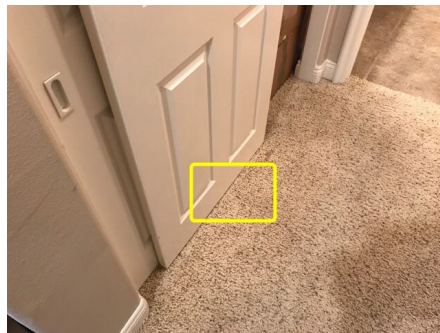
236: - Closet door is missing lower track guide. Children can get their hands stuck under this door. This is a safety hazard. Recommend installation of a lower track guide by a general contractor immediately.

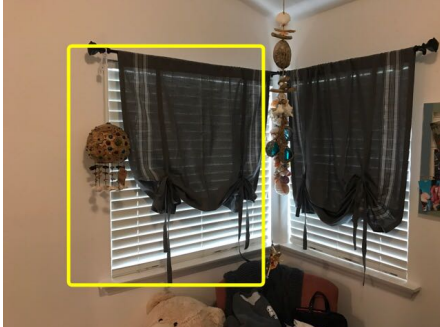
238: - Window shows sign of loss of seal/condensation. Recommend further evaluation, by a window contractor, of all windows and/or repair or replace the defective windows, to provide energy savings and prevent hazed window from limiting view out of window.

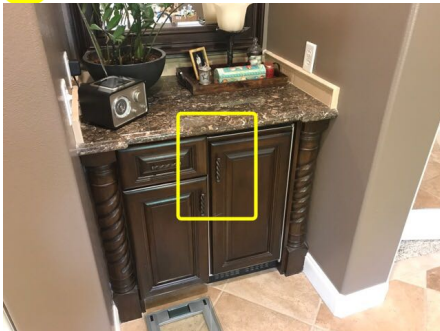
240: - Cabinet hits drawer. Recommend correction by a general contractor.

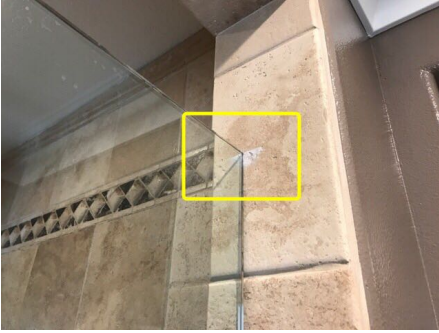
243: - Shower door does not close completely. Door hits the wall. This could break the glass. This is a safety hazard. Recommend adjusting the hardware immediately.

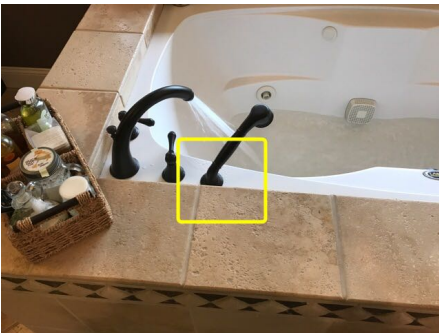
247: - Wand leaks under the tub while operating. This is a moisture intrusion hazard. Recommend contacting a plumber to repair.

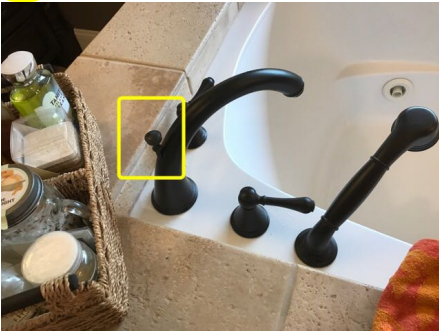
248: - Drain stop is dislodged from the drain. Recommend repair or replacement by a plumbing contractor.

249: - Tub/wand actuator difficult to operate. Recommend repair by a plumber.

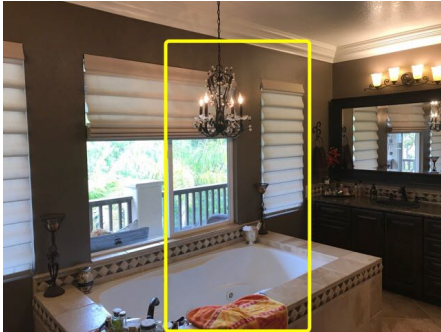
250: - Pendant lighting within 3' of the tub or shower and/or less than 8' above the tub. Do not grab this electrical device while standing in water. This is a shock hazard. Recommend moving or removing the pendant lighting by an electrical contractor immediately.

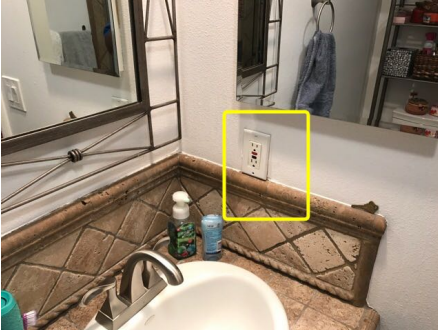
257: - Redundant GFCI. When the GFCI trips, another GFCI outlet in the house also trips and you must reset both GFCI's. The second reset is in the kitchen. Although there is nothing wrong with this, you now have to reset both GFCI's in order to restore the power at the first GFCI outlet. If you only want to have to reset one GFCI, have an electrical contractor remove the redundant GFCI.

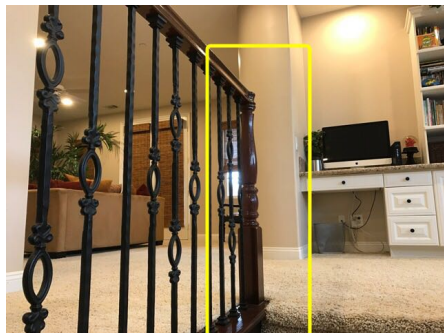
266: - Handrail loose. This is a safety hazard. Someone could fall down the stairs should this railing give away. Recommend correction by a general contractor.

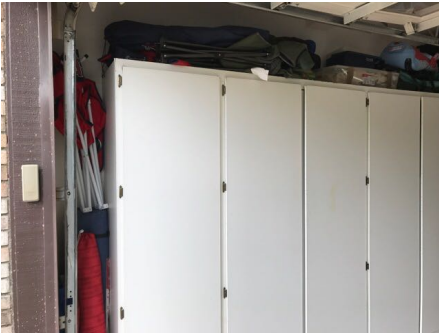
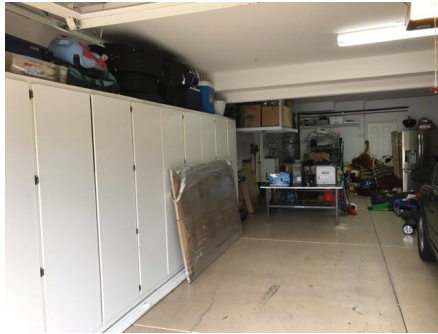
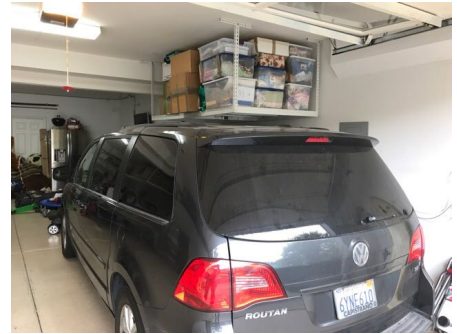
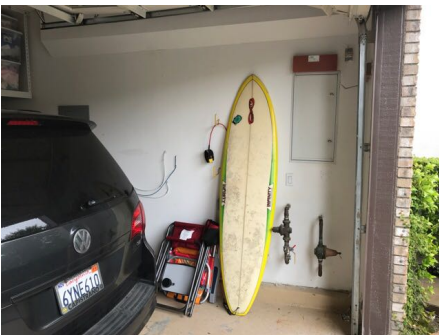
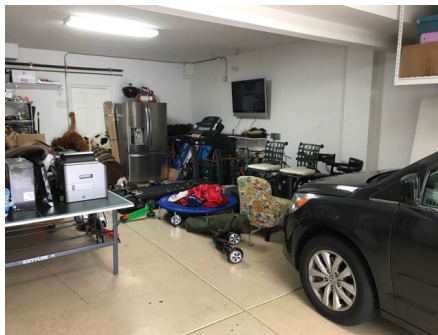
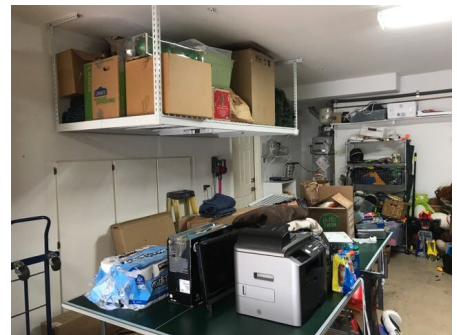
309: - Limited inspection, garage contained a large volume of personal items. I was unable to see many parts of the garage.

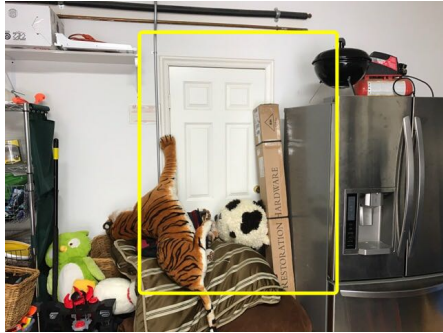
315: - Door was blocked by personal items. Door not inspected. Ask seller to demonstrate at final walk through.

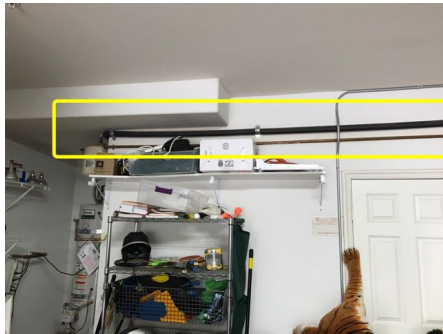
318: - An additional water line has been added to the home, in the garage. This is unusual. Recommend you check the disclosures and ask the seller why this was done.

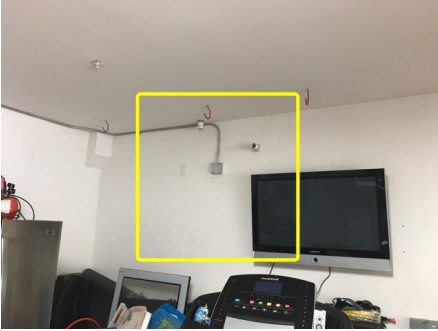
322: - Central vacuum lines noted; beyond the scope of this inspection. Suggest verification of performance prior to closing. (Canister missing)

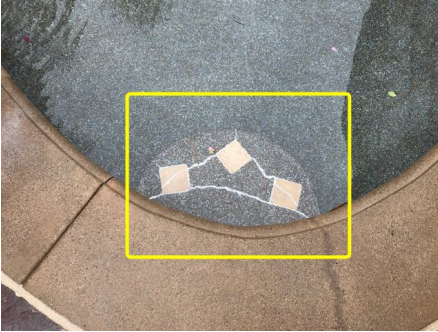
330: - I observed what appears to be cracking in the finish. I cannot see how deep this crack is or if this crack is leaking. Unable to tell if there is additional hidden damage under the finish. I recommend contacting a pool contractor for further evaluation and / or repairs.

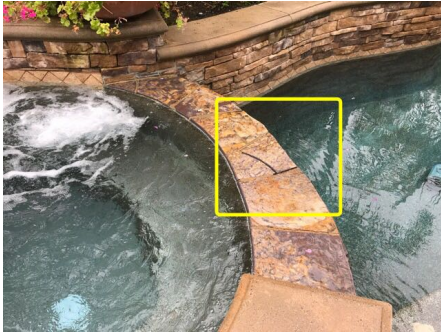
349: - Coping around the pool is cracked. Unable to tell if there is additional hidden damage behind the wall. This is a moisture intrusion hazard. Recommend repair or replacement by a pool and spa contractor.

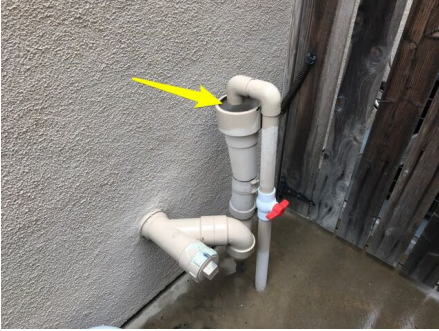
375: - No air gap present. This is a cross contamination hazard. Recommend installing an air gap prior to the P Trap where backwash connects to the city sewer, by a plumbing or pool and spa contractor.
