# Aerial Survey and Permit Review: Maietta Quarry and Gravel Pit

534 Pequawket Trail  
(Route 113)  
West Baldwin, ME 04091

TRC Environmental, Inc.

**FINAL – 2016/August/15**

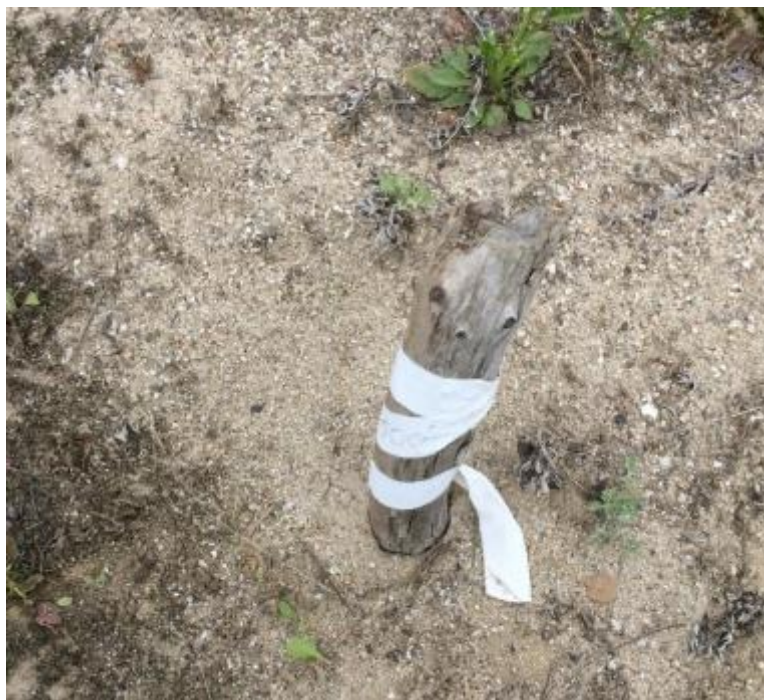
Condition 1 of the 1992 Agreement required that all setbacks should be established "on the face of the earth" and "shall remain clearly visible". During its site visit, TRC only observed a single wooden stake in the midst of Phase 2, marking a 500-foot setback from the Saco River, though its accuracy was not verified. No other evidence of boundary or setback marking was observed.

*Figure 1. Stake in pit (phase 3) marking presumed 500' buffer from Saco River (we believe this was installed by SRCC in the Spring of 2016).*

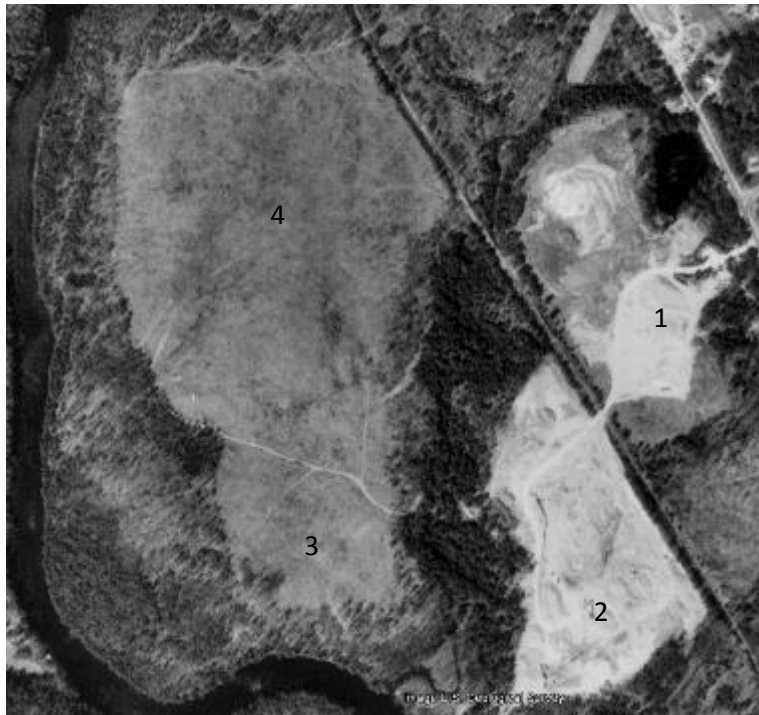
**Figure 2. April 1998 - Earliest photo found shows activity within Phases 1 and 2.  
No activity has occurred within Phases 3 or 4.**

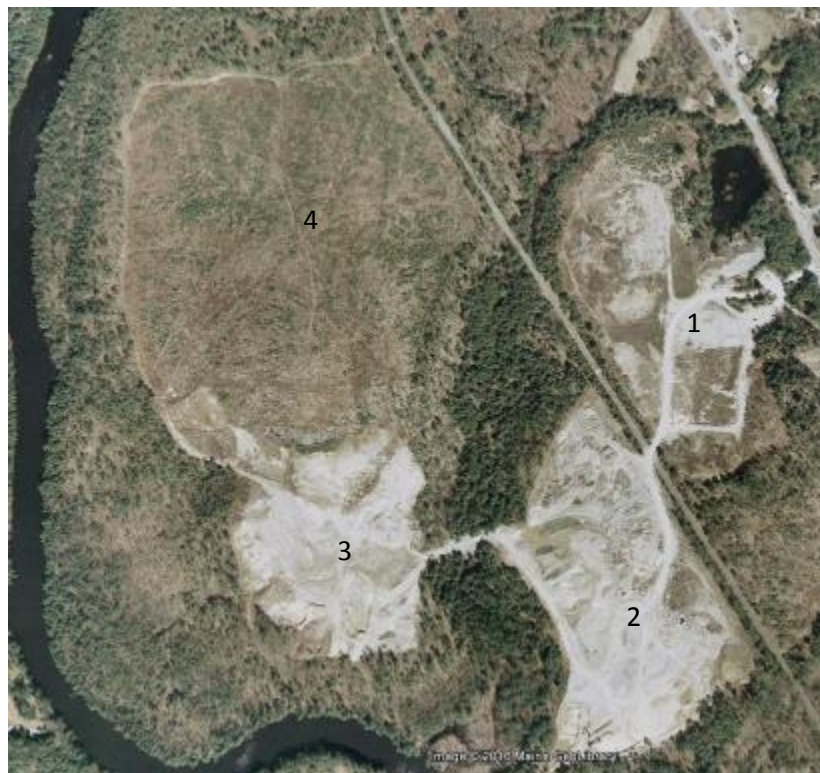
**Figure 3. December 2003 - Phase 3 work has commenced and Phase 1 shows signs of reclamation,  
including plantings along the northerly portion. No activity within Phase 4.**

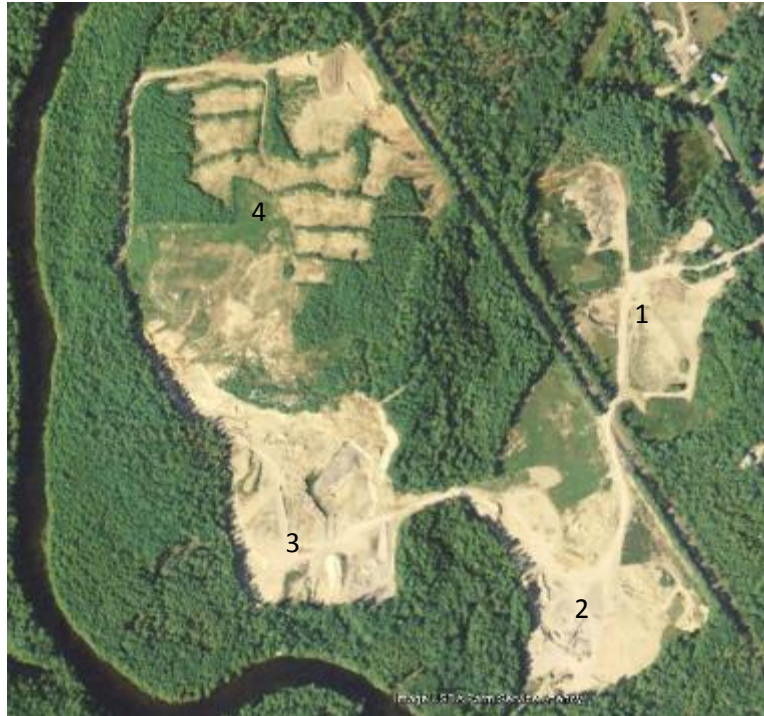
*Figure 4. October 2006 - Phase 4 has been substantially cleared and topographic relief indicates some removal and/or stockpiling of material at the northeasterly corner of Phase 4. Quarrying has commenced within Phase 3. A portion of Phase 2 has been reclaimed*

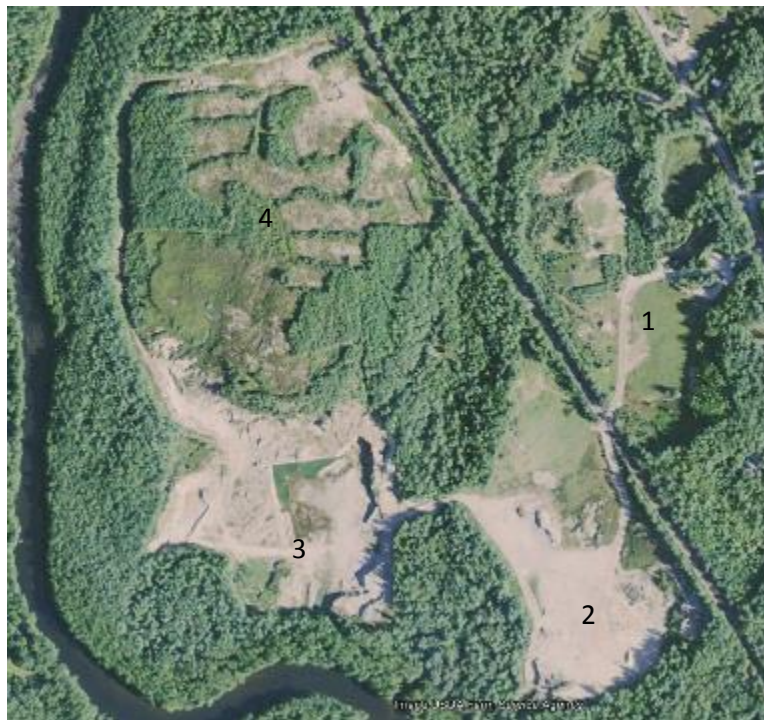
The disturbed area within Phase 3 appears to encroach significantly on the westerly 150-foot setback along land (N/F) owned by Central Maine Power Company, as shown on the plans (Appendix 1). The encroachment appears to extend further onto the abutter's property though it should be noted that no boundary survey was conducted by TRC and the boundary shown on the plans was taken from the 1989 permit drawings.

*Figure 5. November 2011 - The size of the quarry within Phase 3 has increased, as has the boundary of activity at the westerly side, adjacent to the land of Central Maine Power Co. The vegetation within the reclaimed area of Phase 1 has been revived or replaced. The beginnings of the ponded area within the quarry can be seen at this point.*

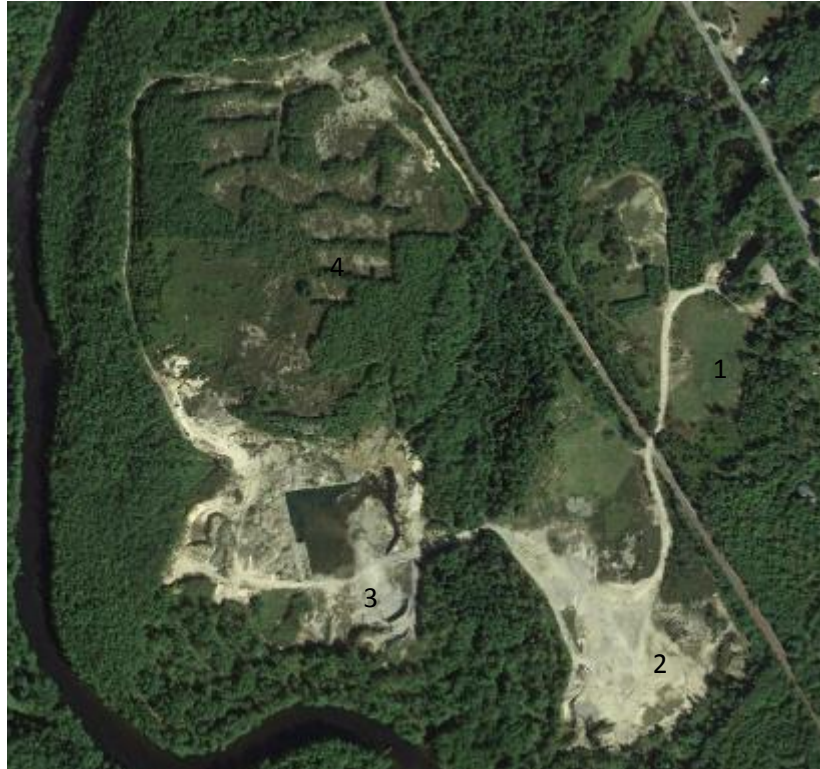
*Figure 6. September 2013 - Limited change from the 2011 photo with maturing vegetation in some previously disturbed areas of the site. The quarry pond is at its current size by 2013.*

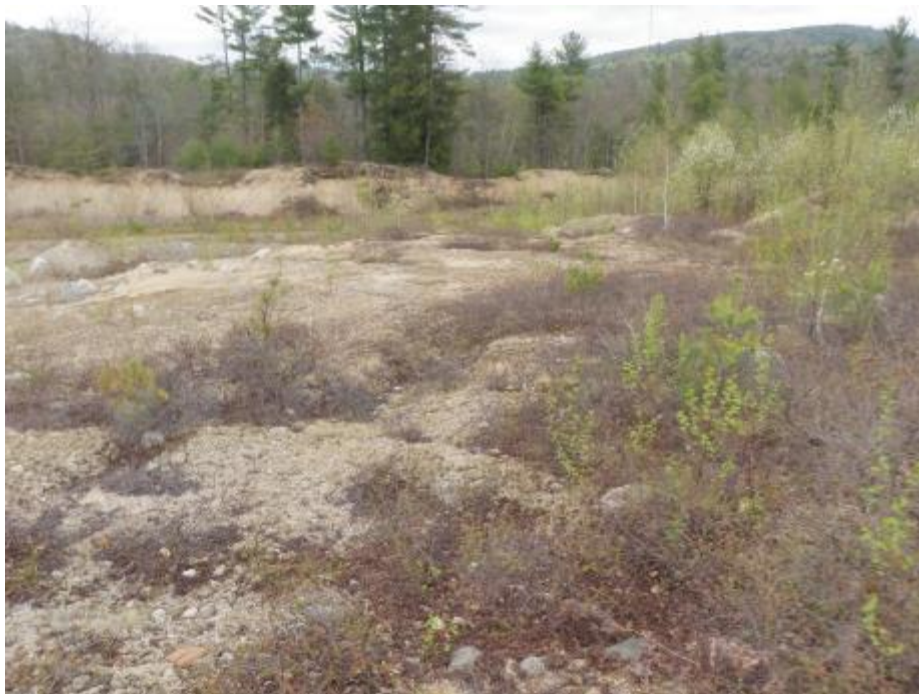
*Figure 7. Evidence of some disturbance in northeast corner of Phase 4.*

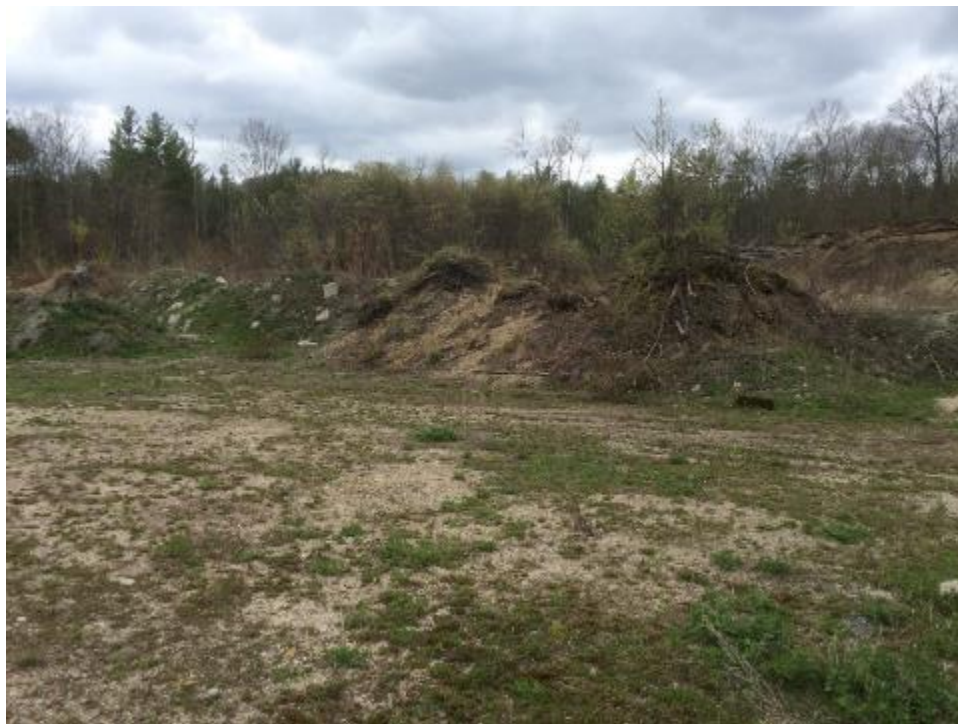
Permit condition 12 of the CUP states, “No materials of any kind shall be imported to the site for processing except for ledge spoil from the applicant’s own construction sites to be crushed.” While on site with members of the Board of Selectmen, TRC observed areas within Phase 3 where it appears that demolition debris was imported and dumped onsite. Debris was located within the excavated pit area, to the northeast of the quarry pond and within the fill and debris near the large slope cut and fill area on the western edge of Phase 3. This debris includes concrete, brick, portions of demolished tiled walls, and asphalt. TRC recommends that a more detailed assessment of the type and volume of the objectionable materials be made, and a discussion with the owner be conducted, in order to properly assess what, if any, materials were brought onto the site out of compliance with the CUP, and what level of effort would be required to bring the site into conformance with permit conditions.

*Figure 9. Piles of mixed demolition materials in Phase 3.*

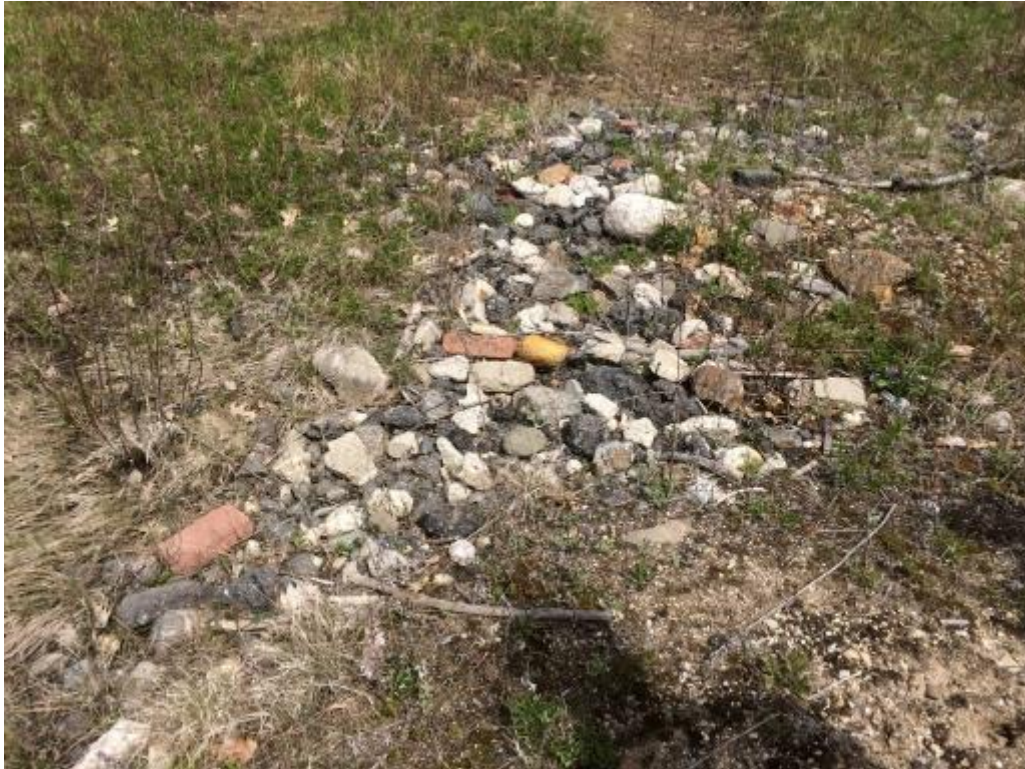
*Figure 10. Close-up of some demolition debris found onsite.*

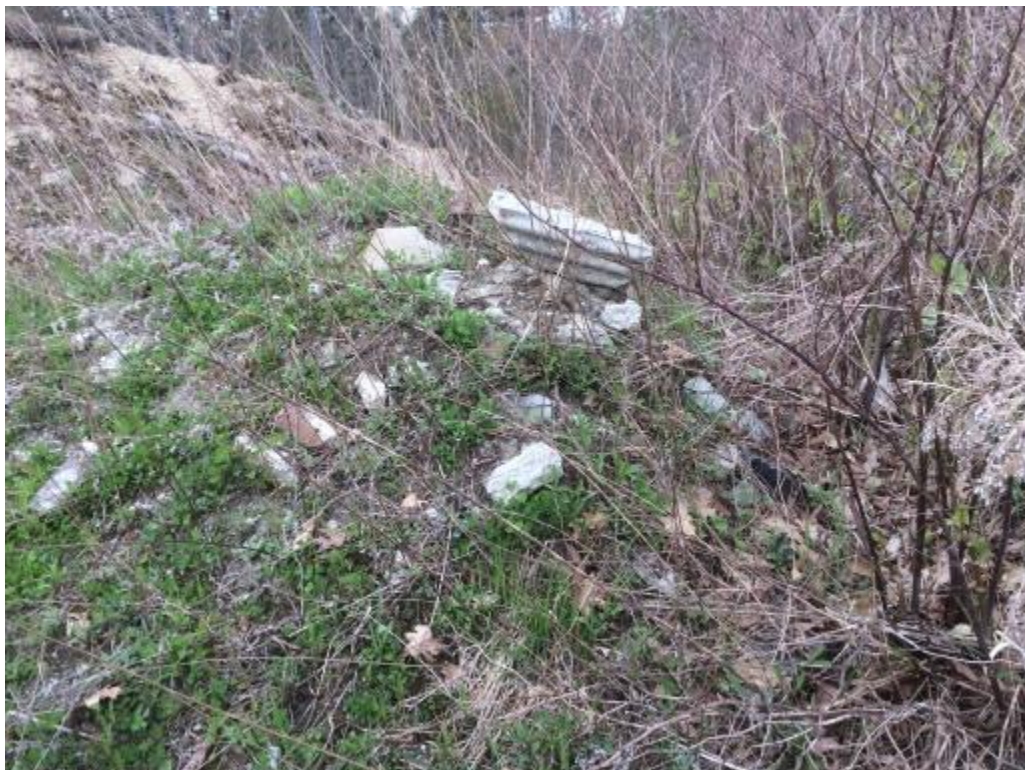
*Figure 11. Close-up of some demolition debris found onsite.*

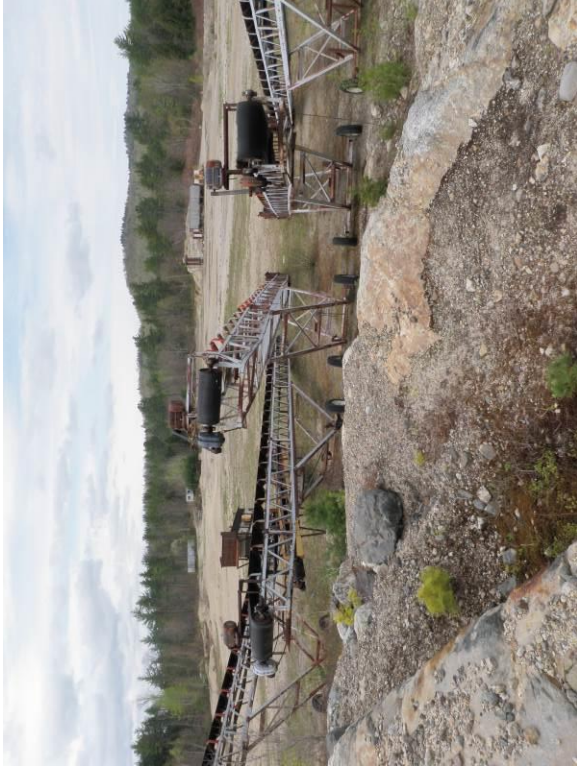
Out of service industrial equipment typical of gravel pit operations (conveyers, shakers, portions of a crusher plant, etc.) were observed in the southern cleared area of the Site. Equipment appears to have been idle for a number of years. Associated with this equipment, approximate six storage containers/trailers were observed containing various equipment and supplies (filters, spare parts, office supplies, etc.) to support former gravel pit operations. Disconnected hydraulic lines were observed on and around the equipment. Minor staining was noted on the ground surface in some locations.

1. Industrial equipment observed at the Maietta Pit.

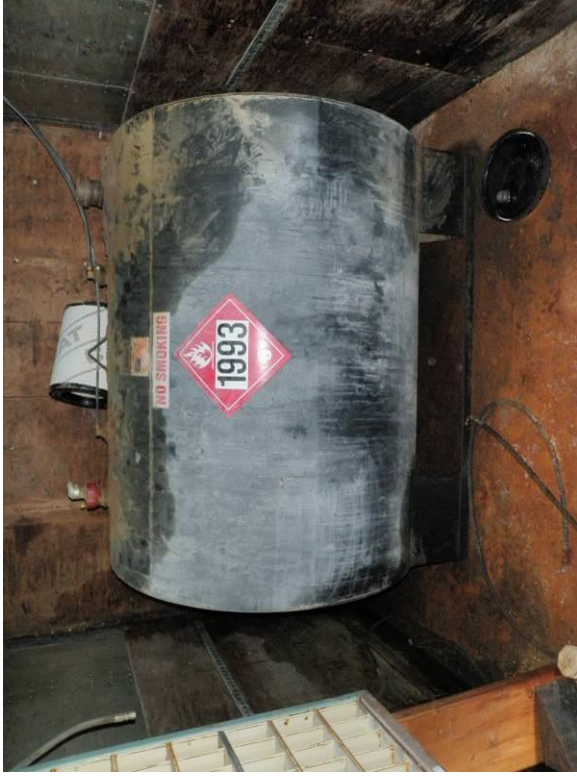
Two Aboveground Storage Tanks (ASTs) were observed in the southern cleared area of the Site. One 300-gal (approximate) diesel/fuel oil AST was located within a trailer. The fill gauge read approximately  $\frac{1}{4}$  full. Staining was observed within the trailer on the AST and on the floor and walls. The exterior of the trailer exhibited only minor staining. Staining was not observed on the ground surface below the trailer. The second fiberglass AST (unknown size) was observed on the ground surface and overgrown with vegetation. The former use of the AST is not known. Staining was not observed on the ground surface surrounding this AST.

2. One 300-gal (approximate) diesel/fuel oil AST – The fill gauge read approximately  $\frac{1}{4}$  full. Staining observed.

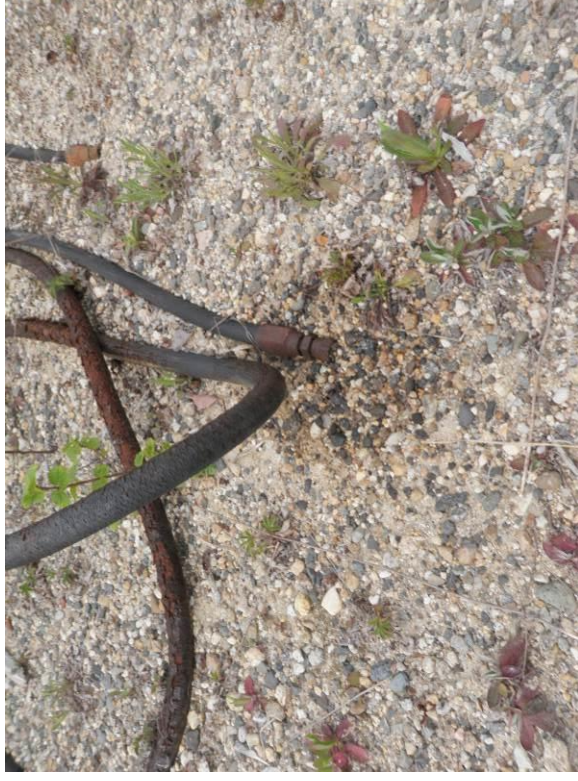
4. Hydraulic hoses with observed staining.

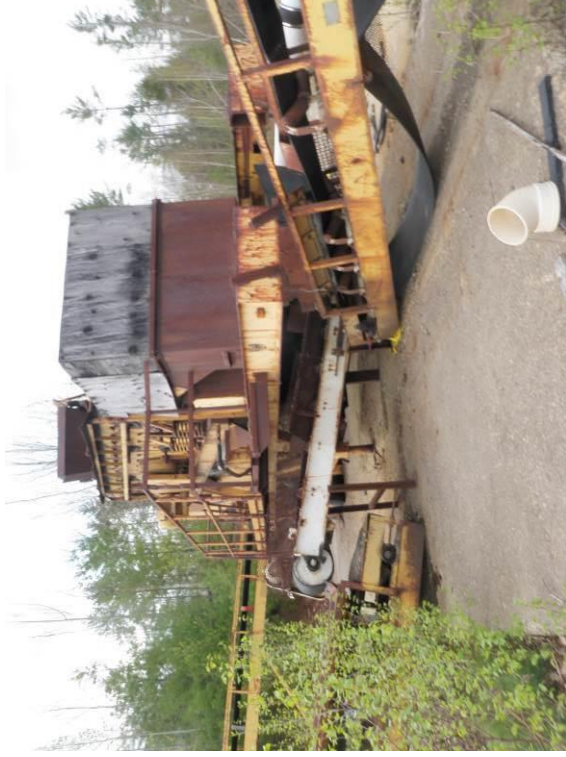
3. Industrial equipment observed at the Maietta Pit.

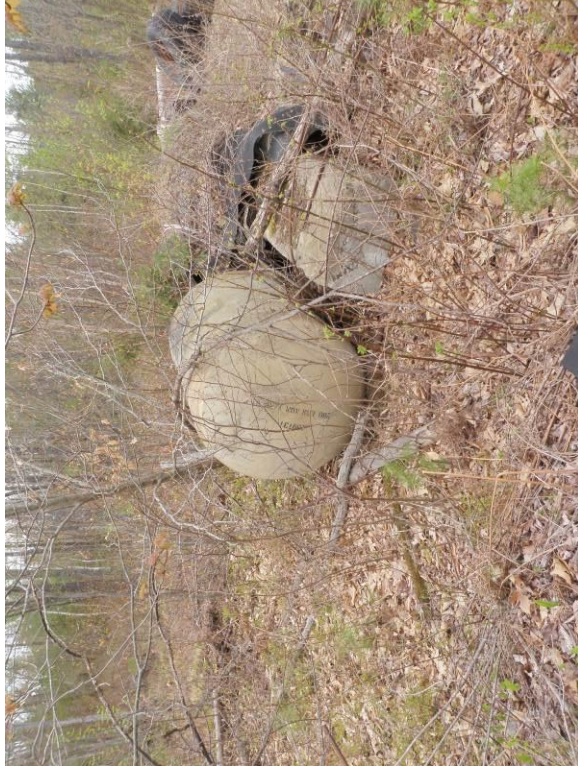
5. Fiberglass AST (unknown size) (unknown content). Staining was not observed on the ground surface.

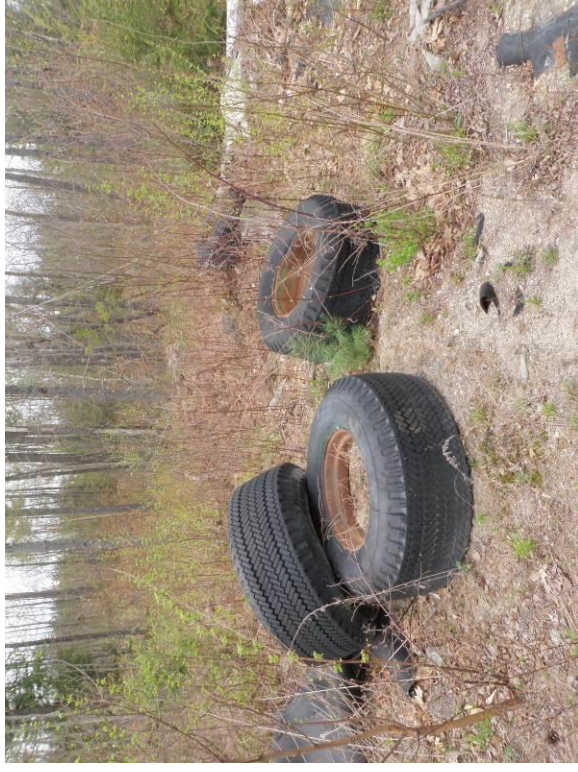
Across the cleared portions of the Site, minor evidence of debris were observed, including PVC piping, 5-gal buckets, water hose, plastic sheeting, tires, concrete/brick rubble, etc. Significant dump areas were not identified.

6. Tires and debris observed throughout the Maietta Pit.

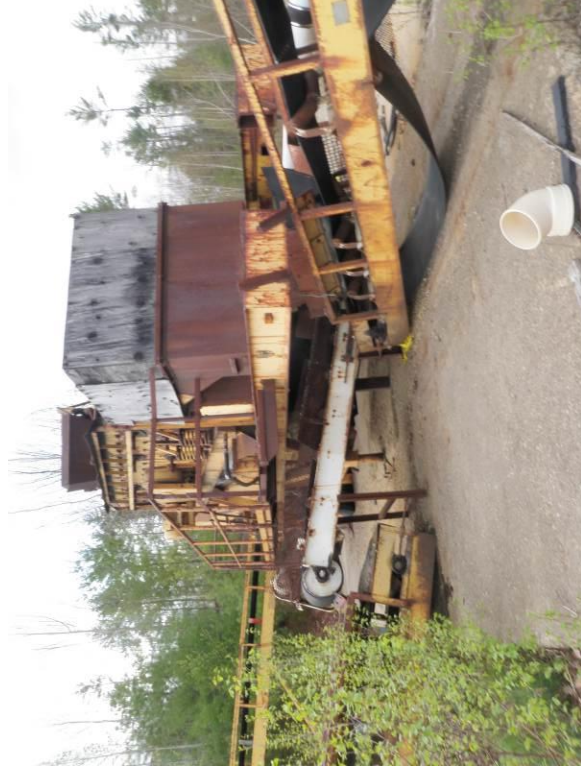
7. Industrial equipment observed at the Maietta Pit.

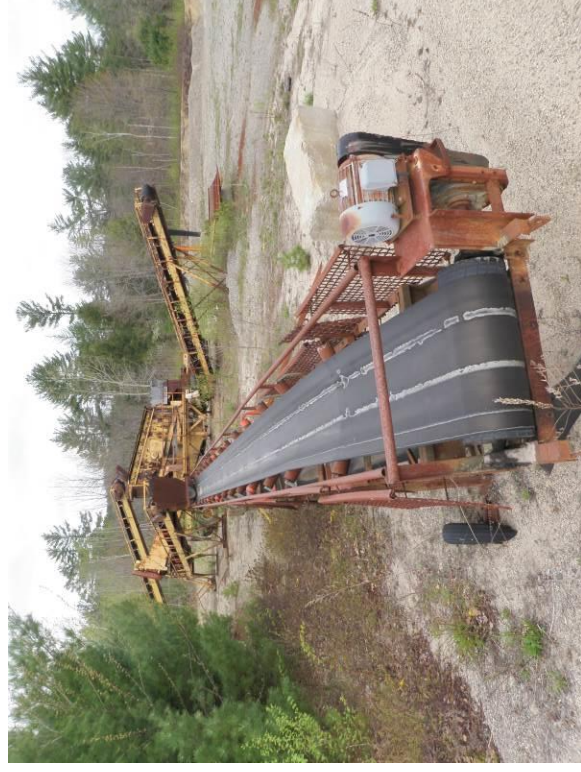
8. Industrial equipment observed at the Maietta Pit.

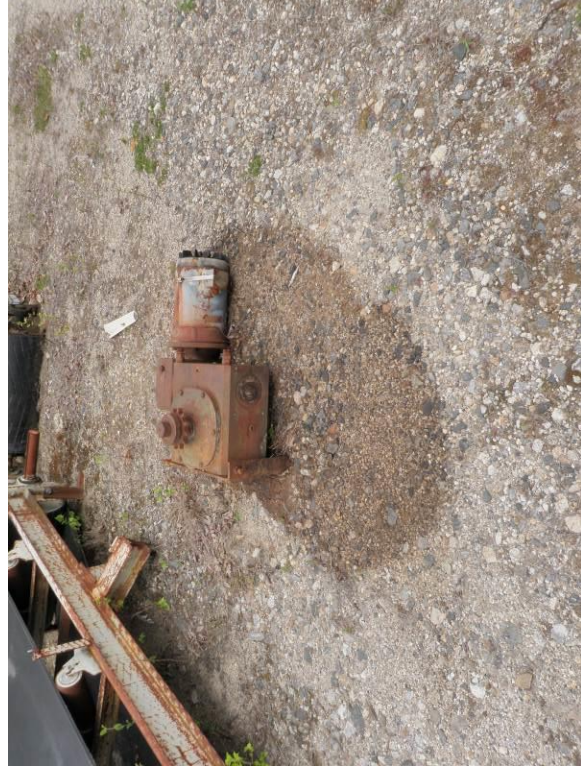
11. Staining observed at the Maietta Pit.
