Fan Housing Vibration Caused by Resonance

Application of Modal & Vibration Analysis

Ken Singleton
KSC Consulting LLC

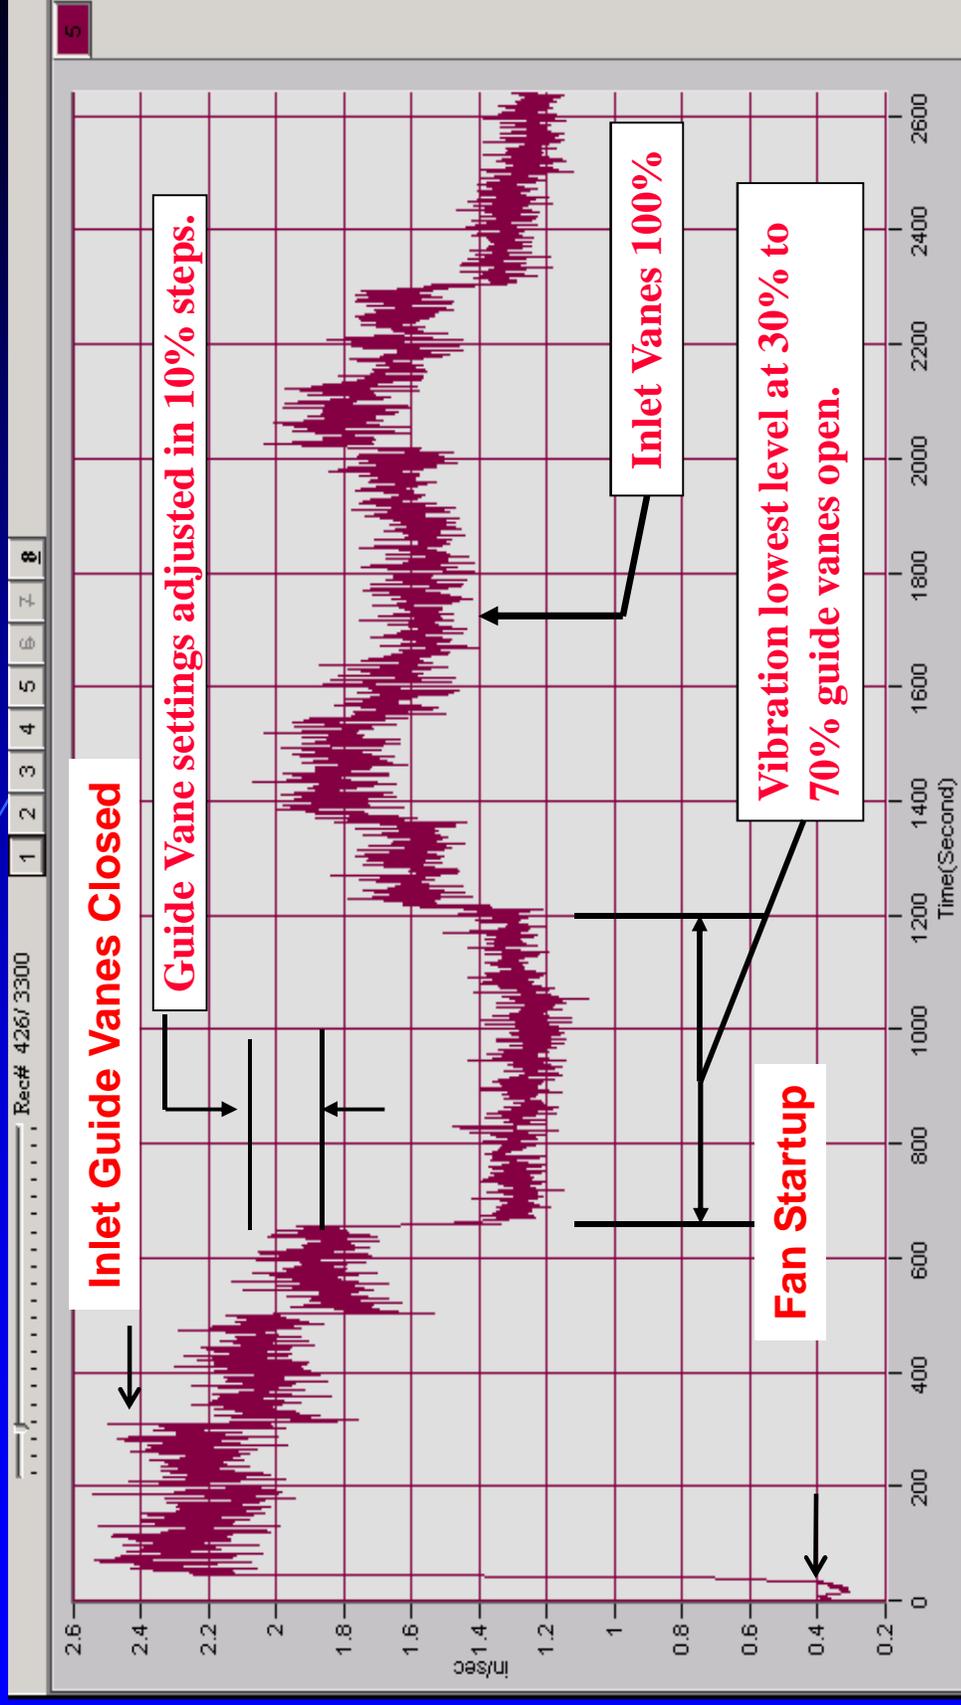
During second visit to site Feb 2002. Bearing & fan housing vibration was measured. A single accelerometer was attached to the fan housing though a hole drilled in the insulation. **Minimum 1.2 in/sec was present.**

Figure 2. Overall Vibration (in/sec) of Fan #4 Housing Measured Prior to Startup of the Fan and During Inlet Guide Vane Adjustments to Full Open, Closed and Shut Down.

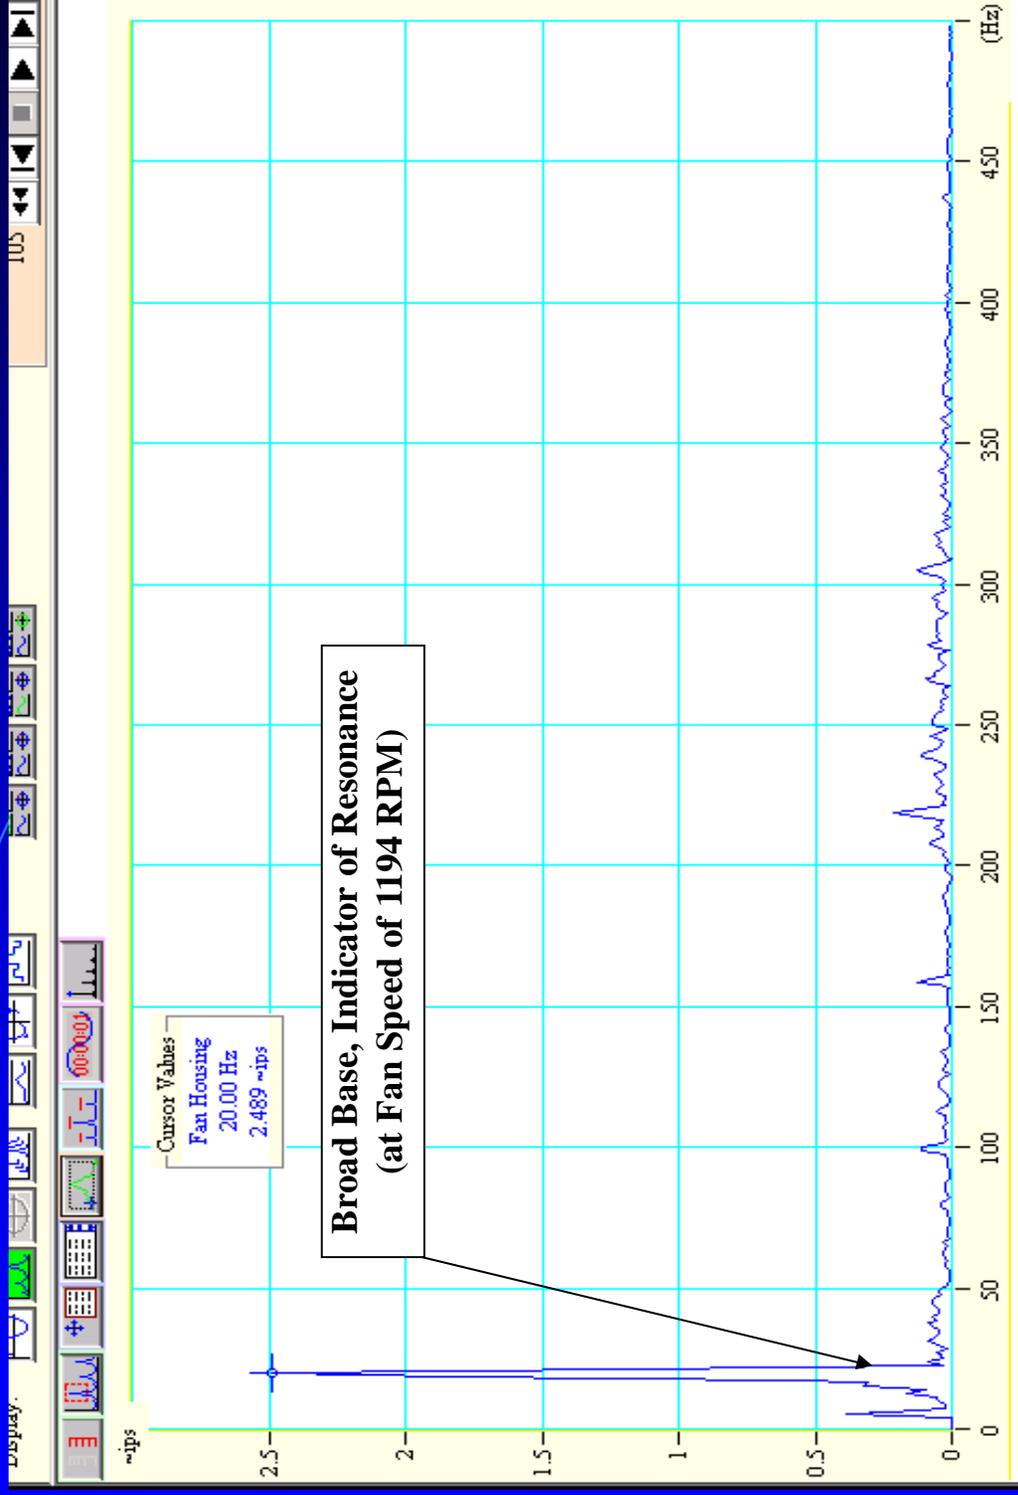
Figure 3. Fan #4 Housing Vibration Spectrum. Most Vibration Energy was at about 20 Hz (1200 CPM), or 1 X Fan Running Speed (2.5 in/sec). The Response Appeared to be Caused by Resonance of the Housing.

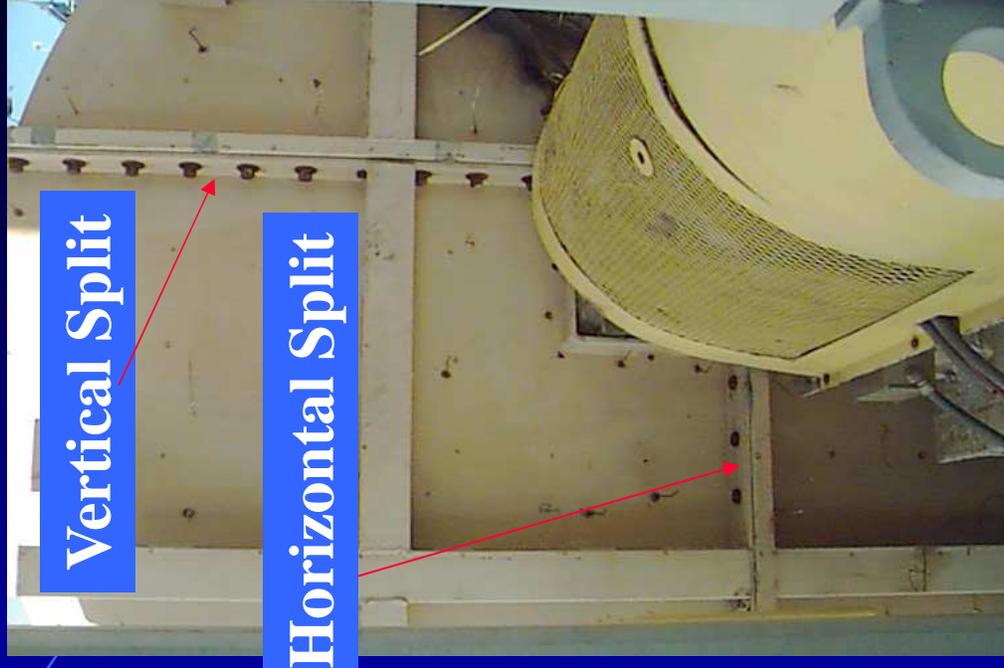
It was learned that sections of the housing flanges (4 inch Channel) had been removed using a cutting torch to provide clearance for the shaft. The removal of these stiffeners in the center of the housing significantly reduced the rigidity of the housing.

Figure 5. Fan Housing Showing Vertical and Horizontal Joints and Intersection Near the Fan Centerline

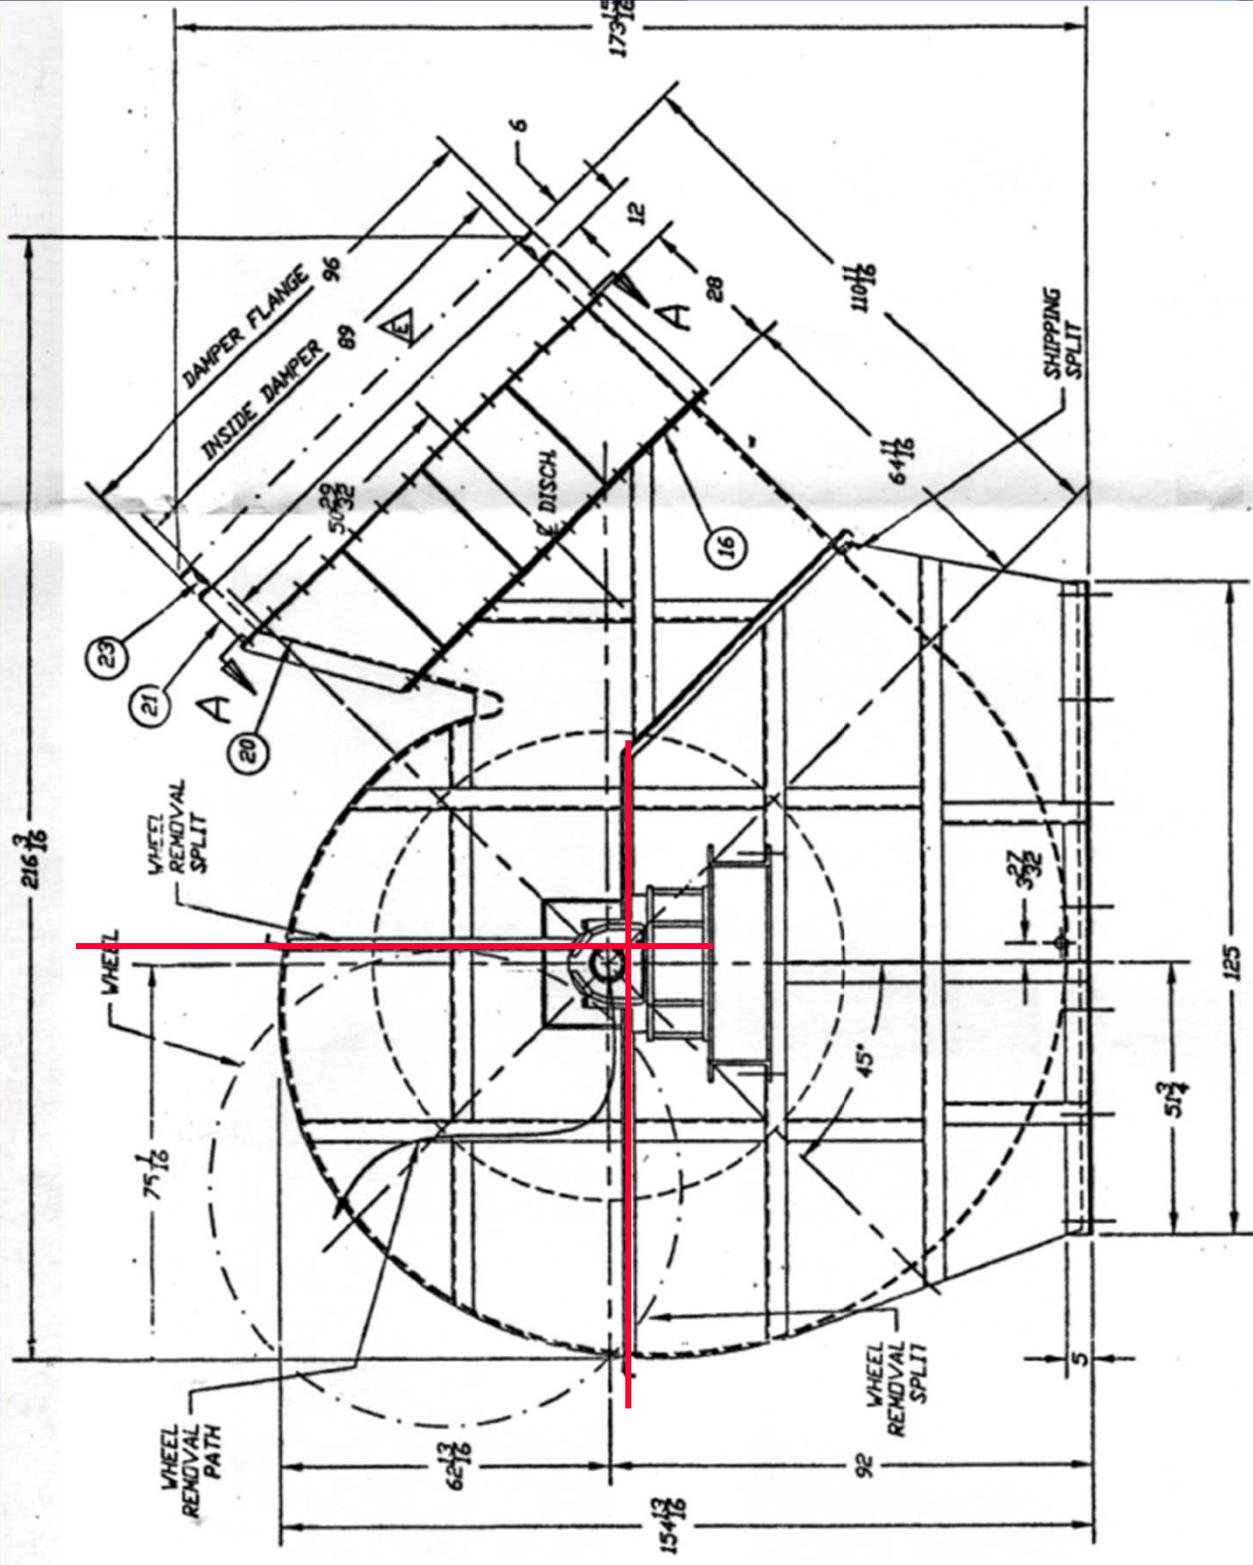
Figure 4. The Drawing by the Fan OEM Indicates the Vertical and Horizontal Flanges were Designed to be Very Close to the Shaft. Extending Lines for the Vertical and Horizontal Flanges Indicate Potential Shaft Interference.

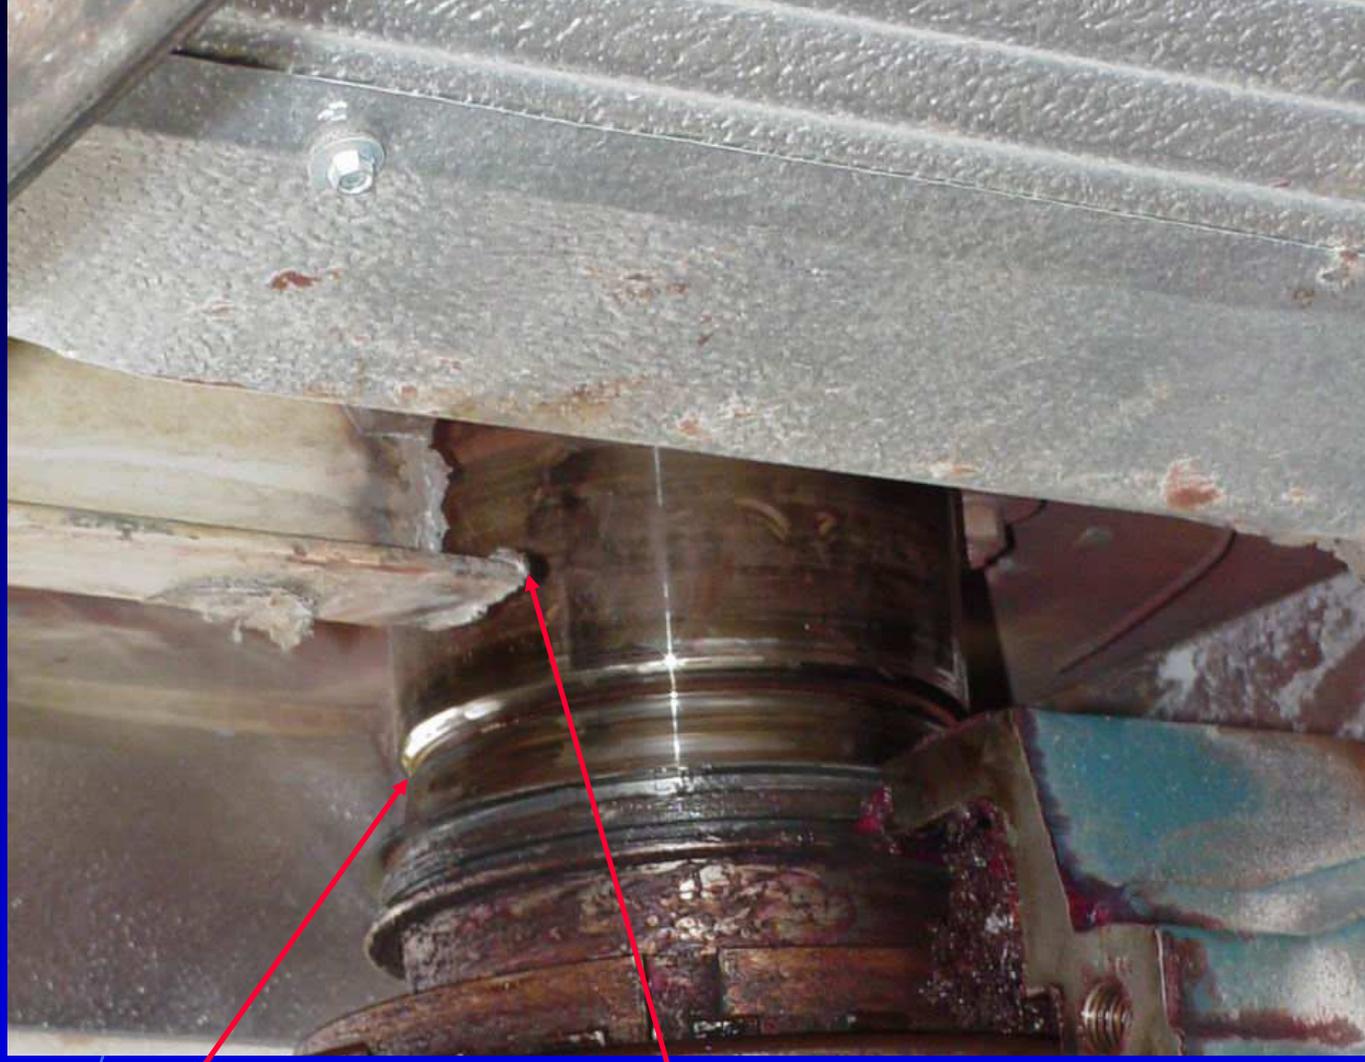
Figure 6. Groove Worn In Fan Shaft Caused by Continuous Contact With Rubber Air Seal.

Note Fan Housing Structural Members of 4" Channel Cut with Torch to Provide Fan Shaft Clearance.

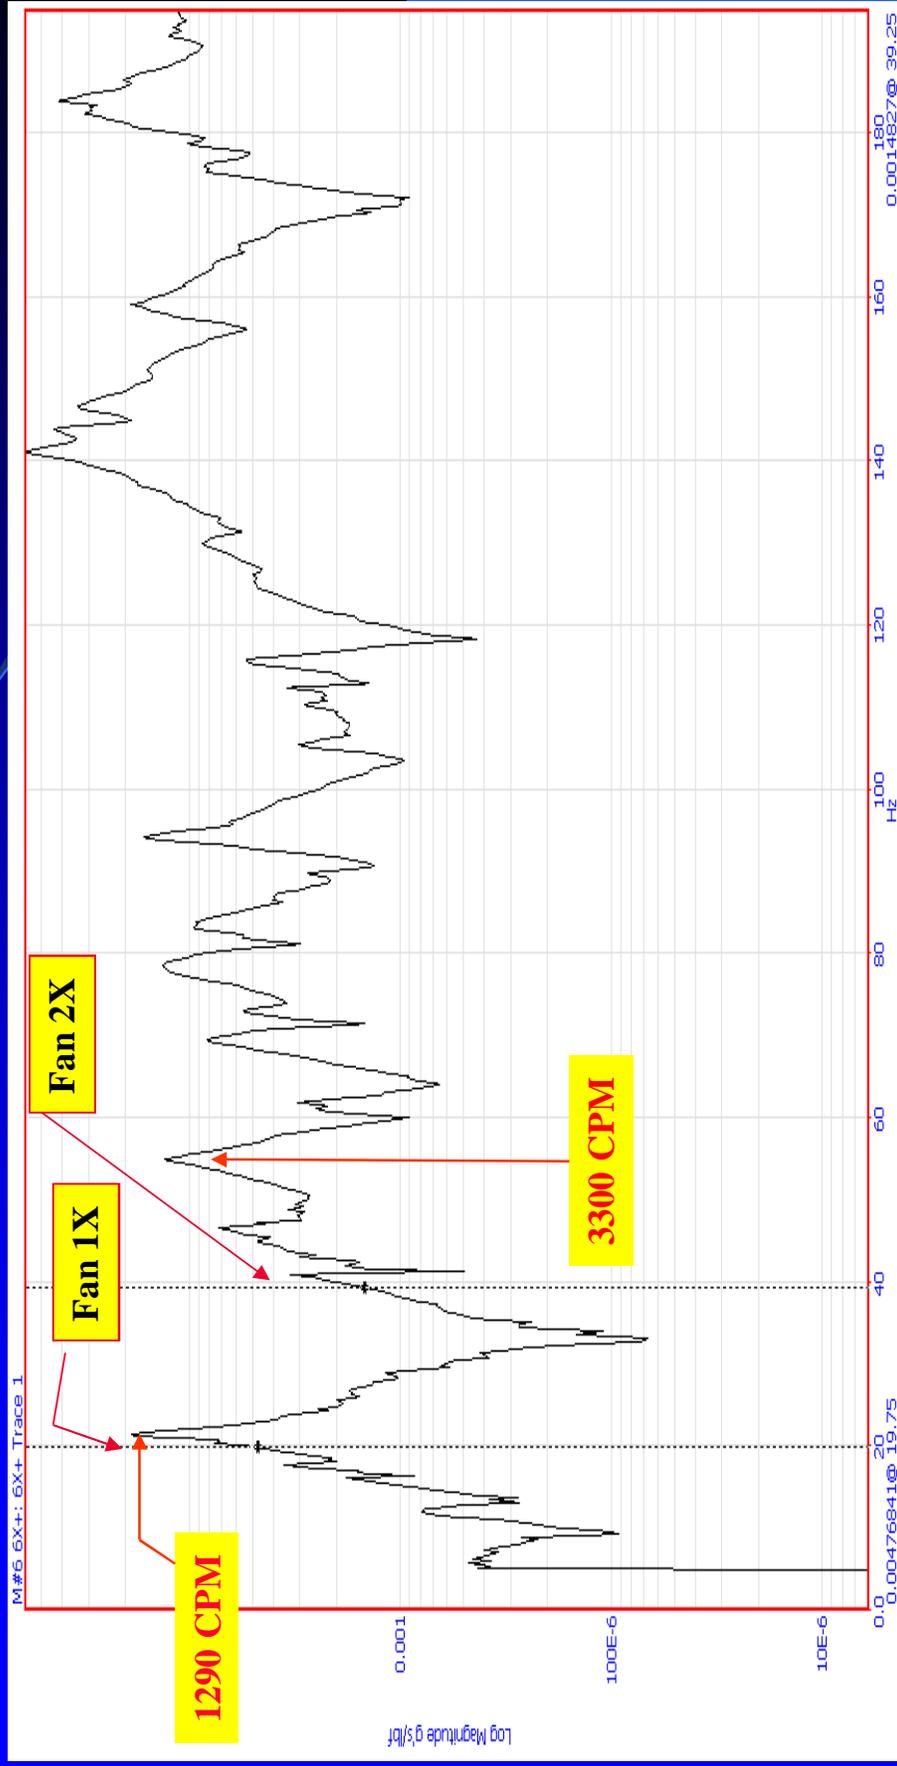
Driving Point Frequency Response Function (FRF) taken on the fan housing showed many Natural Frequencies.

There was a very responsive natural frequency at 1290 CPM (21.5 Hz) near Fan 1X running speed, which turned out to be the primary problem.

Figure 9. Frequency Response Function (FRF) of Housing Inertance Magnitude Plot (g/lb_f)

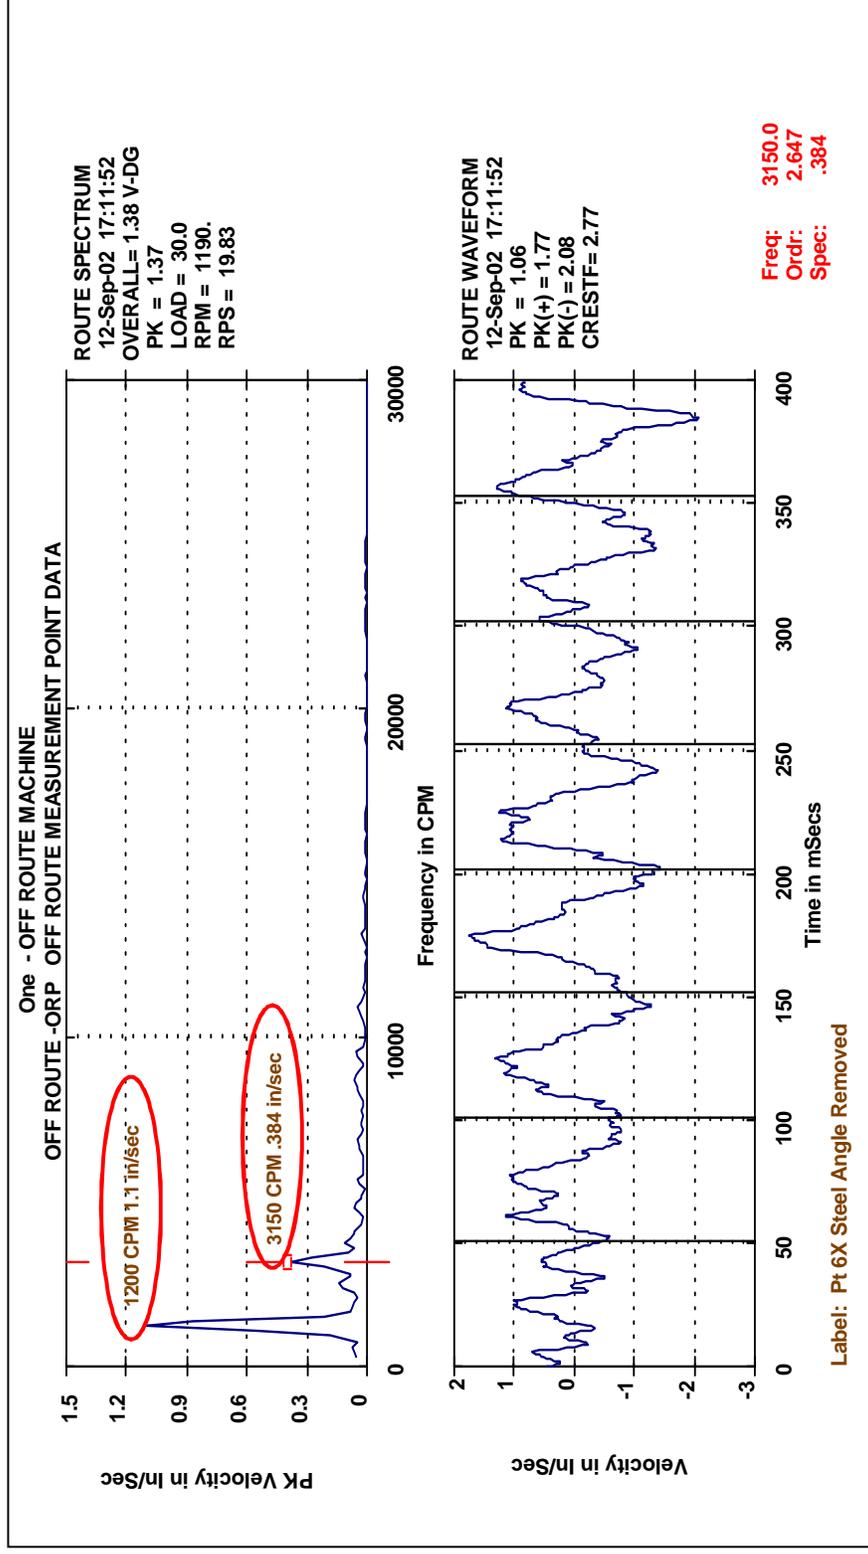
Figure 10 shows a Spectrum taken on Driving Point 6X with the fan running. Showed high vibration of 1.10 in/sec at 1 X Fan speed on fan housing. Also showed a notable level of .384 in/sec at 3150 CPM (near the 2nd Mode identified in Figure 9).

Figure 10. Vibration at DOF 6X which was the Modal Test Driving Point Location. Most Vibration was Found at 1200 and 3150 CPM (20.0 and 52.5 Hz).

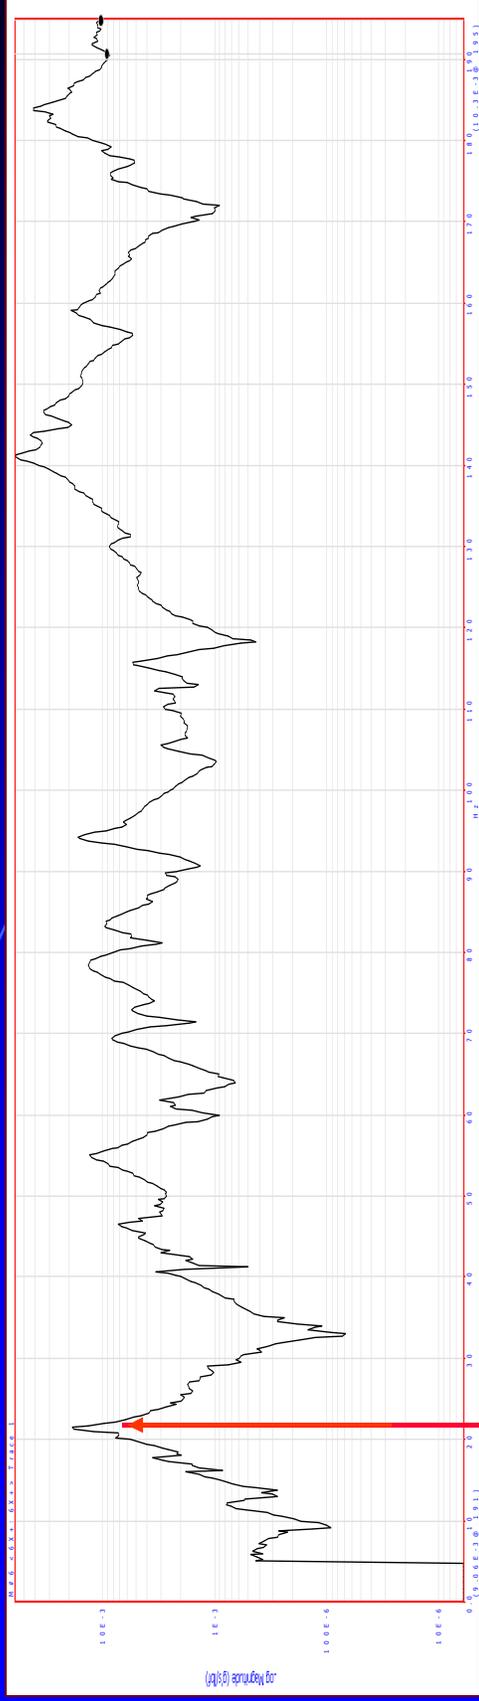
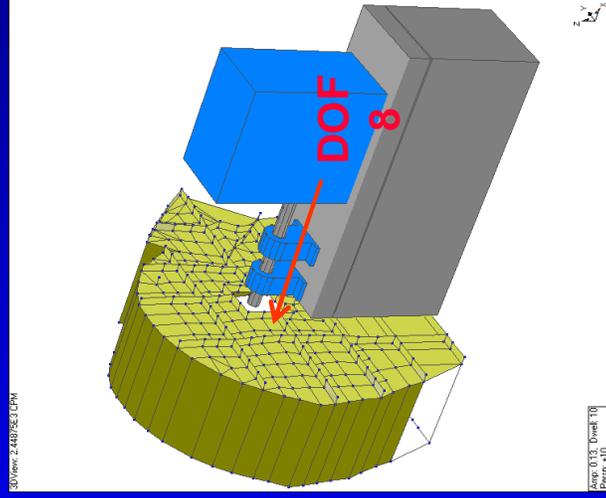
Figure 11. Driving Pt 6X/6X, Cursor on 1277 CPM (21.28 Hz) Mode.

Figure 12. Mode Shape at 1277 CPM (21.28 Hz).
This Circular Mode was the Primary Contributor to Fan Housing Vibration.

The housing was moving in and out perpendicular to the shaft axis **due to cut stiffeners.**

1st Circular Mode Shape (near 1194 RPM fan running speed).

Max vibration, measured during the test was DOF 8X at 1.72 ips (near the fan housing cutout where the shaft passes through the housing - see Illustration B).

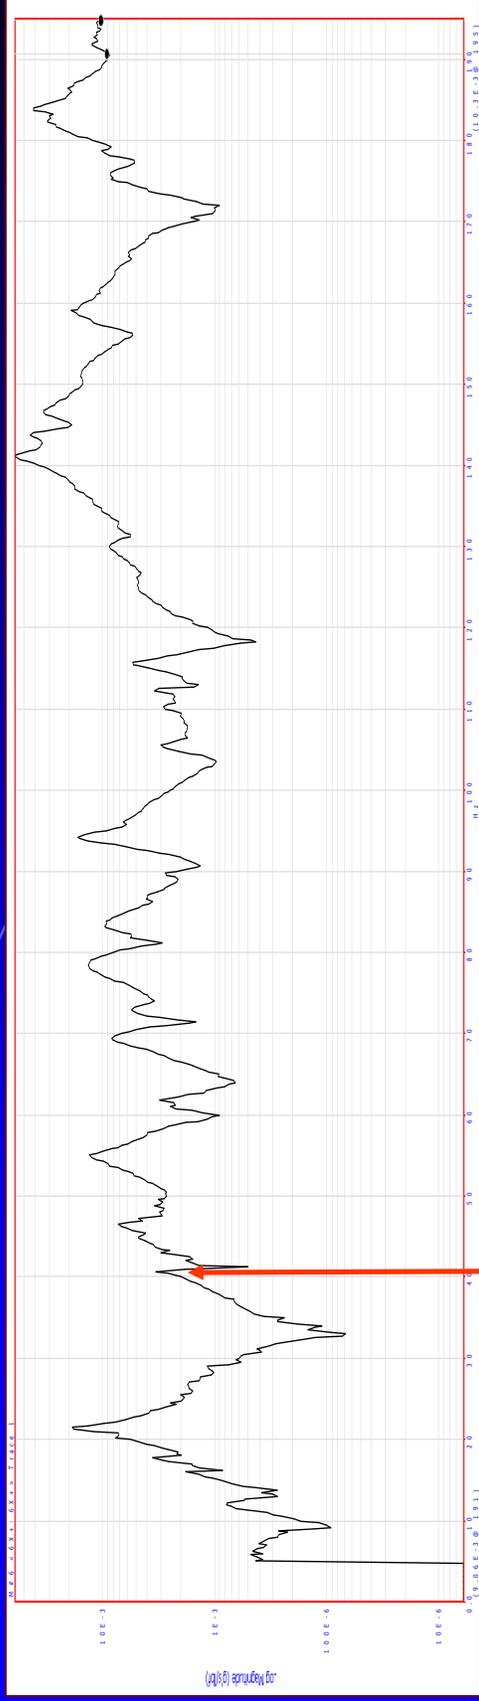
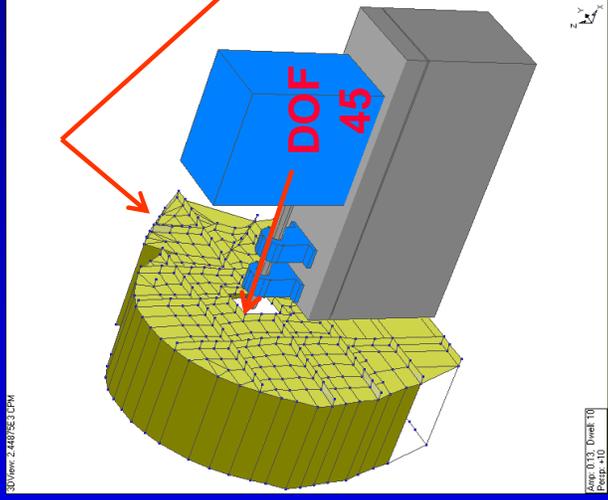
Figure 13. Driving Pt 6X/6X, Cursor on 2449 CPM (40.8 Hz) Mode.

Figure 14. Mode Shape at 2449 CPM (40.8 Hz) is near 2 X Fan Speed.

The housing motion is out of phase on each side of the housing centerline.

Discharge nozzle participates in the mode – **fatigue failure of welds.**

Max vibration. measured during the test was DOF 45 at 0.155 ips (see Illustration B).

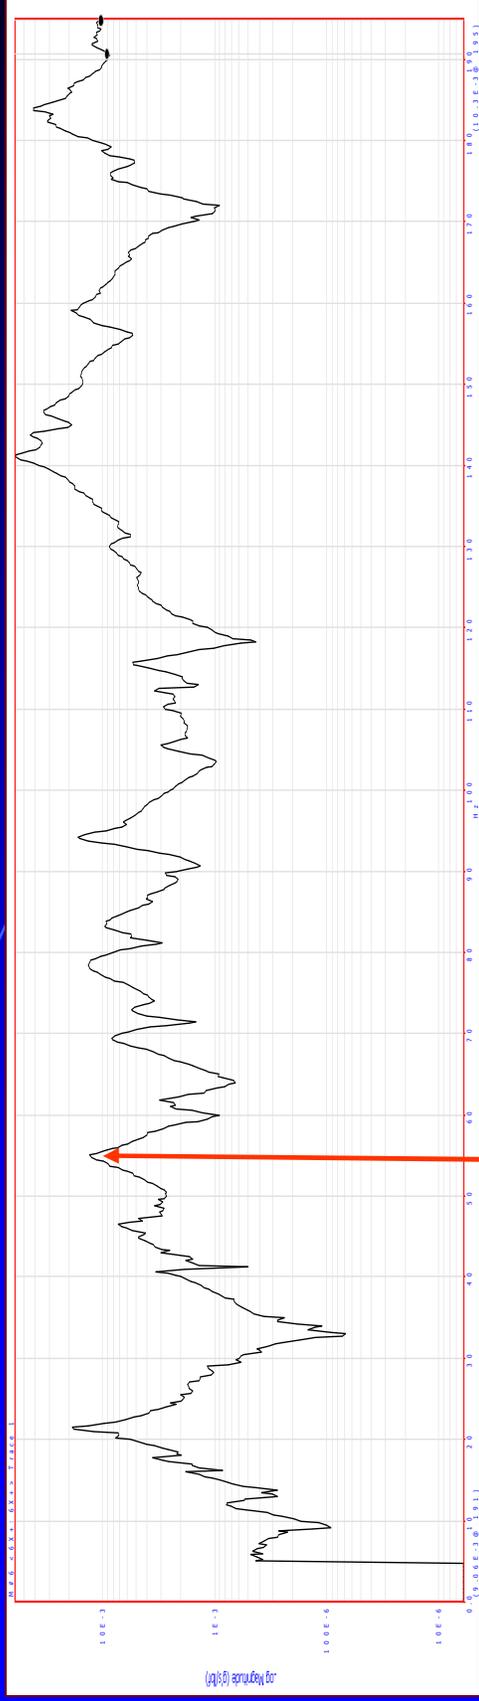
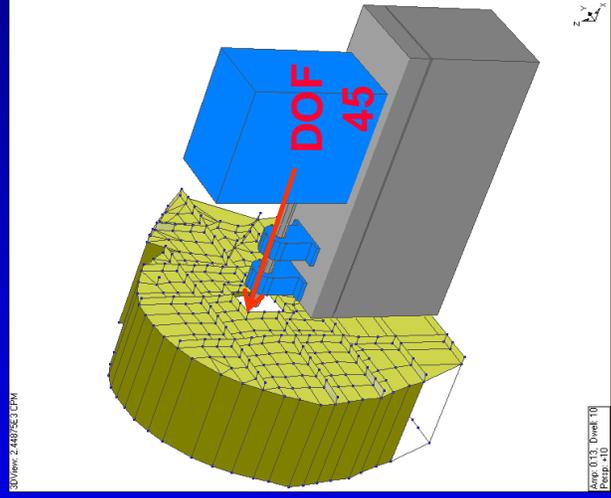
Figure 15. Driving Pt 6X/6X, Cursor on 3299 CPM (55.0 Hz) Mode.

Figure 16. Mode Shape at 3299 CPM (55.0 Hz). This was the 2nd Most Responsive Mode.

The housing motion is out of phase each side of the centerline.

Discharge nozzle does not participate in the mode.

Max vibration, measured during the test was DOF 45 at 0.455 ips.

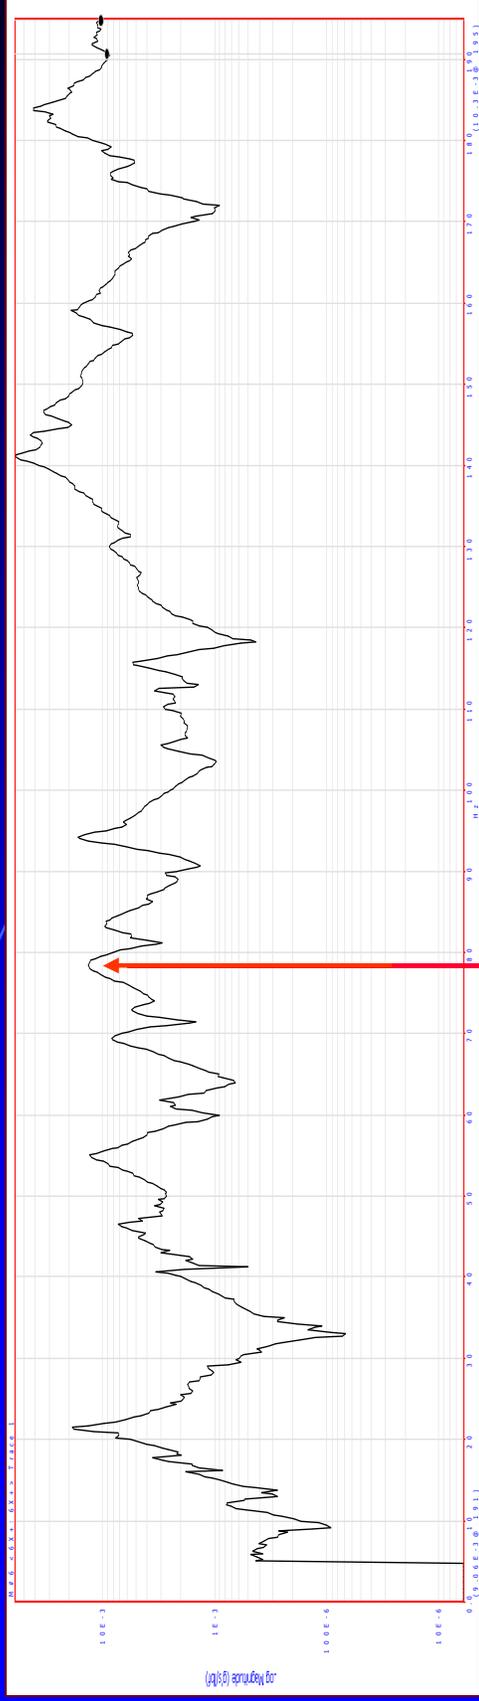
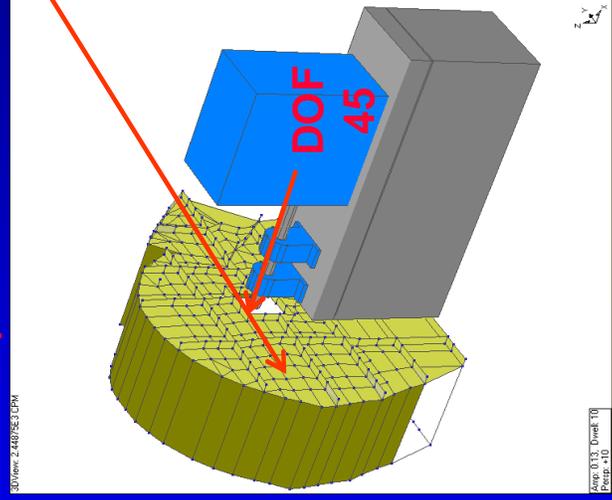
Figure 17. Driving Pt 6X/6X, Cursor on 4713 CPM (78.55) Hz Mode.

Figure 18. Mode Shape at 4713 CPM (78.65 Hz). Note Motion on Left Side of Blower Housing.

Primarily panel circular mode left side of housing.

Max vibration measured during the test was DOF 45 at 0.10 ips.

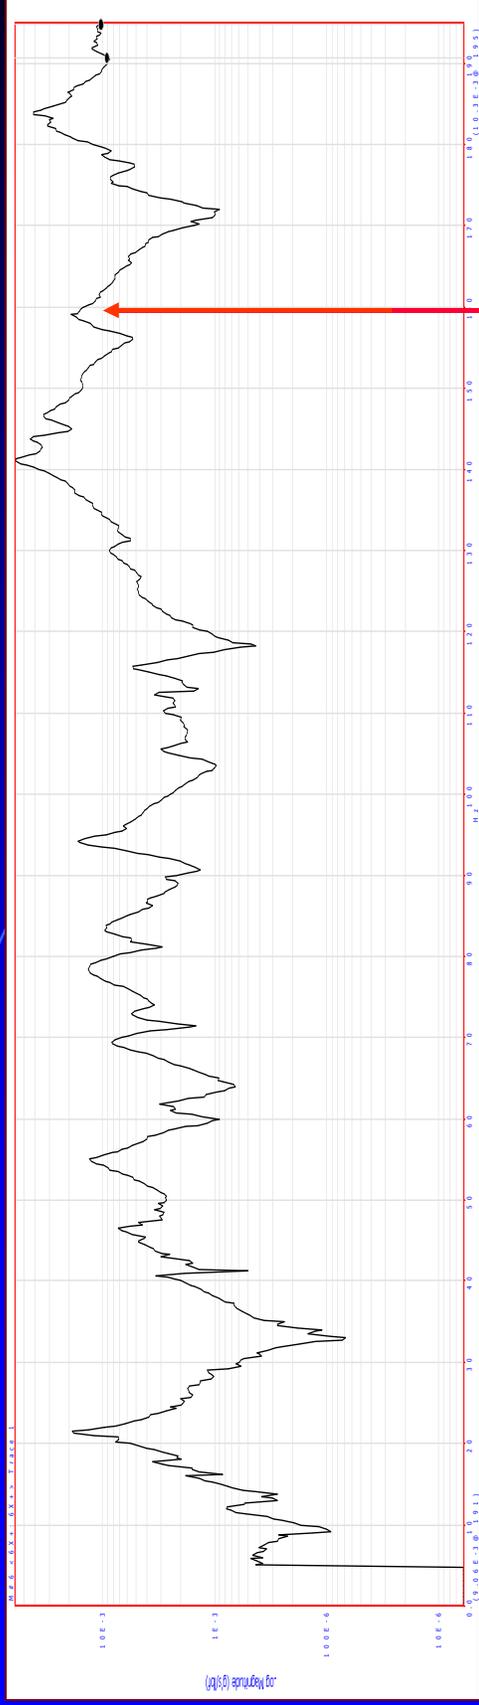
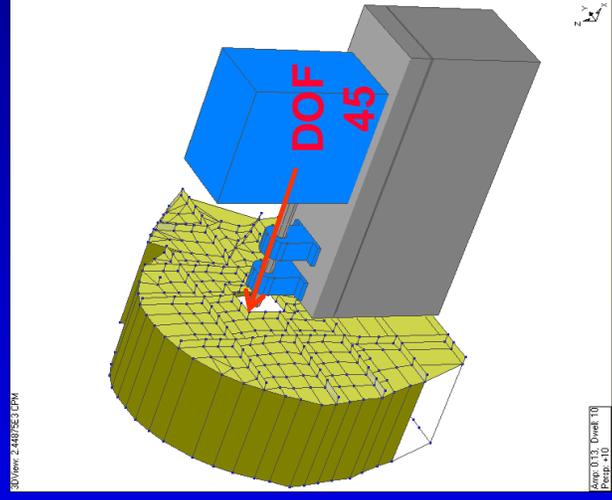
Figure 19. Driving Pt 6X/6X, Cursor on 9580 CPM (159.7 Hz) Mode.

Figure 20. Mode Shape at 9580 CPM (159.7 Hz). Primarily Panel Bending Modes of Fan Housing.

Primarily panel circular modes of the fan housing.

Max vibration measured during the test was DOF 45 at 0.144 ips.

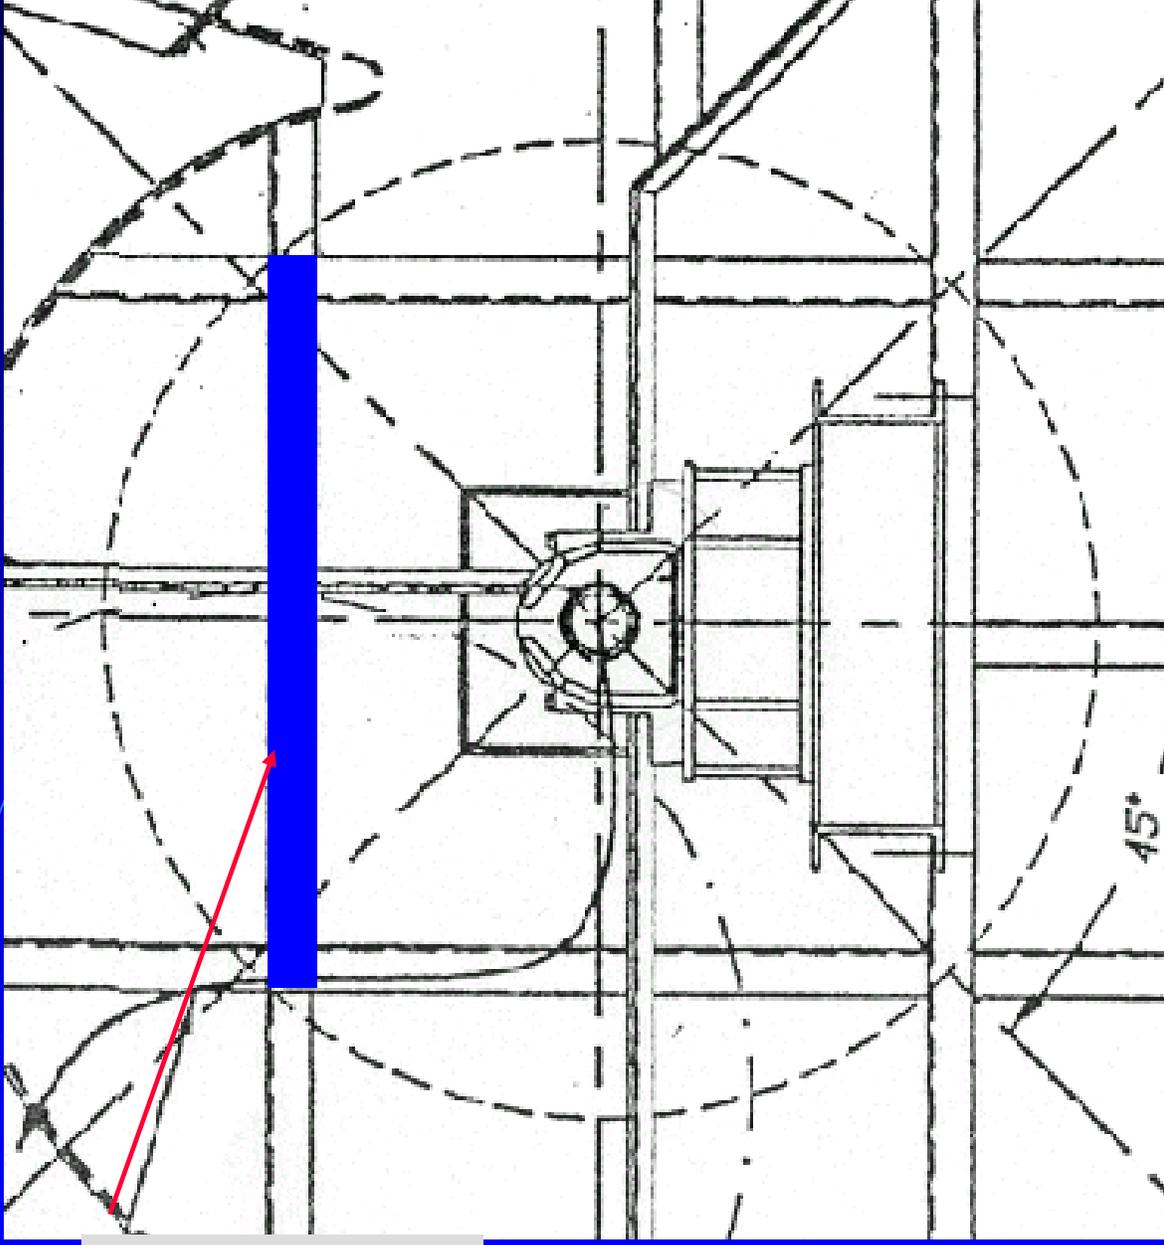
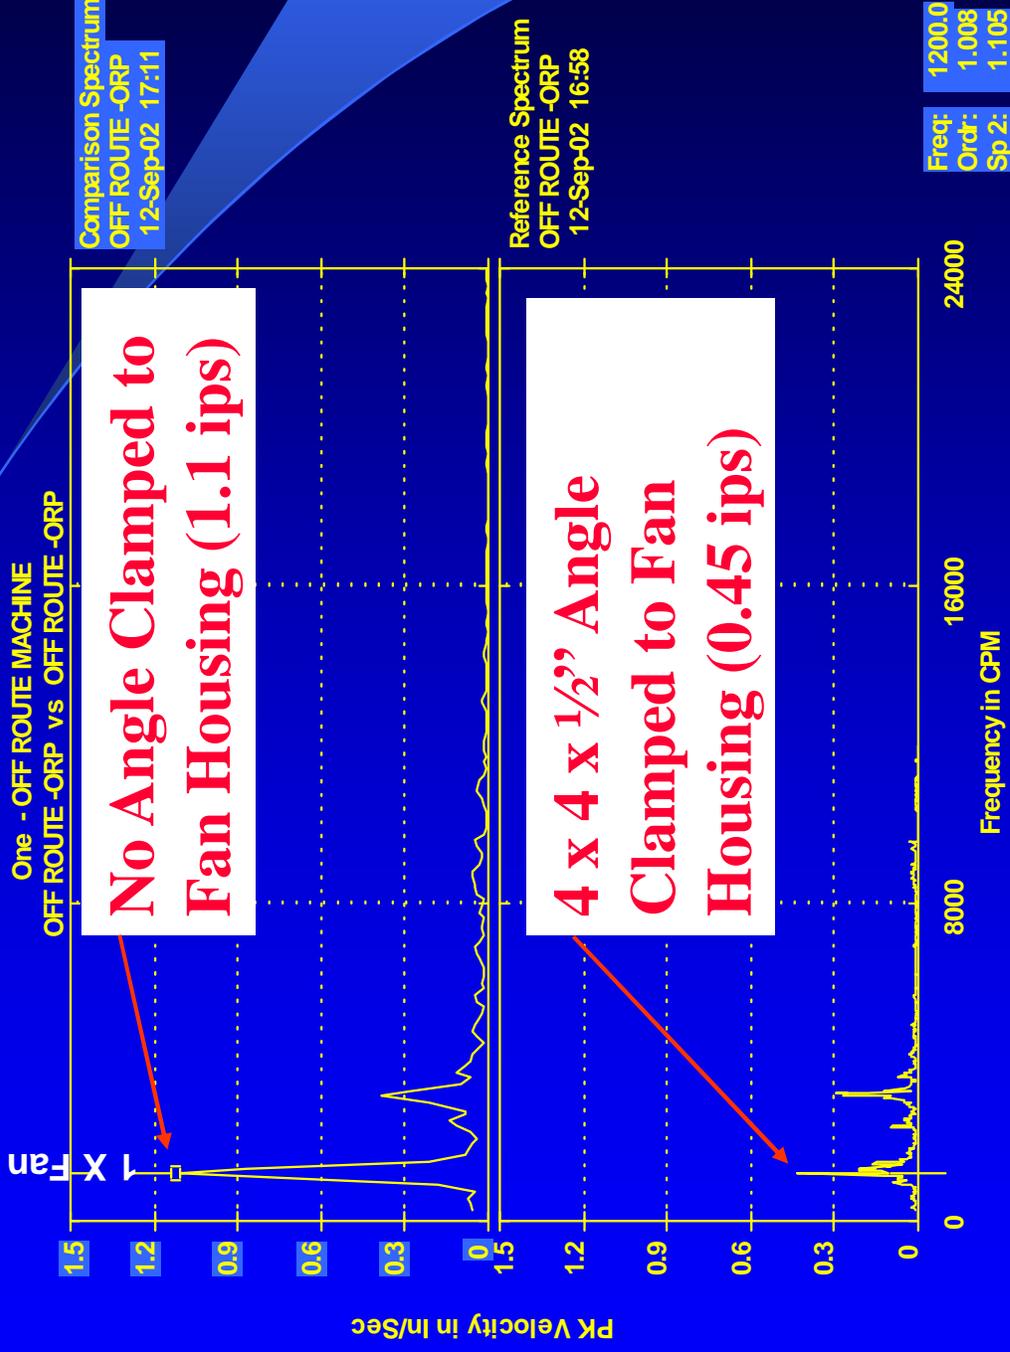
Figure 21. Vibration was Taken With & Without the Angle Attached to the Housing.

Fan Running with Temporary 4 x 4 Angle clamped to the fan housing. Vibration was predominantly at DOF 6X (Illustration B).
Temporary stiffener did prove to be effective in reducing vibration

After the Modal Test, a Temporary 4" x 4" Angle was Clamped to the Fan Housing and the Fan was Restarted.

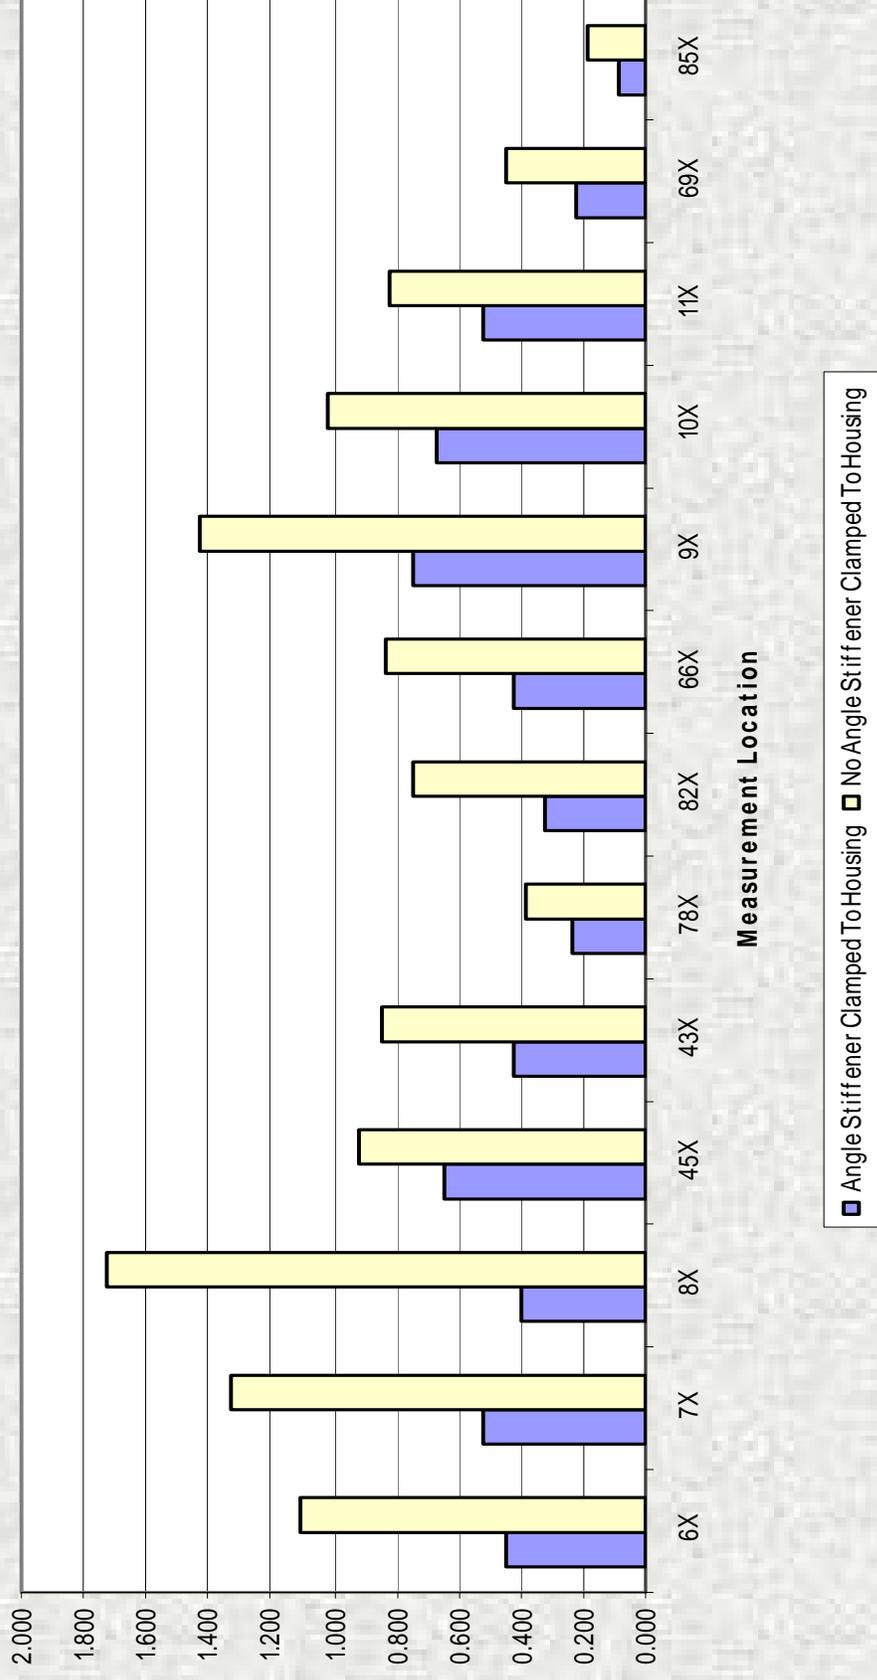
Chart 1. Vibration at 1200 CPM Frequency with Temporary Angle Clamped to Housing Acting as a Stiffener (Blue) and the Angle Removed (Yellow). 11B-16

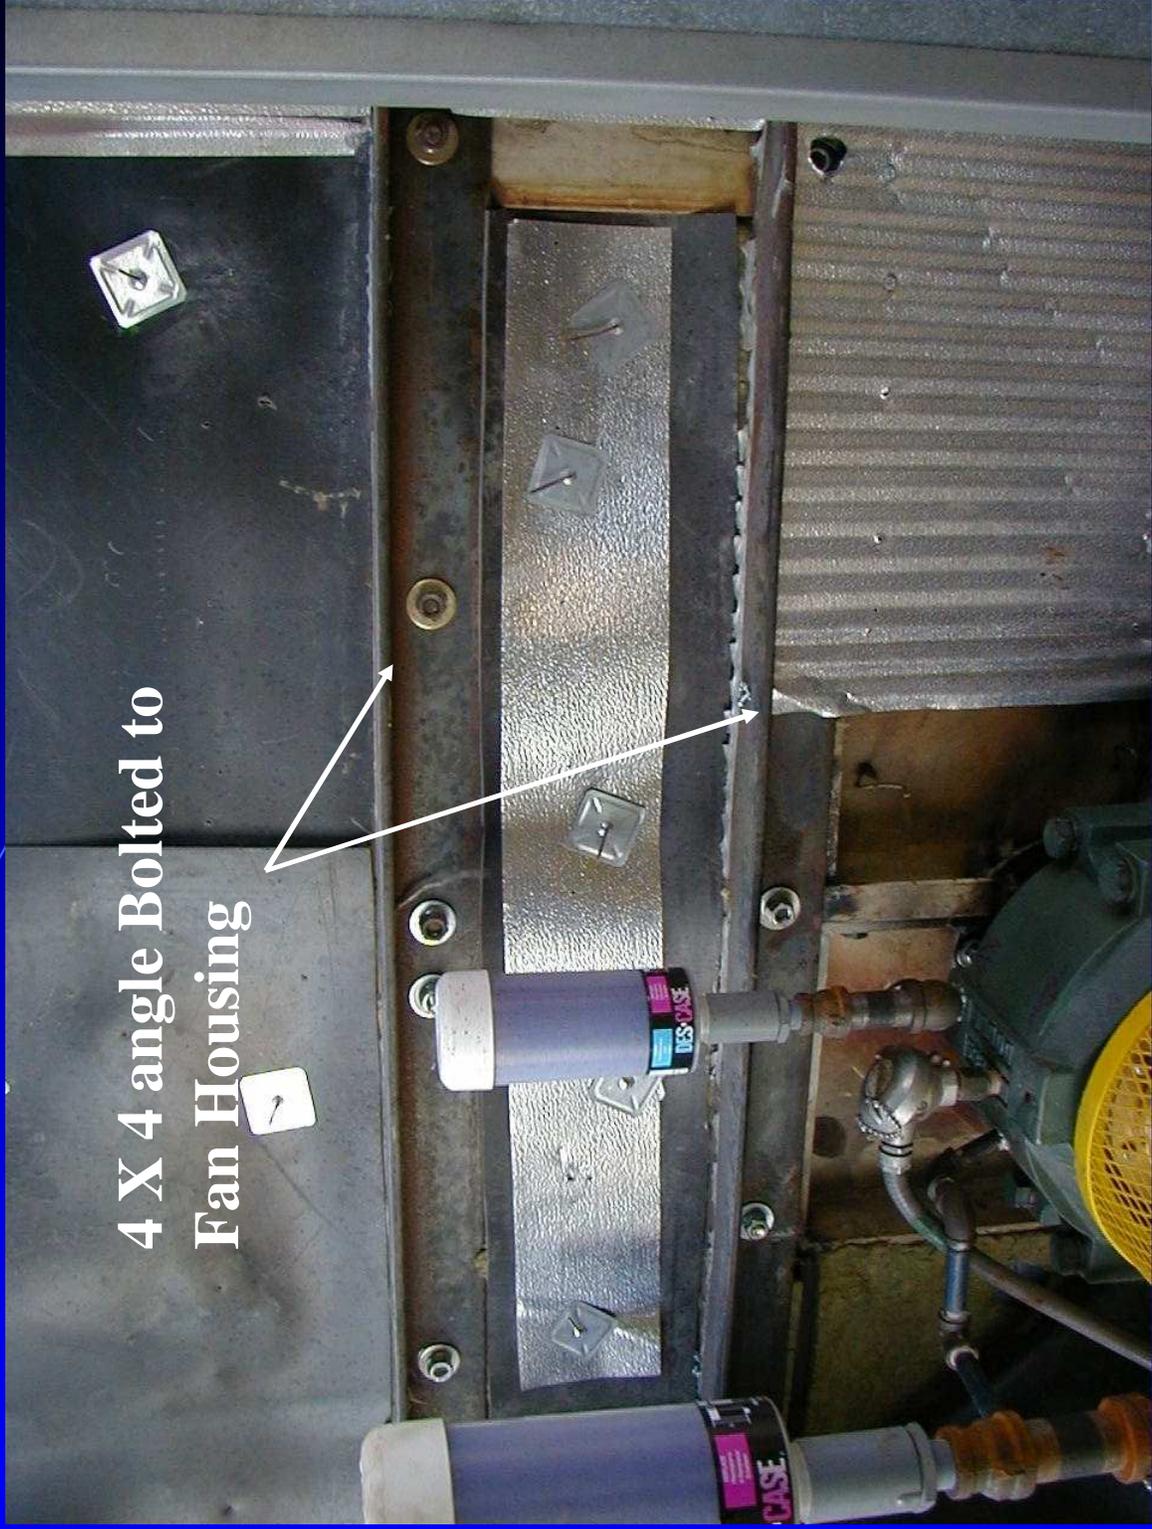
Figure 23.

Initial vibration measured 1.6 in/sec, pk at 40% inlet guide vane setting.

After angle was bolted to the housing, vibration was reduced to 0.15 in/sec, Pk at 1X, showing a 10.7:1 reduction (91% decrease).
