Fan Housing Vibration Caused by Resonance

Application of Modal & Vibration Analysis

Ken Singleton
KSC Consulting LLC

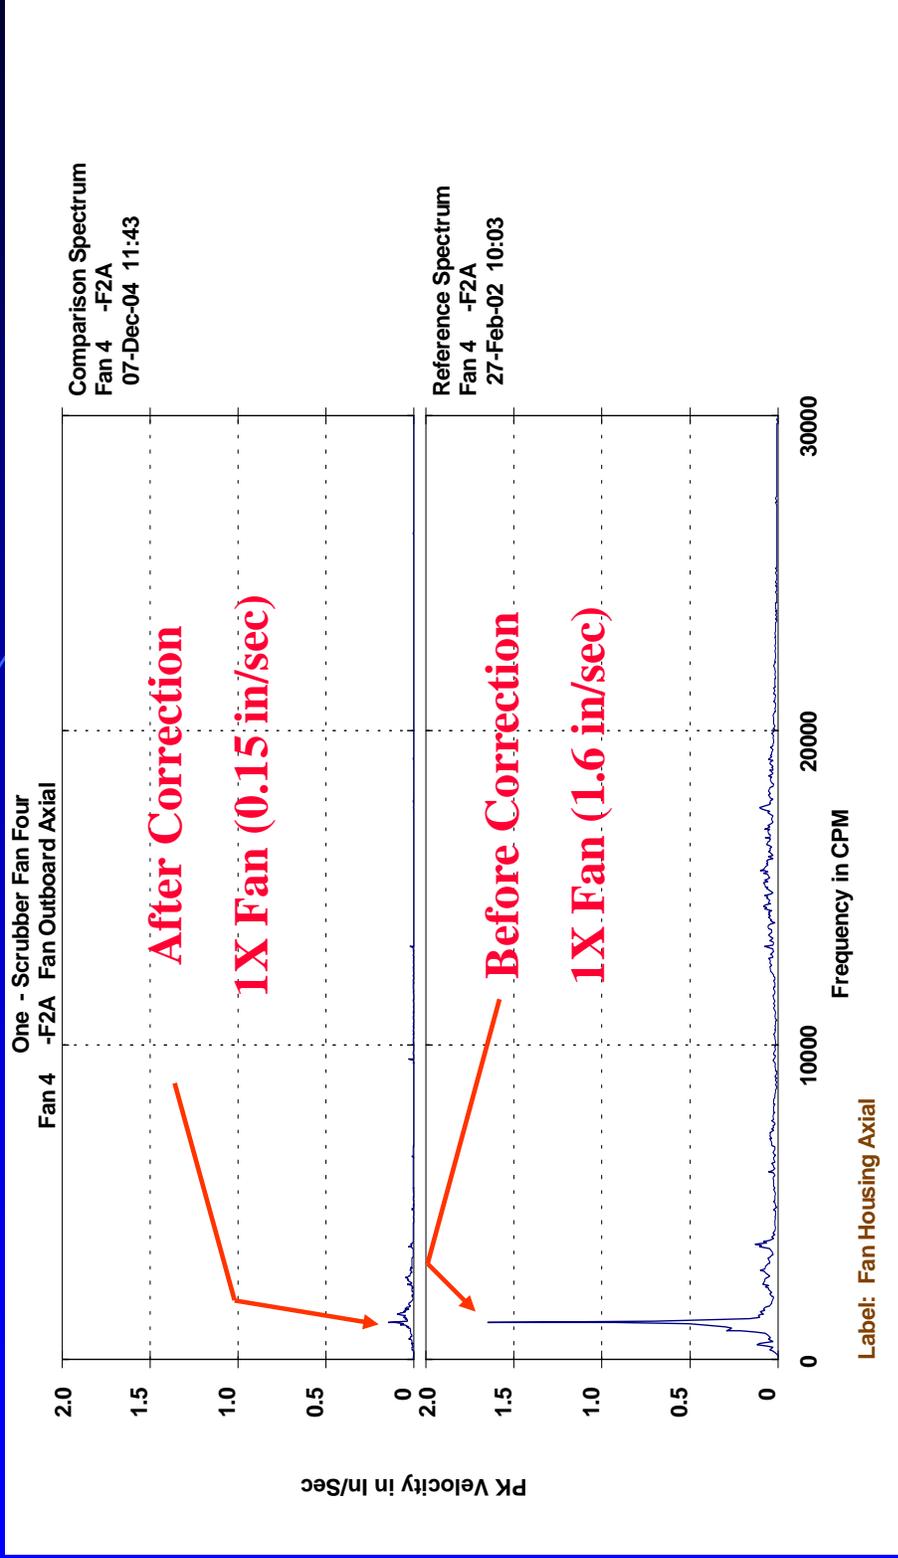
Figure 24. Comparison of Before and After Vibration Spectra Measured on Fan #4 Housing, DOF 6X at Fan Housing Split Line Structural Member.

Initial Fan 1X vibration measured 1.6 in/sec, pk at 40% inlet guide vane setting.

After angle was bolted to the housing, vibration was reduced to 0.15 in/sec, Pk at 1X, showing a 10.7:1 reduction (91% decrease).

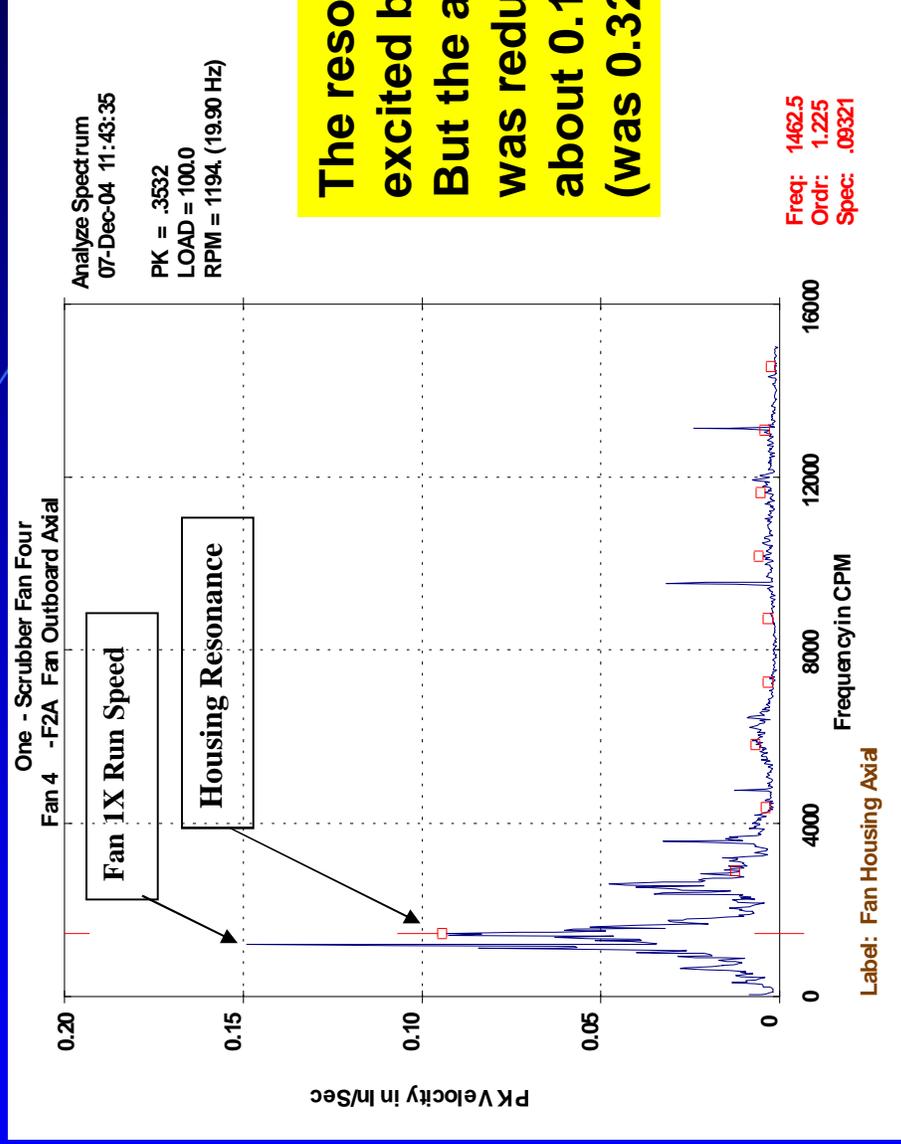
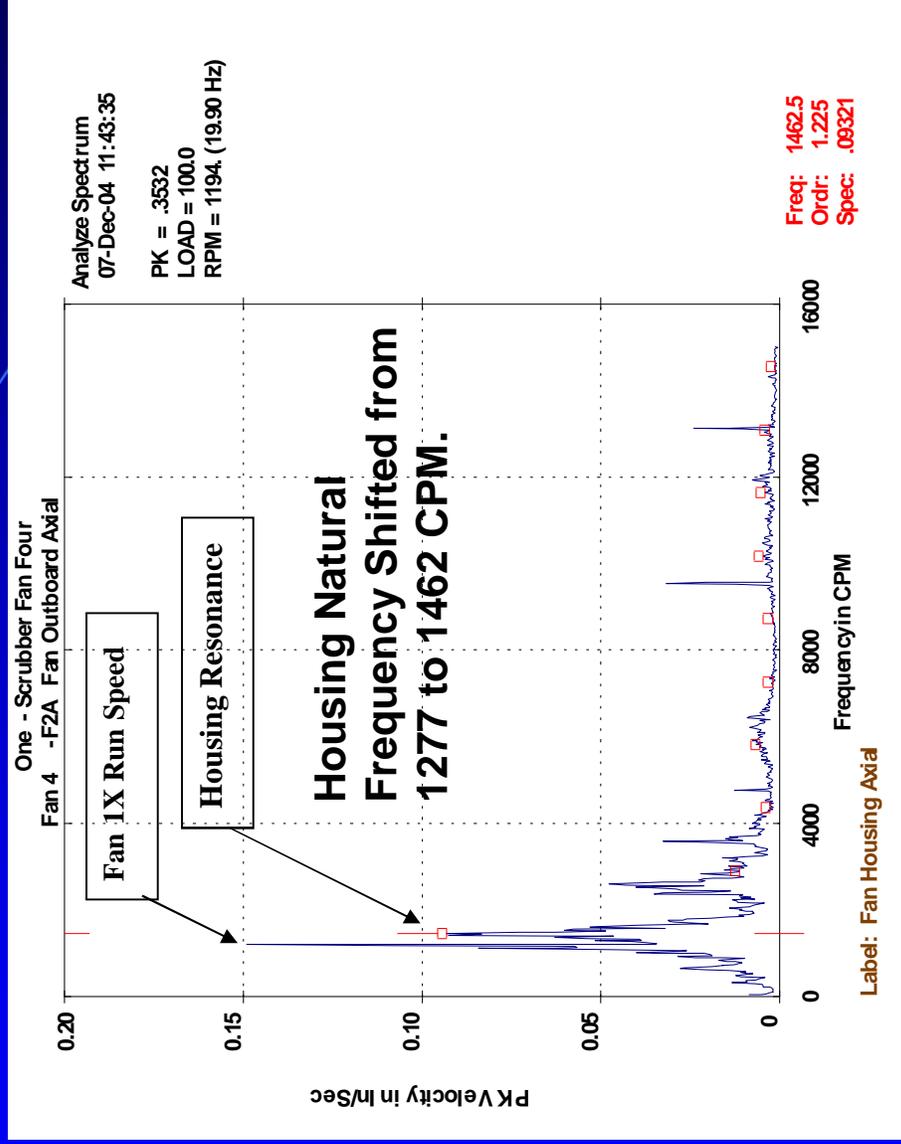
The resonance is still excited by air flow; But the amplitude was reduced to only about 0.1 in/sec, pk (was 0.32 in/sec, pk).

Figure 25. The Housing Vibration after Angle Bolted to Housing. Spectrum Shows the Housing Natural Frequency has Increased from Approximately 1277 CPM to 1462 CPM (20.0 to 24.4 Hz).

The resonance is still present but is shifted 14.5% higher in frequency away from fan running speed.

After modifications, the Mode measured 1462 CPM or 22.0% from Fan 1X. Prior to modifications, the Mode measured 1277 CPM or 6.5% from Fan 1X.

Figure 25. The Housing Vibration after Angle Bolted to Housing. Spectrum Shows the Housing Natural Frequency has Shifted from Approximately 1277 CPM to 1462 CPM (21.3 to 24.4 Hz).
