INSPECTION REPORT

For the Property at:
1 ANYWHERE LN
BEACH, NY

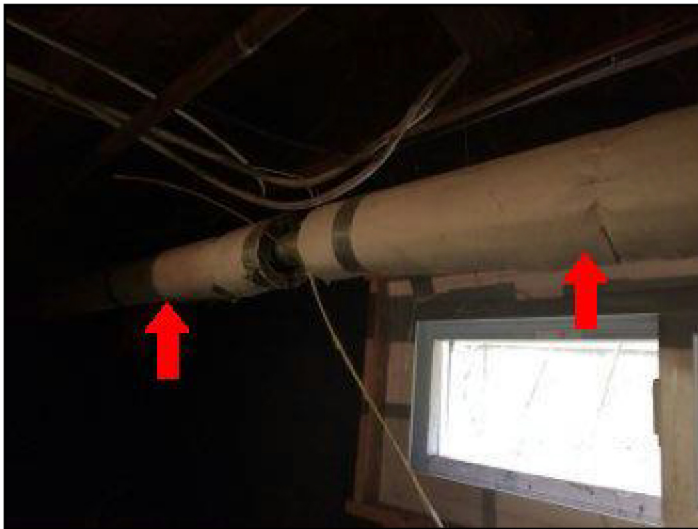
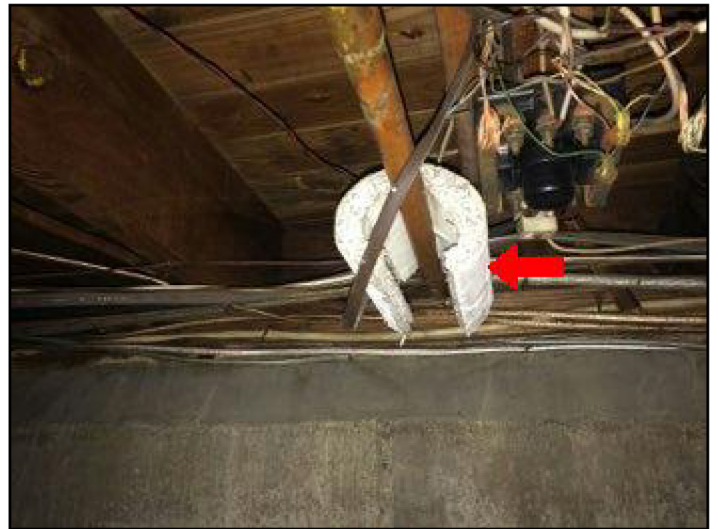
OIL HOT WATER BOILER \ Pipes

Condition: • possible asbestos covering on pipes - asbestos testing is beyond the scope of this inspection - any asbestos should be removed or encapsulated

Location: Basement

Task: Remove

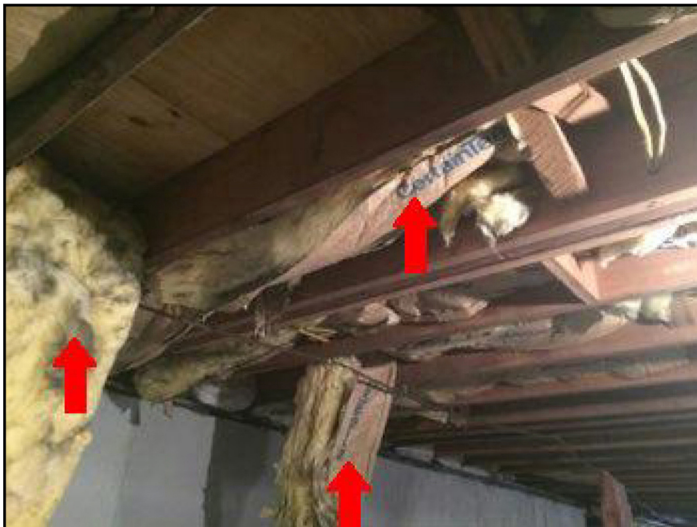
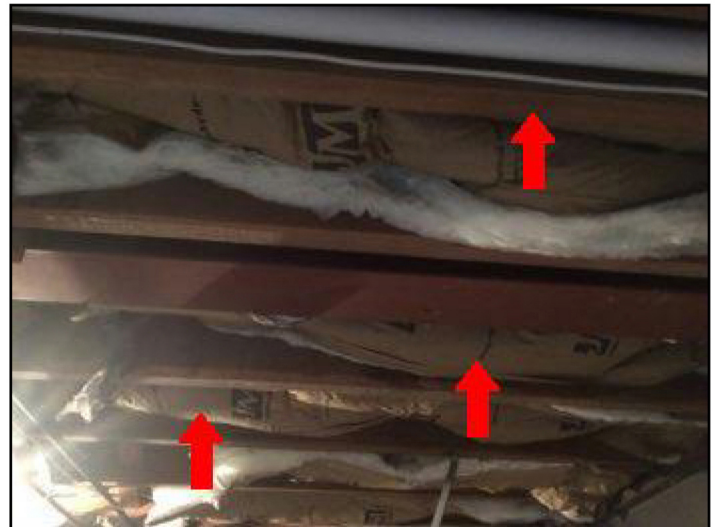
FOUNDATION \ Interior insulation

Condition: • [Vapor barrier in wrong location](#)

Location: Basement

Task: Improve

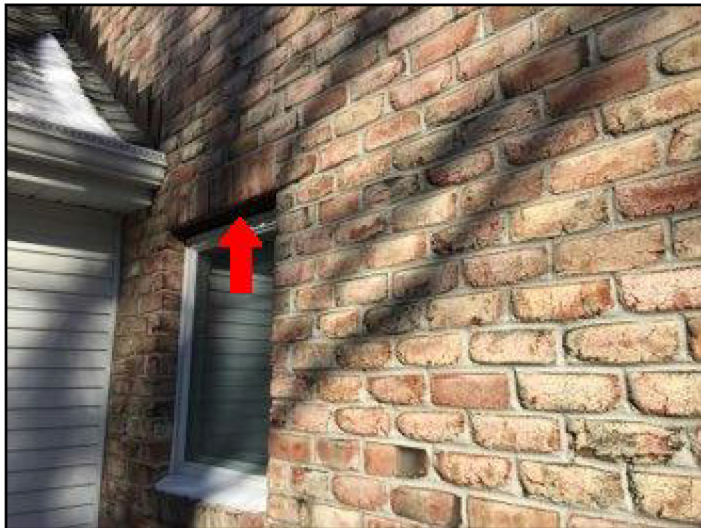
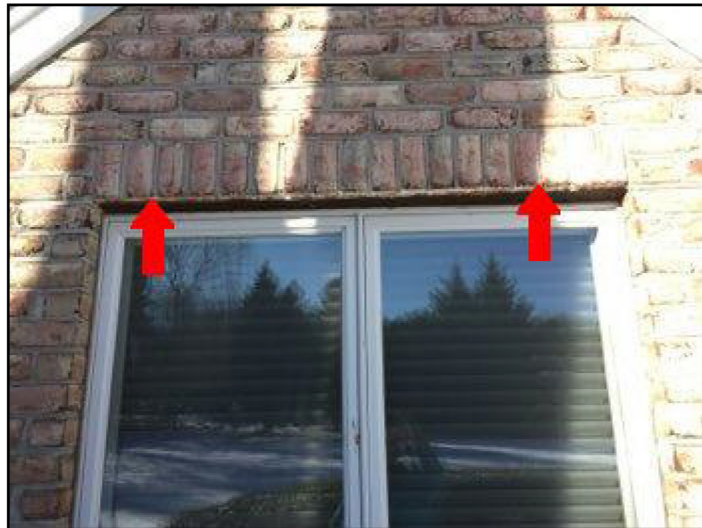
EXTERIOR GLASS \ General

Condition: • [Lintel rusting](#)

Location: Front

Task: Improve
