Beach House Home Inspections, Inc.

Home Inspection Report

1234 Any Road

Inspected on Mon, May 14 2018 at 3:48 PM

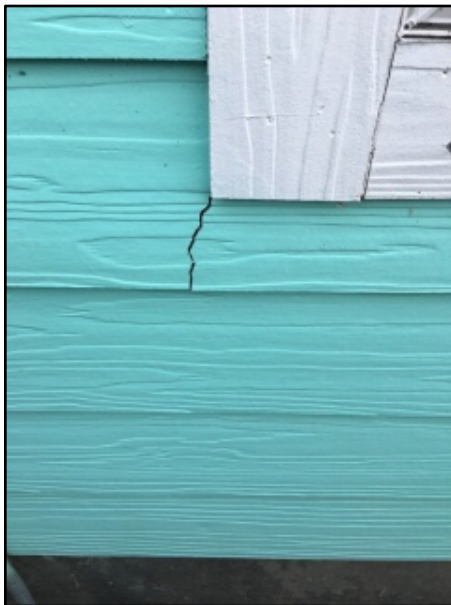
Figure 7-1

1) Settlement crack was noted on bedroom window on east face of house .
Should be caulked to prevent moisture intrusion.
This could be performed by homeowner or handyman.

**Comment 7:**
Settlement crack was noted on bedroom window on east face of house .
Should be caulked to prevent moisture intrusion.
This could be performed by homeowner or handyman.

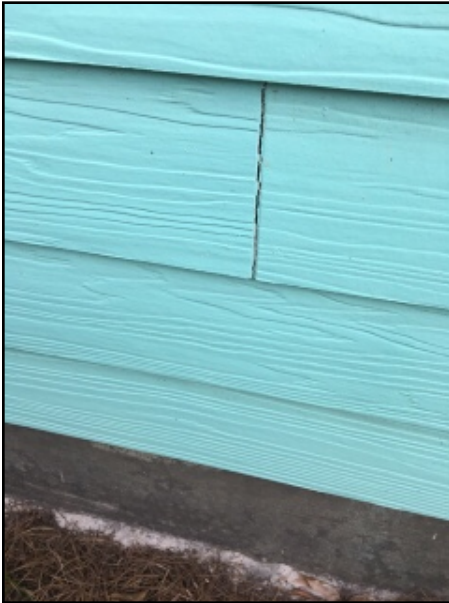
Figure 8-1

2) Caulk needs to be replaced to prevent moisture intrusion.
This can be done by the
homeowners or handyman.

Caulk needs to be replaced to prevent moisture intrusion. This can be done by the homeowners or handyman.

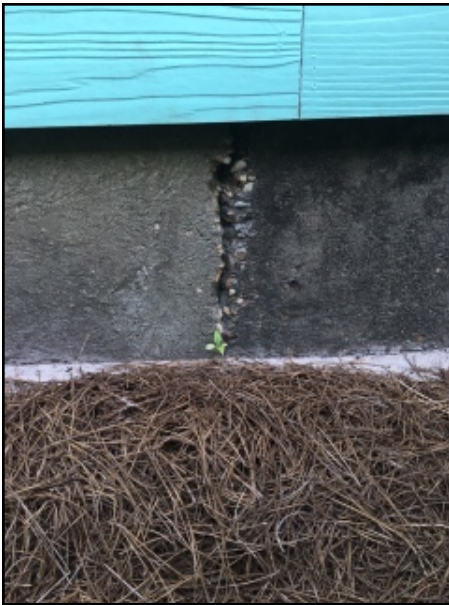
Figure 10-1

i Comment 10:
This is a cement joint where an addition was added. It is not a structural issue

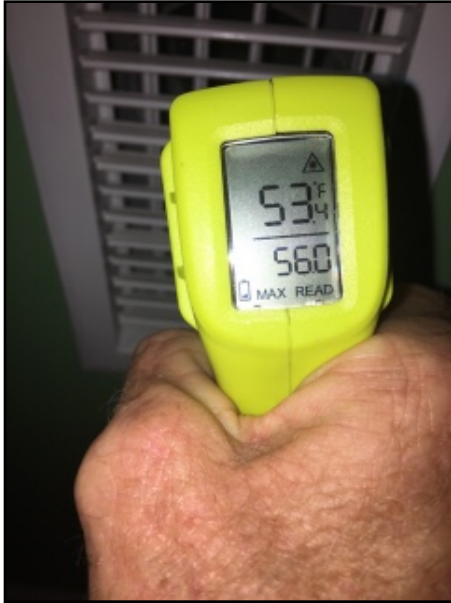
Figure 13-1

Comment 13:
53°F.

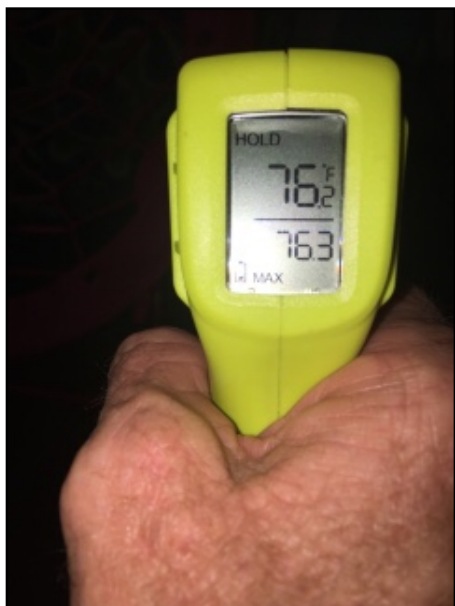
Figure 14-1

Comment 14:
76°F.

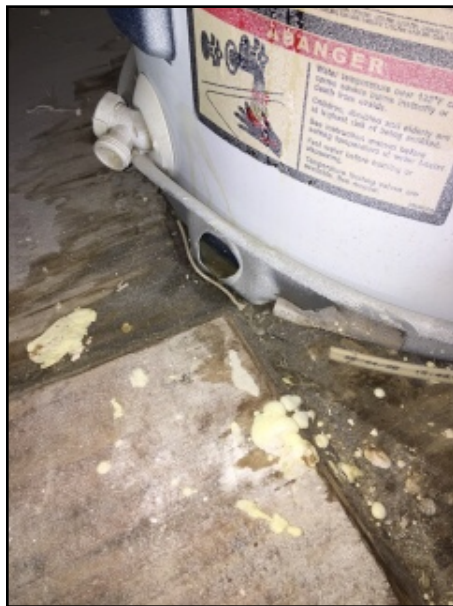
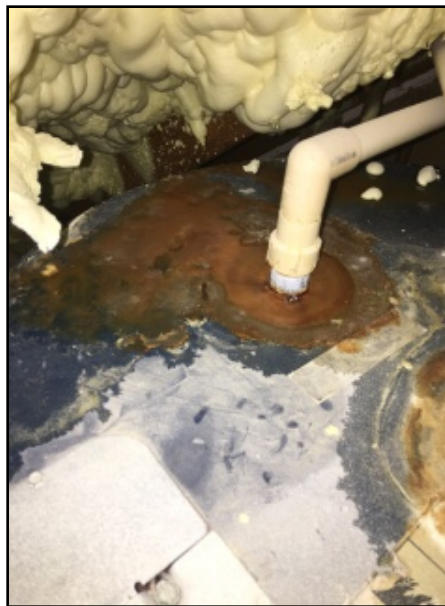
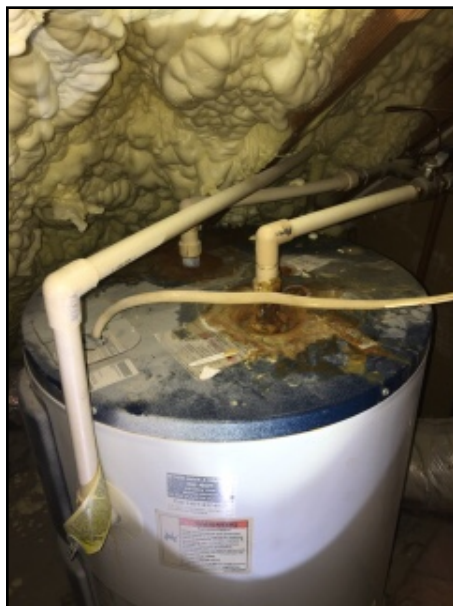
3) Water heater has an active leak.
The water heater is located in attic and it does not drain to the exterior. Should there be a problem with the water heater in the future there is a possibility of water damage to the rooms below. This should to be corrected by licensed plumber.

Water heater has an active leak.

The water heater is located in attic and it does not drain to the exterior. Should there be a problem with the water heater in the future there is a possibility of water damage to the rooms below. This should to be corrected by licensed plumber.

Manufacturer:	Whirlpool
Fuel:	Electric
Capacity:	28 gal
Approximate Age:	2007
Temp & Pressure Relief Valve:	Present With Blow Off Leg Condition: Satisfactory
Fuel Disconnect:	Downstairs electric panel
Recommendations :	Further evaluation by a licensed plumber. Condition: Repair or Replace
