I spent some time reviewing the alarms for the EF-11 fan failures and this is what I found. You will notice the fan status to “on” follows the comand failure by at least 4 hours in every instance. Therefore, fails the immediate command to run.

Alarms are being issued and recorded that appear to be in error and are non-synchronous to operation of the unit EF-11.

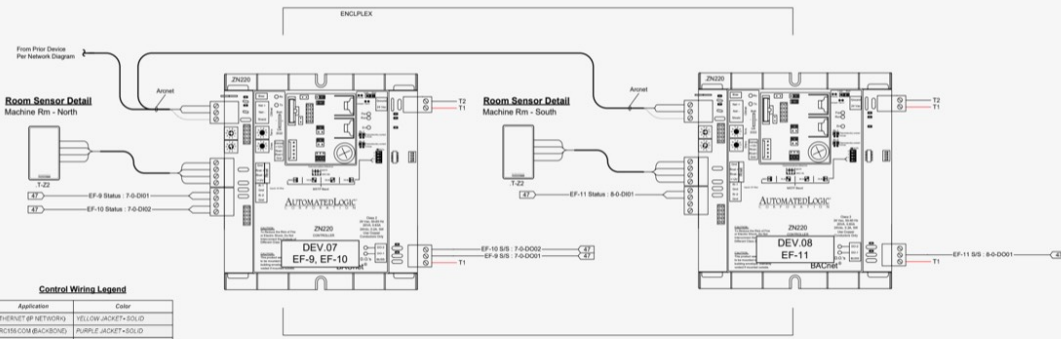
Propeller Exhaust Fan Detail

According to the as-built drawings supplied by your organization (see below). The controller is shown wired to a RIB relay (not found) at the fan unit and there is no integral damper actuator shown that opens the OA damper before fan operation either. No Sequence Of Operation (SOO) is described.

Examining the control panel I found one, not two controllers, operating both rooms with EF-9,10,&11. The fans are wired to existing IDEC “ice cube relays” in the old Honeywell panel and appear to have DO1 output connect to orange wire and DO2&3 (EF-9&10) with gray wired to the outputs and spliced to white wire at the relays (why?). There is a newly installed spring return Belimo actuator wired to open each exhaust fan damper and (I assume) the power to the fan is wired through the limit switch on the actuator, requiring "proof of open" before the fan starts. The as-built diagram in no way represents this.

Please have your technician review the programming and wiring and have the programs corrected. Also, correct the erroneous as-built document to the correct wiring and controller name and address.

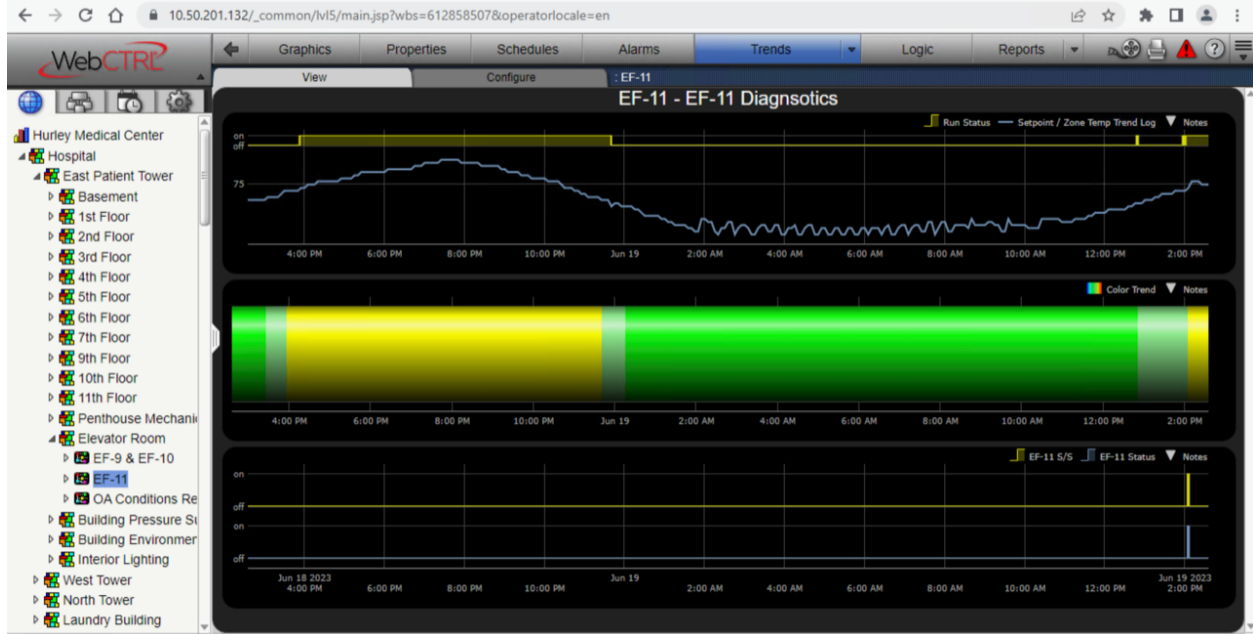
I discovered this after reviewing the graphics and putting some trends to them. When putting the fan in "on" in the EF-11 graphical "Unit override" switch the graphics shows a command of "on" for the output. However, at the controller wired to the relay, (DO1) does not energize. It does nothing. Unless overridden in the logic on the graphic dedicated to EF-9 & EF-10- which shows EF-11 on that logic does DO1 energize. So I am not sure any of the logic or graphics on EF-11 graphic is doing anything correctly.

This trend **discloses the fan works fine and does not run and is not commanded on???**- and was only commanded on by me- the far right yellow and blue "blips".

Physical checkout , after seeing the wiring and going to the EF9&10 logic page was simple and worked for EF-11. However, overriding teh zone temperature for the EF-11 Zone on the EF-11 graphics page shhowed a cooling 100% response but no actual fan came on.
