Phase I Environmental Site Assessment Addendum

US 30 Corridor Improvements Project – Western Section

**North Versailles and North Huntingdon Townships
Allegheny and Westmoreland Counties, Pennsylvania**

Markosky Project File 15-003B

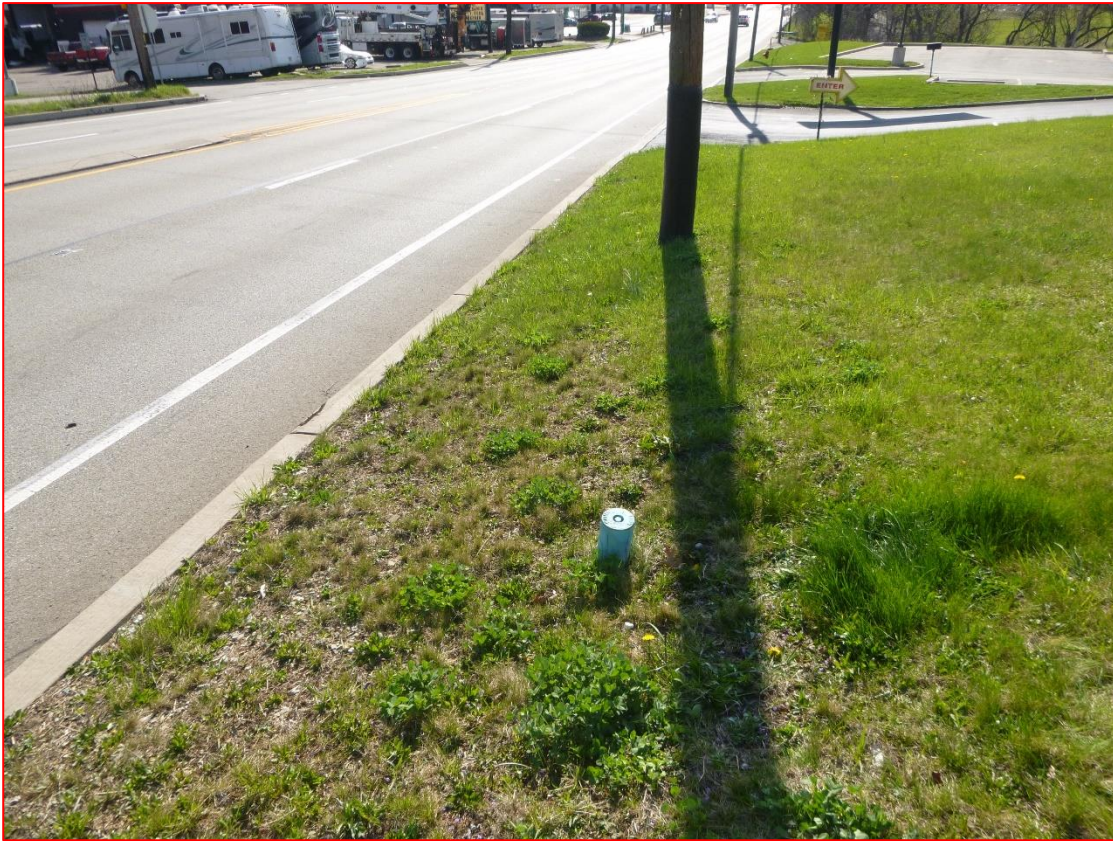
The study area was extended north to include a segment of Route 30 adjacent to Costa Oil (a quick oil-change business) and a bump-out between the business sign and power pole on the west side of the road. The extension contained a stormwater drainage grate and sewer access cover on the east side of the road; two stormwater drainage grates were present in the Costa Oil driveway, and one was present in the O'Reilly's driveway, all outside of, but adjacent to, the study area. A water line access point was located on the west side of Route 30 in the study area bump-out.

Photo 1: Costa Oil Greenspace, Water Line – Facing Southeast (04.12.2023)

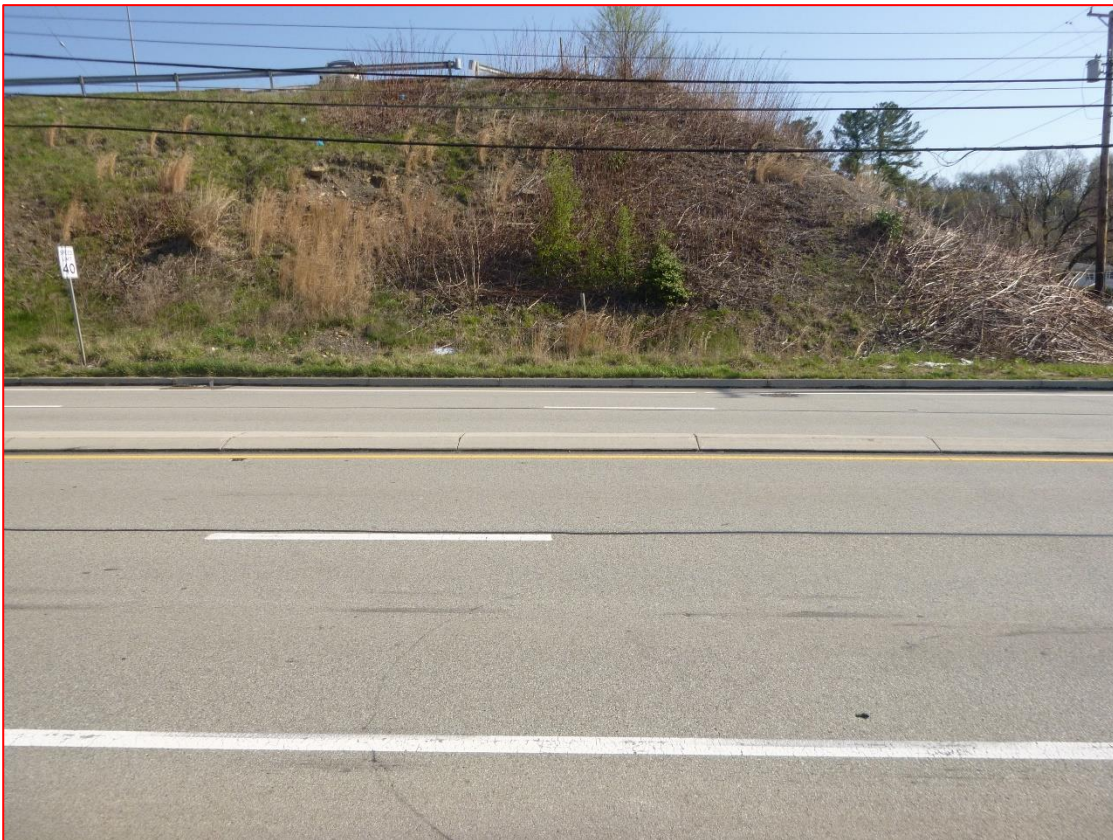
Photo 2: Route 30 extended study area encompasses roadway, sewer access cover, stormwater drainage grate – Facing Northeast (04.12.2023)

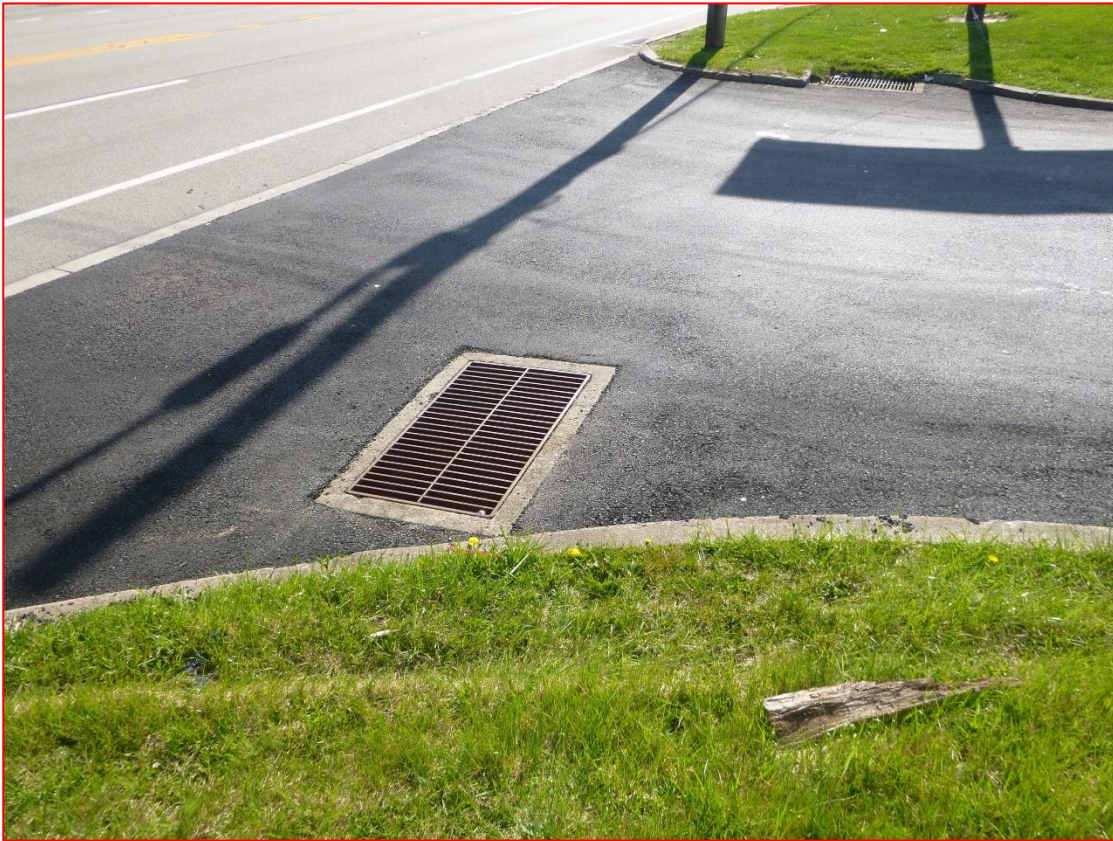
Markosky spoke with Jay Divito, the manager of Costa Oil, located at 1716 Lincoln Hwy, North Versailles, PA 15137. Jay mentioned that the business has been in operation for 20-30 years, with frequent collisions from customers turning left from the westbound lanes into both Costa Oil and their neighbor to the south, O'Reilly's Auto Parts.

Photo 3: Costa Oil driveway and stormwater drainages – Facing Southeast (04.12.2023)

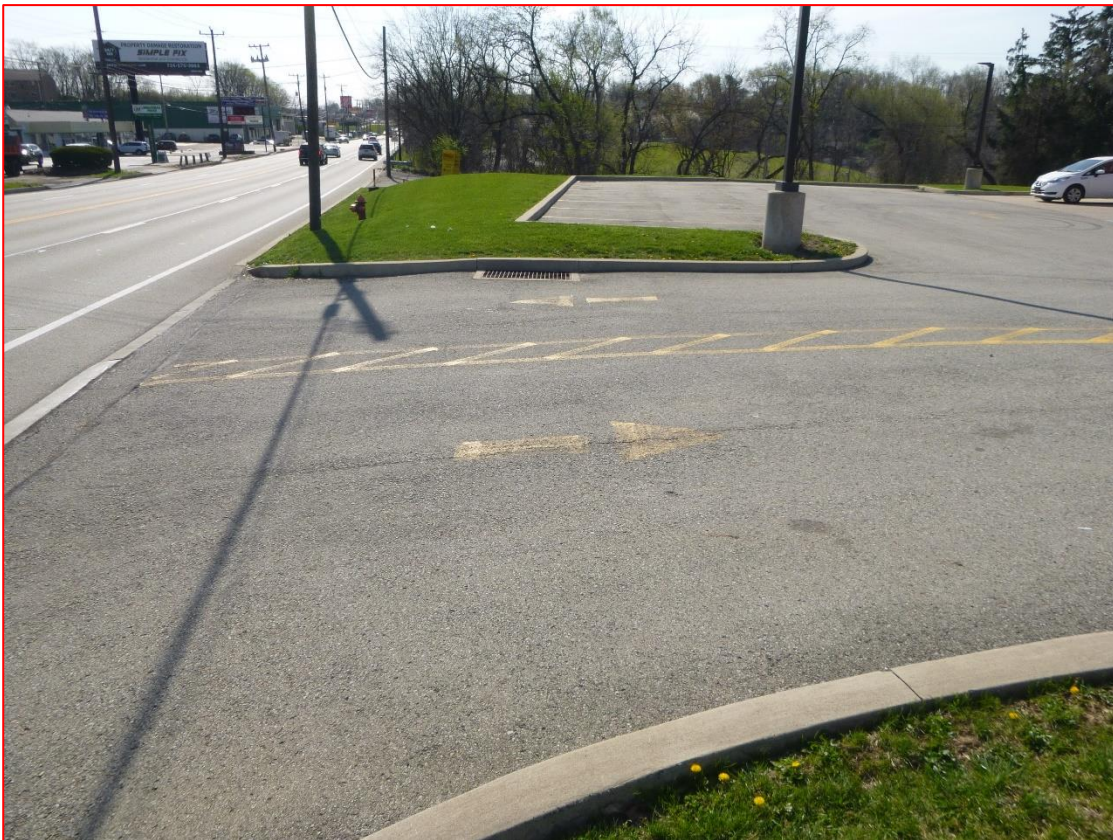
Photo 4: O'Reilly's Driveway and stormwater drainage grate – Facing Southeast (04.12.2023)

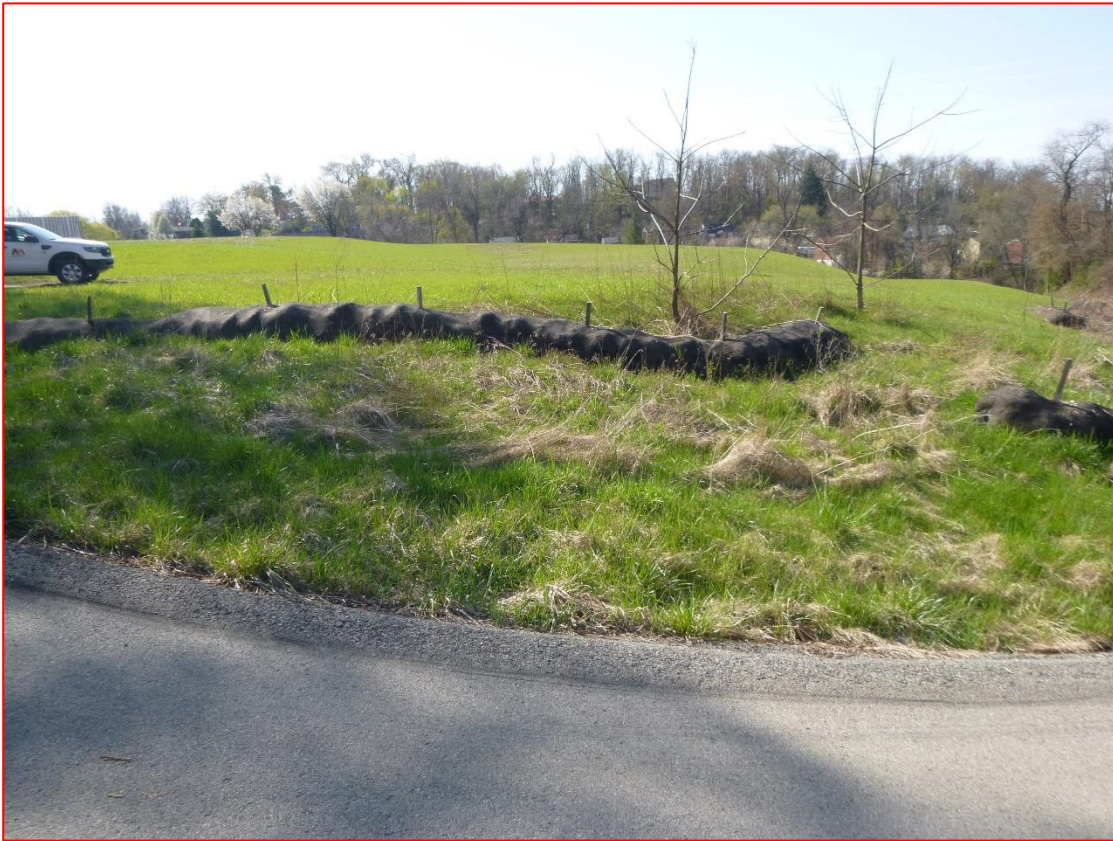
Two sewer access covers were located near the road bend as the road turned west, adjacent to the expanded area where a vacant lot was, with the cover to the south inside the study area and the cover to the north outside the study area. The vacant asphalt lot documented in the previous field visit was not present, having been removed and replaced with soil and grass seed. Filter socks were placed along Hoffman Road on the south and west side along the embankment. A gas line was located near the former driveway into that lot.

Photo 5: Hoffman Road Vacant lot – Facing South (04.12.2023)

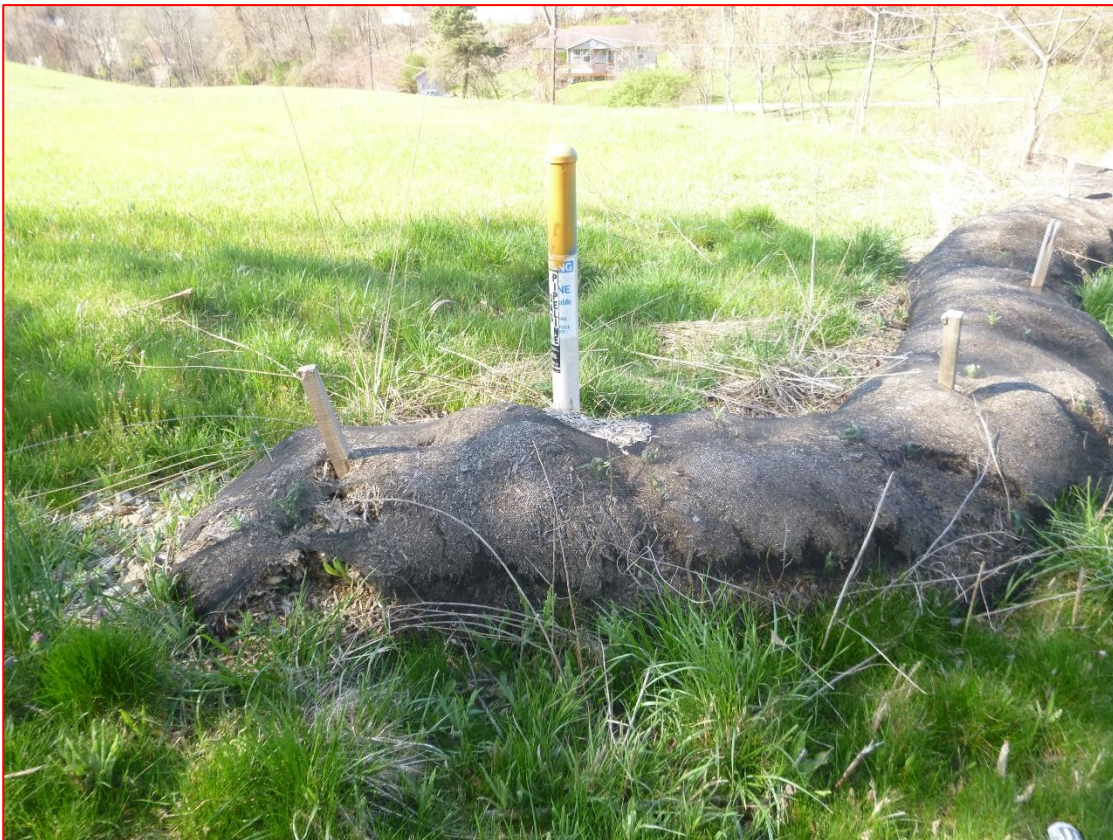
Photo 6: Hoffman Road Vacant lot – Facing South (04.12.2023)

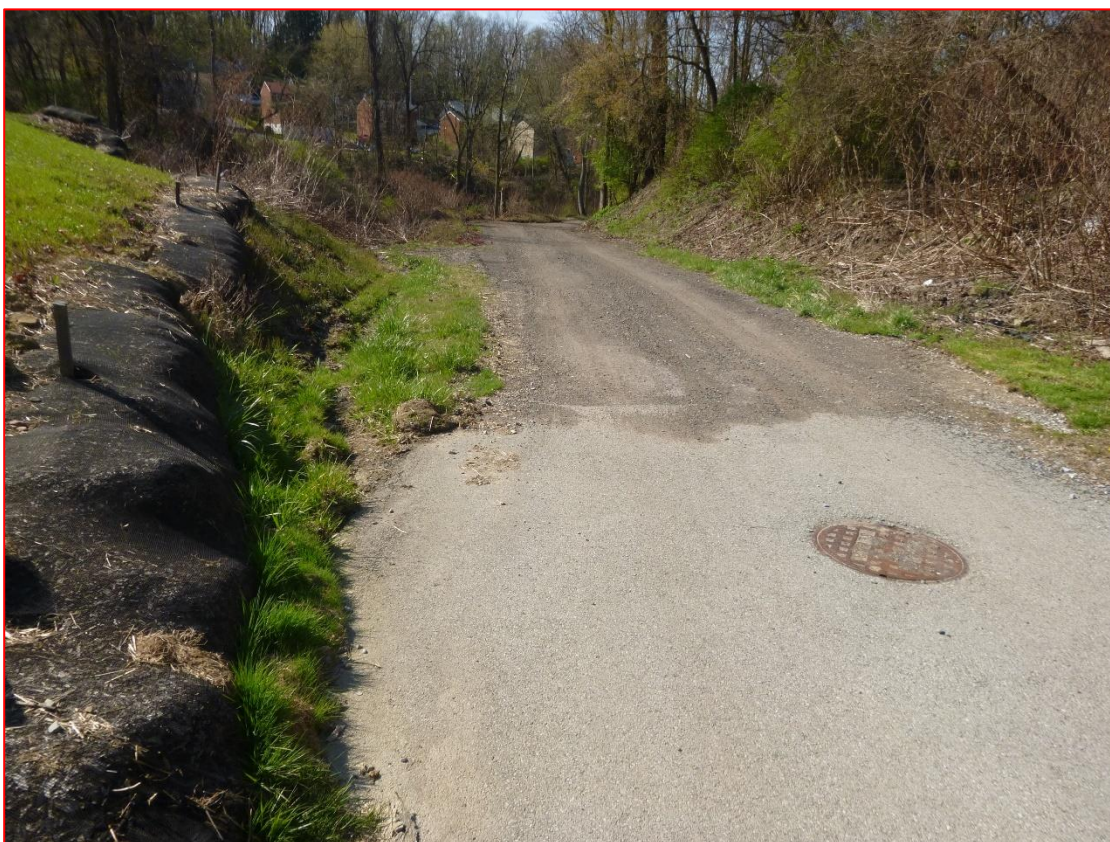
Several stormwater drainage grates were present along the road, with two of the grates within or adjacent to the expanded study area. One sewer access cover was observed at the end of the paved section of the road.

Photo 8: Hoffman Road sewer access within the southern extent of the Hoffman road study area – Facing Northwest (04.12.2023)

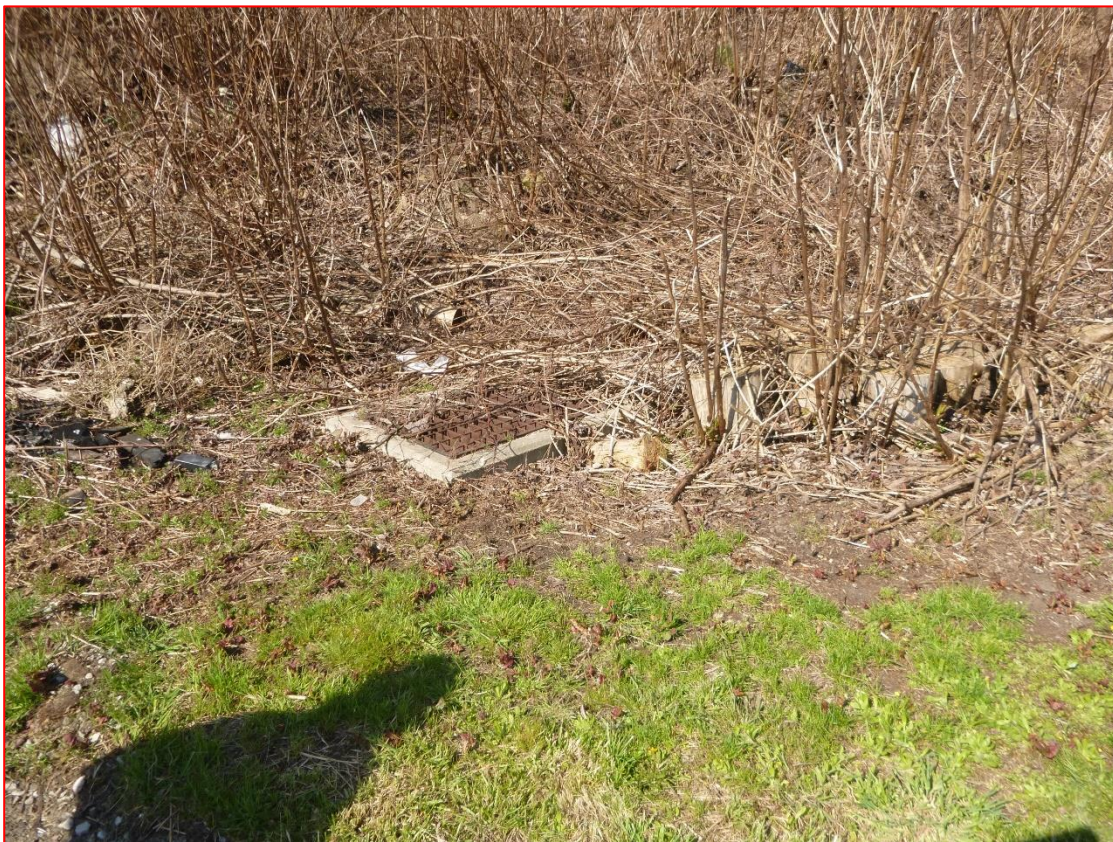
Photo 9: Hoffman Road Stormwater Drainage grate adjacent [west of] to the southern extent of the Hoffman road study area – Facing Northwest (04.12.2023)

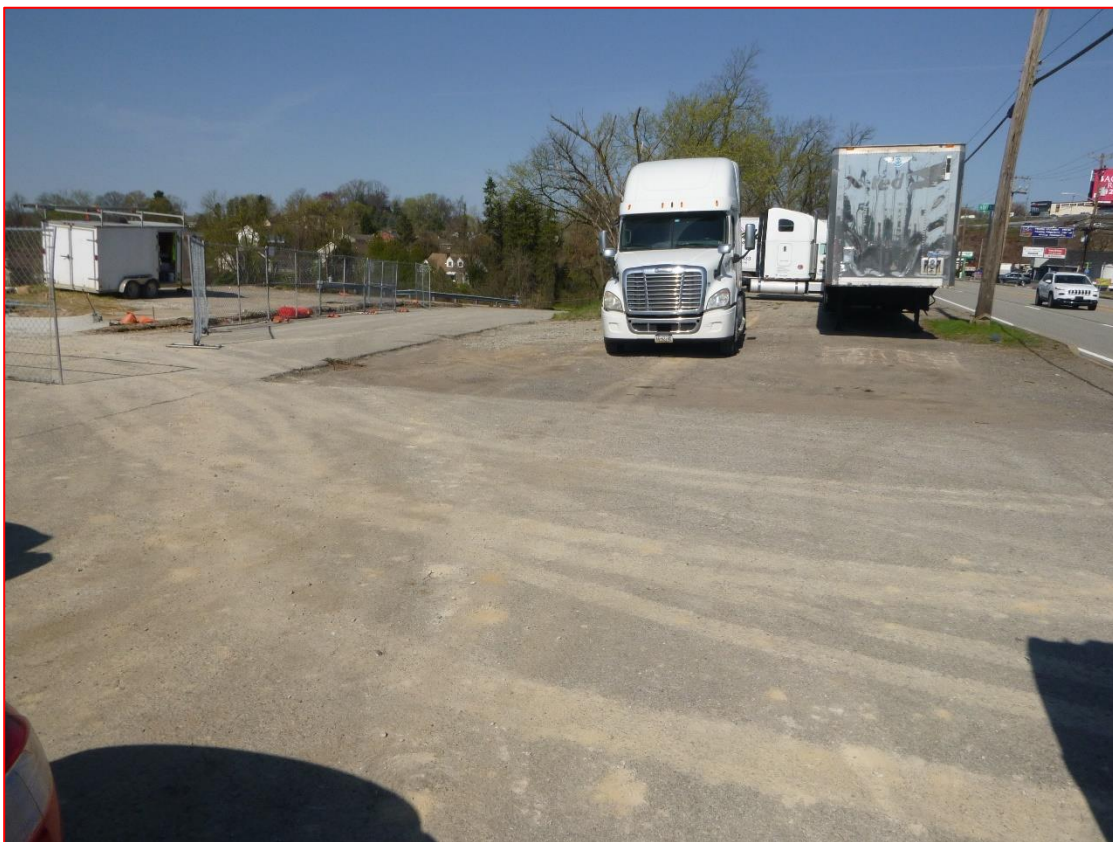
Photo 10: Hoffman Road Entrance, new construction adjacent – Facing Northwest (04.12.2023)

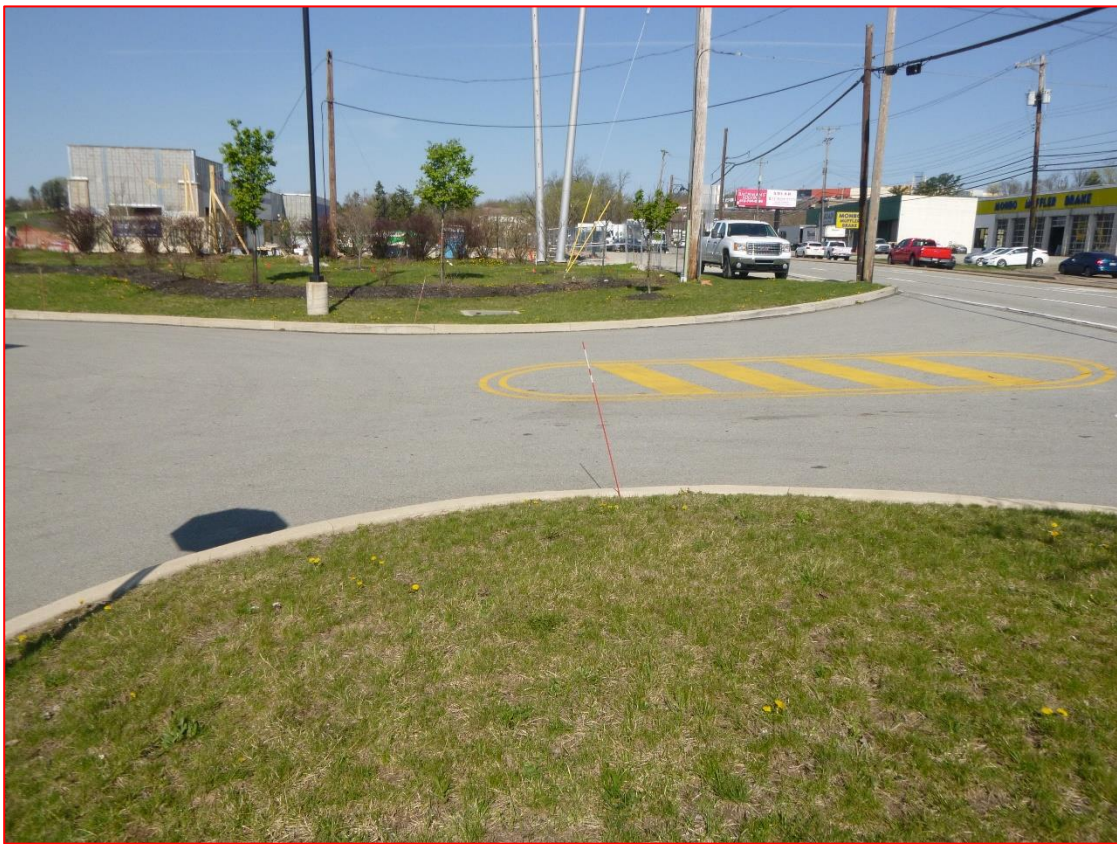
The study area was expanded to include the access driveways closest to the intersection of Jacks Run Road and Route 30 at the northwest corner, accessing the GetGo fuel and service station. The eastern drive and green spaces along Route 30 included the asphalt lot and a maintenance access panel on the northern side of the driveway. No other changes were documented.

Photo 11: Route 30 entrance to Getgo – Facing Northwest (04.12.2023)

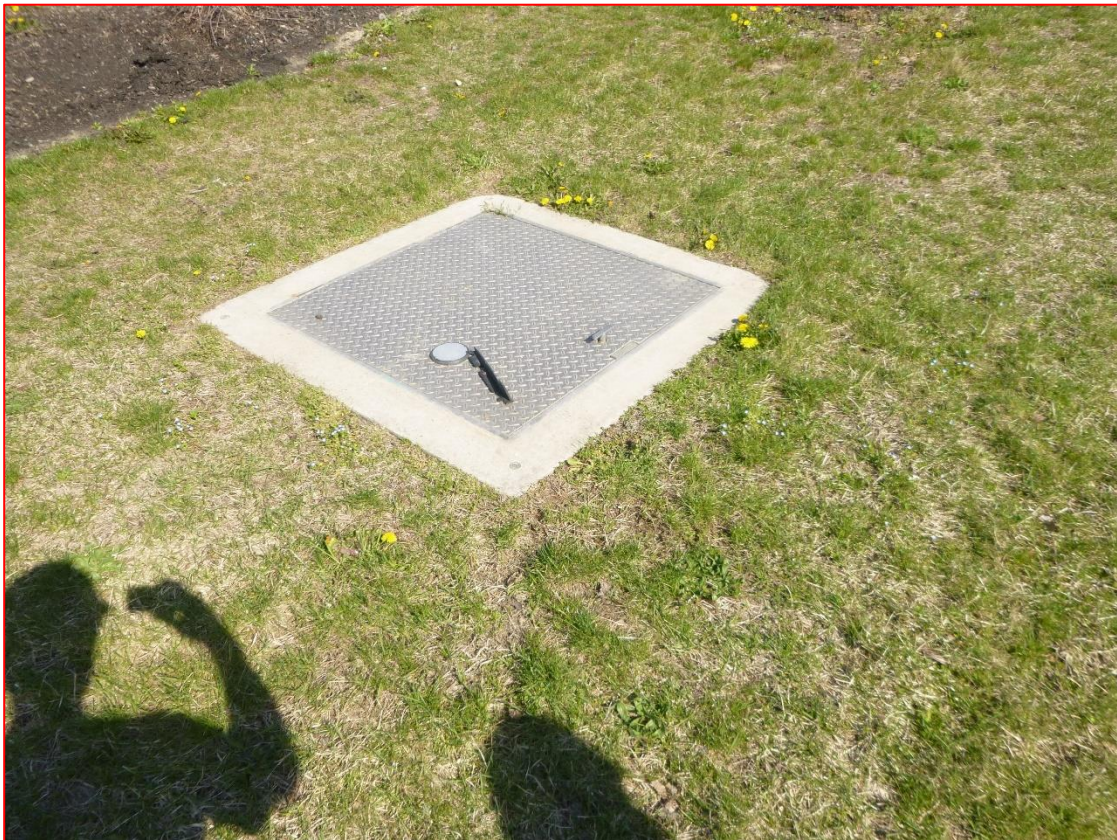
Photo 12: Maintenance Access Panel near Route 30 driveway to Getgo – Facing North (04.12.2023)

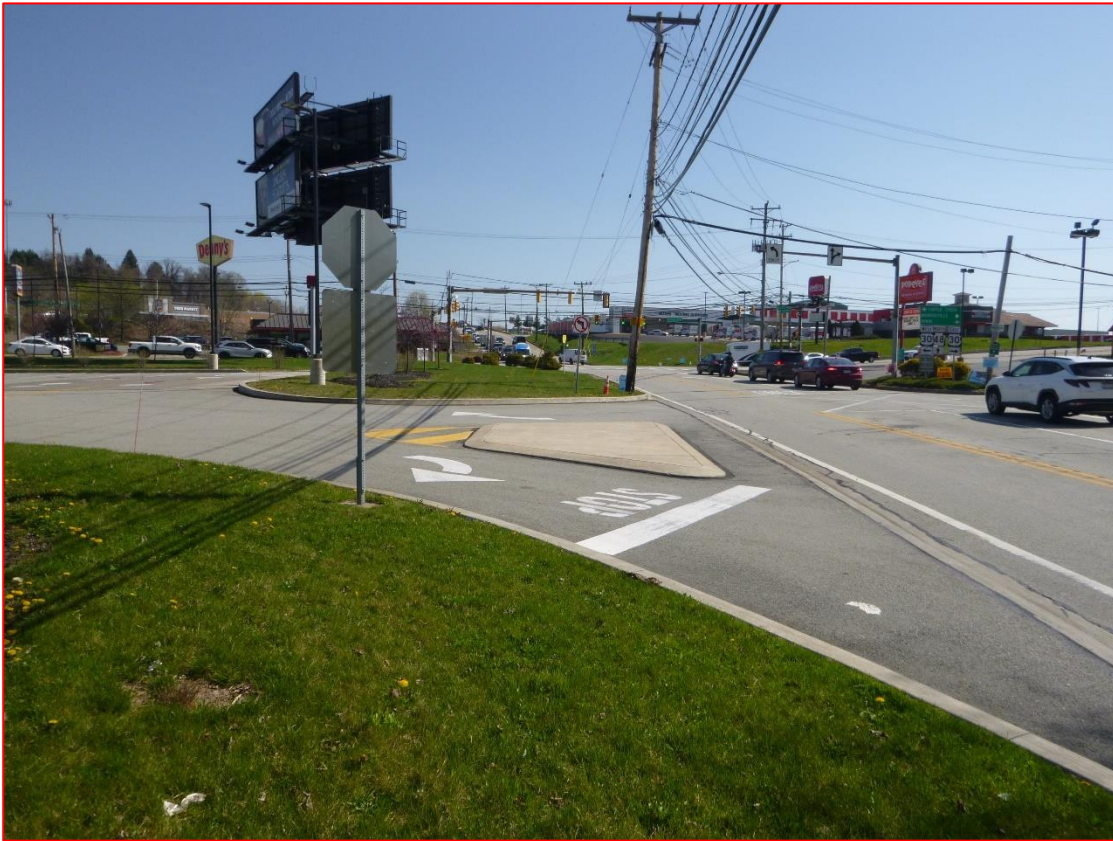
The western drive along Jack's Run Road contained an access panel adjacent to one of the lot light poles. The eastern drive along Jack's Run Road was nearest to the fill ports for the concrete UST basin in the GetGo lot and a sewer access cover.

Photo 13: Jacks Run Road driveway to Getgo – Facing Northeast (04.12.2023)

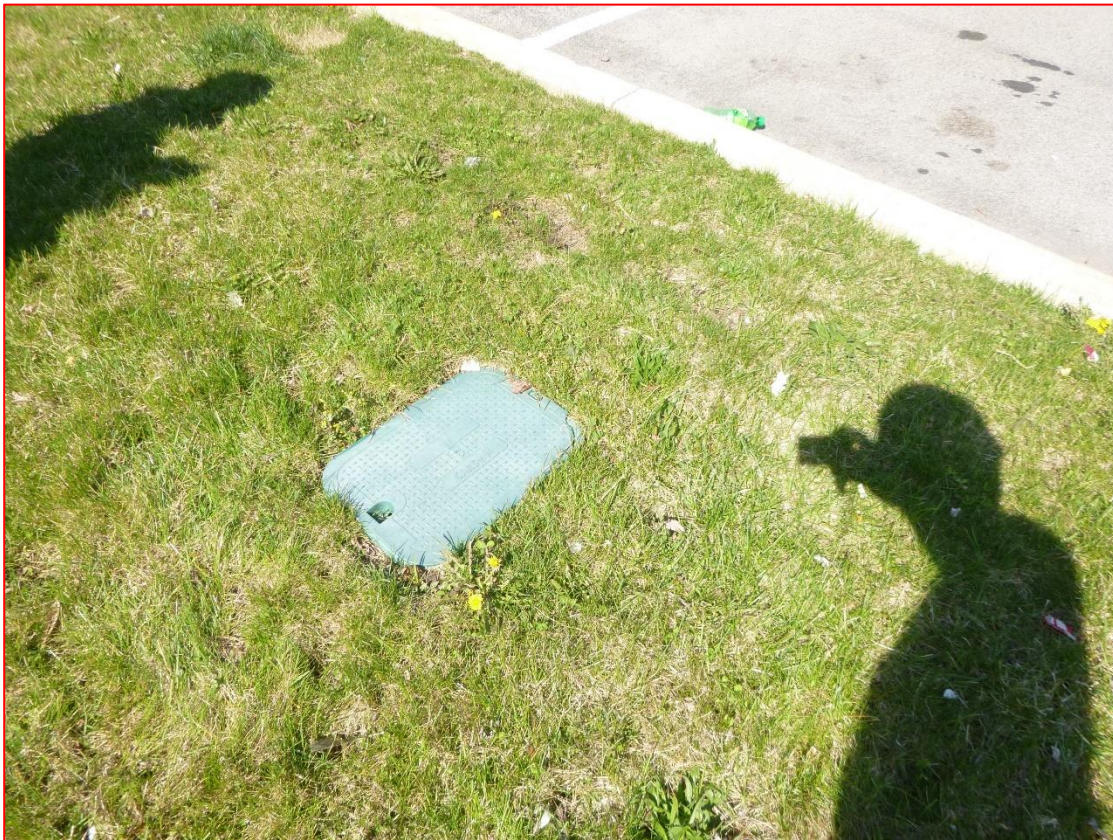
Photo 14: Getgo near Jacks Run Road, small electrical access panel – Facing Northwest (04.12.2023)

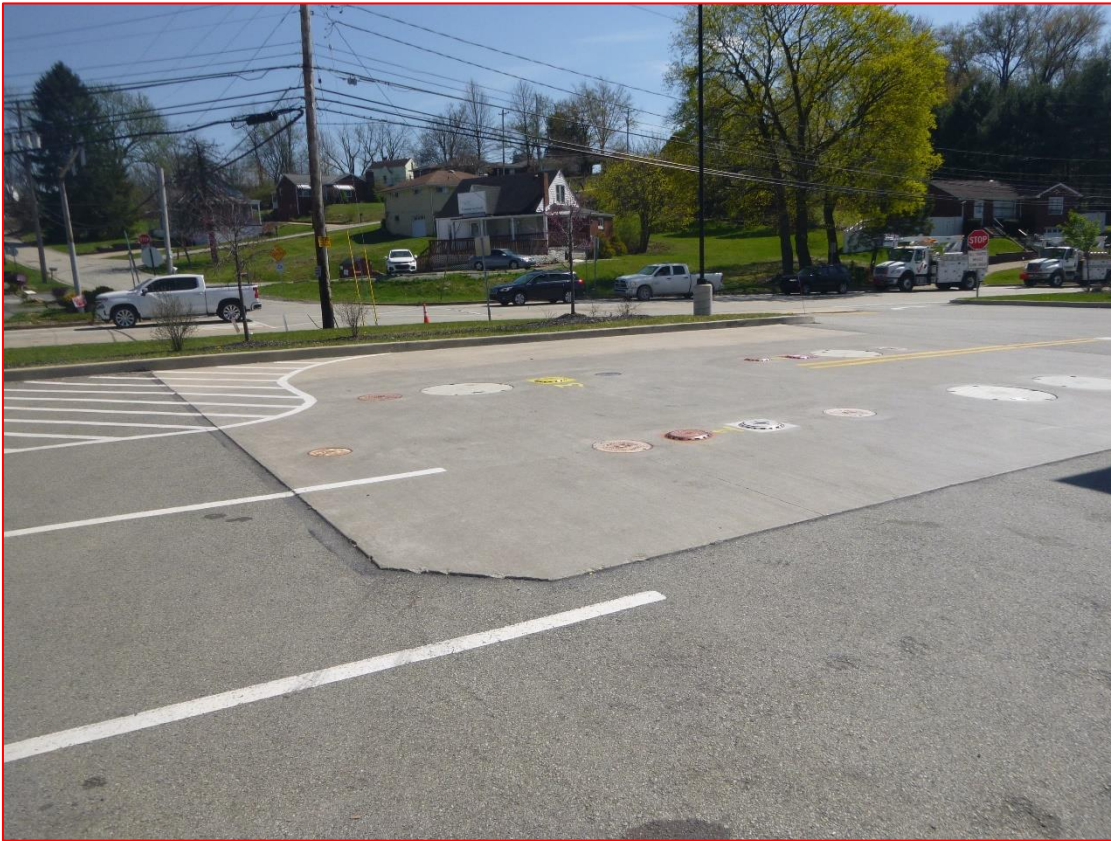
Records for the permitting of the underground storage tanks located at the site (Site ID: 842239, Permit 1309750) included a 20,000-gal gasoline underground storage tank (UST), a 6,000-gal gasoline UST, and a 6,000-gal diesel UST. The records for the facility are limited, as the facility was still under construction at the time of the original field investigation (then labeled "Marathon/GetGo Construction Site in the field photographs). Two violations are listed for the facility in the DEP eFacts database, one for a failure to comply with UST system monthly operation and maintenance walkthrough inspections and another as failure to meet performance standards for new/upgraded tanks, both of which show a status of "corrected/abated".

Photo 15: Getgo UST basin at the northeast corner of the property – Facing Southeast (04.12.2023)

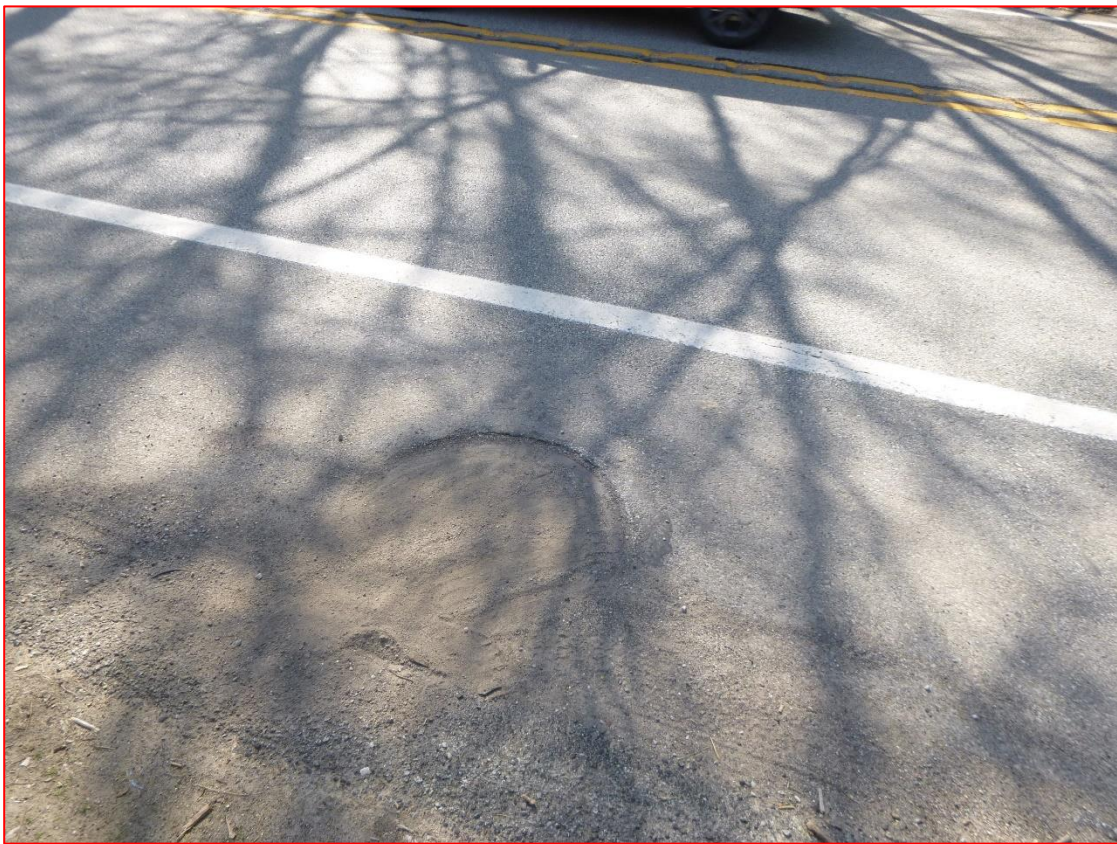
The study area was extended down Jacks Run Road past the entrances to GetGo and included a sewer access cover on the north side of the road nearest an office building. A gas pipeline was marked on the hillside across the road from the sewer access.

Photo 17: Jacks Run Road South, sewer access cover – Facing East (04.12.2023)

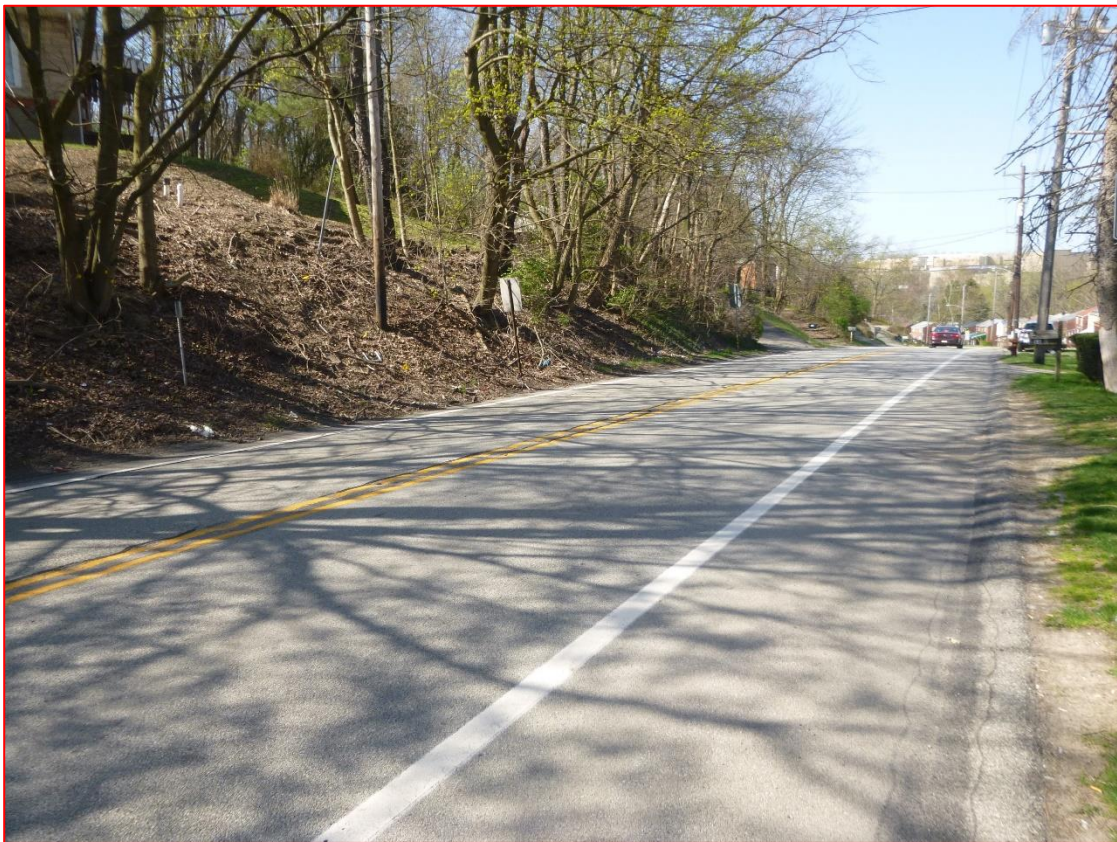
Photo 18: Jacks Run Road South – Facing Southwest (04.12.2023)

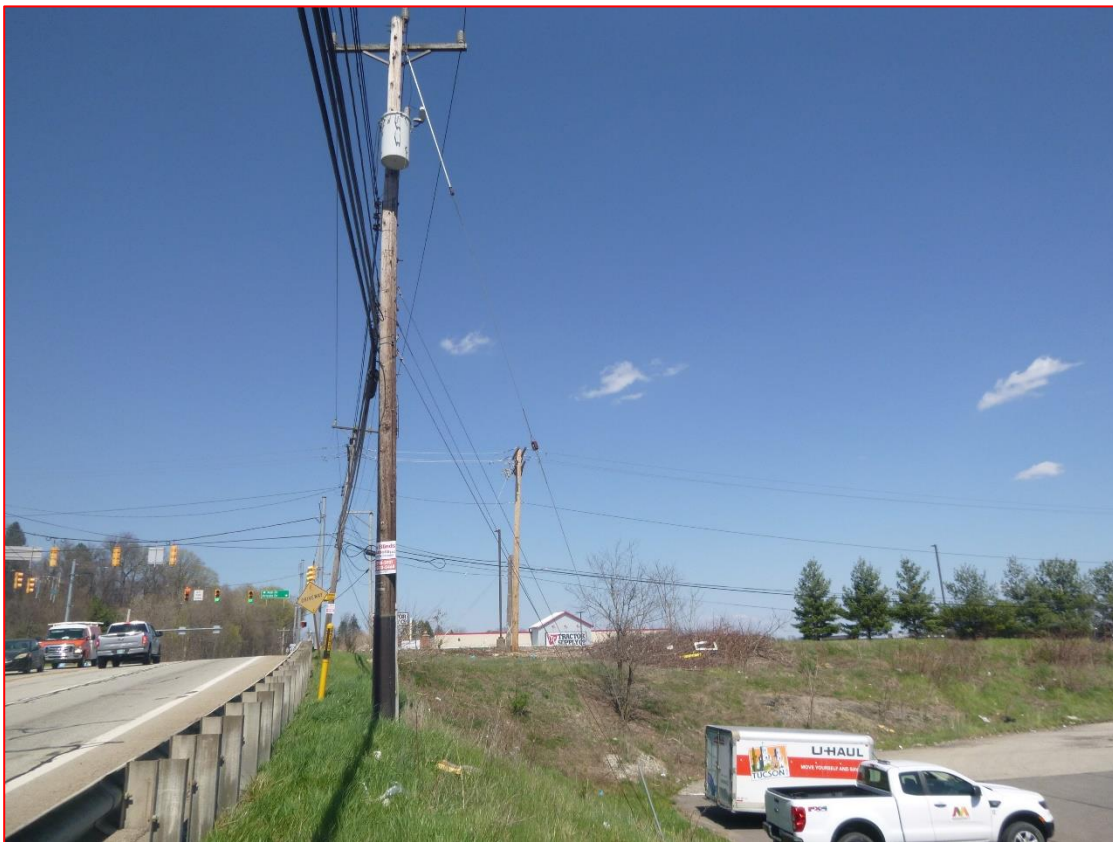
A portion of the study area branching off down Jack's Run Road travelling east from the intersection with Route 30 contained a pole-mounted transformer on the south side of the road, and a gas line access. The roadway and the included roadside areas were all low grasses and maintained greenspace. No other features were noted.

Photo 19: Jacks Run Road North area, Transformer and gas line adjacent to roadway – Facing Northeast (04.12.2023)

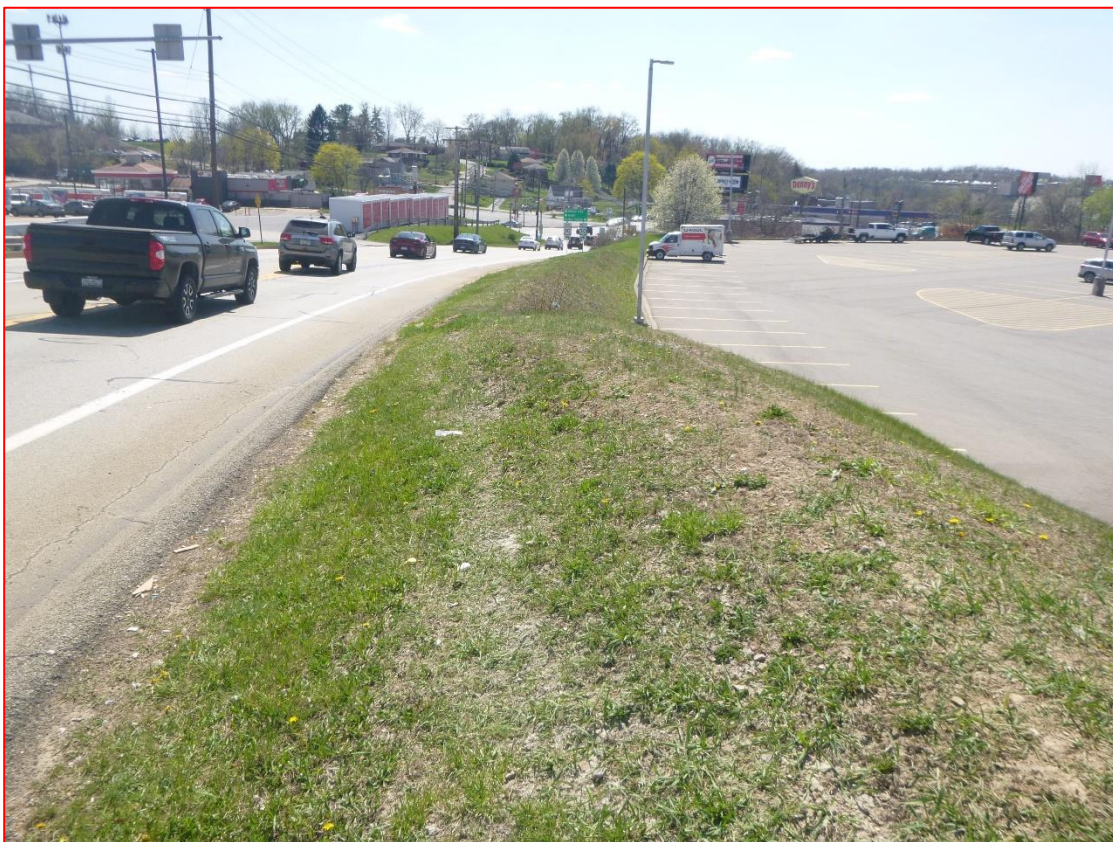
Photo 20: Greenspace on the west side of Jacks Run Road (north) – Facing Southwest (04.12.2023)

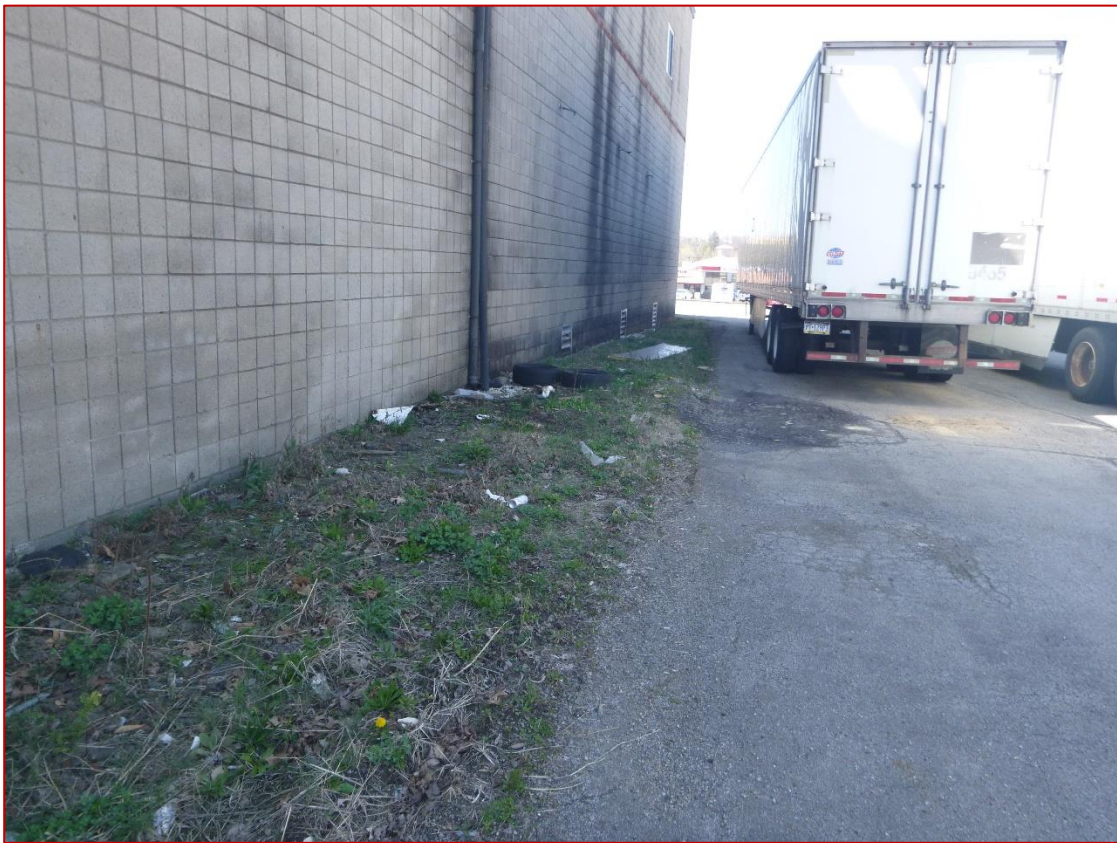
A small extension of the study area near the former K-mart parking lot behind Casa Dice contained a sliver of gravel between the asphalt lot and the Casa Dice structure adjacent to Route 30. A municipal waste dumpster was near the extension, as well as minor grass/herbaceous vegetation. No other features were noted.

Photo 21: Former K-Mart Parking Lot – Facing Northwest (04.12.2023)

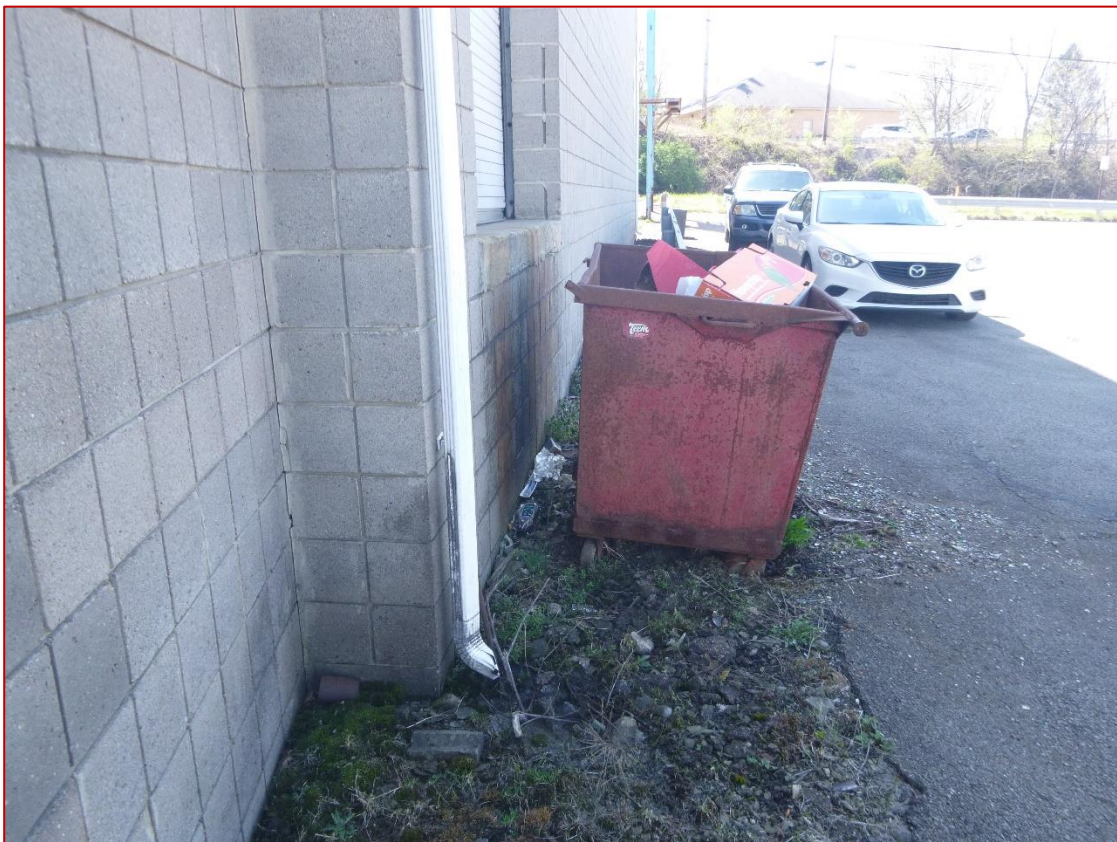
Photo 22: Former K-Mart Parking Lot – Facing Southwest (04.12.2023)

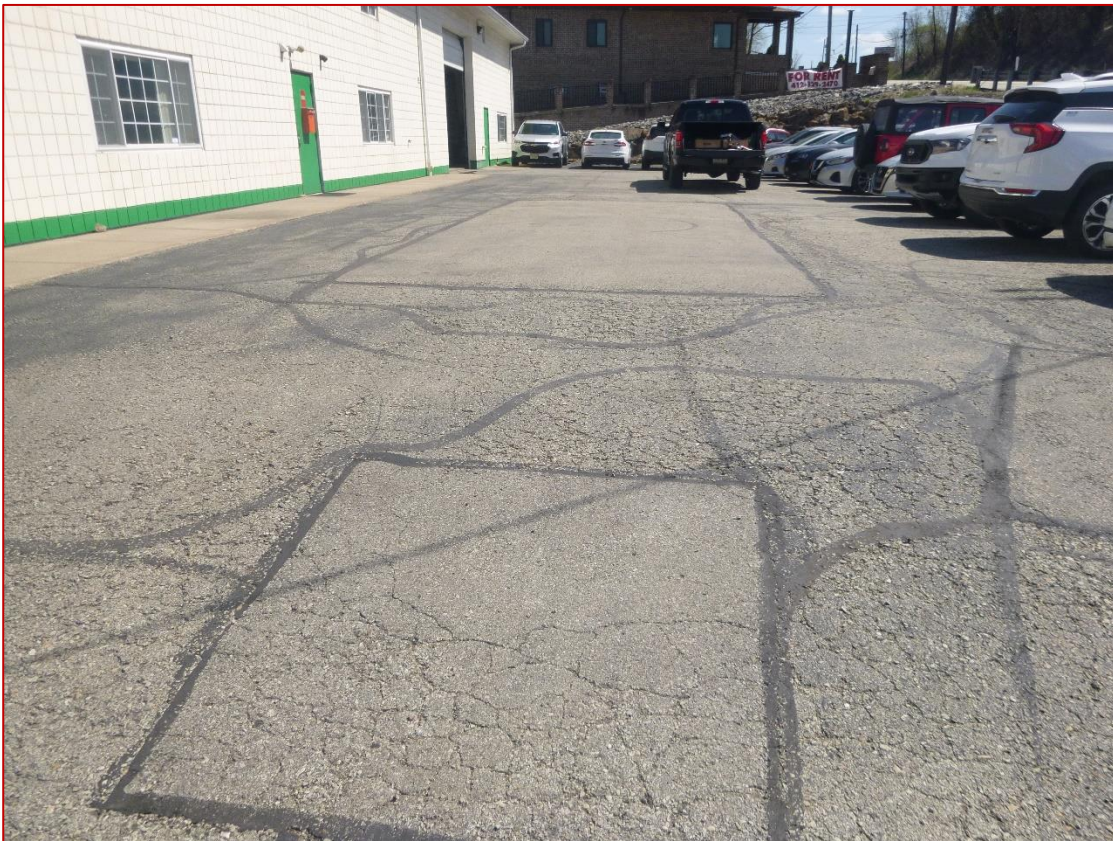
The study area was extended into the Dent Wizard asphalt lot; no additional features were noted.

Photo 23: Dent Wizard Lot – Facing South (04.12.2023)

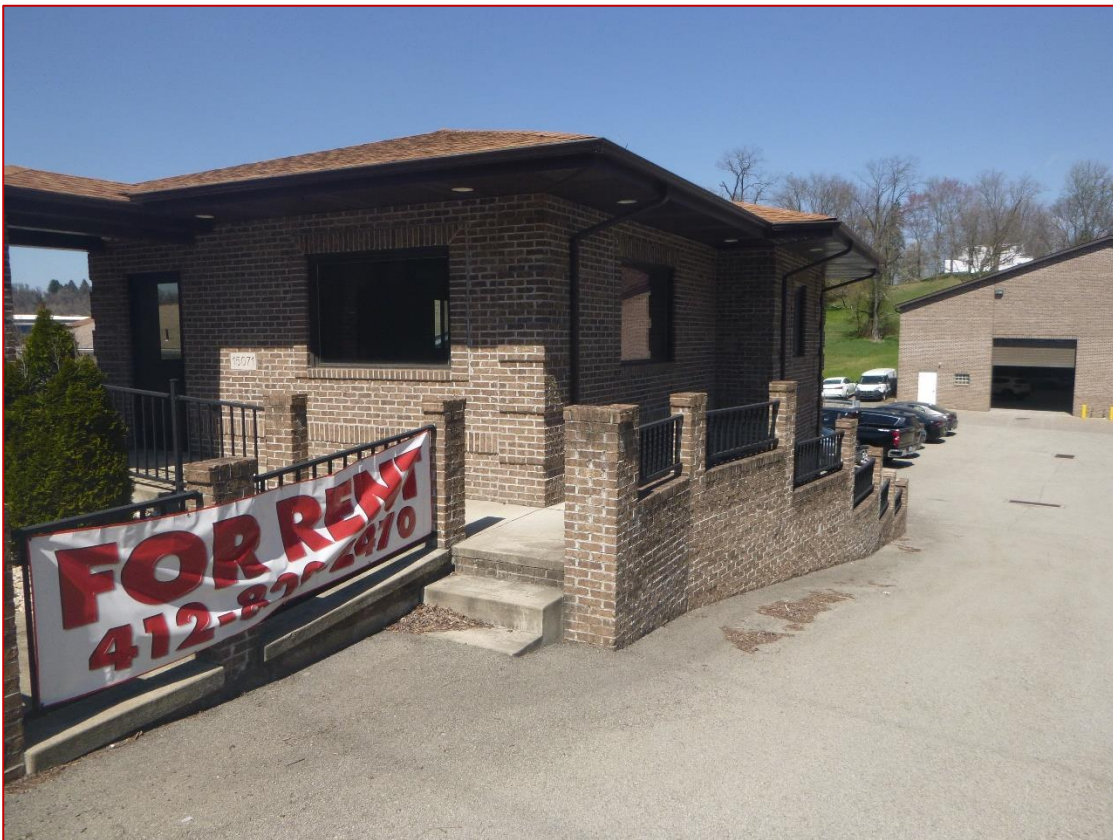
The asphalt lot surrounding the vacant building contained a set of small 6-in sewer maintenance access covers.

Photo 24: Vacant building and asphalt lot adjacent to Dent Wizard – Facing Northeast (04.12.2023)
