Phase I Environmental Site Assessment Addendum

US 30 Corridor Improvements Project – Western Section

**North Versailles and North Huntingdon Townships
Allegheny and Westmoreland Counties, Pennsylvania**

Markosky Project File 15-003B

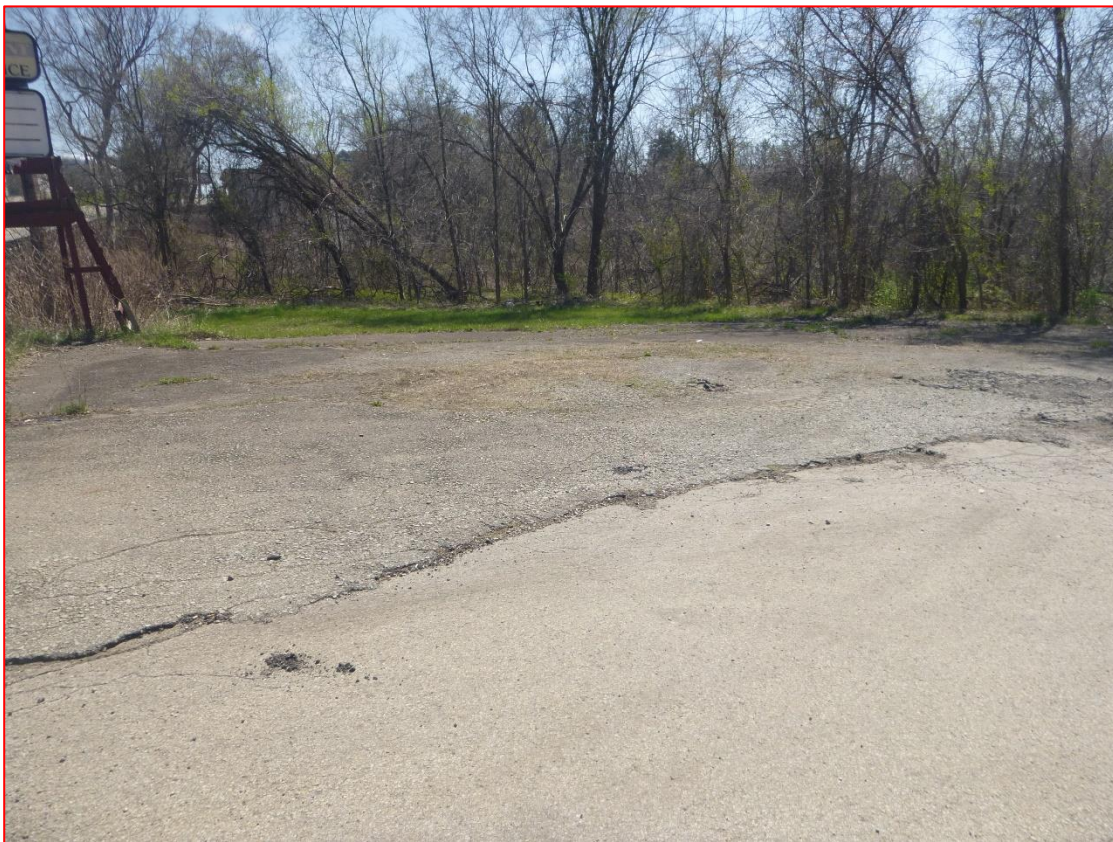
The northern expansion included the vacant asphalt parking lot south and adjacent to the restaurant structure and did not contain any features of concern during the site visit.

Photo 25: Liz's Restaurant lot – Facing South (04.12.2023)

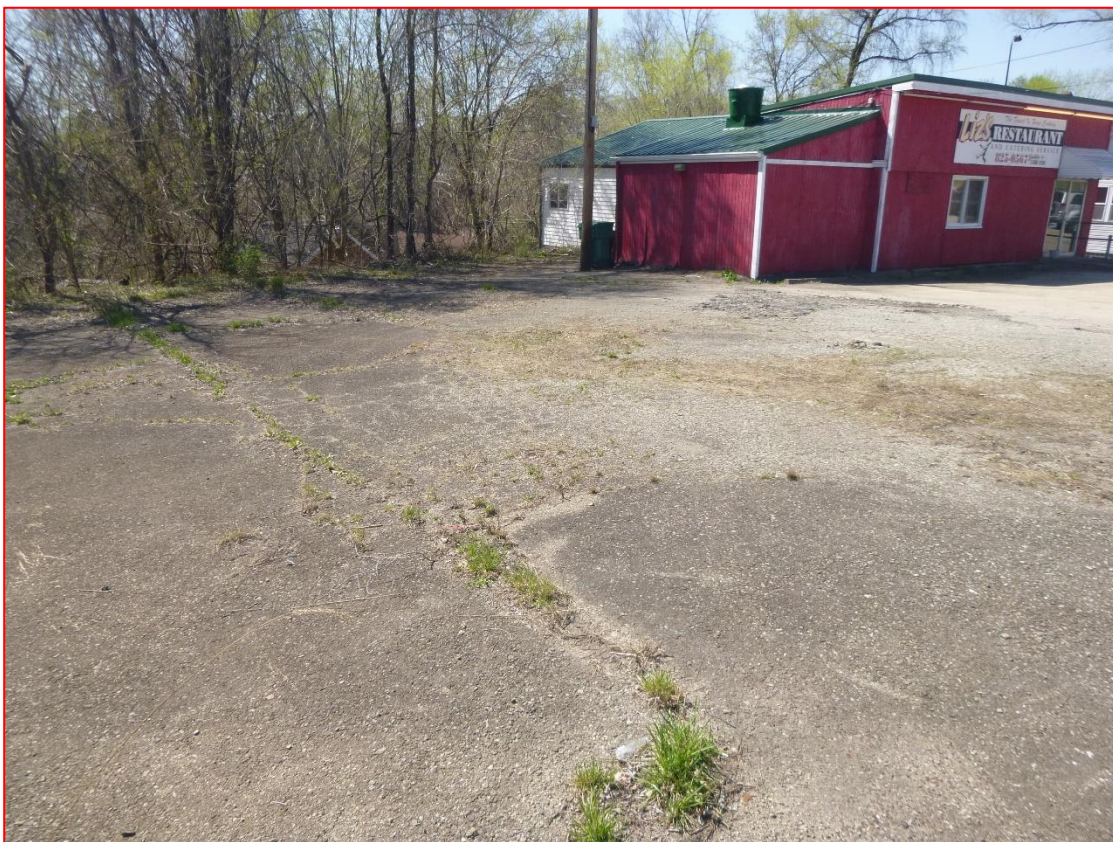
Photo 26: Liz's Restaurant Lot – Facing Northwest (04.12.2023)

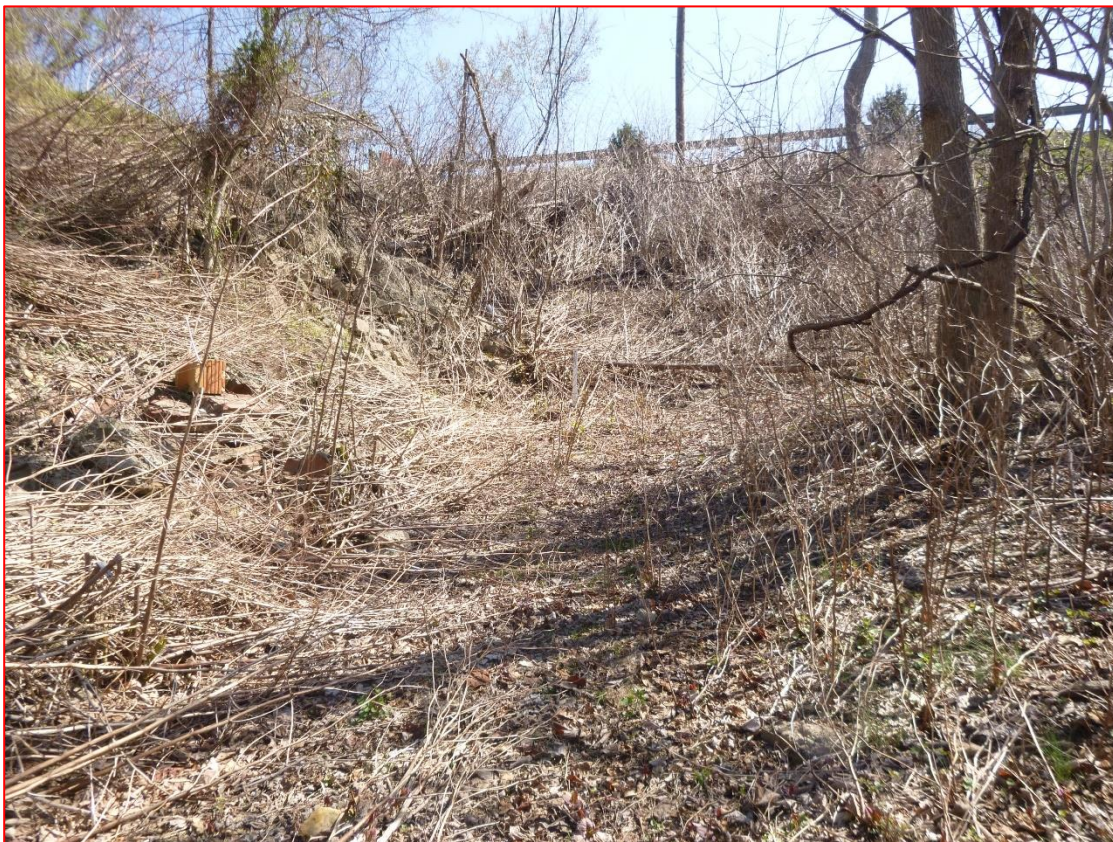
The southern study area extension was a sliver area along Route 30 south of the restaurant, containing a ravine with what appeared to be a dirt pathway/drive to access a sewer access cover at the base of the Route 30 embankment.

Photo 27: Liz's Restaurant South, gully access to sewer access cover – Facing East (04.12.2023)

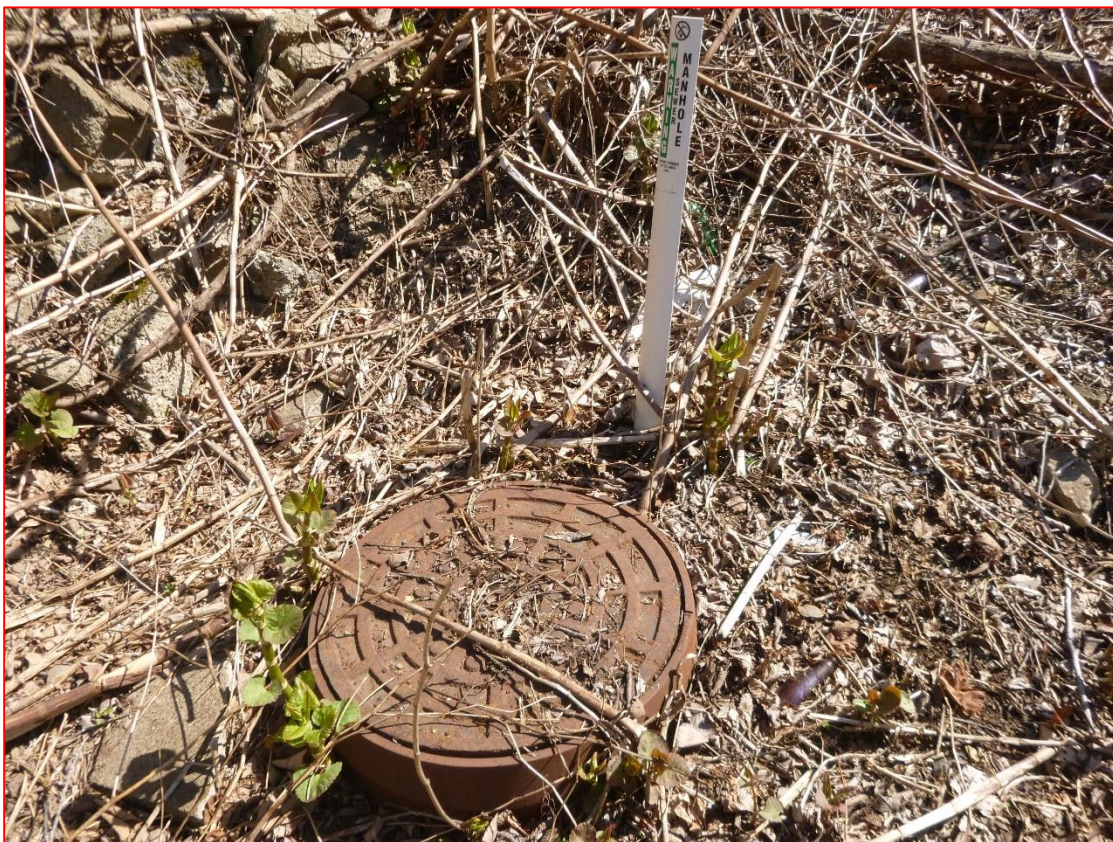
Photo 28: Liz's Restaurant South, sewer access cover – Facing Northeast (04.12.2023)

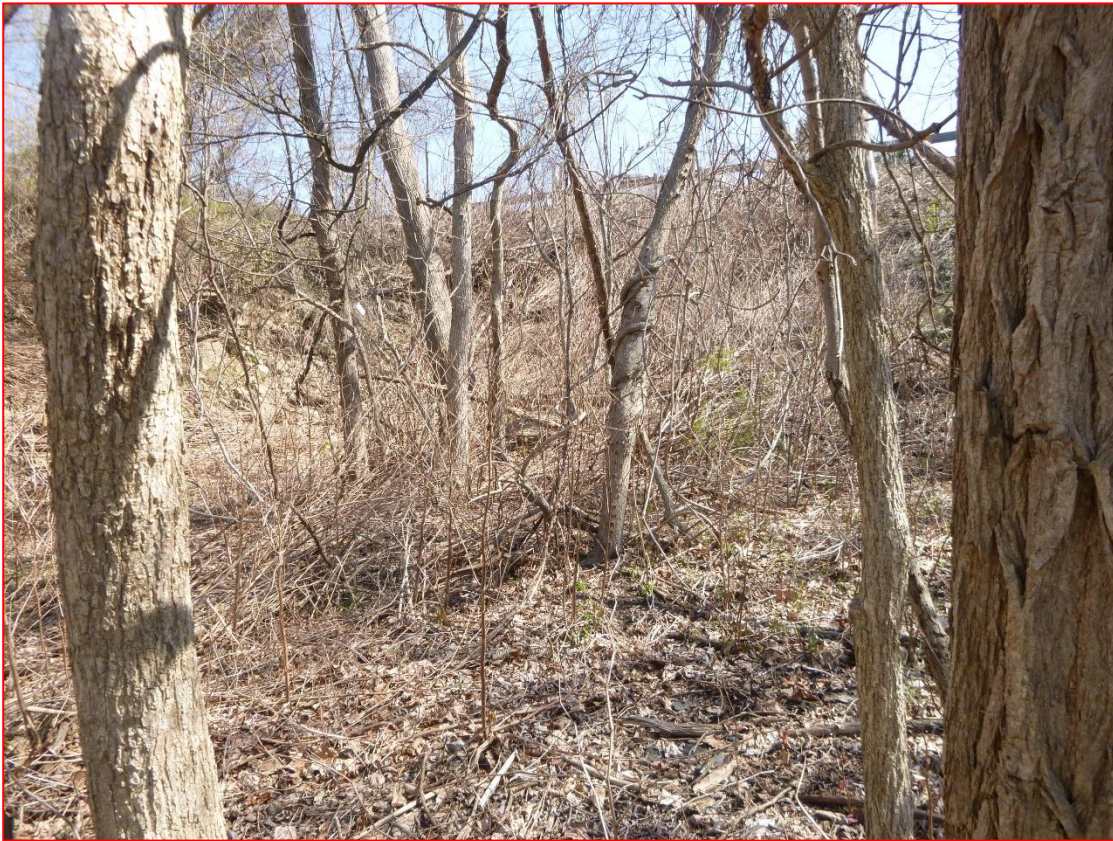
Photo 29: Liz's Restaurant South – Facing North (04.12.2023)

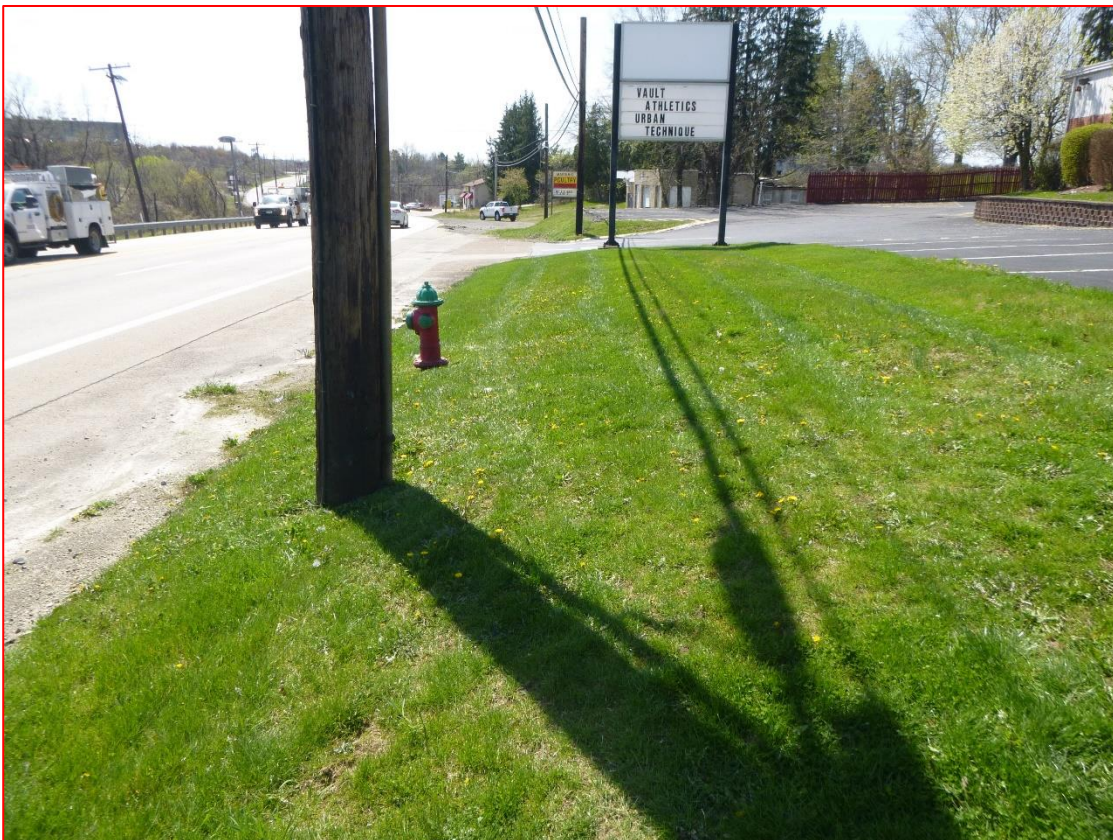
Photo 30: Massung Poultry North, residential lawn area – Facing South (04.12.2023)

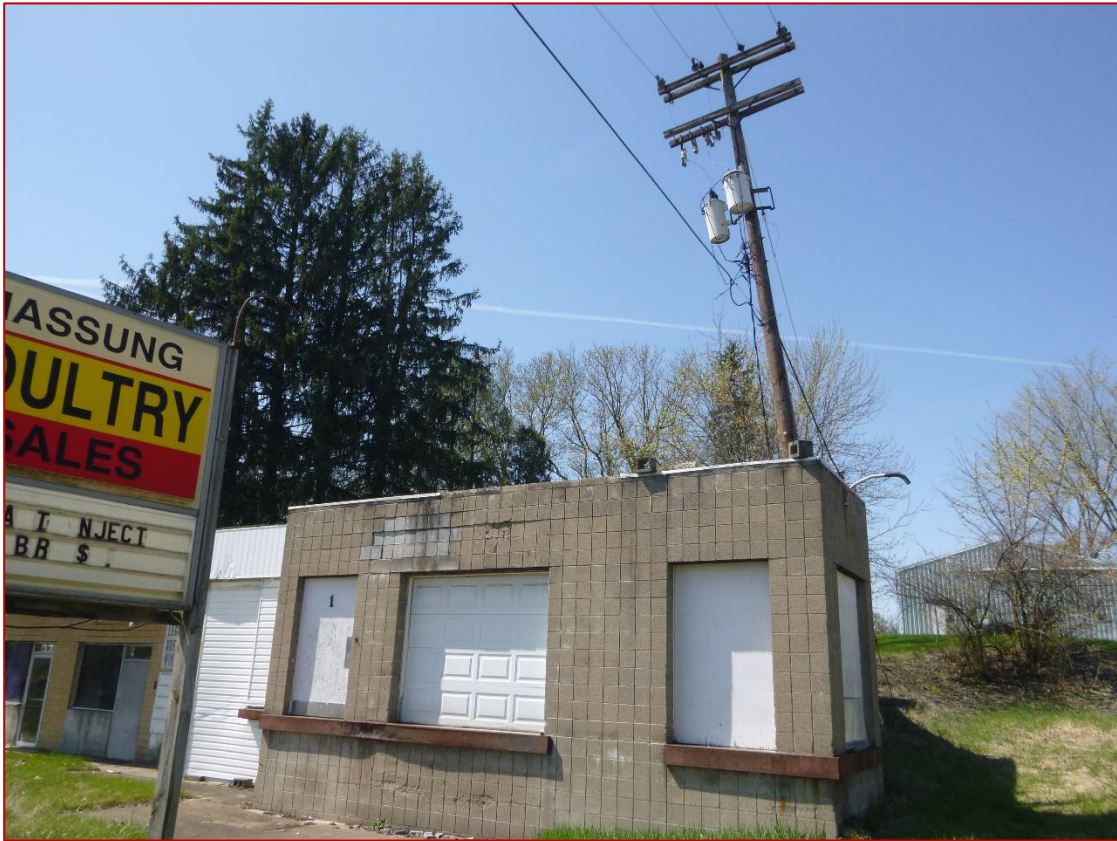
Photo 31: Massung Poultry Central area, transformers in the rear of the structure adjacent to study area – Facing West (04.12.2023)

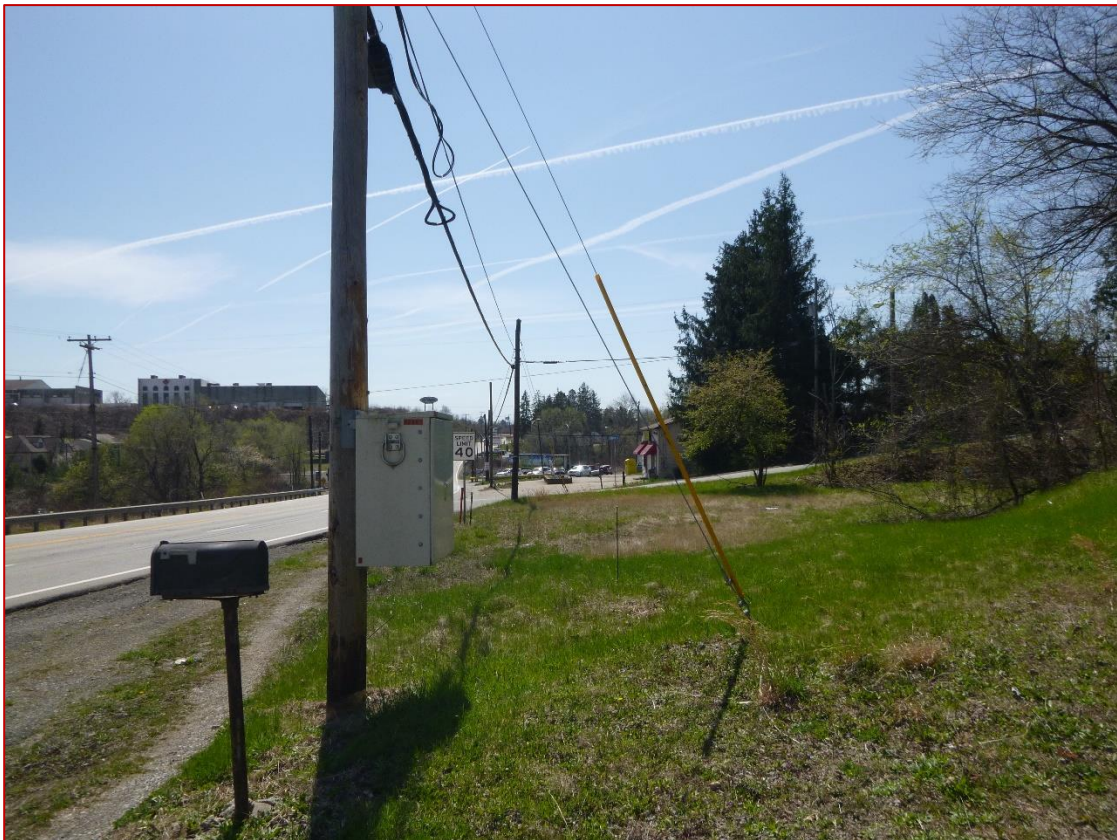
Photo 32: Massung Poultry Central area – Facing South (04.12.2023)

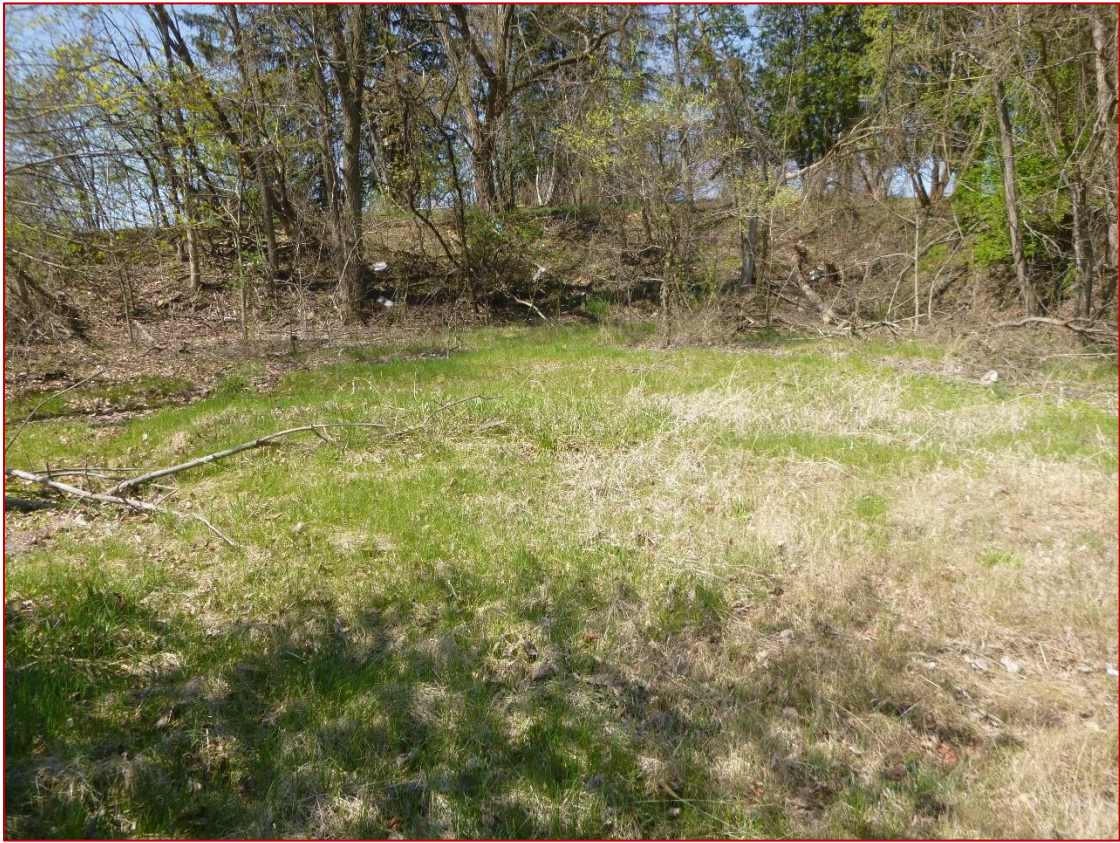
The southern area contained a vacant vegetated lot and a cistern/cistern access cover. A culvert was noted passing under the road. A second study area extension to the south and west included a portion of the treeline separating the parcel to the west and a wooded hillside west of the vacant lot adjacent to Route 30. No other features were observed.

Photo 33: Massung Poultry south, Vacant Lot – Facing West (04.12.2023)

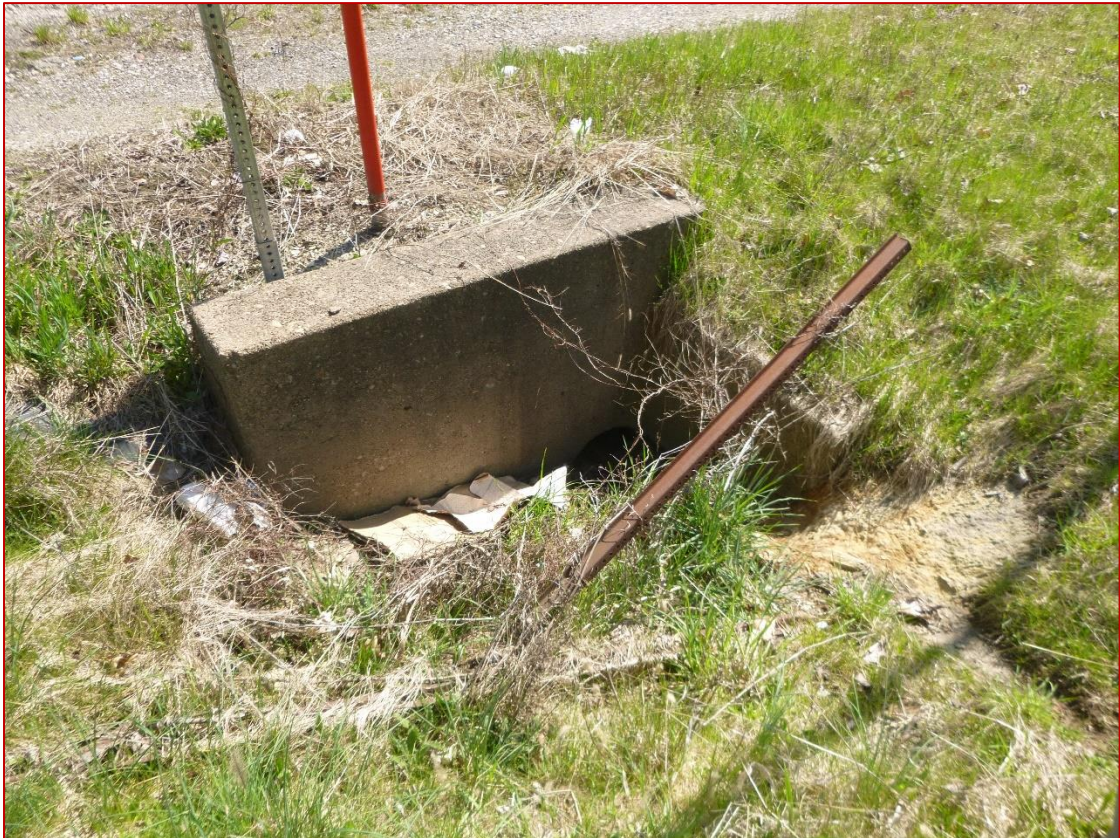
Photo 34: Massung Poultry South, culvert under – Facing Northwest (04.12.2023)

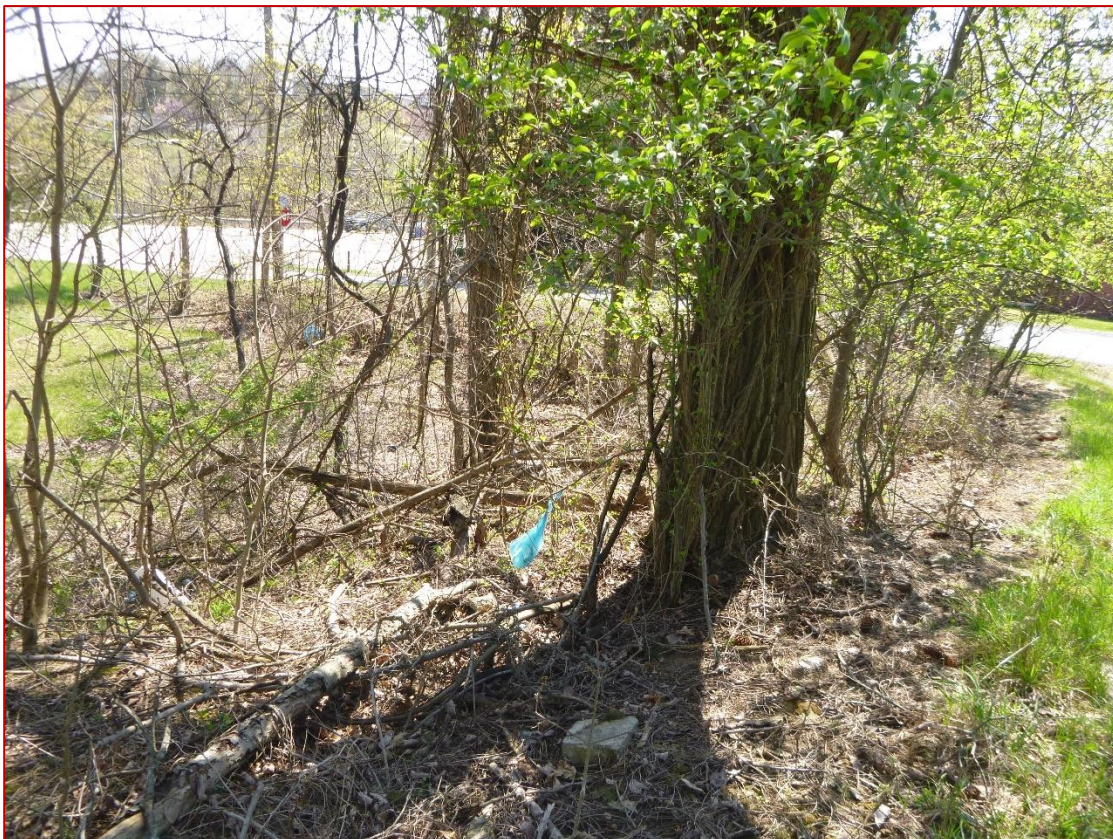
Photo 35: Massung Poultry south, vacant lot border – Facing Southeast (04.12.2023)

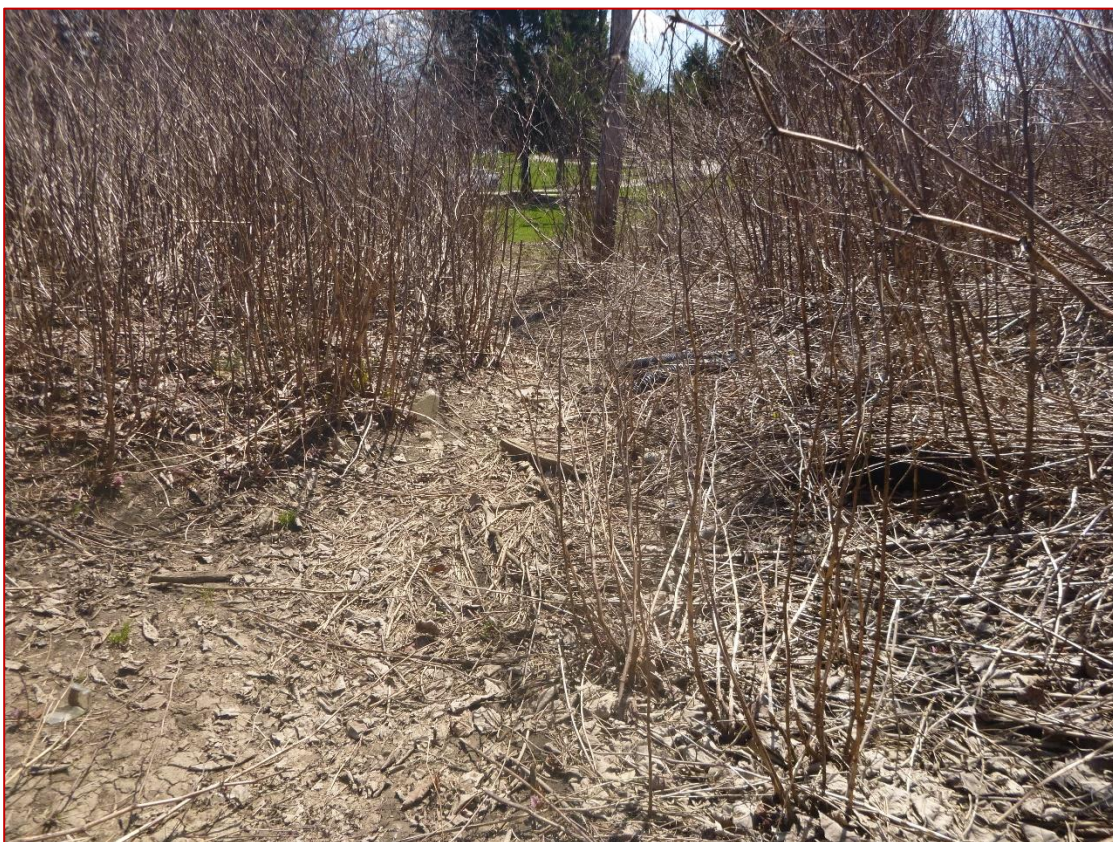
Photo 36: Penn Lincoln Memorial North, heavily vegetated area – Facing South (04.12.2023)

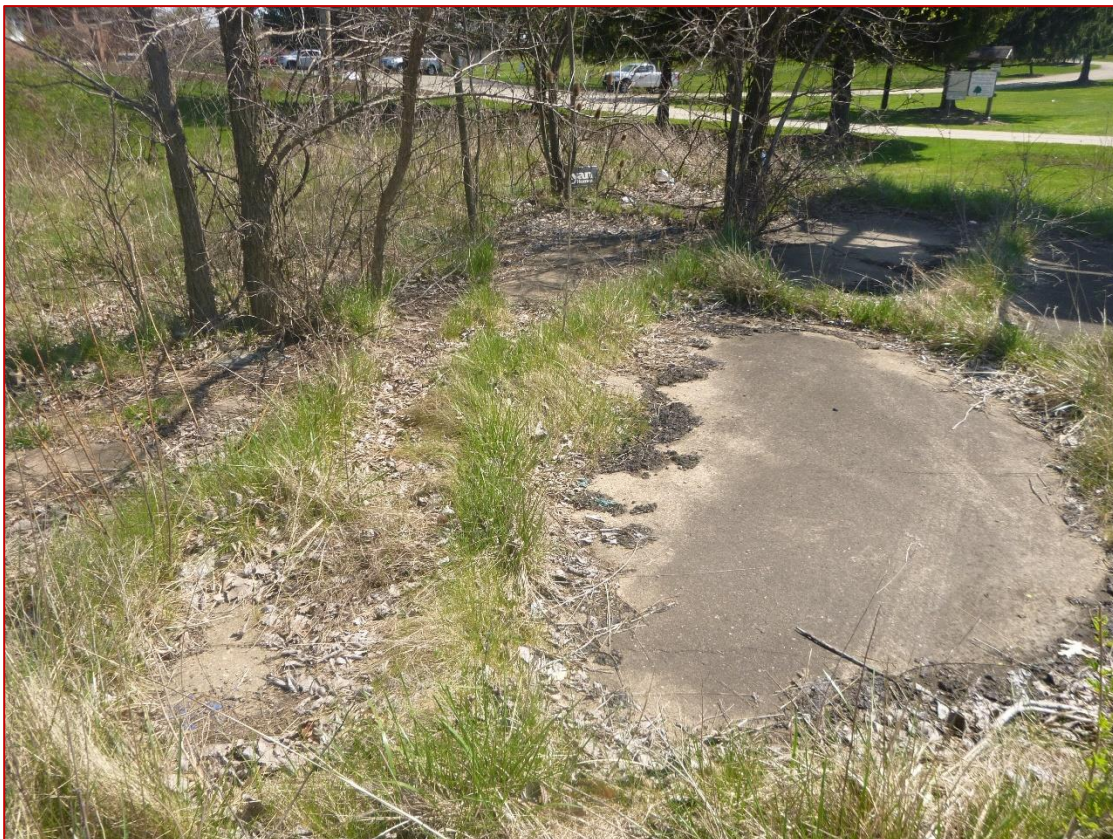
Photo 37: Penn Lincoln Memorial North, concrete slabs/vacant lot – Facing South (04.12.2023)

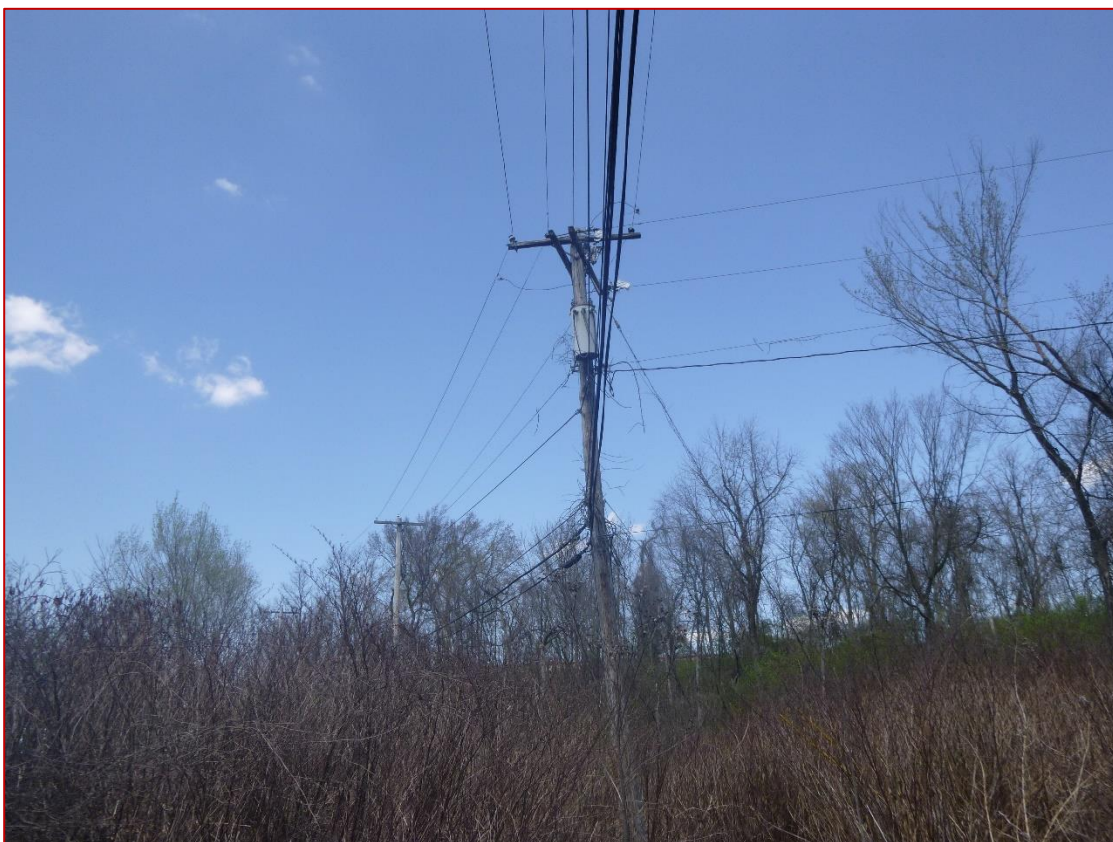
The area to the north was an area of dense shrub/scrub vegetation with hummocky terrain and a pole-mounted transformer at the north side of the area. The area on the west side of the study area expansion is comprised of concrete slabs and an adjacent billboard. No other features were observed.

Photo 38: Penn Lincoln Memorial North, transformer in heavily vegetated area – Facing North (04.12.2023)

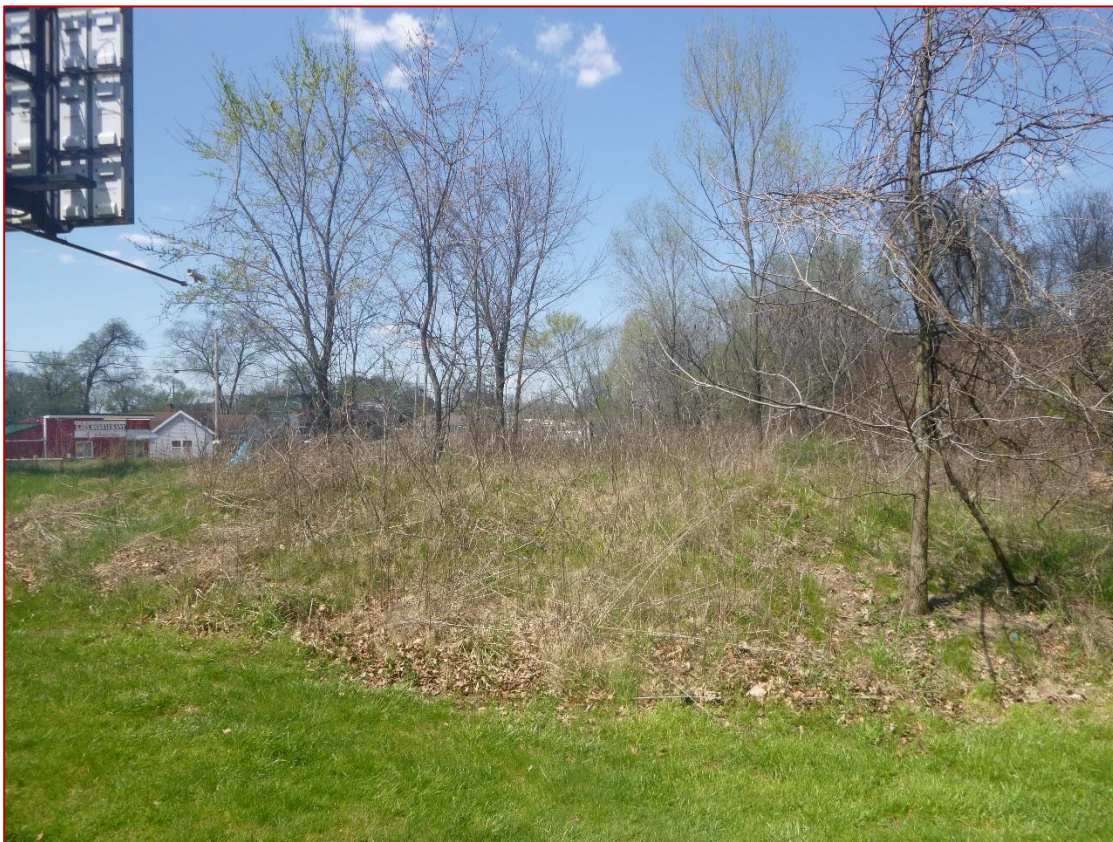
Photo 39: Penn Lincoln Memorial North, residential/grassy area at the south end of the study area – Facing North (04.12.2023)

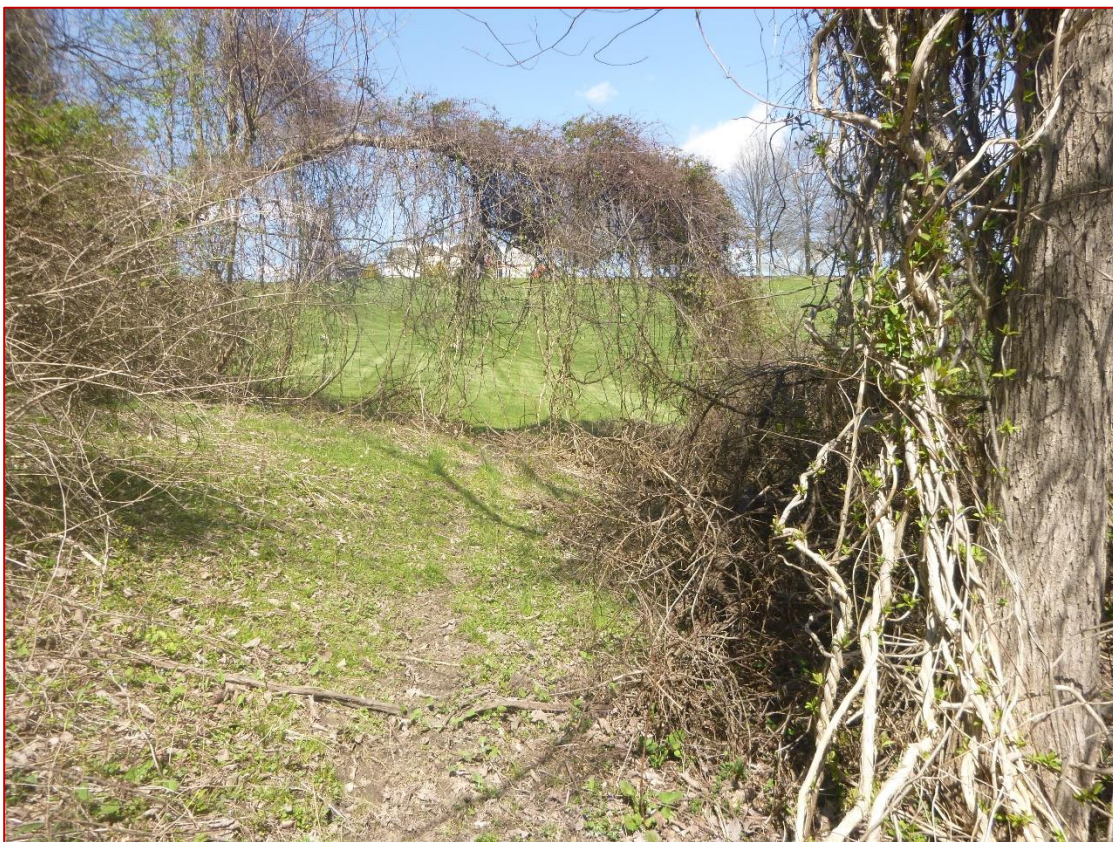
Photo 40: Penn Lincoln Memorial Central – Facing North (04.12.2023)

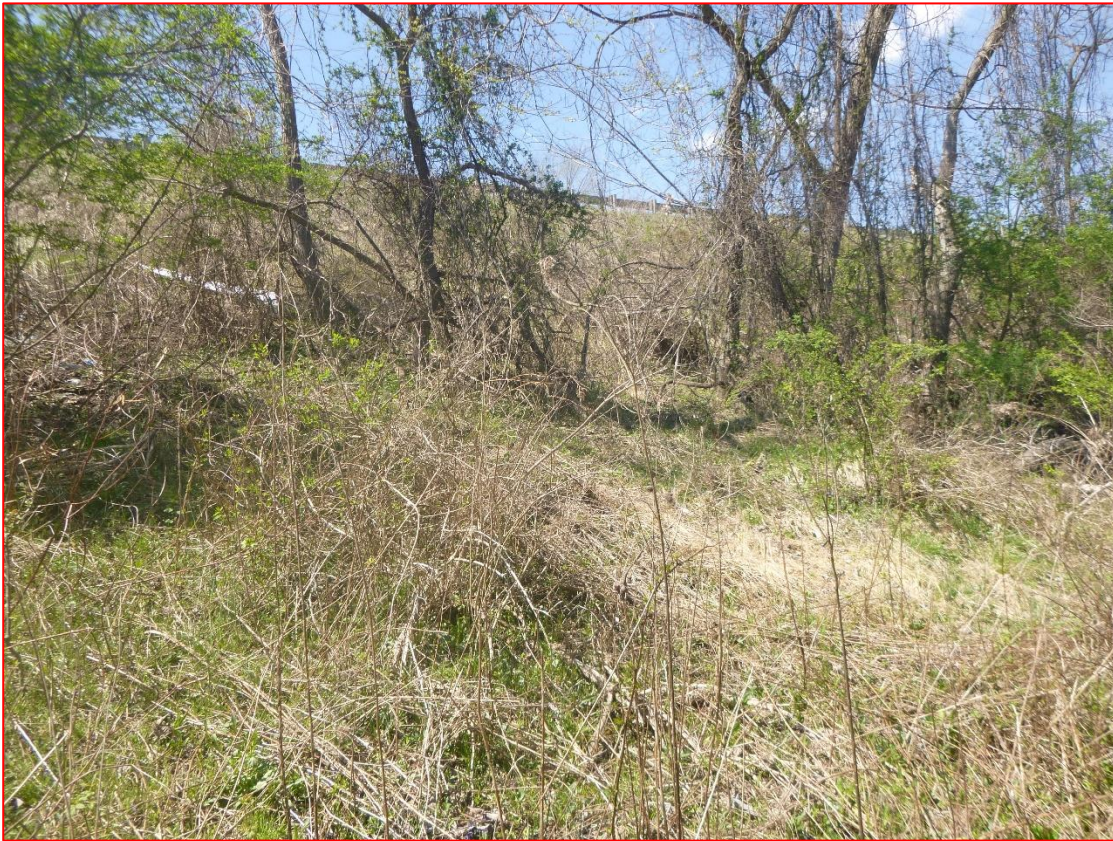
Photo 41: Penn Lincoln Memorial Central, Road embankment of Route 30 – Facing West (04.12.2023)

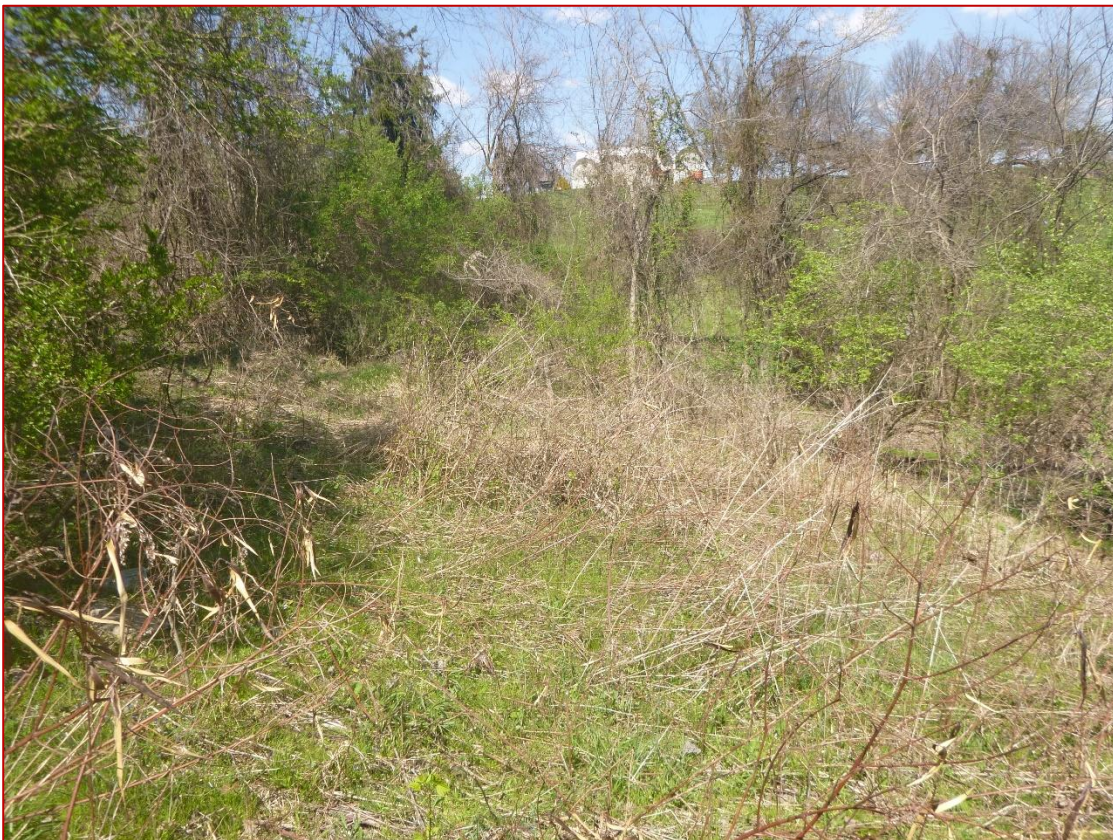
Photo 42: Penn Lincoln Memorial Central wooded area – Facing North (04.12.2023)

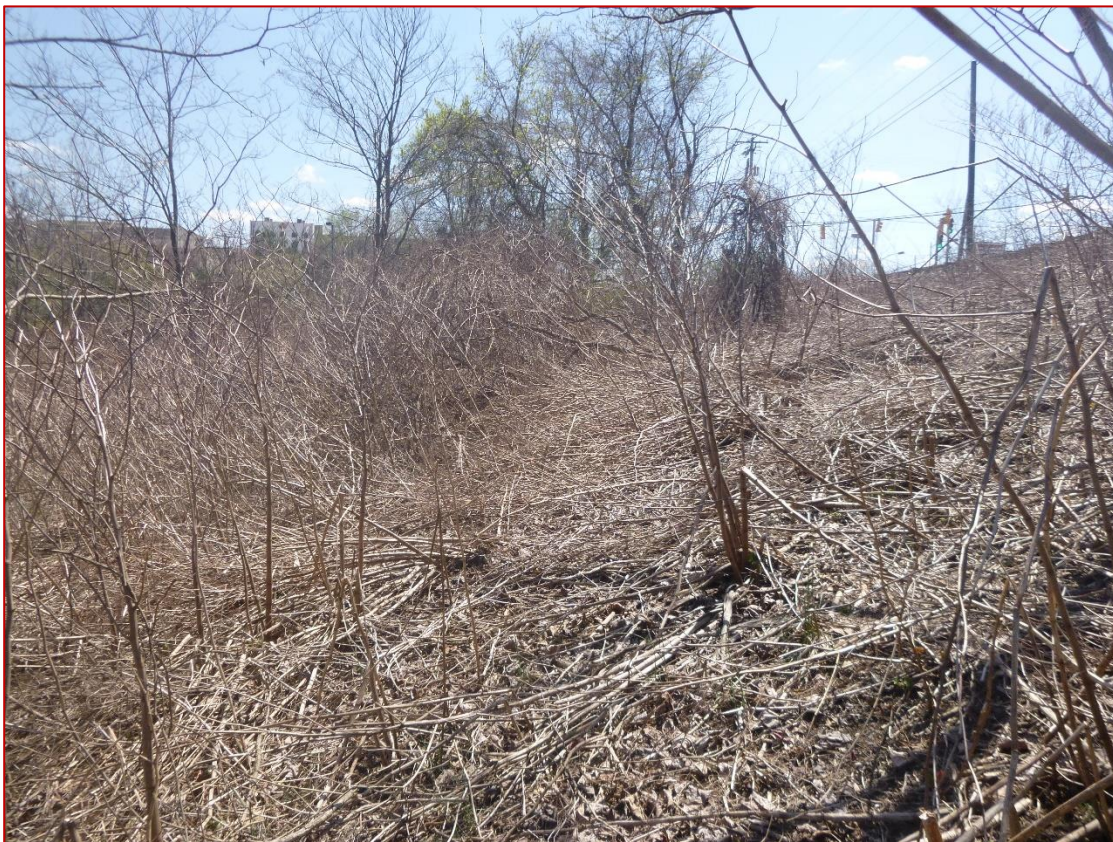
Photo 43: Penn Lincoln Memorial South, heavily vegetated area – Facing South (04.12.2023)

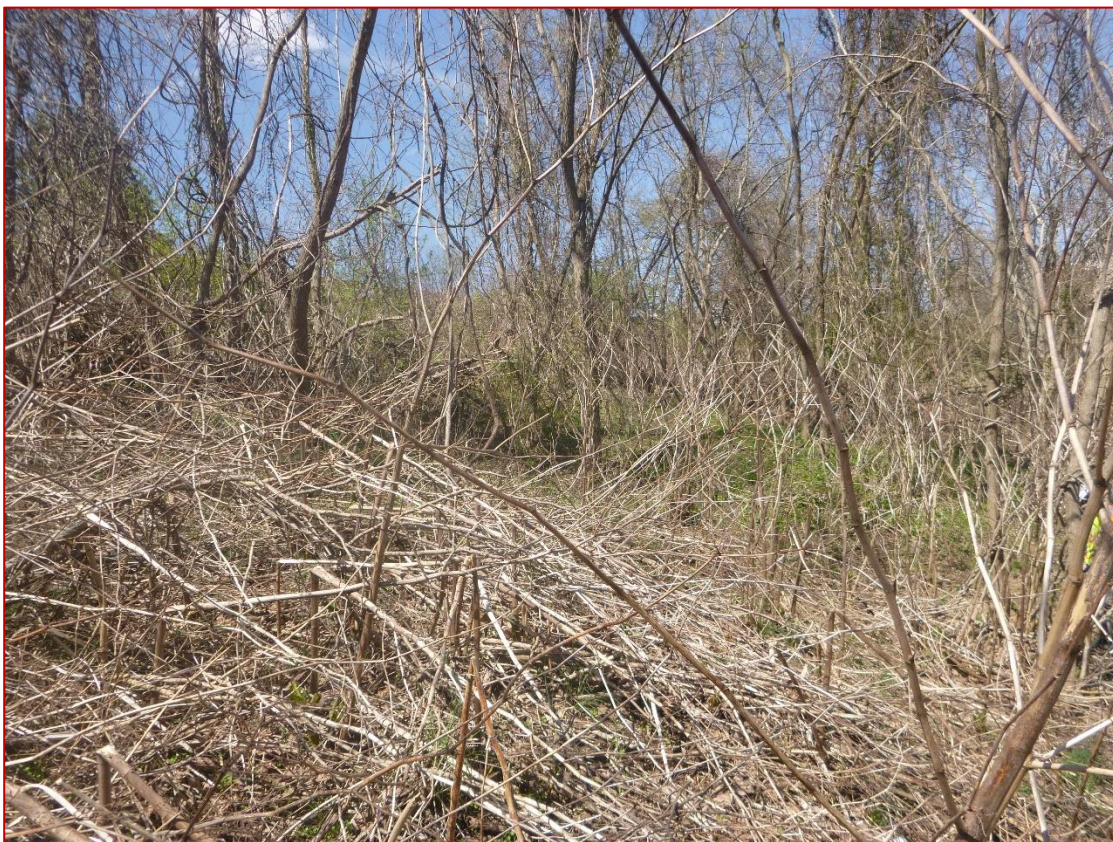
Photo 44: Penn Lincoln Memorial South, heavily vegetated woody area – Facing North (04.12.2023)

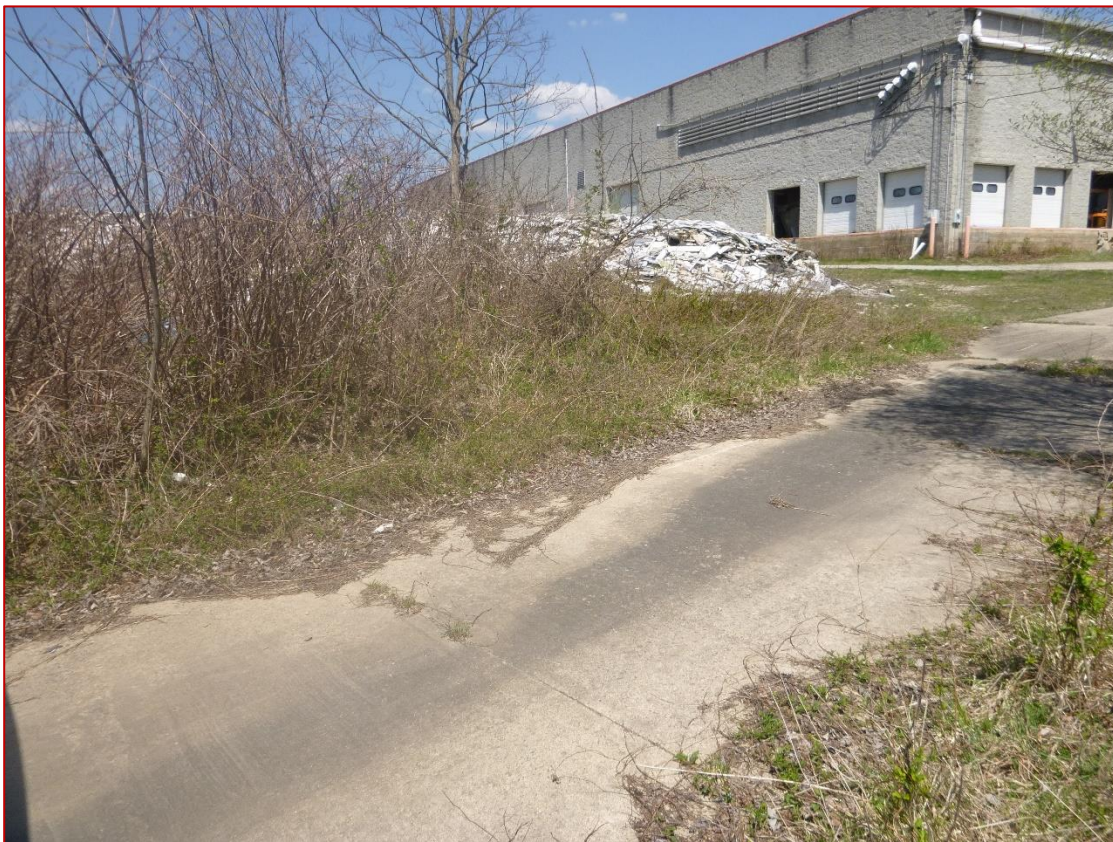
Photo 45: Vangura Laminating driveway, heavily vegetated area to the northwest – Facing North (04.12.2023)

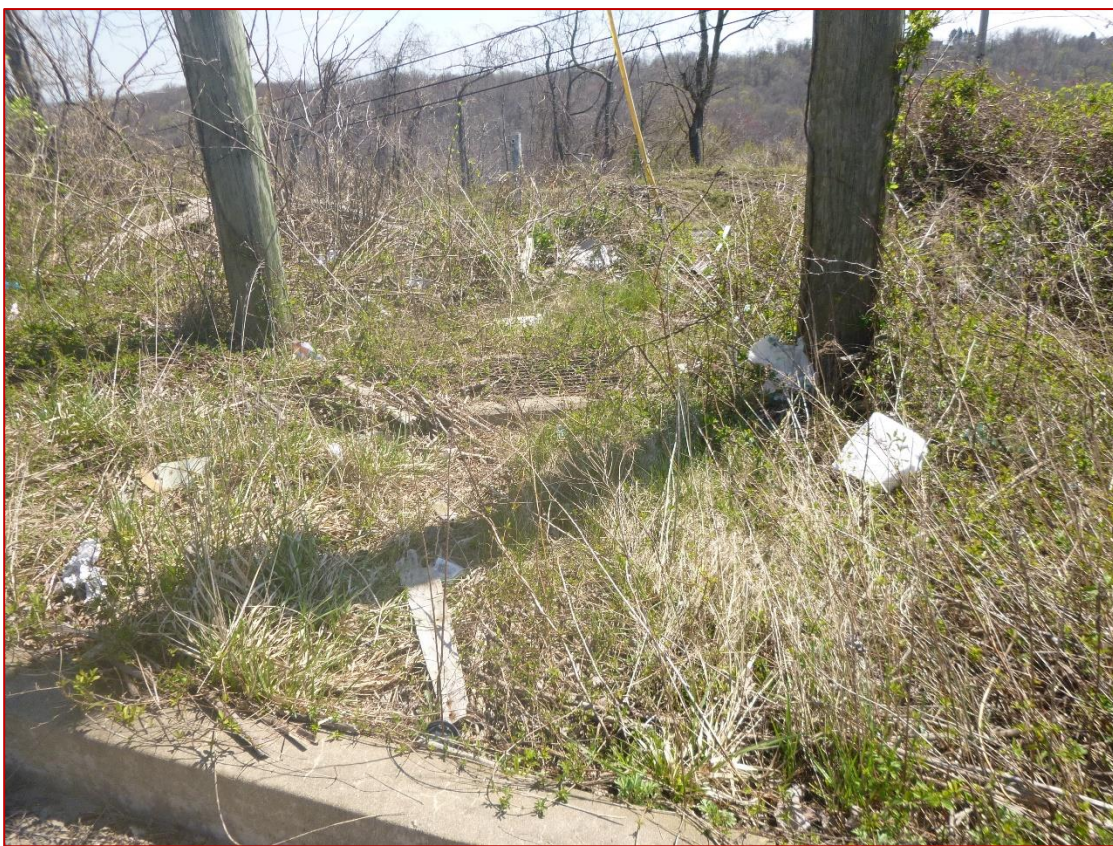
The gateway contained more heavy vegetation along the concrete drive as well as several nearby pole mounted transformers in good condition over a stormwater drainage grate.

Photo 46: Vangura Laminating, Stormwater drainage grate below four pole-mounted transformers – Facing Southeast (04.12.2023)

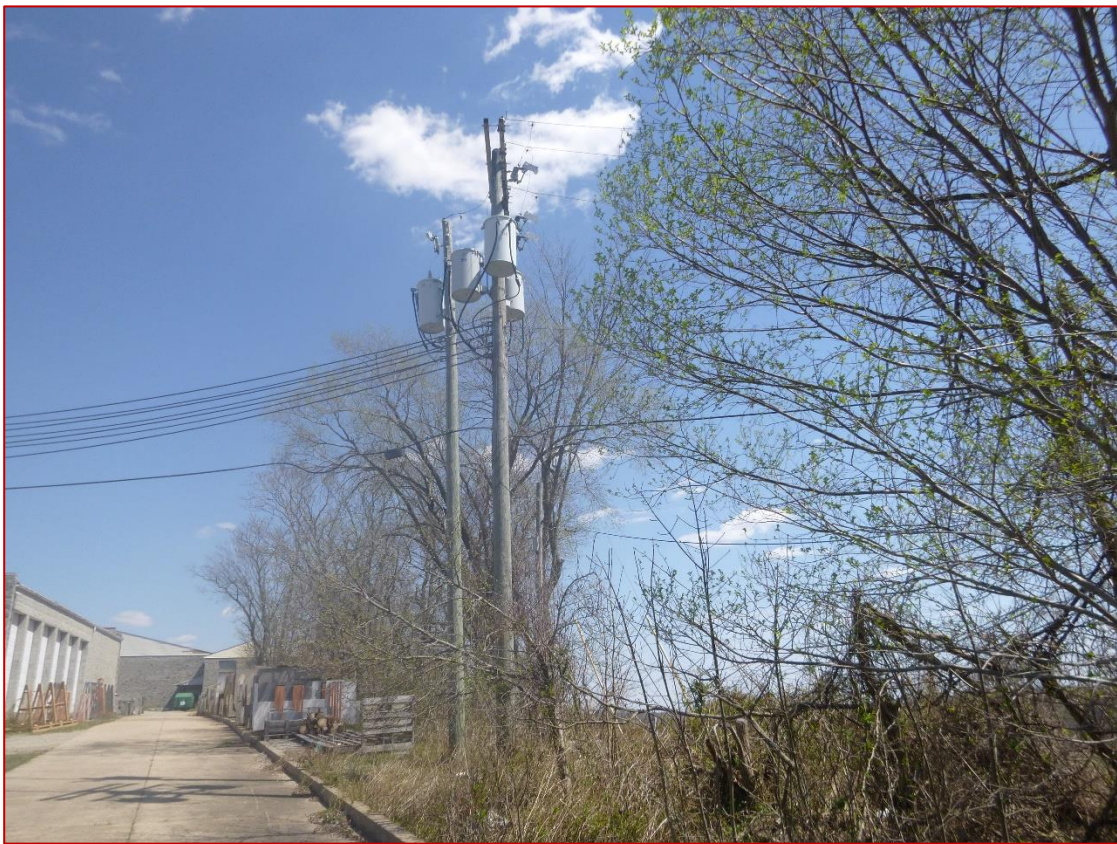
Photo 47: Vangura Laminating, east area, four pole-mounted transformers at the edge of the paved lot – Facing East (04.12.2023)
