Phase I Environmental Site Assessment Addendum

US 30 Corridor Improvements Project – Western Section

**North Versailles and North Huntingdon Townships
Allegheny and Westmoreland Counties, Pennsylvania**

Markosky Project File 15-003B

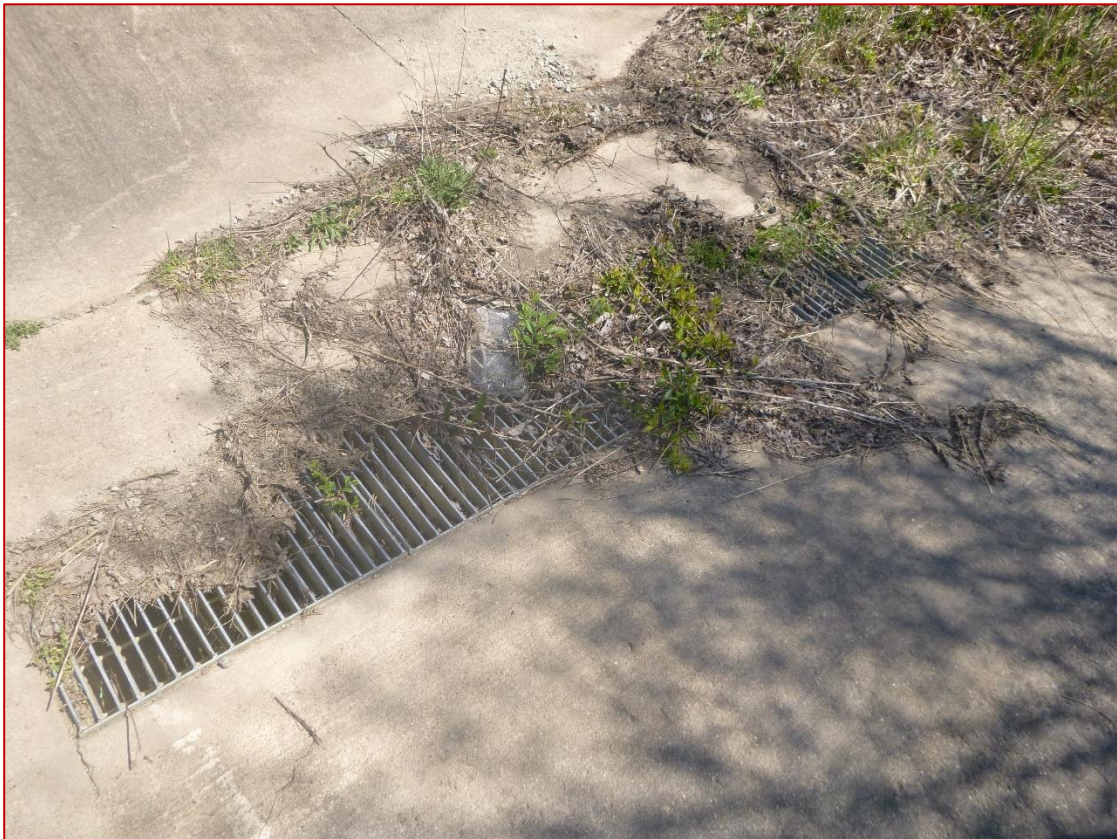
Photo 48: Vangura Laminating, east area, Stormwater drainage grate in the driveway – Facing North (04.12.2023)

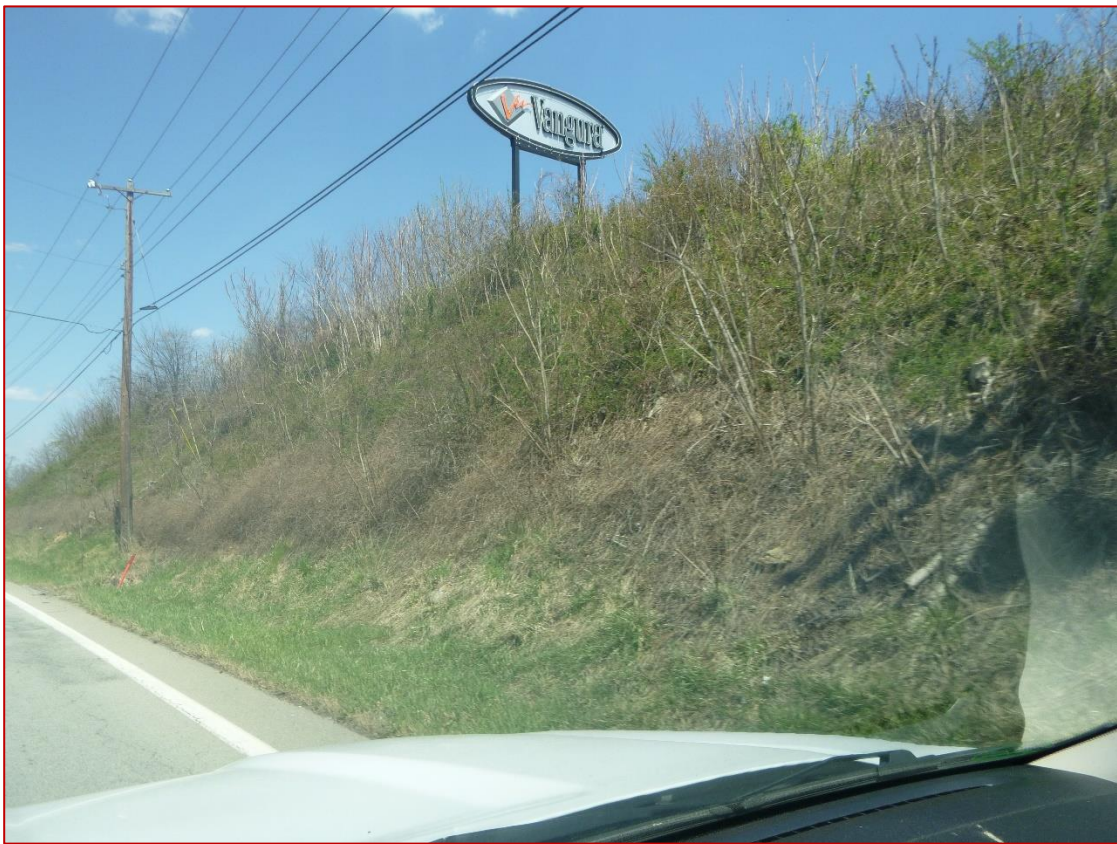
The western portion of the study area extension near Vangura Laminating was a heavily vegetated hillside. No new features were observed.

Photo 49: Vangura Laminating, west area, heavily vegetated but no other features – Facing North (04.12.2023)

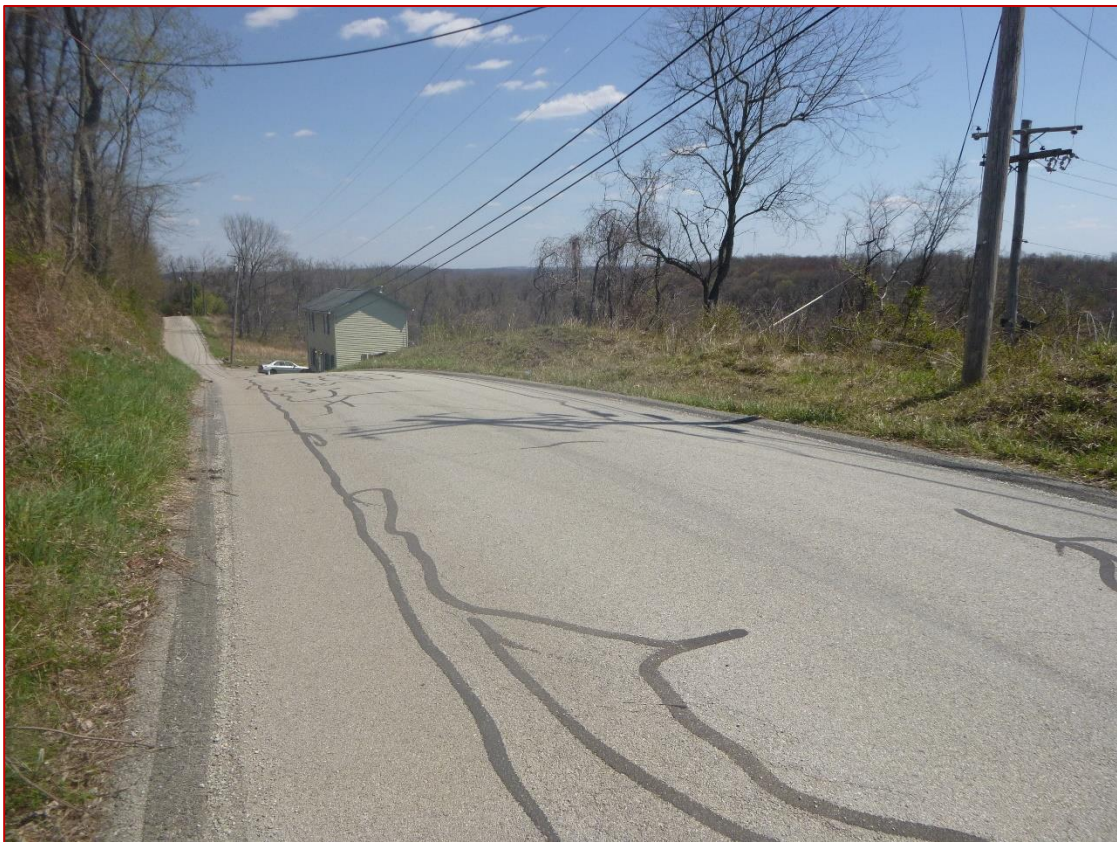
Photo 50: Magnus Lane, roadway – Facing Northeast (04.12.2023)

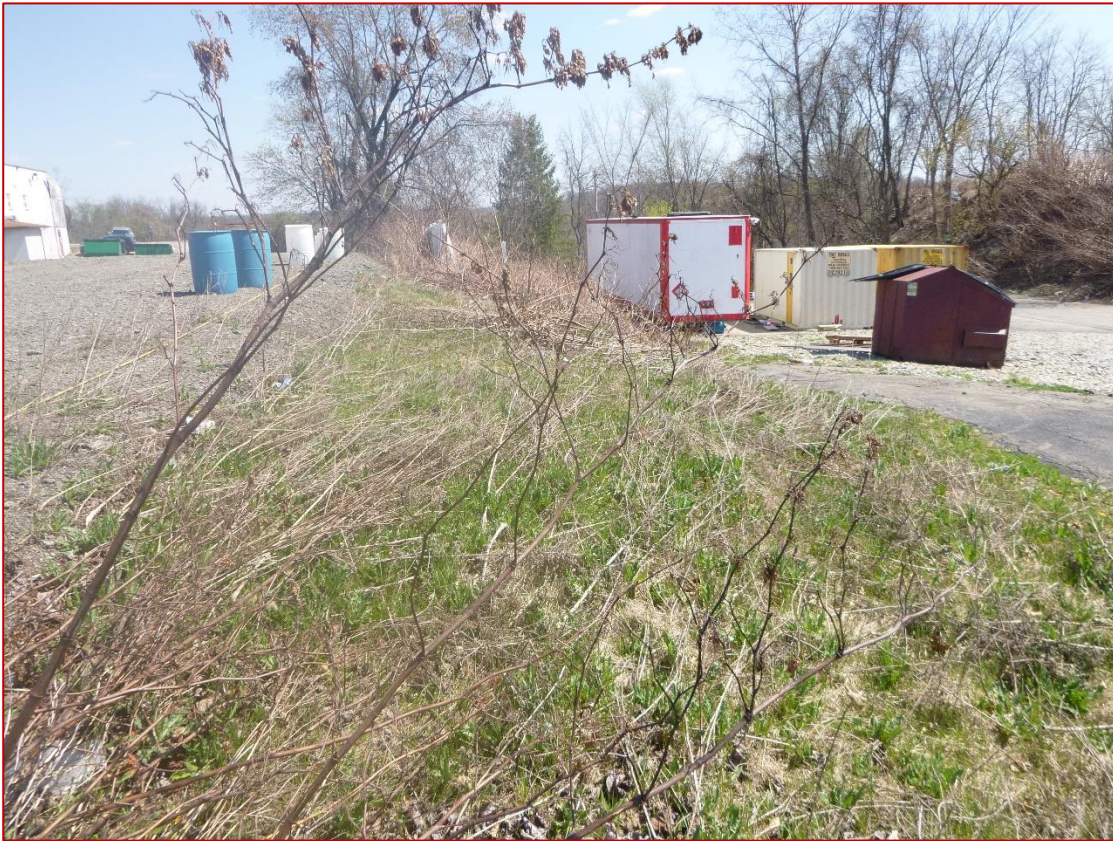
Photo 51: Hartford Township Volunteer Fire Department, north area, vegetated sloped hillside – Facing East (04.12.2023)

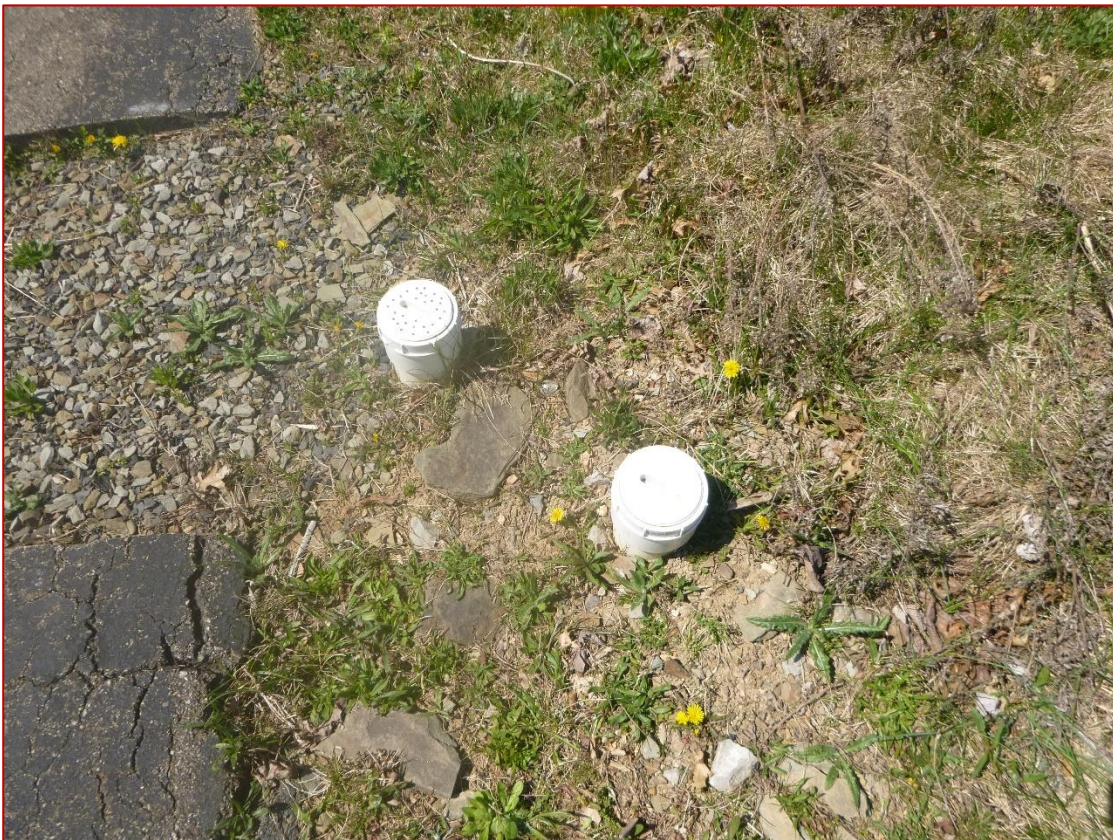
The northern of the two areas was a sliver separating the fire department from the gravel lot and contained three PVC stack pipes of unknown use. No other features were noted.

Photo 52: Hartford Township Volunteer Fire Department, north area, PVC pipe vent stacks – Facing West (04.12.2023)

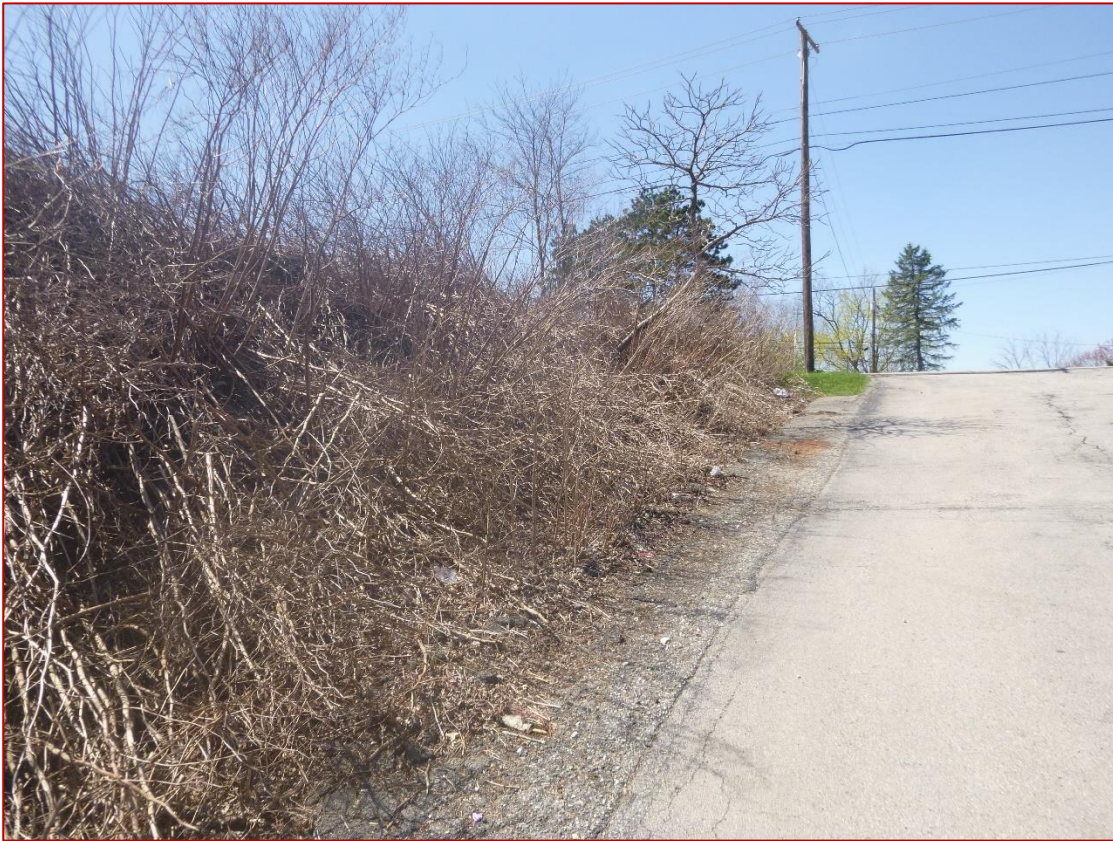
The southernmost area was a hillside covered in heavy vegetation. No other features were observed.

Photo 53: Hartford Township Volunteer Fire Department, south area, vegetated sloped hillside – Facing West (04.12.2023)

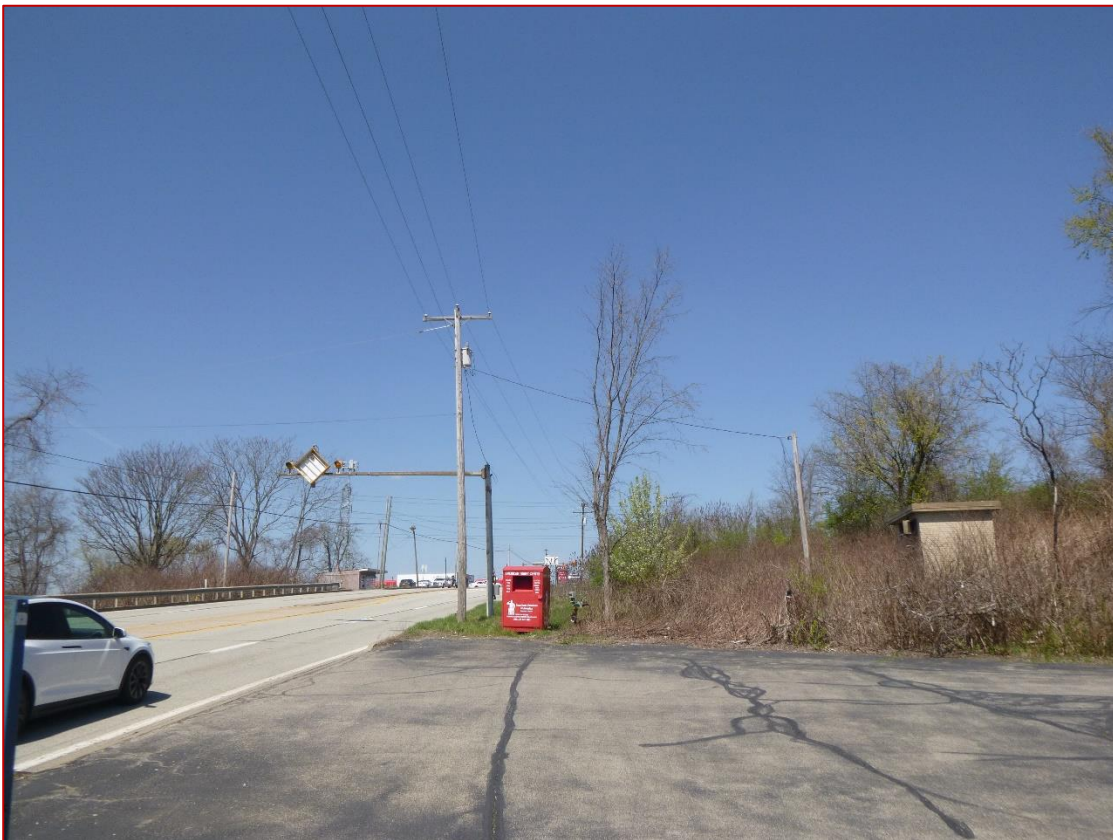
Photo 54: Laser Car Wash, north area, asphalt lot – Facing Northwest (04.12.2023)

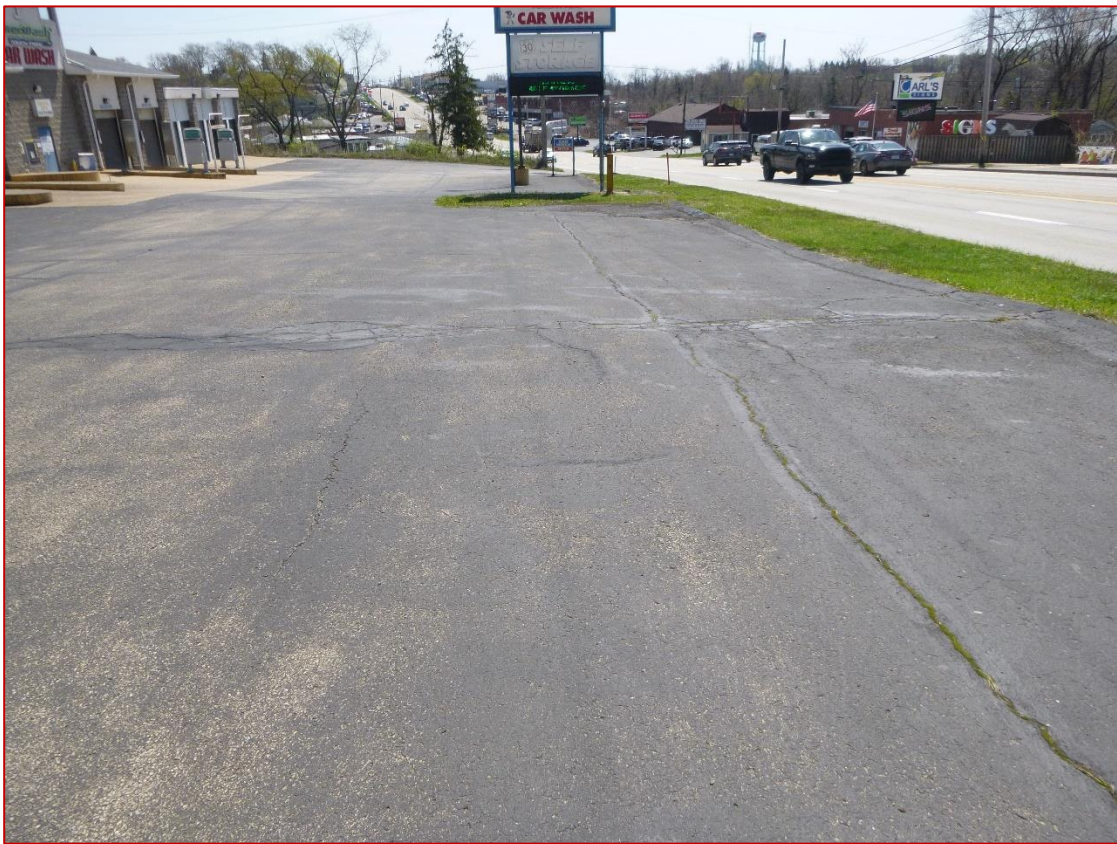
Photo 55: Laser Car Wash, north area, asphalt lot – Facing Southeast (04.12.2023)

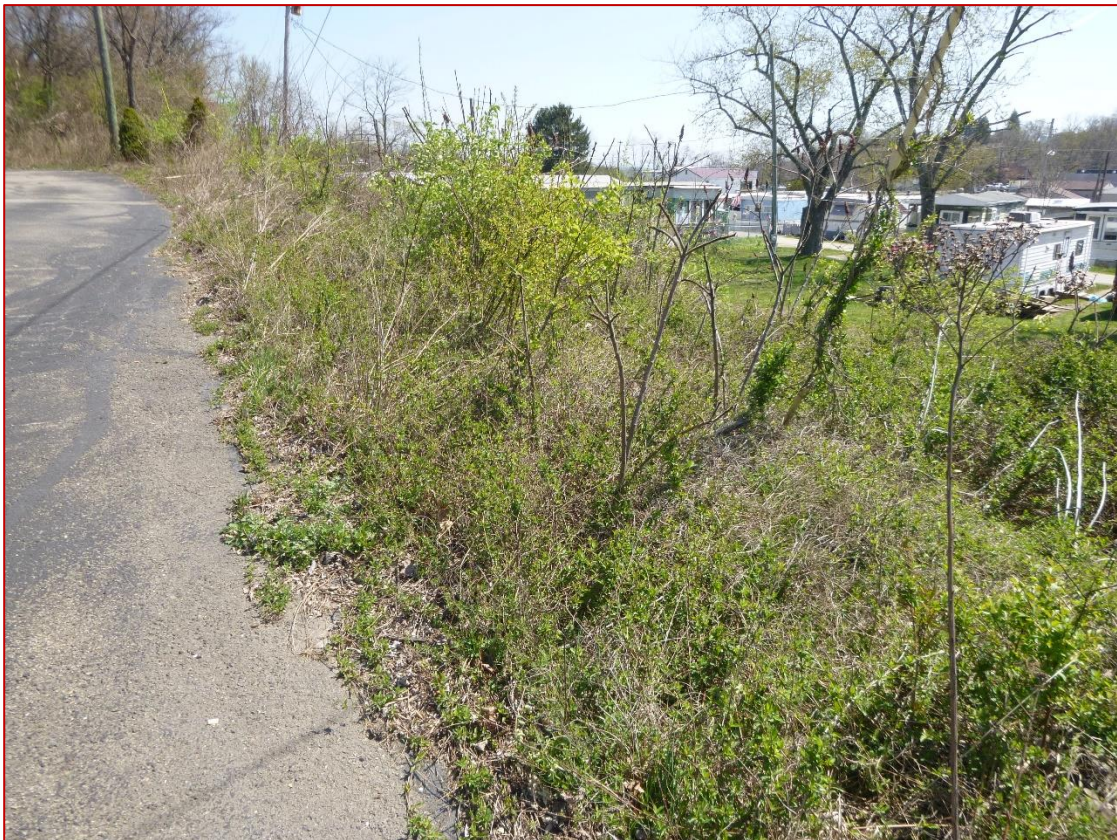
The study area boundary near the south end of the Laser Wash parking lot was extended to include a slope separating the lot from the mobile homes to the south. Short herbaceous and woody vegetation were noted, with no other features apparent.

Photo 56: Laser Car Wash, south area – Facing East (04.12.2023)

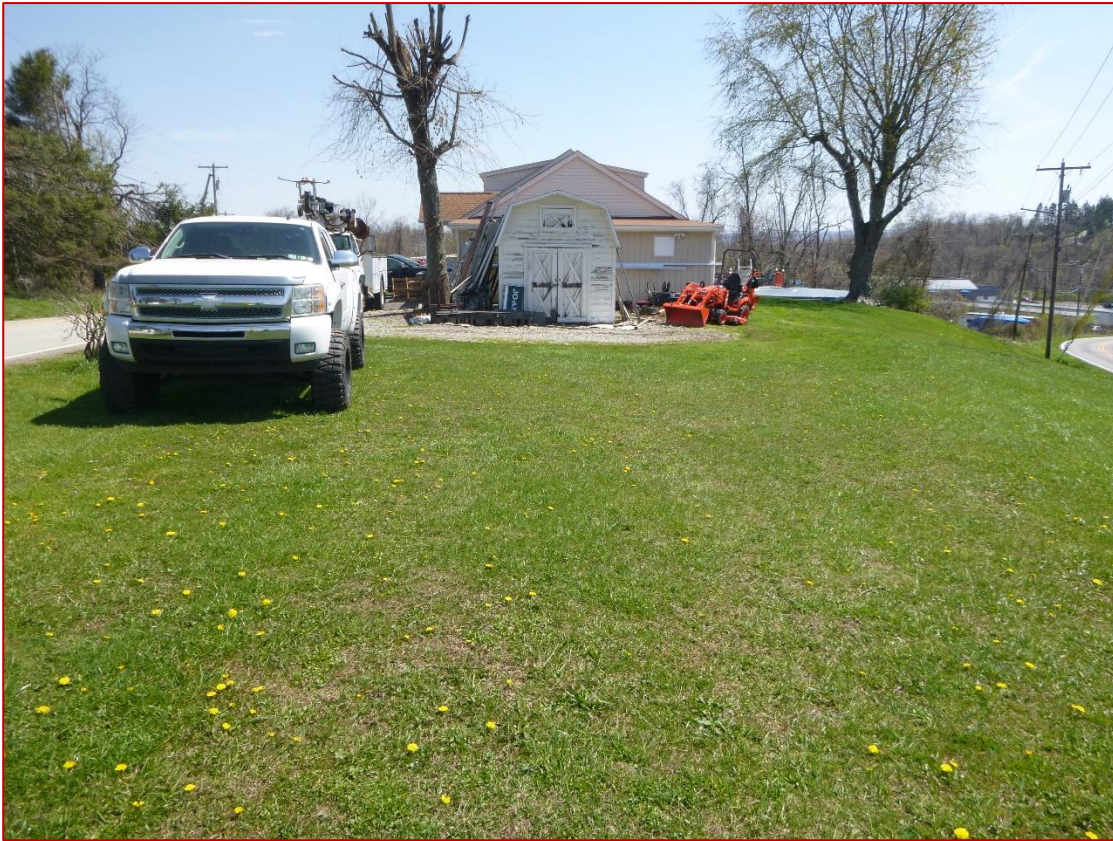
Photo 57: Ledger Road, west area, residential lawn the study area – Facing East (04.12.2023)

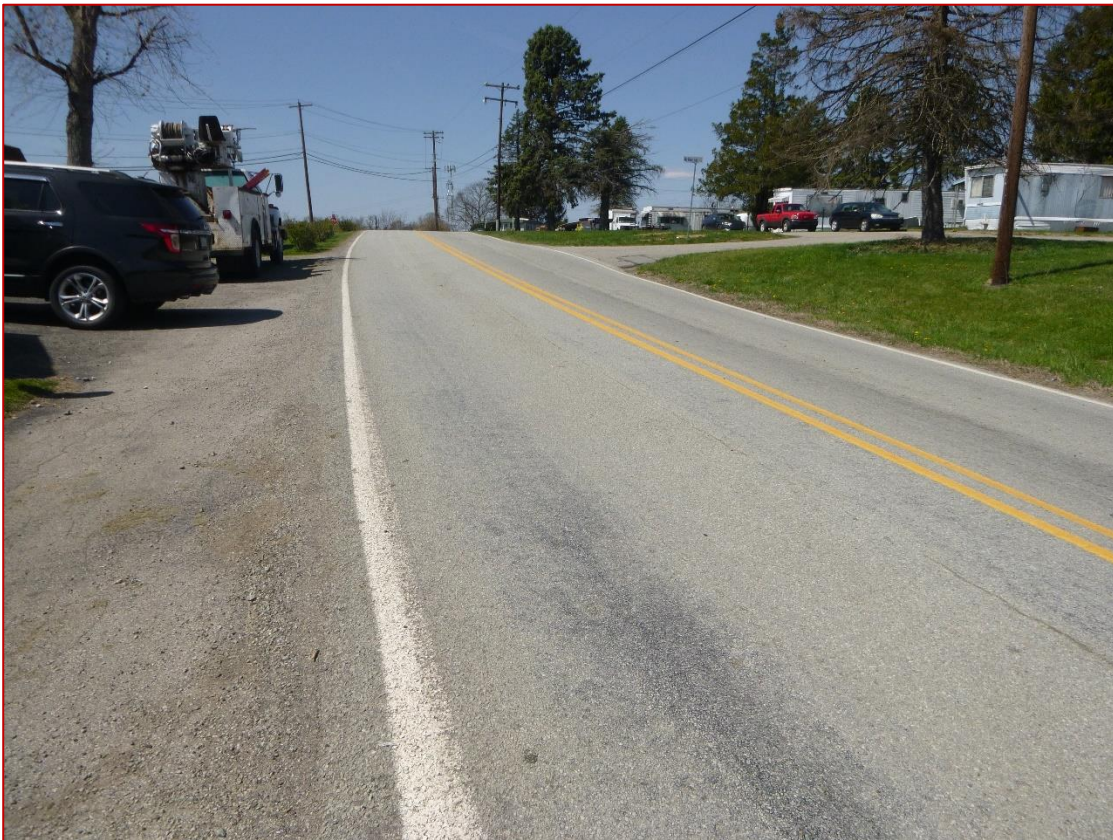
Photo 58: Ledger Road, east area, roadway and roadside vegetation – Facing West (04.12.2023)

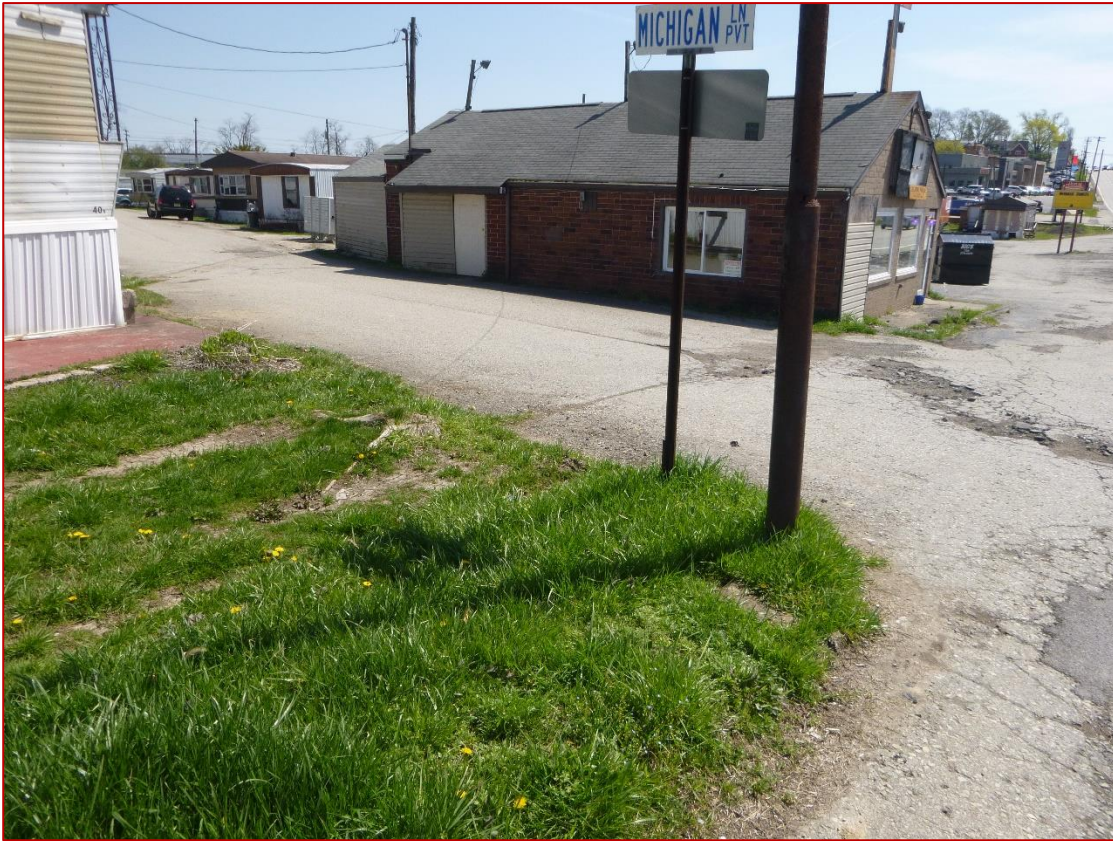
Photo 59: Michigan Lane Area, residential lawn the study area – Facing Northeast (04.12.2023)

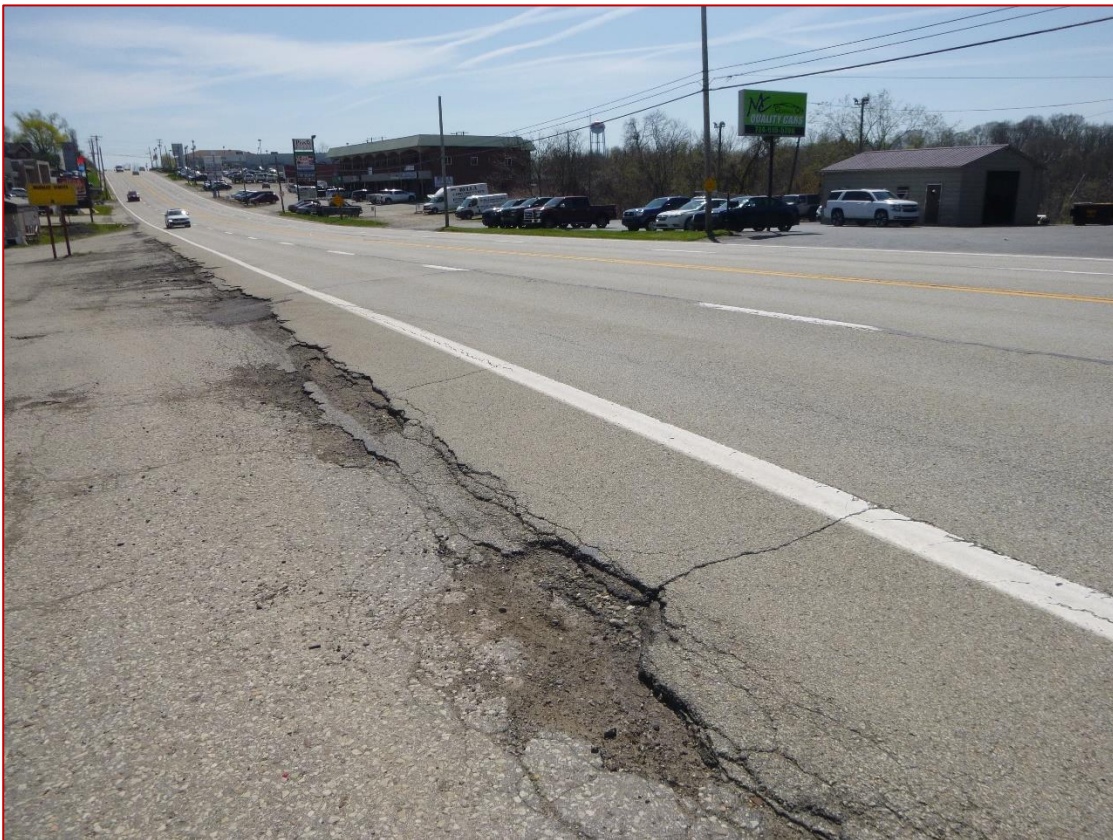
The study area boundary at the south end of the corridor was extended to include more of the roadway. No additional features were noted.

Photo 60: Route 30 south end of study area, roadway – Facing South (04.12.2023)
