Field Observation Report

Arby's
4948 Highway 42
Louisville, KY
Reference Purchase Order 64430

Date:
5/4/2011

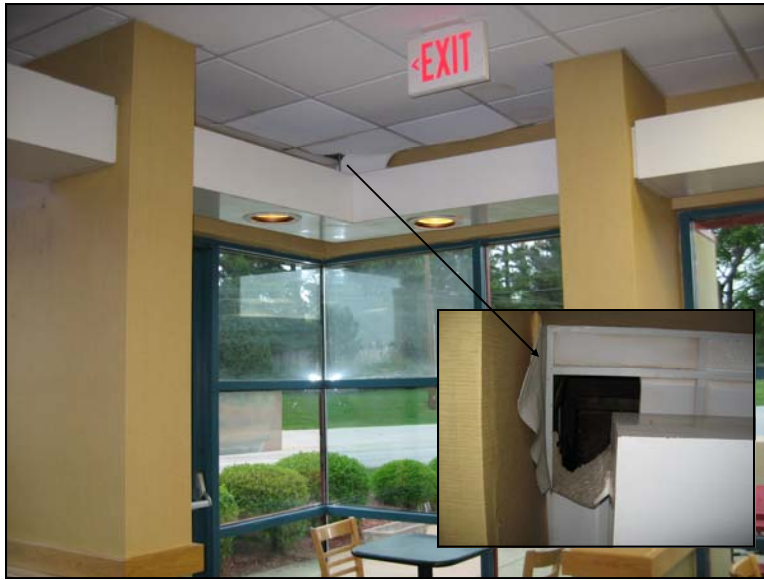
1. Water damage in Northwest Corner in the dining room - Photo 1
2. We found water damage on the next booth location from the above corner - Photo 1A
3. We found water damage on the East wall - Photo 1B
4. We found water damage on the atrium light in the customer waiting area - Photo 1C
5. We found water damage in the managers office
6. Several damaged surface areas on the exterior walls
7. Several deficient construction details
8. Several deficient maintenance repairs
9. Standing water on several roof locations

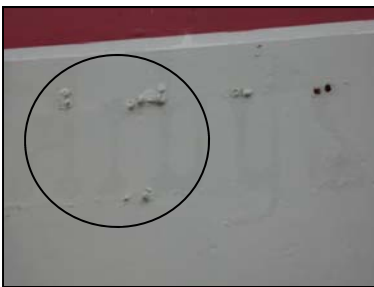
Grid location B6 - Improper patch from old sign.

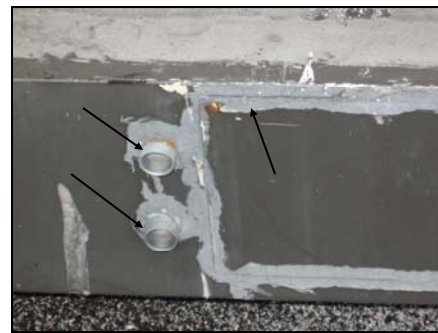
Grid location B6 - Old sign race way on roof not been removed. Conduit openings are exposed and access panels are not sealed. This is allowing water entry.

- **The old sign raceway should be removed or at very least sealed to prevent water entry.**

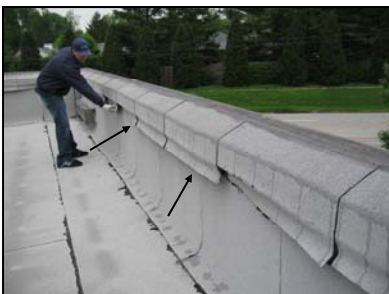
Entire cap flashing has failed in the area above the interior leak. Improper cap flashing. This is happening around the entire building perimeter. A metal cap should have been used.

- **Parapet Cap: Needs to have the entire asphalt membrane removed. A layer of Ice and Water shield applied from 1 1/2" on the face to return completely over the top and return on to the roofing membrane. Secure a 1" x 12" pressure treated lumber to the top of the existing parapet and install metal cap over the entire section. The should extend 4 - 6" inches on to the face of the Dryvit.**

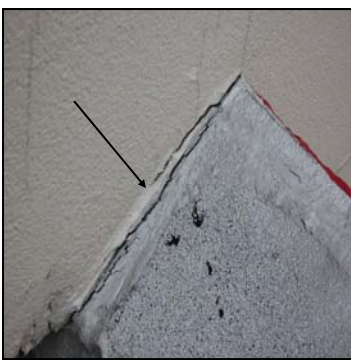
Cracks allowing water in to wall.

- **Cracks in lamina need to have new base coat and mesh installed, with new finish**

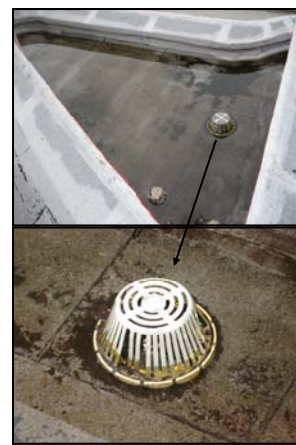
Standing water with drain photo showing drain sitting higher than the roof.

- **The drive through roof drain should be lowered and cleaned out to allow water drainage.**

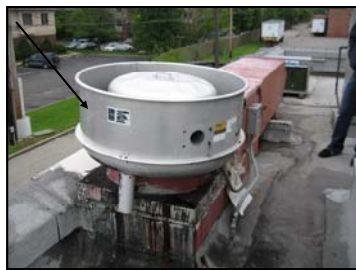
Hood exhaust fan is unbalanced. This unit is shaking so severely that the duct work is shaking.

- **The exhaust fan should be balanced and the concrete block removed, the roof repaired and a rubber pad placed on top of the roof and new concrete block installed.**

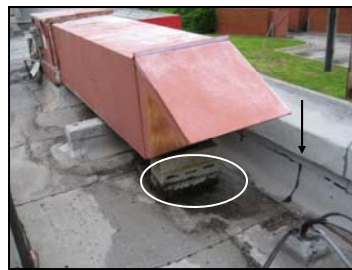
The shaking duct work is setting directly on a concrete block that is setting directly on the roof. The vibration from the unbalanced fan has caused the cement block to wear a hole in the roof directly above the managers desk.

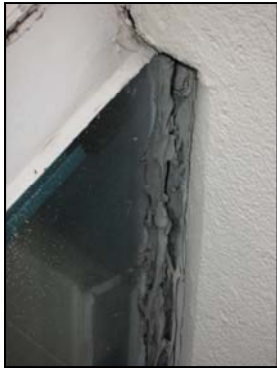
Atrium has failed sealants and needs to be properly sealed. All the old sealant needs to be removed and installed to industry standards.

- **Windows, utilities, atrium terminations and all through wall penetrations are in need of new sealants to prevent water entry. Scope to include**
 1. *Properly seal perimeter*
 2. *Remove old sealant*
 3. *Brush clean*
 4. *Dispose of used sealant as needed*
 5. *Wipe down all metal components*
 6. *Tape off sealant joint as needed*
 7. *Install either bond breaker tape or backer rod*
 8. *Install Dow Corning Silicone sealant per manufacturer's recommendations.*

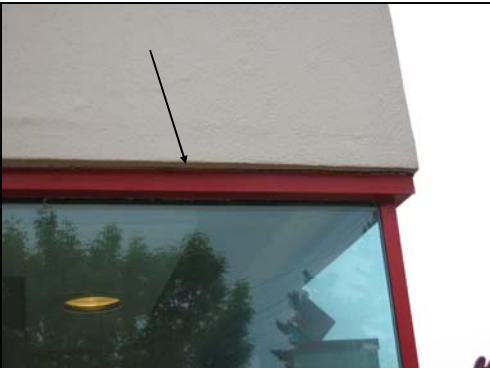
All window and EIFS terminations need to be sealed to industry standards.

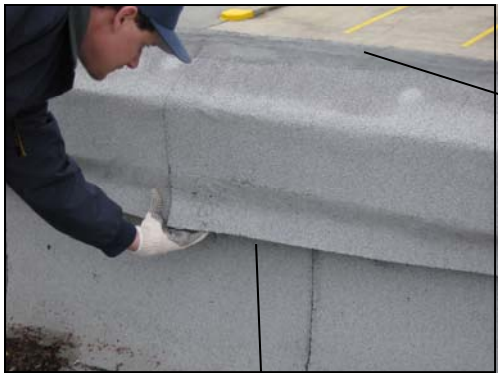
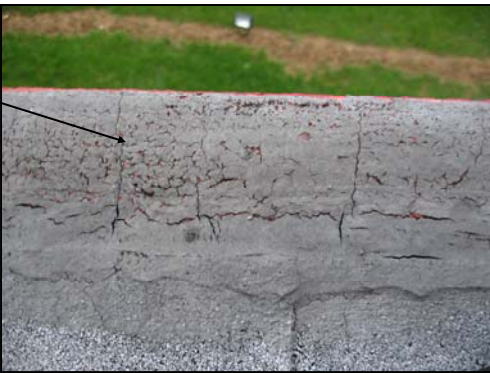
Roofing failure at edge of parapet cap.

The entire parapet needs to be redone. Petroleum based products should never be used in conjunction with an EIFS/Dryvit type system. The petroleum will eat away at the acrylic finish and the foam. Hot asphalt that is applied will simply melt the system. The entire parapet cap needs to be redone so that it can accommodate a metal cap. This cap is a catastrophic failure that will continually get worse over time allowing more water into the wall assembly.

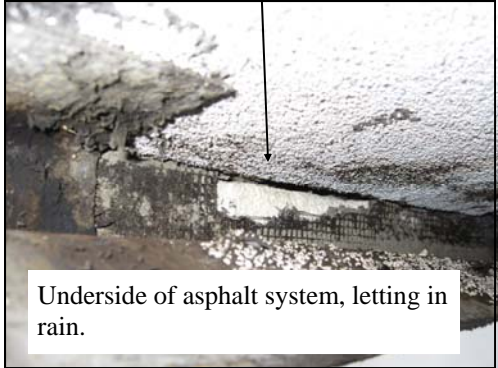
Underside of asphalt system, letting in rain.

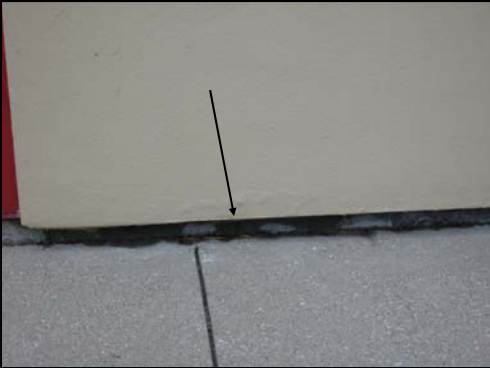
Water is traveling behind the wall and exiting at the bottom of the wall at the foundation.
