# Transition Study for The Creekside Crossing Homeowners Association Plainfield, Illinois April 22, 2014

The Creekside Crossing Homeowners Association Plainfield, Illinois

Reference #: 140041

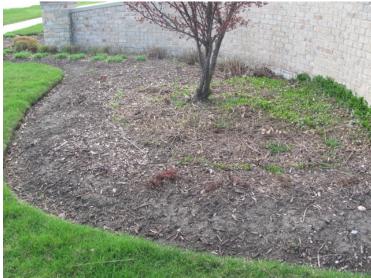
Missing plantings on opposite side of Renwick Road and Cove Circle entrance

Landscape, Trees, Shrubs and Plantings – Approximately 35 trees, 60 shrubs and 45 plants throughout the property are either prematurely deteriorated or missing, as shown on Pages 3-5 of the August 16, 2004 Final Landscape Improvement Plans Units 1-4 and Page 4 of the March 14, 2005 Final Landscape Improvement Plans Units 5-7. Locations include the Indian Boundary Road entrance, the Creekview Drive and Renwick Road entrance, along both sides of Drauden Road, south of Renwick Road, north of Renwick Road and the entrance at Renwick Road and Cove Circle. Pages 5.2 through 5.4 of *Photographs* depict these conditions. Remediation will require installation of missing trees, shrubs and plants along with replacement of dead or deteriorated plants. We estimate a cost of \$15,500 to remedy these construction and condition defects on Line Item 1 of *Estimated Remediation Expenditures*.

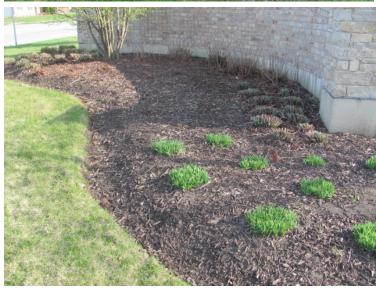
Missing plantings at Indian Boundary Road entrance

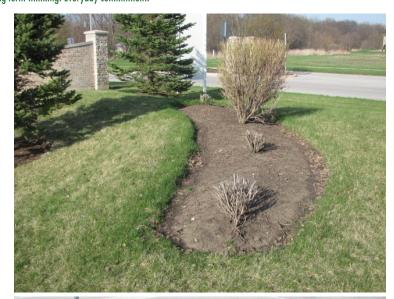
Dead shrubs at Indian Boundary Road entrance

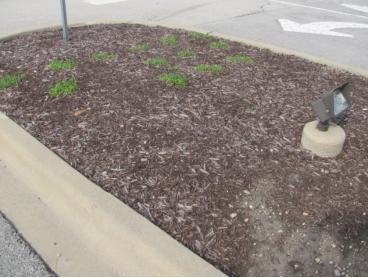
Missing plantings at Renwick Road and Crossing Drive entrance

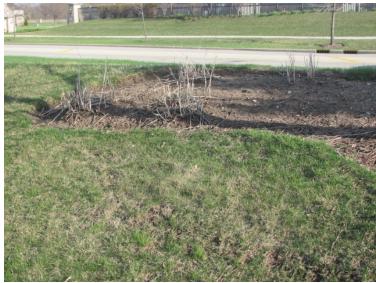
Dead shrubs along Renwick Road

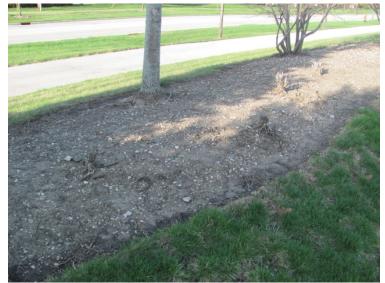
Missing plantings along Renwick Road

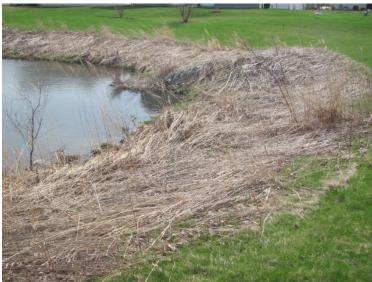
Missing plantings along Stormwater Management Area South

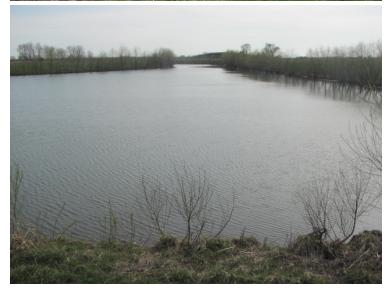
**Pond, Shoreline Buffer Zone, Area A** – Stormwater Management Area A lacks approximately 15,800 square yards of the designed buffer zone of natural plantings and includes a dense planting of willow trees. Pages 5.4 and 5.5 of *Photographs* depict these conditions. The close proximity of the trees will create overgrowth issues in the future, higher costs of

maintenance and organic debris deposits into the pond. The natural debris and lack of a proper buffer zone promotes growth of invasive species of plants and premature aging of the pond causing the need for more frequent dredging, pond treatments or both. Remediation will require removal of all trees lining the pond, shoreline regrading, seeding and plugging to promote growth and reestablishment of a proper buffer zone, and installation of a fence to protect the area. We concur with the estimate of cost of \$4.24 per square yard as quoted *by Pizzo and Associates, Ltd.* on May 23, 2014 to remediate this construction defect on Line Item 2 of *Estimated Remediation Expenditures*.

Stormwater Management Area A overview

Note: Lined with trees and lacks buffer zone

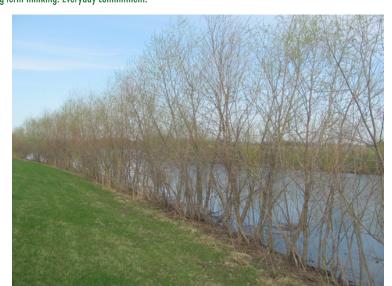
Trees along Stormwater Management Area A

Note: Absence of buffer zone

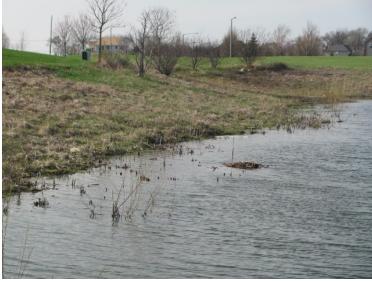
Pond, Shoreline Buffer Zone, Area North – The shoreline buffer zone of Stormwater Management Area North has thinned and deteriorated due to a lack of proper maintenance. Page 5.5 of *Photographs* depicts an overview of the shoreline. Remediation will require removal of any invasive species and seeding to promote growth and thickness of the buffer zone. We concur with the estimate of cost of \$7,000 as quoted *by Pizzo and Associates, Ltd.* on May 23, 2014 to remediate this condition defect on Line Item 3 of *Estimated Remediation Expenditures*.

Stormwater Management Area North shoreline

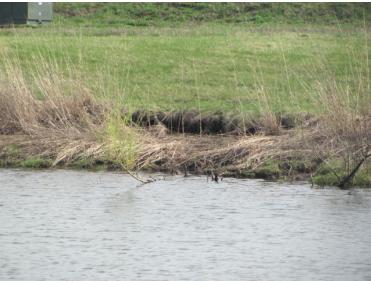
Ponds, Shoreline Buffer Zones, Areas B and South – The shoreline buffer zones of Stormwater Management Areas B and South have shrunk and deteriorated due to a lack of proper maintenance. The buffer zones lack approximately 12,000 square yards of natural plantings. We also note erosion along the south perimeter and west side of Area South as shown on Pages 5.5 and 5.6 of *Photographs*. The lack of a proper buffer zone promotes growth of invasive species of plants. Remediation will require removal of all invasive species, shoreline regrading, and seeding and plugging to promote growth and reestablishment of a proper buffer zone. We concur with the estimate of cost of \$48,000 as quoted *by Pizzo and Associates*, *Ltd.* on

Shoreline erosion at south perimeter of Stormwater Management Area South

May 23, 2014 to remediate these condition defects on Line Item 4 of *Estimated Remediation Expenditures*.

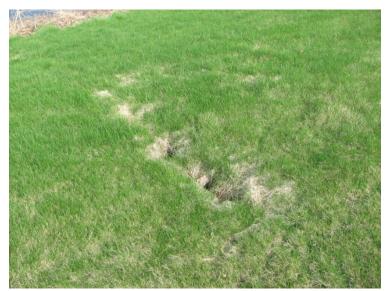
Erosion along west side of Stormwater Management Area South

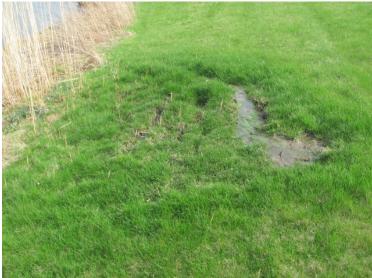
Erosion along west side of Stormwater Management Area South

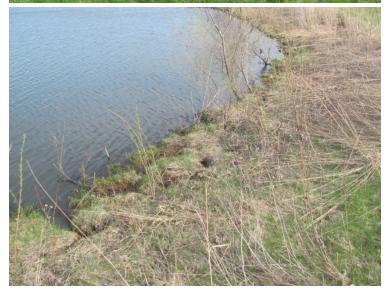
Stormwater Management Area South shoreline

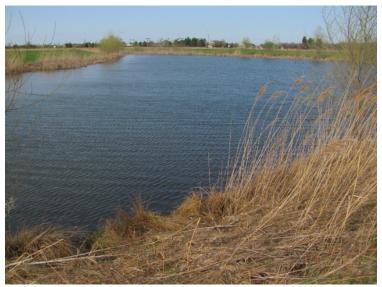
Stormwater Management Area B overview

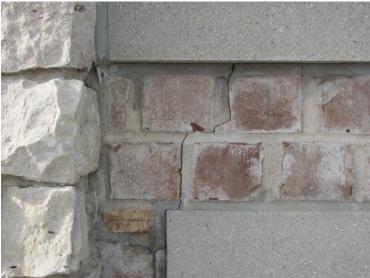
Step crack at Renwick Road and Creekview Drive entrance monument

The above defects, although smaller in scope and cost remedy, detract from the perceived quality and usefulness of Creekside Crossing. The aggregated cost to remedy the above defects appears on Line Item 6 of *Estimated Remediation Expenditures*.

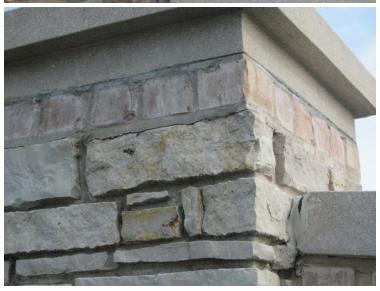
Mortar crack at Renwick Road and Cove Circle entrance monument

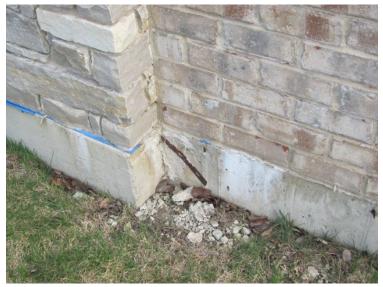
Exposed anchor at Renwick Road and Cove Circle entrance monument

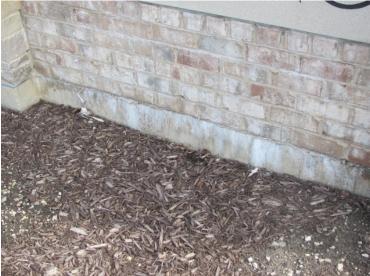
Efflorescence at Renwick Road and Crossing Drive entrance monument

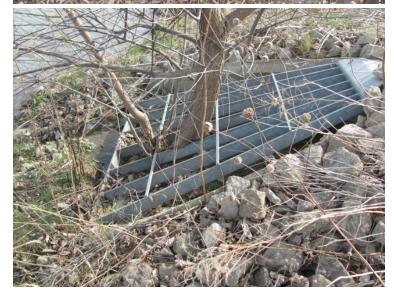
Tree through water flow structure of Stormwater Management Area South
