SERVICE BULLETIN	
Service Bulletin #	AASB-1-1-2011
Superseded Bulletin #	n/a
Issue Date	1-31-2011
Effective Date	1-31-2011
Limitations for Completion	Next scheduled inspection
Make & Model Affected	Lightning LS-1 SLSA & ELSA
	SN87 thru 107
Page 1 of 3

1. Applicability: Lightning LS-1 SLSA or ELSA aircraft in the effected serial range of SN87 thru SN107.

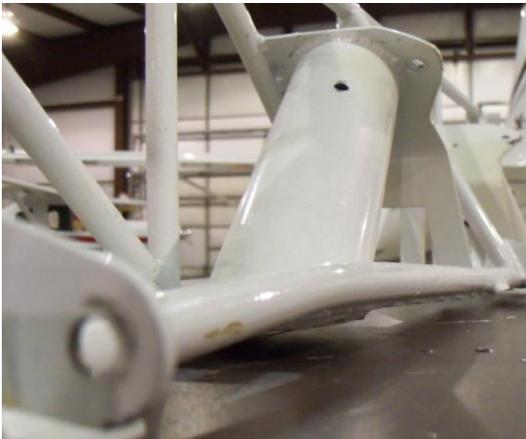
Figure 1: deformation of rear ½" tube box V1

Refer to figure 1: The lowest and most aft tube adjacent to the gear plate must be inspected. This tube is about 1/2" in diameter and should be flat with no upwards bowing to it. If deformed upwards it will be the greatest at the outboard end of the lower socket plate. Use a straight edge on the tube to determine if it is bent. Any deformation in this tube is cause for replacement.

If it is found that upon inspection the rear spar-box has deformed, section 4 of this SB must be complied with, within the next 25 hours of service. Arion Aircraft LLC must be notified before any service is to take place.

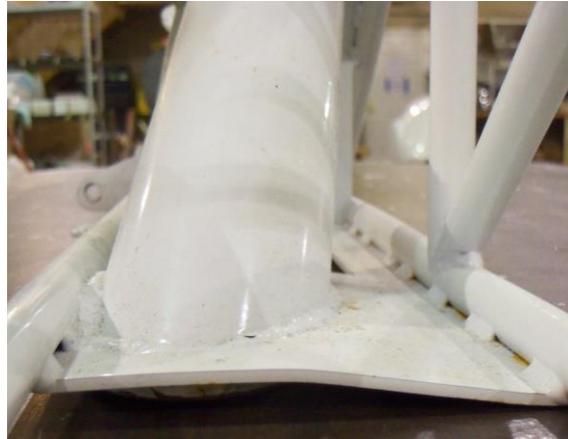
Figure 2: deformation of lower socket plate V1

Refer to figure 2: The lower socket plate must be inspected as well. This plate may have up to 1/16" flex upwards and be with in serviceable tolerance. However should more than that be found upon inspection the box should be replaced. Check by using a short straight edge set between the spar box tubes across the plate. Measure the deflection if any.

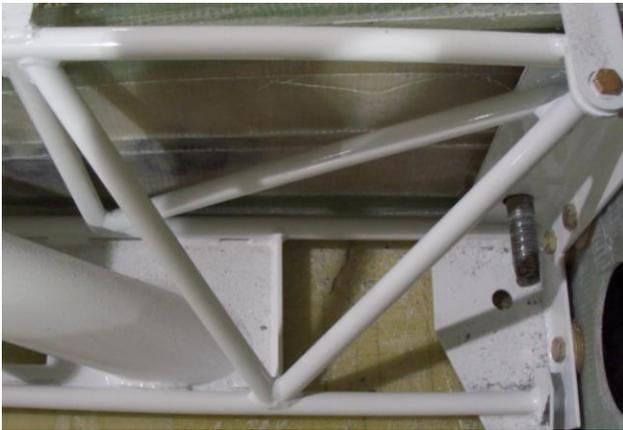
Figure 3: Compression tubes added V2

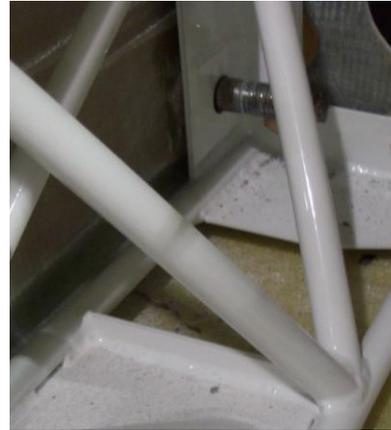
Figure 4: Gusset added to lower plate V2
