Inspection Report

Property Address:
513 Moore Street
San Marcos TX 78666

PROPERTY INSPECTION REPORT

By: Chad Garrett 6785 / Austinspect 5/30/2014

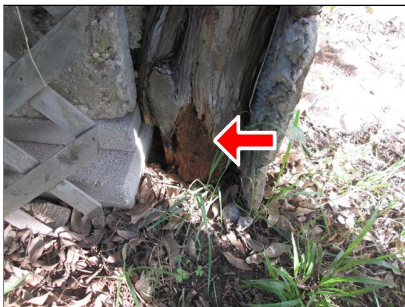
A. Item 1(Picture)

(1) Interior flooring is uneven due to settlement. The house is not level. Further evaluation recommended by a foundation specialist

(2) Cedar and stacked block piers should be replaced by solid concrete piers

(3) no strapping at pier to beam connections in crawlspace, current code requires beams to be secured to supporting piers

(4) Termite damage/rot at various cedar piers. Replace damaged piers

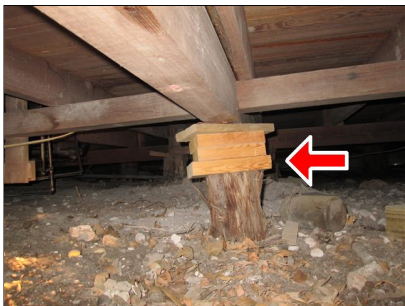
A. Item 2(Picture)

(5) wood shims are present at pier tops in most areas of crawlspace. wood shims can compress causing cracks in interior walls and ceilings. metal shims recommended

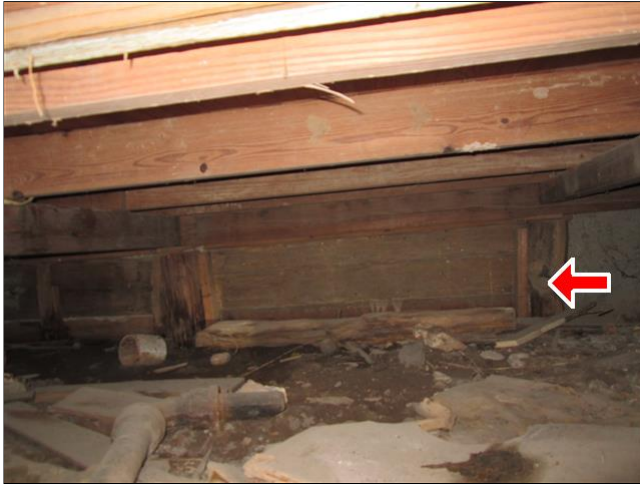
A. Item 3(Picture)

(6) no under floor insulation or moisture barrier present in crawlspace

(7) Wood underpinning is in contact with the ground in various areas of crawlspace. This can cause deterioration and attract wood eating insects.

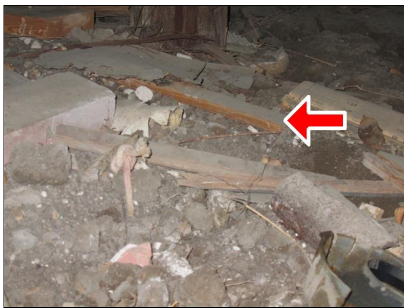
A. Item 4(Picture)

(8) The construction debris needs removing from the crawlspace under home.

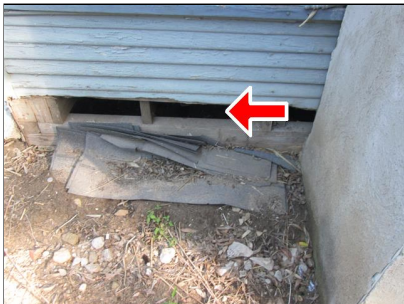
A. Item 5(Picture)

(9) additional crawlspace ventilation recommended. Current code requires 1 sq foot of ventilation for each 150 sq feet of under floor space

(10) The support posts are under-cut in areas in the crawlspace. Repairs are needed. A qualified engineer should inspect and repair or replace as needed.

(11) Seal all openings into crawlspace space to prevent pest intrusion

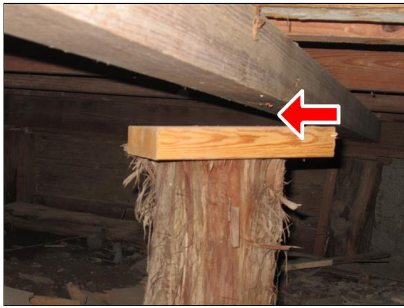
A. Item 6(Picture)

(12) Cracks noted at various areas of foundation underpinning. Cracks appeared cosmetic only. If further evaluation is desired a foundation specialist is recommended

- (13) underpinning is damaged and missing in various areas
(14) some piers are not bearing on beams, repair as needed

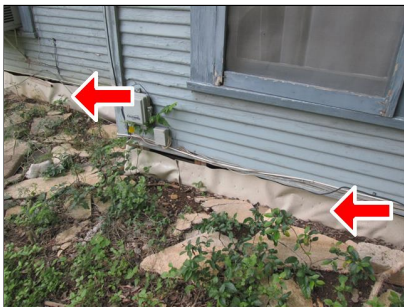
A. Item 7(Picture)

- (15) foundation underpinning is missing or is incomplete in many areas

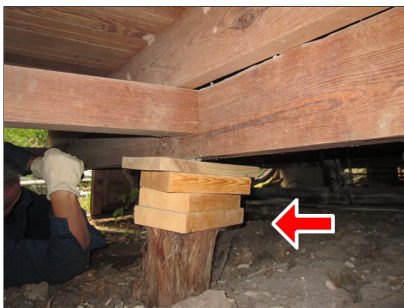
A. Item 11(Picture)

- (16) remove construction debris from around and under the home
(17) some piers are leaning and may not support the floor beams properly

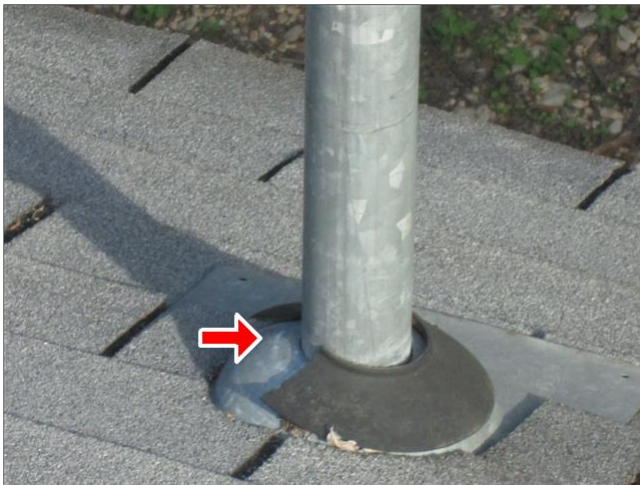
C. Item 1(Picture)

- (1) The roof is older. Shingles are raised in various areas
- (2) Rubber seal around service mast needs replacement

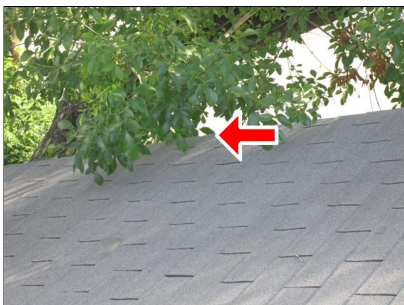
C. Item 4(Picture)

(4) The tree limbs that are in contact with roof or hanging near roof should be trimmed.

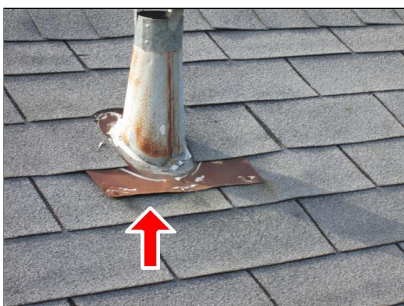
C. Item 5(Picture)

(5) seal caulk at all exposed fasteners on roof, these repairs should be done by a qualified roofing contractor

(6) secure raised flashing at roof vents

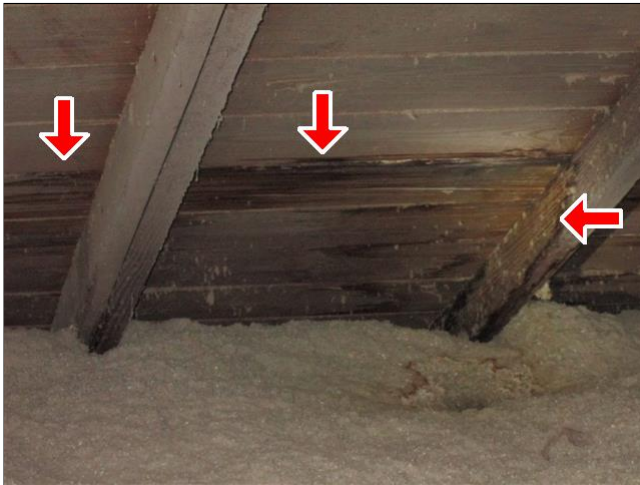
D. Item 1(Picture)

(2) water staining at right attic roof decking, unable to determine if leak is active. Replace all damaged building materials and repair roof as needed

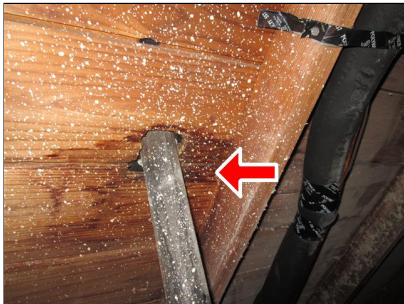
D. Item 2(Picture)

(3) water staining around plumbing roof vent, repair as needed

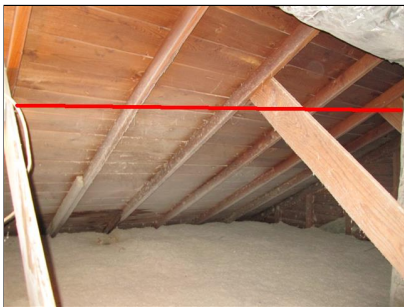
D. Item 5(Picture)

(6) Roof supports should be the same size as the lumber that they support. 2x4 roof rafters are being supported by 1x8 supports. No purlin bracing is present. recommend installation of purlin. This is a current code standard. The roof and structure were performing as intended at the time of inspection

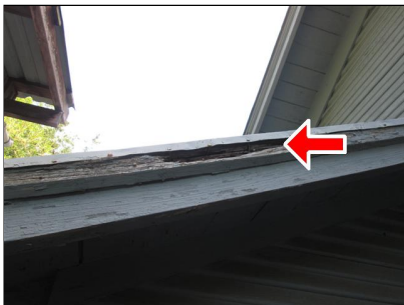
D. Item 6(Picture)

(7) rot at rear porch rake edge trim

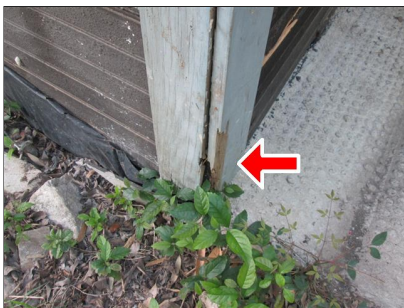
E. Item 3(Picture)

(2) water table trim is missing and or damaged in many areas around foundation perimeter

(3) missing and damaged trim at various areas, repair and seal as needed

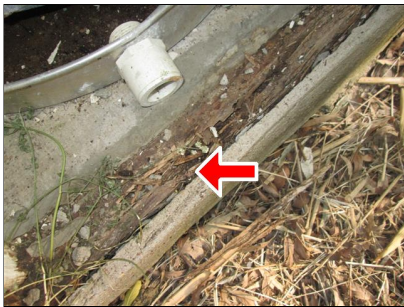
E. Item 6(Picture)

(5) termite damage and rot at water heater closet

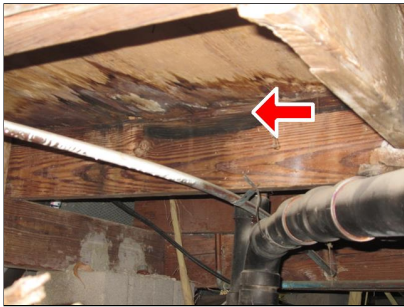
F. Item 2(Picture)

- (2) wood flooring is uneven in many areas of the home due to settlement
- (3) refrigerator is leaning rearward, evaluate and repair flooring under this area
- (4) water damage is present at flooring under bathrooms and kitchen, replace all damaged building materials as needed

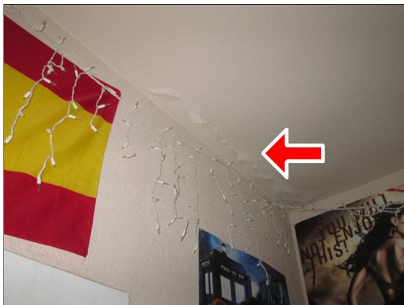
F. Item 3(Picture)

- (5) possible water damage at living room ceiling

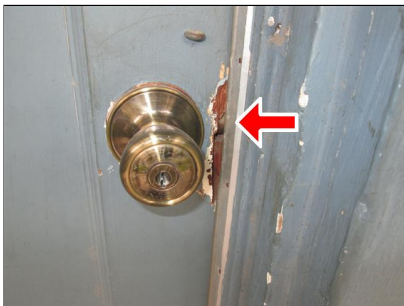
G. Item 2(Picture)

- (2) no dead bolt at front door
- (3) rear door dead bolt is inoperable
- (4) front door has been pried open at some point and door is damaged in striker area

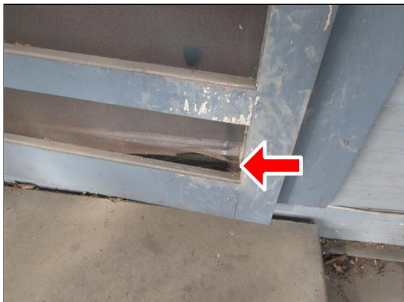
G. Item 3(Picture)

- (5) screen at front screen door is damaged

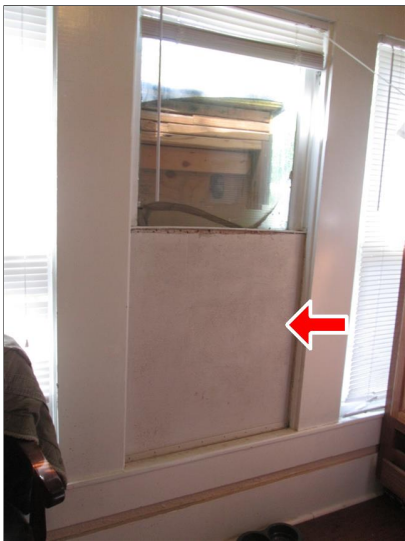
H. Item 1(Picture)

- (1) Window glazing is damaged at various windows
- (2) many windows have cracked windowpanes
- (3) all windows are painted shut. Fire egress hazard
- (4) one window in rear bedroom is boarded up

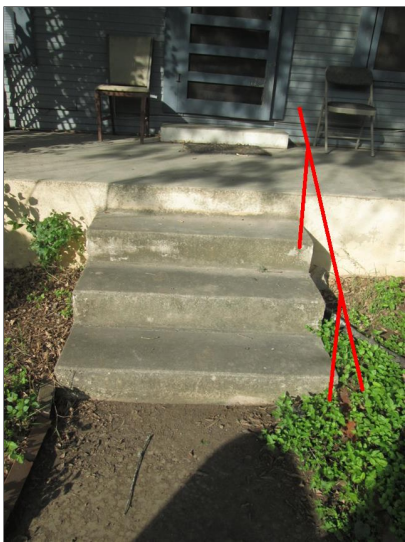
I. Item 1(Picture)

Missing hand railing at front porch steps. Required at 4 or more steps

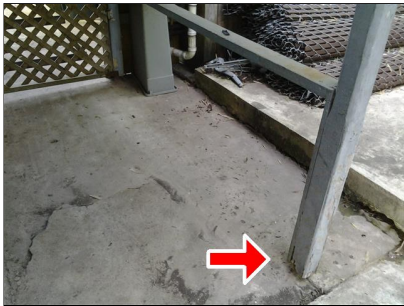
K. Item 1(Picture)

(1) Rear porch posts are not bearing. Roof load should be supported

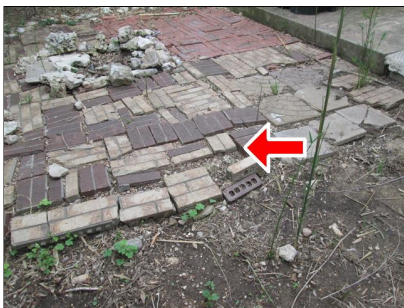
K. Item 2(Picture)

(2) loose brick at rear patio, possible tripping hazard

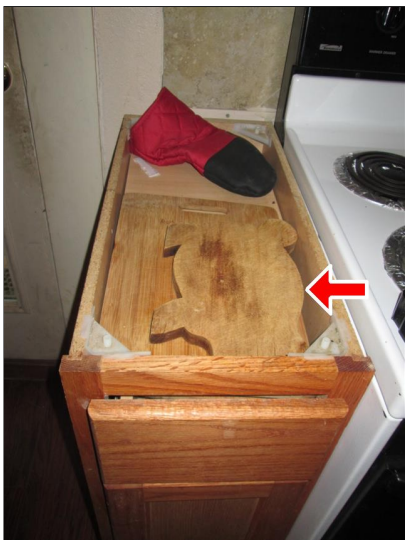
L. Item 1(Picture)

cabinet left of stove is damaged

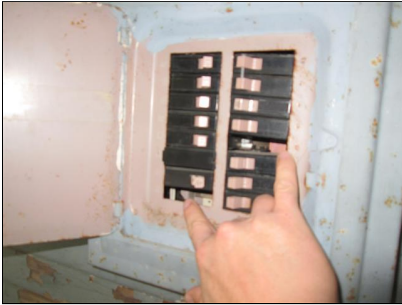
A. Item 1(Picture)

(1) missing knock out plates at both electrical panels, repair for safety

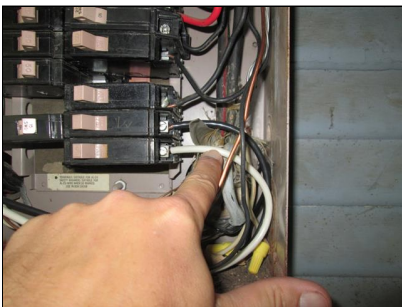
A. Item 5(Picture)

(3) neutral wiring being used in the hot position should be wrapped in red or black tape

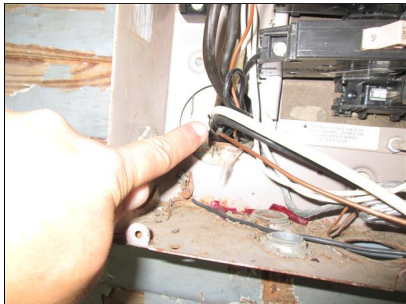
A. Item 6(Picture)

(4) missing proper wire protection/clamps at several panel penetrations

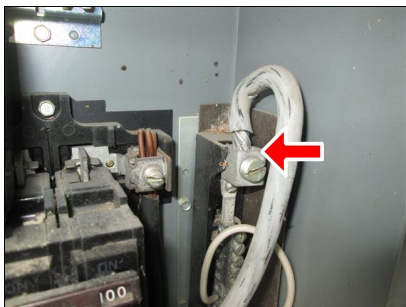
A. Item 7(Picture)

(5) missing antioxidant at several aluminum connections in panels

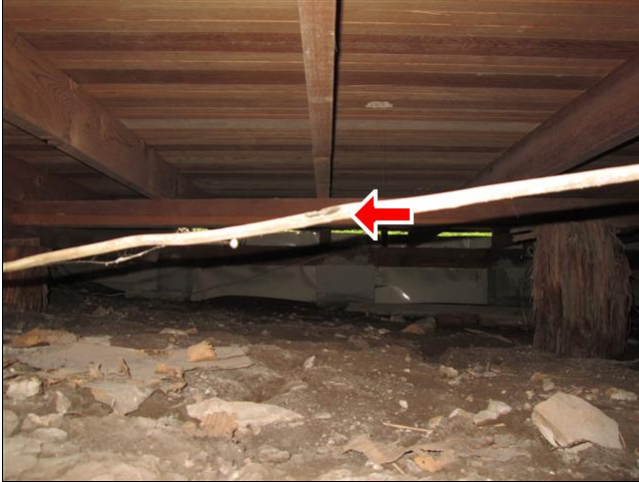
B. Item 3(Picture)

(2) chewed wiring in crawlspace, replace as needed. All wiring in crawlspace should be secured away from grade

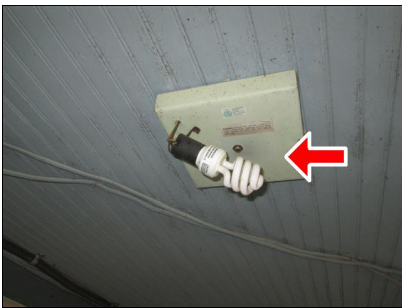
B. Item 4(Picture)

(3) Missing bulb shield at various lights. Bulb shields recommended at all exposed bulbs

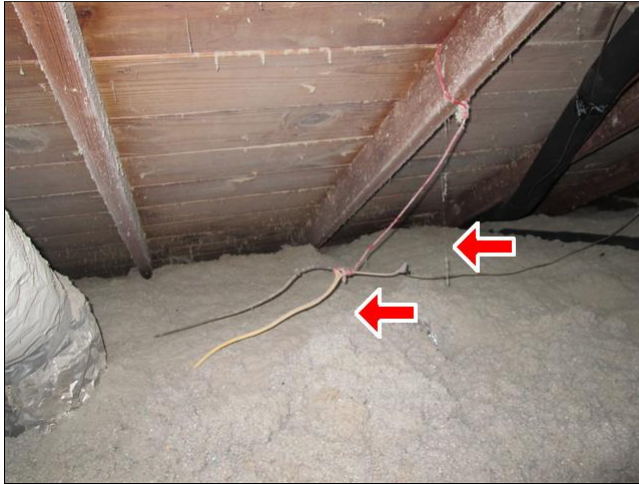
B. Item 6(Picture)

(9) The attic is insulated and "Knob and Tube" wiring is present. As a safety rule Knob and Tube wiring should never have insulation covering this wire or over heating can occur. If new insulation is added, an electrical contractor should first replace knob and tubing wires with updated wiring.

(10) recommend removal of all knob and tube wiring for safety

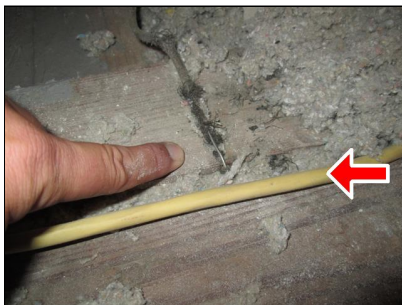
(12) Electrical wiring should be secured away from attic access to prevent damage

B. Item 8(Picture) bare wiring near attic access

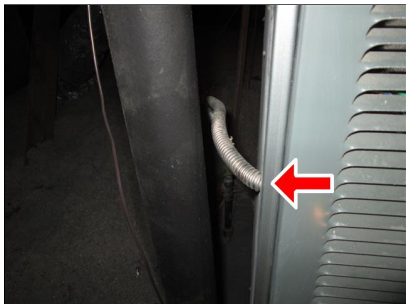
A. Item 1(Picture)

(1) flex gas line leading into furnace housing is a recognized safety hazard. rigid pipe exiting the housing is recommended

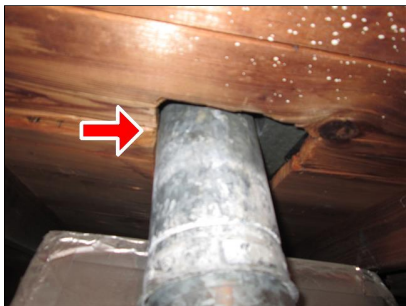
A. Item 2(Picture)

(2) Furnace vent is in contact with flammable material, 1" clearance required

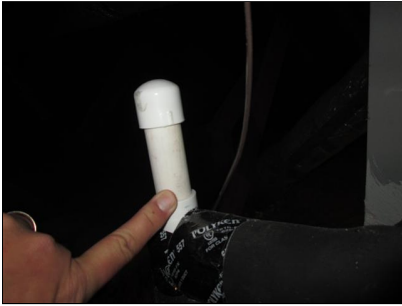
B. Item 1(Picture)

(1) vertical HVAC unit is being used in attic area, there is not a drain pan or safety float switch present for the unit. If the condensate drain line clogs building materials will be damaged. Have a licensed HVAC contractor evaluate and repair as needed

(2) missing safety float sensor at condensate drain line in HVAC closet. Have a licensed HVAC contractor install to prevent water damage

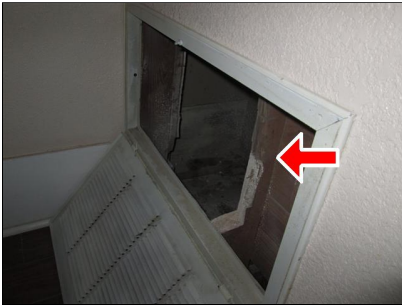
C. Item 1(Picture)

(1) The HVAC system is being operated without a return filter. The system may be dirty. Cleaning and service recommended

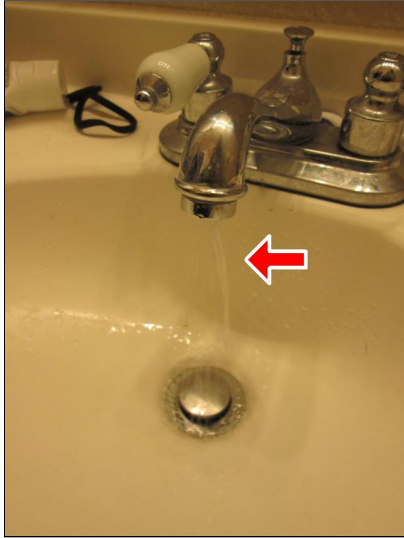
A. Item 1(Picture)

(1) No water pressure at bathroom sinks. Aerators need to be cleaned

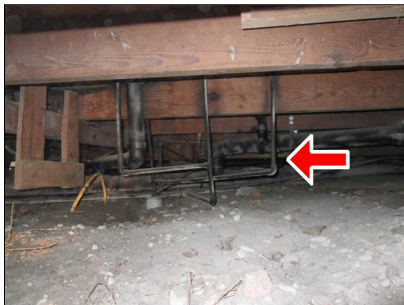
A. Item 2(Picture)

(5) PVC water lines are in use in crawlspace. Lines appear undersized and may not meet today's plumbing code. Have a plumber evaluate

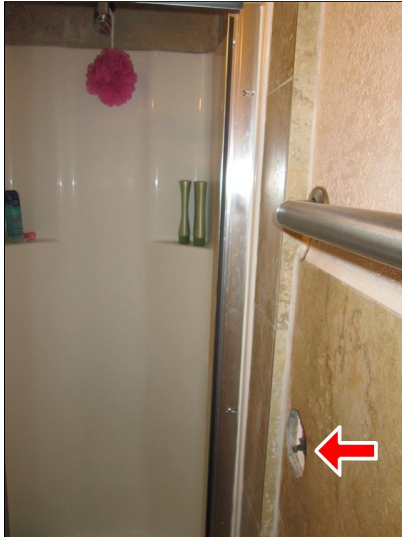
A. Item 3(Picture)

(6) rear bathroom shower fixture is located outside of shower and is missing handle and wall escutcheon. Fixture handle should be located inside shower area

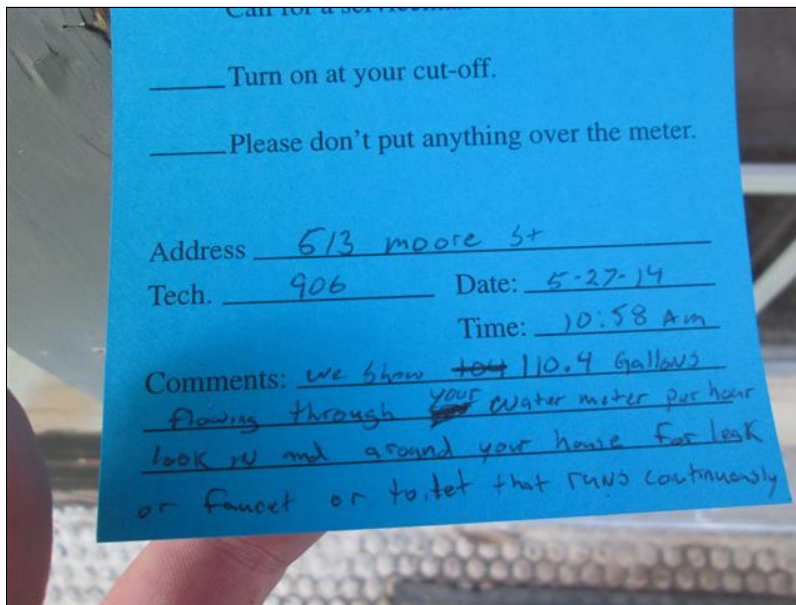
A. Item 5(Picture)

(8) water company left a notice on the door stating that the home was using 110 gallons an hour. Have all plumbing lines evaluated prior to closing

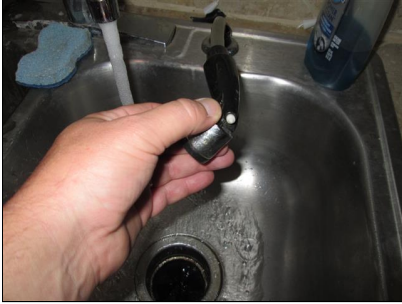
A. Item 7(Picture)

(9) kitchen sink sprayer is inoperable

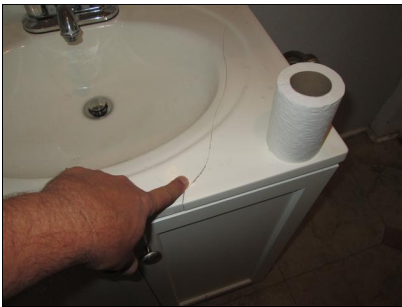
A. Item 8(Picture)

(10) front bathroom sink is cracked

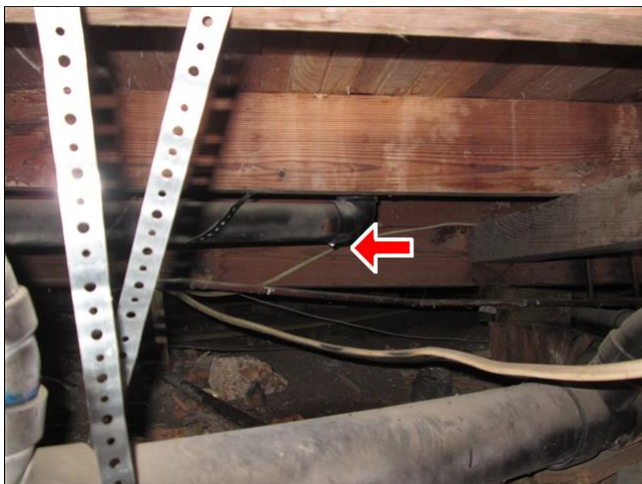
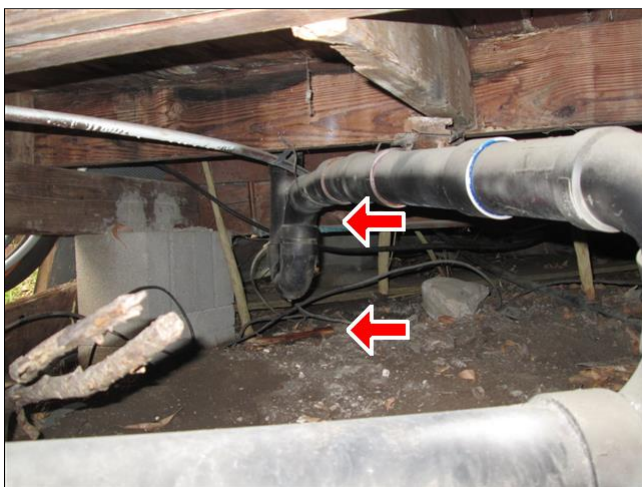
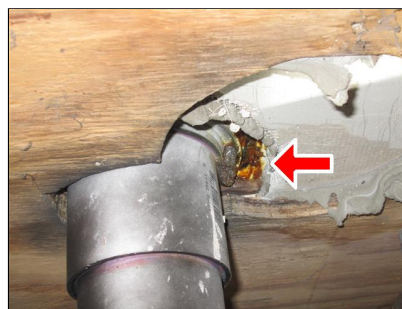
(1) active leaks under bathrooms in crawlspace. Have all plumbing further evaluated

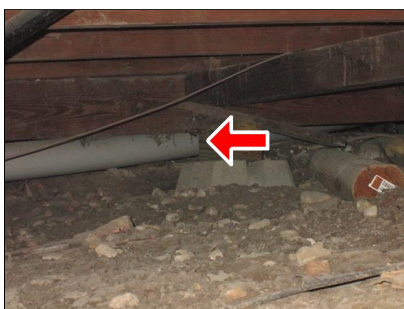
B. Item 4(Picture)

(2) beam in one area of crawlspace appears to be resting on drain line. repair as needed

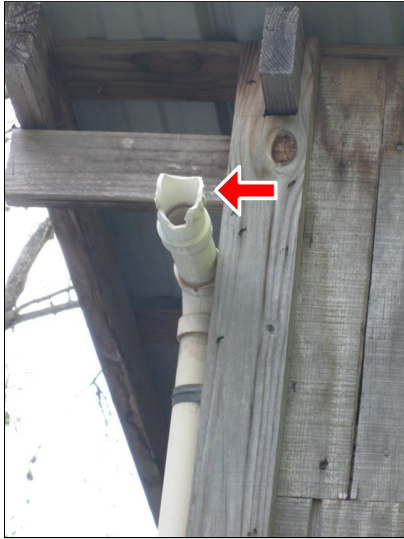
B. Item 5(Picture)

(3) damaged plumbing vent at detached building

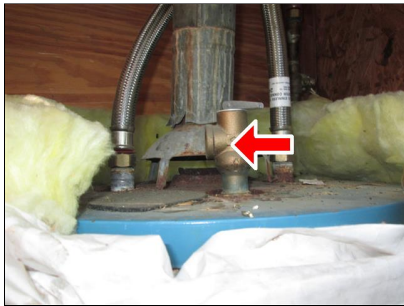
C. Item 1(Picture)

- (1) water heater vent is in contact with roof decking. 1" clearance required
- (2) missing sediment trap at water heater gas supply line per todays code standards
- (3) water heater pressure relief valve piping should terminate to the exterior

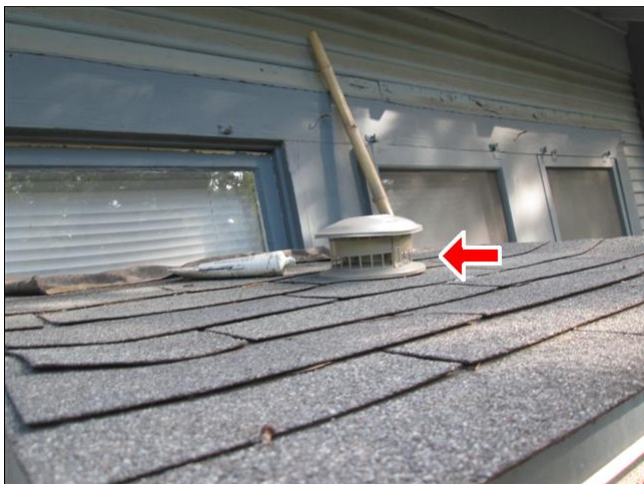
C. Item 2(Picture)

- (4) water heater should be elevated 18" above closet floor
- (5) missing ceiling collar at water heater vent in water heater closet
- (6) water heater drain pans should terminate to the exterior
- (7) insulate water lines at the top of water heater to prevent freezing
- (8) water heater vent does not appear to have proper clearance from roof, 3' clearance required by todays standards

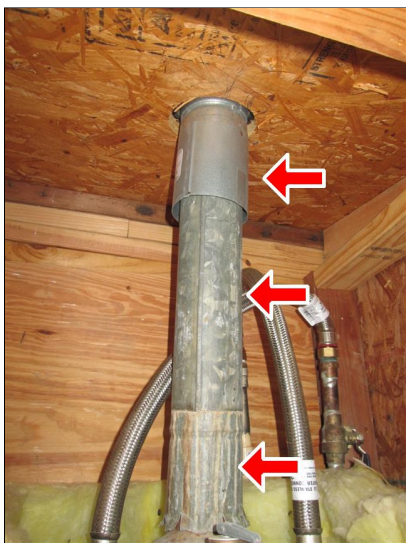
C. Item 3(Picture)

(9) no combustion or draft air vents present for water heater closet

(10) flue material should be type B double walled type for safety. Vent is not properly sealed

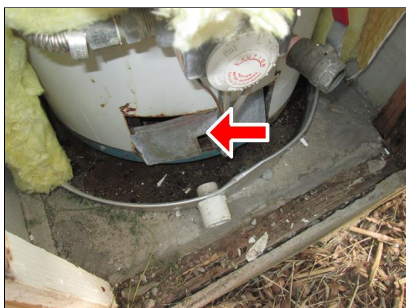
C. Item 4(Picture)

(11) missing burner cover
