RESERVE STUDY REPORT

PREPARED FOR
Windstone Community Association II
Sugar Grove, Illinois

WEC PROJECT #: 13C-426
DATE OF REPORT: April 22, 2014

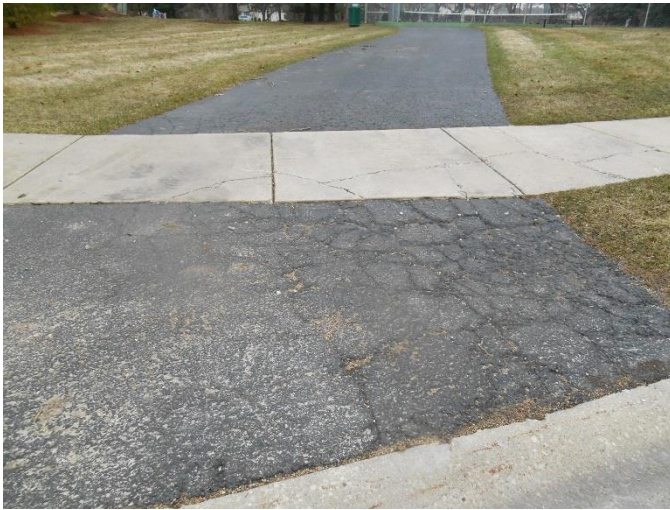
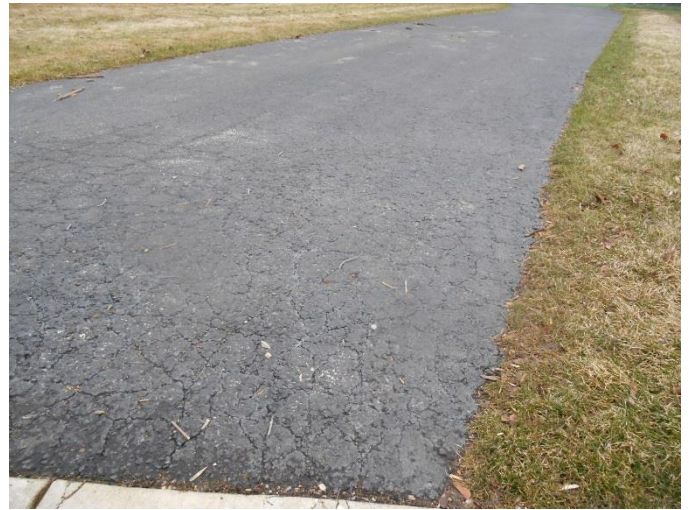
The west entrance tennis court has a service drive constructed of asphalt pavement. The asphalt was in overall satisfactory condition; however, it is showing signs of aging in the form of cracking and minor deterioration.

Tennis court service drive asphalt.

Periodic seal coating and crack filling is important preventative maintenance that can be done to extend the life of the pavement. Cracks that are greater than 1/8" in width should be routed out, cleaned, and filled with a rubberized hot tar crack sealant to prevent water from penetrating the pavement. Seal coating minimizes oils from evaporating, reduces the degradation that occurs from ultraviolet light, and prevents water from penetrating the pavement. Seal coating, crack sealing, and select patching are considered to be maintenance expenses; therefore, adequate funding should be allocated to the operating and maintenance budget for such expenses.

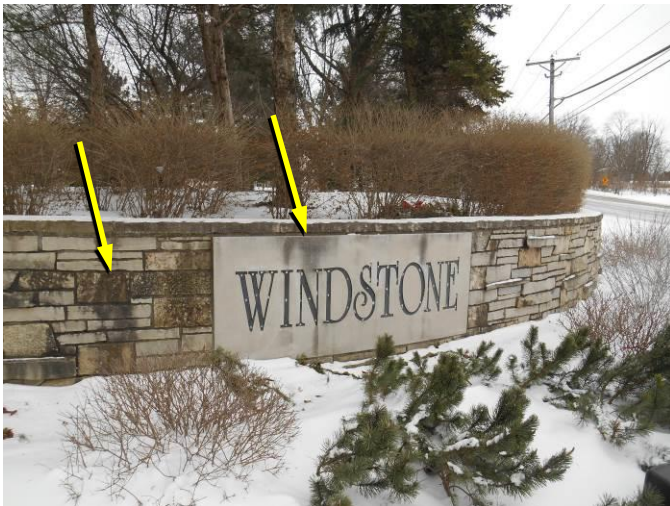
- The entrance monuments are stained with dirt and organic growth. Organic growth holds moisture which can accelerate deterioration. In effort to restore the appearance of the entrance monuments, cleaning is recommended as part of ongoing routine maintenance.

South entrance monument. Note: staining.

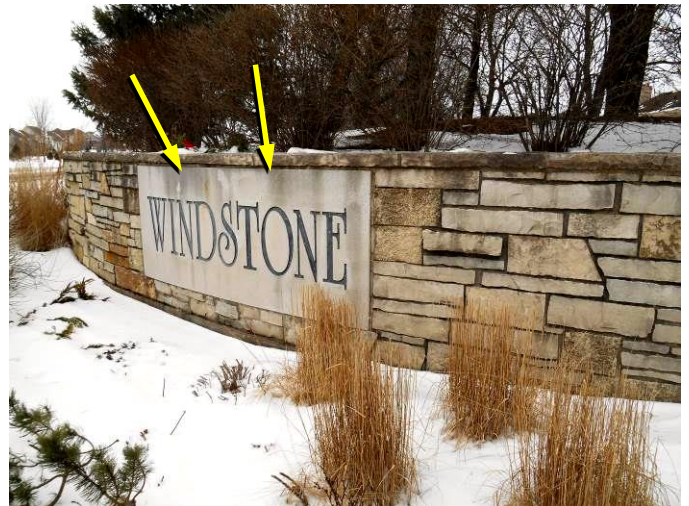
North entrance monument. Note: staining.

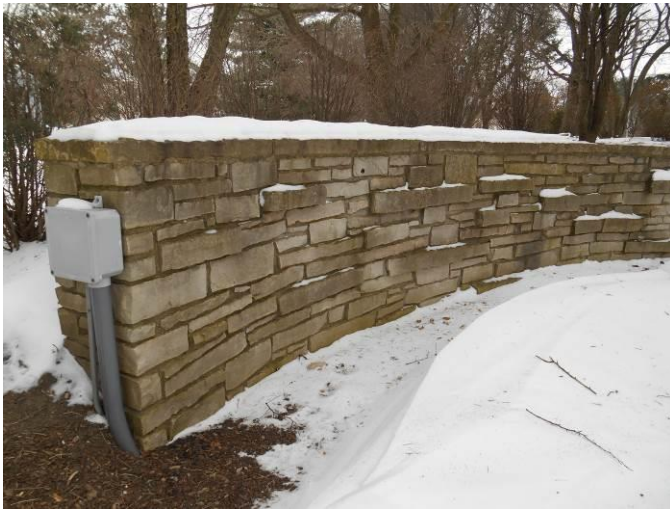
It is recommended that the organic growth at the entrance monuments be cleaned.

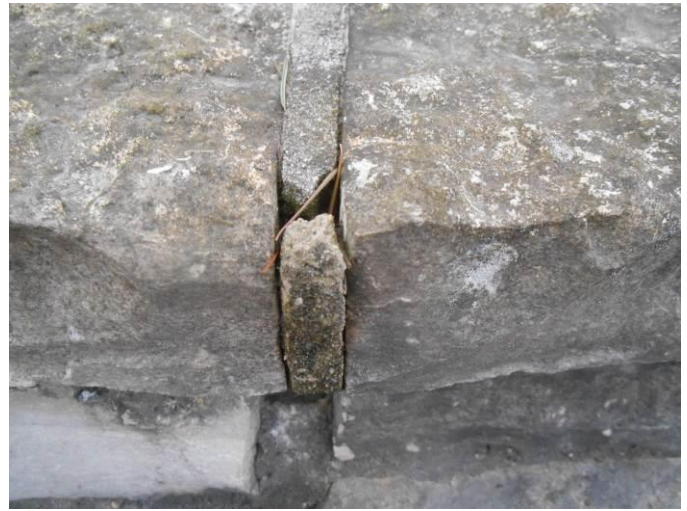
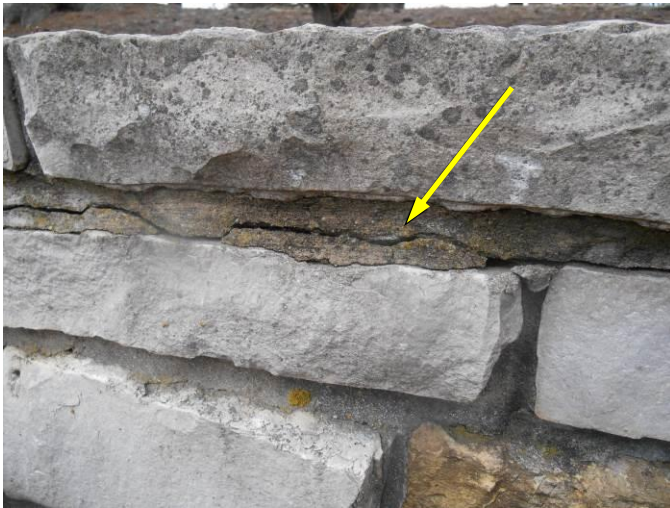
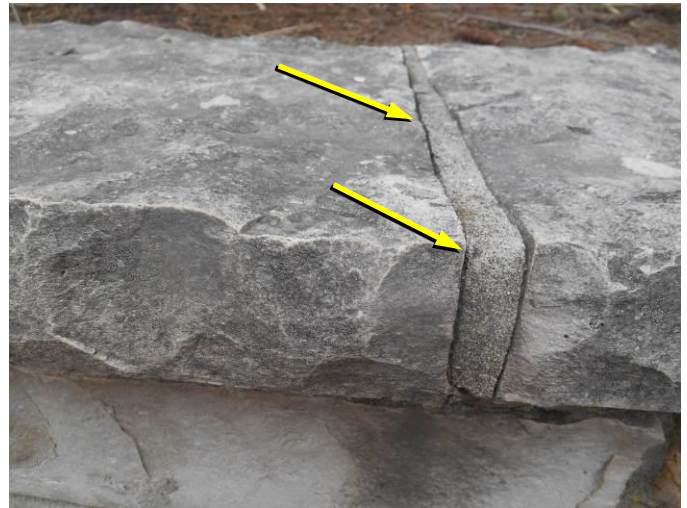
- The entrance monument lettering was faded and flaking off. Re-painting by a qualified professional as part of ongoing maintenance is recommended.
- Isolated mortar joints at the entrance monuments were cracked and deteriorated, especially along the capstones. There is also a broken capstone on the north monument. The cracks will allow moisture to penetrate and lead to further masonry deterioration. It is recommended that the entrance monuments be repaired by a qualified mason to prevent further deterioration.

Deteriorated mortar and cracks allow moisture to penetrate leading to further deterioration. The entrance monuments require tuckpointing.

Based on the observed conditions, known history, and expected useful life, funding has been allocated for periodic partial tuckpointing repairs of the entrance monuments every five years over the reserve term starting in year 2015. Please refer to the table below for a summary of the element quantities, present day cost, and remaining useful life as well as to Exhibits 2A (3% inflation rate) and 2B (5% inflation rate) for the estimated expenses and scheduling. Re-painting the lettering, cleaning, and lighting replacement should be budgeted for, and performed as part of ongoing routine maintenance.

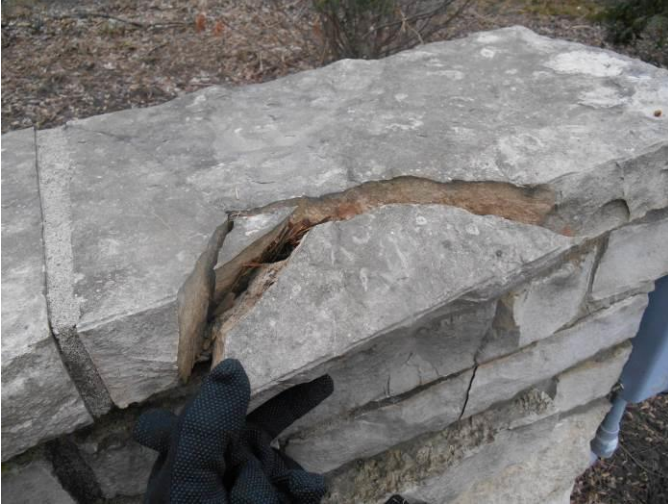
Broken capstone on the north entrance monument.

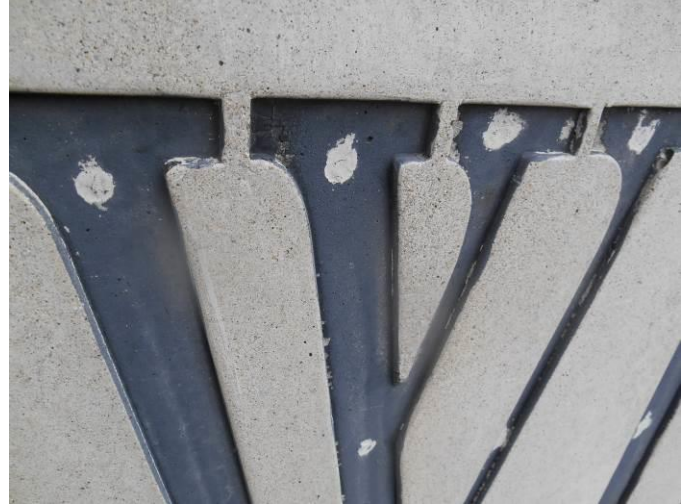
Faded and peeling lettering.

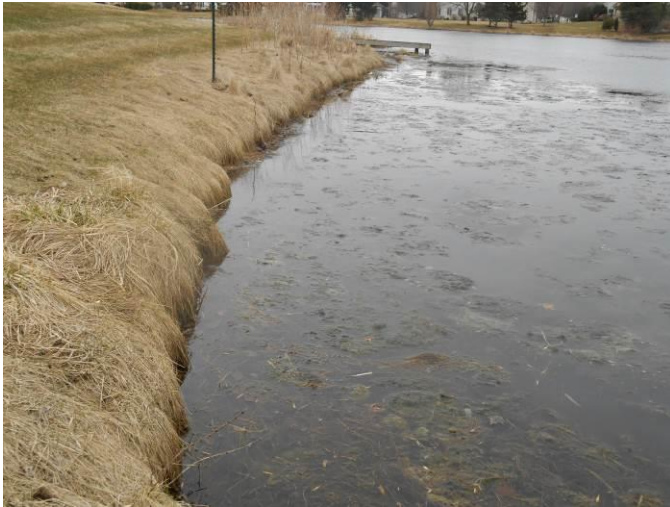
South east shoreline toe erosion.

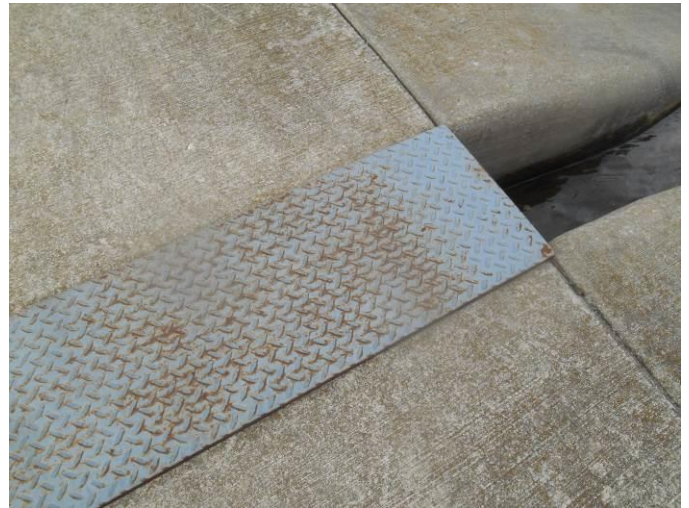
The steel plates covering the spillway channels exhibited rusting. It is recommended that the steel plates be properly prepared and painted with a rust inhibiting paint to prevent premature deterioration and prolong their expected useful life.

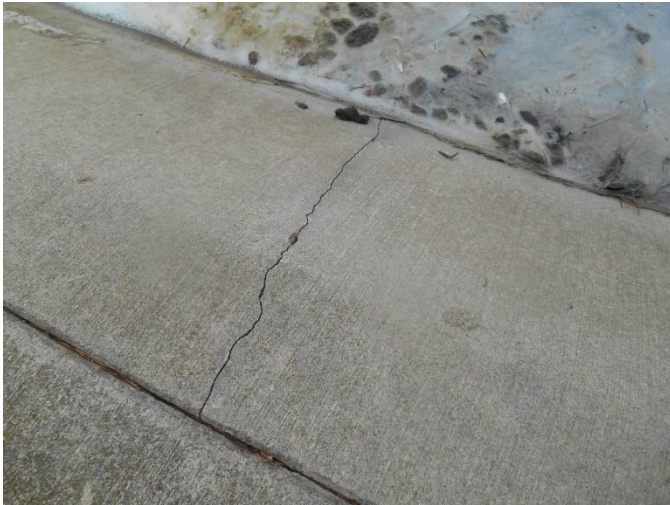
Minor cracking was observed in the spillway concrete. It is recommended that the cracks be sealed to limit damage that may occur due to moisture penetration and freeze/thaw cycles.

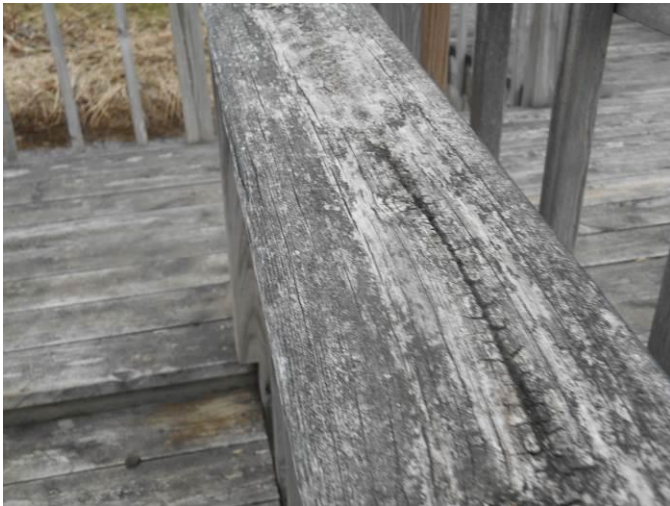
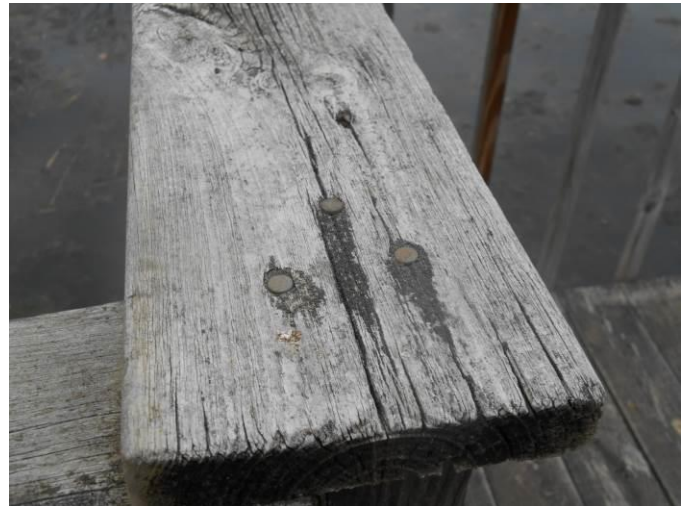
Large wood pier deterioration.

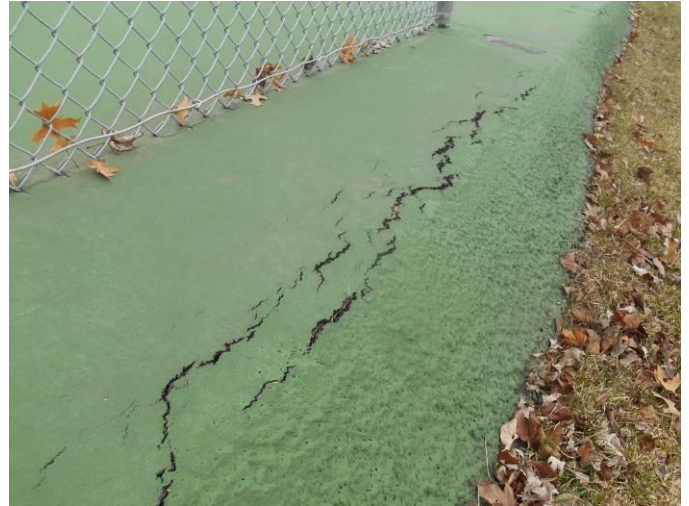
Minor cracking at north tennis court.
