Building Inspection Report

123 Client Address, Calgary, AB

Report Number:
12090408

Report Overview

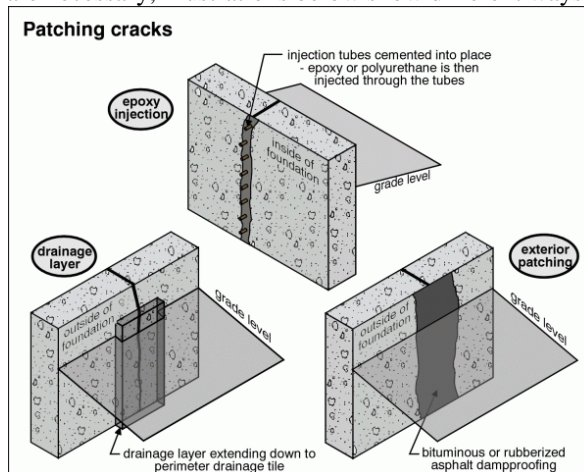
- **Monitor:** Typical foundation cracks were noted on the exterior. They appear to be stable. However, at this time it cannot be determined if future movement or leakage will occur. Recommend monitoring all cracks and repair if necessary. Please refer to the lot grading and surface water control comments in the exterior section of the report for related information. If repairs are necessary, illustrations below show different ways cracks can be sealed.

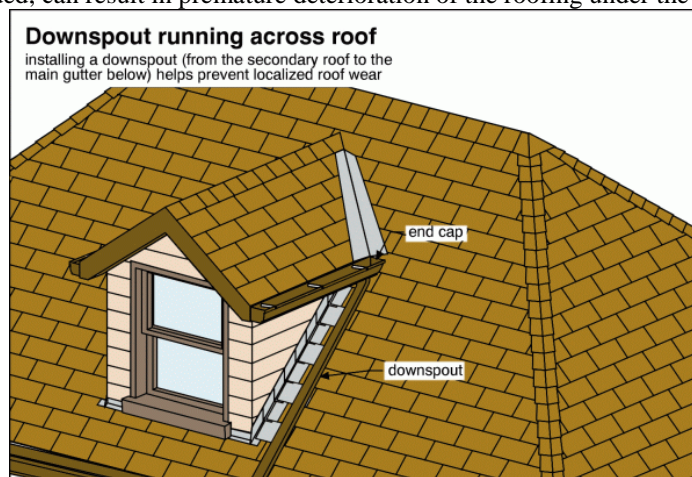
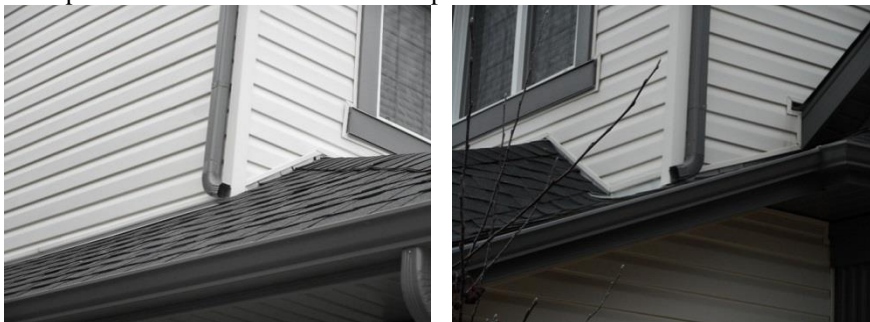
- **Repair:** Downspout(s) that discharge onto the roof should be extended to discharge directly into the gutters below. This condition, if left unattended, can result in premature deterioration of the roofing under the end of the downspout.

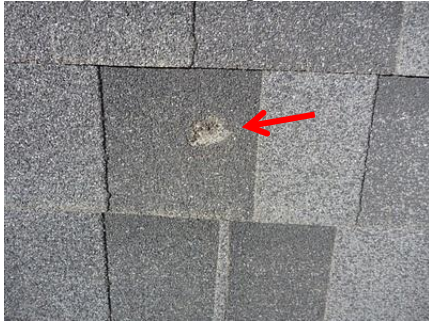
Above garage entrance

- **Repair:** Minor repairs to the roofing are needed.

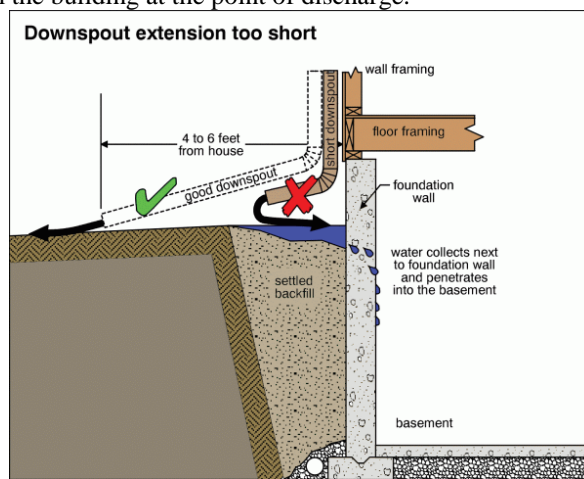
- **Repair:** The downspout(s) should discharge water at least five (5) feet from the house. Storm water should be encouraged to flow away from the building at the point of discharge.

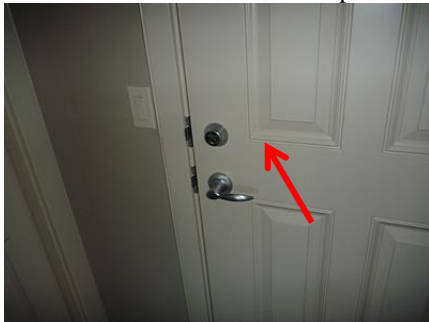
- **Repair:** The door between the garage and the interior of the house should be equipped with an auto-closer device to close and latch the door to prevent automobile fumes from entering the house.

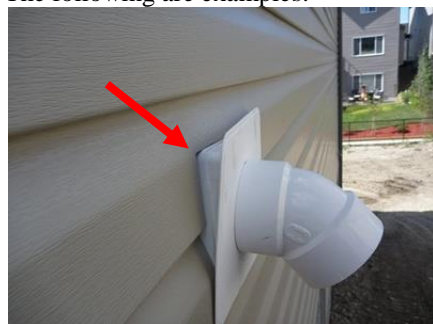
- **Improve:** There are places around vent pipes where the trim is loose and should be properly secured and sealed.

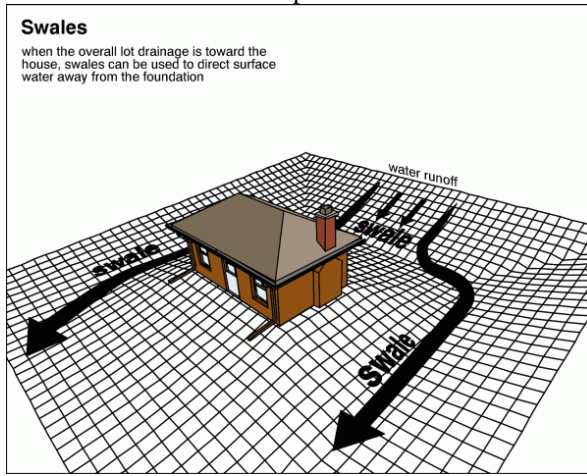
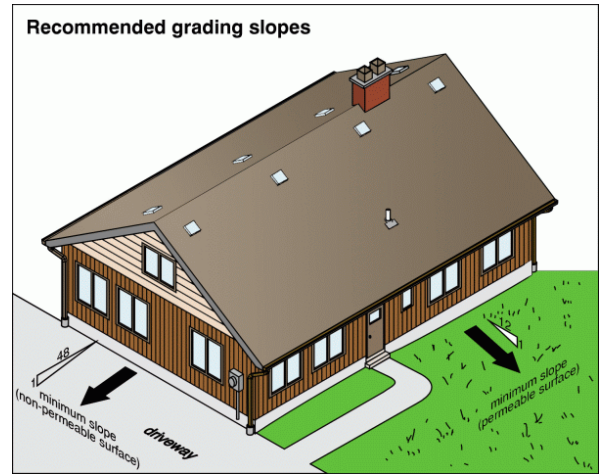
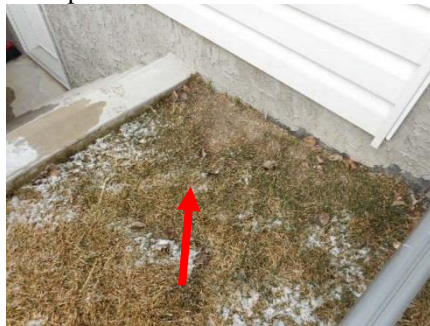
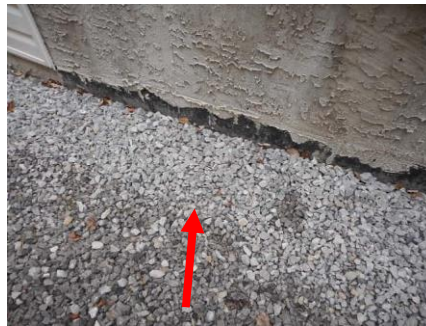
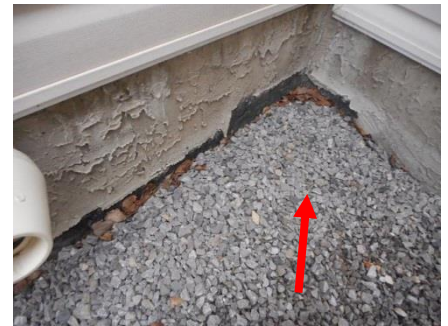
- Repair:** The grading should be monitored during a heavy rain storm. If water ponds against the foundation, the grading should be improved to promote the flow of storm water away from the house. This can often be accomplished by the addition or removal of top soil. The grading should start about 6" below the bottom of the siding and slope away from the house at a rate of one inch per foot.

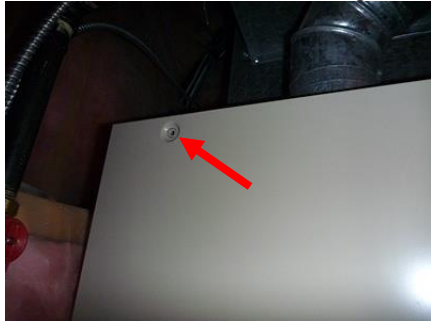
- **Monitor:** A screw is missing on the electrical panel. Replacing the screw is recommended.

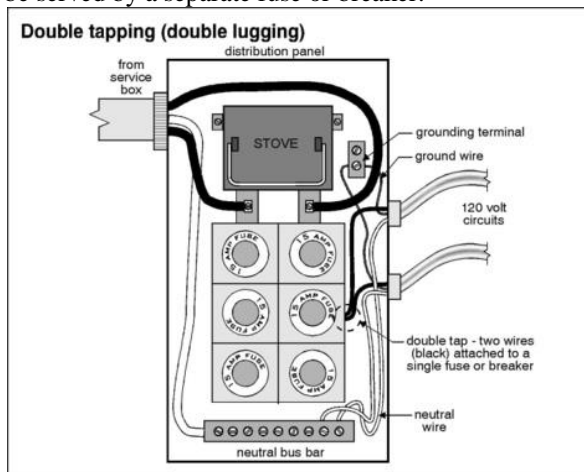
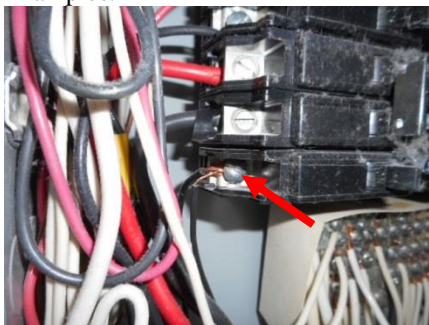
- **Repair:** Circuits within the main distribution panel that are doubled up (referred to as “double taps”) should be separated. Each circuit should be served by a separate fuse or breaker.

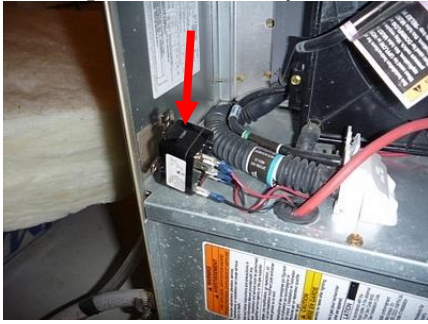
- **Repair:** A loose relay inside the furnace should be properly secured.

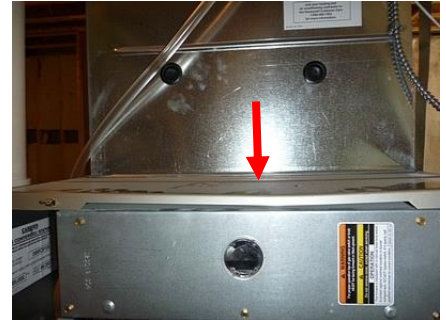
- **Repair:** The furnace cabinet and front panel is damaged in several locations. Although this does not affect the functionality of the furnace, the damage is noticeable.

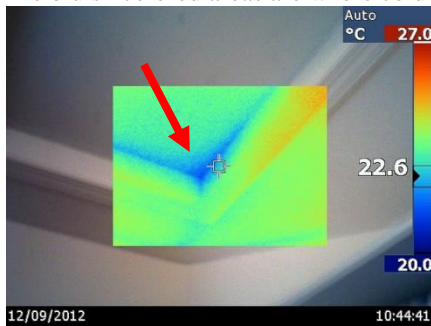
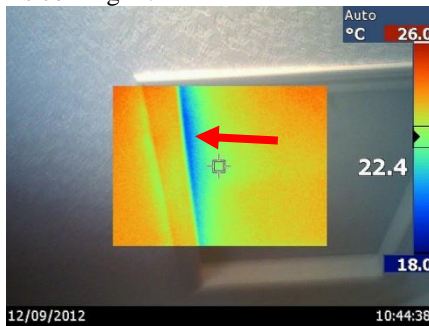
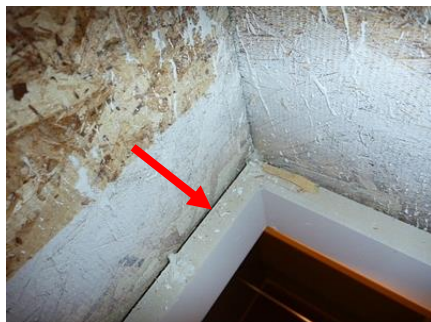
- **Improve:** The attic access hatch should be better insulated. Foam tape around the edges and insulation on top should reduce heat/cold loss at that location.

The bluish colored areas are where cold air is coming in:

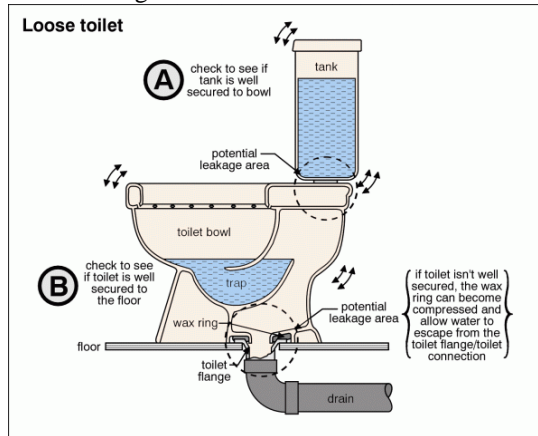
- **Repair:** Loose toilets should be re-set and tightened.

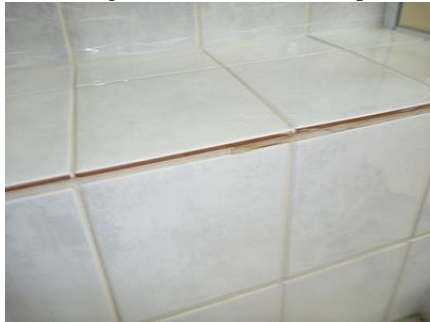
- **Monitor:** Moisture meter readings were high around the bench in the main bathroom shower stall. This may be due to the density of the material used for the base of the bench. There were no visible signs of excessive moisture or water damage at the time of the inspection. This should be monitored and repaired if necessary.

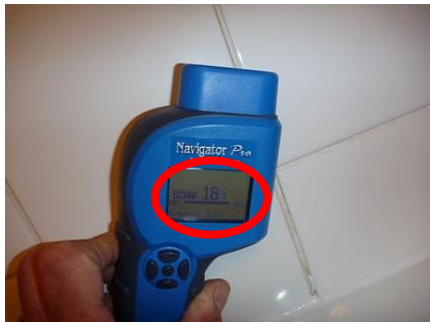
High moisture readings

- **Major Concern:** Moisture meter test of the walls around the basement shower found excessive moisture on the back wall towards the front of the stall. The inspector also found that the wall was soft to the touch. Water stains on the back side of the drywall were also noted from the furnace room. There may be hidden damage behind the tiles. This condition should be examined further and repaired.

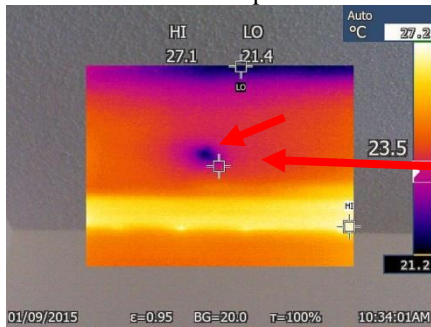
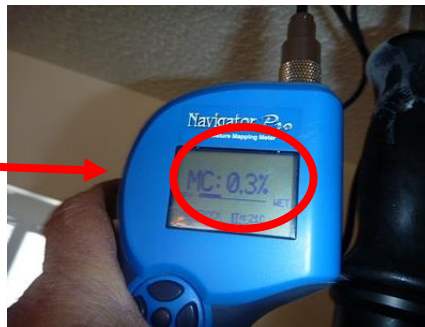
- **Repair:** Thermal imaging found the results of a waste pipe leak under the main bathroom upstairs. A moisture meter test confirmed the presence of water.

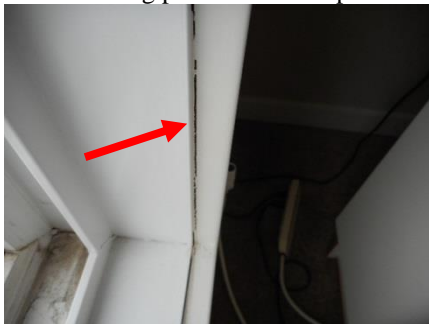
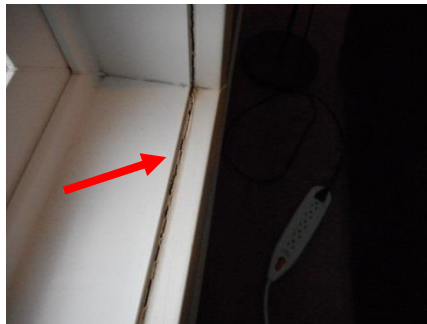
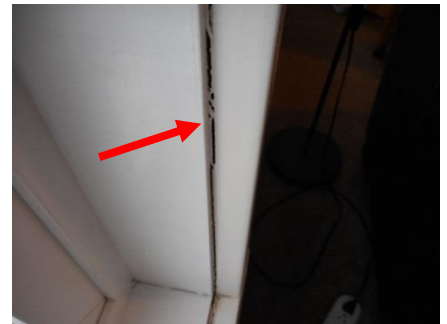
- **Repair:** Caulking is needed around some of the windows to seal the cracks between the sill and trim and/or window frame to help prevent moisture from penetrating below the sill.

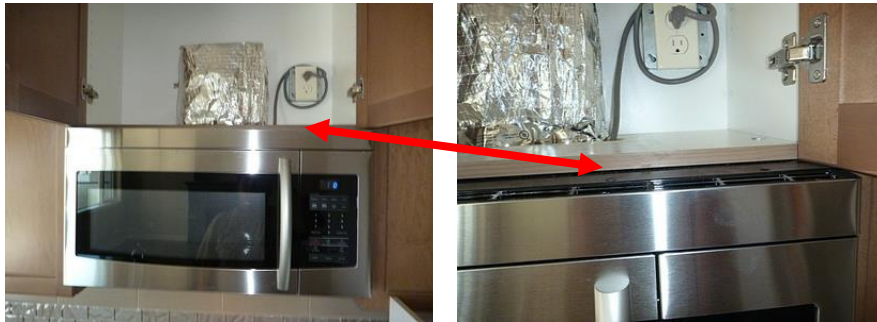
- **Repair:** The cook top exhaust fan does not completely discharge to the building exterior. Air leakage was noted between the cabinet and the top of the microwave and exhaust fan unit. Sealing the duct work to the unit is recommended.
