# Property Inspection Report

56 Inspection Place

Property NJ 08000

## Terra Home Inspections LLC

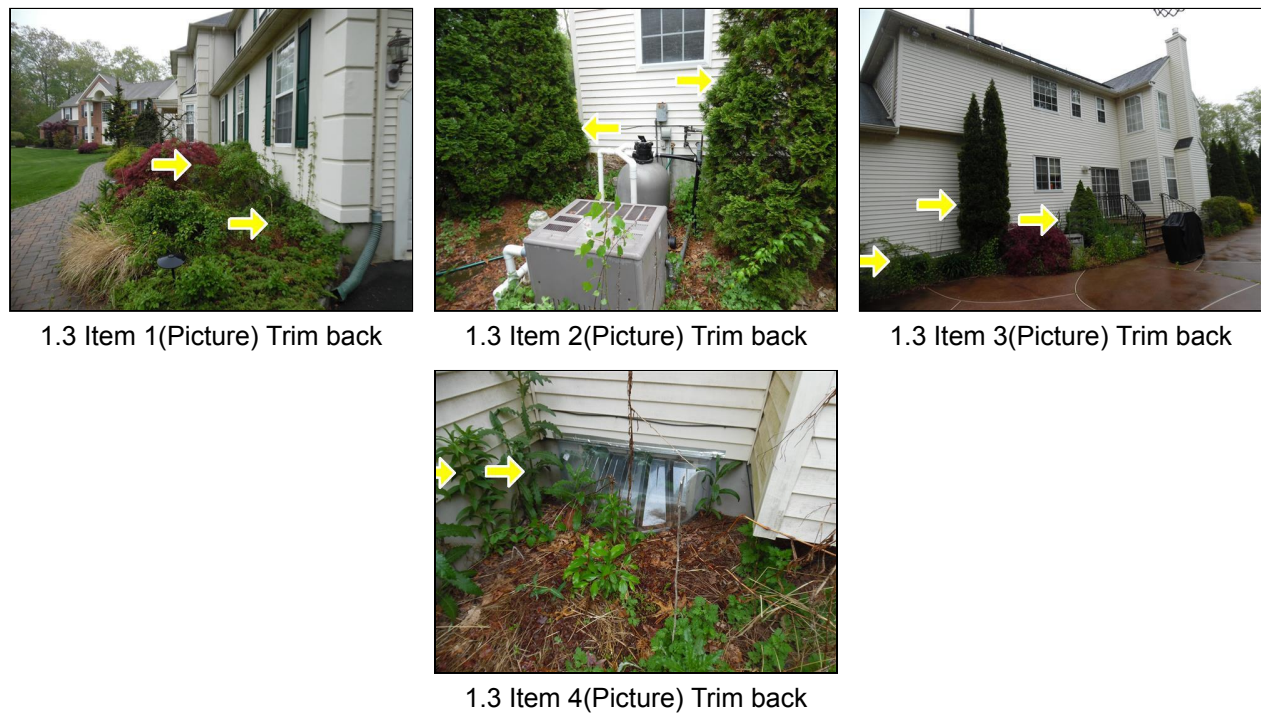
1.3 There was some vegetation observed near or touching the exterior of the house. This vegetation at full growth should be kept at least a foot (preferably 18 inches) from house siding and windows. Keep trees away from foundation and the roof. Vegetation in contact or proximity to the house can provide pathways for wood destroying insects, as well as abrade and damage siding, screens and roofs. Recommend trimming back the vegetation near the exterior of the house.

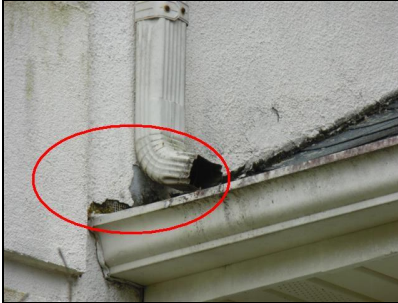
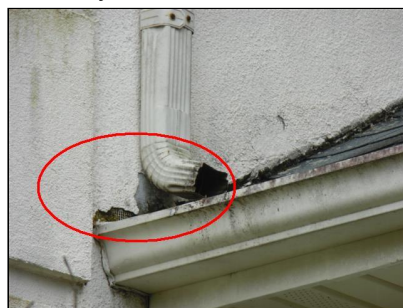
**2.0 (2)** The EIFS on the bottom of the right side wall where it meets the roofline appears to have a 2"-3" diameter hole in it. Water can easily run down the roof and may run into this hole.

2.0 Item 1(Picture) Hole in EIFS-  
Right front wall

(2) The EIFS on the bottom of the right side wall where it meets the roofline appears to have a 2"-3" diameter hole in it. Water can easily run down the roof and may run into this hole.

**2.0 (1)** The front exterior wall surface of the house appears to be clad with EIFS (exterior insulation and finishing system). There were numerous defects observed in the EIFS on the front of the house. I will list each defect observed in individual segments following this segment. If these defects are not repaired, the elements and wildlife/pests could get into the wall structure and the interior of the house thus damaging the wall structure and interior. A known problem with EIFS is once moisture gets behind the system, there is no where for the water to go, and because the insulation board is attached to the exterior of the sheathing, the system holds water against the sheathing, slowing normal evaporation and promoting decay of the structure and most often, creating conditions that are conducive to mold and fungi growth. Recommend a further evaluation of the entire front EIFS cladding for repairs by a licensed contractor specializing and qualified in EIFS inspections and repairs.

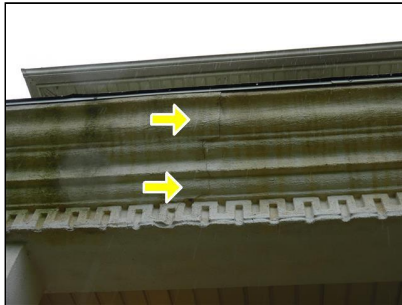
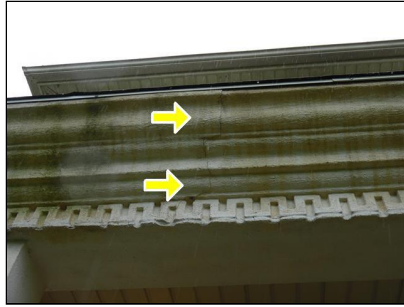
**2.0 (3)** There was a crack observed in the EIFS on the structure above the front door.

2.0 Item 2(Picture) Cracks in  
EIFS- Above front entry

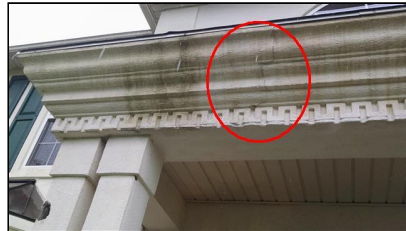
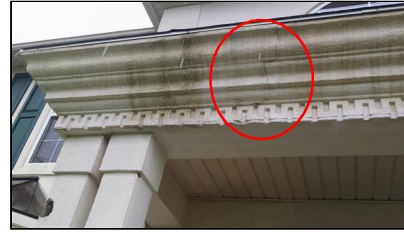
2.0 Item 3(Picture) Area of  
concern above front entry

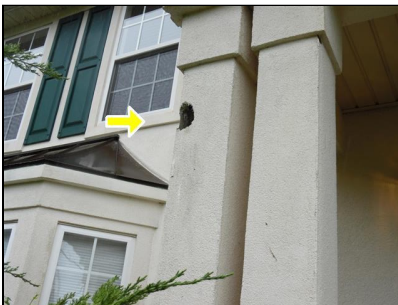
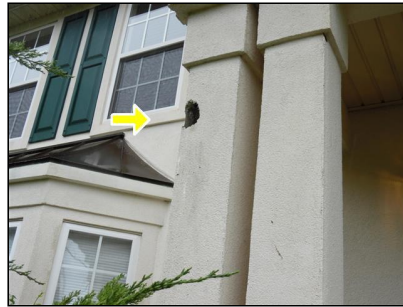
**2.0 (4)** There was a hole observed in the left side EIFS column.

2.0 Item 4(Picture) Hole in EIFS  
column

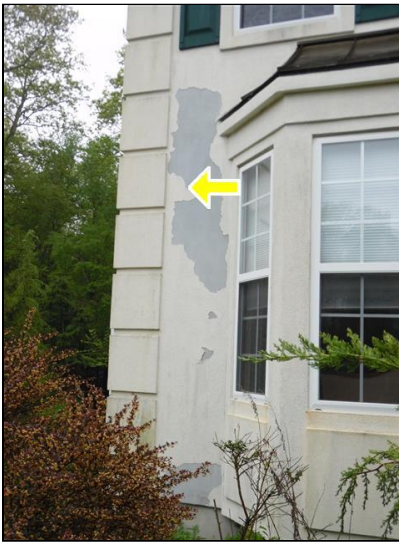
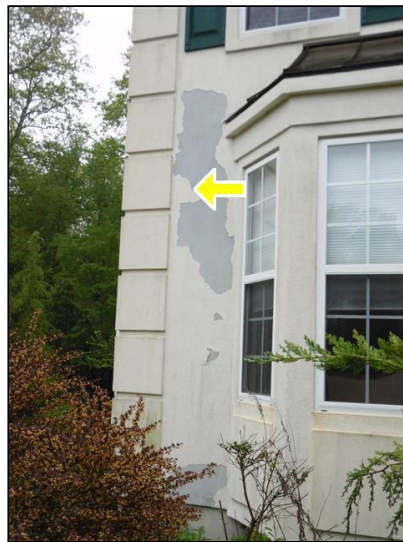
**2.0** (5) Part of the EIFS final coat on the left front side of the house was peeling.

2.0 Item 5(Picture) Final coat on EIFS peeling- left front side of house

2.0 Item 5(Picture) Final coat on  
EIFS peeling- left front side of  
house

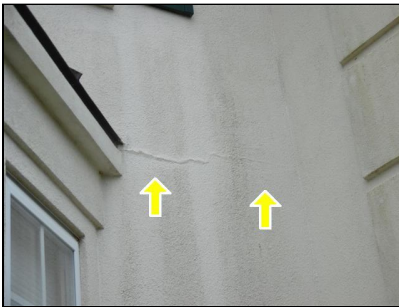
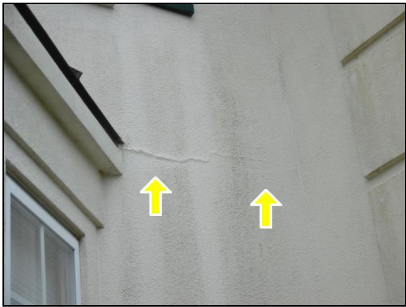
**2.0** (6) There was a small crack or what may be an imperfection or separation in the EIFS in the area to the right of the left front bay window.

2.0 Item 6(Picture) Area of concern- To the right of left front bay window

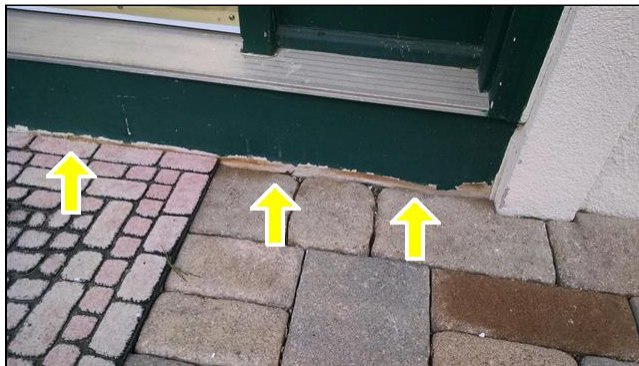
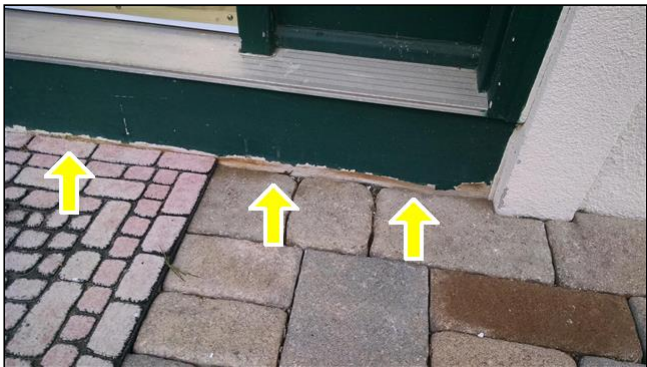
2.2 Item 1(Picture)

**2.2** The paint on the wood trim below the front door is peeling leaving the wood exposed to the elements. If not repaired, moisture damage and wood rot could occur. Recommend further evaluation for repairs by a qualified, licensed contractor.

The paint on the wood trim below the front door is peeling leaving the wood exposed to the elements. If not repaired, moisture damage and wood rot could occur. Recommend further evaluation for repairs by a qualified, licensed contractor.

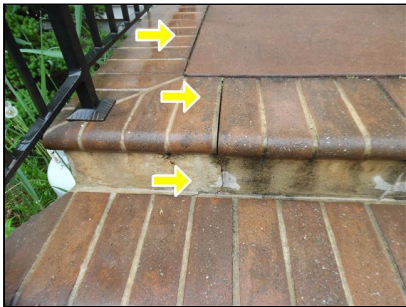
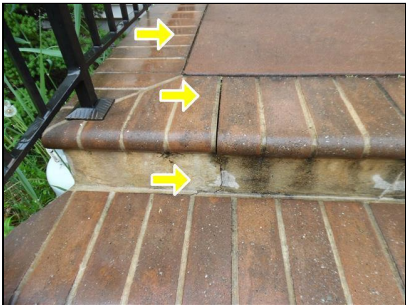
2.6 There were numerous cracks observed in the rear masonry steps in both the tread and riser areas and on the right side of the steps structure. If not repaired, deterioration of the exposed masonry and the structure underneath could occur. Recommend further evaluation for repairs by a qualified, licensed masonry contractor.

2.6 Item 1(Picture) Cracks in steps

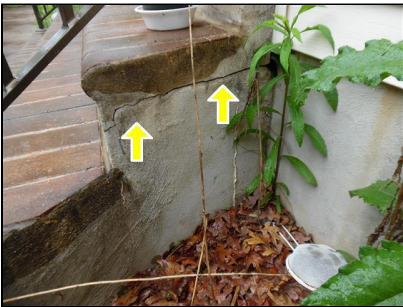
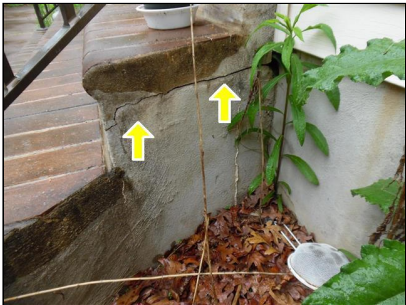
2.6 Item 2(Picture) Cracked parging on right side of rear steps

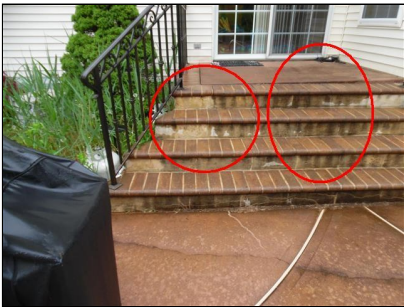
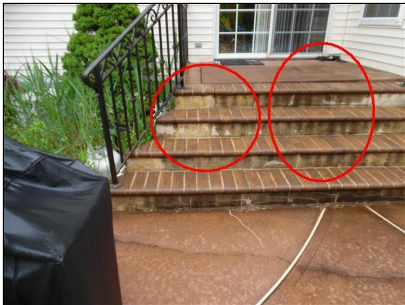
2.6 Item 3(Picture) Area of cracks in rear steps

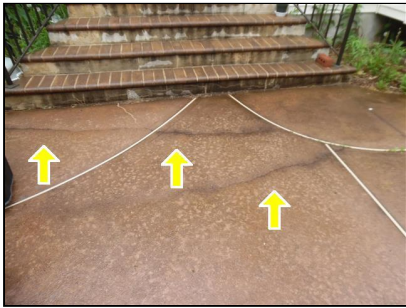
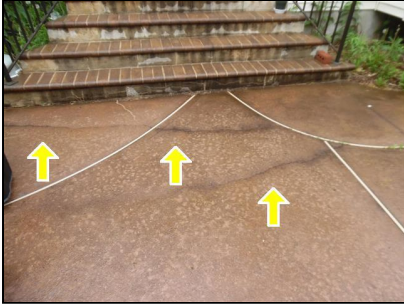
2.10 There were numerous cracks observed in various areas of the concrete backyard patio. If not repaired, water could get into the cracks and the concrete patio could deteriorate especially in the winter time during the freeze and thaw cycles. Recommend further evaluation for repairs by a qualified, licensed masonry contractor.

2.10 Item 1(Picture) Cracks in concrete patio

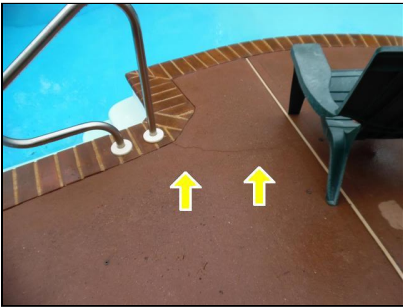
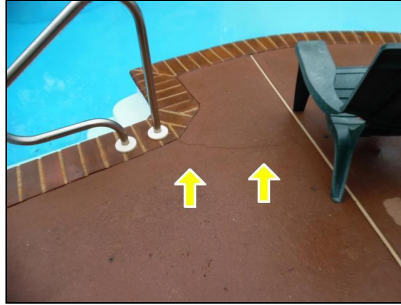
2.10 Item 2(Picture) Cracks in concrete patio

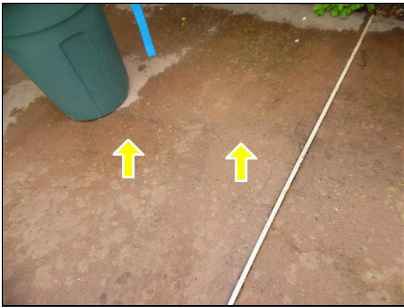
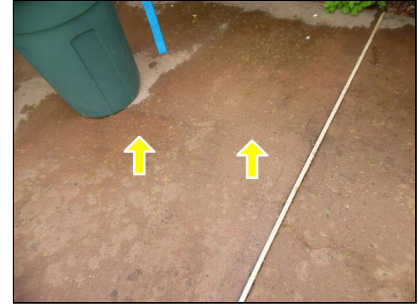
2.10 Item 3(Picture) Crack in concrete patio

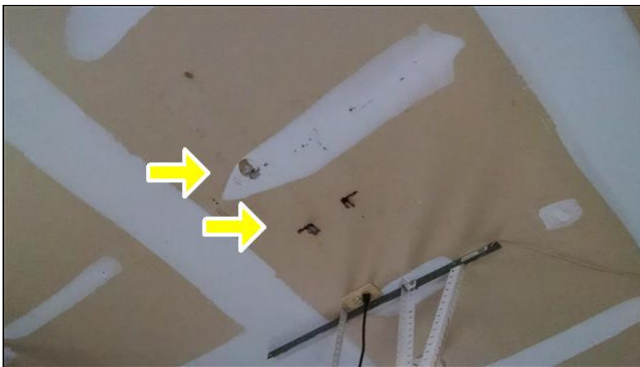
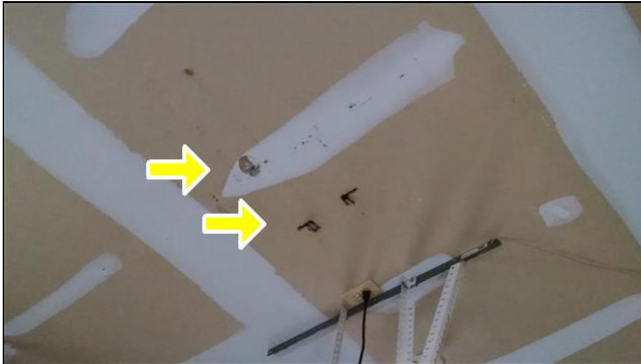
**3.7** The ceiling in the garage has a few small holes in the drywall. The garage ceiling drywall should be 100% sealed to prevent carbon monoxide from entering the living space above and also from a fire block standpoint. Recommend further evaluation for repairs by a qualified, licensed contractor.

3.7 Item 1(Picture) Holes in drywall on ceiling

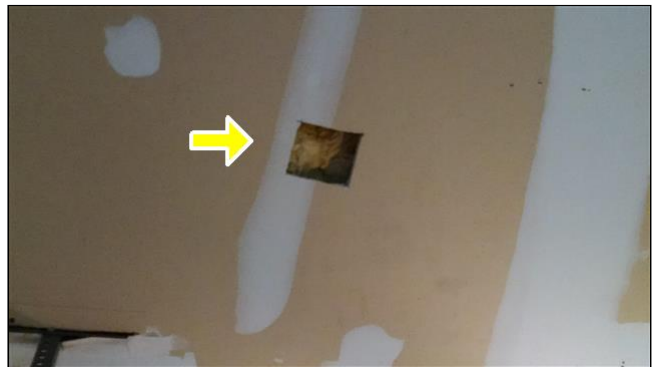
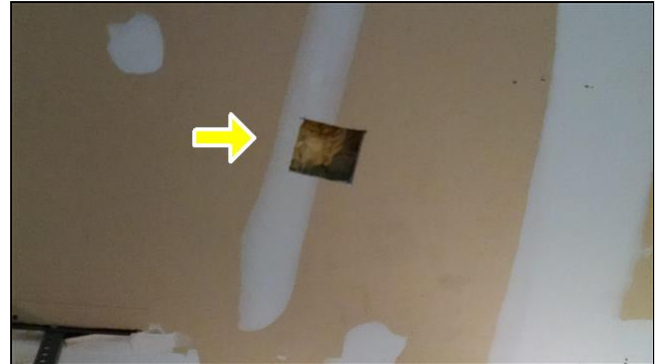
3.7 Item 2(Picture) Holes in drywall on ceiling

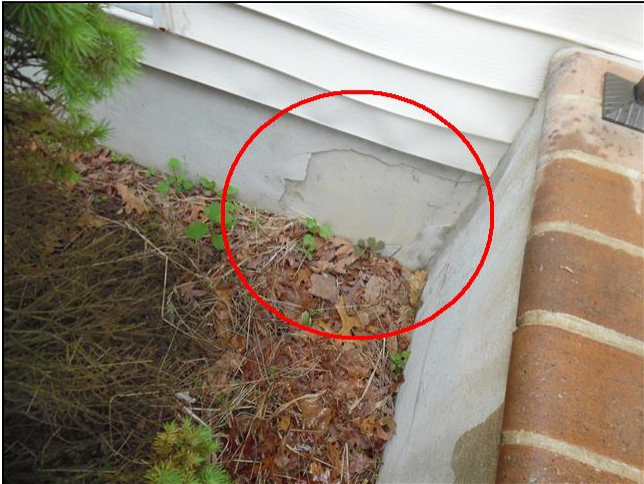
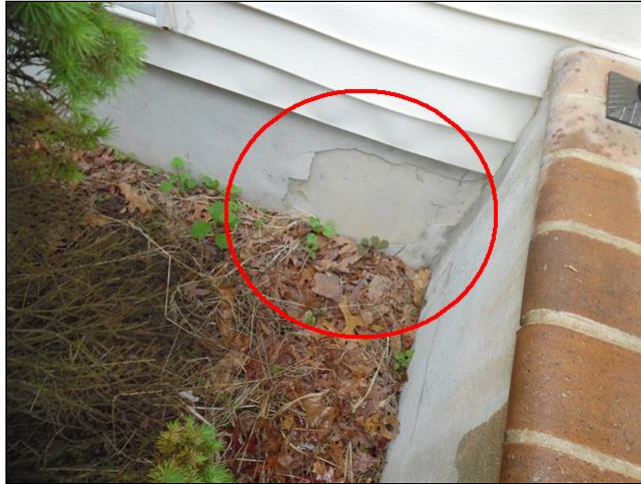
5.0 The paint on the rear exterior foundation wall to the left of the rear steps is peeling off. If not repaired, deterioration of the foundation wall could occur. Recommend further evaluation for repairs by a qualified, licensed contractor.

5.0 Item 1(Picture) Paint is peeling on exterior foundation wall

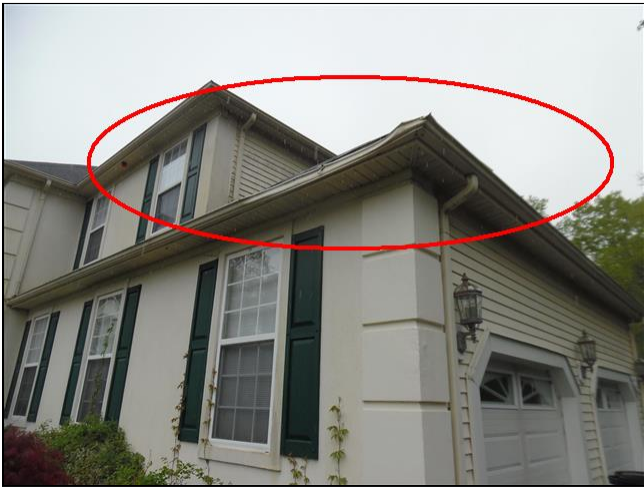
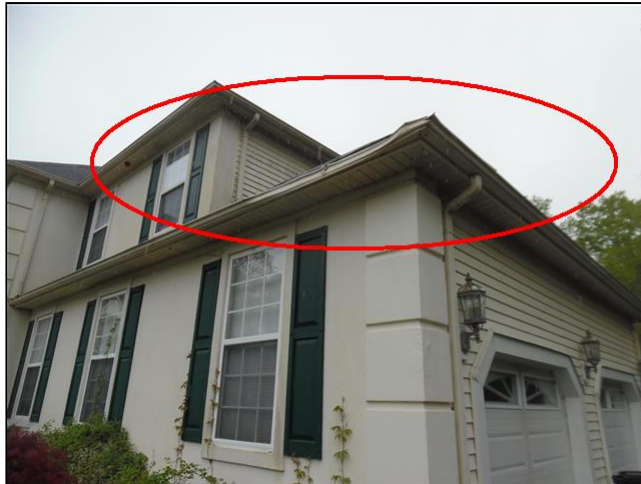
6.2 Item 1(Picture)

6.2 The gutter assembly on the right front corner of the home is damaged. It appears a tree or tree branch may have fallen on it. If not repaired, water could backup in the gutters and overflow and may enter the interior walls damaging the structure. Recommend further evaluation for repairs by a qualified, licensed contractor.

The gutter assembly on the right front corner of the home is damaged. It appears a tree or tree branch may have fallen on it. If not repaired, water could backup in the gutters and overflow and may enter the interior walls damaging the structure. Recommend further evaluation for repairs by a qualified, licensed contractor.

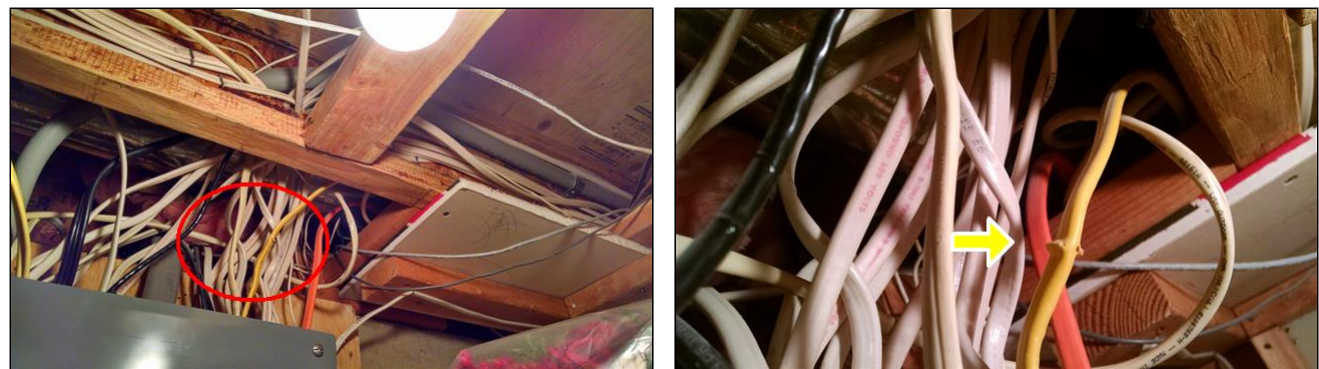
8.7 The vinyl jacket on one of the romex electrical branch wires located above the main electric service panel located in the basement appeared to be nicked. This means the vinyl jacket containing the wires inside was cut and the insulation on the wires inside may have been cut also. This condition may result in the wires inside arcing if the insulation on them was in fact cut. This is a safety issue. Recommend further evaluation for repairs by a qualified, licensed electrician.

8.7 Item 1(Picture) Nicked wire

8.7 Item 2(Picture) Nicked wire

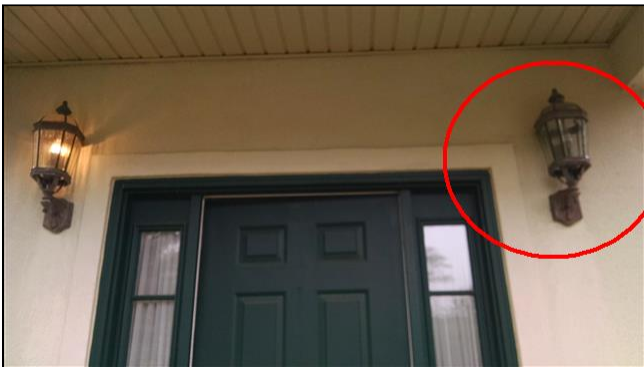
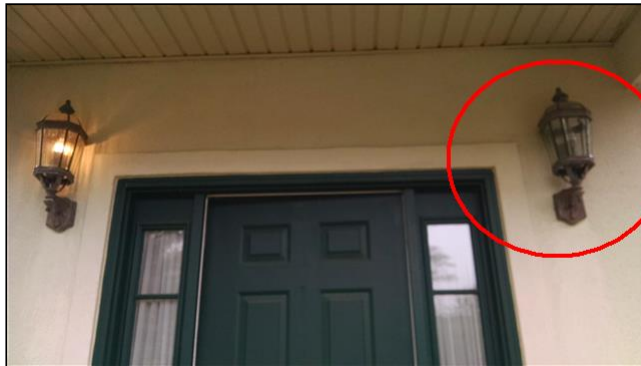
8.8 (1) The 3 light bulbs in the right front exterior light fixture appeared to be burned out. Recommend installing new light bulbs.

8.8 Item 1(Picture) Right front light needs new bulbs

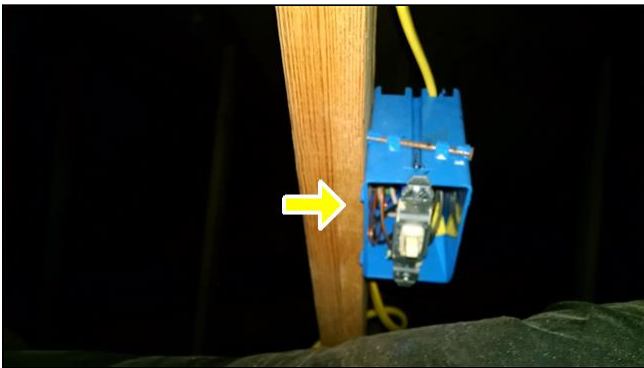
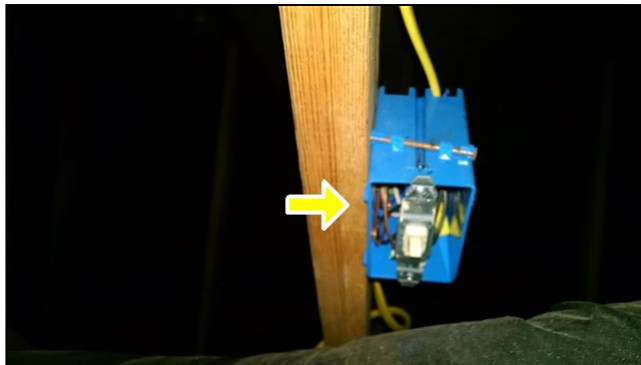
8.8 (2) There was an electrical switch for the air handler located above the air handler in the attic that didn't have the required cover plate on it. The cover plate is required in order to contain any arcing which would potentially cause a fire. If a wire is loose, the amperage will go up, which causes heat. This excessive heat is also capable of causing a fire. The idea is to keep all splices enclosed to reduce the risk of fire and to prevent damage to the wires due to accidental contact. Recommend further evaluation for repairs by a qualified, licensed electrician.

8.8 Item 2(Picture) Switch missing cover

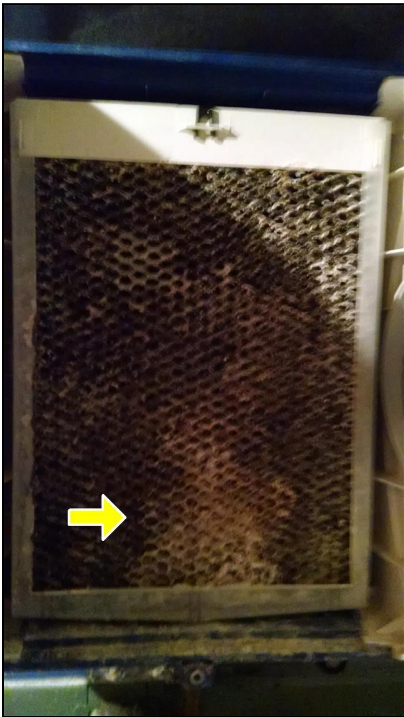
11.0 Item 1(Picture)

11.0 (2) The pad in the whole house humidifier located on the side of the furnace cabinet needs to be replaced. Recommend replacing it with a like pad. These pads are available at Lowes and the Home Depot.

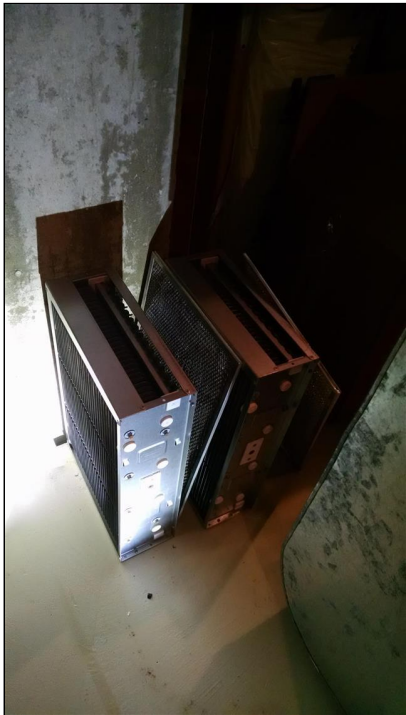
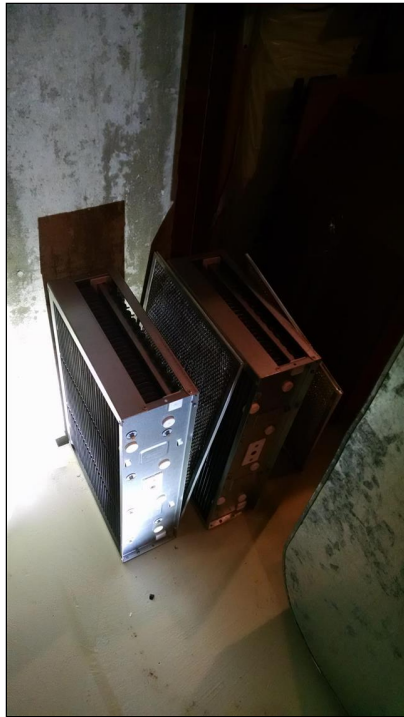
11.4 The furnace was equipped with a Electro-Air electronic air filter located in the return air duct. For some reason, the OEM electronic air filter was taken out and a disposable type filter was put inside the electronic air filter cabinet in its place. The switch for the electronic air filter was in the off position. Recommend further evaluation by a qualified, licensed HVAC professional.

11.4 Item 1(Picture) Electronic air cleaner elements

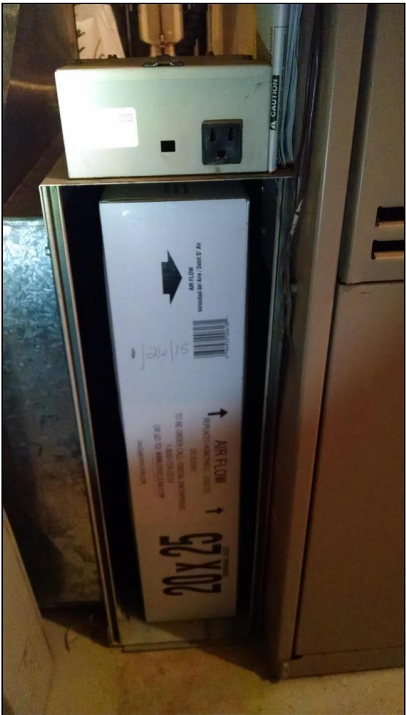
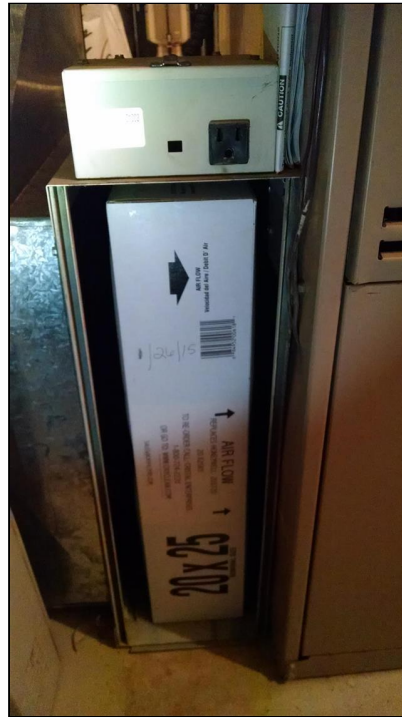
11.4 Item 2(Picture) Disposable filter in cabinet where OEM filter should be

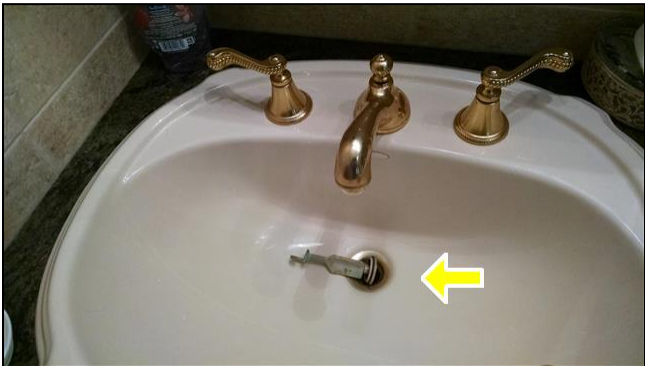
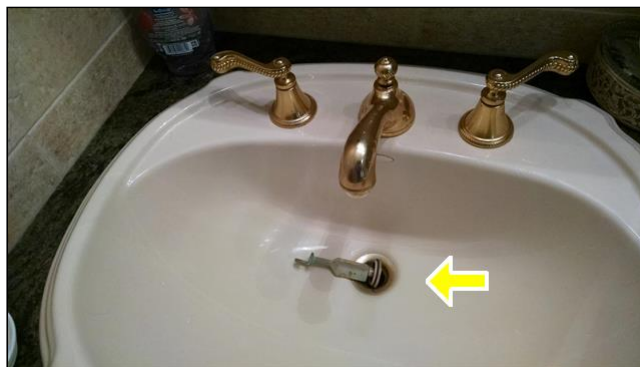
**14.2** The sink stopper for the left side sink in the master bedroom bathroom was lying in the sink and not hooked up to the internal operating mechanism under the sink. Recommend further evaluation for repairs by a qualified, licensed plumber.

14.2 Item 1(Picture) Sink stopper lying in the sink

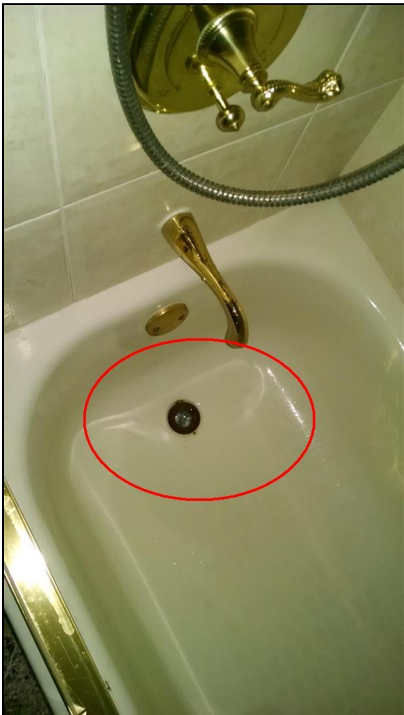
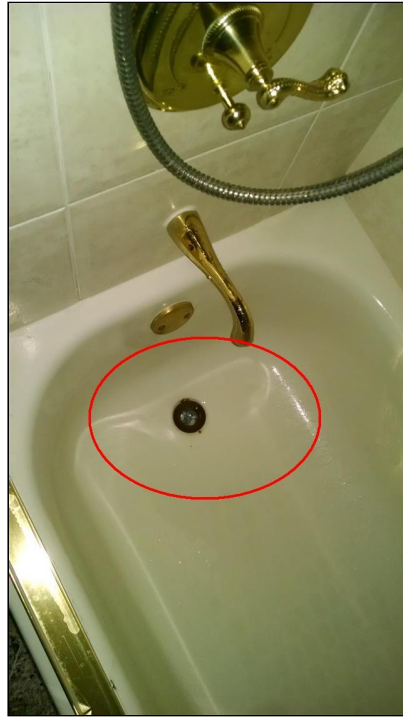
14.3 (1) The tub stopper for the 2nd floor hallway bathroom tub was missing. Recommend installing the required tub stopper.

14.3 Item 1(Picture) Tub stopper missing

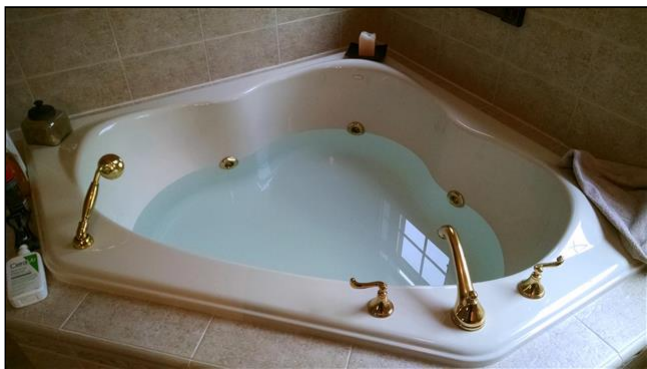
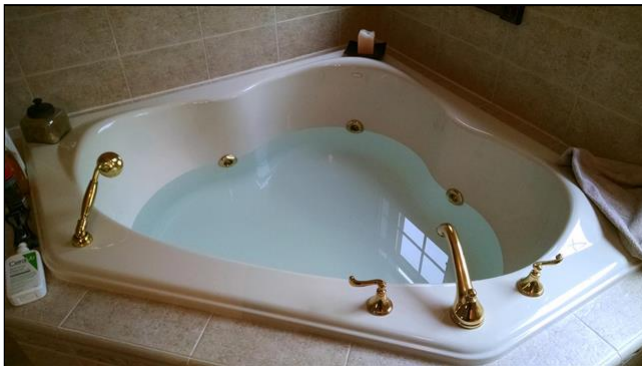
14.3 (2) The circulating jets in the jacuzzi in the master bedroom bathroom would not operate when tested. The homeowner, when asked if the circulating jets were operating, stated they didn't work for an unknown reason. The circuit breaker in the main service panel for the jacuzzi was in the on position . In addition, there was no access in the side of the structure built around the jacuzzi to service the circulating pump. Recommend further evaluation for repairs by a qualified, licensed electrician.

14.3 Item 2(Picture) The jacuzzi jets would not operate

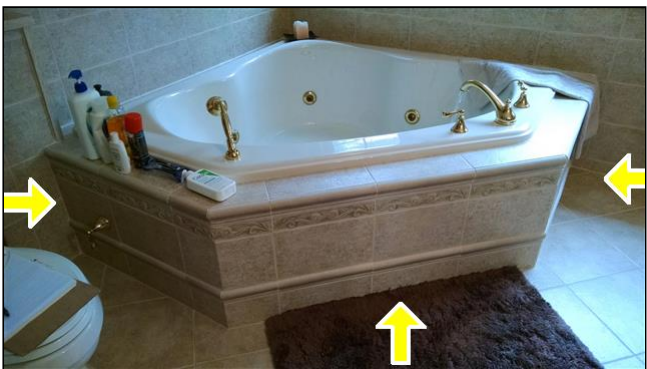
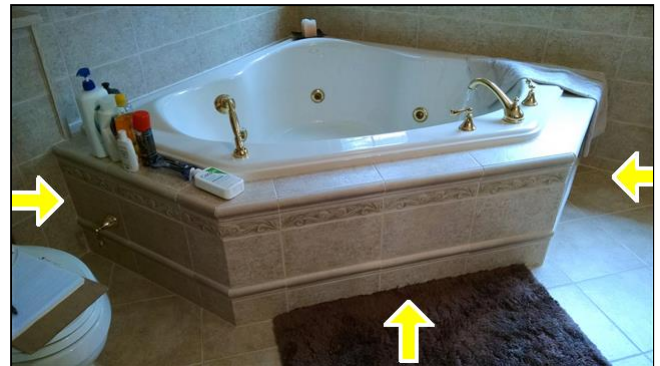
14.3 Item 3(Picture) No access panel present

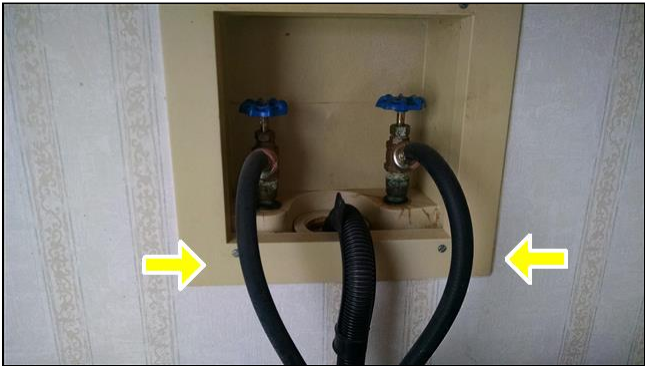
**16.1** Rubber water supply fill hoses for the clothes washing machine were observed in the laundry area. Rubber fill hoses have a limited life span and are prone to bursting. A burst hose can result in flooding and serious water damage. It is recommended to replace rubber washing machine hoses with braided stainless steel mesh, burst resistant hoses. These hoses are available at the Home Depot, Lowes or any other home center and usually cost around \$20-\$30.

16.1 Item 1(Picture) Rubber water supply lines

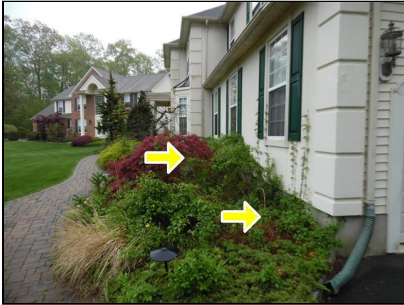
There was some vegetation observed near or touching the exterior of the house. This vegetation at full growth should be kept at least a foot (preferably 18 inches) from house siding and windows. Keep trees away from foundation and the roof. Vegetation in contact or proximity to the house can provide pathways for wood destroying insects, as well as abrade and damage siding, screens and roofs. Recommend trimming back the vegetation near the exterior of the house.

1.3 Item 1(Picture) Trim back

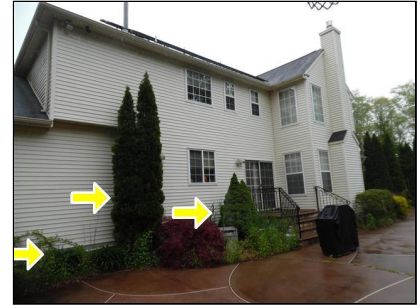
1.3 Item 3(Picture) Trim back

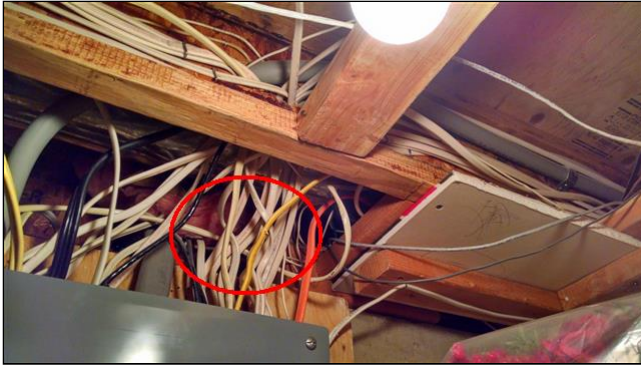
The vinyl jacket on one of the romex electrical branch wires located above the main electric service panel located in the basement appeared to be nicked. This means the vinyl jacket containing the wires inside was cut and the insulation on the wires inside may have been cut also. This condition may result in the wires inside arcing if the insulation on them was in fact cut. This is a safety issue. Recommend further evaluation for repairs by a qualified, licensed electrician.

8.7 Item 1(Picture) Nicked wire

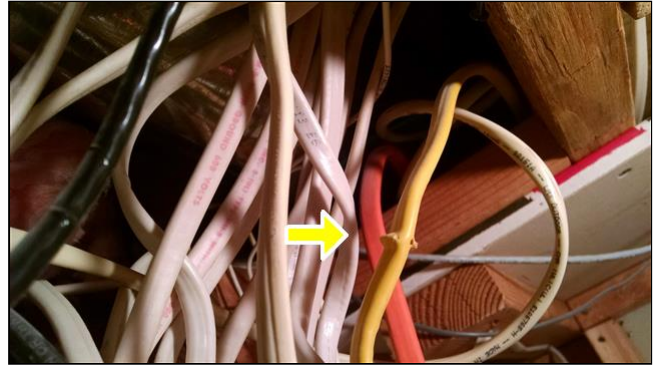
8.7 Item 2(Picture) Nicked wire
