# PROPERTY CONDITION ASSESSMENT

1234 Main Street

January 2, 2017

RE: 1234 Main Street  
Des Plaines, IL 60000

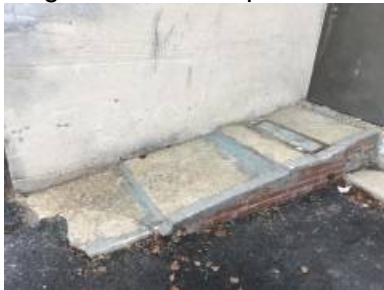
### Access and Egress

Access and egress to the subject property are via doorway. The ramp in the back of the building is no longer smooth/flat plane surface, repair or replace as needed.

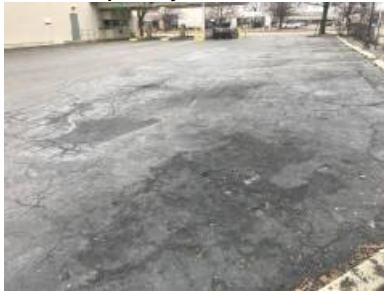
### Paving, Curbing and Parking

All parking surfaces on the lot are paved with asphalt. Erosion to asphalt was noted at several areas. There are approximately 62 marked parking spaces for the subject property, 2 of which are marked for handicap only.

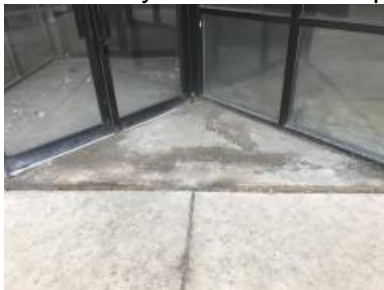
### Flatwork

All walkways on the site are paved with concrete. Poor condition noted,

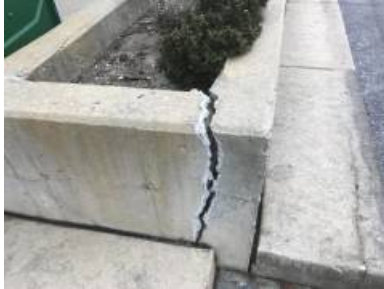
**Landscaping**

Concrete planter are cracking beyond repair. The walls of the planters have shifted.

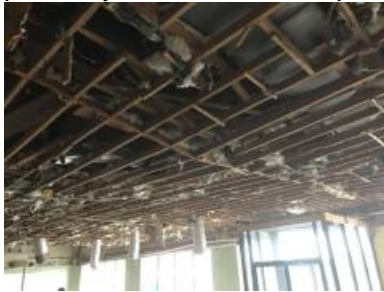
#### Floor Framing

The attic flooring framing is undersized and/or overspanned when compared to today's standards but was probably considered adequate at the time of construction.

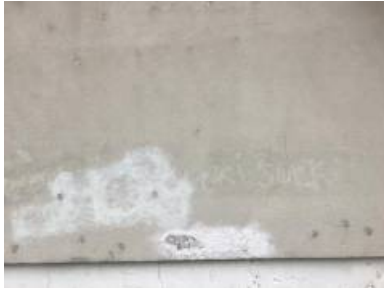
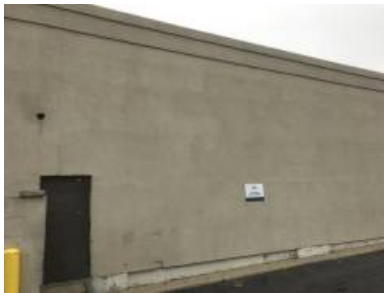
**Sidewall Systems**

Sidewall system(s) consists of stucco. Damage/deterioration noted at the following areas: All four exterior side of the building.

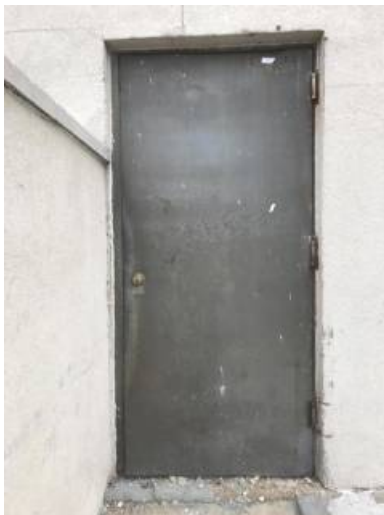
**Fenestration Systems - Walk Doors**

The exterior walk doors are storefront type. The doors at the following locations are in need of replacement:

Back and side doors.

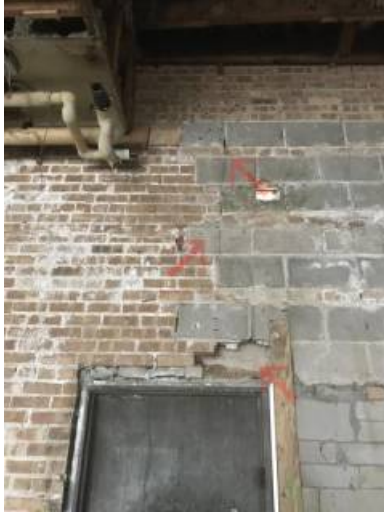
**Exterior Wall From Interior View:**

The window at the back of the building is boarded up.

Cracks noted above the back exterior door. Insure all exterior block wall structure is repair before installing insulation and dry-walling.

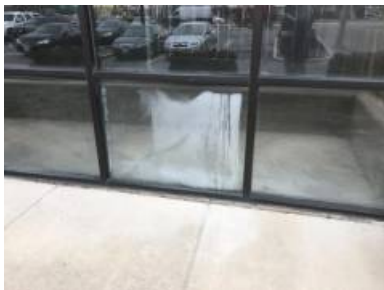
**Fenestration Systems - Windows**

Windows are of the storefront type. The dual pane seal has failed at one or more windows in this building, as evidenced by moisture/discoloration between the panes. Some failures are difficult to detect due to lighting conditions at the time of the inspection. For this reason, you may encounter additional windows that exhibit this condition which are not noted in this report. Seals which have failed were noted on several windows.

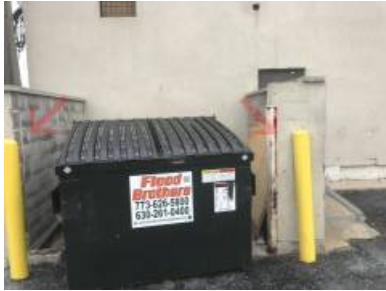
**Other Building Envelope Observations**

The block wall around the trash dumper is damages. Moreover, the front left wall is broken off and is on the ground.

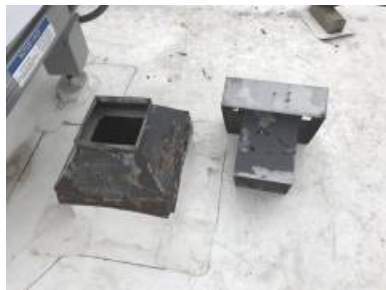
### Vent Cover:

One of the vent cover was not in place.

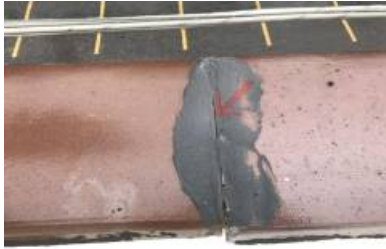
### Roof Flashings

The potential for water entry is present at the coping tiles of the roof capping the parapet wall. The perimeter of these flashings have been sealed at the time of the re-roof (instead of removing the old flashings and reinstalling them along with the new roof). This practice is acceptable only if the original roof is still water tight, because when the sealant deteriorates, moisture will gain access to the underside of the new roof.

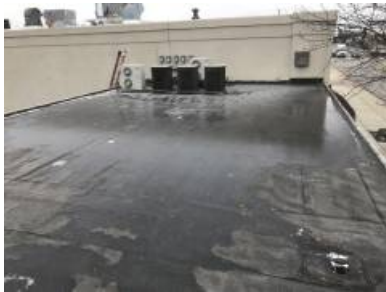
**Other Roofing Observations**

The canopy roof over the drive up lanes have standing water. This roof is not properly pitched towards the drains.

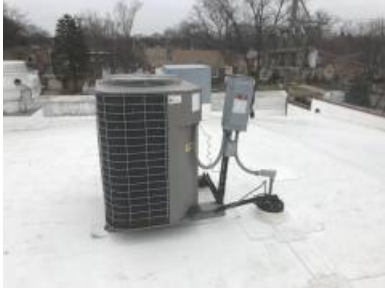
The unit appears to be abandoned.

Unable to read identification plate, but past the end of its expected life.

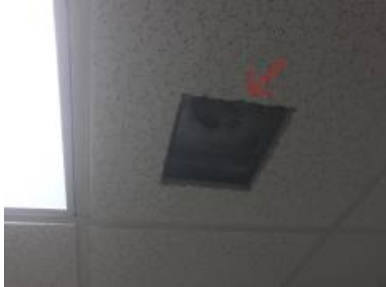
**Bathroom/Restroom Ventilation**

The exhaust fan cover is missing in lady's bathroom.

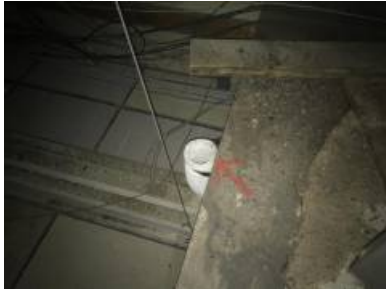
**Workspace Ventilation**

Workspace ventilation(TEL/COM) room is not venting to the outside.

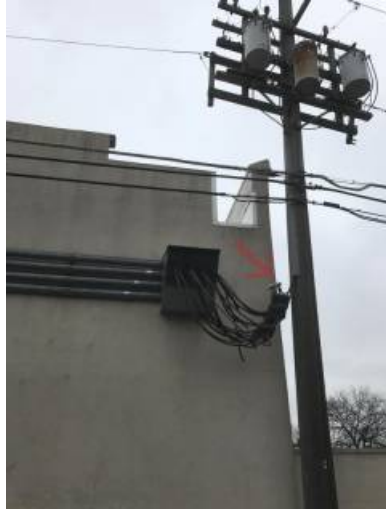
### **Service Conductors**

Electrical service to the property is via overhead conductors from the utility company. Entrance cables are aluminum. The cover damaged / missing connections were noted at the masthead.

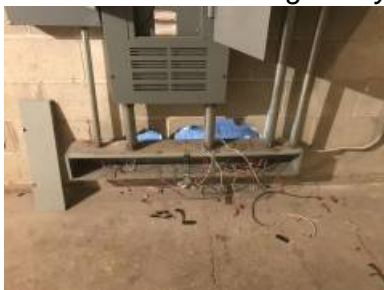
**Overall Condition of Electrical Panels**

*We found the following safety concerns regarding the open electrical trough directly below panel #5*

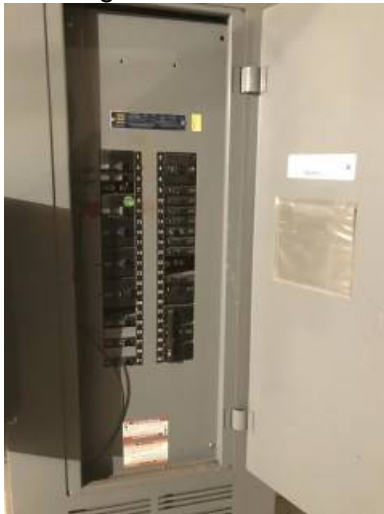
**Panel #2**

Located in electrical room  
Labeling of breakers is incomplete, not legible.

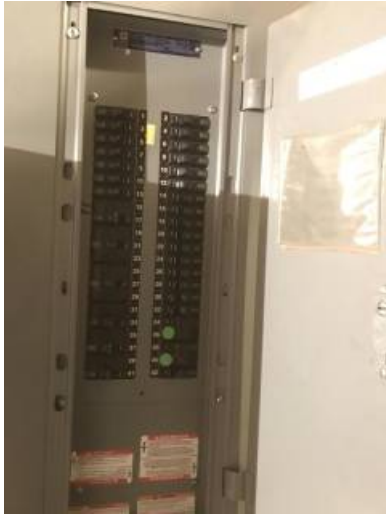
**Panel #3**

Located in electrical room  
Labeling of breakers is incomplete, not legible.

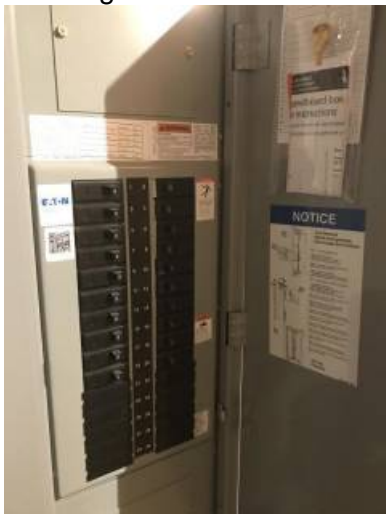
**Panel #4**

Located in electrical room  
Labeling of breakers is incomplete, not legible.
