Inspection Report

Property Address:
11111 25th Street
Olympia WA 98513

CCS Inspection Services, LLC

Date: 1/30/2017	Time: 11:50 AM	Report ID: 29/01/17
Property: 11111 25th Street Olympia WA 98513	Customer: Client Name	Real Estate Professional:

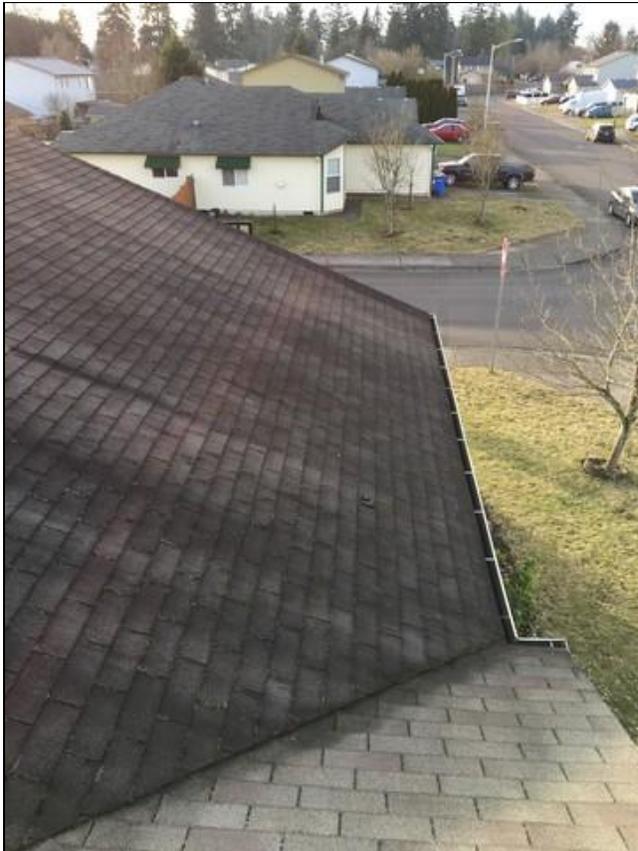
1.0 Item 1(Picture)

Roof covering is at end of service life . The asphalt shingle roof surface is displaying indicators that the protective roof covering is at or near the end of its service life. The average expected service life of a asphalt shingle roof that has been properly cared for is 20 years. As a result of a review of the roof covering, the overall condition is such that the roof is deemed to be at or beyond its limits of its serviceable life. Extensive indicators of age are noted. Consideration should be given to replacing the roof covering; the timing to ultimate failure of the roof covering in preventing water infiltration is unpredictable. Failing to replace the roof covering may result in damage to the structure and contents of the home.

Asphalt shingles are missing. A missing roof shingle represents a localized reduction in the ability of the roof surface to protect against moisture penetration. Progressive damage may occur to underlying and adjacent shingles. The condition may result in water infiltration to the interior. Missing shingle covering should be immediately repaired. A roofing specialist may be required to perform the repairs.

Asphalt shingle roof is patched. An area of roof covering is observed to have been patched as a result of a previous repair activity. Areas of shingle surface repair are often susceptible to future deterioration. Repairs often involve use of roofing adhesives which are exposed, and are therefore prone to deterioration from ultraviolet rays from the sun. Repaired areas should be closely monitored for indications of degradation that could affect the ability of the roof surface to protect against water infiltration. Extensive repairs may be an indication that the roof is near or past its useful life expectancy, and may be due for replacement.

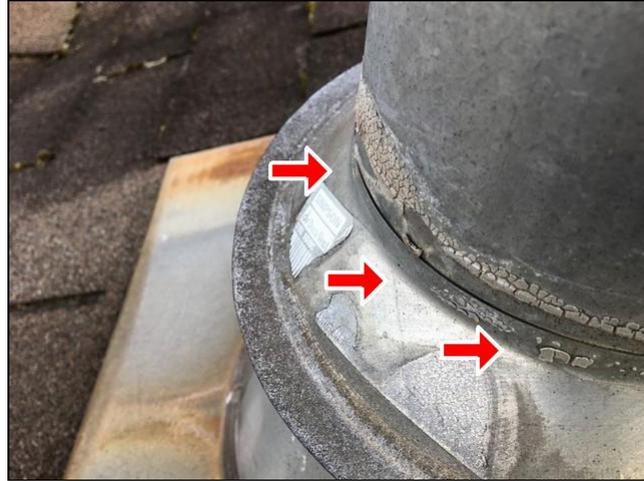
1.1 Item 1(Picture)

Sealant Missing. Sealant has deteriorated around the rain shield to the point that it no longer deflects water and can potentially cause water infiltration.

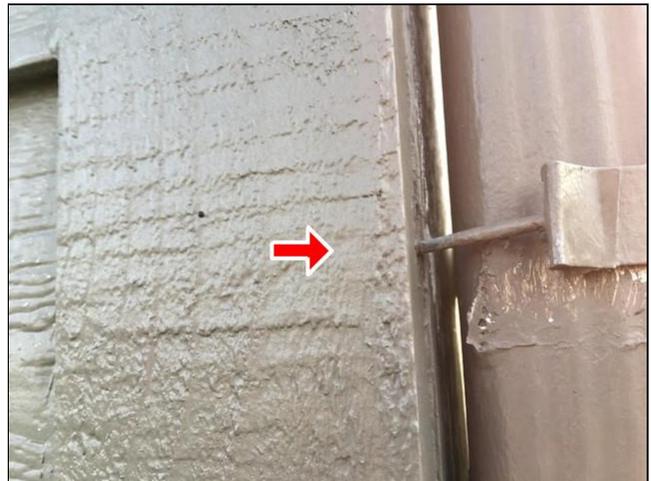
1.3 Item 2(Picture)

Gutter downspout is loose. Loose downspouts will over time become detached. Repairs should be conducted as soon as possible to prevent damage to the downspout. Repair should include properly securing the downspout to the structure and assuring that water freely flows and drains from the downspout

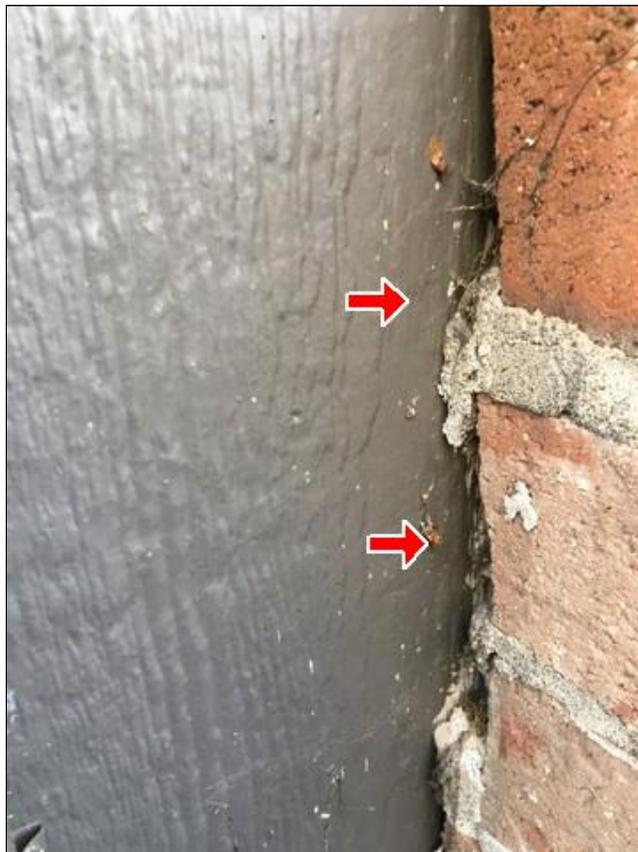
2.0 Item 4(Picture)

(3) **Joints between cladding materials are not properly sealed.** The junction areas between different cladding materials need to be sealed to prevent water, air, and pest infiltration into the home. The usual method of sealing is by caulking the gaps created at the junction areas.

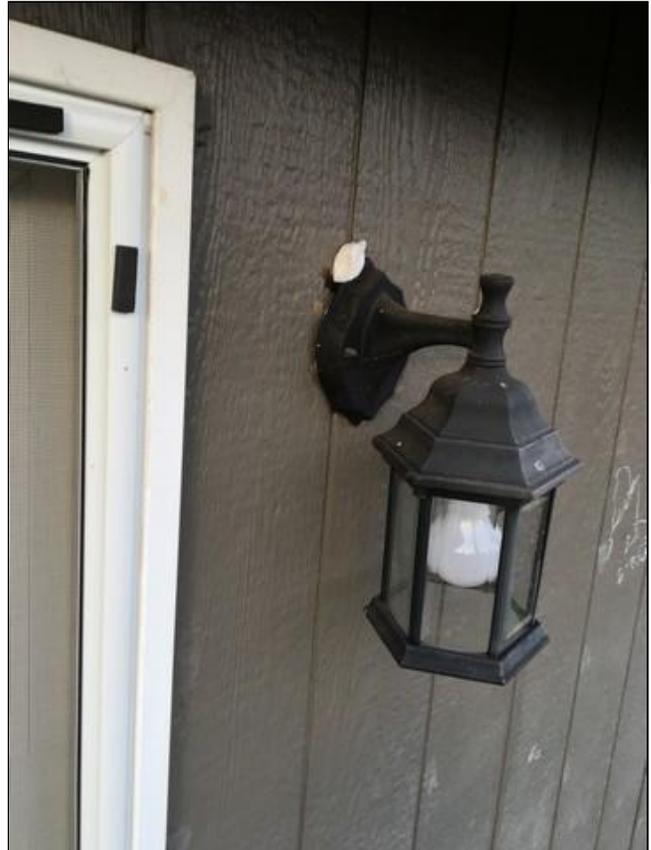
2.0 Item 8(Picture)

(4) **Hole in the exterior siding is observed.** Unintended water, air or pest infiltration into the house can result in significant damage to surfaces and property, and if not corrected, may lead to damage and rot to structural elements. Unintended air infiltration may affect interior air quality and conditioning. Unintended pest entry can

result in damage to interior finishes and belongings, and in some cases may present health risks. Corrective action is required to seal all openings through the exterior wall system.

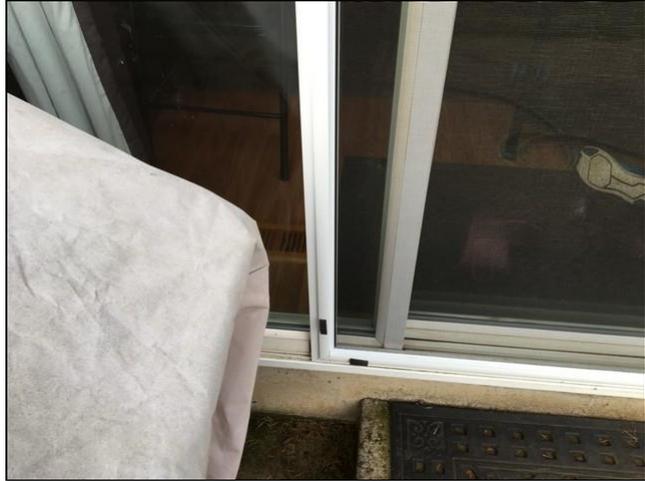
2.1 Item 1(Picture)

Sliding glass screen is improper size.
Screen door restricts access

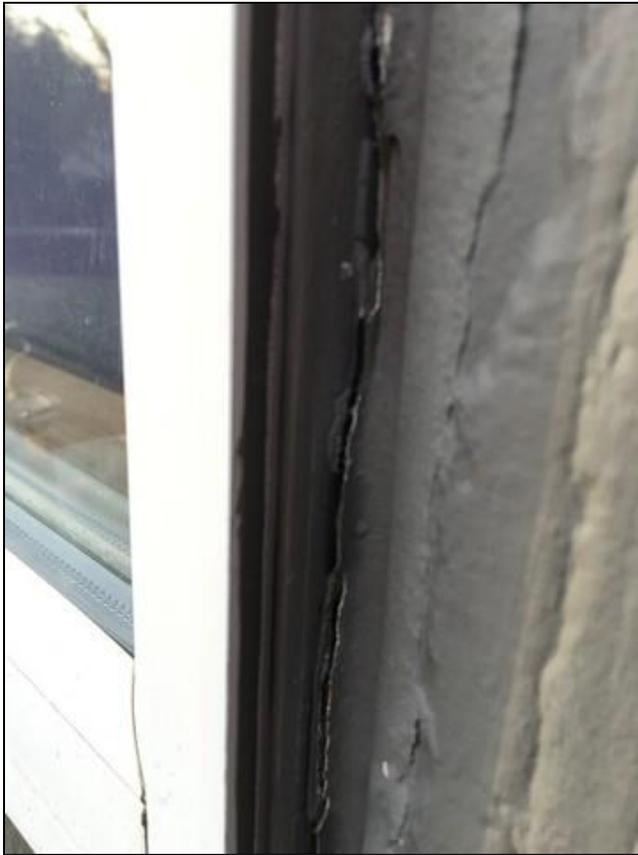
2.2 Item 1(Picture)

(1) **Windows need caulking at several locations.** Caulking at window frames serves several functions, including preventing air, water, and pest infiltration, and restricting heat loss or gain through the exterior wall. Moisture has the greatest potential for damage; unintended water infiltration into the house can cause significant damage to surfaces and property, and if not corrected, may lead to damage and rot to structural elements. Caulking repairs are required at the noted location(s), and should be performed at the earliest opportunity. Preventative maintenance should include reviewing and repairing exterior caulking at doors, windows, and wall penetrations at least twice a year.

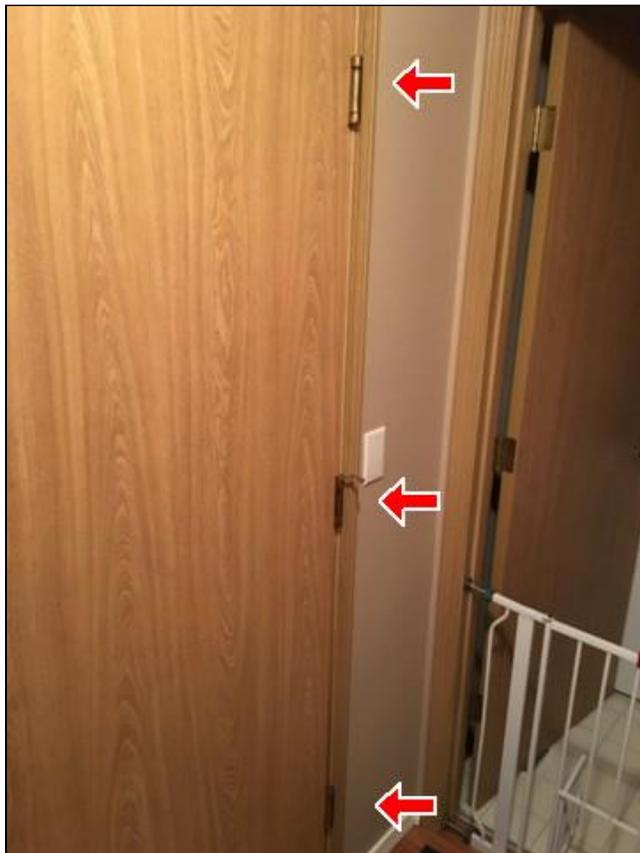
3.2 Item 1(Picture)

Garage occupant door automatic closer is defective or missing. A door closer provided for the door between the home interior and the garage shall be installed in a manner to ensure the door closes and latches in accordance with current industry standards for installation and safety. Doors between a home and an attached garage must be maintained to be gas-proof.

Locking mechanism on garage door handle was inoperable at the time of inspection.

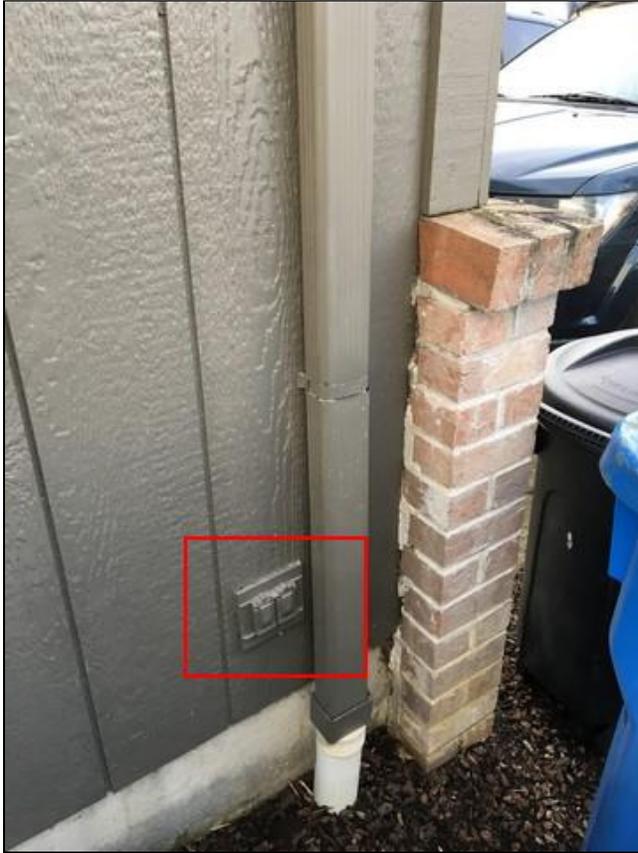
4.2 Item 1(Picture)

(1) **An electrical outlet is observed to be damaged.** The usual cause is due to impact or other forms of mechanical action to fracture the insulating body of the outlet. An outlet that has been damaged may result in the internal contacts not being secured as required, and the risk of short circuiting and arcing is now possible. Damaged outlets should be considered a safety hazard and should be immediately replaced.

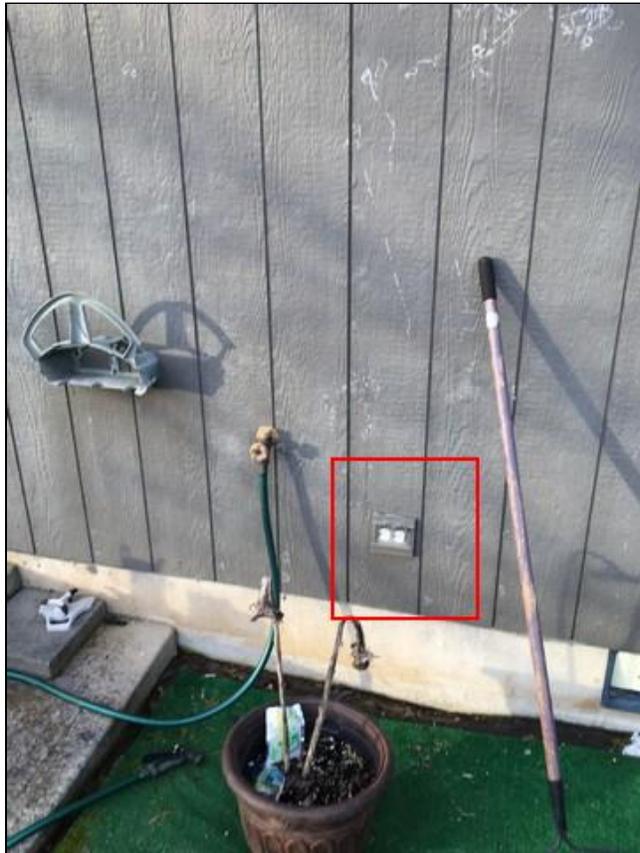
4.2 Item 3(Picture)

Damaged exterior outlet cover. Electrical outlets installed in outdoor locations require protection from water entry and contaminants. An outlet with a missing or damaged cover, when in an outdoor location, is subject to damage and deterioration if its weathertight protection has been compromised. Receptacles displaying damage or deterioration should be immediately replaced and a suitable cover installed.

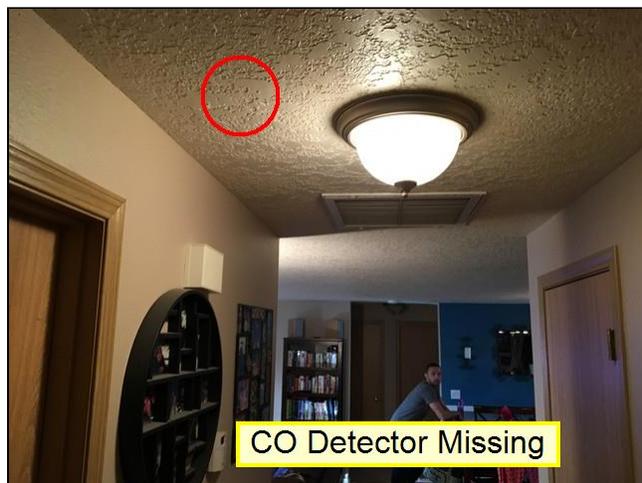
4.6 Item 1(Picture)

(1) **Carbon Monoxide alarms are missing or installed at improper locations.** Washington state requires carbon monoxide alarms to be installed in dwelling units built or manufactured in the state; requires the seller of any owner-occupied single-family residence to equip the resident with carbon monoxide alarms before the buyer or any other person may legally occupy the residence; allows the building code council to exempt categories of residential buildings if it determines that requiring carbon monoxide alarms are unnecessary to protect the welfare of the occupants.

Smoke alarms appear to be past their life expectancy of 10 years.

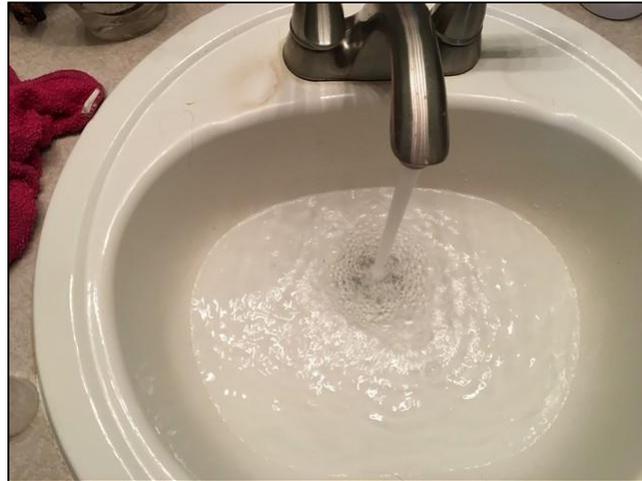
5.1 Item 1(Picture)

(1) **Sink is blocked or slow-draining.** A blockage in a fixture can result in back-up of waste water, affecting the performance of the sink. In some cases, a blocked drain can result in an overflow at the sink, which can result in extensive water damage.

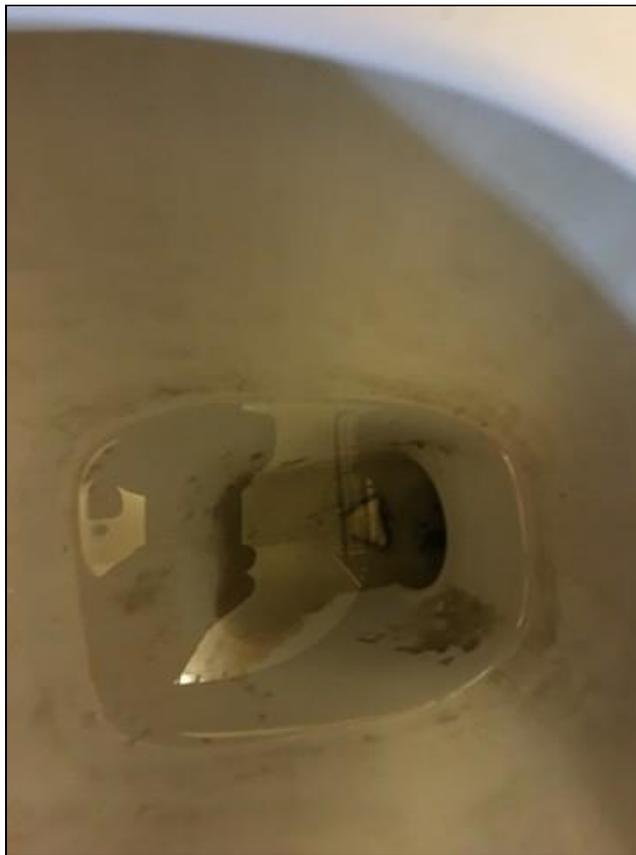
5.1 Item 2(Picture)

Toilet valve runs on when tank is full. This condition creates unnecessary waste of water, and the noise of the continually running water can be an annoyance. The toilet valve does not achieve its intended function of turning off the water supply fully when the tank is full.

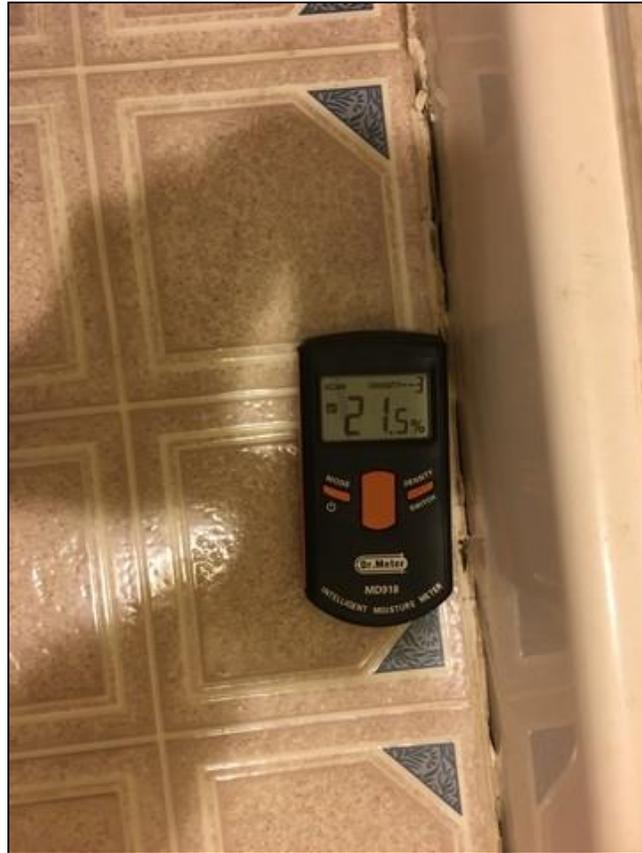
5.1 Item 4(Picture)

(3) **Caulking is incomplete at shower floor.** Caulking is a preventative action to keep water from seeping into floors, and causing damage associated with leaks. Failure to provide effective sealing can result in damage and costly repairs. In order for **bacterial growth** to form, moisture content needs to exceed 19%. At certain points of the floor next to the shower pan, moisture readings have exceeded that.

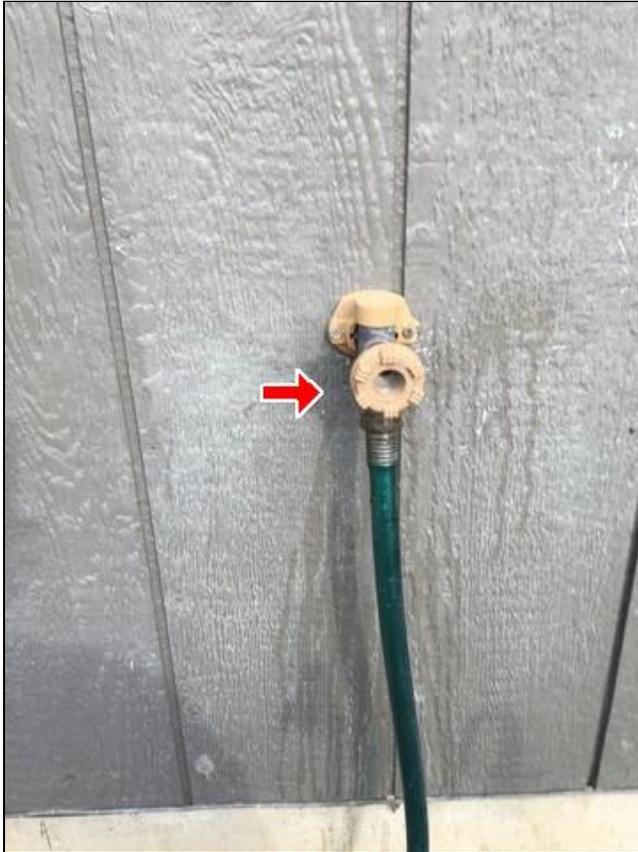
5.1 Item 5(Picture)

(4) Exterior (rear) hose bib control valve missing attachment screw.

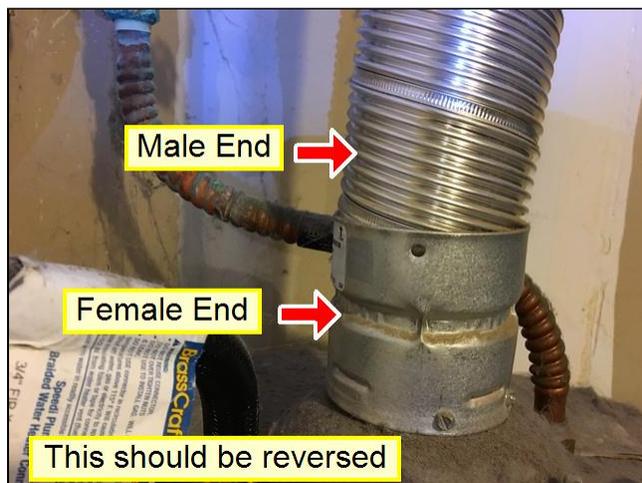
5.2 Item 1(Picture)

The exhaust vent pipe for the hot water tank has been improperly installed. To permit safe venting of exhaust gases, where ever there is a connection made, it should be from male end to female end. Currently, the vent piping is installed reversed, causing gases to leak out into the garage.

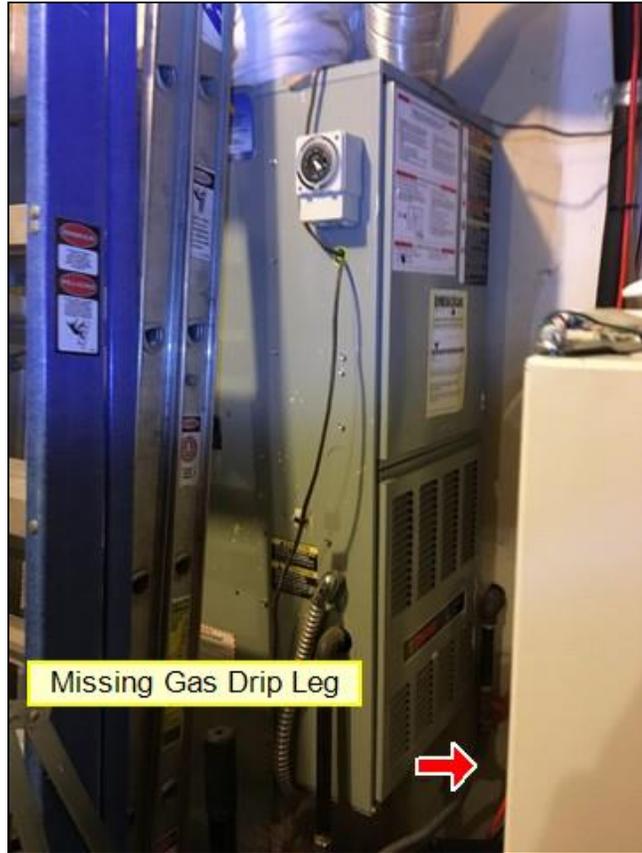
5.4 Item 1(Picture)

Appliance gas line does not have a drip-leg, or small vertical pipe designed to catch particulates before they reach and block the orifice in the gas control valve.

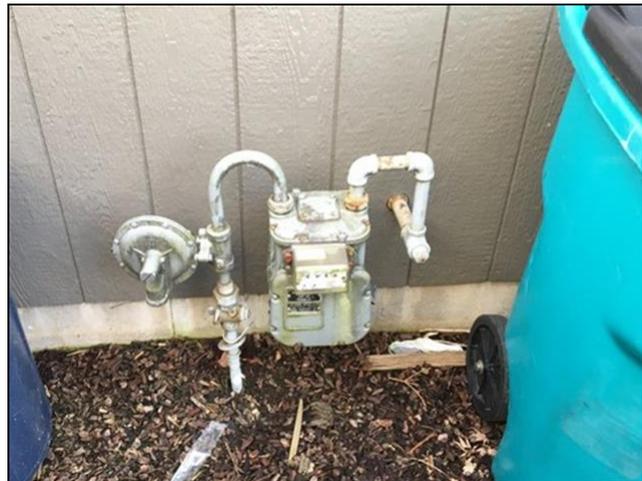
5.5 Item 1(Picture)

The main fuel shut off is at gas meter outside

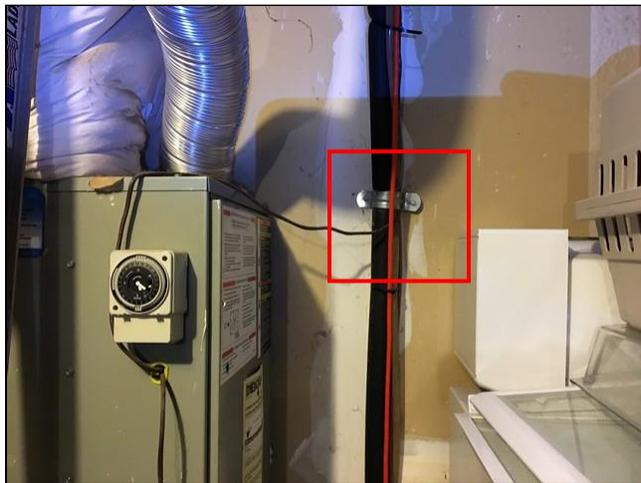
6.0 Item 1(Picture)

Mounting hardware loose or missing.

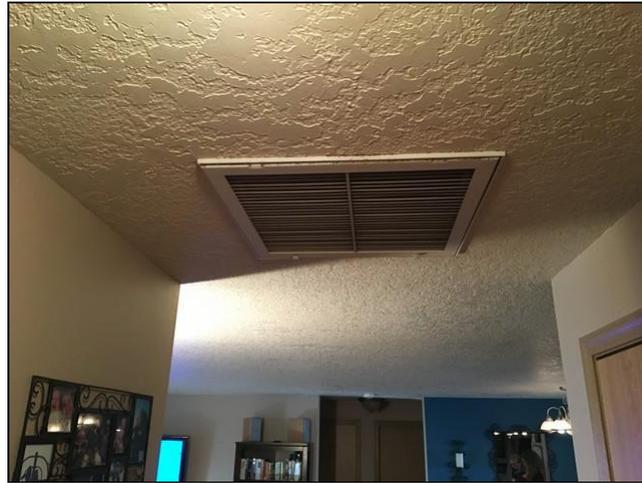
6.3 Item 1(Picture)

(1) **The air filter for this furnace was dirty and should be changed.** Filters should be checked every three months and replaced when they reach a condition in which accumulation of particles becomes so thick that particles may be blown loose from the filter and into indoor air. Homes in areas with high indoor levels of airborne pollen or dust may need to have air filters checked and changed more frequently. Failure to change the filter when needed may result in the following problems:

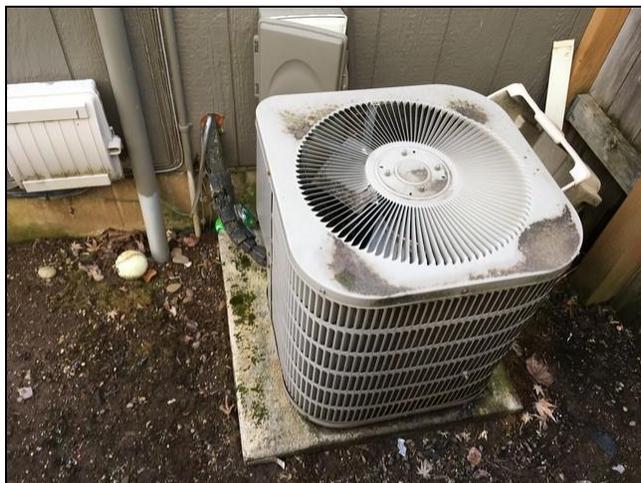
6.8 Item 1(Picture)

The future performance of the air conditioner is suspect. The current condition of the AC is such that the functionality of the unit to provide adequate cooling in the future is suspect. As a minimum, it is suggested that the AC be checked and tested by a HVAC specialist to better evaluate its current condition and future capability to provide cooling. Alternatively, consideration should be given to provide for future replacement should the AC fail to functionally and economically meet the cooling needs for this home.

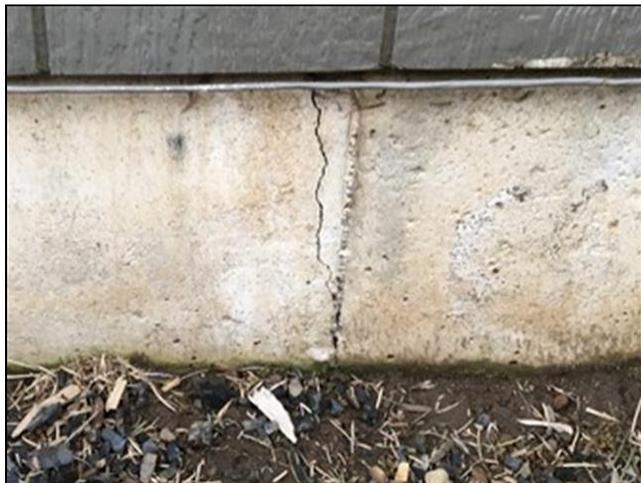
7.0 Item 1(Picture)

Cracks in the foundation wall are observed during examination of the exterior of the home. At the time of inspection, the crack(s) are regarded to be **minor**. Ascertaining the cause of a crack cannot be readily determined during a home inspection, but are typically due to shrinkage of the concrete during curing, settlement of soils below the footings, pressure of soils against the foundation wall, or from a physical shock, seismic or hydrological event. **At the time of inspection, adverse effects are not observed.**

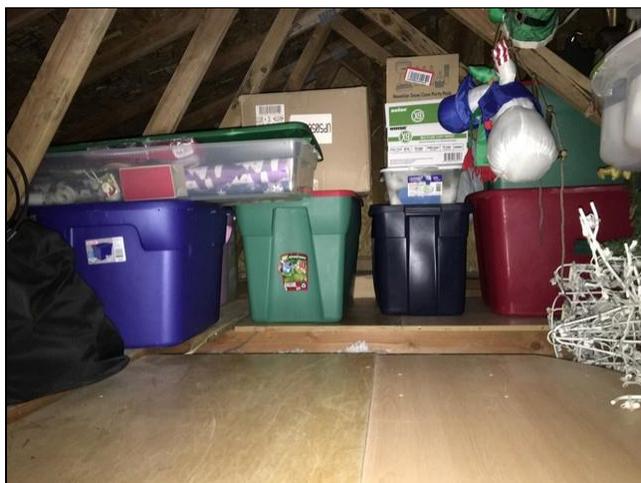
7.5 Item 1(Picture)

Alterations resulting in the addition of load that exceeds the design load for the truss shall not be permitted without verification that the truss is capable of supporting such additional loading. For the most part, attics were not designed as storage spaces. They are a part of the raw underbelly of structure that holds a house together and protects it from the elements. Because of this, installing a floor to an attic always involves some level of disturbance. If the roof structure of your home was designed with prefabricated trusses, your attic was definitely not designed for any storage. There are several reasons for this. First, adding weight to the top of the bottom 2x4 that makes up the truss is a big no-no. Roof trusses are specifically designed to take the weight of the roof (and the snow, wind, rain, etc.) and distribute it downward and outward to the load-bearing exterior walls through a series of interconnecting wood framing pieces known as "chords". Adding storage to any other part of this finely tuned structural marvel risks weakening the roof system.

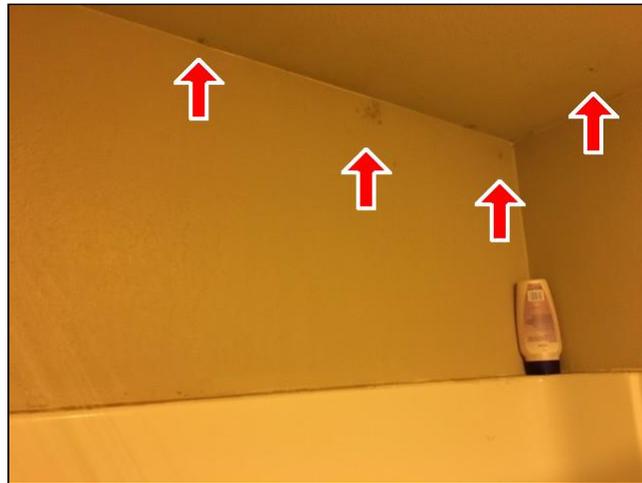
8.0 Item 1(Picture)

Signs of fungi growth are present on ceiling. We did not inspect, test or determine if this growth is or is not a health hazard. The underlying cause is moisture or dampness. I recommend you contact a mold inspector or expert for investigation or correction if needed.

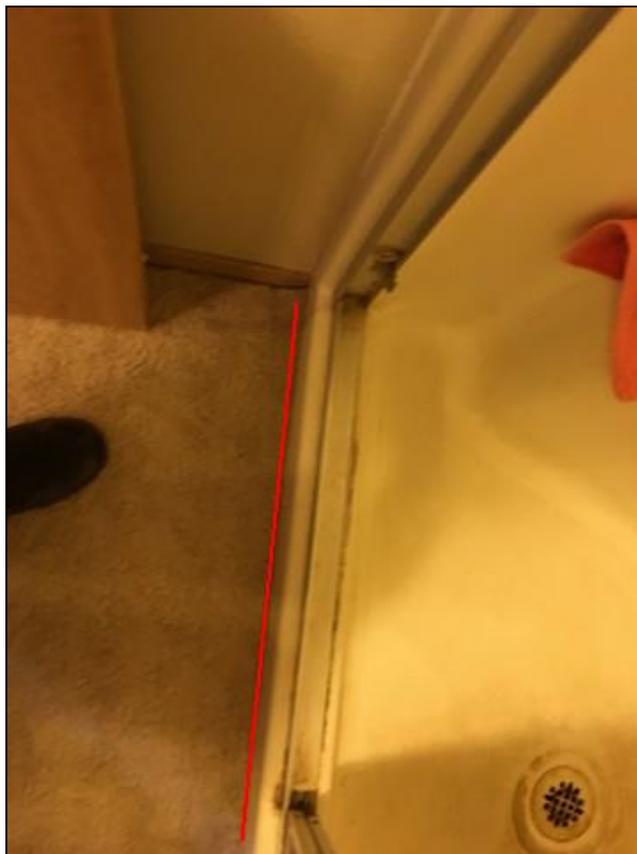
8.2 Item 1(Picture)

(2) **Caulking between bathtub or shower and floor is deteriorated, missing, or incomplete.** Caulking should be installed to prevent water intrusion between to bathtub and floor.

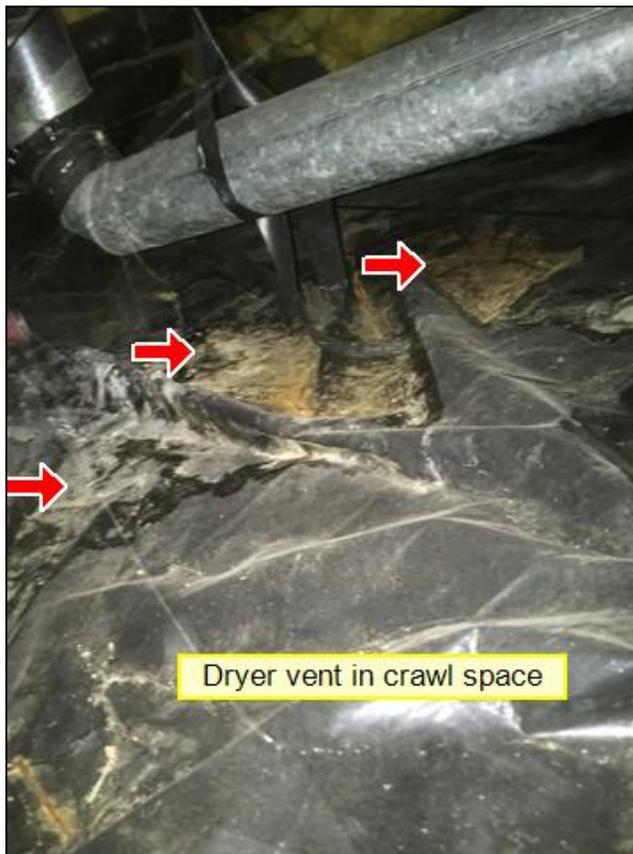
9.4 Item 1(Picture)

Moisture / mildew stains on vapor barrier indicates that dryer vent is damaged or clogged. Excessive lint in a dryer vent is a fire hazard and should be taken care of as soon as possible.

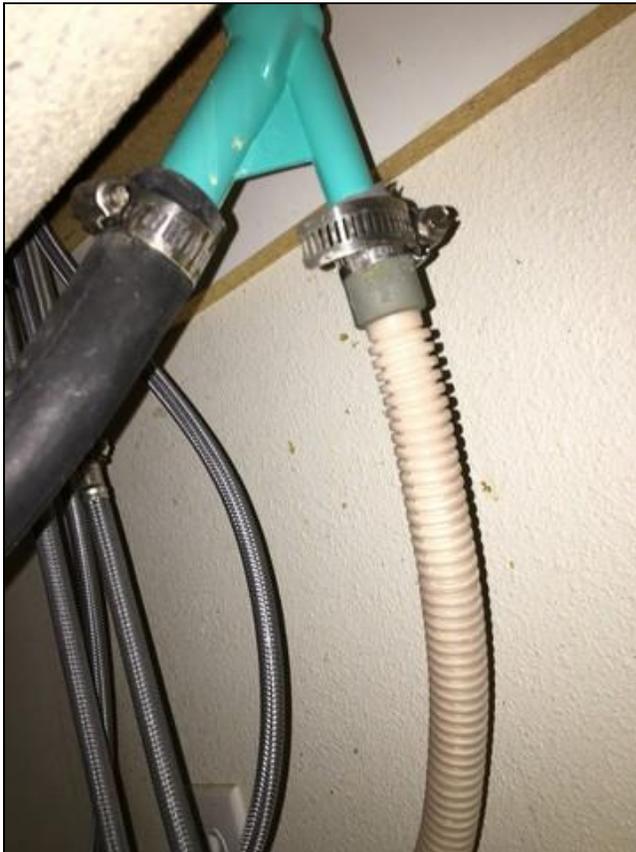
10.0 Item 1(Picture)

The dishwasher washer drain line is not looped to prevent back siphon. The dishwasher is functional but discharges without a mandated anti-siphon valve, which is contrary to the installation instructions, and which also creates a potential drainage problem and a health hazard.

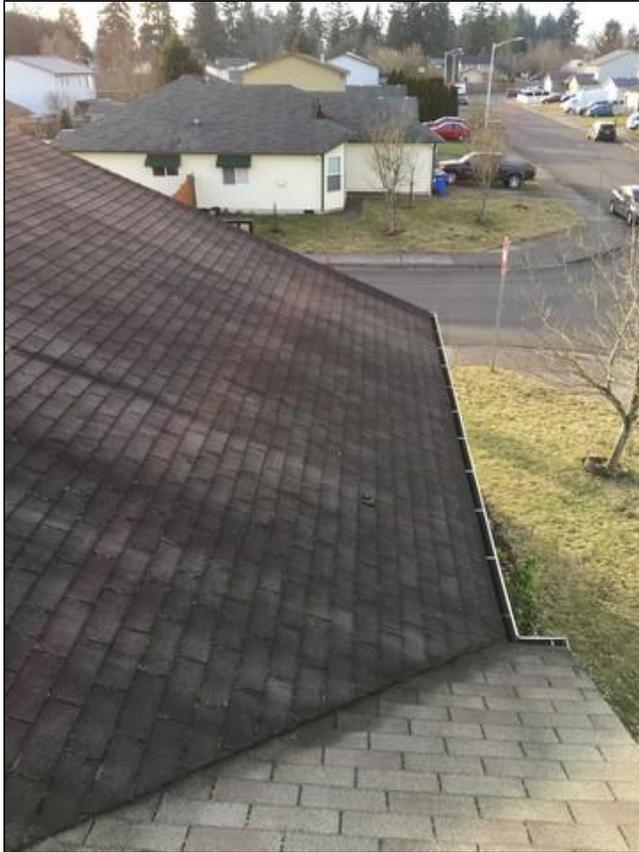
1.0 Item 1(Picture)

Asphalt shingle roof is patched. An area of roof covering is observed to have been patched as a result of a previous repair activity. Areas of shingle surface repair are often susceptible to future deterioration. Repairs often involve use of roofing adhesives which are exposed, and are therefore prone to deterioration from ultraviolet rays from the sun. Repaired areas should be closely monitored for indications of degradation that could affect the ability of the roof surface to protect against water infiltration. Extensive repairs may be an indication that the roof is near or past its useful life expectancy, and may be due for replacement.

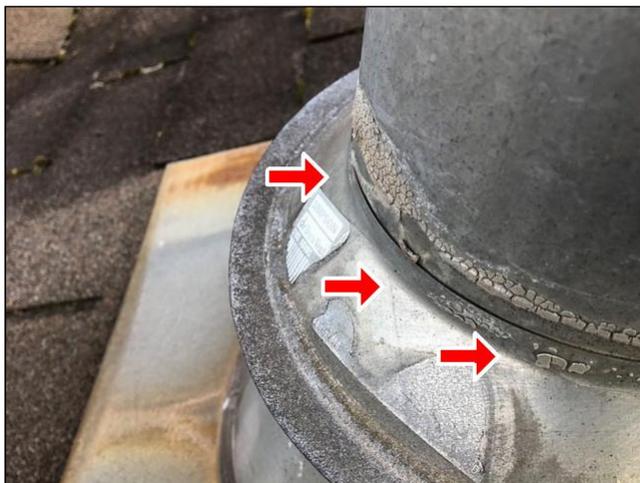
1.1 Item 1(Picture)

Sealant Missing. Sealant has deteriorated around the rain shield to the point that it no longer deflects water and can potentially cause water infiltration.

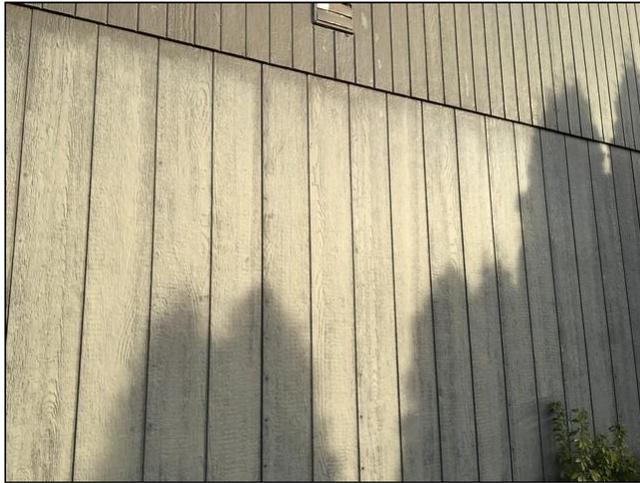
2.0 Item 2(Picture)

(2) **Exterior cladding material (OSB).** This material is prone to moisture damage. Composite wood siding, manufacture with wood chips and glue also called oriented strand board (OSB) siding is prone to swelling and deterioration if caulking and edge paint is not actively maintained .

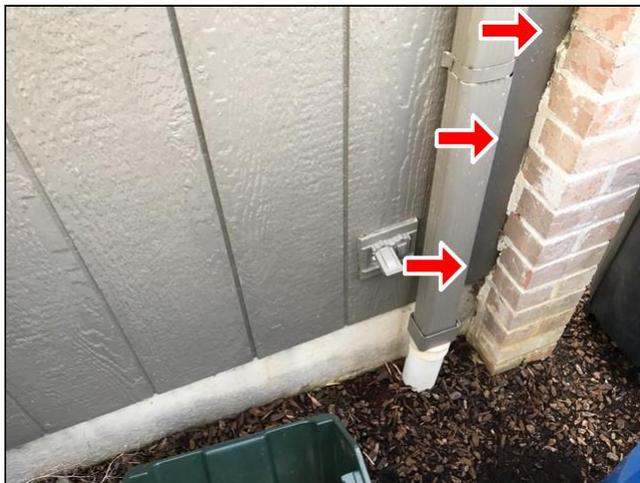
2.0 Item 3(Picture)

(3) **Joints between cladding materials are not properly sealed.** The junction areas between different cladding materials need to be sealed to prevent water, air, and pest infiltration into the home. The usual method of sealing is by caulking the gaps created at the junction areas.

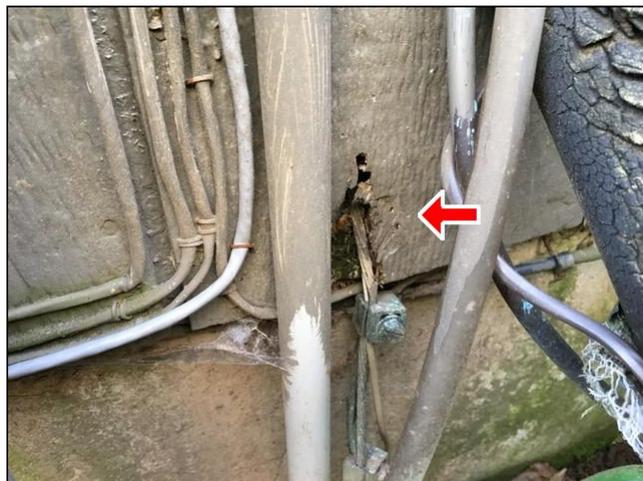
2.0 Item 5(Picture)

(4) **Hole in the exterior siding is observed.** Unintended water, air or pest infiltration into the house can result in significant damage to surfaces and property, and if not corrected, may lead to damage and rot to structural elements. Unintended air infiltration may affect interior air quality and conditioning. Unintended pest entry can result in damage to interior finishes and belongings, and in some cases may present health risks. Corrective action is required to seal all openings through the exterior wall system.

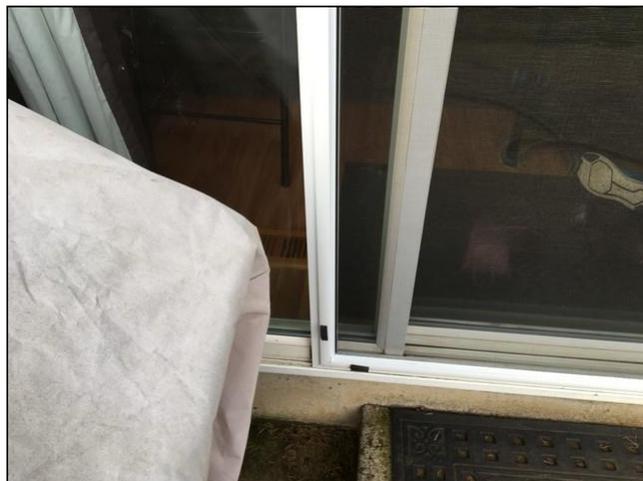
2.1 Item 1(Picture)

Sliding glass screen is improper size. Screen door restricts access

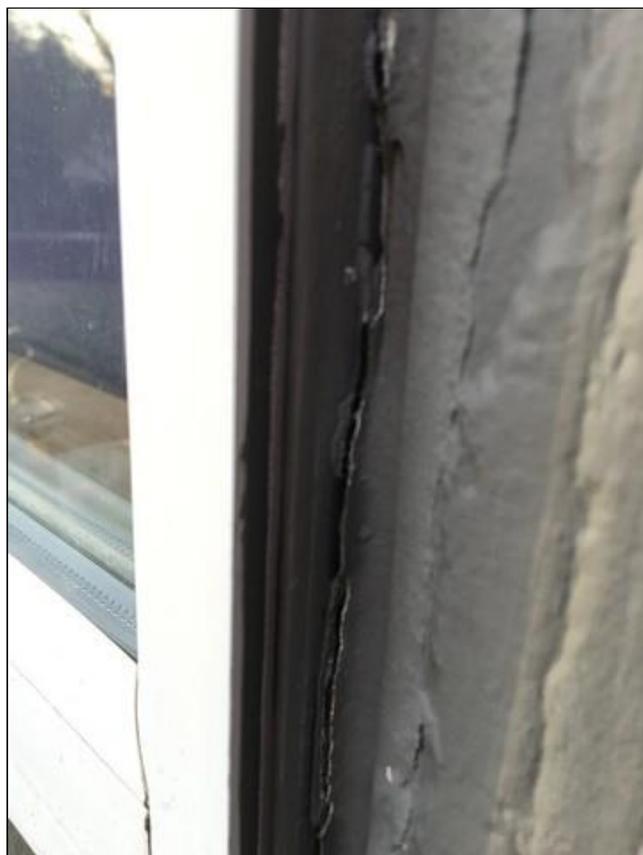
2.2 Item 1(Picture)

(1) **Windows need caulking at several locations.** Caulking at window frames serves several functions, including preventing air, water, and pest infiltration, and restricting heat loss or gain through the exterior wall. Moisture has the greatest potential for damage; unintended water infiltration into the house can cause significant damage to surfaces and property, and if not corrected, may lead to damage and rot to structural elements. Caulking repairs are required at the noted location(s), and should be performed at the earliest opportunity. Preventative maintenance should include reviewing and repairing exterior caulking at doors, windows, and wall penetrations at least twice a year.

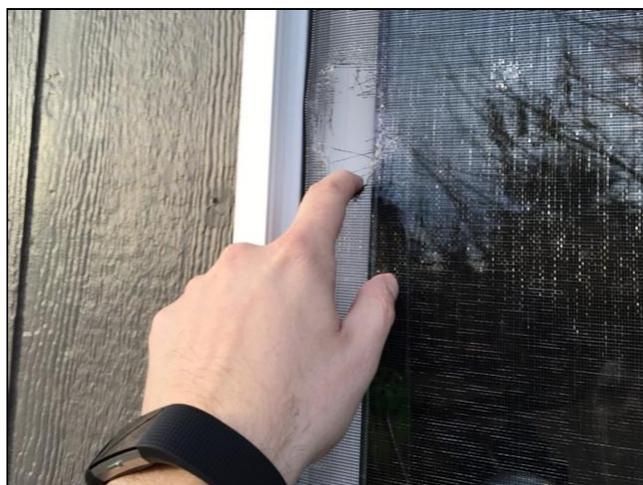
2.2 Item 4(Picture)

(2) **Window screen damage is observed.** The primary purpose of the screen is to prevent pest entry when the window unit is used for ventilation. A secondary function of the screen is to restrict the ability of children or pets to unintentionally leave the house. Damaged screens will often result in unintended consequences, such as pest entry (insects, birds, rodents, etc.) or unintended "escape" of small children or pets. Although screens can be breached, their presence often restricts small children from leaving the home, and becoming exposed to risks to their safety. Windows are often at sufficient height from the ground that fall hazards should be considered as a primary safety concern. Damaged screens at windows are often considered to be cosmetically detracting.

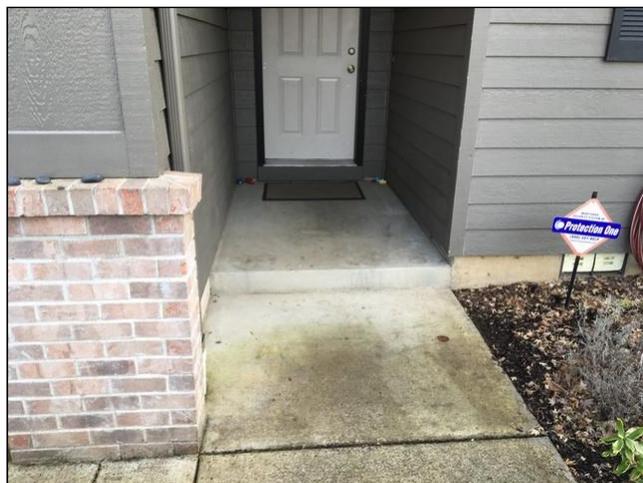
2.3 Item 1(Picture)

Settlement is observed at the porch. Settlement of the porch is often due to poor grading, soil or compaction issues, and ground heave. This condition may impair drainage. Settlement can result in water ponding on the porch, which will promote further deterioration of the porch over time. Low areas on the porch can result in ice patches in the winter, which pose a slip and fall hazard.

Rear porch has settled to the point that water does not completely shed away from the home.

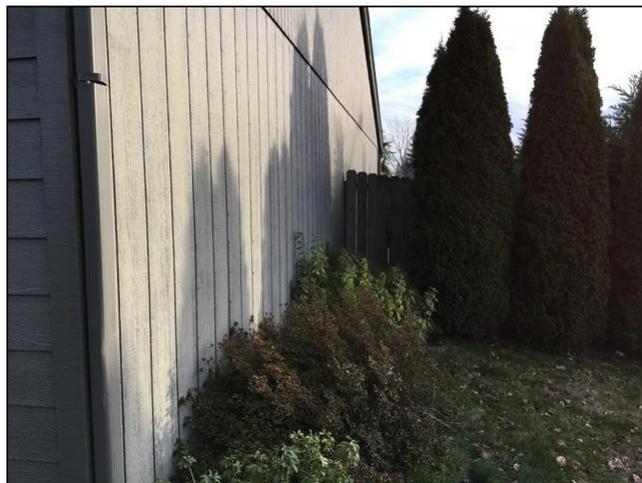
2.4 Item 1(Picture)

Shrubs are planted to close to house. Shrubs planted close to a house may over time cause detrimental effects to the exterior components of the home. Shrubs tend to hold moisture near the house, and can promote moisture-related problems to the home's exterior finishes, and in some cases, the structure in the areas of contact. Some shrubs have water-seeking roots, which can extend to and clog the home's foundation drainage system. As a guide, the maximum outermost branches of a mature shrub should be no closer than 2 feet from any surface of the home.

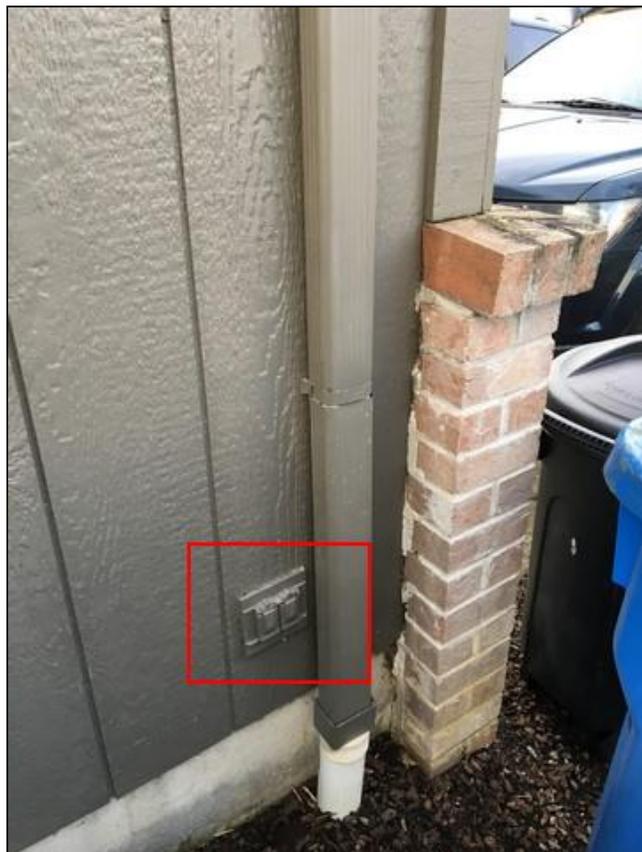
4.2 Item 1(Picture)

(1) **An electrical outlet is observed to be damaged.** The usual cause is due to impact or other forms of mechanical action to fracture the insulating body of the outlet. An outlet that has been damaged may result in the internal contacts not being secured as required, and the risk of short circuiting and arcing is now possible. Damaged outlets should be considered a safety hazard and should be immediately replaced.

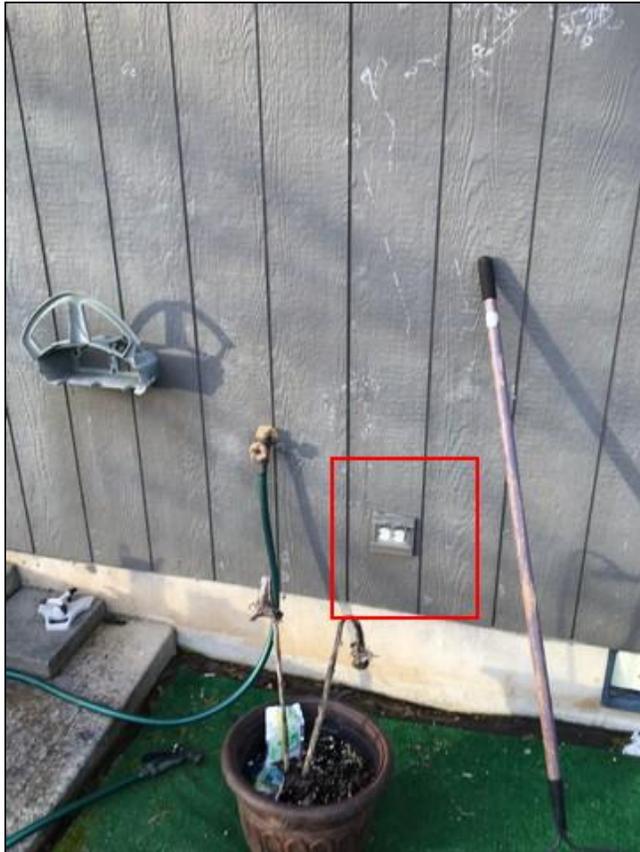
4.2 Item 3(Picture)

Damaged exterior outlet cover. Electrical outlets installed in outdoor locations require protection from water entry and contaminants. An outlet with a missing or damaged cover, when in an outdoor location, is subject to damage and deterioration if its weathertight protection has been compromised. Receptacles displaying damage or deterioration should be immediately replaced and a suitable cover installed.

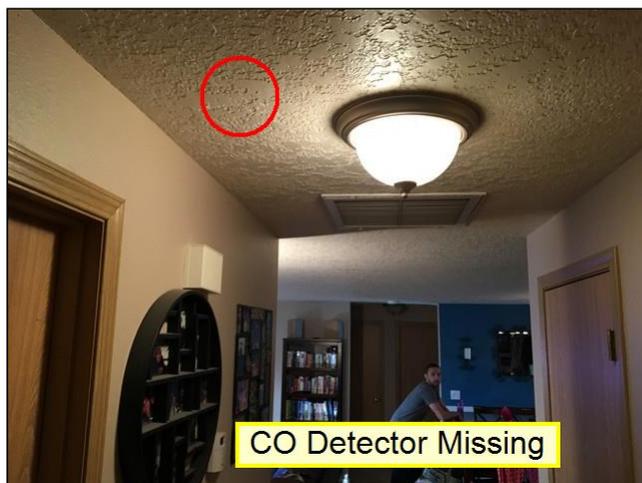
4.6 Item 1(Picture)

Smoke alarms appear to be past their life expectancy of 10 years.

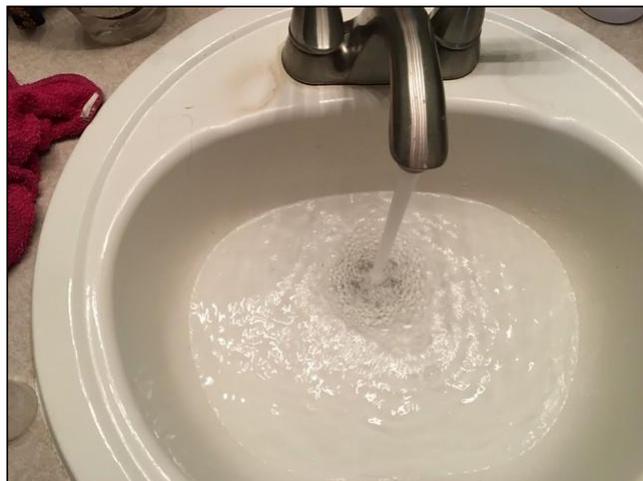
5.1 Item 1(Picture)

(1) **Sink is blocked or slow-draining.** A blockage in a fixture can result in back-up of waste water, affecting the performance of the sink. In some cases, a blocked drain can result in an overflow at the sink, which can result in extensive water damage.

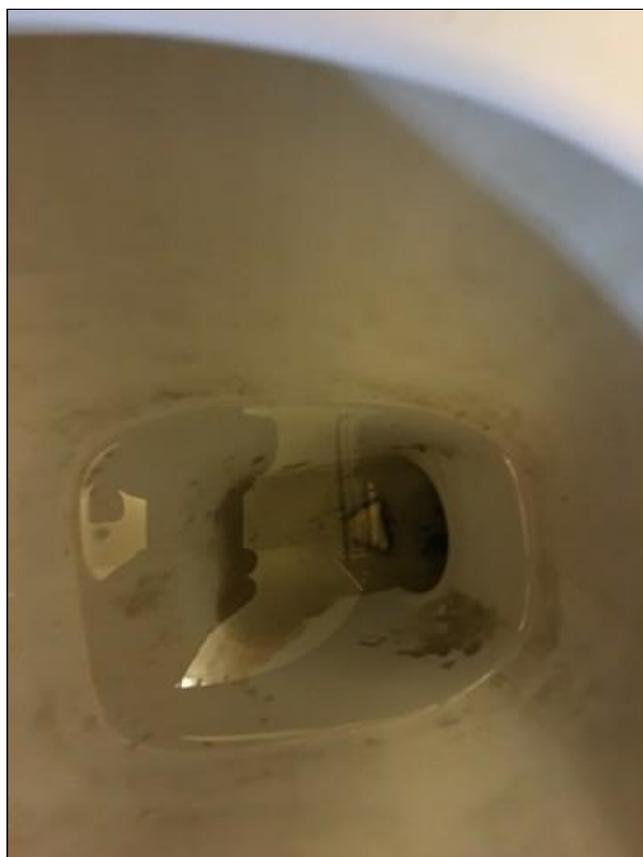
5.1 Item 2(Picture)

Toilet valve runs on when tank is full. This condition creates unnecessary waste of water, and the noise of the continually running water can be an annoyance. The toilet valve does not achieve its intended function of turning off the water supply fully when the tank is full.
