Inspection Report

Property Address:
11111 25th Street
Olympia WA 98513

CCS Inspection Services, LLC

Date: 1/30/2017	Time: 11:50 AM	Report ID: 29/01/17
Property: 11111 25th Street Olympia WA 98513	Customer: Client Name	Real Estate Professional:

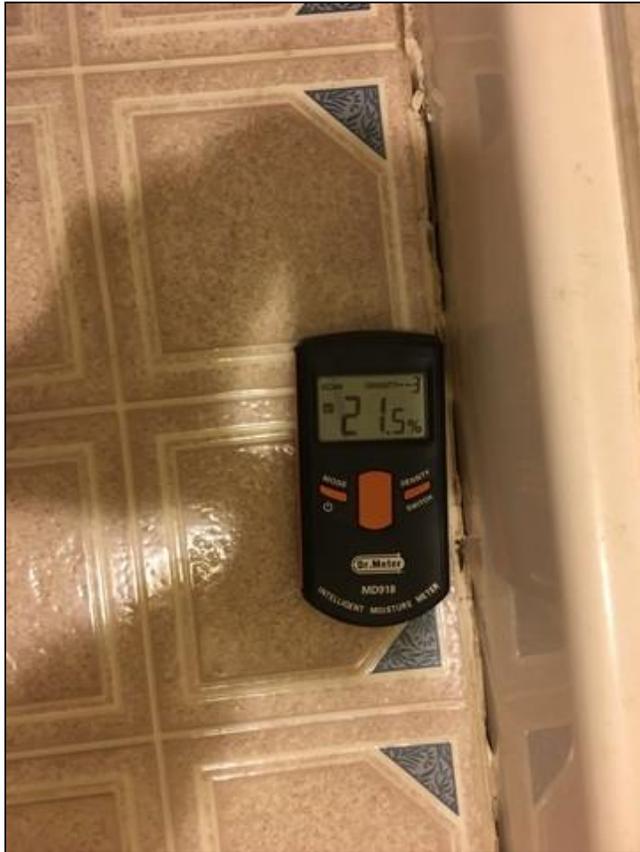
5.1 Item 4(Picture)

(3) **Caulking is incomplete at shower floor**. Caulking is a preventative action to keep water from seeping into floors, and causing damage associated with leaks. Failure to provide effective sealing can result in damage and costly repairs. In order for **bacterial growth** to form, moisture content needs to exceed 19%. At certain points of the floor next to the shower pan, moisture readings have exceeded that.

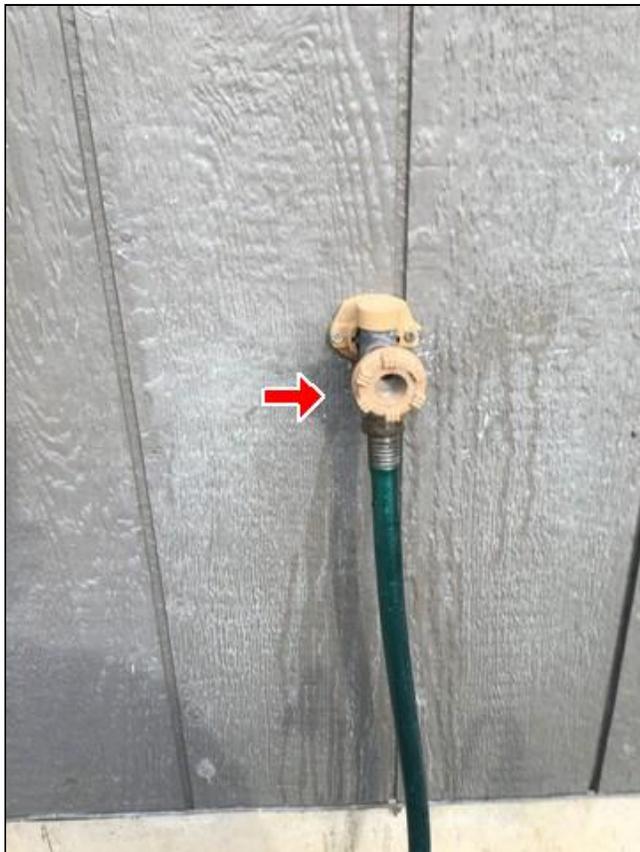
5.1 Item 5(Picture)

(4) Exterior (rear) hose bib control valve missing attachment screw.

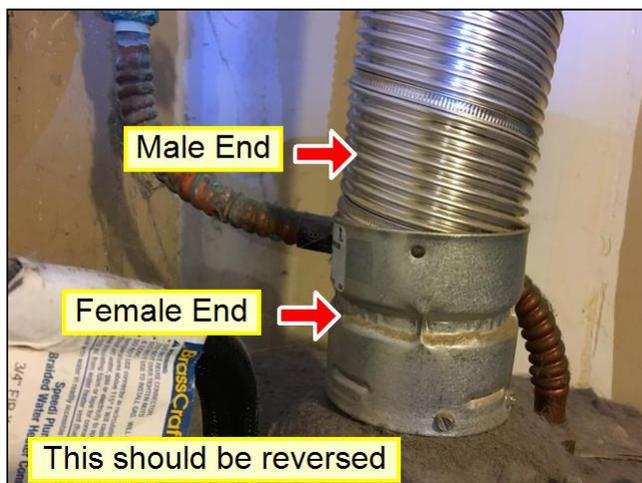
5.2 Item 1(Picture)

The exhaust vent pipe for the hot water tank has been improperly installed. To permit safe venting of exhaust gases, where ever there is a connection made, it should be from male end to female end. Currently, the vent piping is installed reversed, causing gases to leak out into the garage.

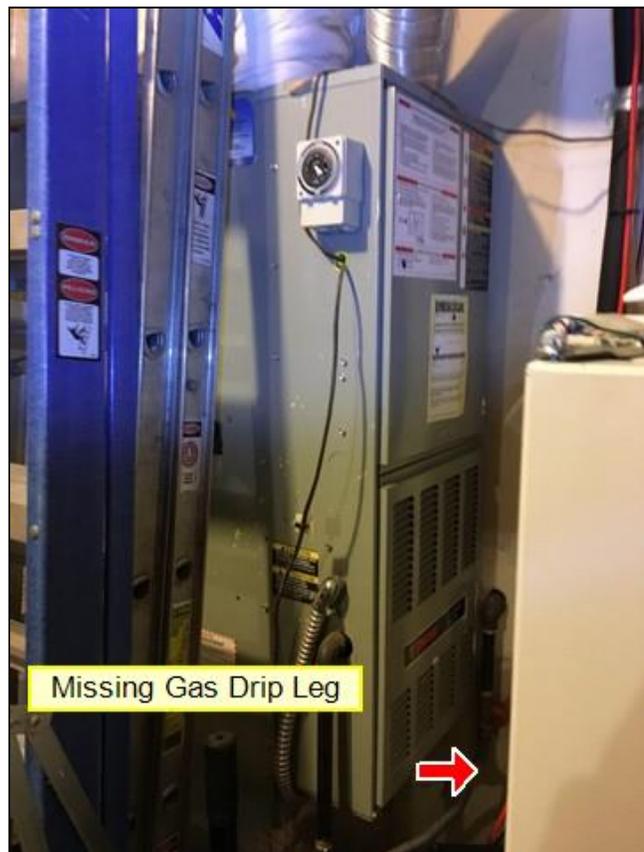
5.4 Item 1(Picture)

Appliance gas line does not have a drip-leg, or small vertical pipe designed to catch particulates before they reach and block the orifice in the gas control valve.

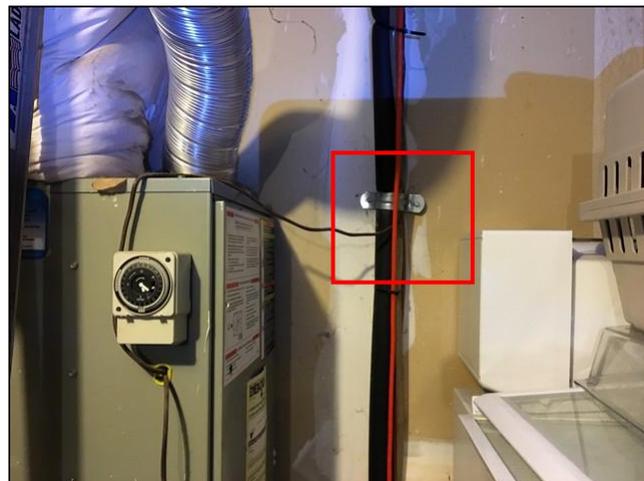
6.0 Item 1(Picture)

Mounting hardware loose or missing.

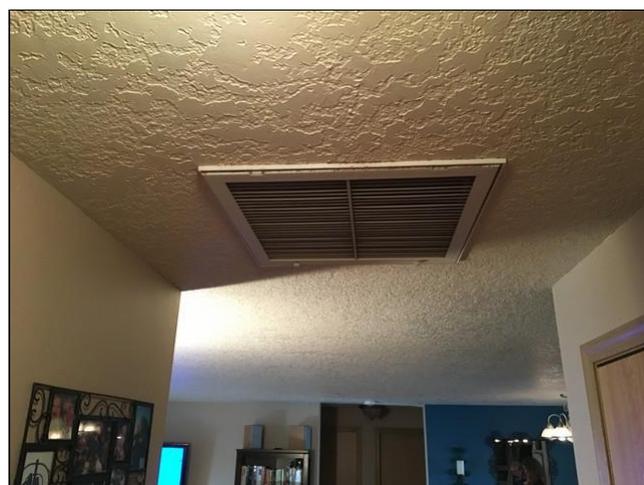
6.3 Item 1(Picture)

Reduced air flow through the home.

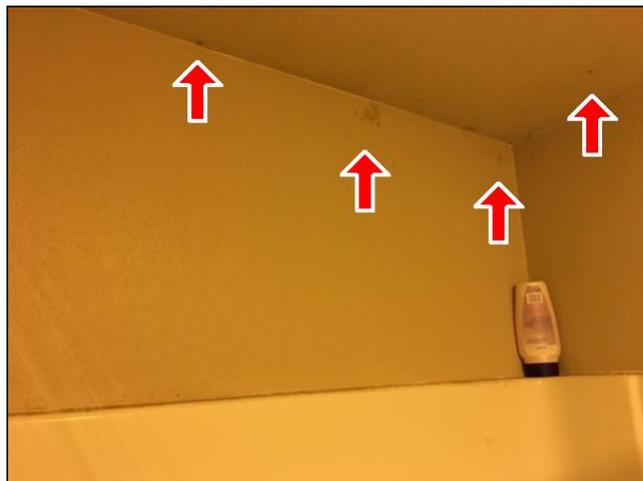
8.0 Item 1(Picture)

Signs of fungi growth are present on ceiling. We did not inspect, test or determine if this growth is or is not a health hazard. The underlying cause is moisture or dampness. I recommend you contact a mold inspector or expert for investigation or correction if needed.

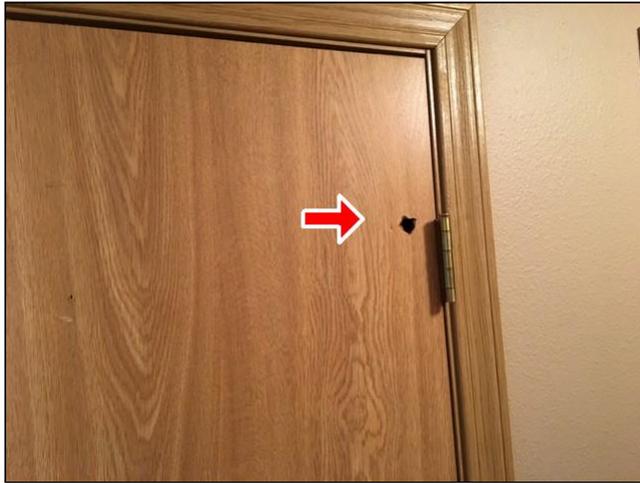
8.3 Item 1(Picture)

Interior door is damaged. A condition of physical damage impairs the appearance of the door. Certain forms of damage may affect the current or future operation of the door.

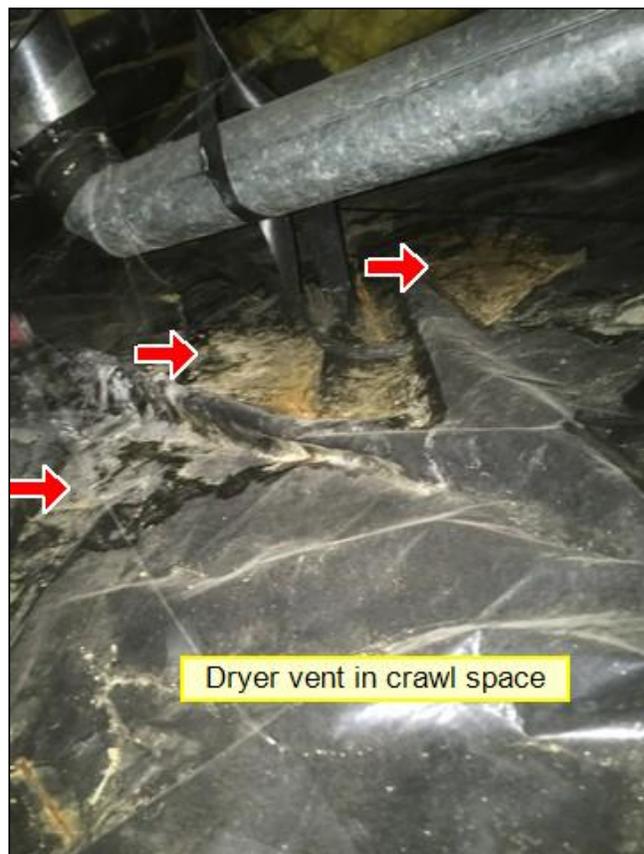
9.4 Item 1(Picture)

Moisture / mildew stains on vapor barrier indicates that dryer vent is damaged or clogged. Excessive lint in a dryer vent is a fire hazard and should be taken care of as soon as possible.

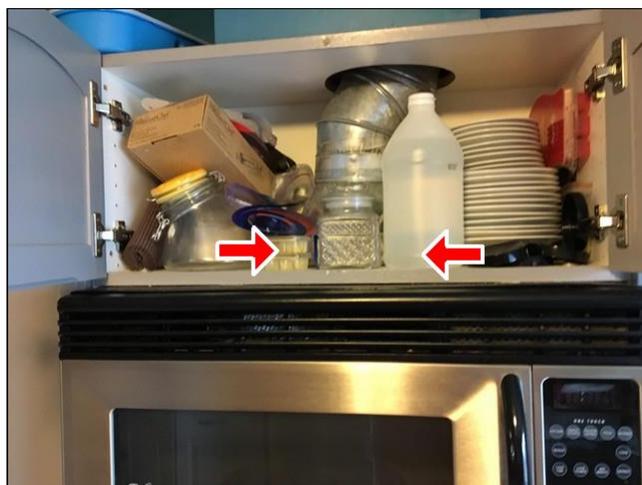
9.5 Item 1(Picture)

(1) Vent above microwave **does not appear to be connected**. When operating the fan on the microwave, air is recirculated into the kitchen instead of through the vent to the exterior of the home.

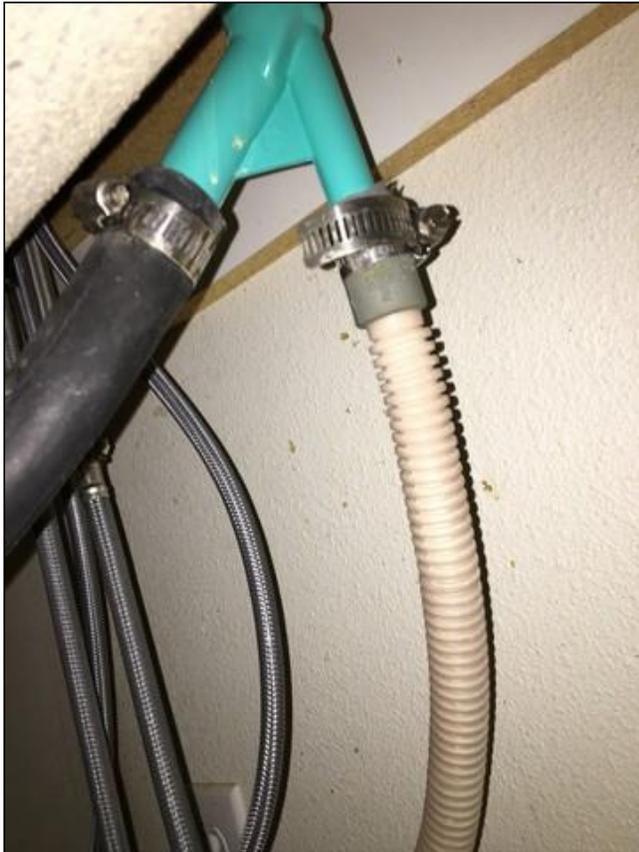
10.0 Item 1(Picture)

The dishwasher washer drain line is not looped to prevent back siphon. The dishwasher is functional but discharges without a mandated anti-siphon valve, which is contrary to the installation instructions, and which also creates a potential drainage problem and a health hazard.
