# Inspection Report

**Property Address:**  
Wantamoveto MT St.  
Missoula MT 59804

**J&S HOME INSPECTIONS**

<b>Date:</b> 6/10/2012	<b>Time:</b> 08:00 AM	<b>Report ID:</b> 942
<b>Property:</b> Wantamoveto MT St. Missoula MT 59804	<b>Customer:</b> Mr. Joe Homebuyer	<b>Real Estate Professional:</b> John Thomas Montana Real Estate

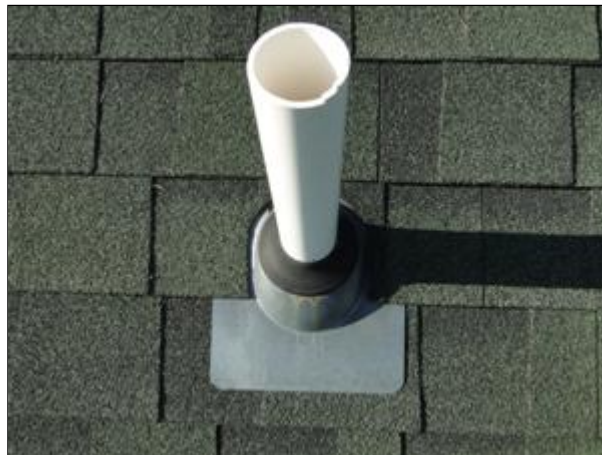
(1) Roof vent stacks and other penetrations have been installed correctly. The bottom edge of the flashing is on top of the shingles.

1.2 Picture 1 Vent stack installed correctly.

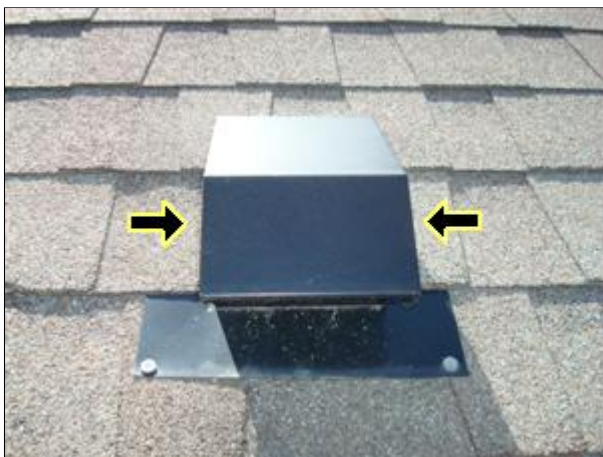
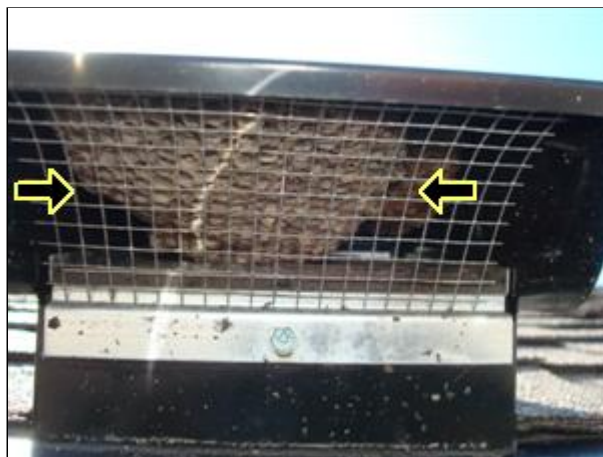
(2) The bathroom vent hood at the roof has a wasp nest located inside it. This is preventing the flap door from working properly and not allowing the bathroom exhaust fan to vent correctly. This condition creates a poor draw for the fan and makes it inefficient. Recommend spray wasp killer spray into vent hood, remove mesh screen, remove wasp nest, test flap door to make sure it moves freely and re-install screen. You will have to check this regularly as it is a common problem.

1.2 Picture 2 Look under this vent hood.

1.2 Picture 3 Large wasps nest present.

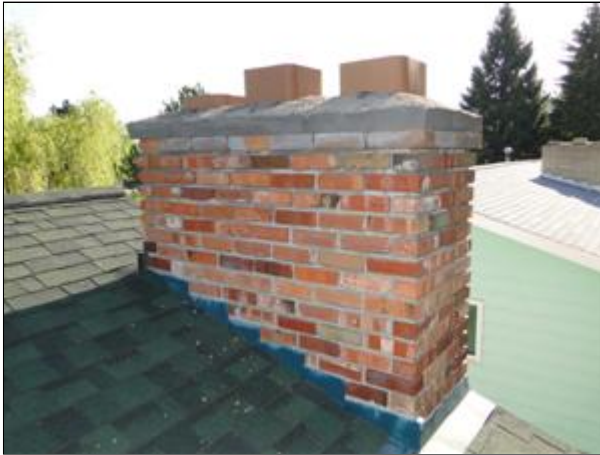
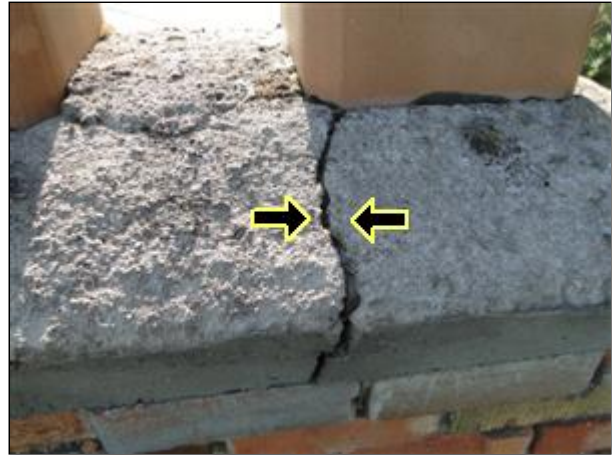
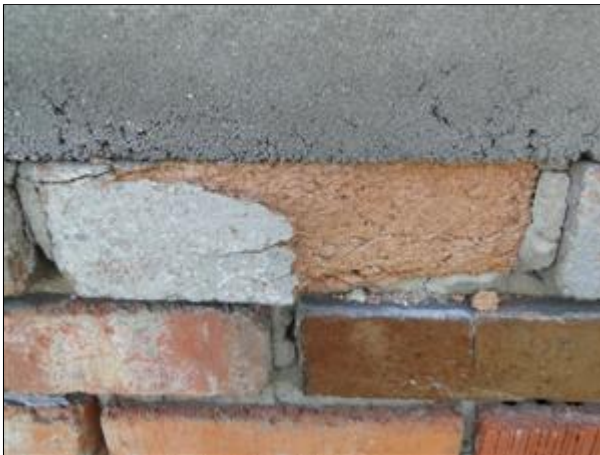
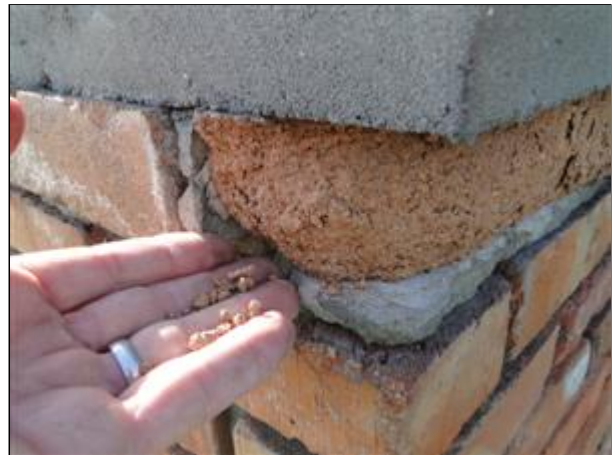
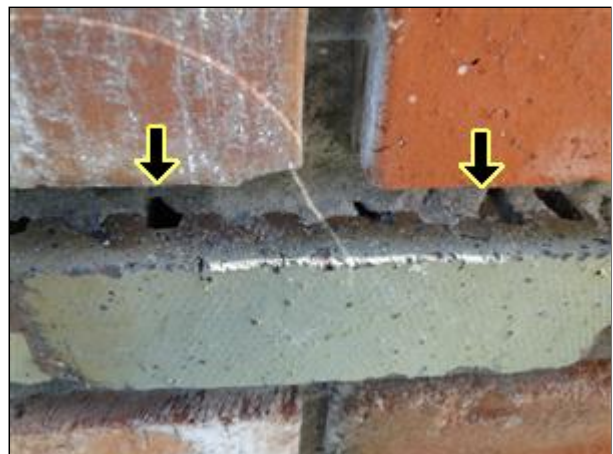
(3) Brick chimney is in need of repairs. The concrete cap is cracked in a few areas, the chimney cap does not extend over the bricks with a proper drip edge, bricks are starting to fail in a few areas due to water flowing over them from the chimney cap, loose bricks at corners, failing mortar etc. Recommend a qualified mason examine chimney and make necessary repairs.

1.2 Picture 4 View of chimney.

1.2 Picture 5 Crack at chimney cap.

1.2 Picture 6 Bricks starting to decay.

1.2 Picture 7 Corner bricks crumbling.

1.2 Picture 9 Mortar missing with bricks that have holes, water penetration point.

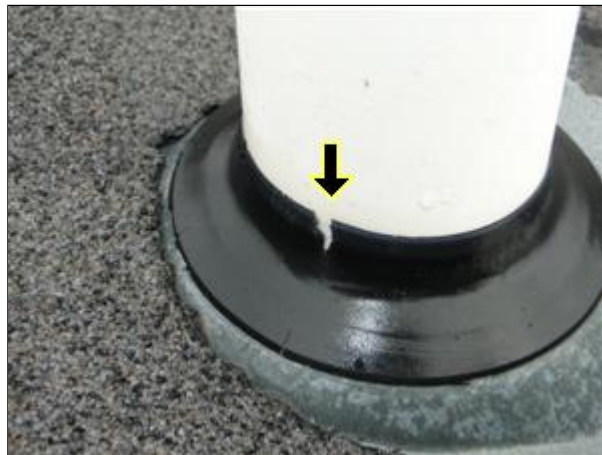
(4) There are cracks in the rubber sleeves of the vent stacks on the north side of the roof. This may allow water past the flashing and down the outside of the vent stack eventually ending up near the plumbing fixture that it is attached to.

1.2 Picture 10 Cracks in rubber sleeve.

Recommend replacing water tight sleeve with a new one or replace flashing and sleeve if needed to help shed water onto metal flashing below. This will help prevent leaks into the attic and home.

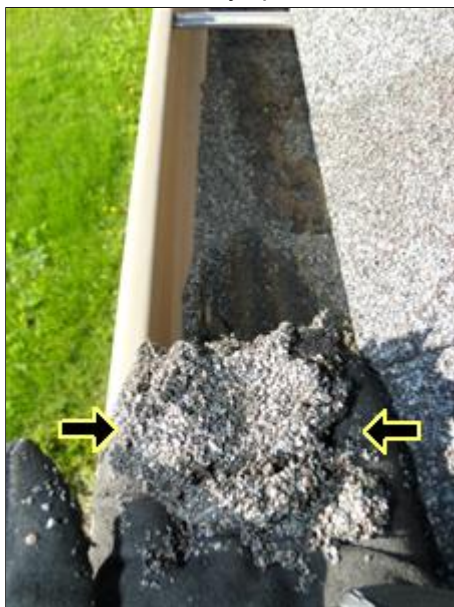
(1) Rain gutters are clear of leaves and debris, however there is a build up of granules from the composition shingles that has gathered in some areas. Recommend once a year cleaning of granules to prevent dirt and sludge build up. Also check your pitch towards downspouts and makes sure it stays positive.

1.4 Picture 1 Handfull of granules from gutter.

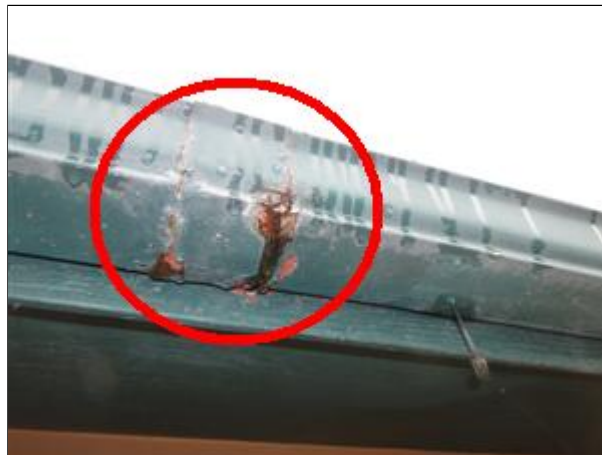
(2) Gutters show signs of rust at several joints. Recommend a qualified contractor examine and repair or replace any sections that show rust failure.

1.4 Picture 2 Rust present at joint here.

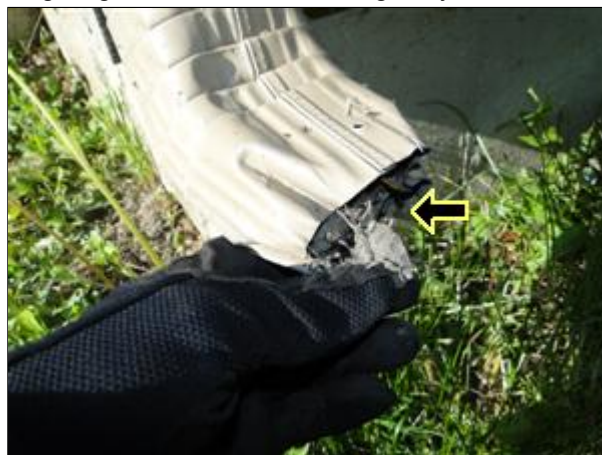
(1) Downspout at north east corner is clogged. This will cause gutters to back up and overflow possibly causing damage to fascia boards. Recommend clearing clog and add extension to grassy area.

1.5 Picture 1 Downspout clogged here.

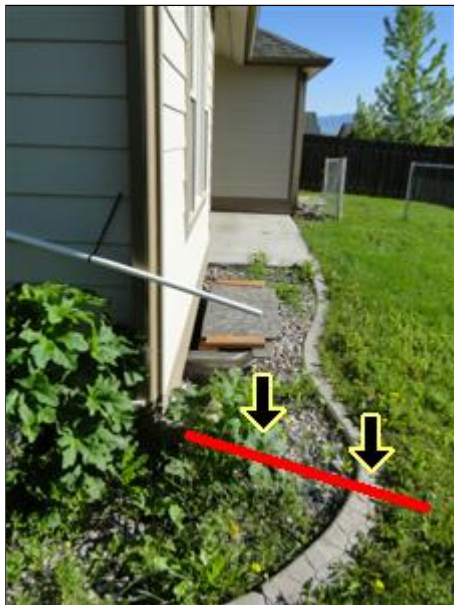
(2) Recommend adding extensions to downspouts around the outside of home. This will help move water away from foundation and prevent intrusion through foundation walls into basement.

1.5 Picture 2 Downspout extension needed here to lawn area.

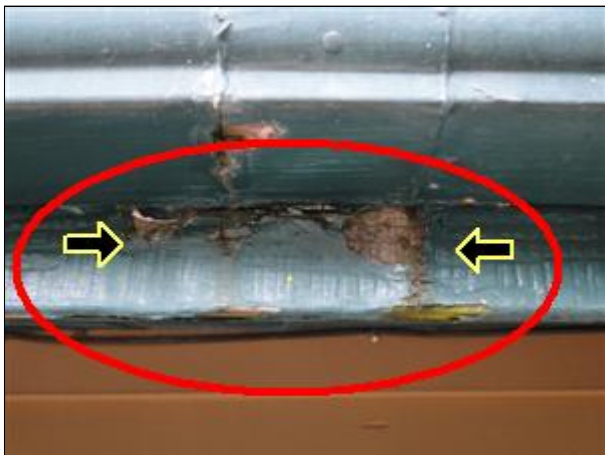
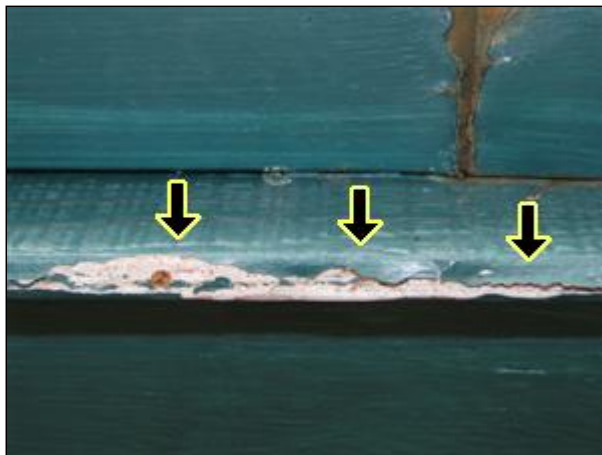
Some areas of the fascia boards around the home show signs of peeling paint and minor wood damage. Recommend scraping all peeling paint to a sound surface, sand if needed, replace any boards that can not be saved with bondo wood restoration or other exterior wood fillers, spot prime and add two coats of fascia color paint. This should be a part of a yearly maintenance program which will extend the life expectancy of the fascia boards.

2.0 Picture 1 Fascia board damage at leaking gutter area.

2.0 Picture 2 Peeling paint at fascia boards.

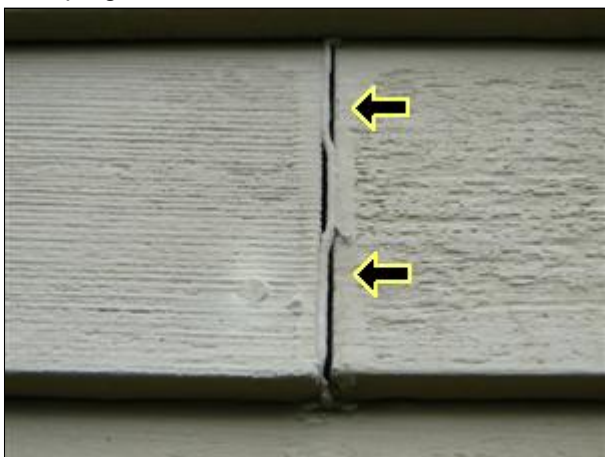
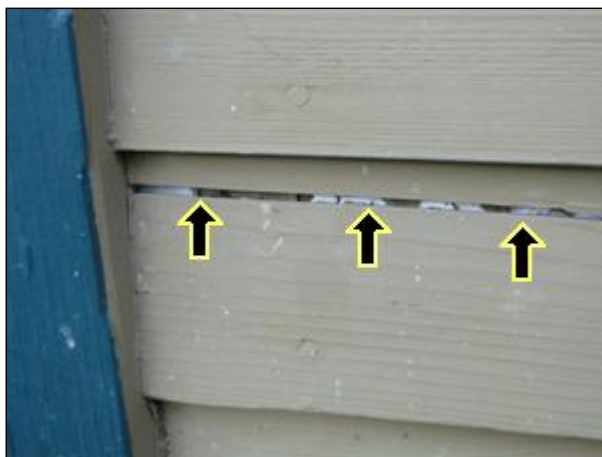
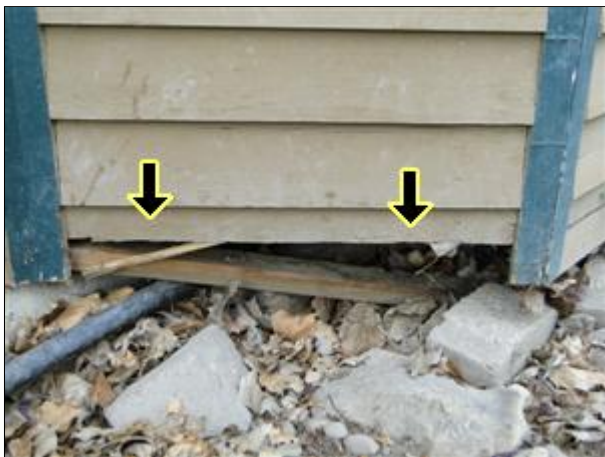
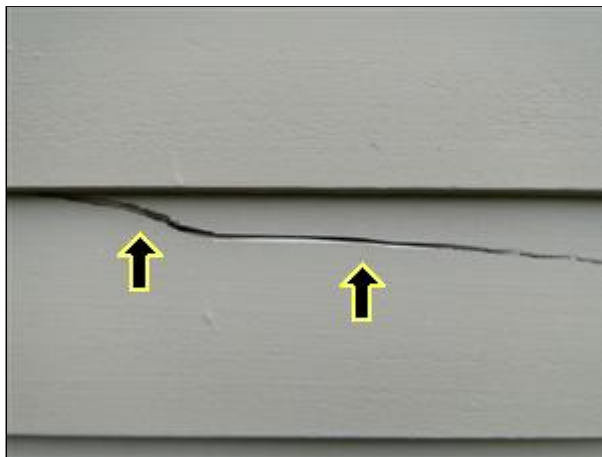
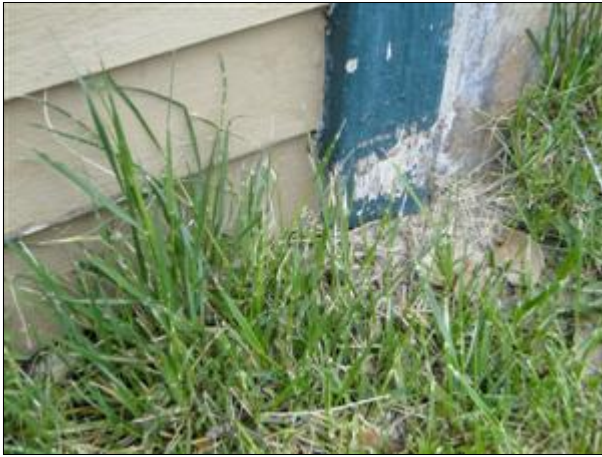
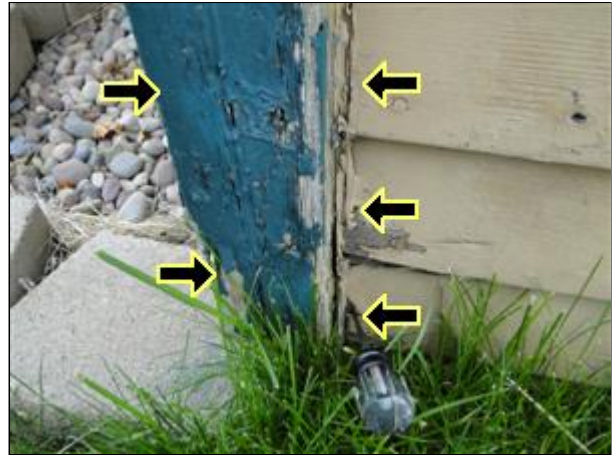
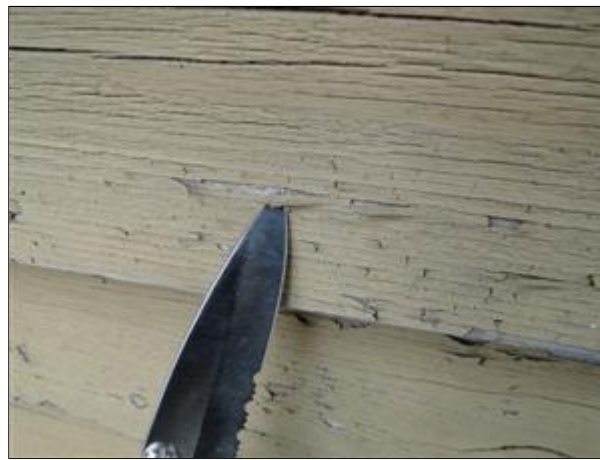
(1) As with most homes of this age there are the usual problems with the wood cladding and trim around the home. Over time water will work its way into the seams of the cladding, nail heads, earth to wood contact and through chips and damage. If these issues are addressed on a yearly basis with regular maintenance it will prolong the life expectancy of the wood cladding. We recommend filling all vertical seams and gaps with a good exterior paintable acrylic caulking. NEVER caulk the horizontal gaps between lap boards. This can trap moisture and cause rot at the bottom boards. These horizontal gaps are needed to allow the building to breathe. Secure loose seams with wood deck screws to pull joints tightly together. Re-set any nail heads that stand proud of the cladding surface. Replace any nails that will not stay in place with deck screws. Use caulking or exterior wood filler to cover all screw and nail heads. Repair any damaged areas of the wood cladding with wood bondo restoration product or a good exterior wood filler. Remove dirt in areas where earth has come into contact with the wood cladding. It may be necessary to remove a few inches of damaged wood cladding where it has come into contact with earth. Try to keep at least 4" inches of clearance between earth and wood cladding at all times and more distance is even better. Replace any wood cladding that can not be saved. After all repairs always spot prime and add two top coats of cladding wall paint color. This should be a part of a yearly maintenance program.

2.1 Picture 1 Failing caulk at butt joints.

2.1 Picture 2 Split cladding board.

2.1 Picture 3 Damaged cladding board.

2.1 Picture 4 Damaged cladding boards south side.

2.1 Picture 5 Earth to cladding and trim contact.

2.1 Picture 6 Trim board needs repair and caulking where cladding boards meet.

2.1 Picture 7 Peeling paint, checking cladding boards.

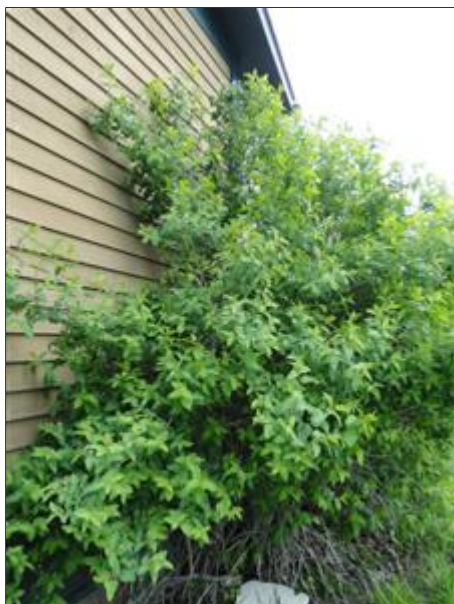
(2) There is vegetation which has come into contact with the wall cladding on the south side of the home. Recommend trimming back vegetation 6" to 8" away from wall cladding. This will give wall cladding a chance to breath and air out after precipitation has occurred.

2.1 Picture 8 Trim back vegetation to allow cladding to breath.

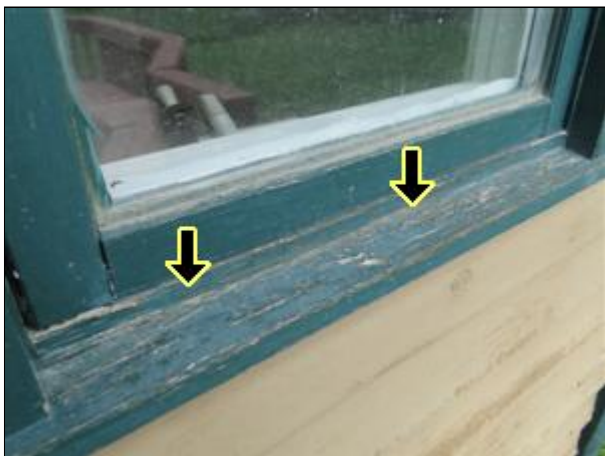
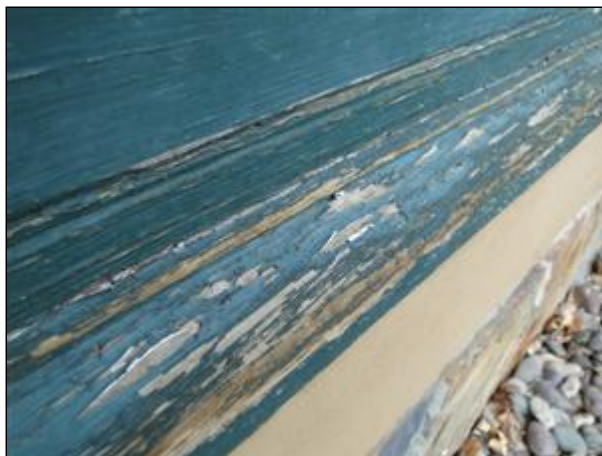
As with most wood windows regular maintenance will be needed to keep windows from rotting. Scrap all peeling paint to a sound surface, spot sand smooth, spot prime, caulk all joints that have gaps or finger joints exposed, add two top coats of window trim color. Always check the caulking around the perimeter of the window and replace as needed. Fill any gaps or voids with caulking to prevent water penetration.

2.2 Picture 1 Maintenance needed htere.

2.2 Picture 2 Close up of damage.

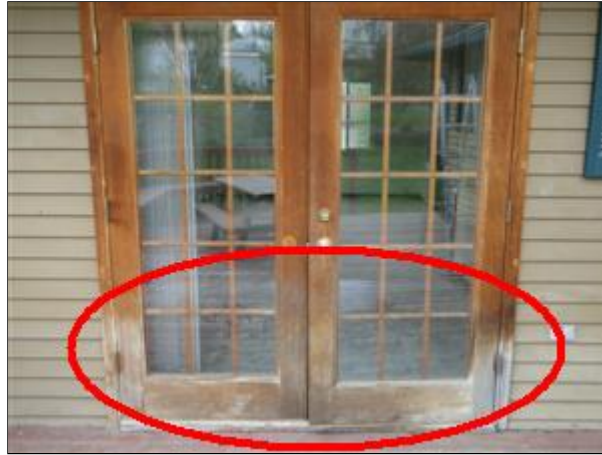
As with most wood exterior doors you will have to refinish them from time to time. This may require sanding the old clear coat off if it is failing, staining and applying several coats of a good spar or marine varnish. This will help protect the wood and prolong the life expectancy of wood doors.

2.3 Picture 1 Wood finish at door failing here.

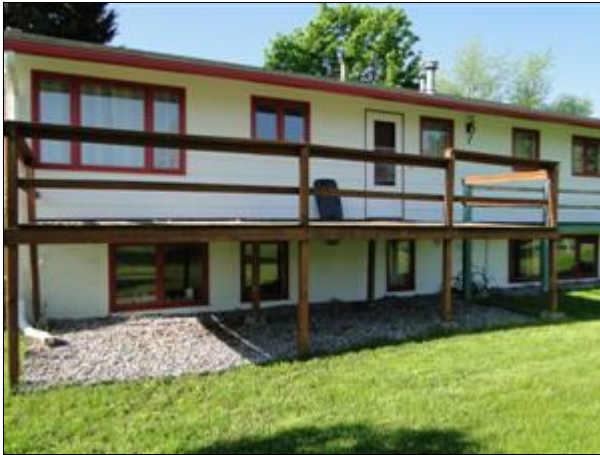
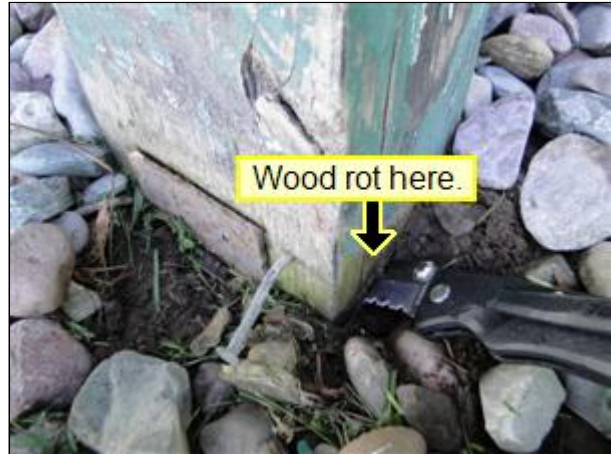
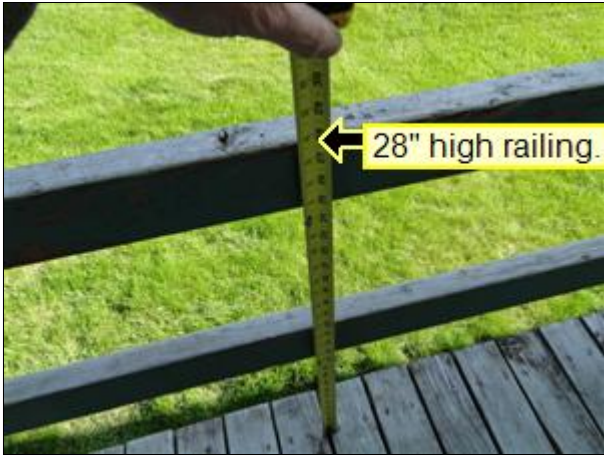
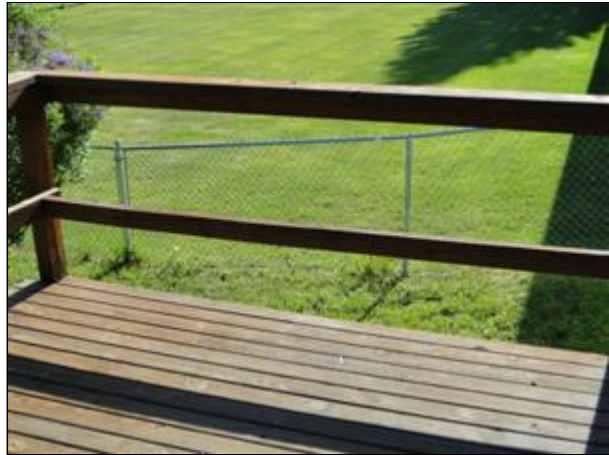
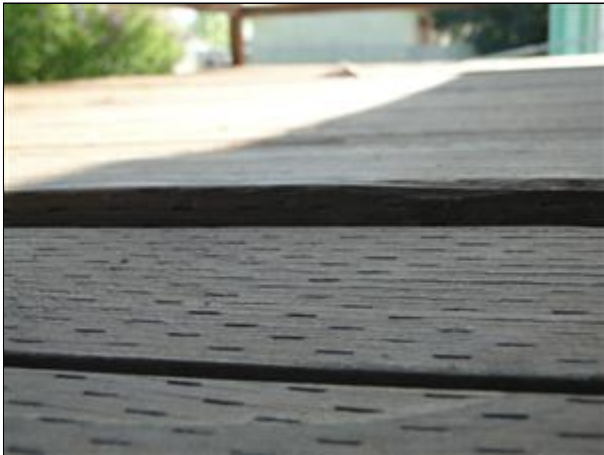
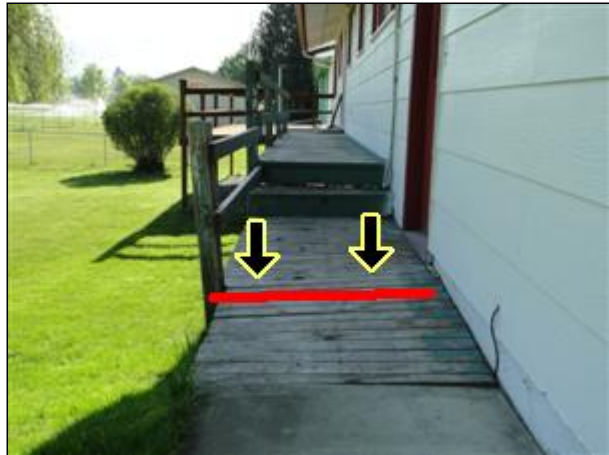
The back deck has been constructed poorly and is a safety hazard. I was able to stand at either corner of the deck and push the deck back and forth with one hand with little effort. Normally we like to see a header board attached to structure with carriage or lag bolts, then floor joist run perpendicular to the header board attached with joist hangers, 6x6 support posts set on concrete footings with post anchors, doubled up rim joist, railings post blocked in and secured with carriage bolts, floor joist 16" on center, deck boards of your choice attached to floor joist, proper drip edge installed between deck and structure, handrailing 34" to 36" tall with spindles no more than 4" apart etc. This deck has uneven deck boards (trip hazard), header attached to structure with screws, floor joists run the wrong direction, joists 24" on center, rotten support posts on old deck, above ground concrete block footings, a wood drip edge which will cause rot between it and structure, sloping walkway, handrailing way too short, spindles missing on hand rails etc. This deck may collapse under the weight of several people (10-20). This deck really needs to be removed and a properly built deck installed.

2.4 Picture 1 Over view of deck.

2.4 Picture 4 Rot at support post, earth to wood contact.

2.4 Picture 5 Railing way too short.

2.4 Picture 6 Spindles missing at railing.

2.4 Picture 7 Trip hazard at deck boards.

2.4 Picture 8 Deck walk way tilted.

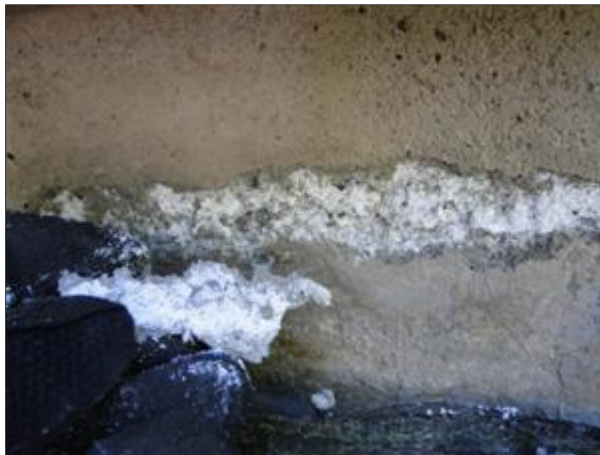
(2) It was noticed on the north foundation wall there is efflorescence present. Efflorescence is caused when soluble salts and other water dispersible materials come to the surface of concrete and mortars. It's induced by low temperatures, moist conditions, condensation, rain, dew and water. It can occur very soon after exposure to moist or cool conditions or gradually, especially when it comes from within the concrete or from the subgrade. This does not necessarily mean that water has penetrated this wall just that it has become wet at some time in the past, usually during original construction which is common on foundation walls. There were no signs of water penetration at the basement in this location.

2.5 Picture 2 View of north foundation and white powdery substance.

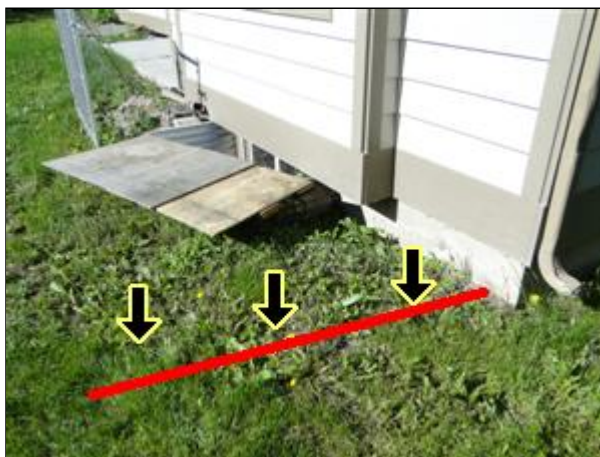
As always we recommend having a 5 degree slope of landscape away from the foundation. This will help move water away from the foundation. This means at six feet from the foundation you should have a three inch drop in landscaping height. Recommend grading earth around the home to meet this standard.

2.7 Picture 1 Landscaping slopes towards home.

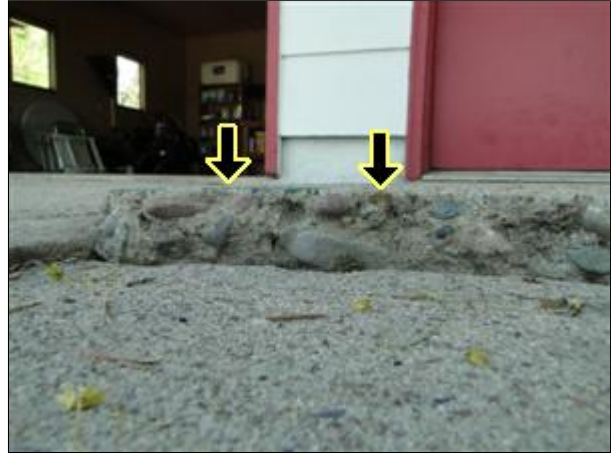
(1) The concrete walk way has some substantial cracks that may cause a trip hazard. The walk way is reaching its life expectancy in this area and should be replaced soon. Recommend consulting with a concrete contractor for recommendations for grinding trip hazard down or replacing with new concrete.

2.11 Picture 2 View of off set concrete, over 2" inches.

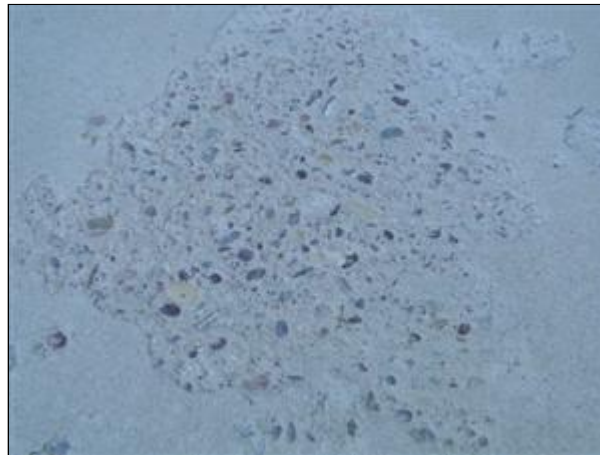
(2) The walk way is aged concrete with spalling revealing the concrete's aggregate. This will eventually lead to severe cracking and concrete failure. Recommend resurfacing concrete walkway in these areas to prevent further damage.

2.11 Picture 3 Spalling, exposing aggregate.

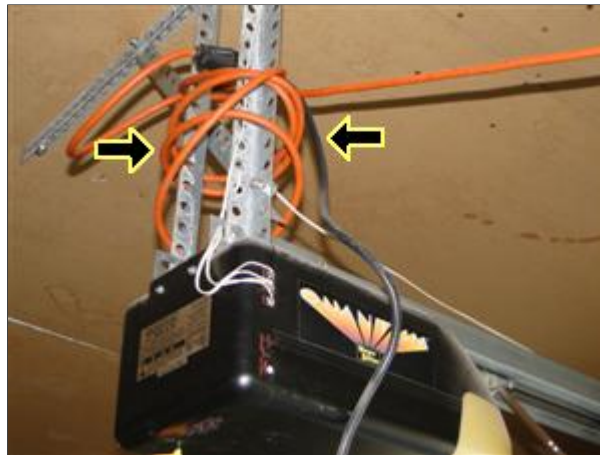
(2) An orange extension cord has been used to supply permanent power to the garage door opener. Extension cords are for temporary use only and should never be used for a permanent power source. Recommend a licensed electrician add an additional junction box and outlet near the garage opener so it can be plugged in directly.

3.0 Picture 1 Orange extension cord at opener.

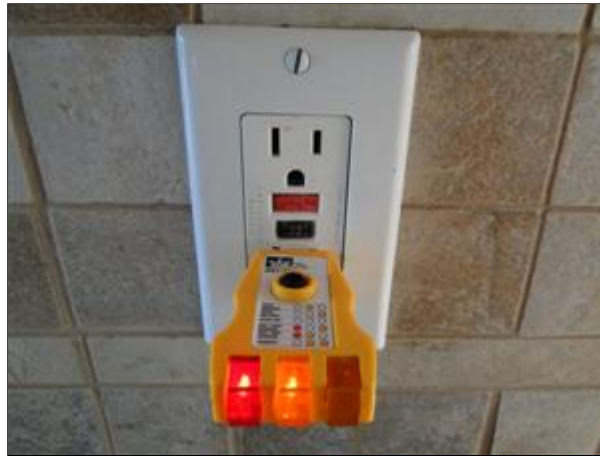
(2) Note: GFCI on east wall has a hot neutral reverse. Recommend a licensed electrician correct this wiring issue.

5.8 Picture 1 Hot Neutral reverse east wall.

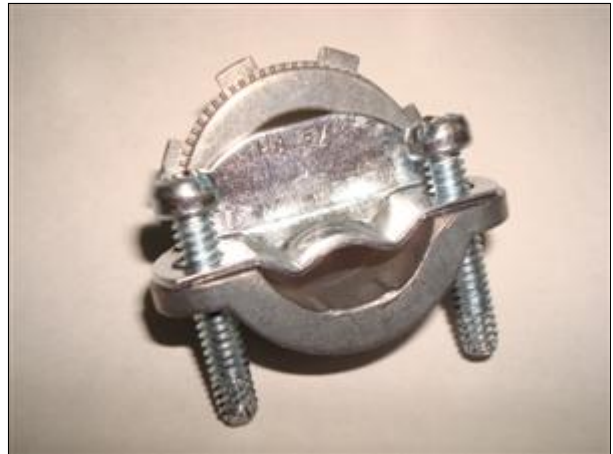
(2) The garbage disposal is missing a power cable wire collar where the power cord enters the unit. Recommend a licensed electrician remove power wire and add the proper wire collar. This will help prevent pulling the power cord loose and possibly causing a short or shock hazard.

5.12 Picture 2 Cable collar needed.

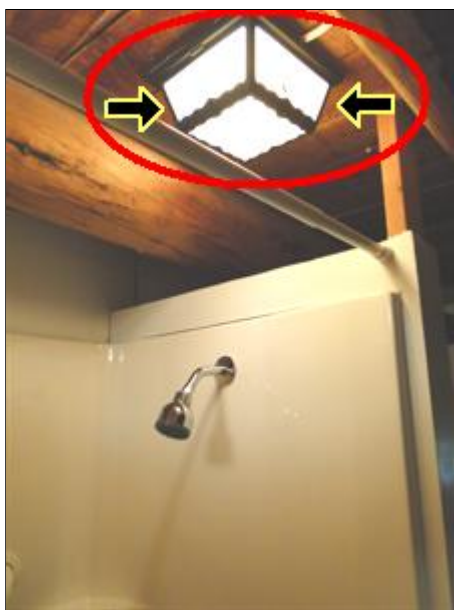
(2) The downstairs spare shower surround has a light fixture located within the shower surround. You CANNOT mount a light fixture like this one within a shower surround location. You are 100% grounded in water and if you touch this fixture as it shorts out and it will KILL you. Recommend a licensed electrician remove this light fixture and install an approved wet location light fixture or move this light fixture outside the shower surround. This is so dangerous, please do not take a shower until this issue has been corrected.

6.7 Picture 1 Shock hazard at light fixture.

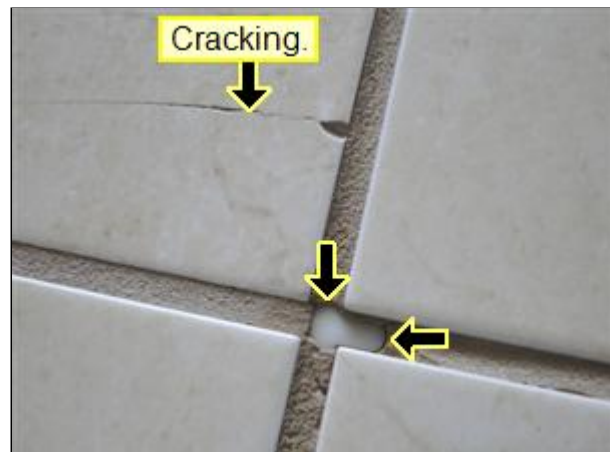
The tiles at the front entry have lost their mechanical bond in some areas. This is easily determined by knocking on the tiles and listening for a hollow sound. This means the tile has lost adhesion with the substrate below. This will cause the grout lines to crack and eventually the tiles will crack as well. Recommend removing grout around loose tiles, remove tiles from floor and clean back side, clean concrete floor, re-install tiles using the proper thinset mortar for this application with the correct bonding additives, once tiles set up over night grout and seal grout after it has cured per manufacturers recommendations.

7.2 Picture 2 Spacers left in at joints, cracking.

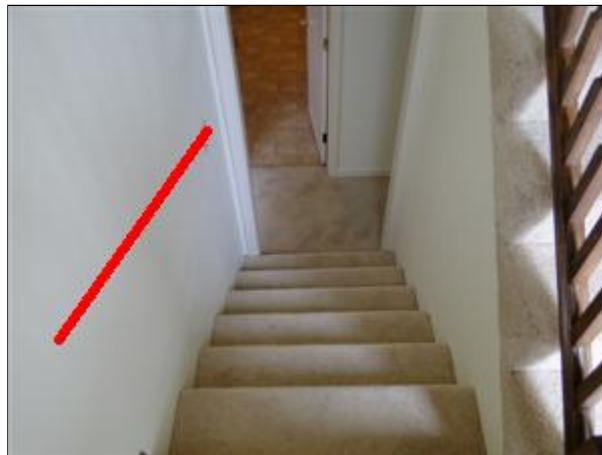
There are no handrails in the stairwell from the upstairs to the basement area. Recommend adding handrails to one side or the other to help prevent accidental falls.

7.3 Picture 1 Handrailing needed here.

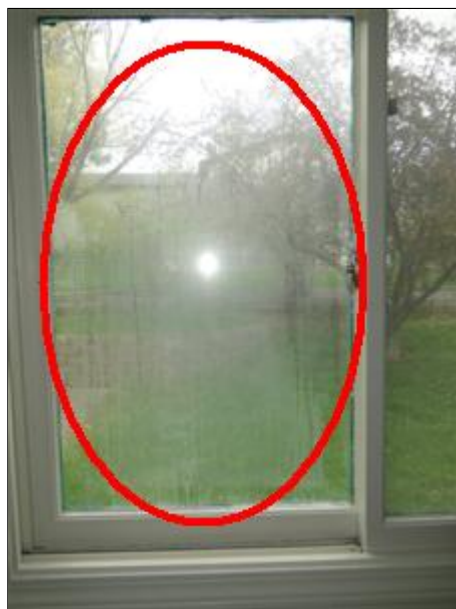
There are signs of broken window seals at the east master bedroom window. This shows as condensation between panes of glass and or white haze between panes of glass. This cannot be cleaned or repaired and can only be fixed by replacing the glass or complete window. Recommend replacing glass or windows in bedrooms where this condition exists.

7.5 Picture 1 Broken seal this window.

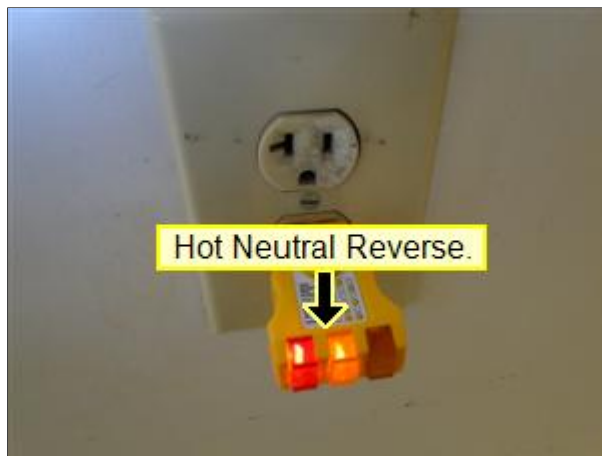
Laundry room west wall outlet has a hot neutral reverse. Recommend a licensed electrician correct this wiring issue.

7.6 Picture 1 Laundry room west outlet.

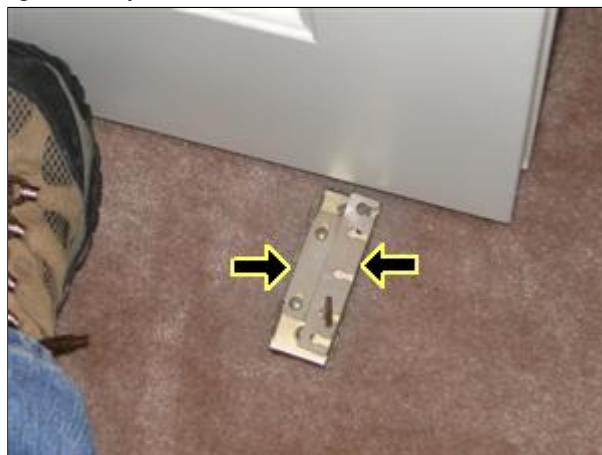
All bedroom closet doors are missing door guides at the bottom. These devices help guide the doors as they open and keep them from swinging in and out which helps keep them aligned on their top rails. Recommend adding closet guide rails to keep closet doors functioning correctly.

7.7 Picture 1 Door guides missing at bedrooms.

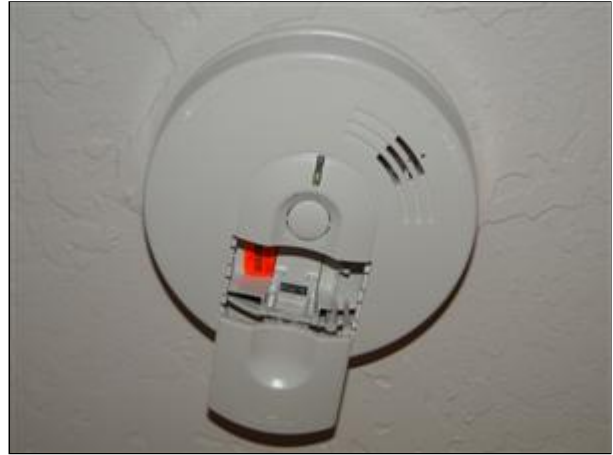
7.8 Picture 2 Most detectors are missing back up batteries.

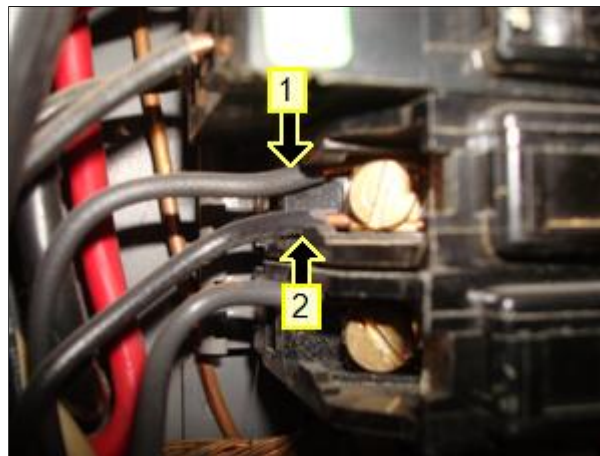
One circuit breaker has been doubled up to the terminal screw in the box located in the garage. This is not usually permitted in older boxes however in newer boxes it is allowed. Opinions can vary from one electrician to the next about this practice. We always recommend not double tapping terminal screws at breakers especially when there are open slots still available within the box. Recommend a licensed electrician add additional circuit breaker to separate the doubled up circuit. This will help prevent overloading this circuit breaker.

8.4 Picture 1 Doubled up at terminal screw.

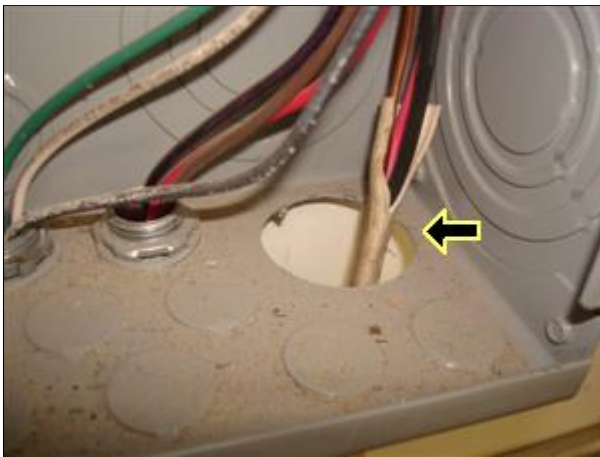
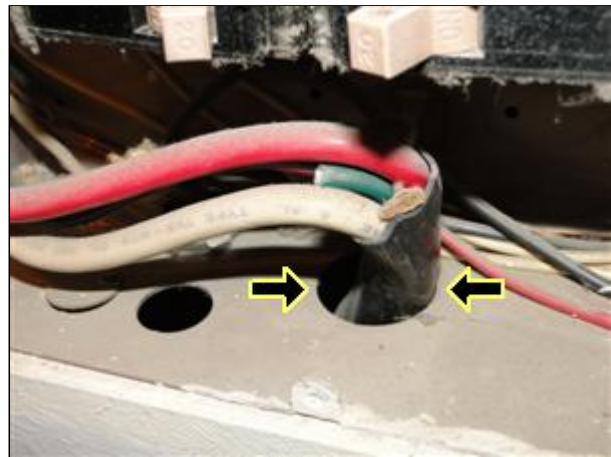
(2) A knock out hole in the main circuit breaker box has been used to run additional electrical wiring to the home. The knock out hole is missing a retaining collar to hold the romex cable tight to the box. This helps prevent pulling wires out of box accidentally which can cause shorts etc. The metal knock holes maybe sharp and could also cut or damage the electrical wires. Recommend a licensed electrician remove these wires and add a cable collar and re-install these two lines to the circuit breaker and neutral bar and ground.

8.8 Picture 2 Knock out missing collar.

8.8 Picture 3 Knock out missing wire collar.

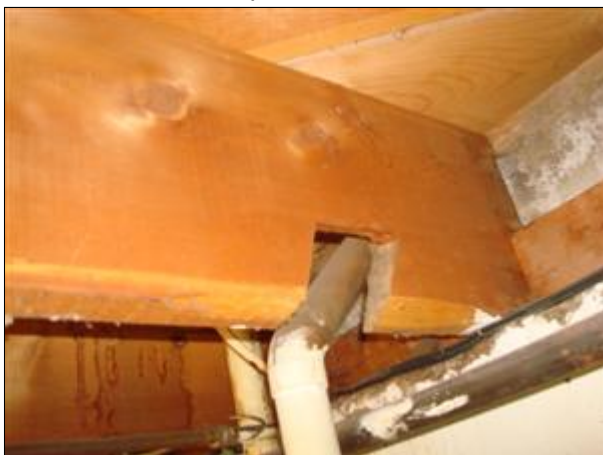
Floor joist in south west corner of crawlspace has been notched to accommodate a plumbing line. This notch appears to be almost half of the width of the floor joist and is out of tolerances for joist notching. This has compromised structure in this location. Recommend a qualified contractor examine and add a sister joist glued and screwed to notched joist.

9.2 Picture 1 Joist over notched.

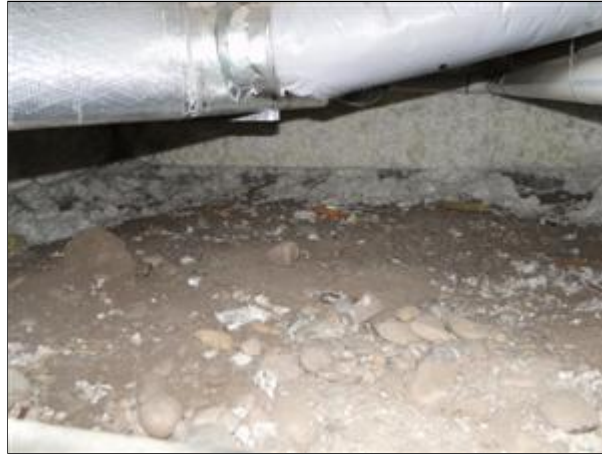
9.4 Picture 1 East crawlspace off of basement does not have vapor barrier.

Recommend adding 6 mil plastic sheeting with at least 6-8 inch overlap at the seams. This will help prevent vapor transmissions from the crawlspace into the home.

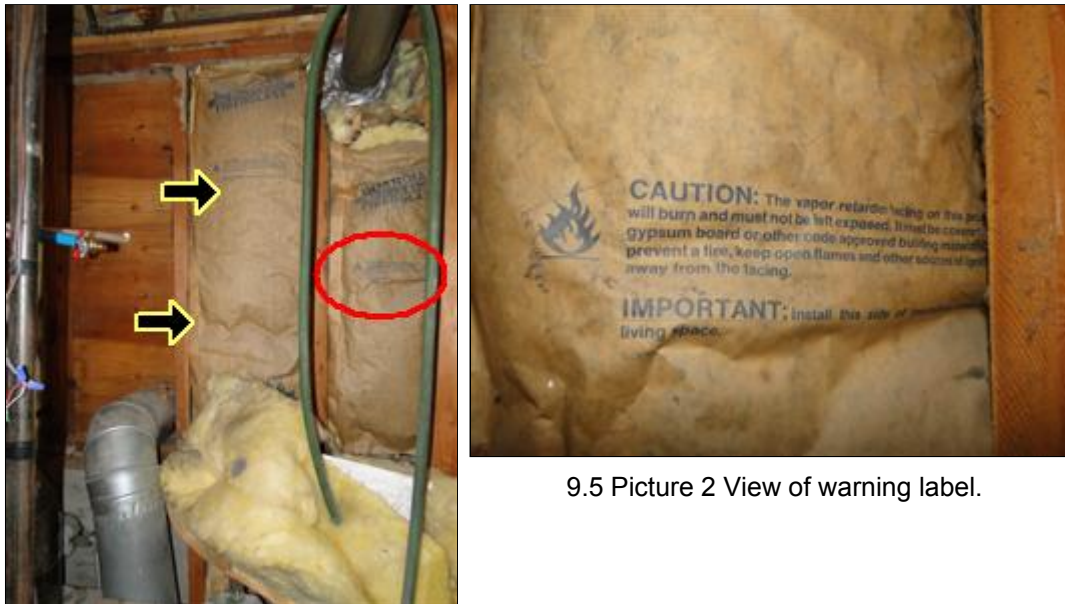
9.5 Picture 1 Kraft back insulation, read warning label.

Recommend removing the paper from the batts. This will help prevent any accidental fires in the crawl space.

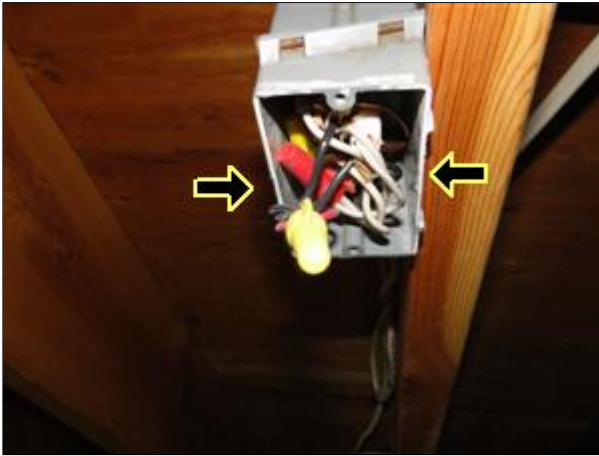
(2) There are open junction boxes located in the basement area. Recommend adding blank plate covers to these junction boxes. This will help contain any sparks should there be a short circuit in these locations.

9.13 Picture 2 Open junction boxes at basement.

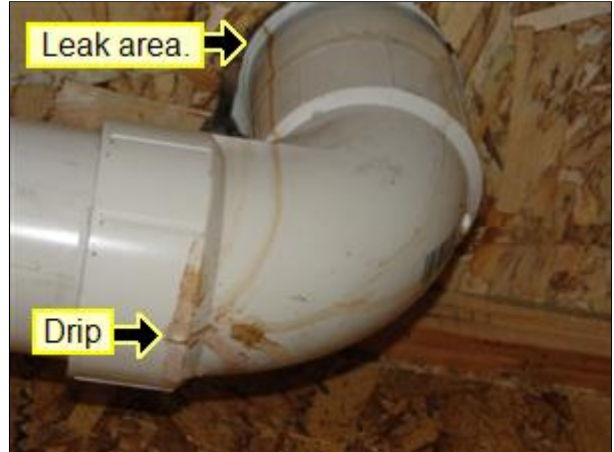
10.0 Picture 2 Close up of leak.

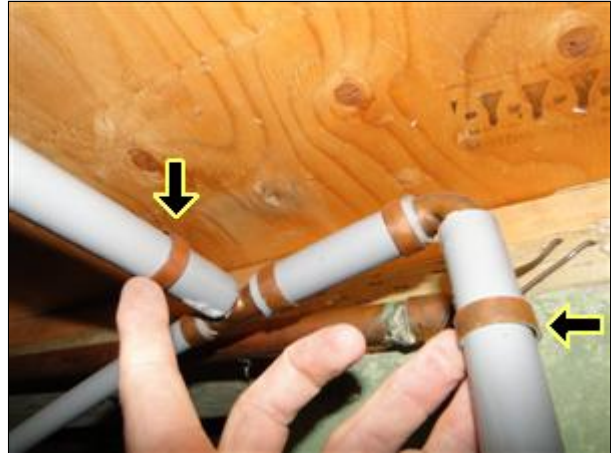
10.1 Picture 2 Loose clamp fittings at unions here.

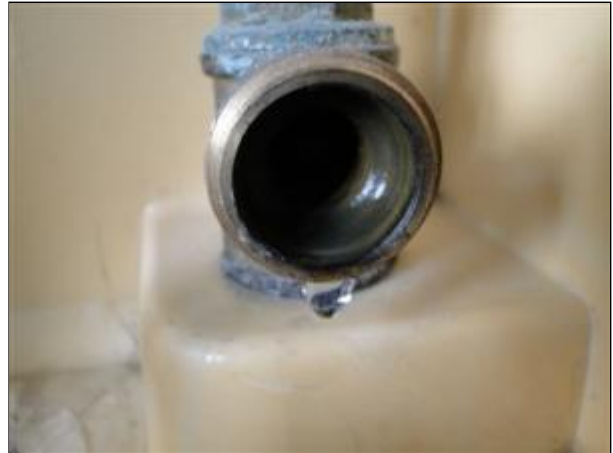
10.11 Picture 2 Close up of drip leak at hot water faucet.

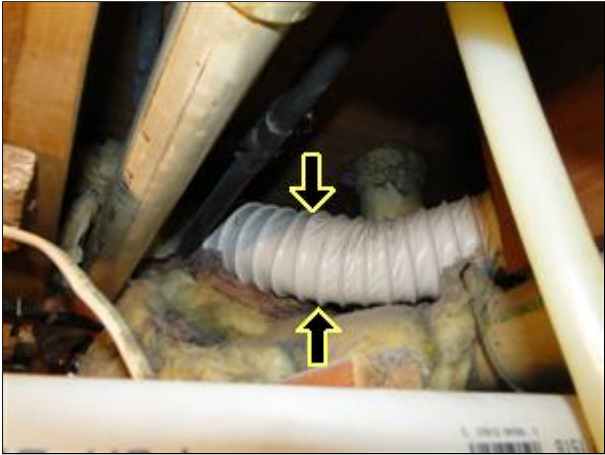
(1) Recommend changing flexible dryer exhaust hose with rigid aluminum or galvanized piping. This will help reduce air flow resistance and help your dryer run more efficiently. Make sure to use metal HVAC tape and not duct tape at all joints.

10.12 Picture 1 Sections of dryer duct work are plastic.

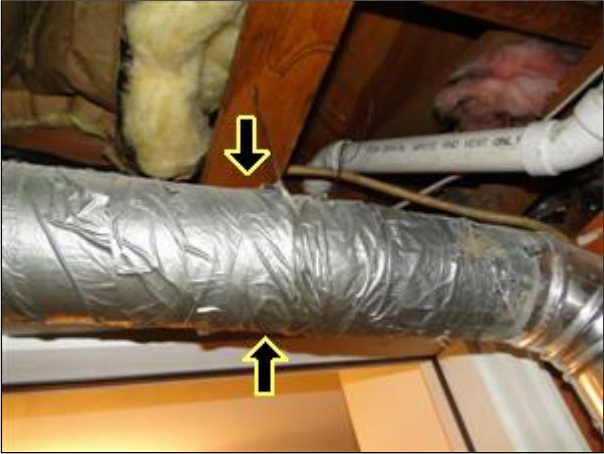
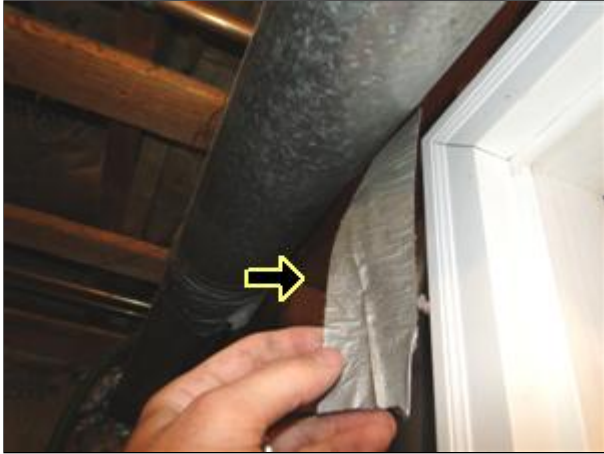
(2) The dryer vent piping is held together at the joints with duct tape. Duct tape adhesive will dry out over a period of time and delaminate. This will allow warm moist air into the crawlspace. Recommend removing all duct tape at joints and replacing with metal HVAC tape.

10.12 Picture 2 Completely wrapped in duct tape indicates issues.

10.12 Picture 3 Duct tape delaminating at joints.

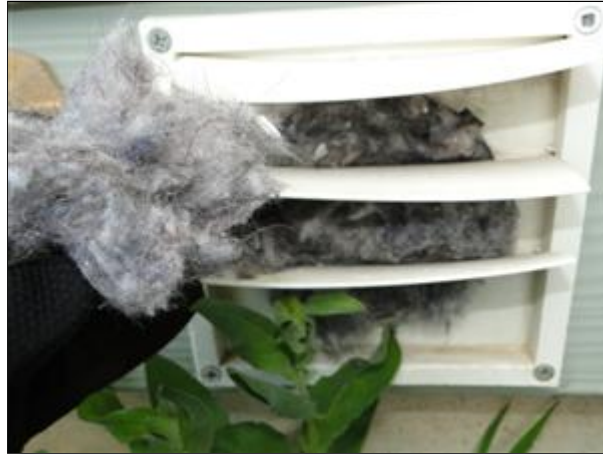
(3) Recommend cleaning dryer vent system regularly to help keep lint build up down. This will help your dryer run more efficiently and help reduce the chance of a lint fire.

10.12 Picture 4 Dryer vent hood completely blocked.
