LYCOMING

SERVICE INSTRUCTION

Service Instruction No. 1011L
(Supersedes Service Instruction No. 1011K
and obsoletes Service Instruction No. 1529C)
Engineering Aspects are
FAA Approved

SUBJECT: Tappets and Lifters
MODELS AFFECTED: All Lycoming engines
TIME OF COMPLIANCE: At overhaul or at owner's discretion
REASON FOR REVISION: Added new replacement part numbers

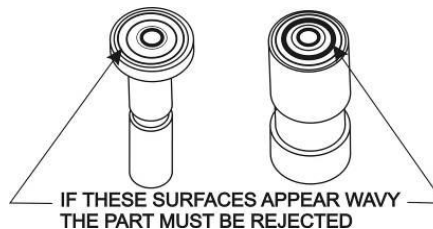
Figure 10
Unacceptable Surfaces

3. If a new camshaft is installed in the engine, replace all of the tappet bodies.		Replace all tappet bodies.
4. Look for discoloration, with circular wear and/or wavy patterns on the face of the tappet body (Figure 10).	Circular wear Wavy pattern(s) Discoloration	If circular wear and/or wavy patterns found, discard the tappet body and replace with a new tappet body. Discoloration, without wavy or circular wear patterns on the tappet face, is not sufficient reason to replace the tappet.

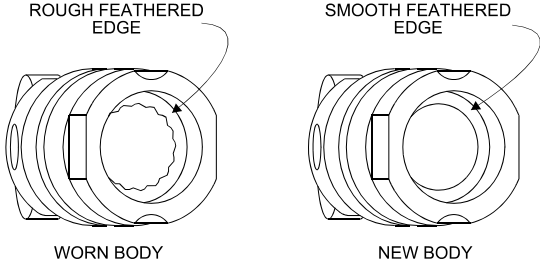
Task	Findings	Corrective Action
5. Look for damage to the lifter face.		If damage is found, discard the tappet body and replace with a new tappet body of the same part number*.
6. Examine the interior bore of the tappet body. a. Look for wear at the interior shoulder. b. Look for a feathered or chipped edge around the shoulder (Figure 11).	Wear found at the interior shoulder and/or Feathered or chipped edge around the shoulder	If wear, feathering or chipped edge found, replace with the tappet body of the same part number*.

<p style="text-align: center;">Figure 11 Comparison Between Worn and New Tappet Body</p>		
7. Record the completion of this inspection in the engine logbook.		
* If an acceptable superseding tappet part number is installed, replace all tappets with tappets of the same replaced part number. Refer to Table 4.

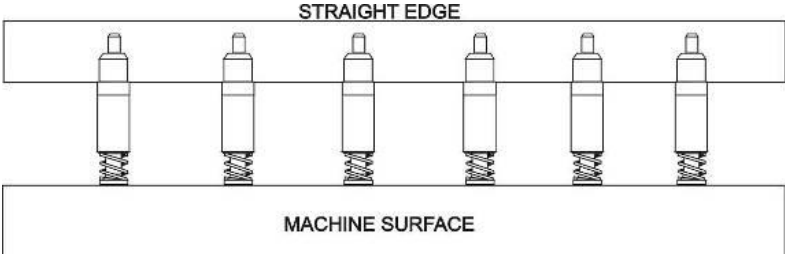
<p>Figure 13 Straight Edge Across Shoulder Surface of Plungers</p>

<p>Figure 12 Chipped Shoulder</p>		
<p>2. Examine the plungers for collapse as follows:</p> <ol style="list-style-type: none"> a. Align all of the removed hydraulic plungers side by side on a clean flat surface. b. Put a straight edge across the shoulder surface of the plungers (Figure 13). c. Measure the distance from the straight edge of any plunger that is not touching the straight edge. d. If there is any plunger that is more than 1/32 in. (0.79 mm) below the straight edge, the plunger is collapsed. 		<p>Discard and replace any collapsed plunger with a new plunger.</p>
