# DETROIT ROOFING INSPECTION SERVICE

Re: Roof Survey  
Project # 10539S-17  
Location: The Fairways – 17 Buildings and Club House  
1085 Fairways Dr.  
Troy, MI 48085

The following report is a summary of our findings, including photographs of deficient areas, a roof plan and recommendations regarding repair/replacement.

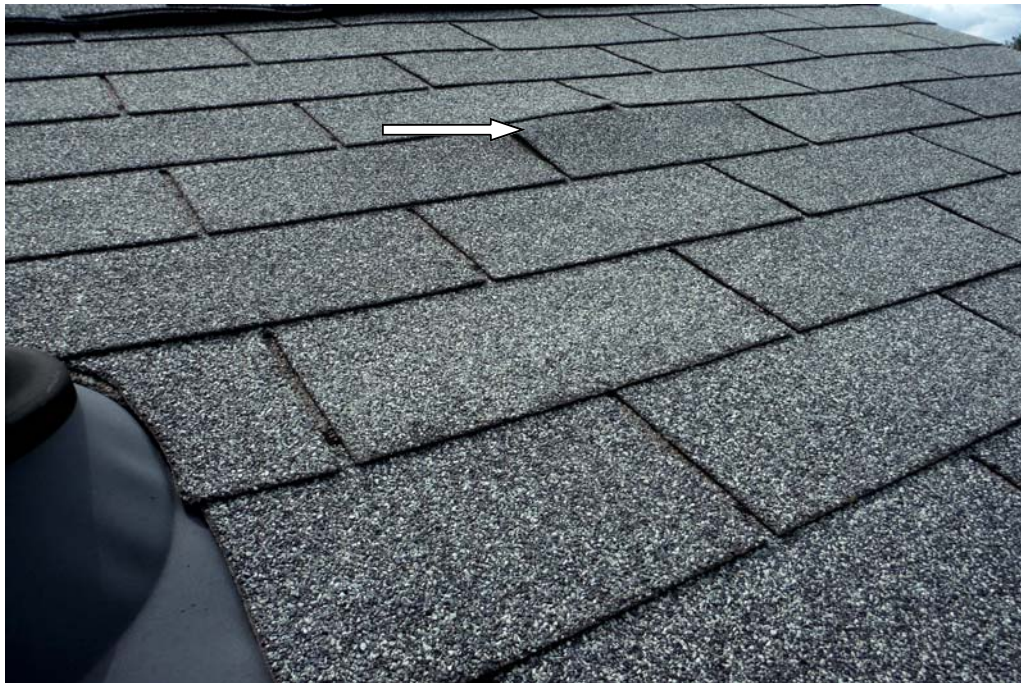
1091-1103 Minor buckled plywood causing the shingles to be raised

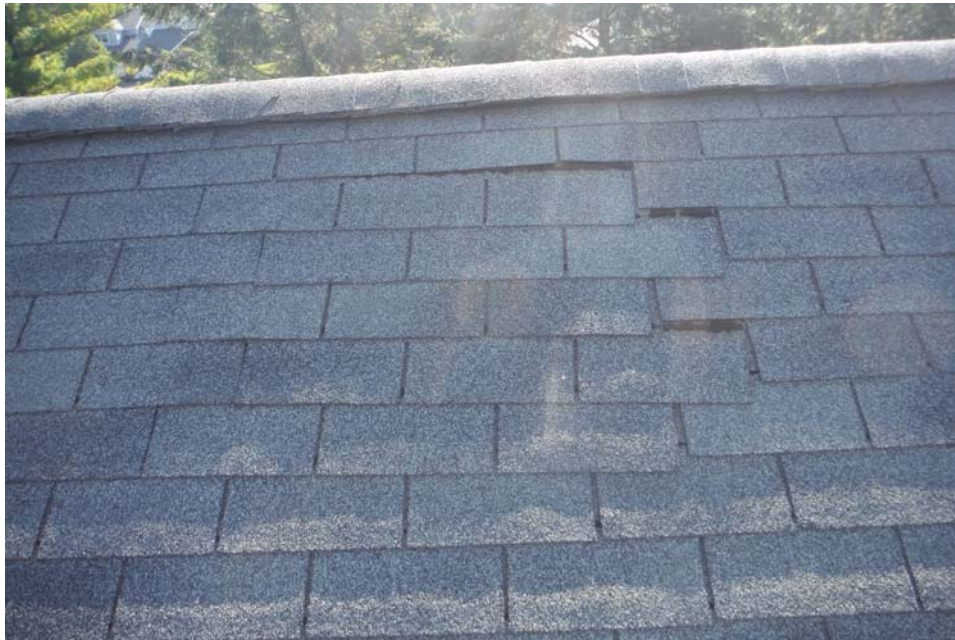
We did note, over several buildings fasteners were missing or installed too high or out of position on the single. Primarily this was highly noted on building address 1102-1108, 1110-1116, 1118-1128, 1165-1177, 5880-5886, 5904-5914 and 5932-5942. Ultimately, this can allow shingles to shift or slide out of position. Shingles are currently sliding or out of position over various slopes on addresses 1105-1117, 1110-1116, 1129-1141, 1165-1177 and 5932-5942.

1102-1108 Shifting and sliding shingles

1. Secure or replace sliding/shifting or missing shingles
2. Remove/replace damaged shingles along vertical walls which are exposing flashings.
3. Address all loose and missing siding.
4. Apply sealant over all exposed flashing fasteners or nail pops.

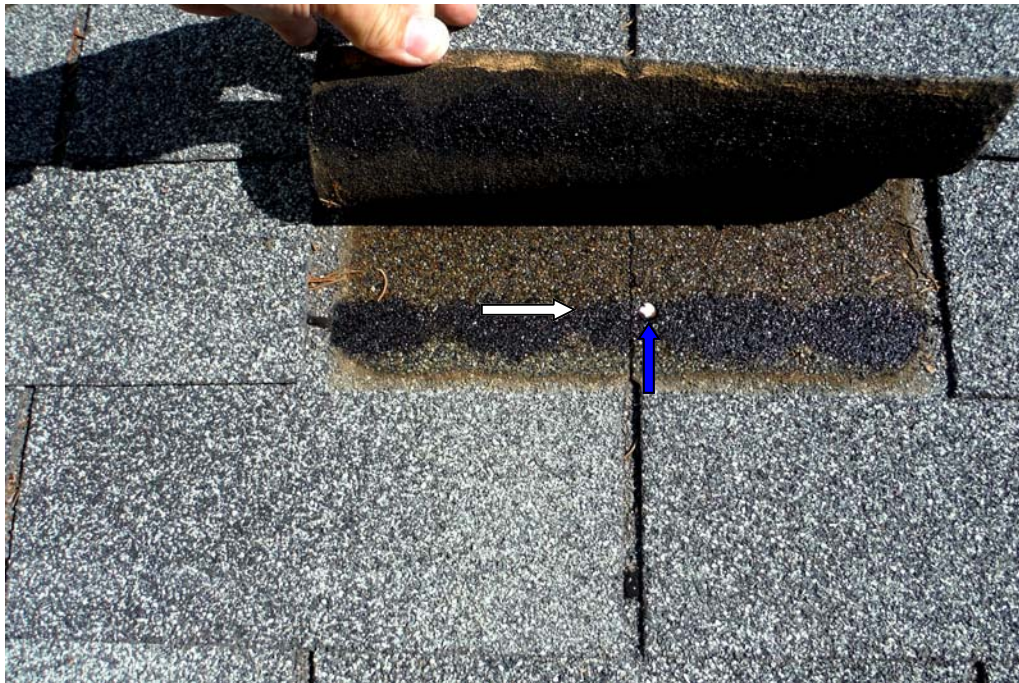
1102-1108 Missing fastener (white arrow) improper placement of fastener (blue arrow)

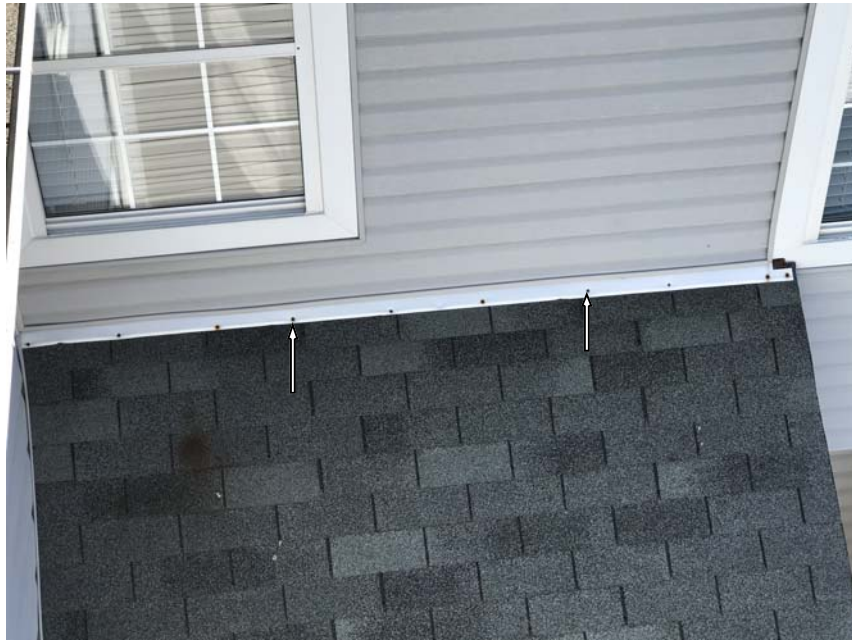
Overall, step flashings are installed between shingle courses over areas checked. However, it is noted that step flashings are missing along various roof slopes or installed higher than the recommended location. In addition, step flashing have been under formed causing shingles to be slightly raised. While this was not common over all building, this can allow moisture to enter into the roof system. While counter flashings are in place along the top shingle course and vertical wall transition, it appears that the flashing was re-used from the original roof system. Multiple exposed flashing fasteners were noted on building 1105-1117.

1105-1117 exposed counter flashing fasteners

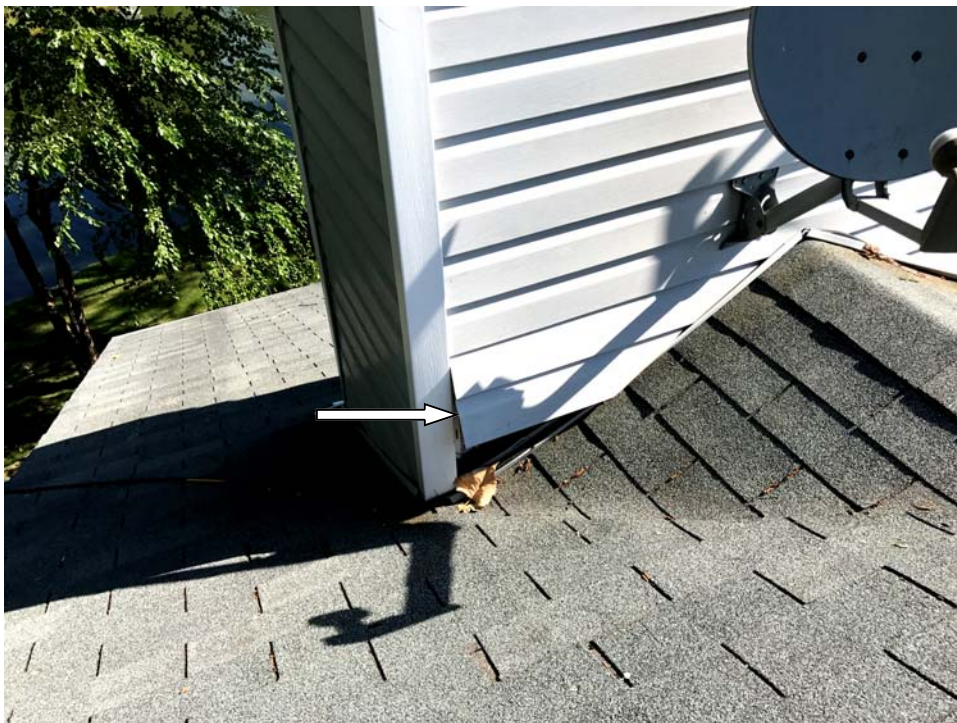
1105-1117 Loose and missing siding along the bottom of the chimney

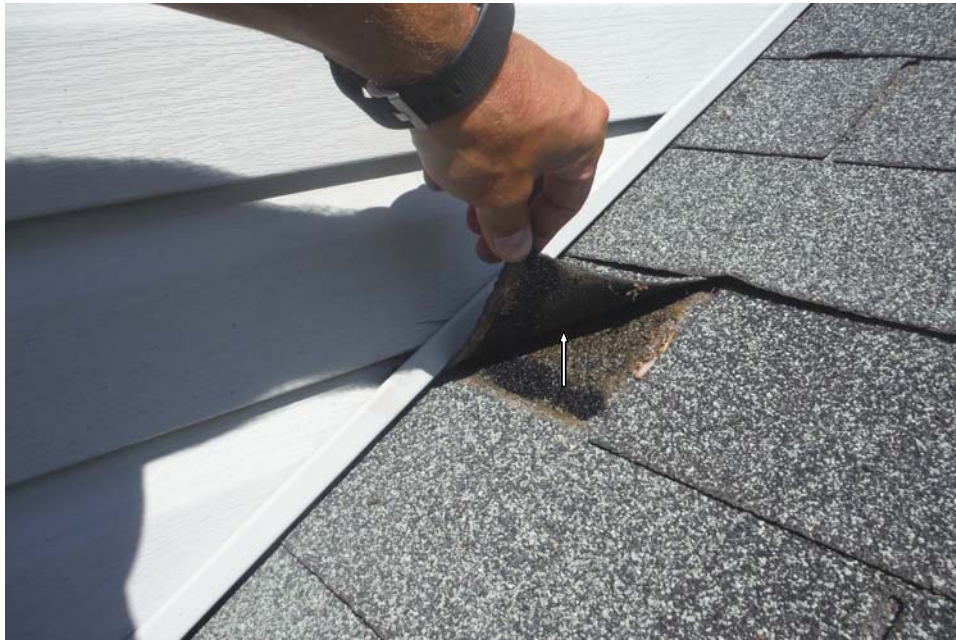
1110-1116 missing step flashing between shingle courses and vertical wall transition

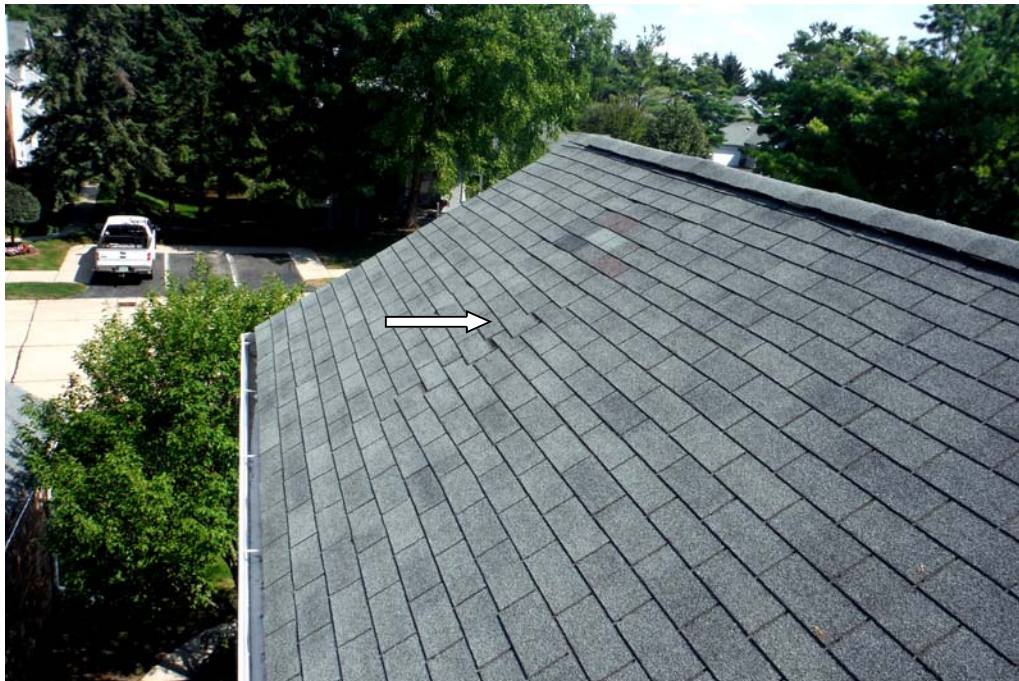
1110-1117 multiple sliding/shifting shingles

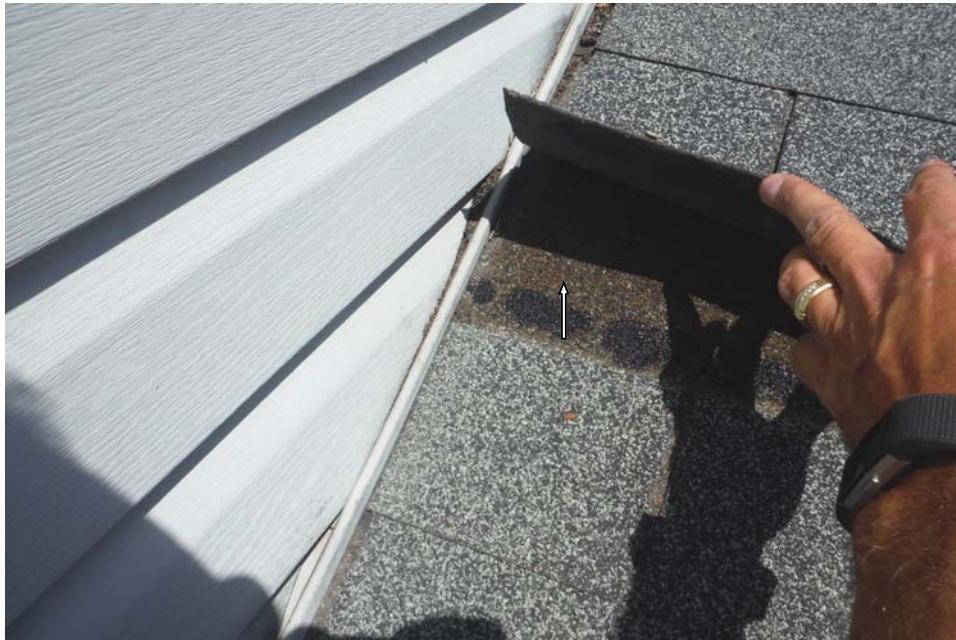
1118-1128 Missing step flashing between shingle courses and vertical wall transition

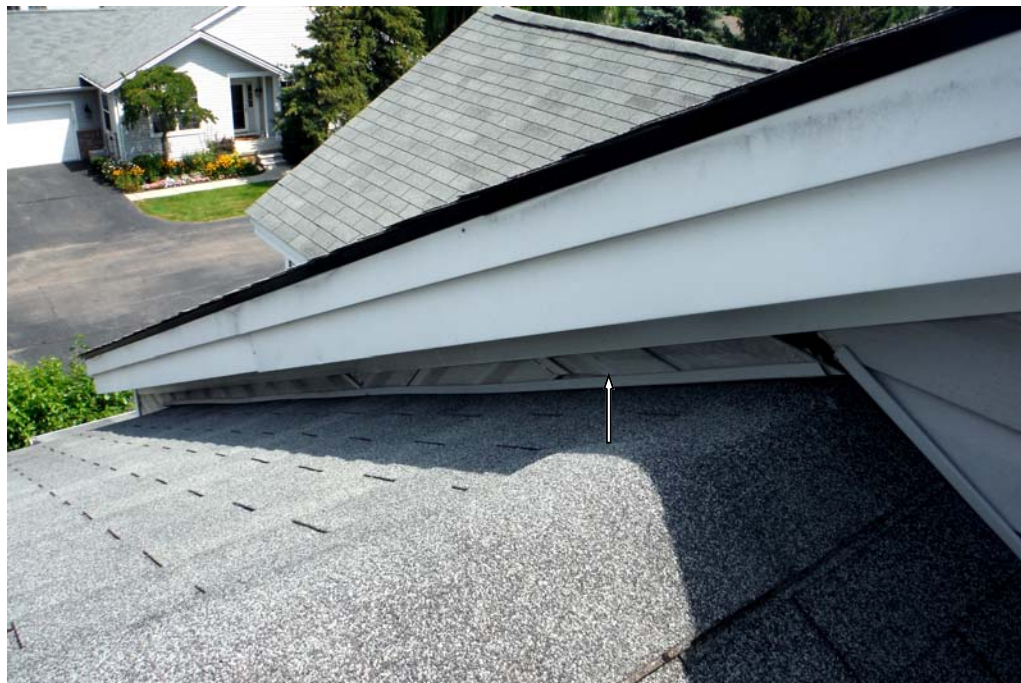
1118-1128 improperly installed siding

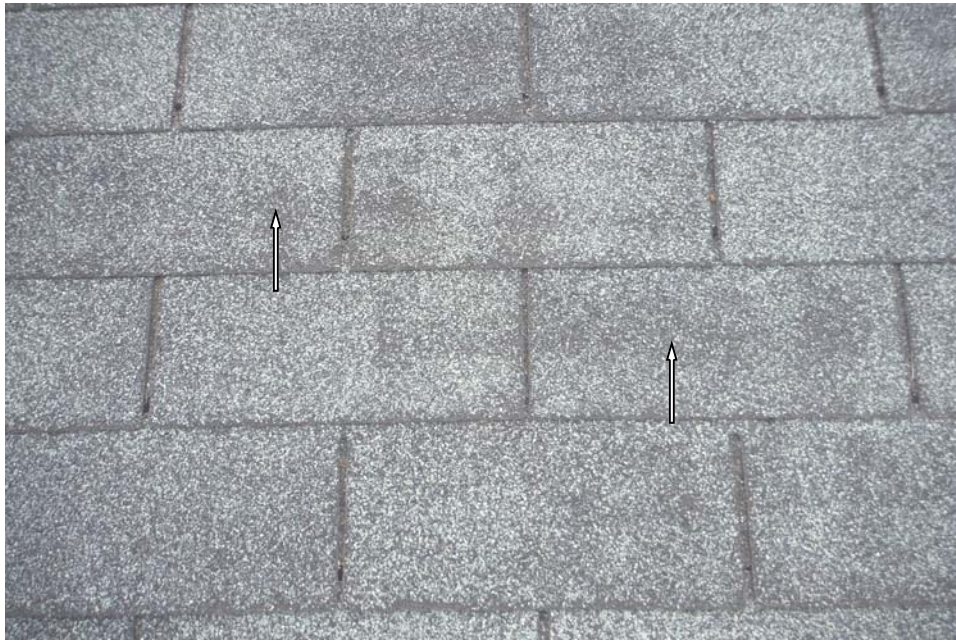
1129-1141 mineral surface loose over the field shingles exposing the asphalt mat

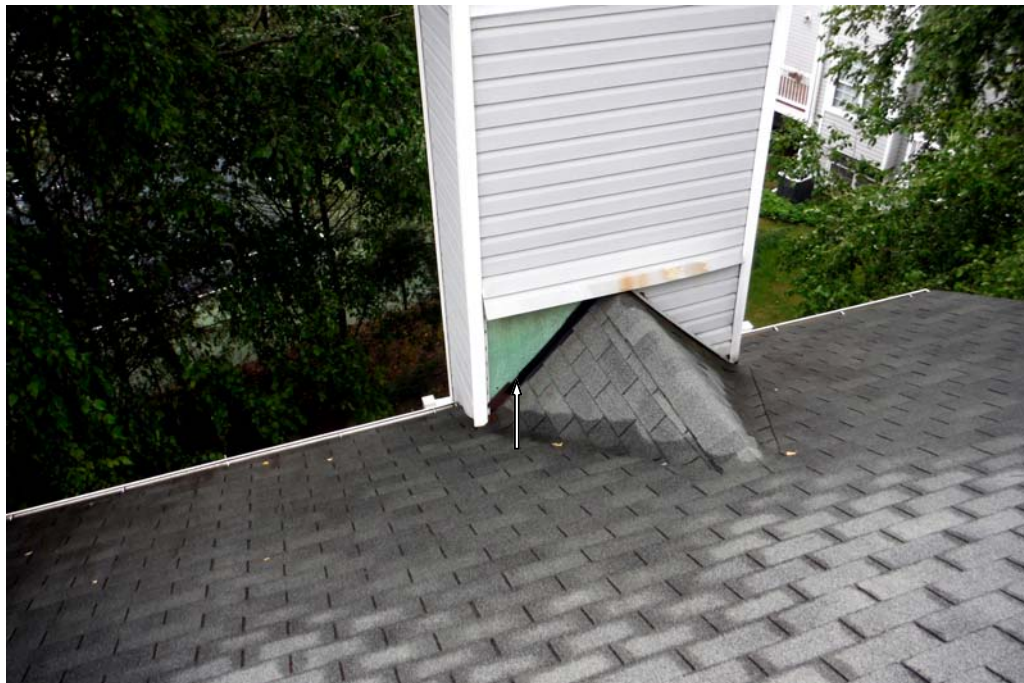
1129-1141 exposed framing and step flashing due to missing siding over the high side of the chimney

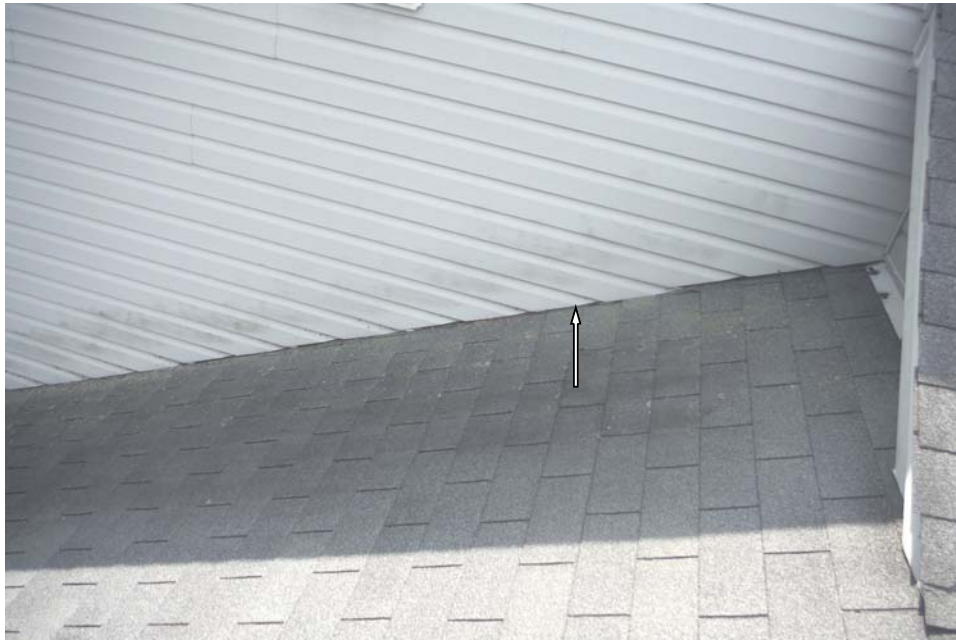
1130-1140 Missing "J Channel"

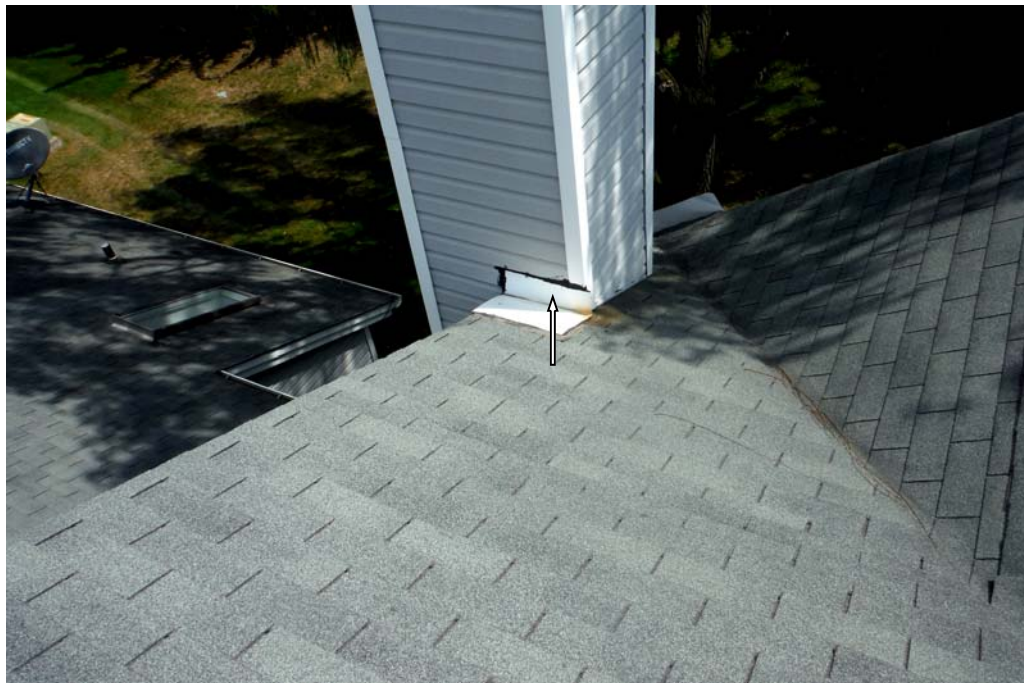
1130-1140 Improper flashing along chimney and roof transition

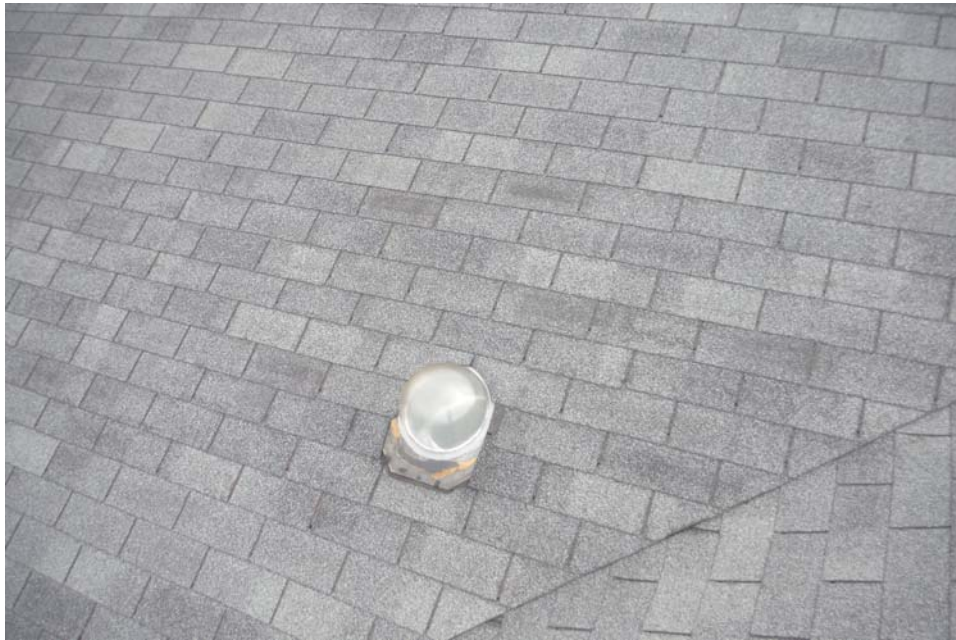
1142-1152 Mineral surface loose over field shingles and within the valley

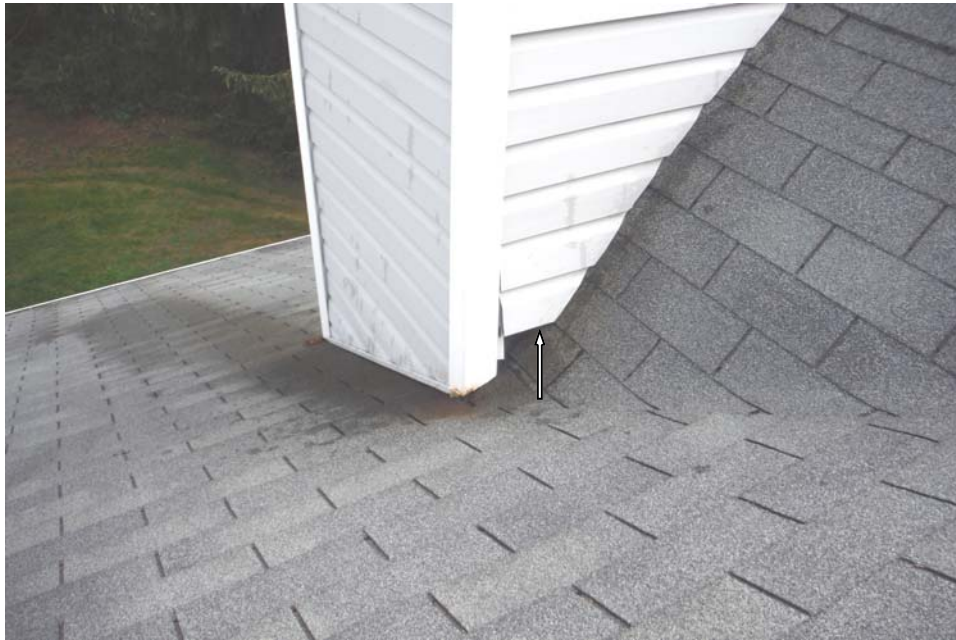
1154-1164 Missing siding and “J Channel” on the high side of the chimney

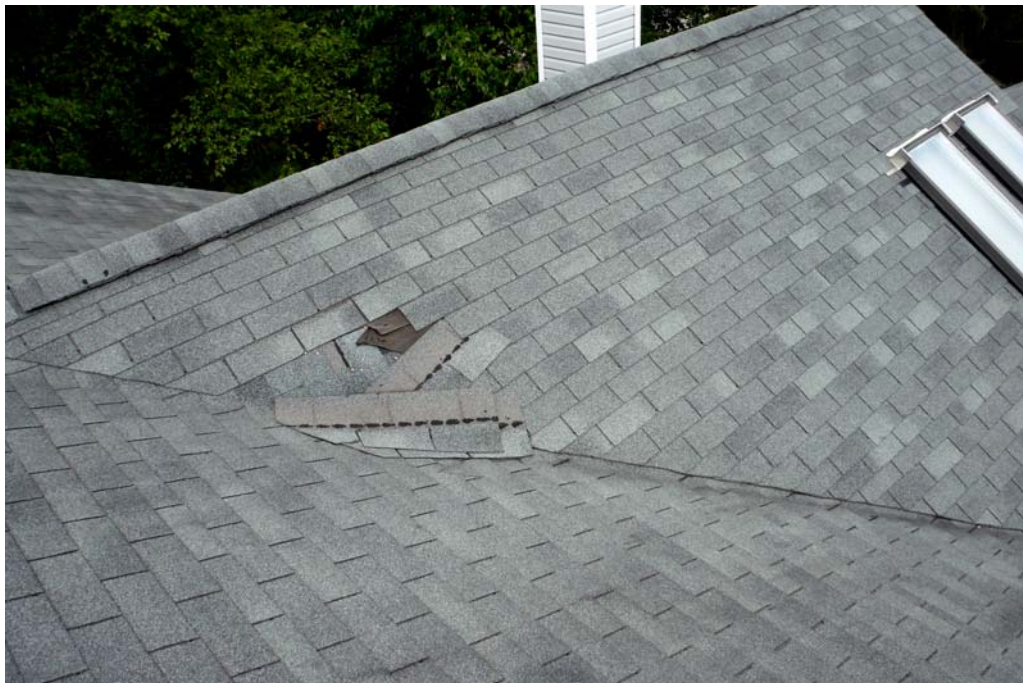
1165-1177 possible win lifted shingles exposing the underlayment

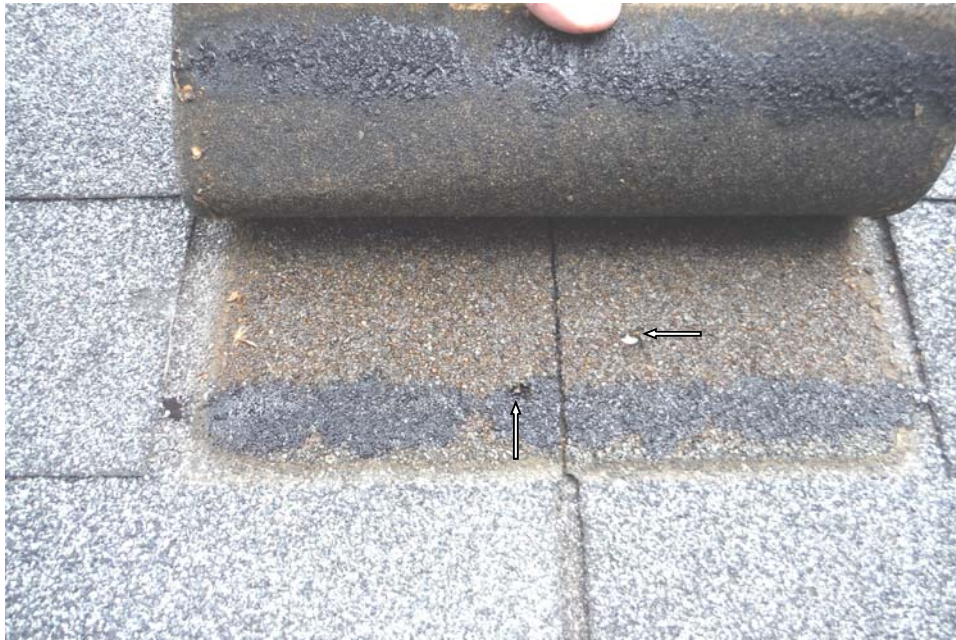
1165-1177 overdriven and improper positioned fasteners at each butt end of the shingle

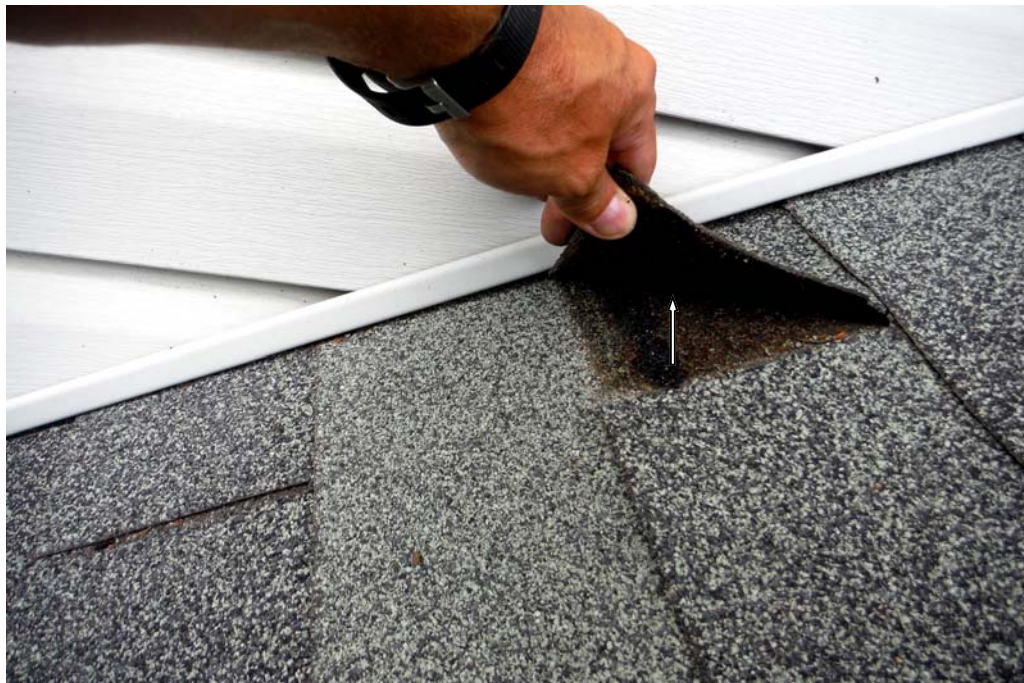
1166-1176 missing step flashing between shingle courses

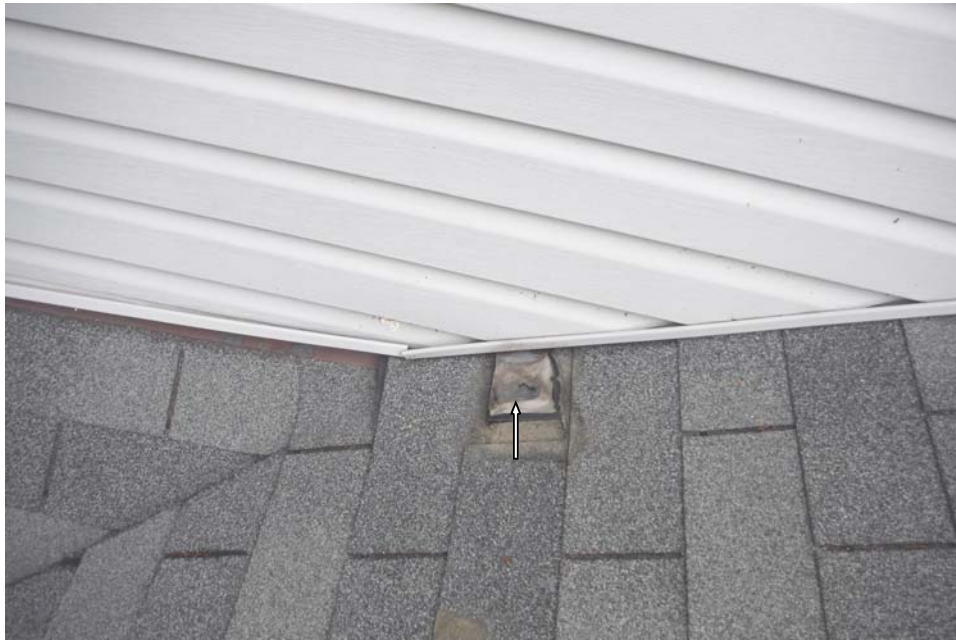
1166-1176 Damaged shingle tab exposing the step flashing

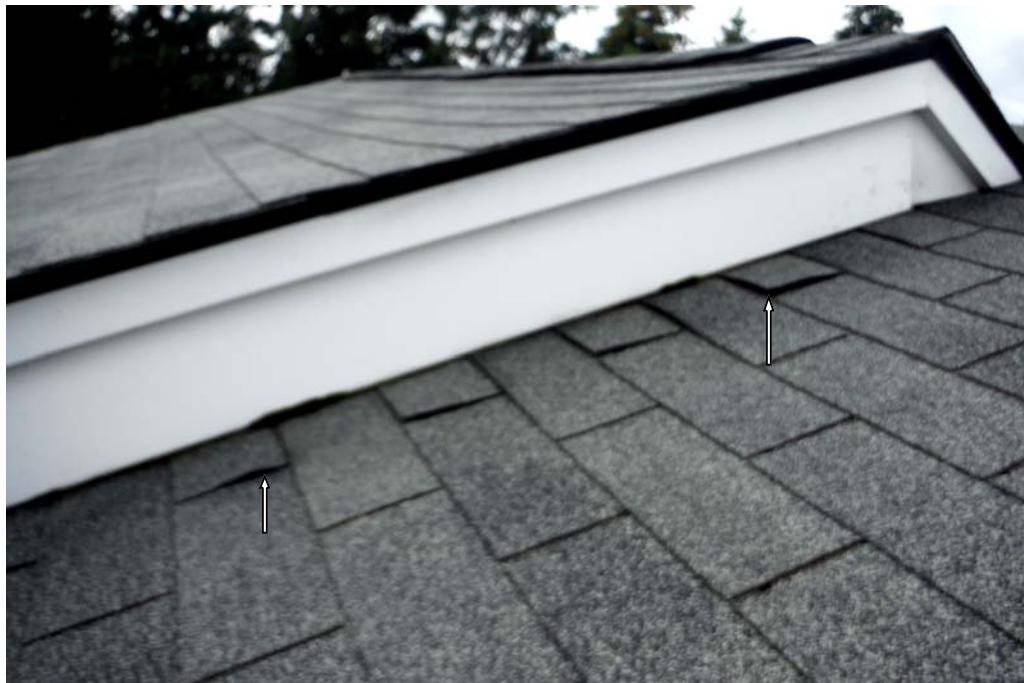
5880-5886 under formed step flashing between shingle courses partially raising the shingles

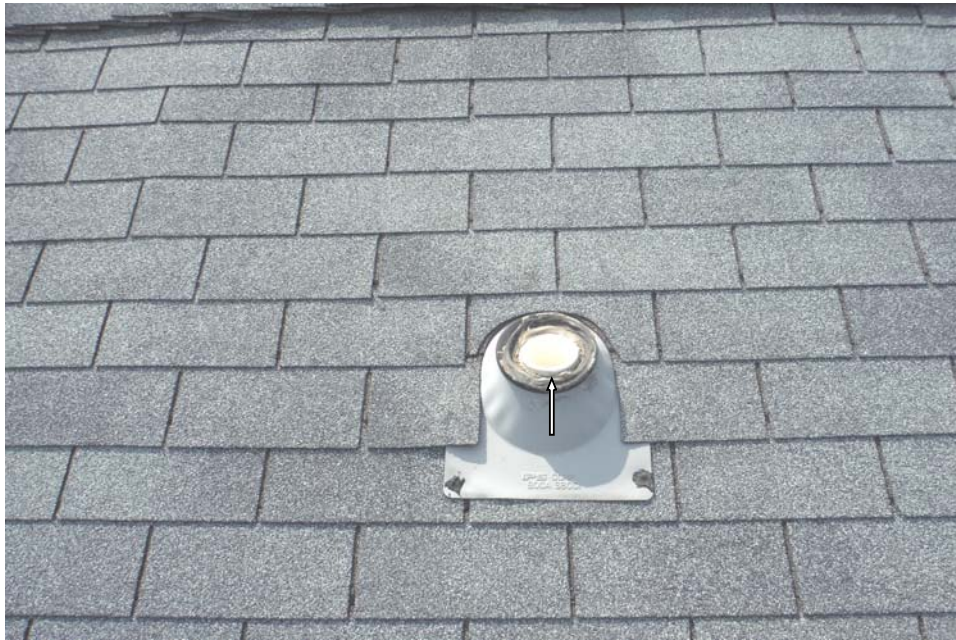
Plumbing stack flashings and heat stack flashings are in place and overall are in good condition. Shingles are installed over the top half of each flashings allowing moisture to shed properly. However, over building 5904-5914, the PVC plumbing stack has been cut or is not supported within the building's interior. As a result the top edge of the stack is flush with the neoprene flashing and will hold water. We would recommend a plumbing contractor address this location. The flashing should be re-evaluated once the plumbing contractor has completed repairs.

5904-5914 PVC plumbing stack not extended through flashing

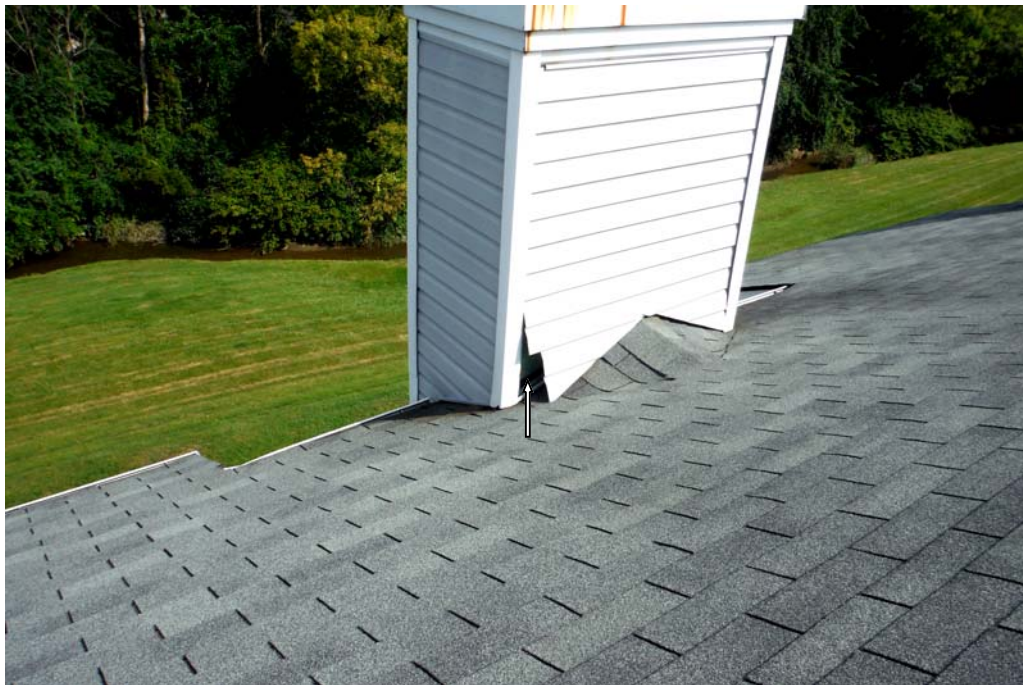
5904-5914 Loose siding

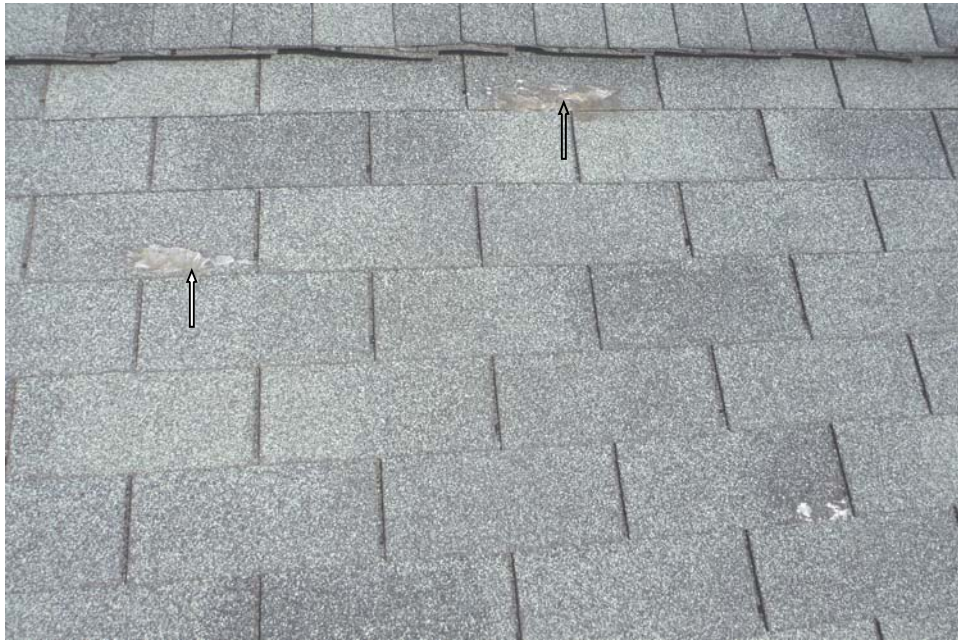
5909-5919 exposed fiberglass reinforcement

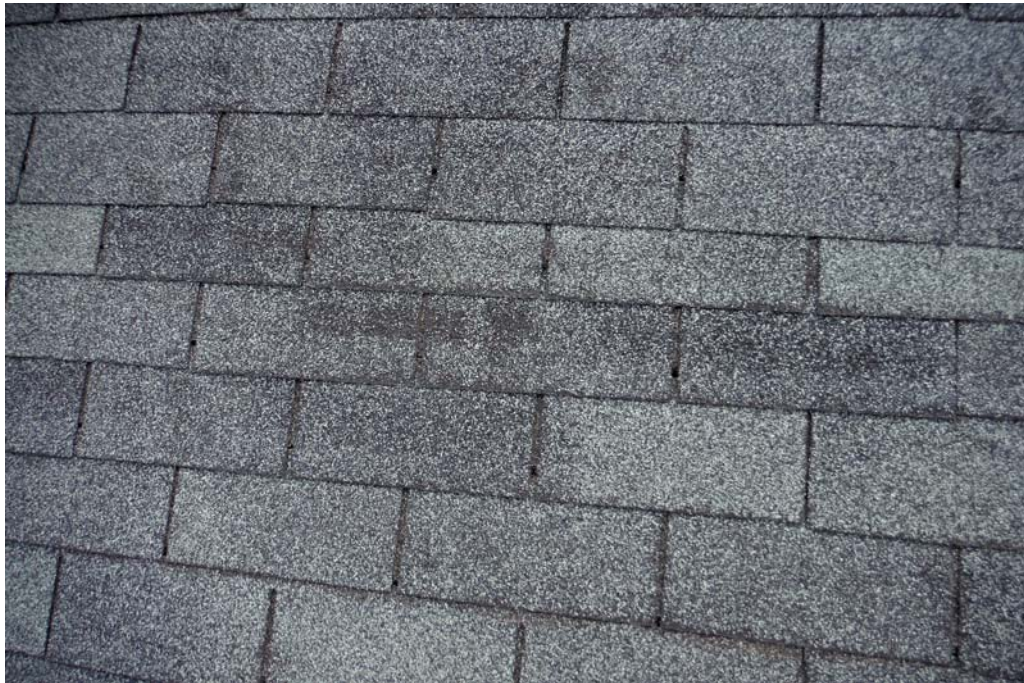
5909-5919 scuffed mineral surface over field shingles

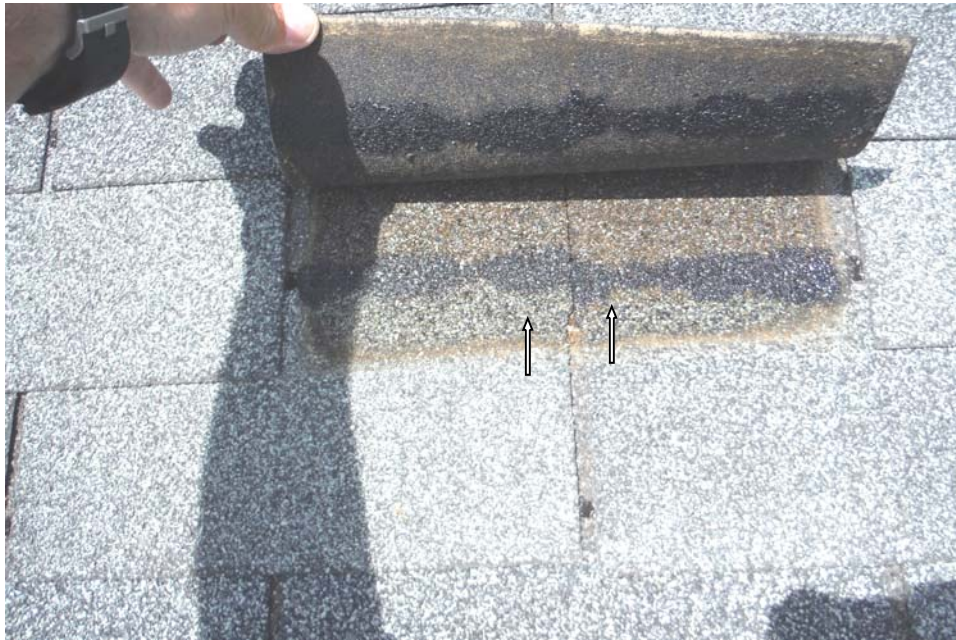
5932-5942 missing fasteners along each butt end of the shingles

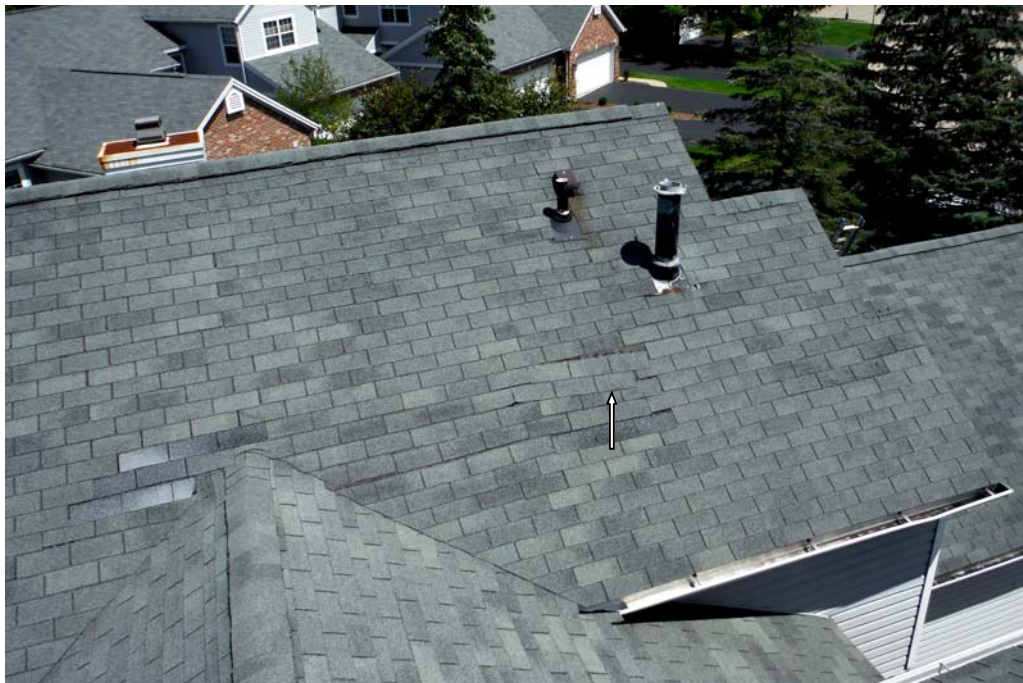
5932-5942 Shifting and sliding shingles

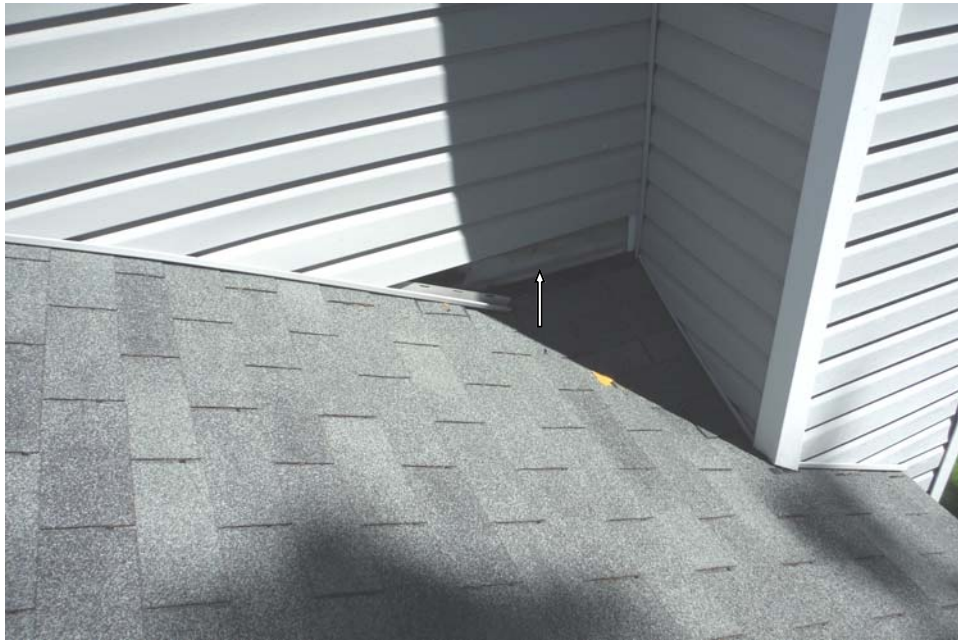
5937-5947 missing siding

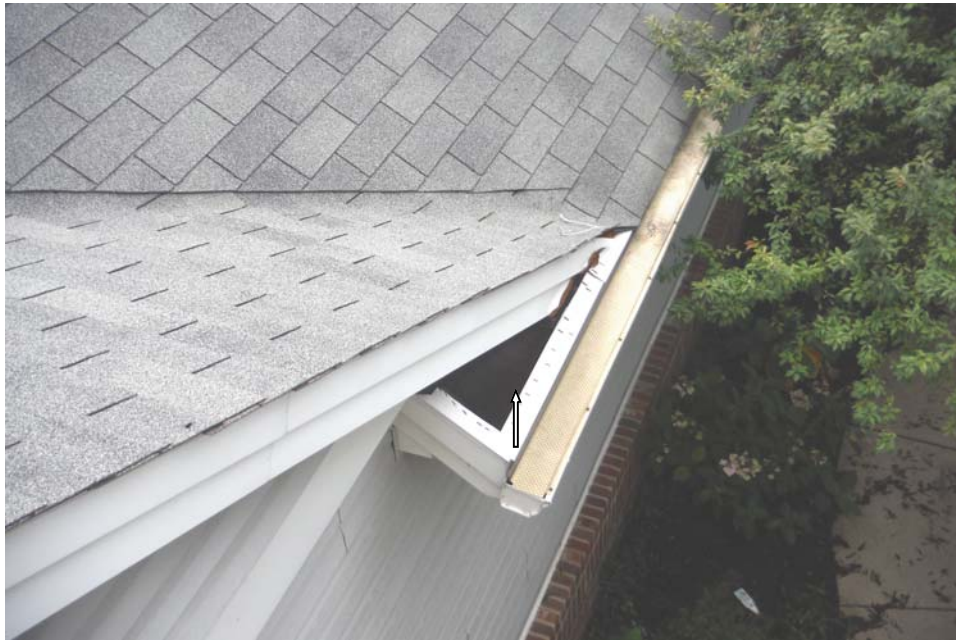
Over various roof areas, partially torn or damaged shingles were noted. This was not a common finding and likely caused from foot traffic damage during installation or maintenance on the roof or building's exterior. Missing shingles were noted along the eave edge of 5960-5970 exposing the underlayment and drip edge.

5960-5970 missing shingles exposing underlayment and drip edge

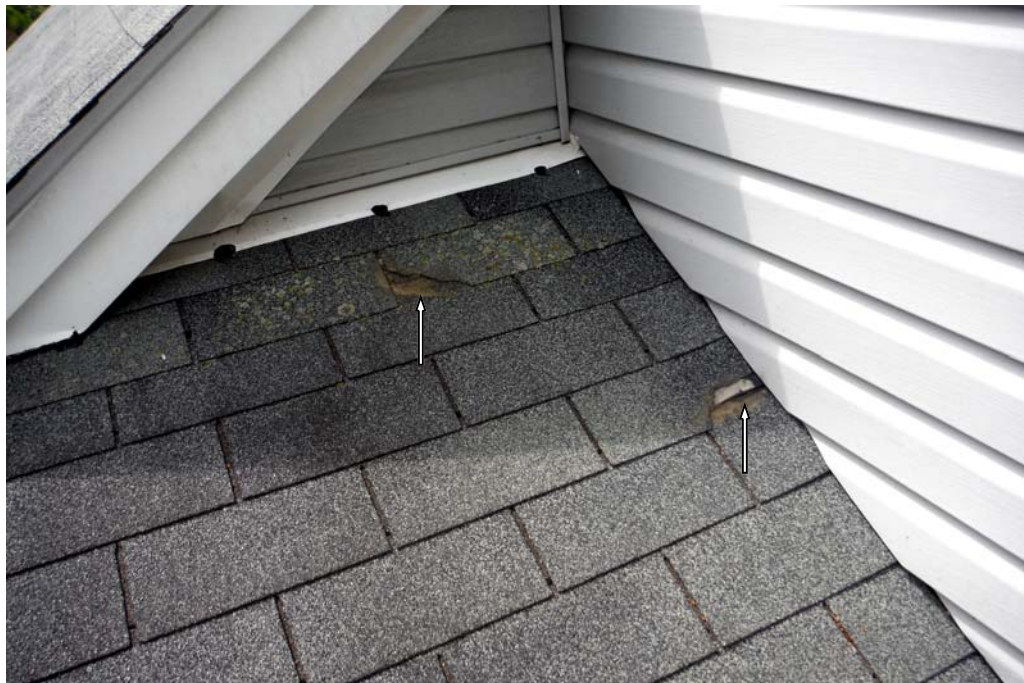
5960-5970 Damaged shingles
