Report: 2658 sheridan road

Confidential Inspection Report 2658 Sheridan Road Evanston, IL 602201

March 31, 2016

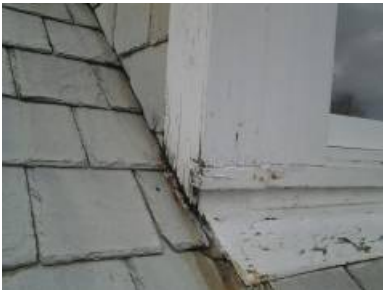
Paint on exterior trim needs repairs.

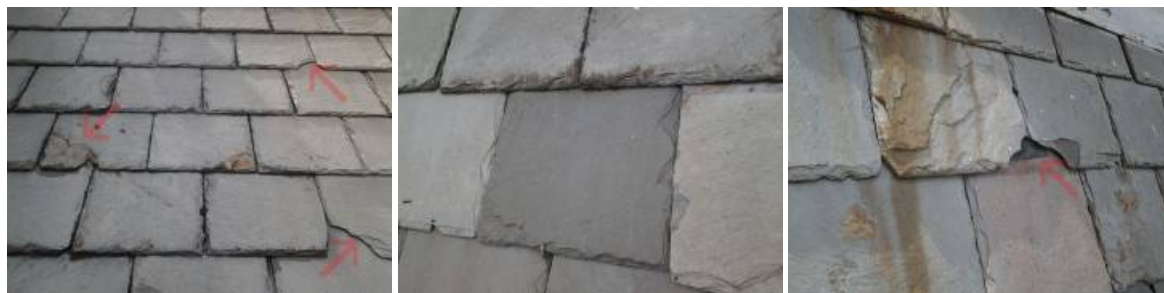
Condition of Roof Covering Material:

Attention- The roof covering material shows signs of deterioration or damage that needs attention to prevent further deterioration or leakage. This roof has signs of aging and a reduced remaining service life. Attention is needed now to prolong its service life.

Repairs noted throughout the roof.

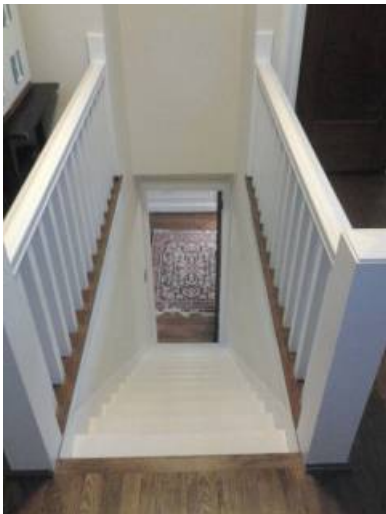
There is a full staircase installed. However, no hand rail installed.

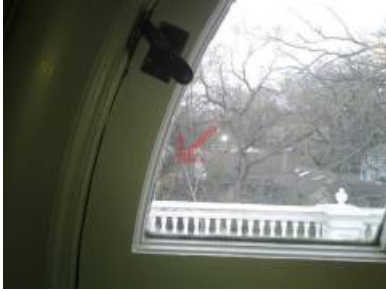
Glass broken in window to the left on the south wall.

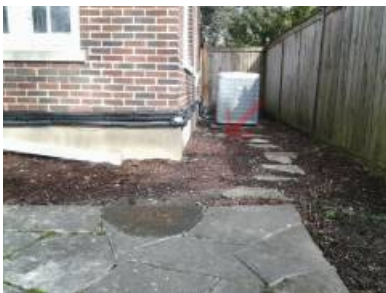
Attention Needed - The area around the AC units needs some minor adjustment in areas to prevent water from standing in the yard.

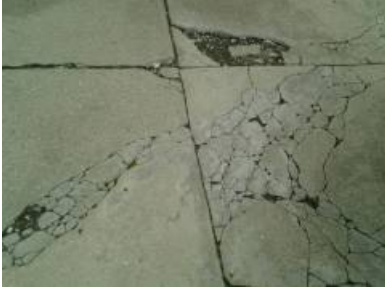
Driveway Condition:

Action Necessary - The driveway needs action. Repair or replacement is indicated.

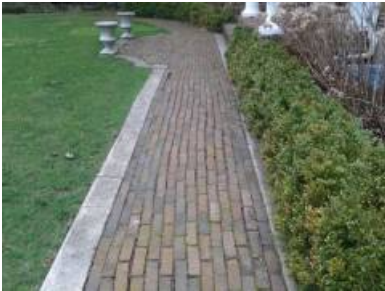
Walkway Condition:

Attention Needed - The walkways need attention and minor repair to prevent further deterioration.

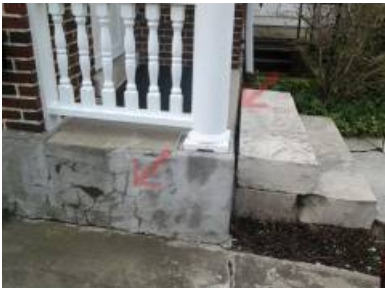
Backdoor Stoop:

Damaged noted.

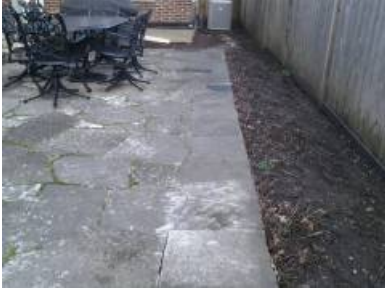
Slab Condition:

Attention Needed - Some flagstones are loose and needs adjustment.

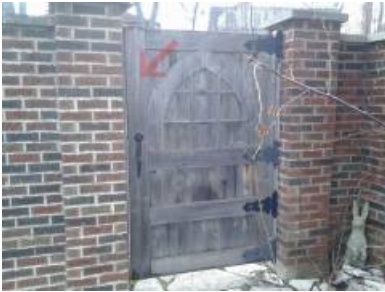
Action Necessary - The gate is deteriorated to the degree that repair or replacement is indicated. One of the board is loose on the gate.

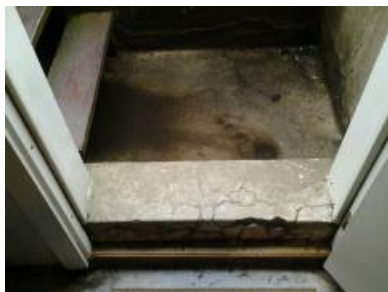
Perimeter Foundation Drainage Surface:

The drain in the back basement stairwell is capped off. A functional drain would prevent water entering basement.

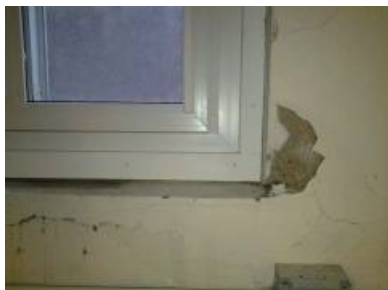
Attention Needed - The interior exposed foundation walls appear to need attention to prevent further deterioration.

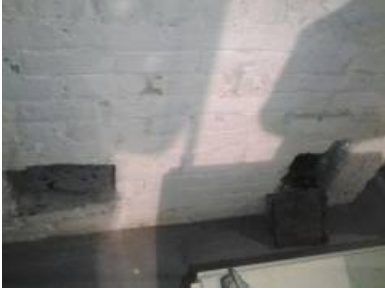
Fire Place Cleanout:

Clean out doors are damaged and are no longer attached to the fireplace brick wall in basement.

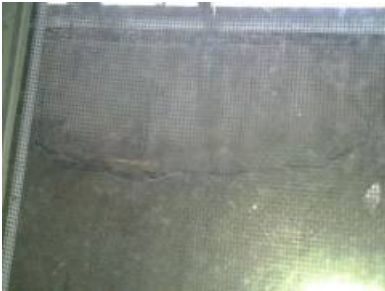
The windows as installed appear to need some adjustment or repair. The windows as installed are not egress accessible. As a result of the lack of egress, the areas should not be considered as living space nor used as a sleeping area for safety reasons.

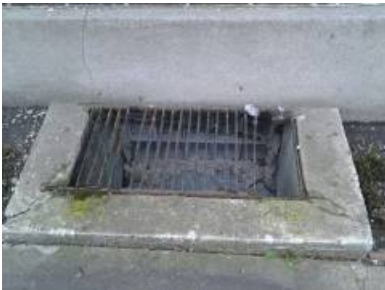
Basement Windows Wells:

Most of the concrete window wells are damaged. Replacing the existing concrete with metal is recommended.

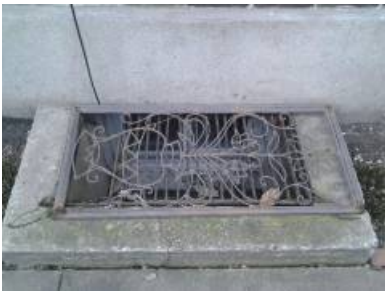
Basement Windows:

The windows as installed appear to need some adjustment or repair.

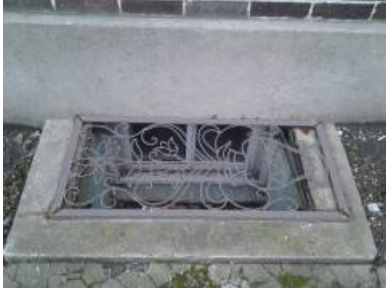
Basement Windows Well Covers:

The windows well covers are broken and need to be replaced.

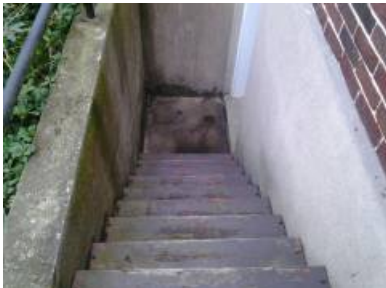
Walkup Basement - Number of Exposed Walls:
Hand rail missing on basement exterior staircase.

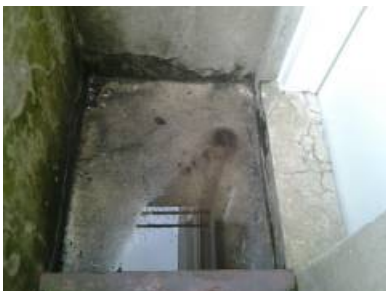
Drainage in Area of Walkout:
Action Necessary - There is evidence of water entry at the doorway. The drain may need to be repaired.

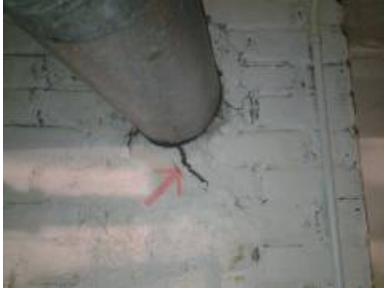
The flue pipe is metal and enters a masonry flue. **Action Necessary** - Some visible portion of the flue/vent system appears to need repairs. There is a crack in the wall where the flue pipe enters. Action is necessary to correct this condition.

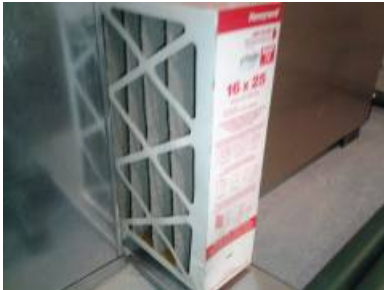
Action Necessary - Replacement is recommended; the filter is not functioning as intended. The filter is in a condition that may cause damage to the heat exchanger due to restricted airflow across the heat exchanger.

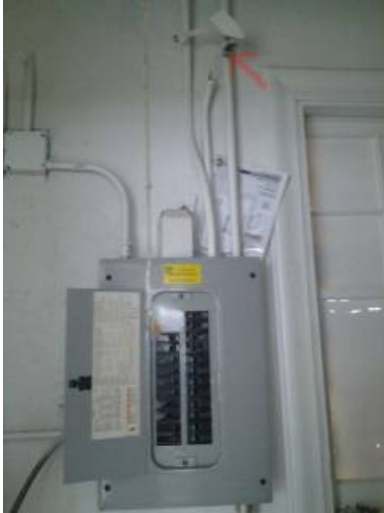
Grounding clamp not connected and it should be.

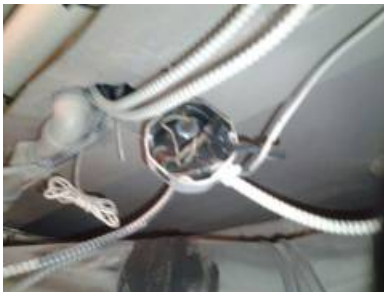
Attention Needed - At least one light outlet noted needs a new outlet cover:

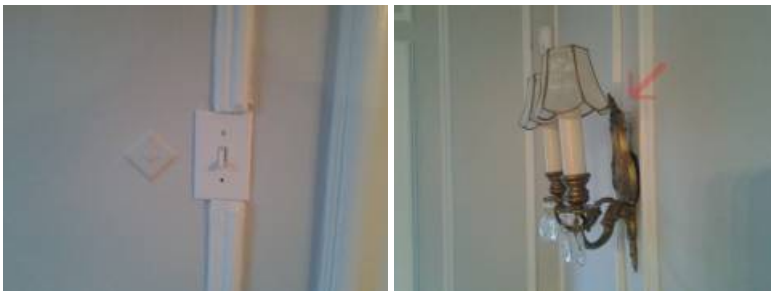
Score is coming detached from the wall.

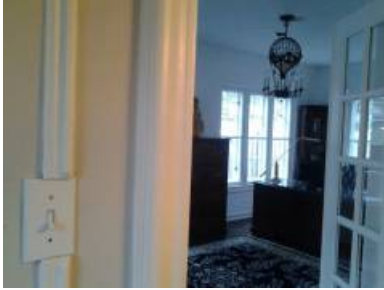
Action Necessary - The light installed in this room did not function using the wall switch. I did not determine if the switch or the light.

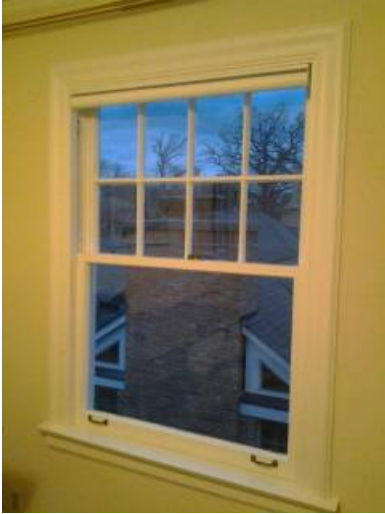
Action Necessary - The window in this room needs repair. There is at least one broken window pane. The window in this room is painted shut or otherwise sealed. There is no window in this bedroom.

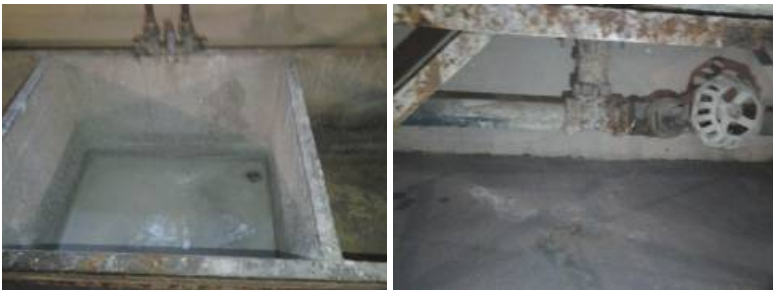
Action Necessary - There is evidence that the basement utility sink leak in the drain piping and drains slowly.

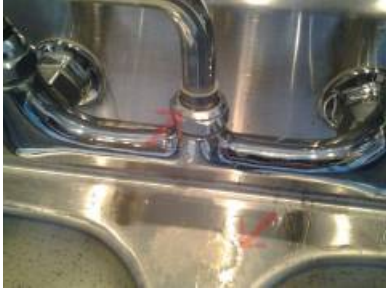
Attention Needed - The kitchen faucet leaks. Attention is needed.

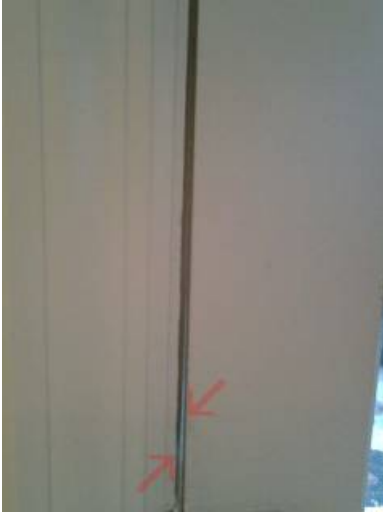
Attention Needed - The outside entry door to the kitchen needs some minor adjustment or repair. The weather strip around the door needs some repair.

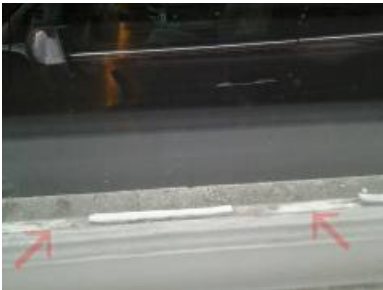
At least one window or associated hardware in the kitchen needs repair. Some portion of the glazing needs repair or replacement.

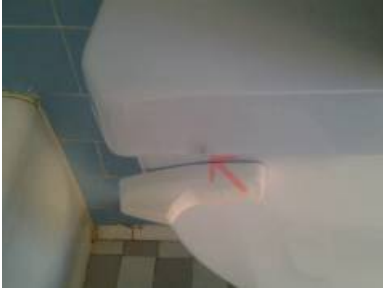
Action Necessary - The toilet in the master bathroom needs repair. Cracked China - There is at least one crack in the china toilet tank, lid, or bowl. These china parts are not repairable. If unsightly or leaking, replacement will be necessary. The new individual parts may not be interchangeable.

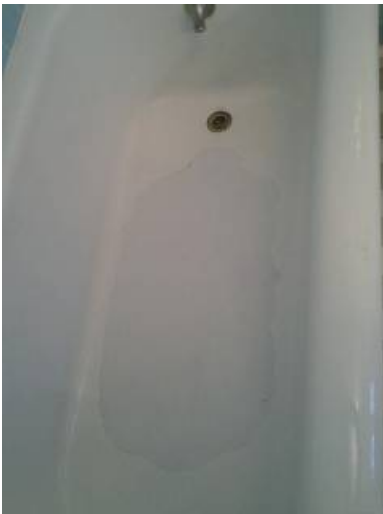
Tub:

Steel Tub OK - The bathtub is a steel material with a solid finish applied. It appears to be in satisfactory condition. **Action Necessary** - The finish on the bathtub is damaged. It is not a leak now. However, when the finish on a steel tub is damaged, it will eventually rust causing a leak. Repair of the damaged area can delay further deterioration.

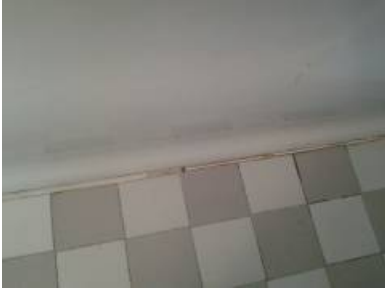
Attention Needed - The caulking in the water contact areas appears to need attention. Damage may result if not corrected. The seam where the tub or the shower meets the flooring needs to be caulked to prevent damage.

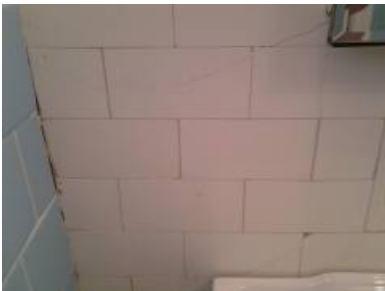
Attention Needed - The walls in this bathroom show some minor cracks. They do not appear to be a serious structural concern at this time. Wall tile cracked.

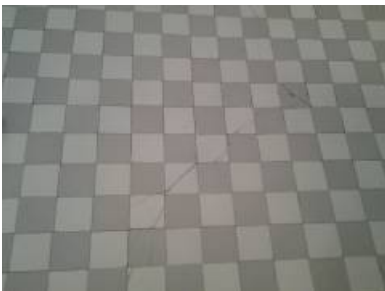
Action Necessary - The flooring in this bathroom is in need of repair.

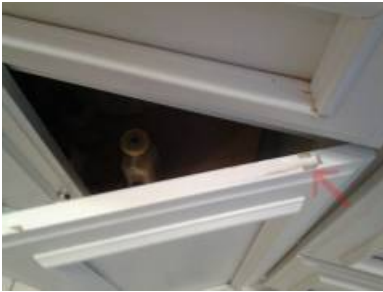
Attention Needed - The vanity cabinet and/or top in this bathroom needs attention. Paint chipping noted on doors.

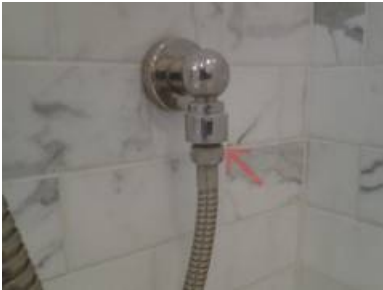
Handheld spray hose leak at wall water supply connection.

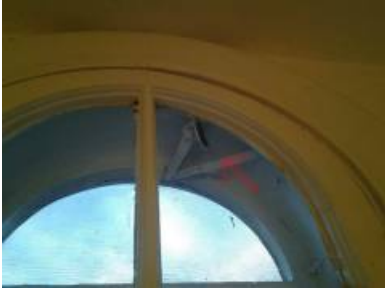
Attention Needed - At least one window or associated hardware in this bathroom needs attention.

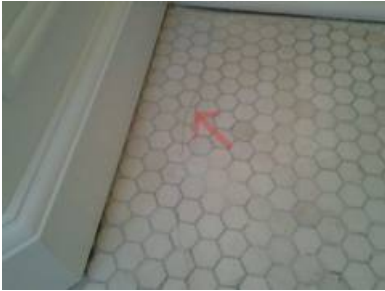
Attention Needed - The flooring in this bathroom is in need of attention(cracked tiles) to prevent further deterioration.

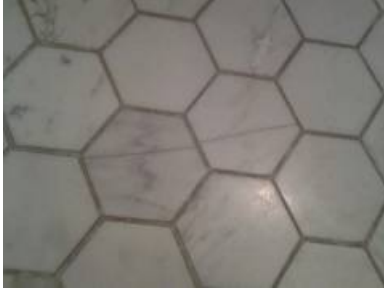
Attention Needed - The flooring in this bathroom is in need of attention(broken tile) to prevent further deterioration.

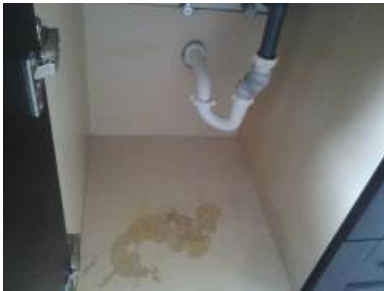
Attention Needed - The vanity cabinet in this bathroom needs attention. Water stains noted in vanity base.

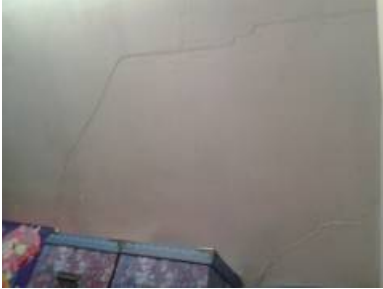
**Closet:**

Ceiling in the closet is damaged.

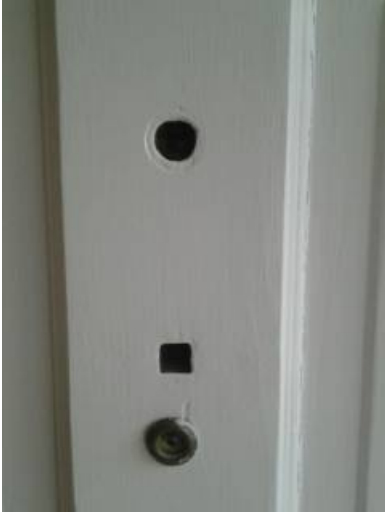
The front door knocker is missing.

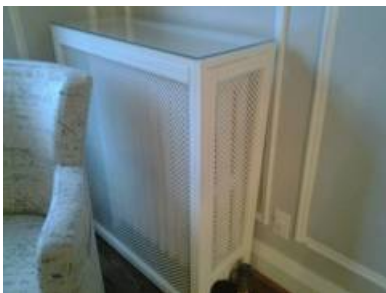
There is a heat source to this room. Not working.

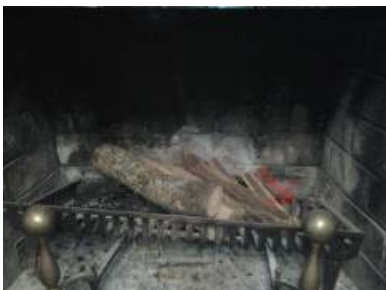
Fireplace:

Yes - There is a fireplace in this room. The log holder is damaged. Tuckpointing repairs are needed inside the fire place. Cleanout floor ash door is broken.

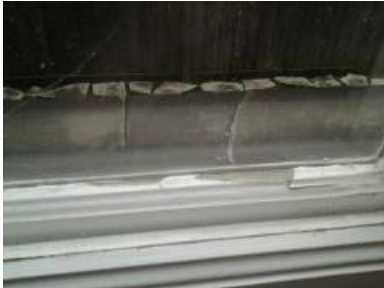
At least one window or associated hardware in the kitchen needs repair. Some portion of the glazing needs repair or replacement.

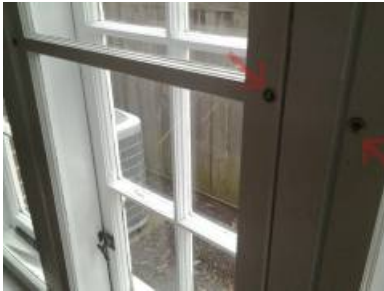
Attention Needed - All the windows in this room are screwed shut. Glazing repairs need.

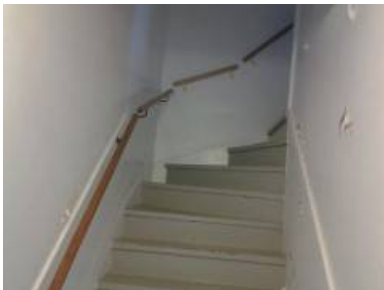
Peeling paint noted on staircase walls going to the second floor.

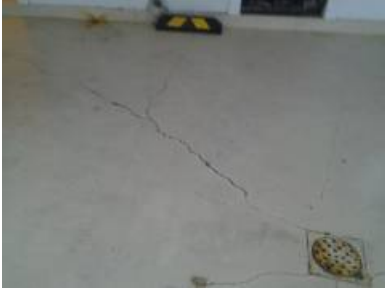
Floor Condition:

Attention Needed - The garage floor needs some minor repair to prevent further deterioration.

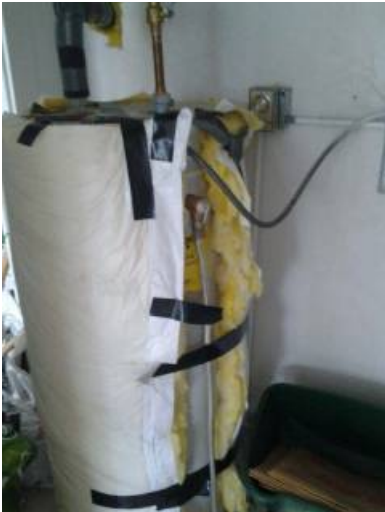
Electric water heater could be better insulated. All exposed water pipes should be insulated. Heater may be needed in garage to protect water piping.
